BRIDGE INSPECTION, INVENTORY AND APPRAISAL III, FY 2016

**FARRINGTON HIGHWAY BOX CULVERT 1 OVER DITCH
BRIDGE NO. 935**

**CITY AND COUNTY OF HONOLULU
DEPARTMENT OF DESIGN AND CONSTRUCTION
CONTRACT NO. SC-DDC-1600113**

NOVEMBER 2016

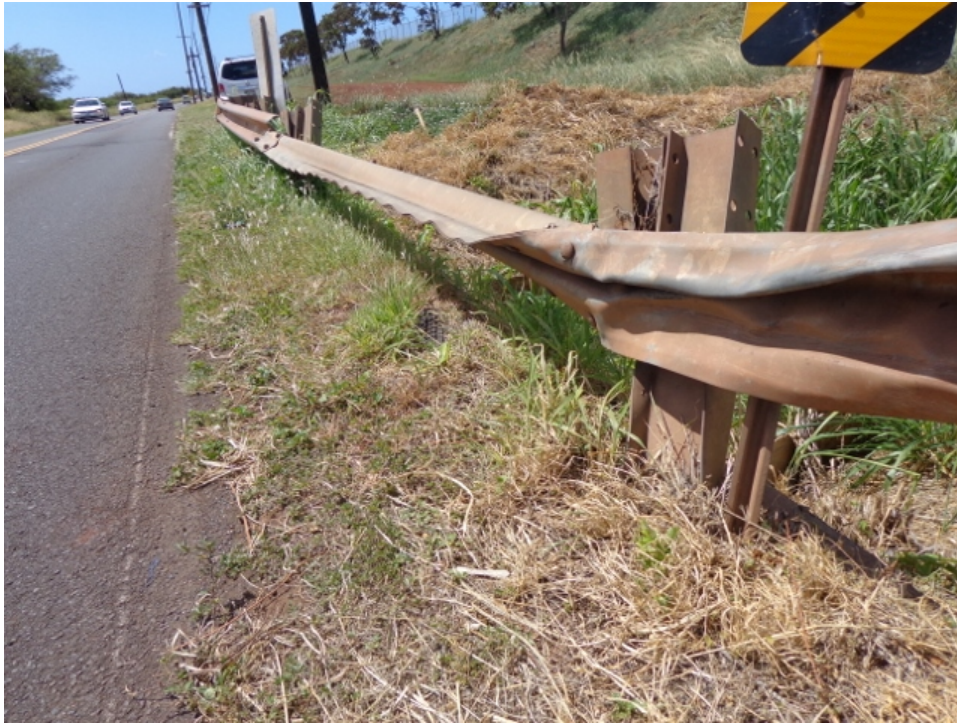
- Culvert railings do not appear to be crash tested
- The upstream guardrail is in a failed state and has been since before the 1996 inspection of the culvert (see Photo 9)

Photo 9: Upstream guardrail/railing

| 1. Railings | <input type="text" value="0"/> | The W-beam guardrails do not meet minimum height requirements for acceptable railings. There is heavy damage along the upstream railing. |

| 7. Railing | <input type="text" value="0"/> | W-beam guardrail along both sides of road. Upstream guardrail is in a FAILED state. All posts are bent and each panel is damaged. The guardrail will likely not retain a stray vehicle. It appears that the guardrail has been in this state since before the inspection on 5/2/96. |

REPAIR RECOMMENDATIONS	ESTIMATED COST
Upgrade bridge railings	\$10000.00
Repair spalls in culvert headwalls and soffit	\$30000.00

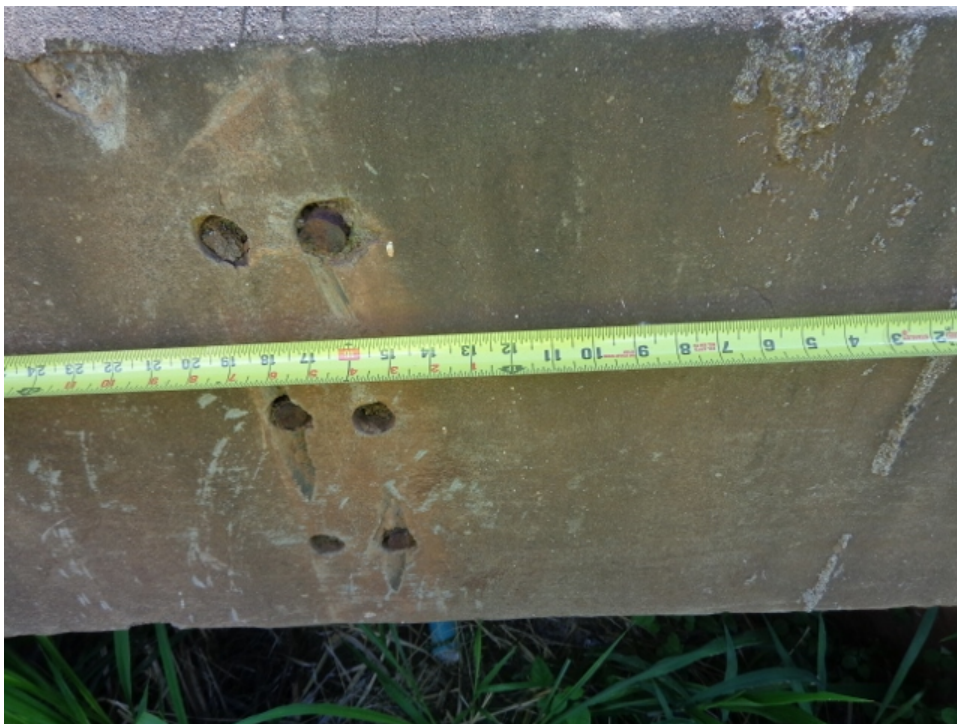
Photo 14: Corroded upstream guardrail posts embedments in upstream headwall

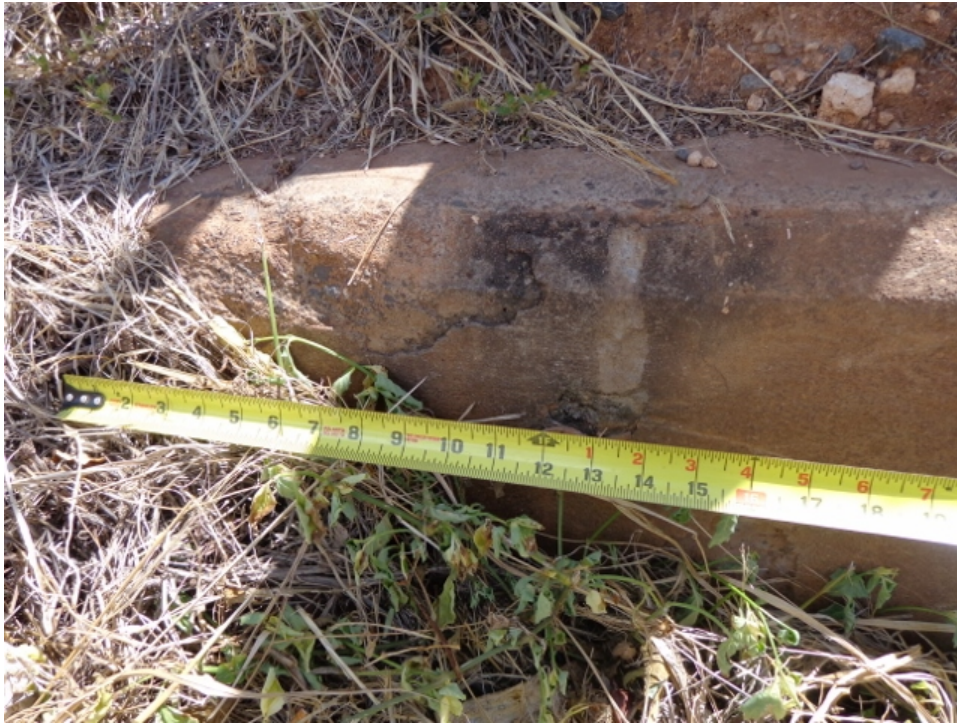
Photo 15: Spall measuring 8" high x 16" wide x 1" deep occurring at the top east corner of the upstream headwall

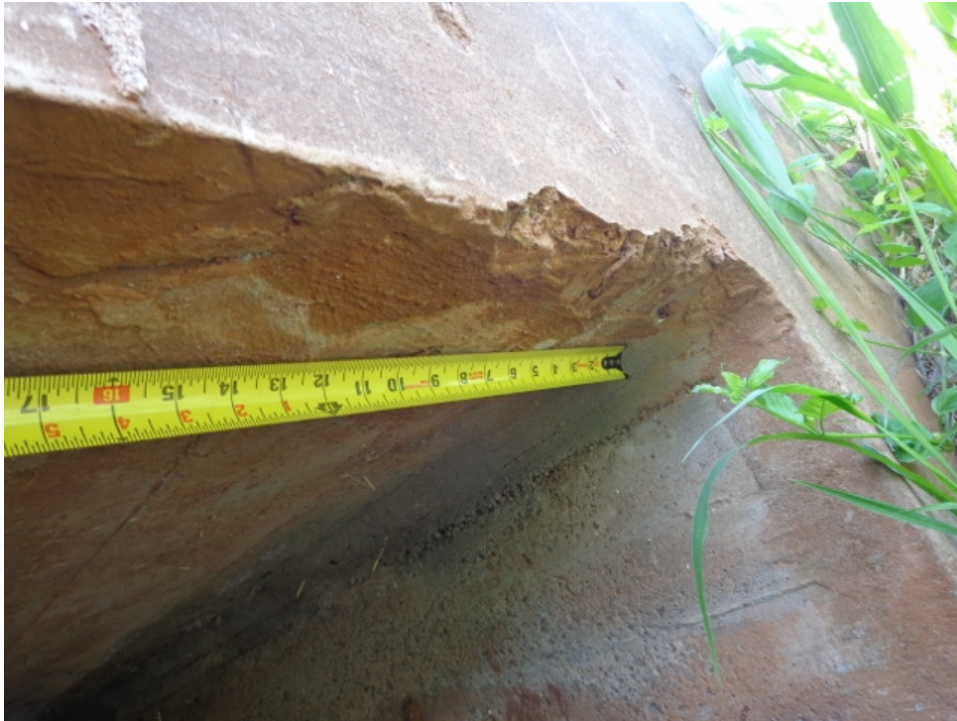
Photo 17: 12" long x 72" wide area of delamination occurring in culvert soffit at inlet

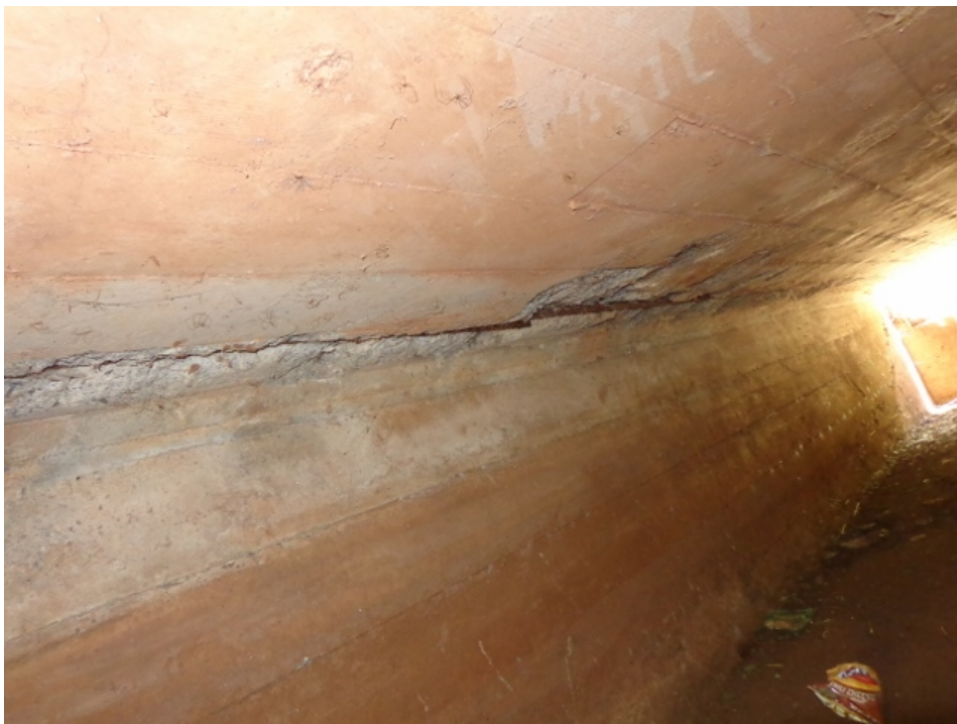
The culvert appears to have been recently cleaned so inspection inside the culvert was possible. Extensive spalling was discovered during this inspection in the culvert soffit with many exposed reinforcing bars,

Photo 18: Spall measuring 10' long x 30" wide x 2" deep with 8 exposed reinforcing bars occurring in culvert soffit near outlet above the east culvert wall

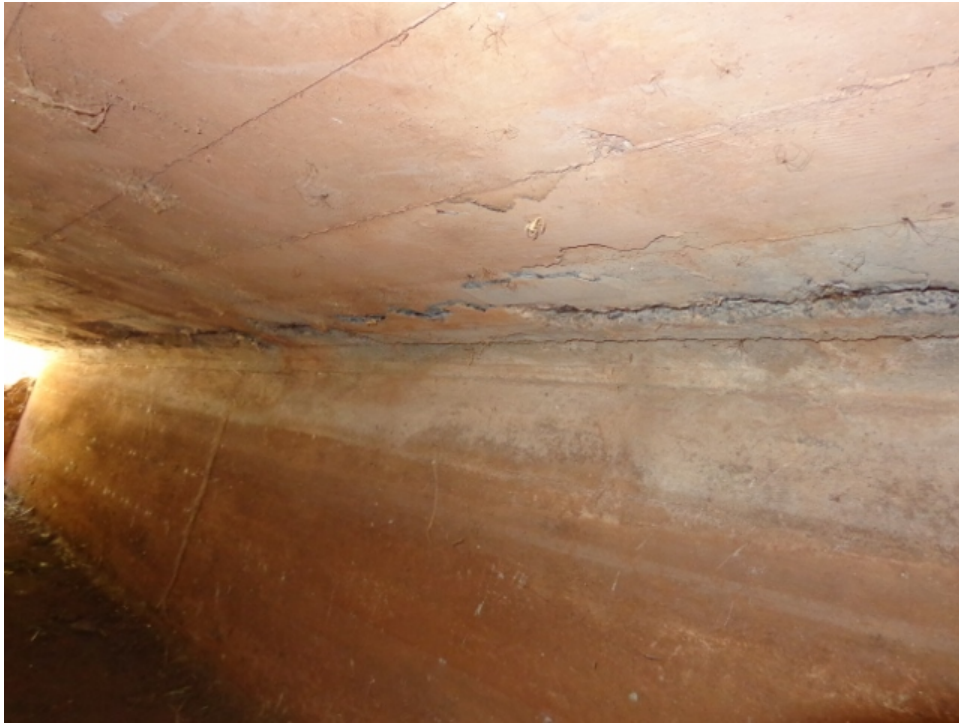
Photo 19: Spall measuring 10' long x 24" wide x 2" deep with 8 exposed reinforcing bars occurring in culvert soffit near outlet above the west culvert wall

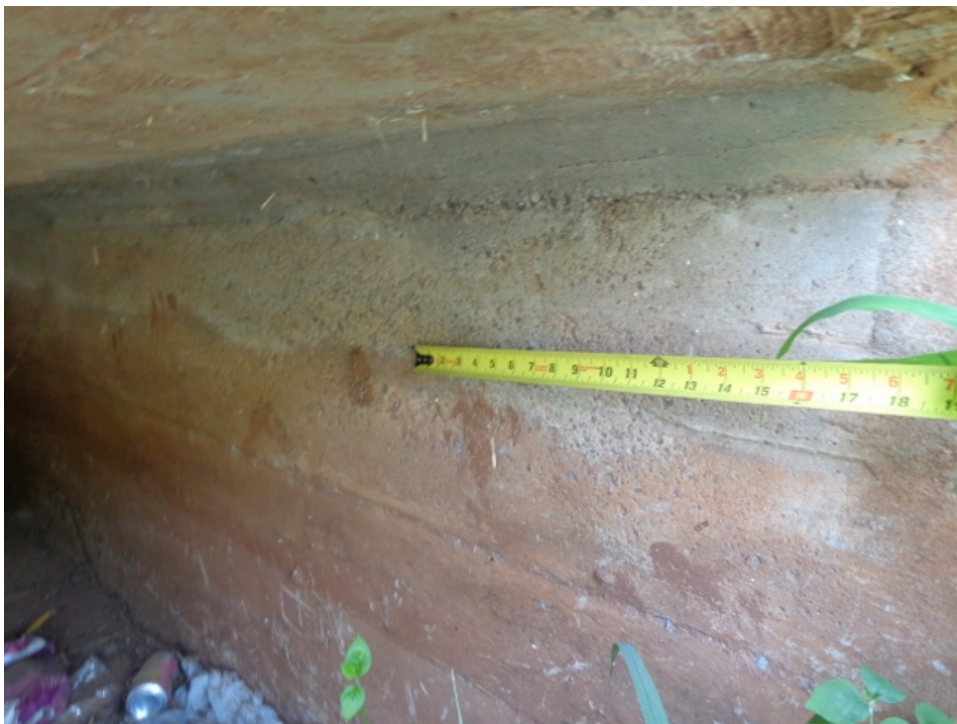
Photo 22: Scaling occurring along the top 12" of the culvert walls, typical

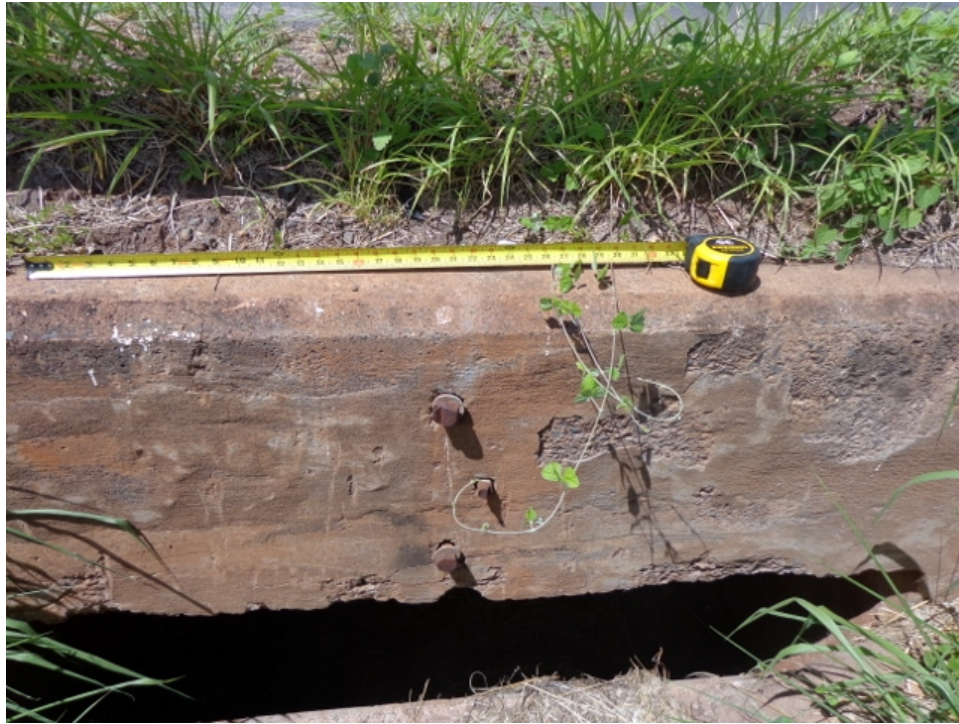
Photo 25: Scattered spalls occurring throughout downstream headwall

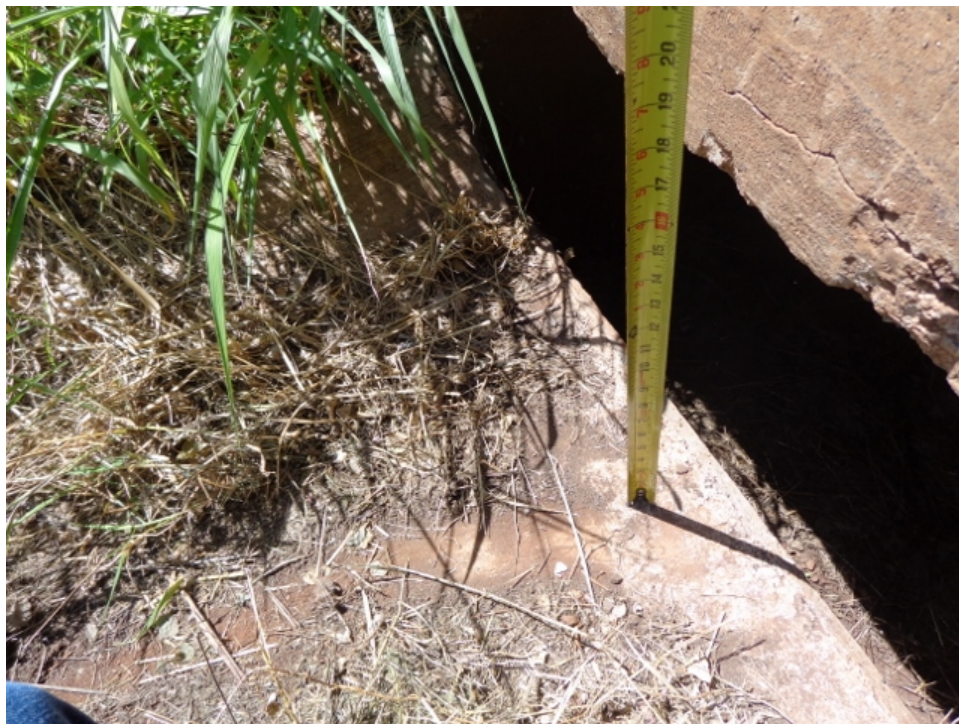
- Concrete block built at outlet leaves only the top 16" of the culvert for water to flow through (see Photo 26)

Photo 26: Concrete block built at outlet leaves only the top 16" of the culvert for water to flow through
