**ROUTINE BRIDGE INSPECTION REPORT  
FEDERAL-AID PROJECT NO. BRIS-NBIS(080)  
CONTRACT NO. SC-DDC-2200014**

**FARRINGTON HIGHWAY BRIDGE OVER HONOULIULI STREAM  
BRIDGE NO. 922  
STRUCTURE NO. 003922001100001**

**DATE OF INSPECTION: September 01, 2021**

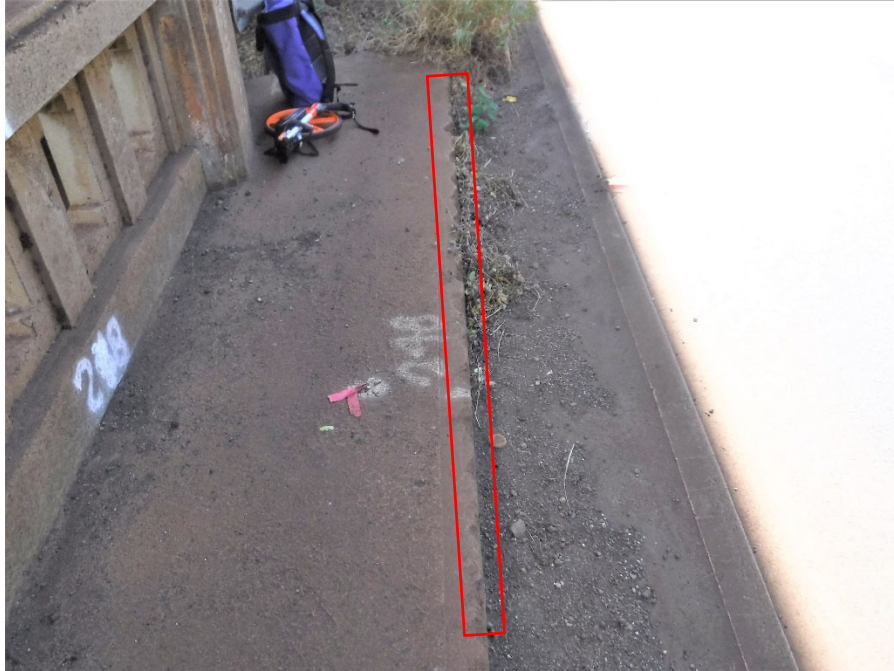
**PHOTO 7** CURB SPALLS AT EAST END OF UPSTREAM SIDEWALK

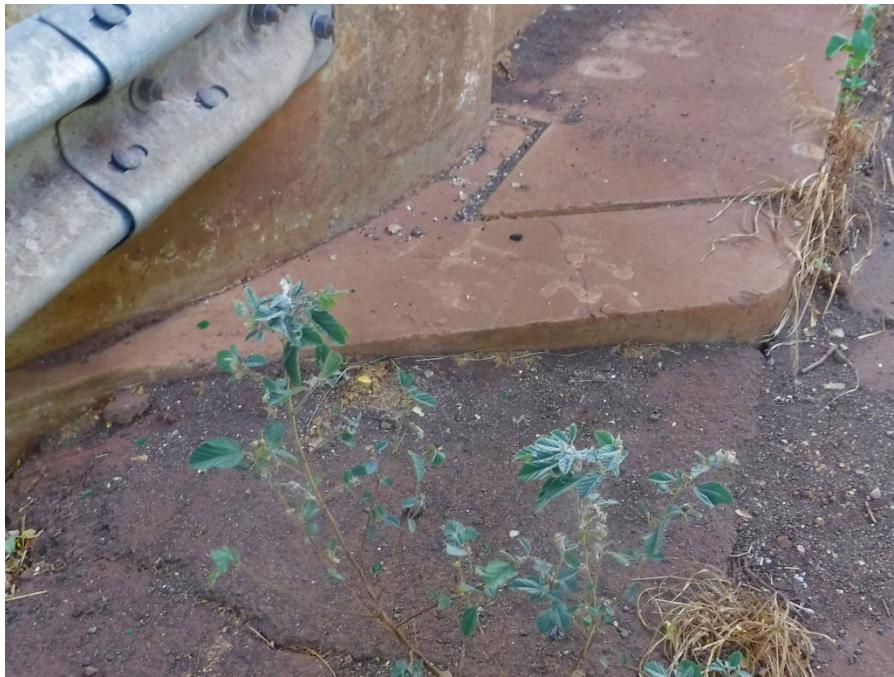
**PHOTO 8** 3-1/2" VERTICAL DIFFERENTIAL AT WEST APPROACH TO UPSTREAM SIDEWALK

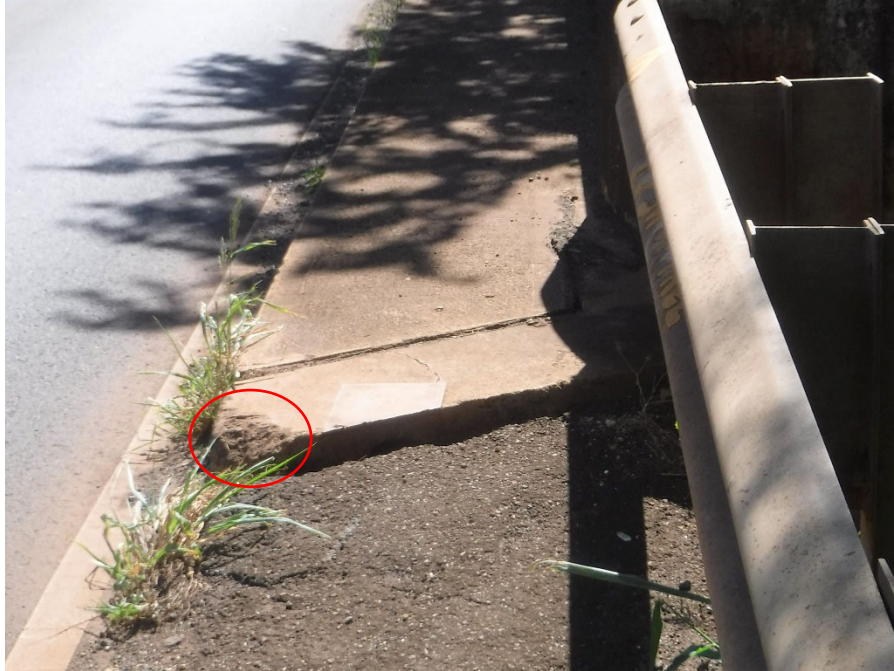
**PHOTO 9** 3" VERTICAL DIFFERENTIAL AND 1/2" GAP AT WEST APPROACH TO DOWSTREAM SIDEWALK AND 6"X6" EDGE SPALL ON CURB

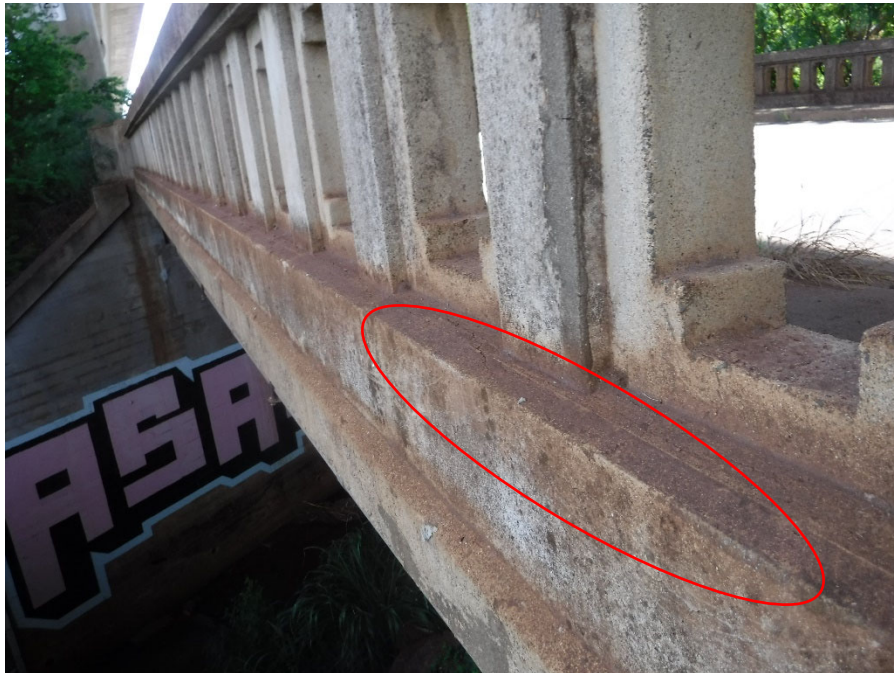
- Typical delaminations and spalls (25FT CS2) on pickets, top and bottom rails of both bridge railings (Photos 10 - 14)

**PHOTO 10** 3'X4" DELAMINATION (3FT 1080 CS2) ON EXTERIOR FACE OF UPSTREAM BOTTOM RAIL NEAR WEST END OF BRIDGE

- Upgrade bridge railings to current acceptable standards (Est. Cost = \$250,000)
- Upgrade guardrail transitions and guardrail ends to meet current acceptable standards ( Off-Bridge Repair Item)
- Repair spalls/delamiantions on bridge railings (Est. Cost = \$15,000)
- Repair cracks on abutments and wingwalls (Est. Cost = \$1,000)

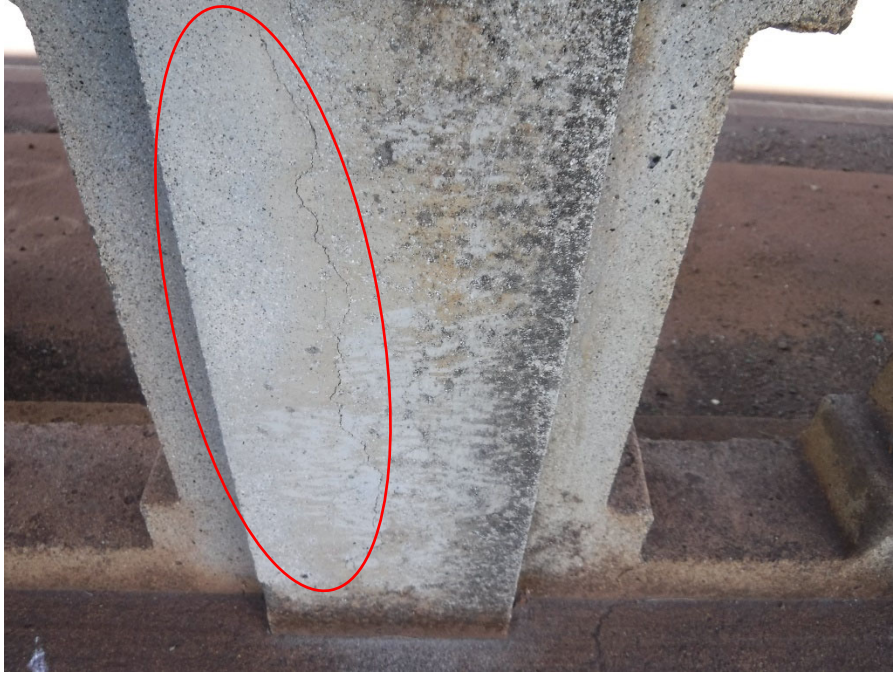
**PHOTO 11** TYPICAL DELAMINATION (1080 CS2) ON EXTERIOR FACE OF UPSTREAM RAILING PICKET

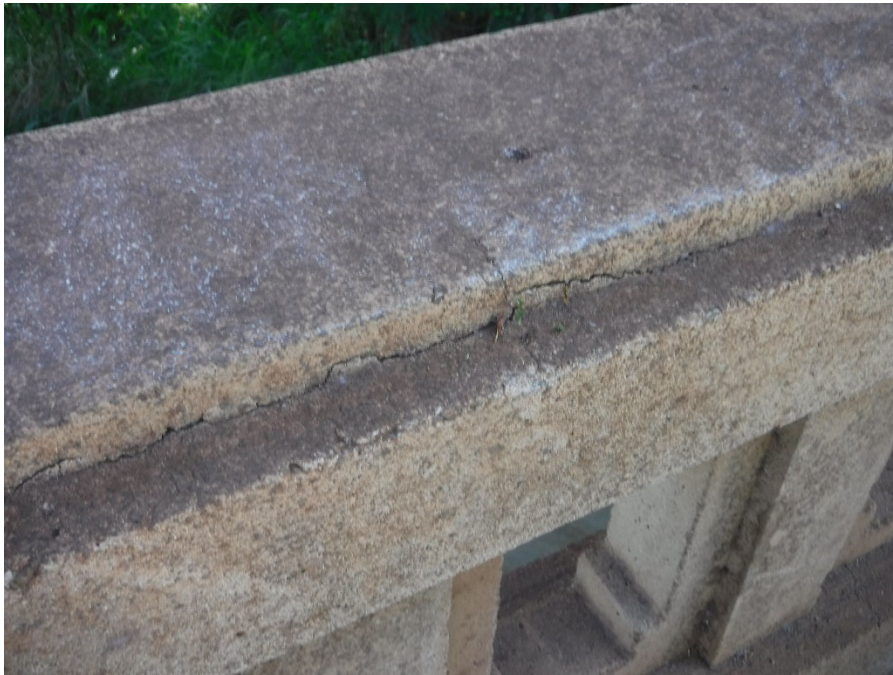
**PHOTO 12** TYPICAL DELAMINATION (1080 CS2) ON UPSTREAM TOP RAIL

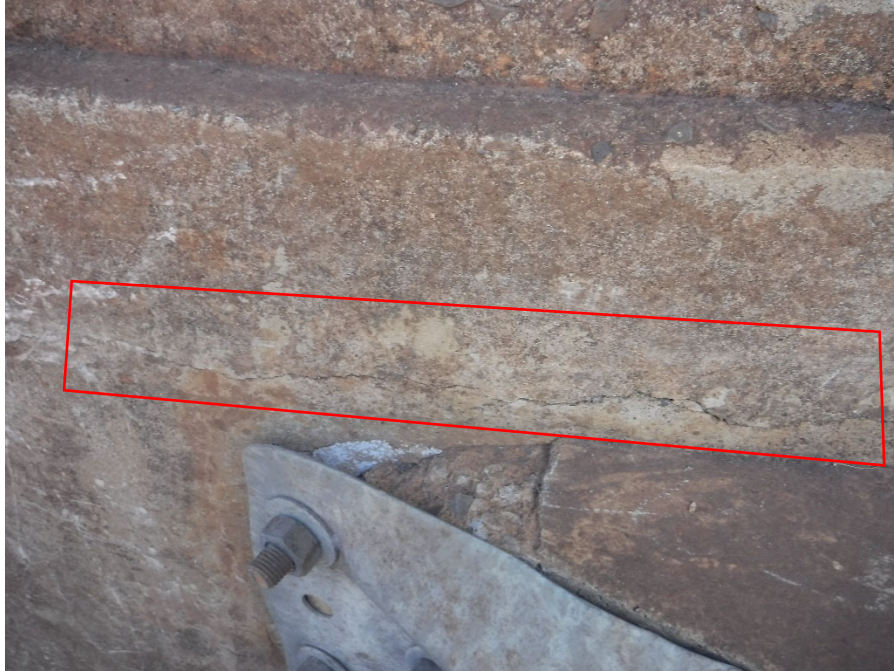
**PHOTO 13** 2 FT LONG HORIZONTAL CRACK AND DELAMINATION (2FT 1080 CS2) ON INTERIOR FACE OF UPSTREAM EAST END POST

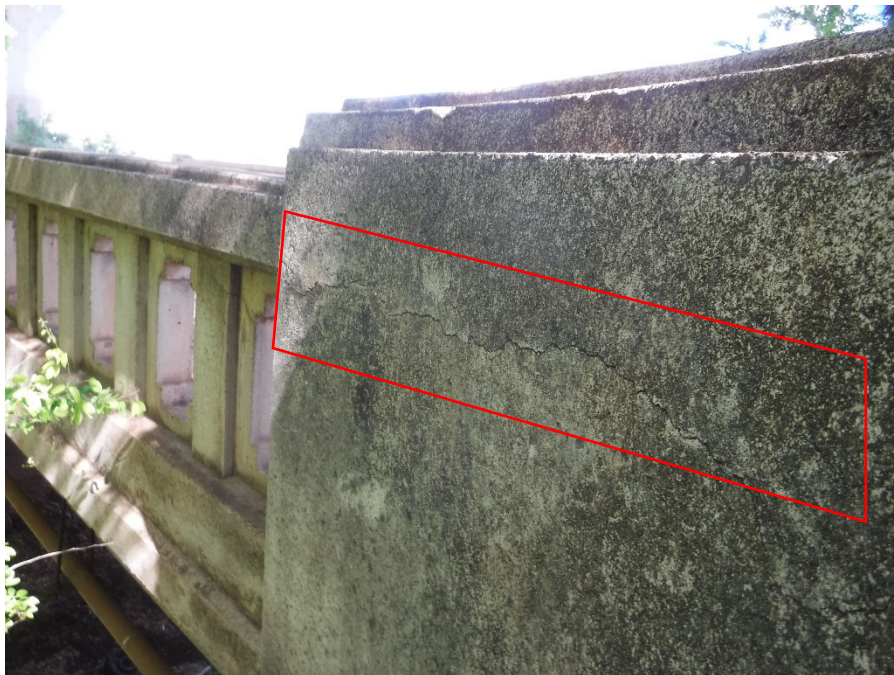
**PHOTO 14** 4FT LONG HORIZONTAL CRACK AND DELAMINATION (4FT 1080 CS2) ON EXTERIOR FACE OF DOWNSTREAM EAST END POST

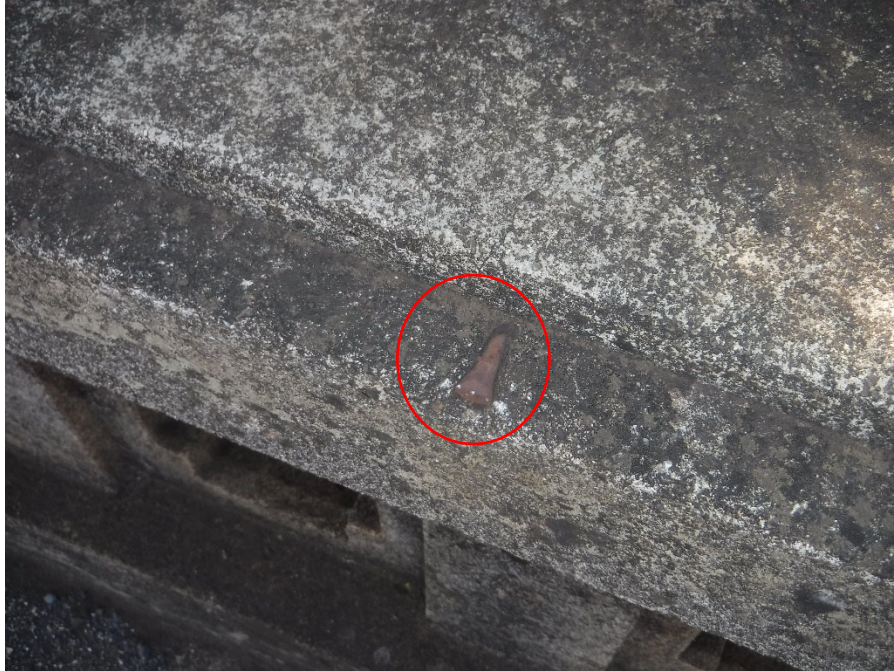
- Exposed rebar without section loss (1FT CS2) on downstream bridge railing (Photo 15)

**PHOTO 15** EXPOSED REBAR WITHOUT SECTION LOSS (1FT 1090 CS2) ON DOWNSTREAM BRIDGE RAILING

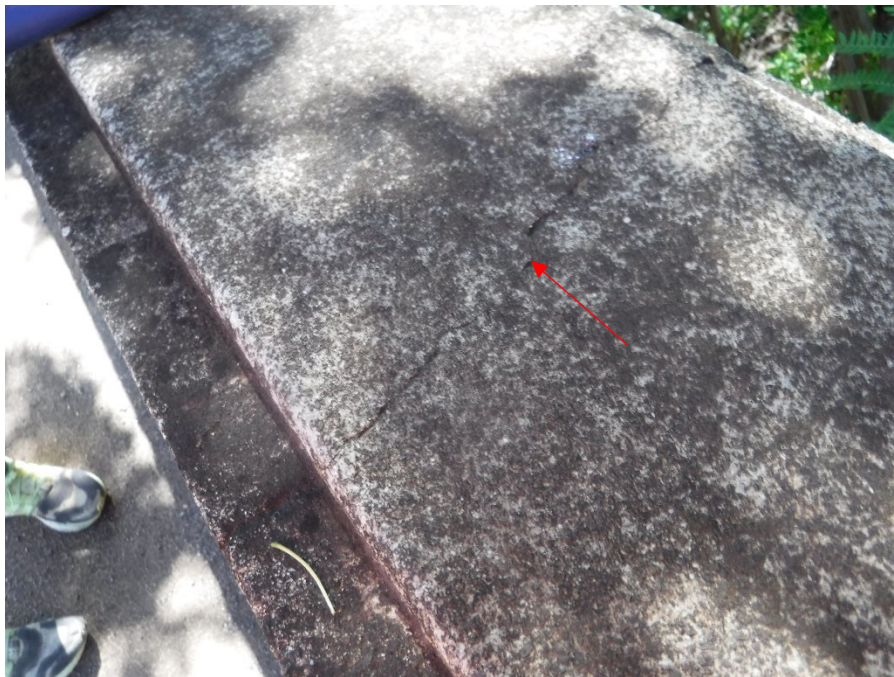
- Typical moderate width cracks (45FT CS2) on both bridge railings (Photo 16)

**PHOTO 16** TYPICAL MODERATE WIDTH CRACK (1130 CS2) ON BOTH BRIDGE RAILINGS

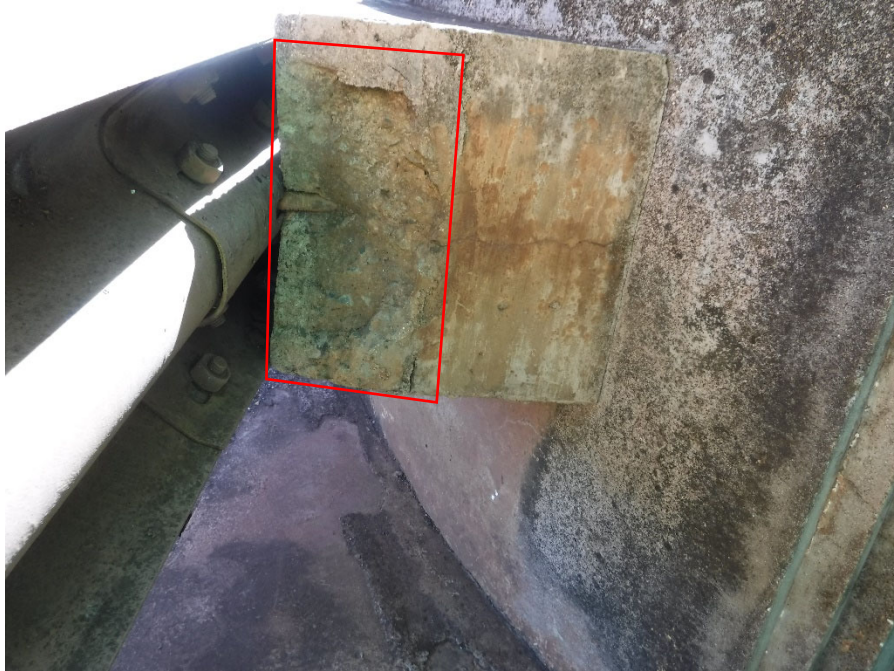
**PHOTO 17** 1'X6" SPALL WITH EXPOSED ANCHOR BOLT ON CONCRETE SPACER BLOCK AT DOWNSTREAM WEST END POST

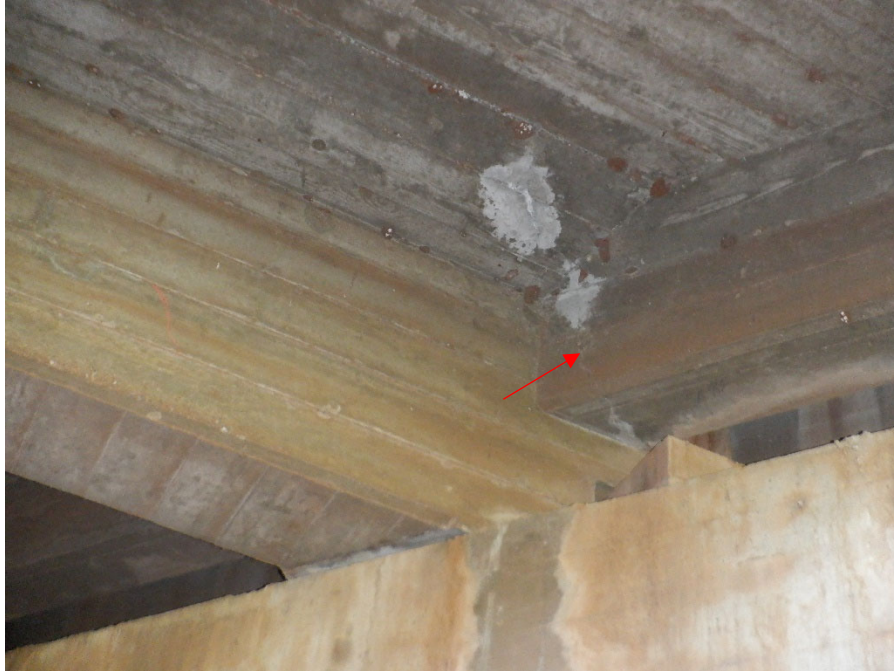
**PHOTO 19** MODERATE WIDTH CRACK WITH EFFLORESCENCE (2SF 1120 CS2) ON TOP FLANGE SOFFIT AND DIAPHRAGM AT ABUTMENT 2 NEAR GIRDER G2

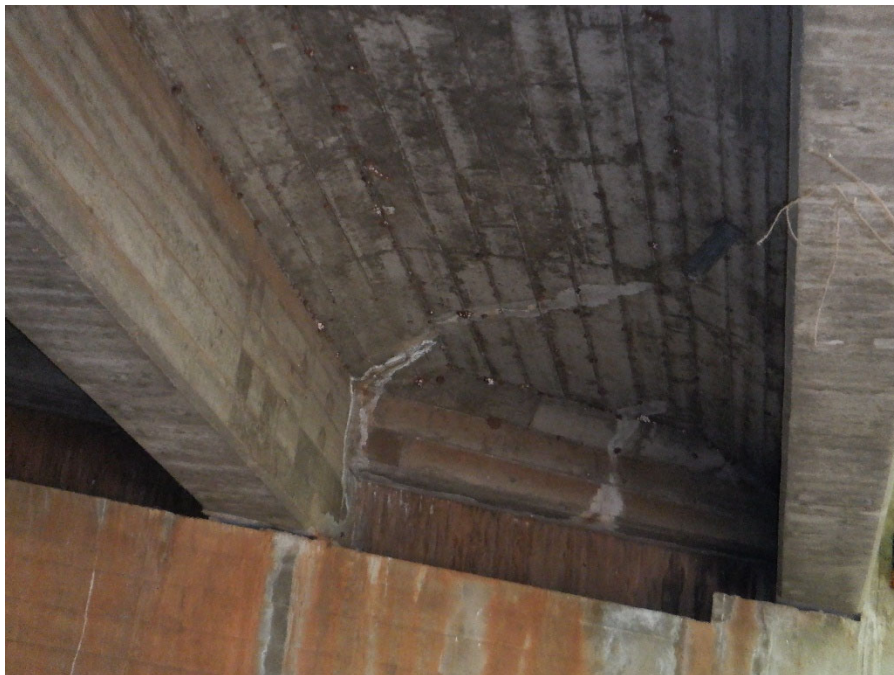
**PHOTO 20** MODERATE WIDTH DIAGONAL CRACK WITH EFFLORESCENCE (8SF 1120 CS2) ON TOP FLANGE SOFFIT BETWEEN GIRDERS G3 AND G4 NEAR ABUTMENT 1

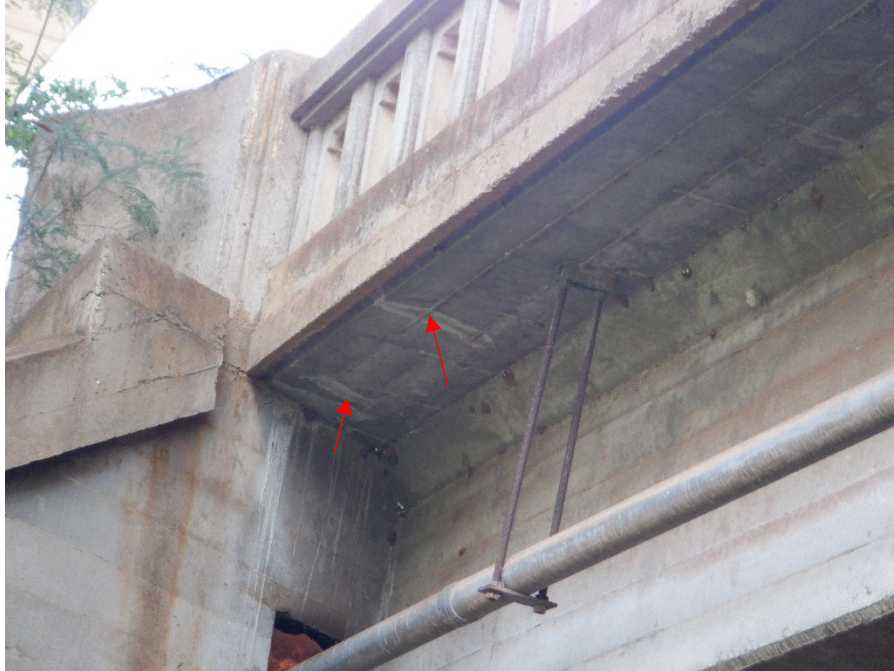
**PHOTO 21** MODERATE WIDTH TRANSVERSE CRACKS WITH EFFLORESCENCE (3SF 1120 CS2) ON UPSTREAM CANTILEVER TOP FLANGE SOFFIT NEAR ABUTMENT 2

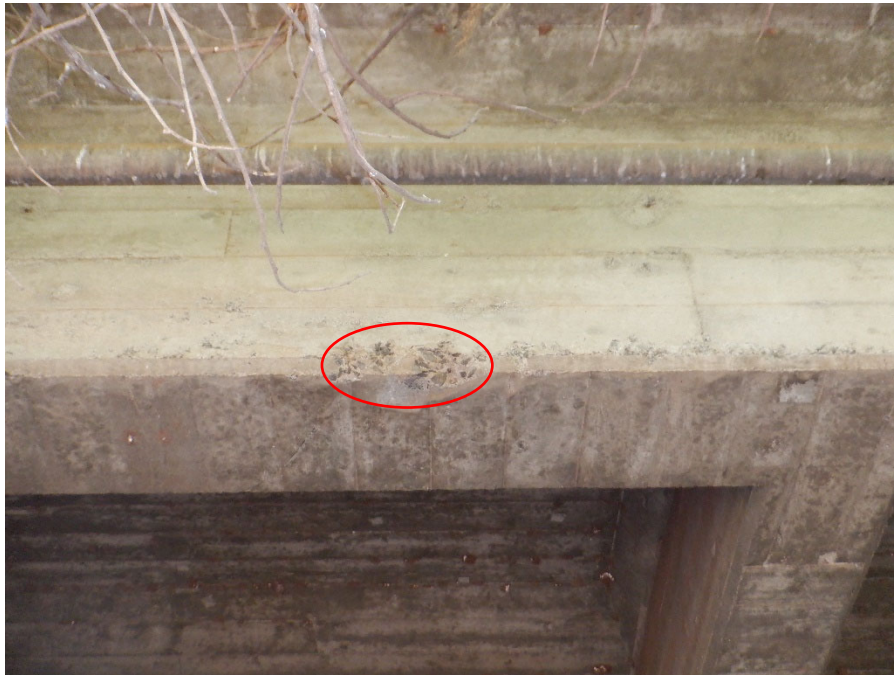
**PHOTO 22** 6"X2"X2" EDGE SPALL (1FT 1080 CS2) ON GIRDER G4

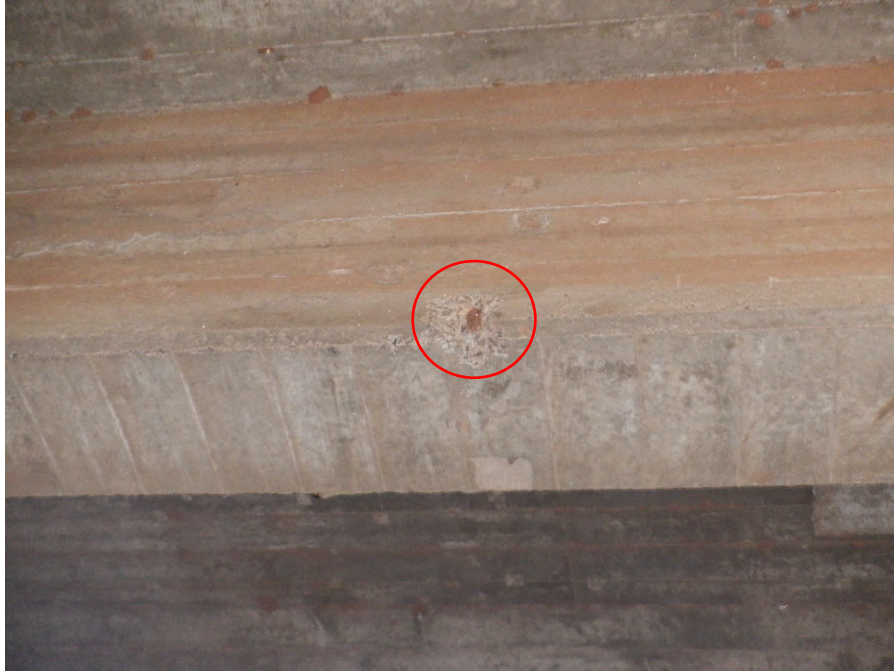
**PHOTO 23** 4"X4" EDGE SPALL WITH EXPOSED REBAR WITHOUT SECTION LOSS (1FT 1090 CS2) ON GIRDER G3

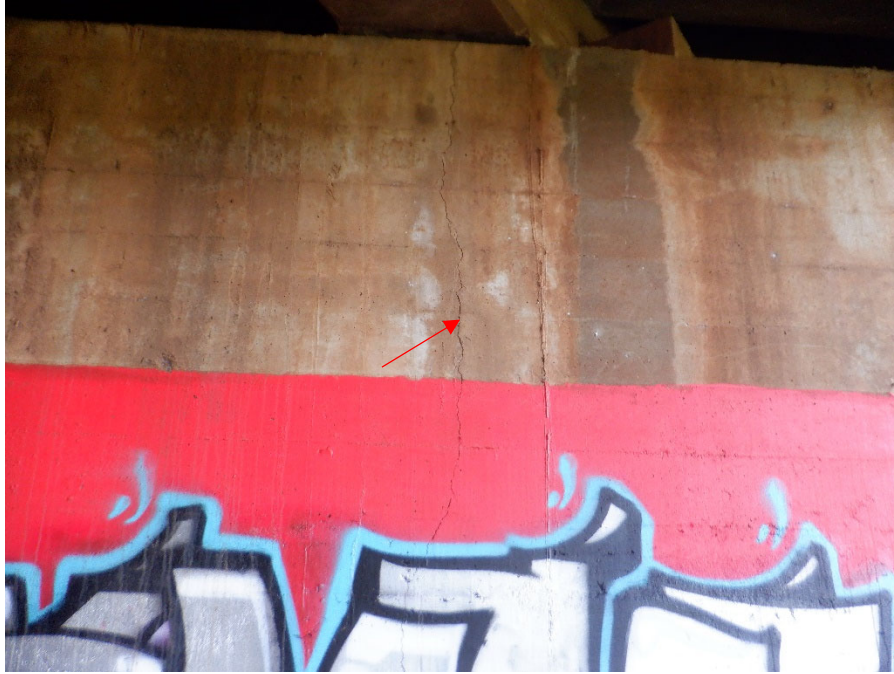
1130	Cracking (RC and Other)		32	ft	0	30	2	0
1190	Abrasion(PSC/RC)		99	ft	0	99	0	0
Defect No. 1130: - Wide vertical crack (1FT CS3) on Abutment 2 below girder G2 (Photo 27) - Wide vertical crack (1FT CS3) on downstream west wingwall (Photo 28) - Moderate width cracks (30FT CS2) on both abutments and all wingwalls (Photo 29)								
Defect No. 1190: - Partial abrasion (99FT CS2) along entire length of Abutment 1 and wingwalls (Photo 30)

**PHOTO 27** WIDE VERTICAL CRACK (1FT 1130 CS3) ON ABUTMENT 2  
BELOW GIRDER G2

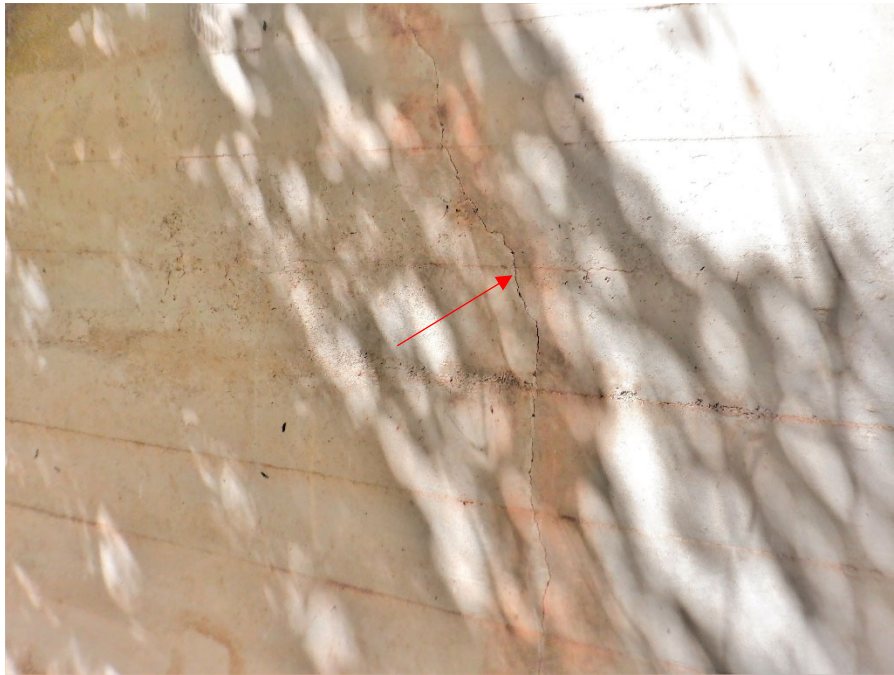
**PHOTO 28** WIDE VERTICAL CRACK (1FT 1130 CS3) ON  
DOWNSTREAM WEST WINGWALL

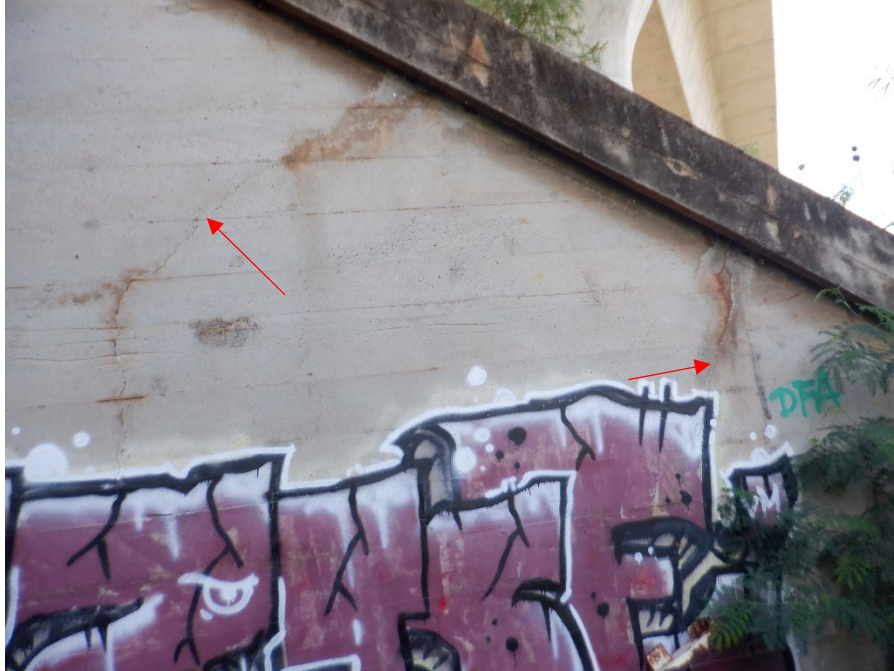
**PHOTO 29** TYPICAL MODERATE WIDTH CRACKS (1130 CS2) ON BOTH ABUTMENTS AND ALL WINGWALLS

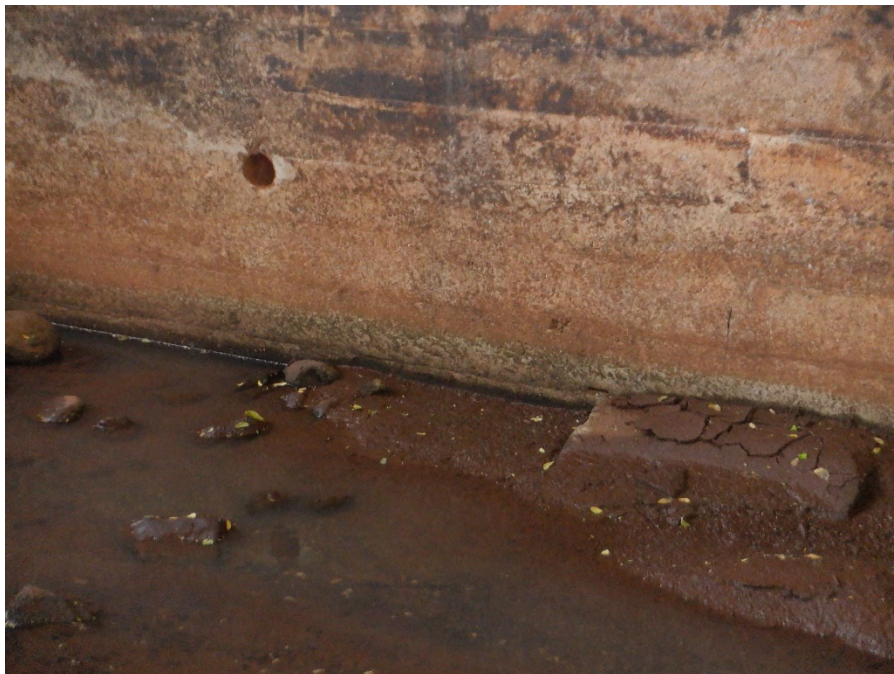
**PHOTO 30** PARTIAL ABRASION (1190 CS2) ALONG ENTIRE LENGTH OF ABUTMENT 1 AND WINGWALLS

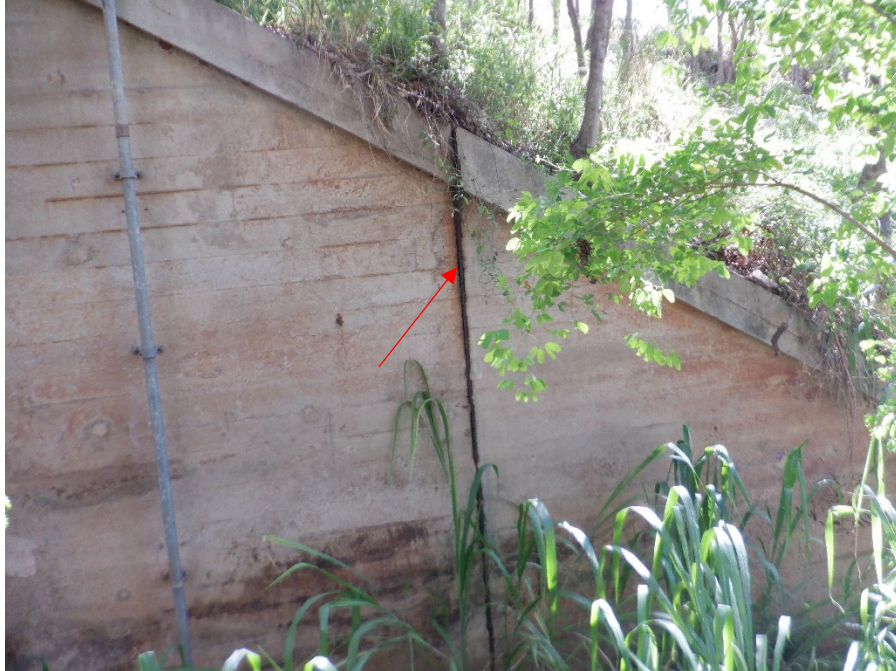
**PHOTO 31** JOINT FILLER PROTRUDING FROM JOINT AT DOWNSTREAM EAST WINGWALL AND 1/2" GAP BETWEEN DOWNSTREAM EAST WINGWALL AND CHANNEL WALL

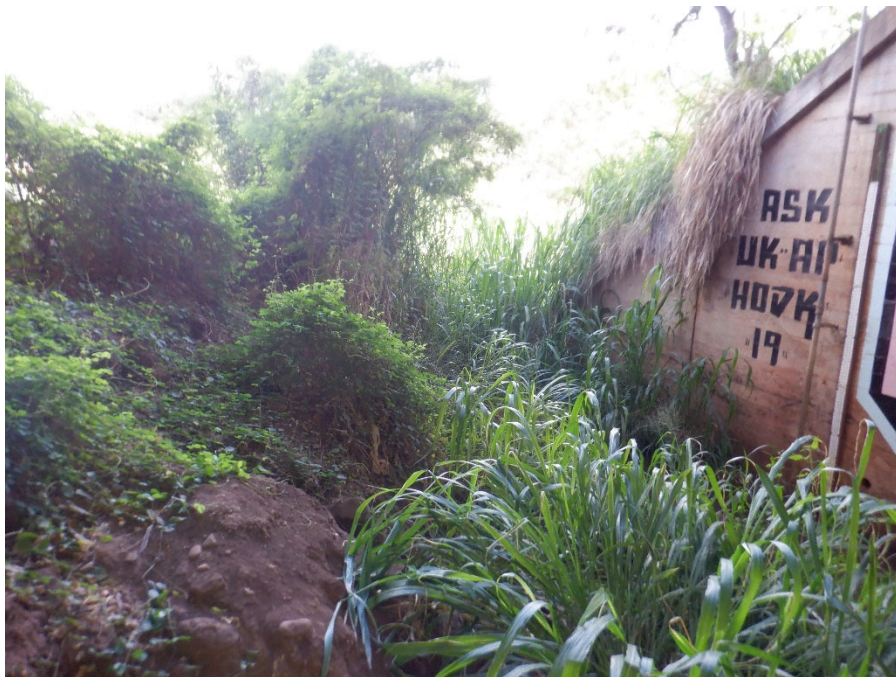
**PHOTO 32** UPSTREAM CHANNEL WITH HEAVY VEGETATION GROWTH

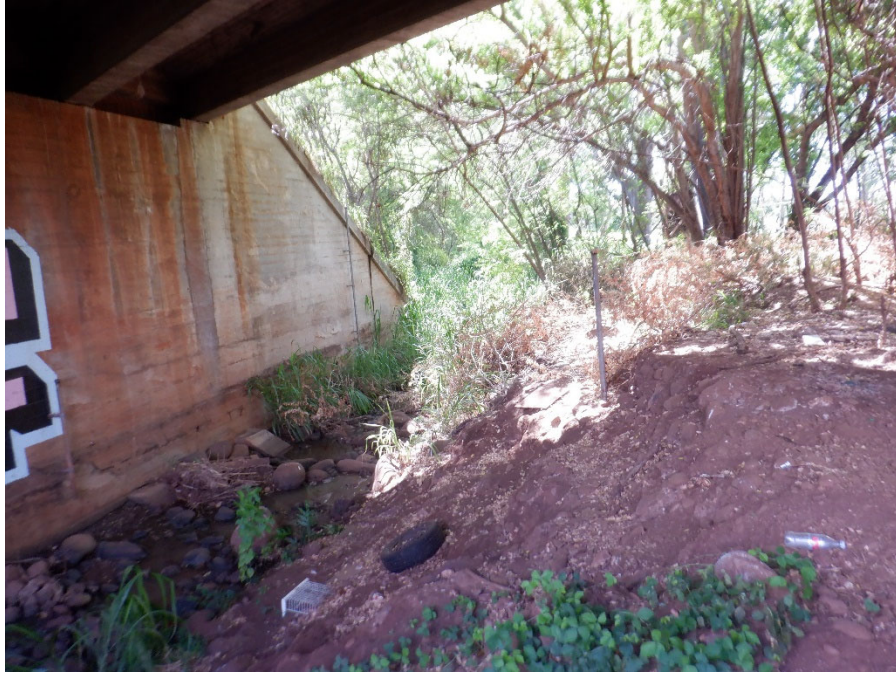
**PHOTO 33** DOWNSTREAM CHANNEL WITH VEGETATION GROWTH
