**ROUTINE BRIDGE INSPECTION REPORT  
FEDERAL-AID PROJECT NO. BRIS-NBIS(080)  
CONTRACT NO. SC-DDC-2200014**

**FARRINGTON HIGHWAY BRIDGE NO. 2 OVER HUNEHUNE STREAM  
BRIDGE NO. 924  
STRUCTURE NO. 003924001100001**

**DATE OF INSPECTION: September 3, 2021**

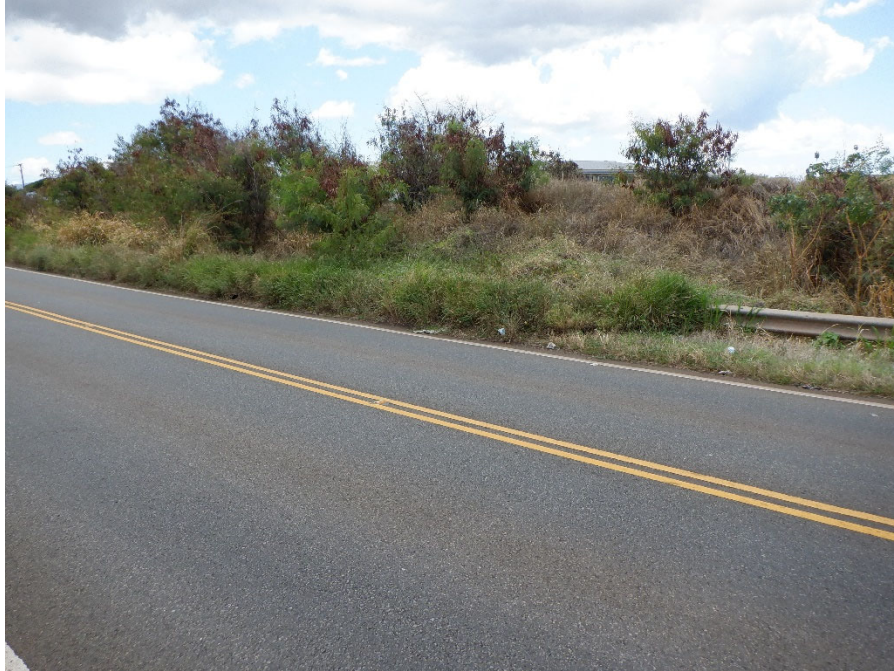
**PHOTO 9** DOWNSTREAM EAST APPROACH GUARDRAIL COVERED BY HEAVY VEGETATION

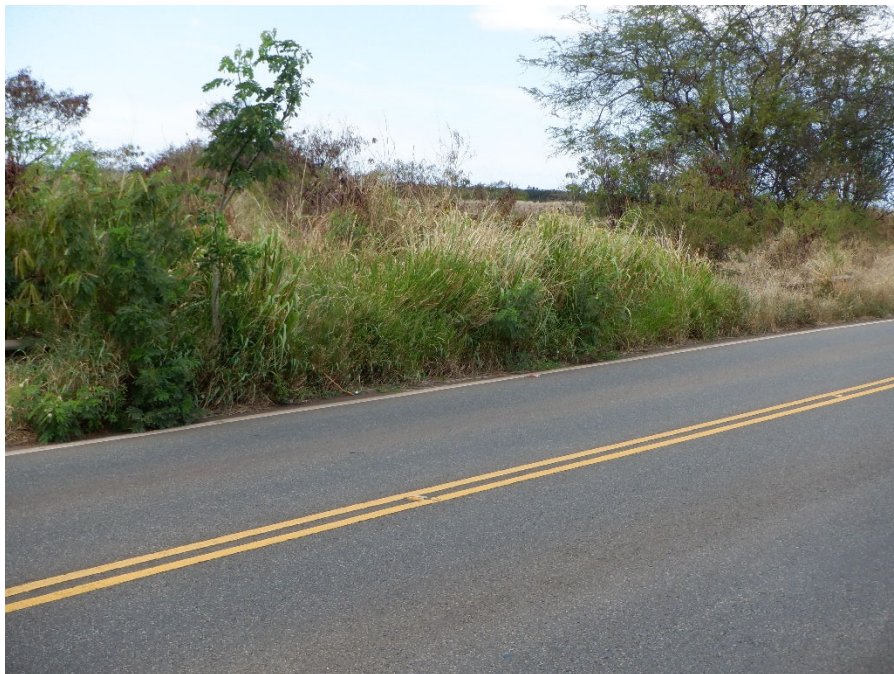
**PHOTO 10** DOWNSTREAM WEST APPROACH GUARDRAIL COVERED BY HEAVY VEGETATION

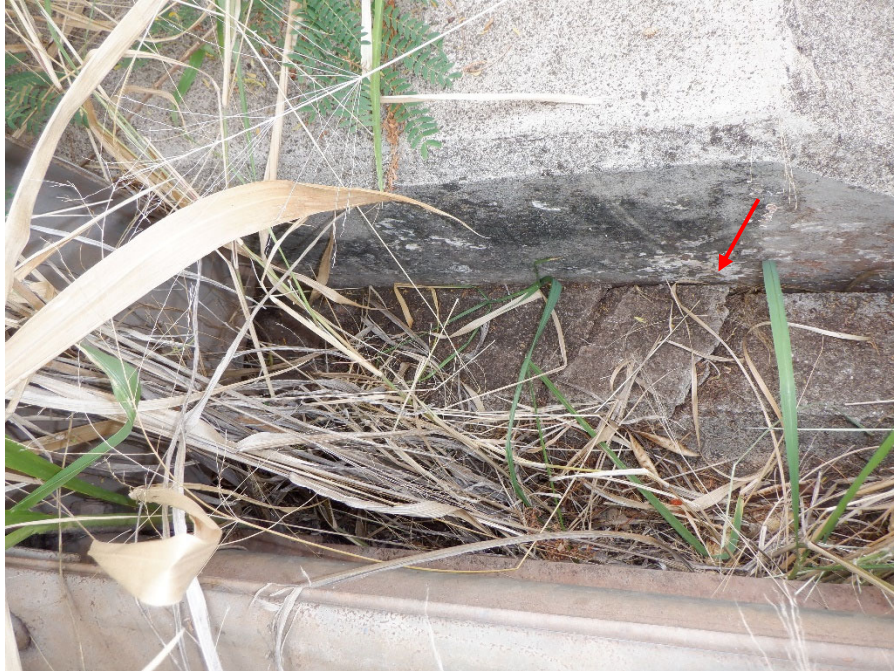
**PHOTO 13** 2'X1' DELAMINATION ON CURB AT BASE OF  
DOWNSTREAM CONCRETE BRIDGE RAILING, NEAR  
WEST END OF BRIDGE

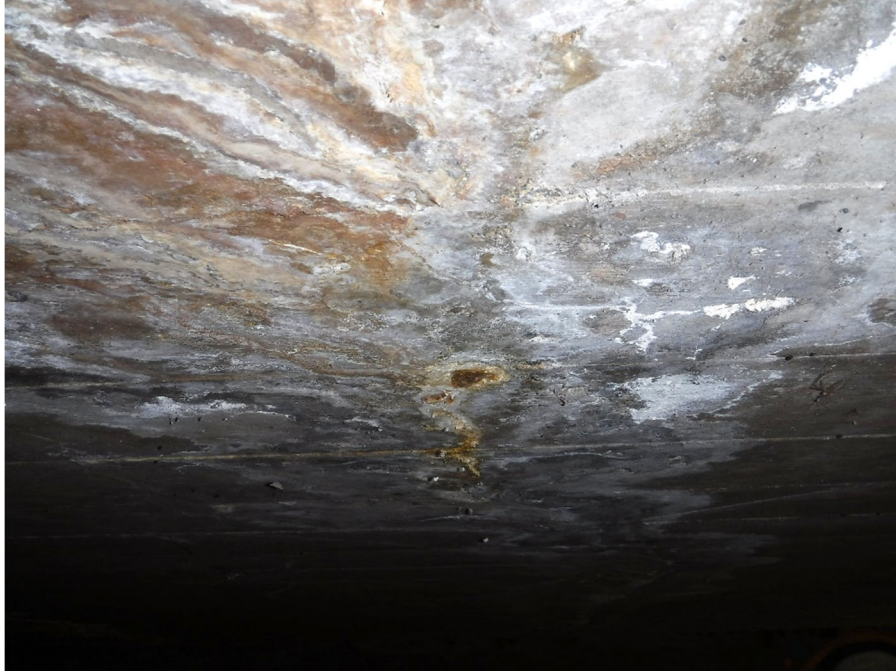
ELEMENT INSPECTION								
ELEM NO.	ELEMENT / DEFECT DESCRIPTION	ENV.	TOTAL QUANTITY	UNIT	CS 1 (Good)	CS 2 (Fair)	CS 3 (Poor)	CS 4 (Severe)
DEFECT								
38	Re Concrete Slab	1	1,013	sq.ft	913	0	100	0
1120	Efflorescence/Rust Staining		100	sq.ft	0	0	100	0
510	Wearing Surfaces		557	sq.ft	557	0	0	0
Defect No. 1120: - Longitudinal crack with built-up efflorescence (25SF CS3) on slab soffit over full length of span, 28' from upstream side (Photo 15) - Longitudinal crack with built-up efflorescence (25SF CS3) on slab soffit over full length of span, 30' from upstream side (Photo 16) - Longitudinal crack with built-up efflorescence (25SF CS3) on slab soffit over full length of span, 32' from upstream side (Photo 17) - Longitudinal crack with built-up efflorescence (25SF CS3) on slab soffit over full length of span, 45' from upstream side (Photo 18)								
215	Re Conc Abutment	1	155	ft	140	13	2	0
1130	Cracking (RC and Other)		15	ft	0	13	2	0

**PHOTO 15** LONGITUDINAL CRACK WITH BUILT-UP EFFLORESCENCE (25SF 1120 CS3) ON SLAB SOFFIT, 28' FROM UPSTREAM SIDE

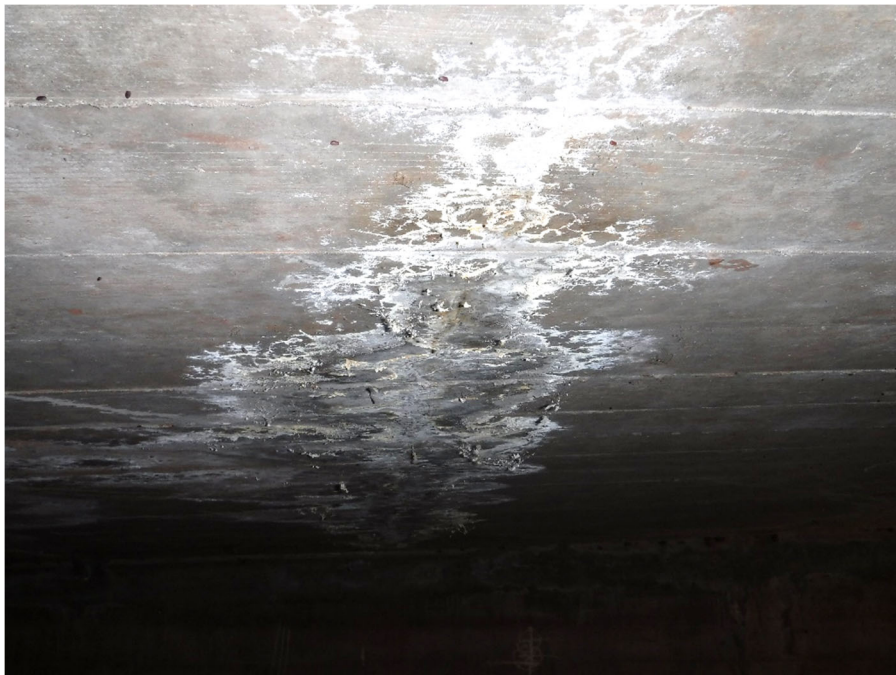
**PHOTO 16** LONGITUDINAL CRACK WITH BUILT-UP EFFLORESCENCE (25SF 1120 CS3) ON SLAB SOFFIT, 30' FROM UPSTREAM SIDE

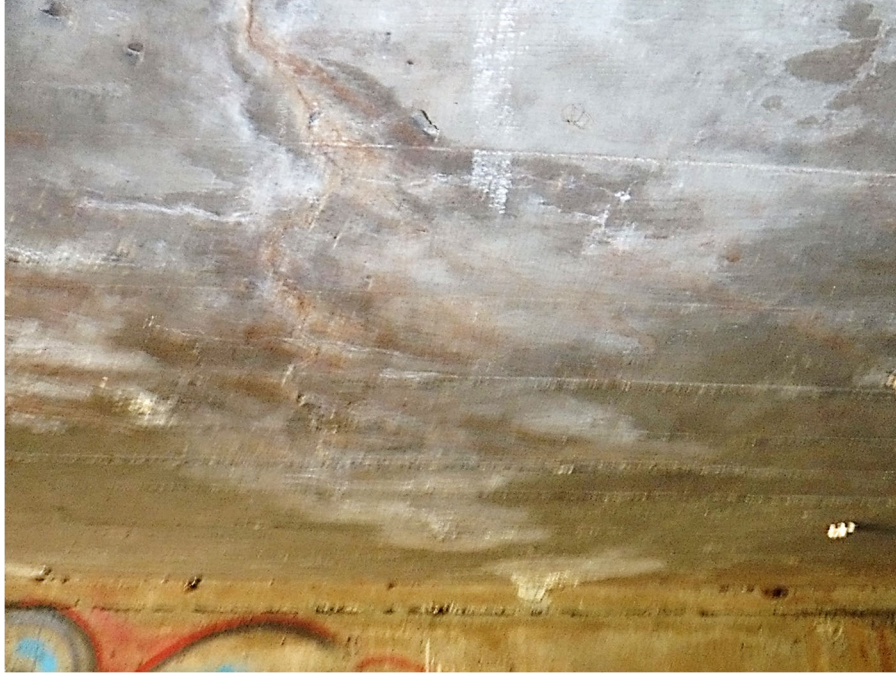
**PHOTO 17** LONGITUDINAL CRACK WITH BUILT-UP EFFLORESCENCE (25SF 1120 CS3) ON SLAB SOFFIT, 32' FROM UPSTREAM SIDE

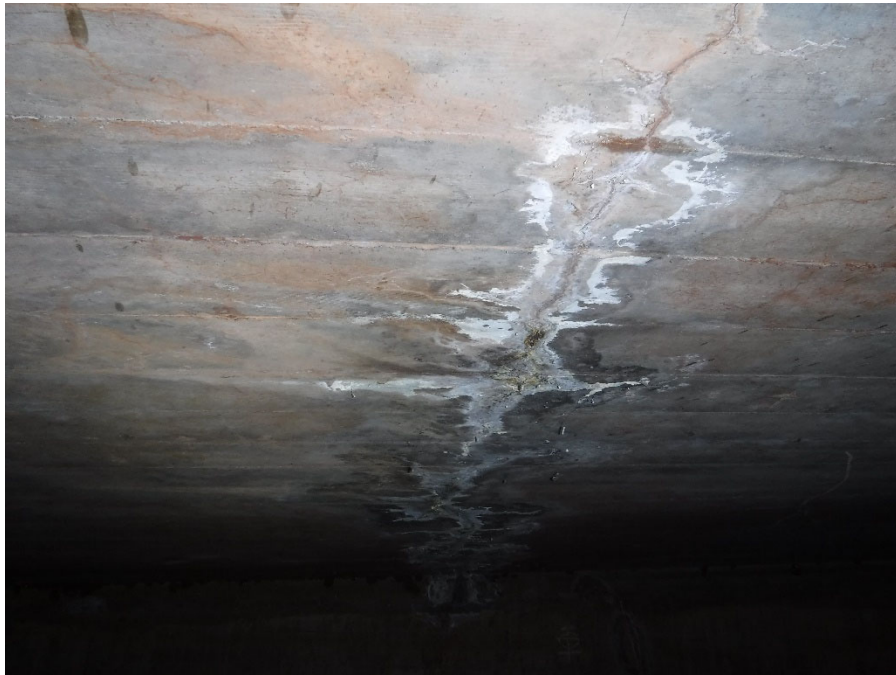
**PHOTO 18** LONGITUDINAL CRACK WITH BUILT-UP EFFLORESCENCE (25SF 1120 CS3) ON SLAB SOFFIT, 45' FROM UPSTREAM SIDE

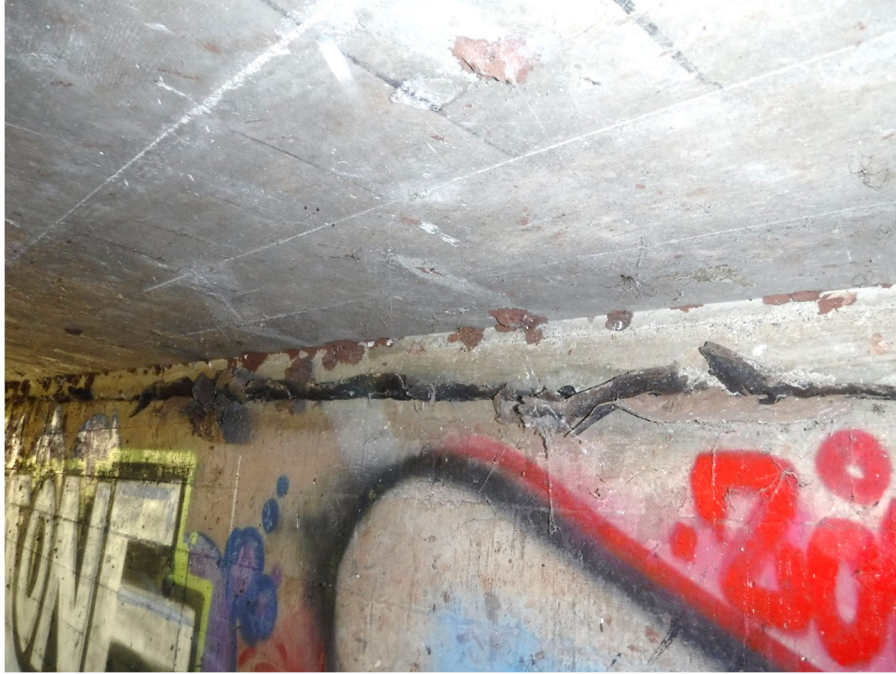
**PHOTO 19** PROTRUDING ROOFING PAPER ALONG TOP OF ABUTMENT 1

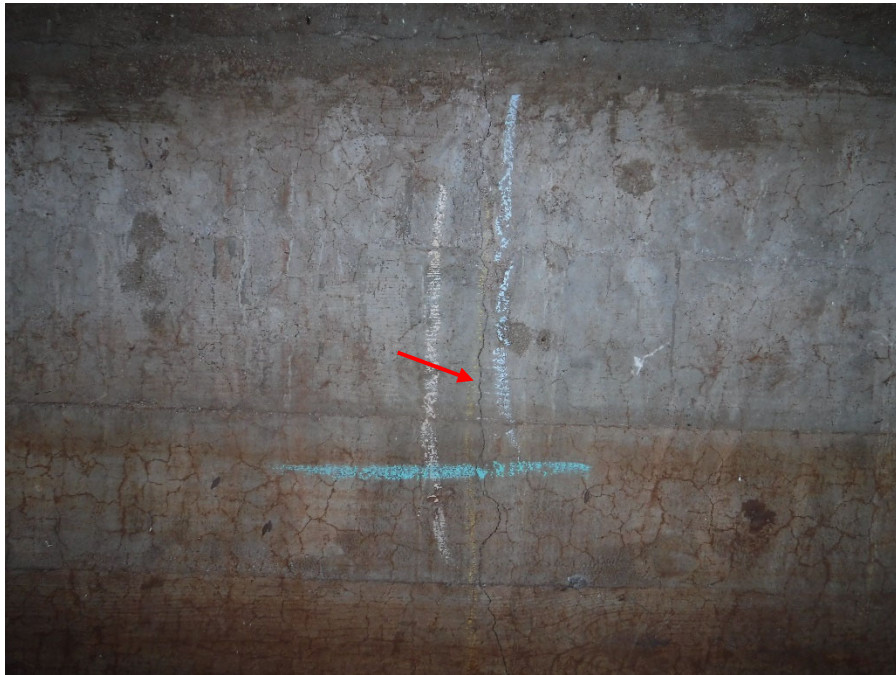
Defect No. 1130: - Moderate width cracks (13FT CS2) on both abutments (Photo 20) - Wide crack (1FT CS3) on Abutment 1, 25' from upstream end (Photo 21) - Wide crack (1FT CS3) on Abutment 1, 45' from upstream end (Photo 22)								
316	Other Bearing	1	1	each	1	0	0	0
331	Re Conc Bridge Railing	1	62	ft	62	0	0	0

**PHOTO 20** TYPICAL MODERATE WIDTH CRACK (1130 CS2) ON BOTH ABUTMENTS

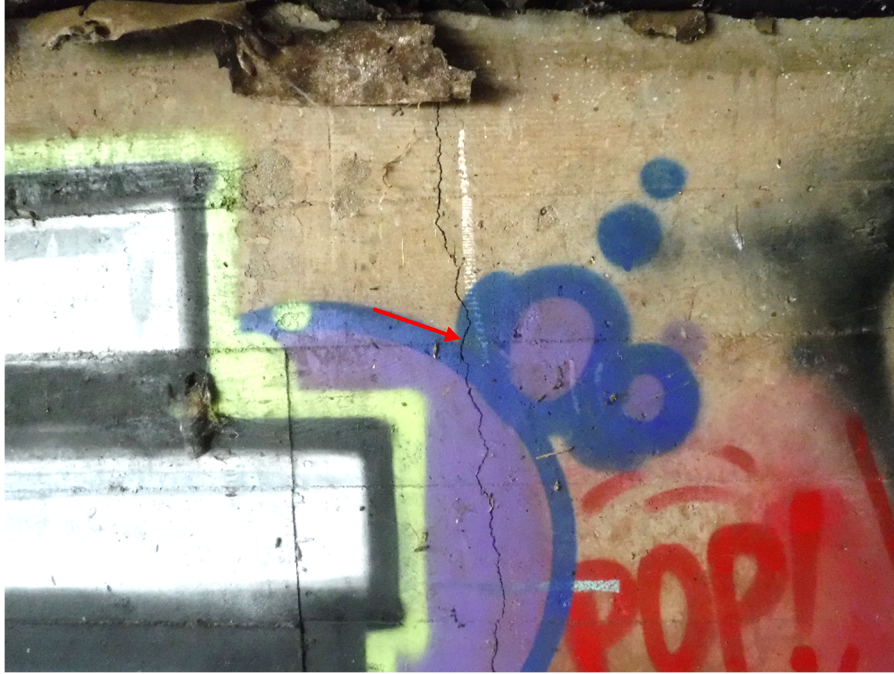
**PHOTO 21** WIDE CRACK (1FT 1130 CS3) ON ABUTMENT 1, 25' FROM UPSTREAM END

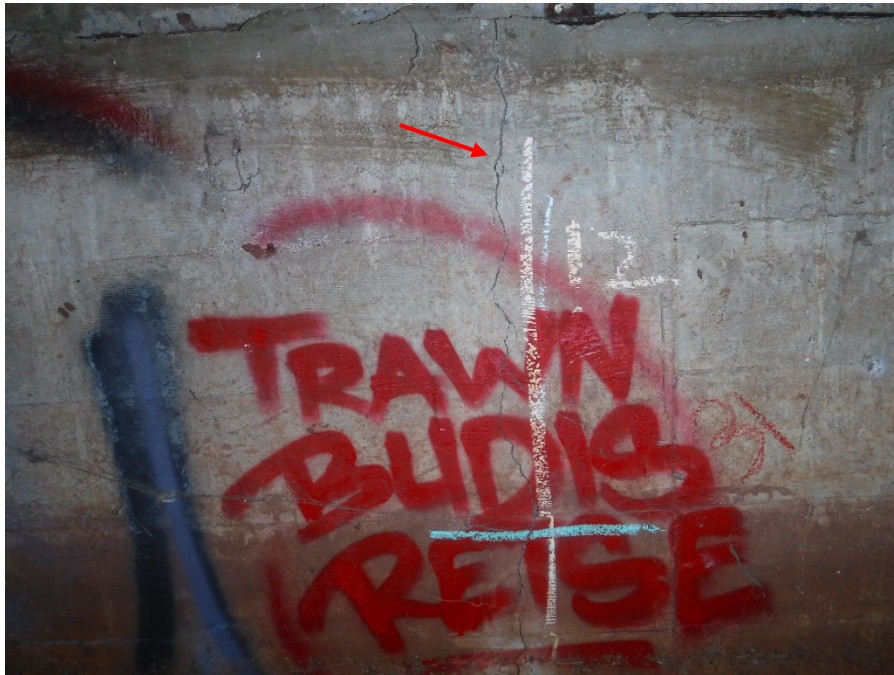
**PHOTO 22** WIDE CRACK (1FT 1130 CS3) ON ABUTMENT 1, 45' FROM UPSTREAM END

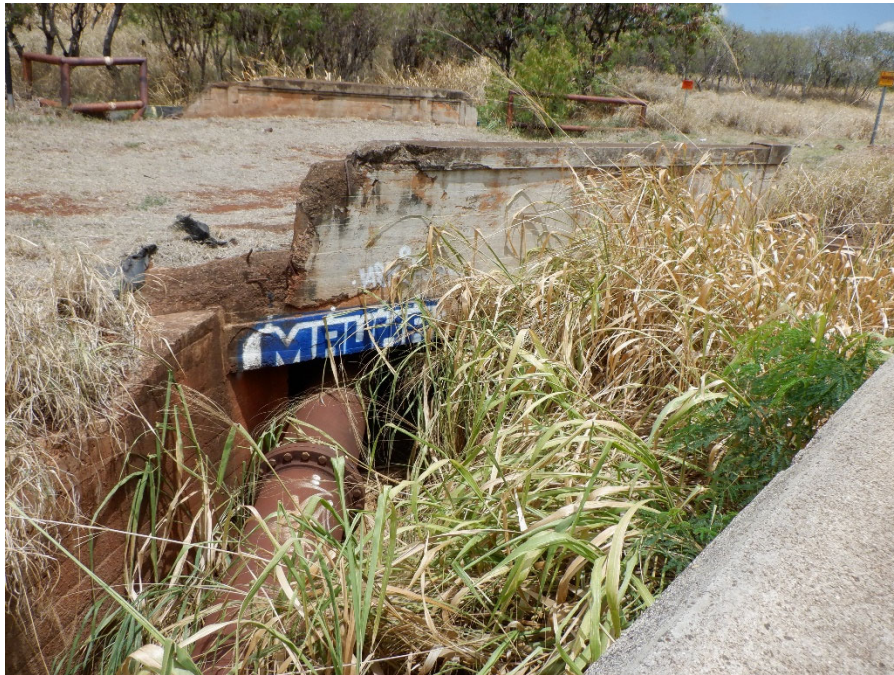
**PHOTO 24** UPSTREAM CHANNEL WITH HEAVY VEGETATION AND EXISTING ABANDONED BRIDGE

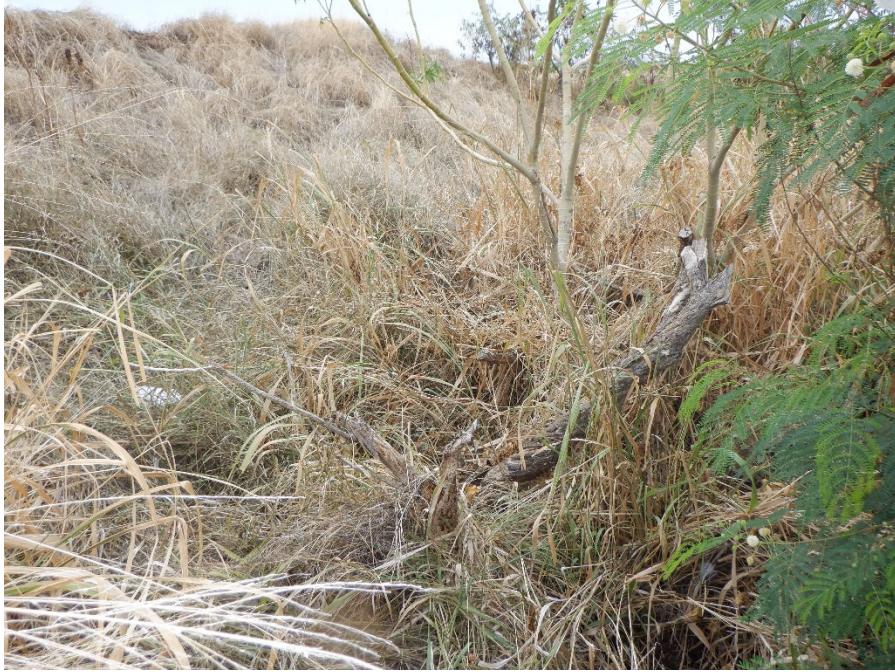
**PHOTO 25** DOWNSTREAM CHANNEL WITH HEAVY VEGETATION
