**ROUTINE BRIDGE INSPECTION REPORT  
FEDERAL-AID PROJECT NO. BRIS-NBIS(080)  
CONTRACT NO. SC-DDC-2200014**

**FARRINGTON HIGHWAY BRIDGE NO. 1 OVER KALOI GULCH  
BRIDGE NO. 923  
STRUCTURE NO. 003923001100001**

**DATE OF INSPECTION: September 1, 2021**

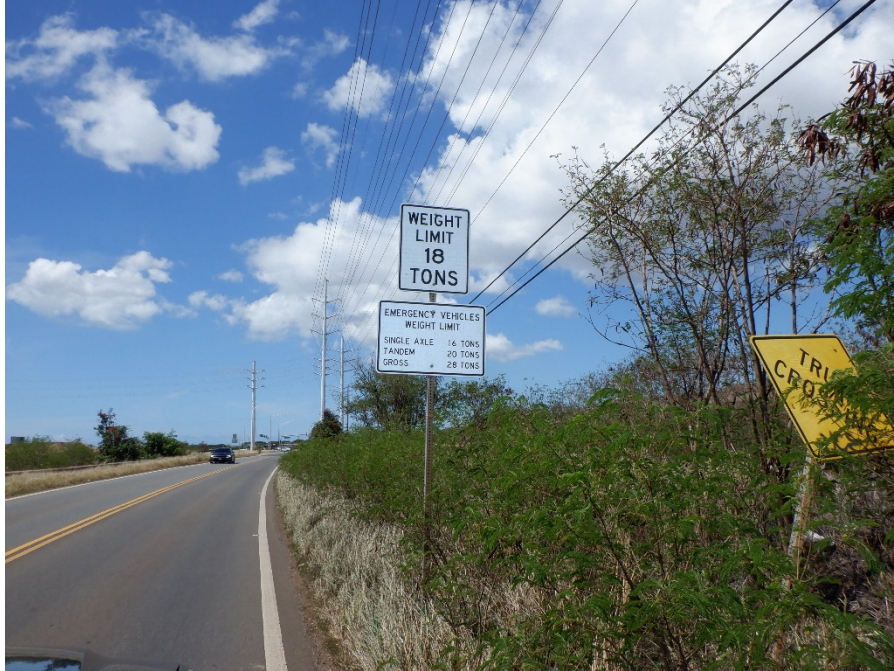
**PHOTO 5** LOAD POSTING SIGNS AND BENT TRUCK CROSSING SIGN ON FARRINGTON HIGHWAY AT EAST APPROACH TO BRIDGE

There is total of 5 Weight limit sign for this bridge.

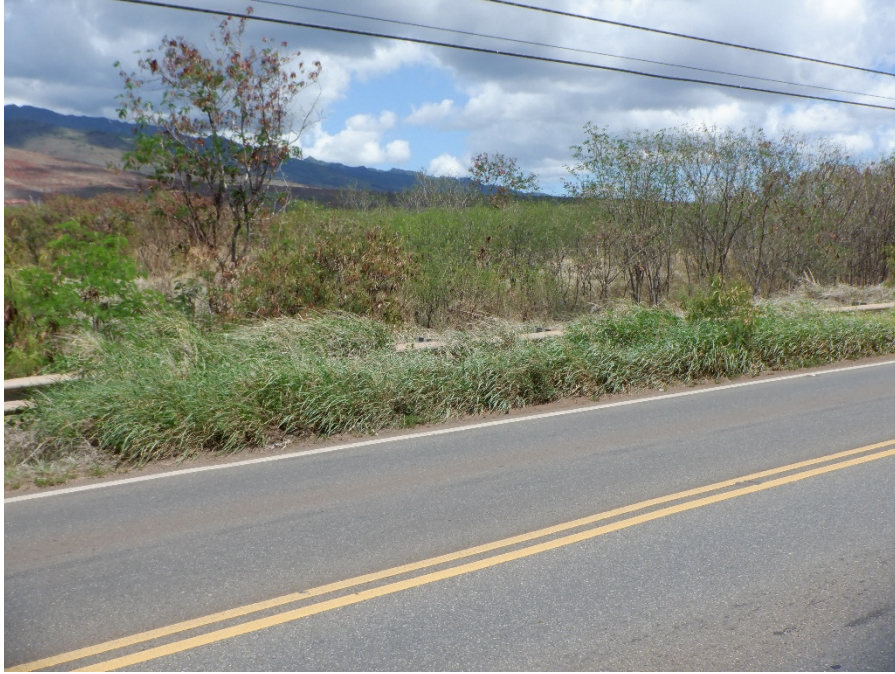
**PHOTO 7** HEAVY VEGETATION AT UPSTREAM EAST APPROACH GUARDRAIL

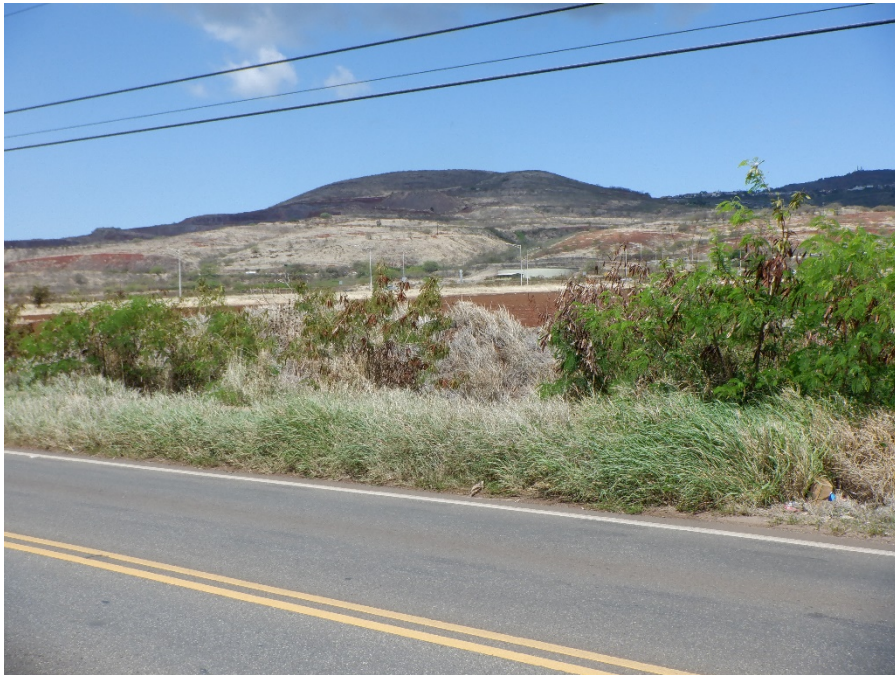
**PHOTO 8** UPSTREAM WEST APPROACH GUARDRAIL COVERED BY HEAVY VEGETATION

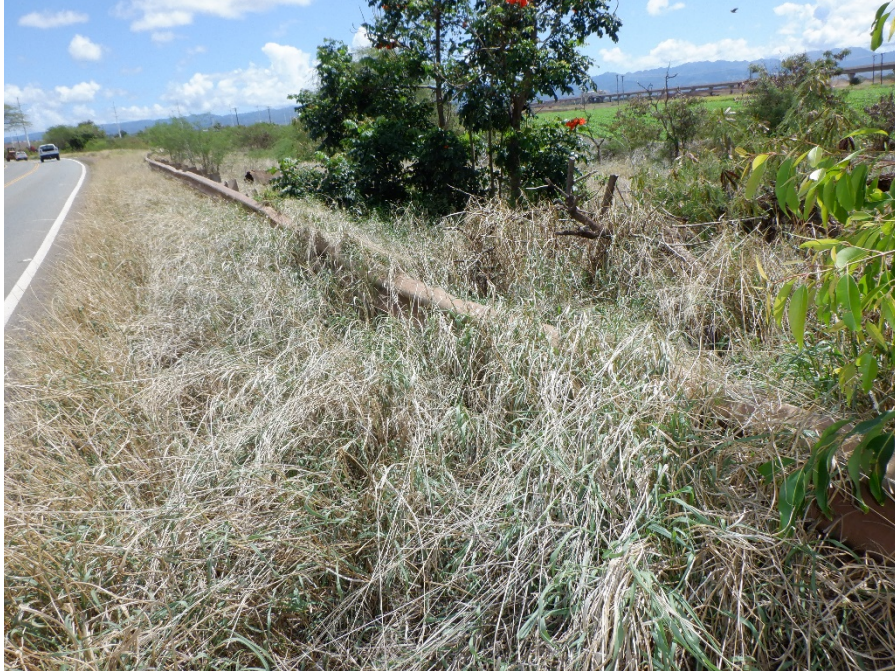
**PHOTO 9** HEAVY VEGETATION AT DOWNSTREAM EAST APPROACH GUARDRAIL

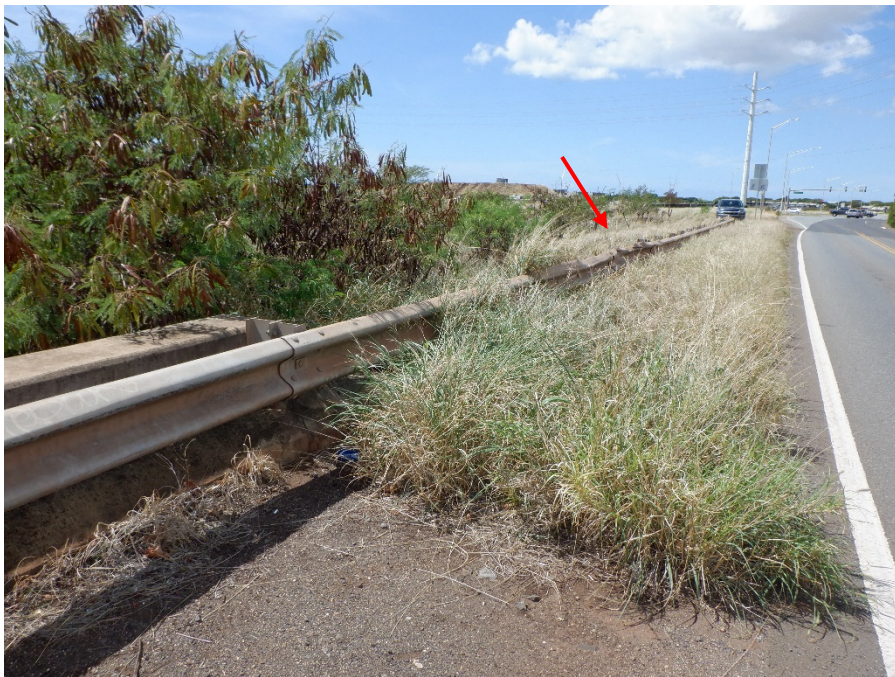
**PHOTO 10** DOWNSTREAM WEST APPROACH GUARDRAIL WITH VEGETATION AND IMPACT DAMAGE (SEE PHOTO 11)

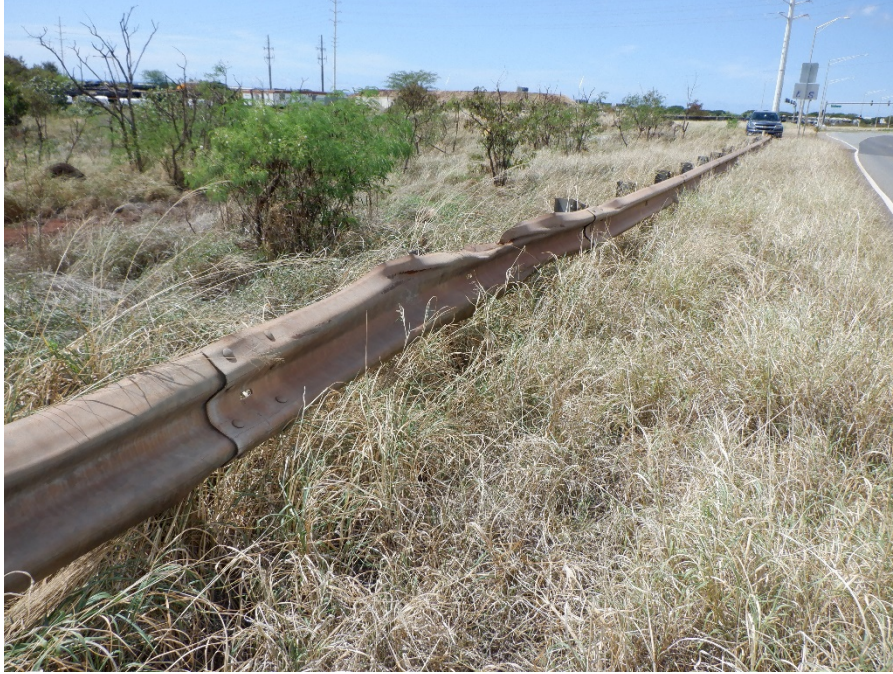
**PHOTO 11** IMPACT DAMAGE AT DOWNSTREAM WEST APPROACH  
GUARDRAIL

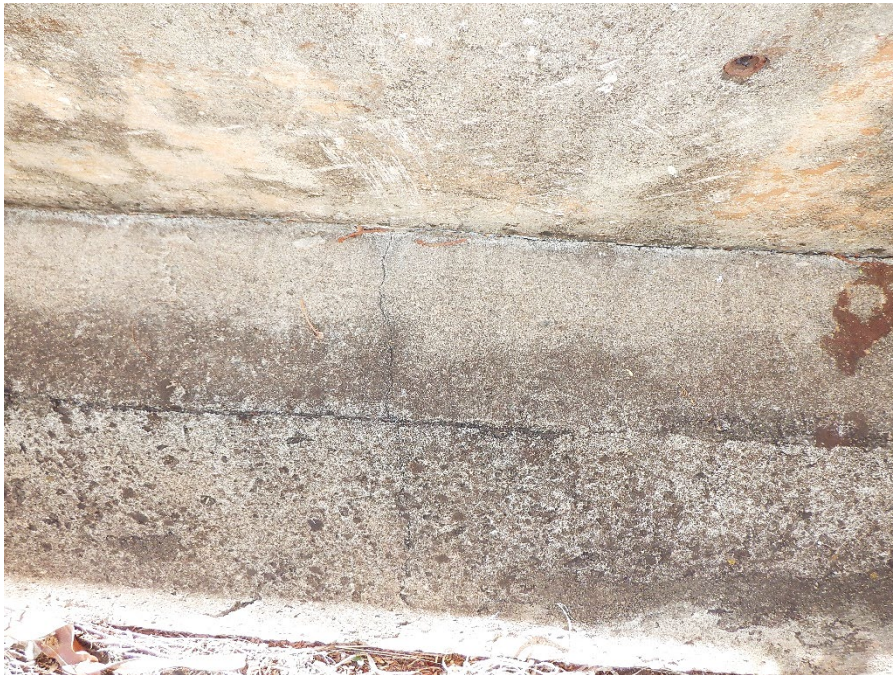
**PHOTO 12** TYPICAL TRANSVERSE CRACK ON DOWNSTREAM CURB

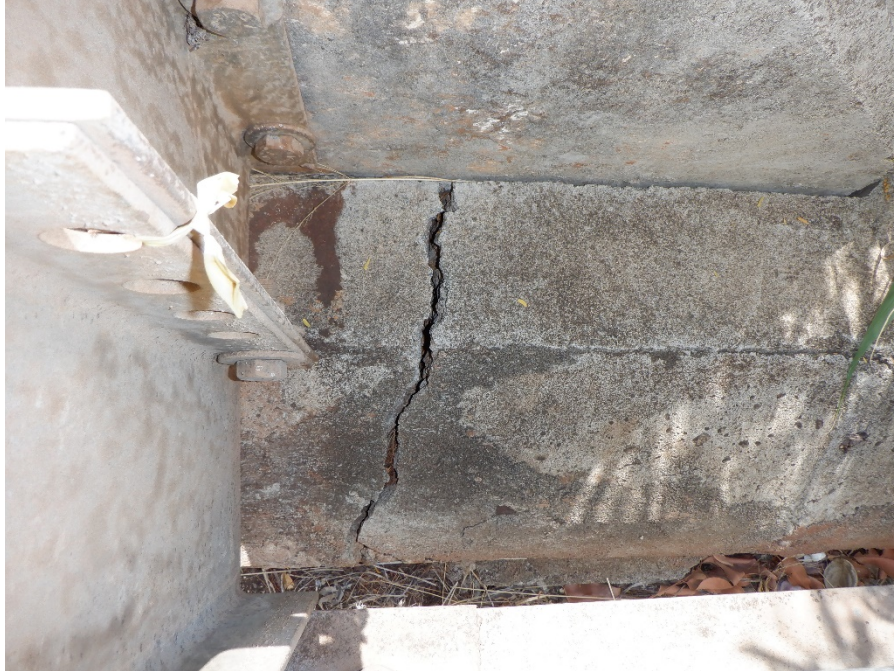
**PHOTO 13** 1/2" WIDE TRANSVERSE CRACK ON DOWNSTREAM CURB, AT WEST END

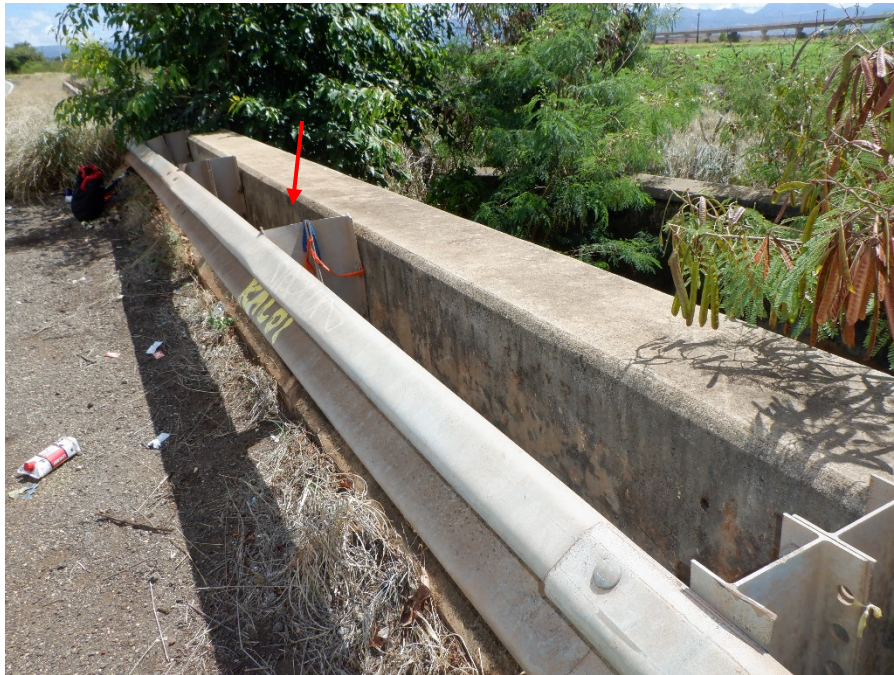
**PHOTO 14** TYPICAL IMPACT DAMAGE AT DOWNSTREAM GUARDRAIL POSTS (SEE PHOTO 15)

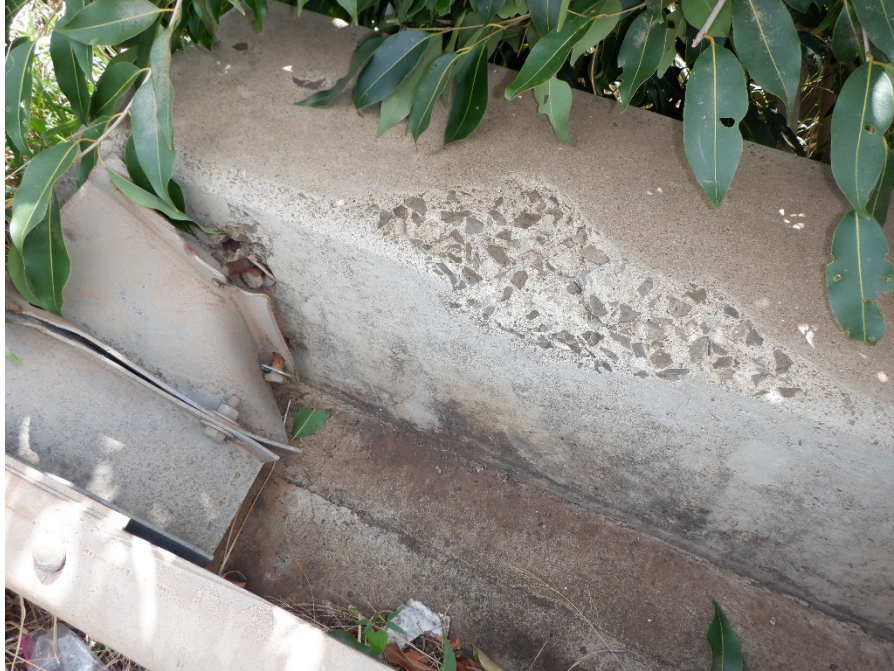
| ELEMENT INSPECTION | | | | | | | | |
|---|---|---|---|---|---|---|---|---|
| Defect No. 1080/7000:<br>- 1'-6"x6" spall (2FT CS2) on downstream railing at east end of bridge (Photo 15) | | | | | | | | |

**PHOTO 15** 1'-6"X6" SPALL (2FT 1080 CS2) ON DOWNSTREAM CONCRETE BRIDGE RAILING AT EAST END OF BRIDGE AND IMPACT DAMAGE AT GUARDRAIL POST

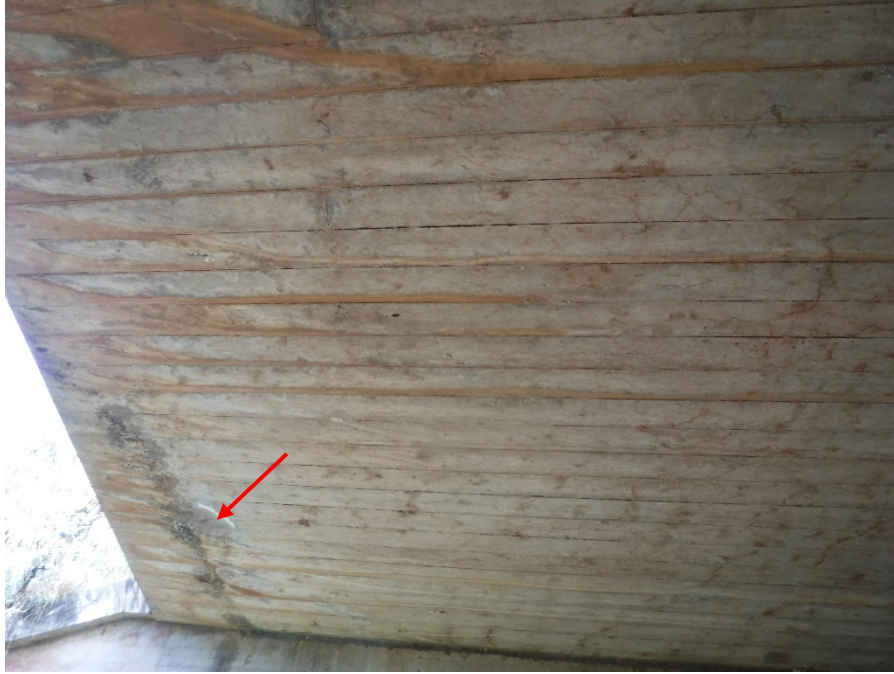
| ELEMENT INSPECTION | | | | | | | | |
|---|---|---|---|---|---|---|---|---|
| Defect No. 1080:<br>- 8'x1' delamination (8SF CS2) at upstream edge of slab soffit, adjacent to Abutment 2 (Photo 17) | | | | | | | | |

**PHOTO 17** 8'X1' DELAMINATION (8SF 1080 CS2) AT UPSTREAM  
EDGE OF SLAB SOFFIT, ADJACENT TO ABUTMENT 2

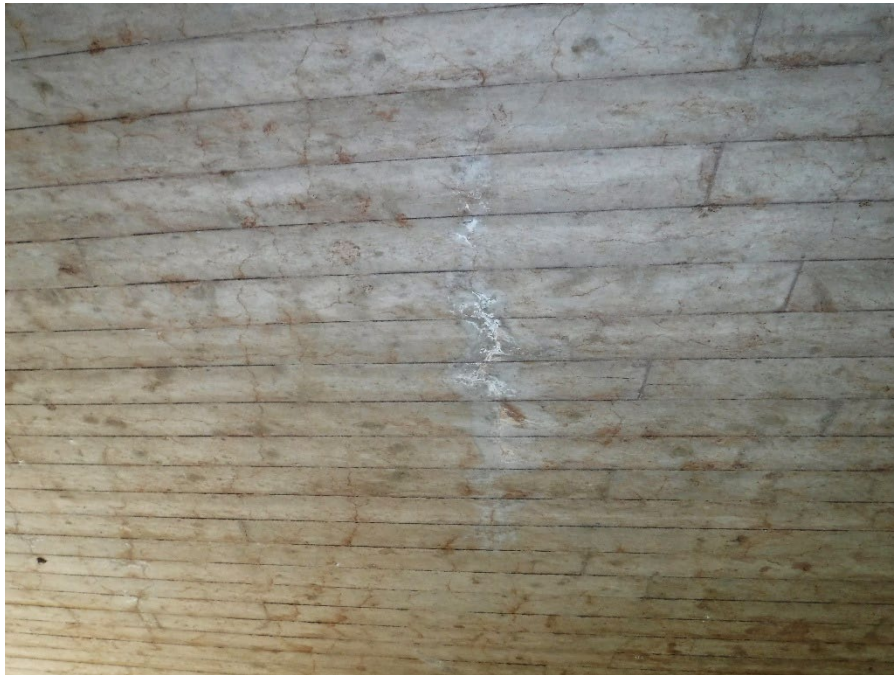
| ELEMENT INSPECTION | | | | | | | | |
|---|---|---|---|---|---|---|---|---|
| Defect No. 1120:<br>- Longitudinal crack with surface white efflorescence (10SF CS2) on slab soffit (Photo 18) | | | | | | | | |

**PHOTO 18** LONGITUDINAL CRACK WITH SURFACE WHITE  
EFFLORESCENCE (10SF 1120 CS2) ON SLAB SOFFIT

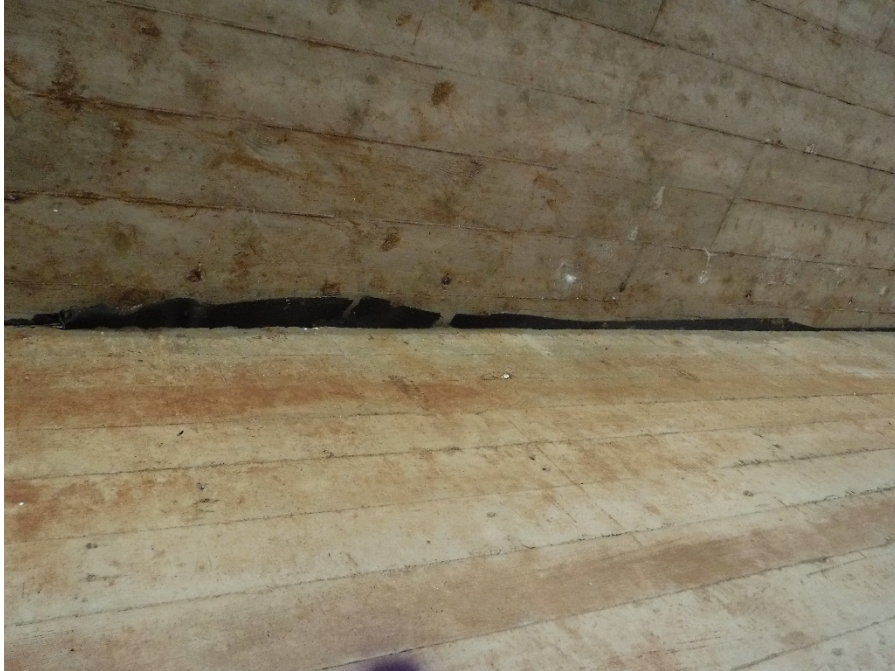
**PHOTO 19** PROTRUDING ROOFING PAPER ALONG TOP OF ABUTMENT 1

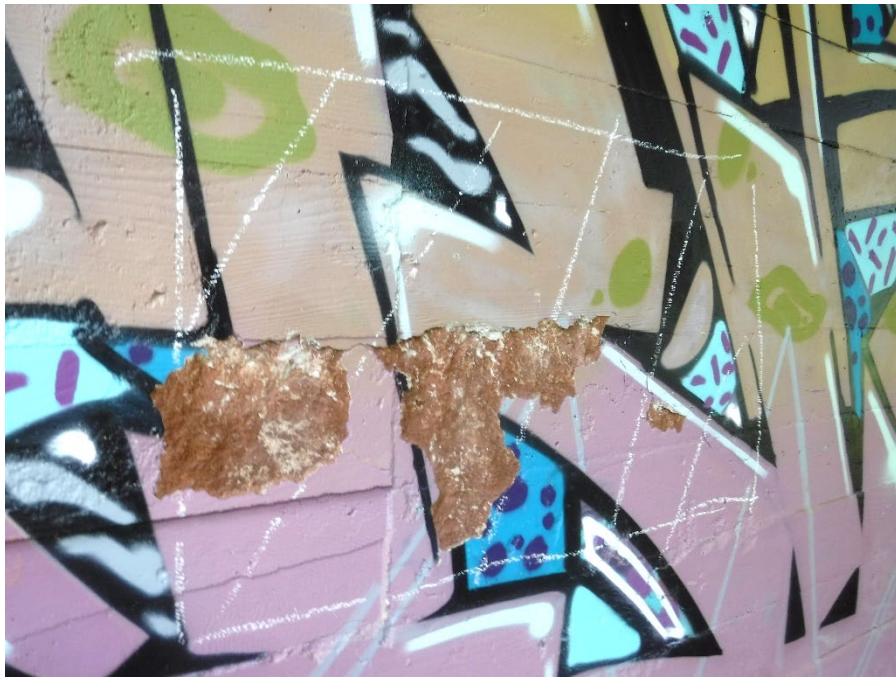
| ELEMENT INSPECTION | | | | | | | | |
|---|---|---|---|---|---|---|---|---|
| Defect No. 1080:<br>- 3'x2' delamination (3FT CS2) on Abutment 1 (Photo 22) | | | | | | | | |

**PHOTO 22** 3'X2' DELAMINATION (3FT 1080 CS2) ON ABUTMENT 1

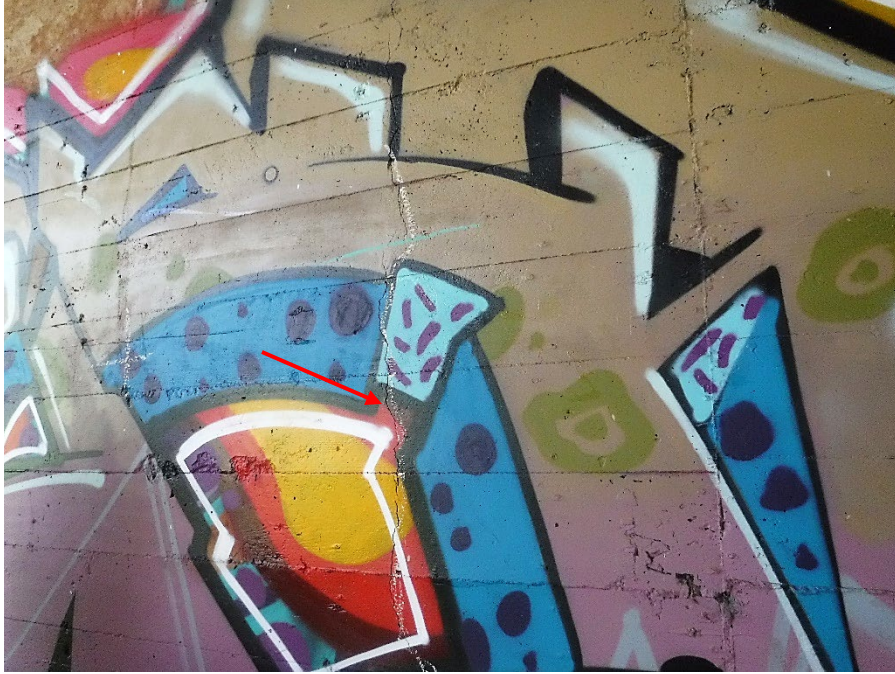
| ELEMENT INSPECTION | | | | | | | | |
|---|---|---|---|---|---|---|---|---|
| Defect No. 1130:<br>- Moderate width cracks (4FT CS2) on both abutments (Photo 23) | | | | | | | | |

**PHOTO 23** MODERATE WIDTH CRACK (1130 CS2) ON ABUTMENT 1, TYPICAL ON BOTH ABUTMENTS

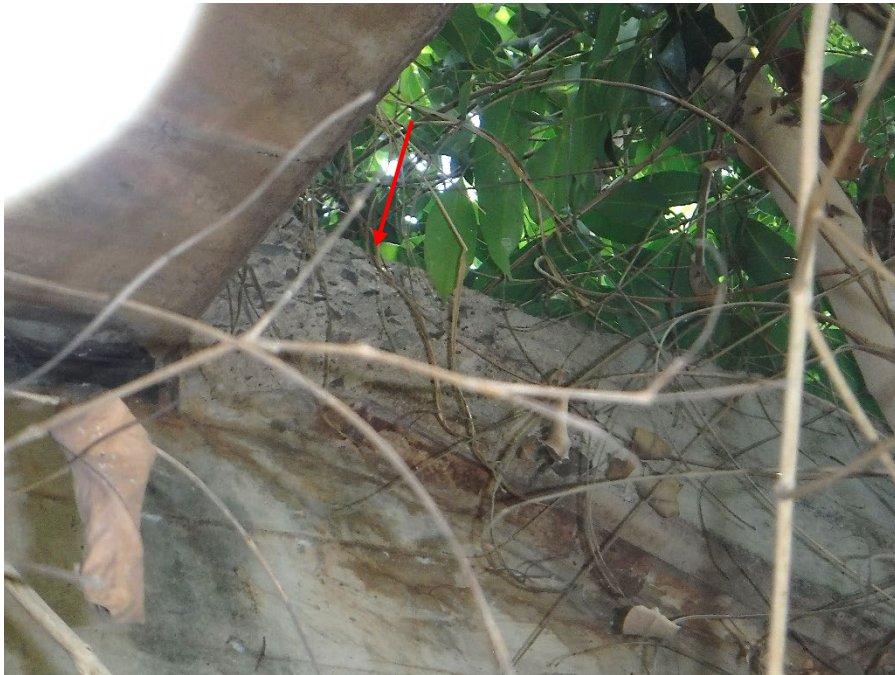
**PHOTO 24** 2'X1' SPALL AT TOP OF DOWNSTREAM EAST WINGWALL

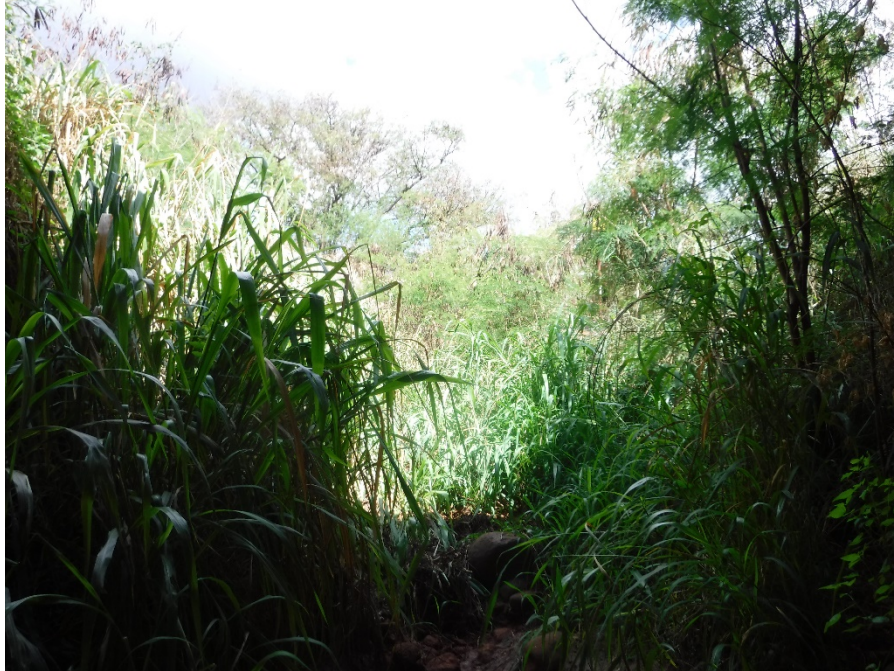
**PHOTO 25** UPSTREAM CHANNEL WITH HEAVY VEGETATION

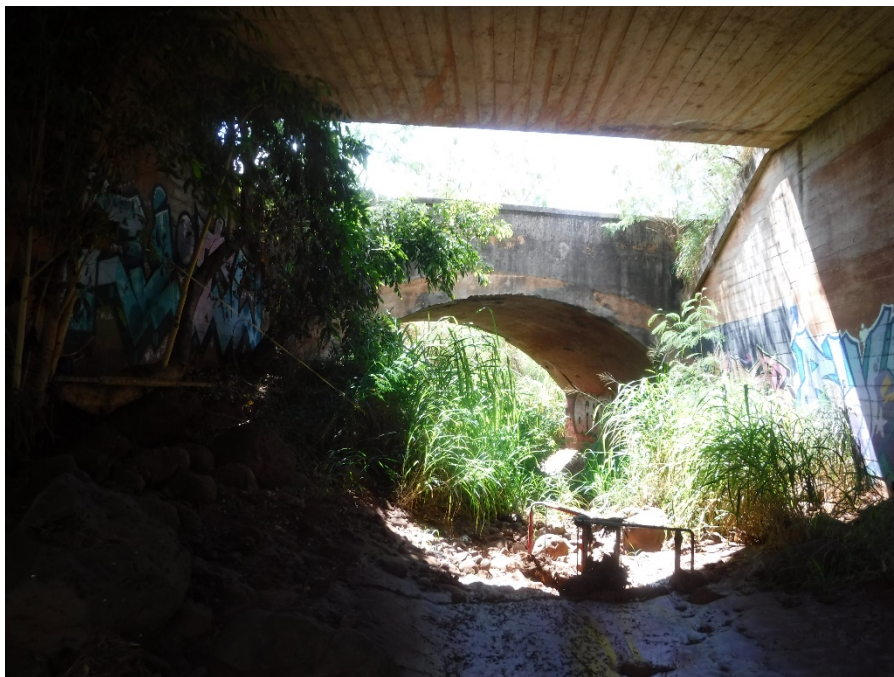
**PHOTO 26** DOWNSTREAM CHANNEL WITH HEAVY VEGETATION
