DOT Parking head-on

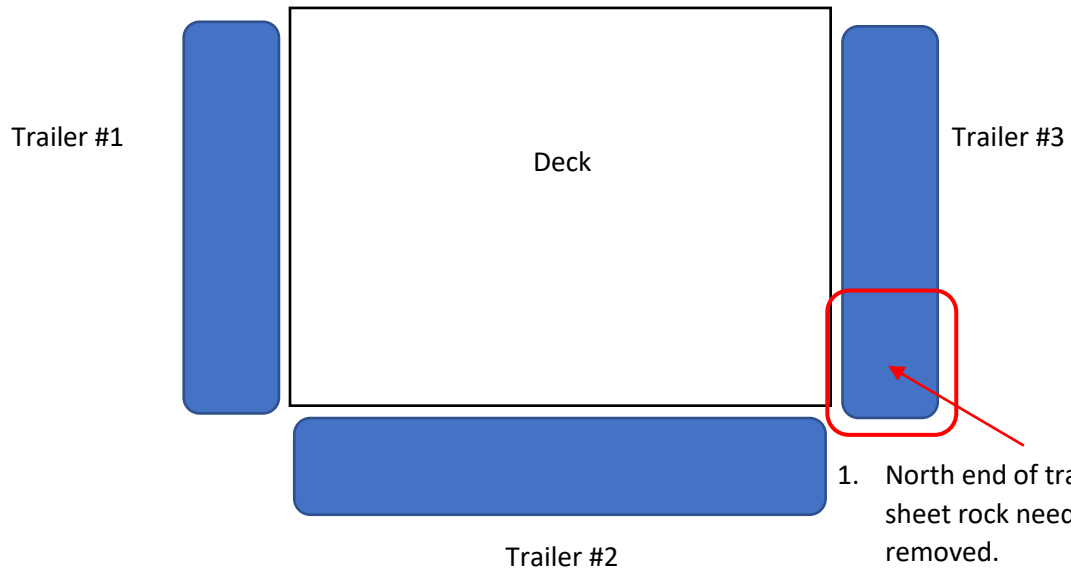
1. North end of trailer interior sheet rock needs to be removed.
2. Check for condensation build up from air con unit.
3. Replace sheet rock, spackle, and paint.
