**KA'AHUMANU HALE ATRIUM TILE FLOORING REPLACEMENT**

**PROJECT IDENTIFIER: JUD-24-1-0200**

Kaahumanu Hale Lobby Floor Tiles – Asbestos Survey

Subject: Kaahumanu Hale Lobby Floor Tiles, RMA #22-019 – Asbestos Survey

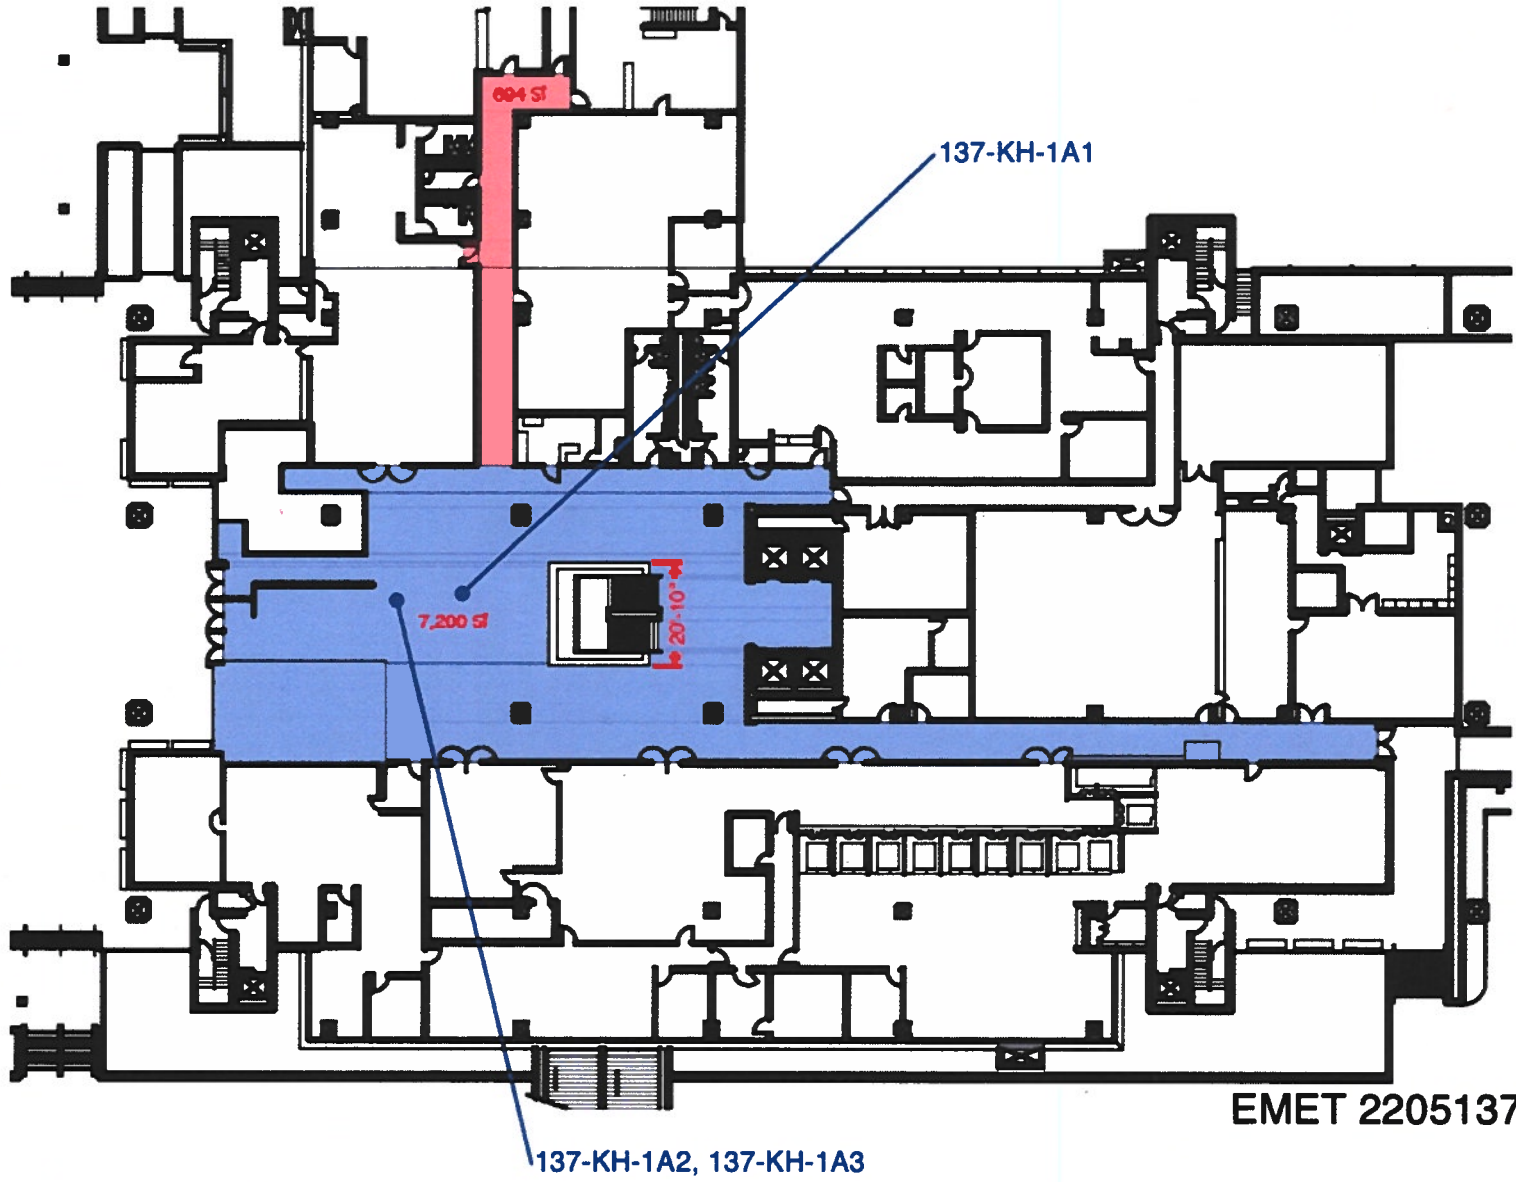
# Kaahumanu Hale Lobby Floor Tile - Asbestos Sample Locations

EMET collected samples from the areas with pre-existing damage to the quarry tiles covered over with wooden plyboards. See the attached sketch for the sample locations.
