ADDENDUM NO. 2

Job No. J00AO99B
DLNR Human Resources Office Improvements
Kalanimoku Building, Room 231
Honolulu, Oahu, Hawaii

HAZARDOUS MATERIALS SURVEY
Kalanimoku Building
Department of Land and Natural Resources Personal Office
1151 Punchbowl Street, Room 231
Honolulu, Hawaii 96813

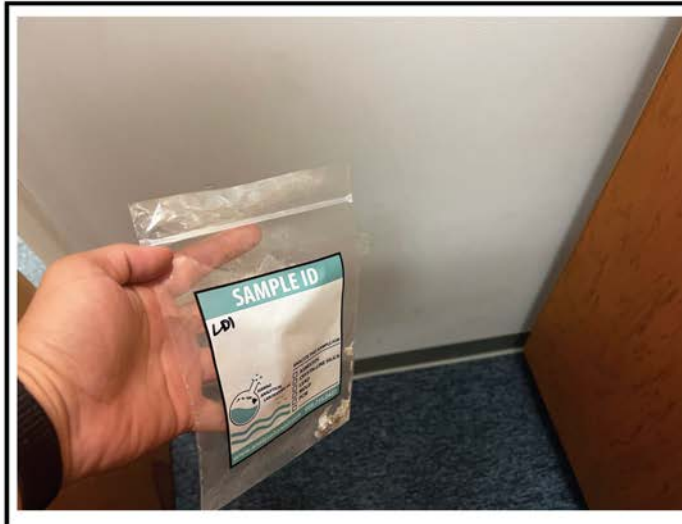
Photograph #3

Sample LD1 – White paint sample from drywall determined not to be lead containing paint.

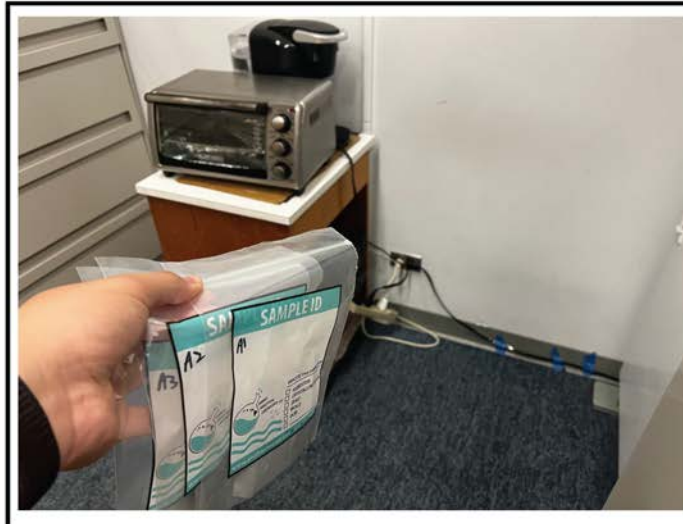
Photograph #5

Samples: A1, A2, & A3: Gray covebase, cream mastic, and brown mastic determined not to be ACM.

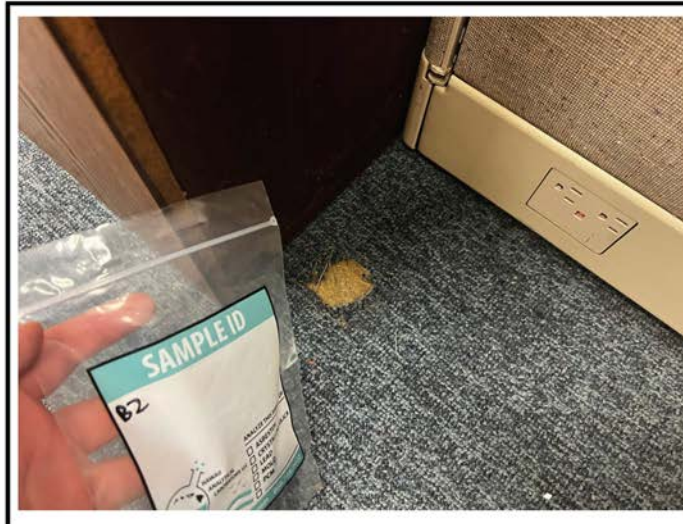
Photograph #7

Sample B2 – Blue carpet and yellow mastic determined not to be ACM.

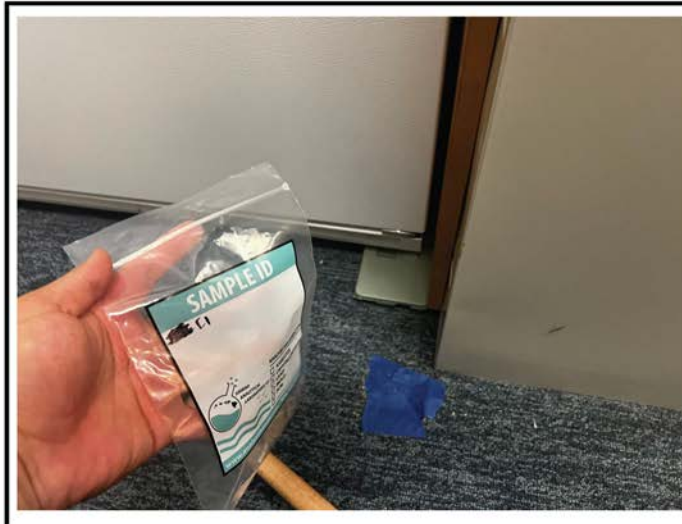
Photograph #9

Sample C1 – Beige floor tile, black mastic, and yellow mastic **determined to be ACM.**

- 1. Removal and disposal of the beige/tan vinyl floor tile (VFT) and associated black mastic located in Room 231 as identified in the Hazardous Material Inspection Report and/or Project Drawings. The black mastic shall be completely removed from the concrete floor substrate.

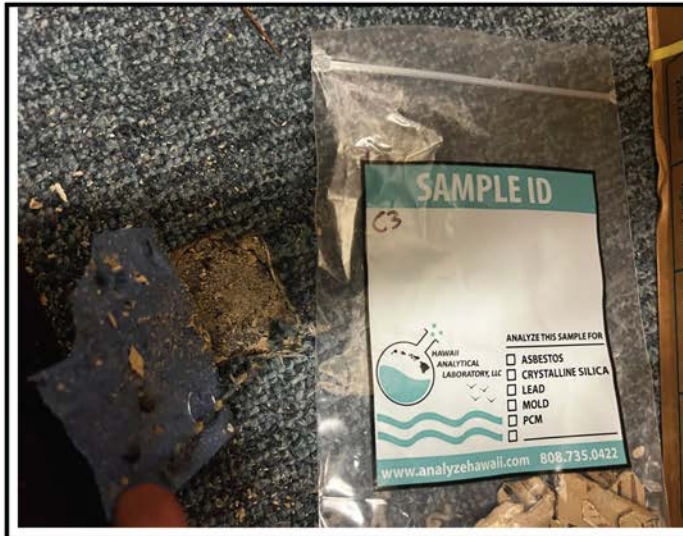
Photograph #11

Sample C3 – Gray floor tile, beige floor tile, black mastic, and yellow mastic determined to be ACM.

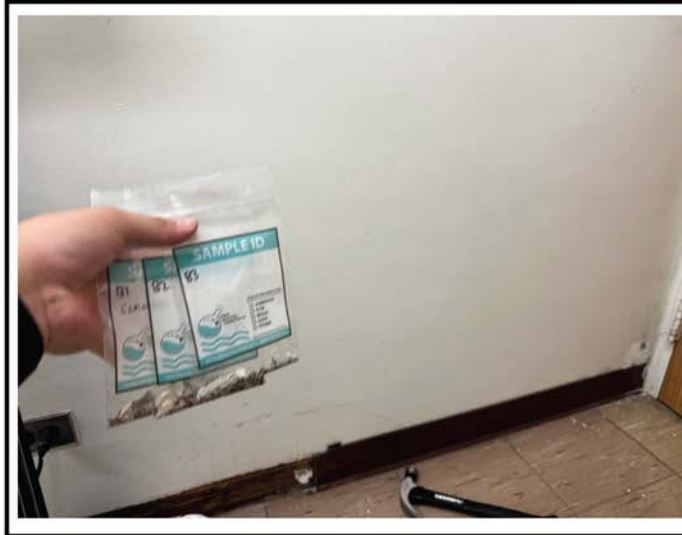
Photograph #13

Sample B1, B2, & B3 – Concrete samples determined not to be ACM.
