Material Analysis and Testing Report

Wilson Tunnel Plenum and Hanger Rods

September 6, 2022

Developed For: State of Hawaii Department of Transportation
District of Oahu

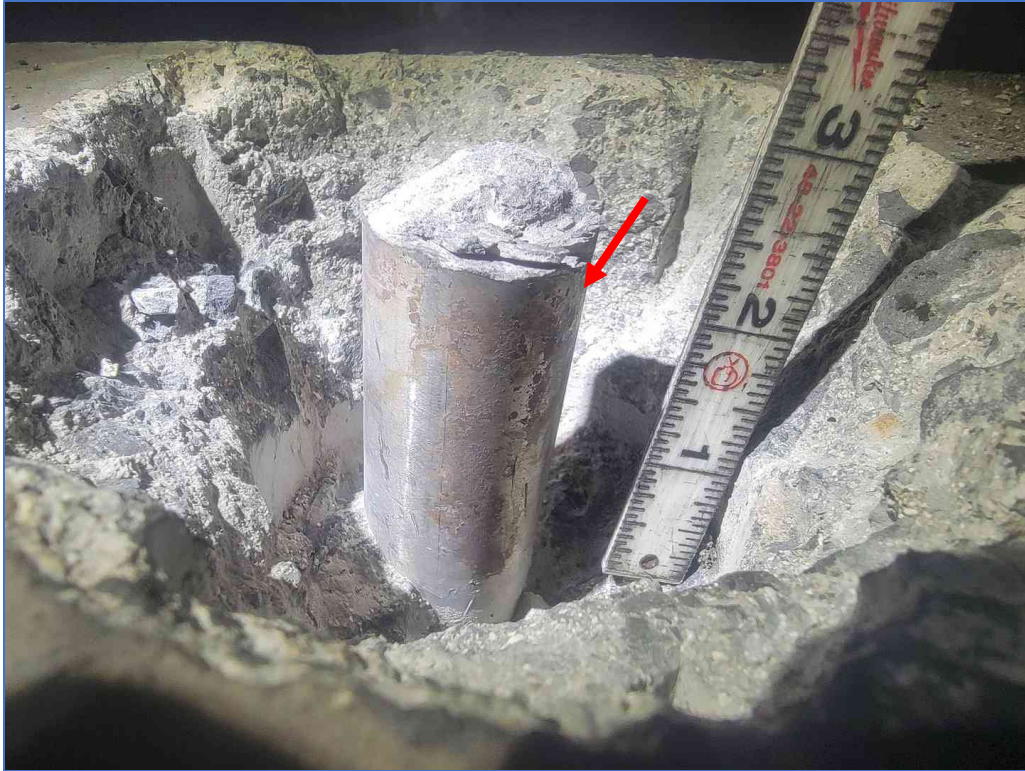
Additionally, the concrete from around the portion of the extracted rod showed corrosion staining at the top 2 in. of the surrounding concrete, and the fracture occurred just below the surface (Photo 5).

Photo 5: Fractured rod with corrosion in the top 2 in. (Rod 41, inbound bore, Kaneohe side).

- Patch concrete spalls throughout top of the concrete plenum slab.
- Clean and coat the existing stainless-steel hanger rods and install high-build epoxy cones at the base of the rods to direct moisture away from the rod/concrete interface.

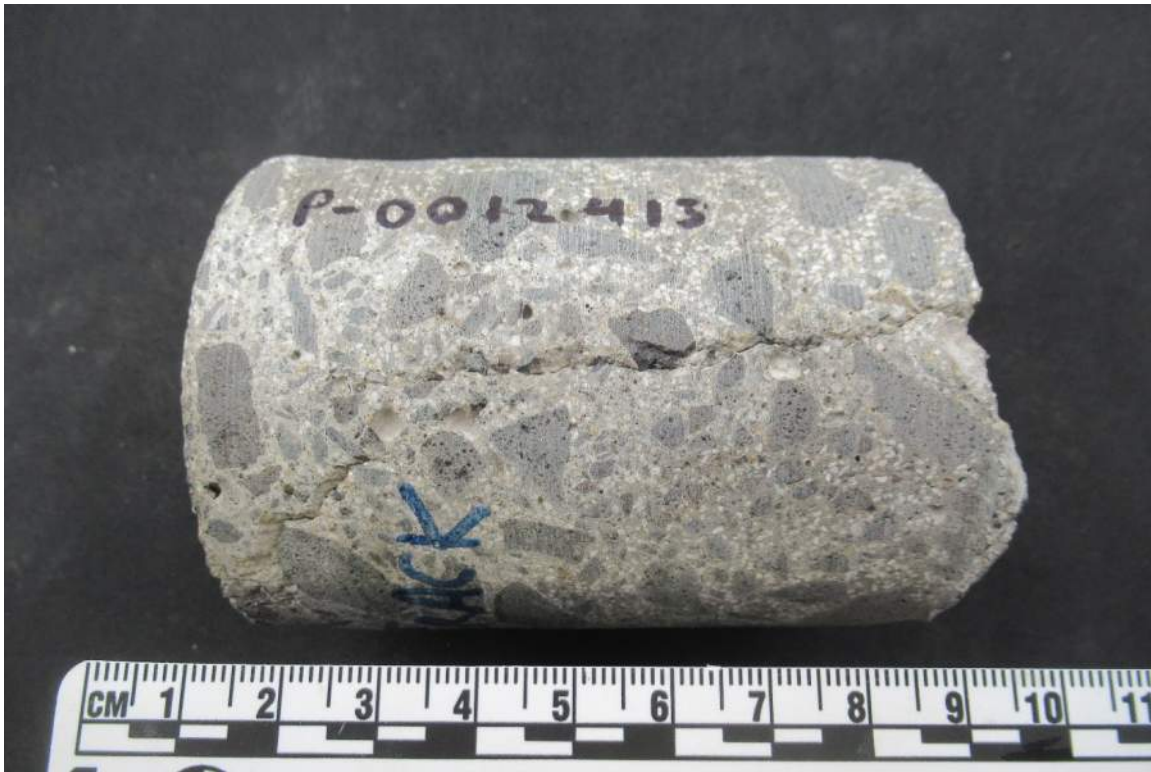
Core 1

Description: The formed outer surface of the sample as received. The red line shows the approximate location of the macrocrack.

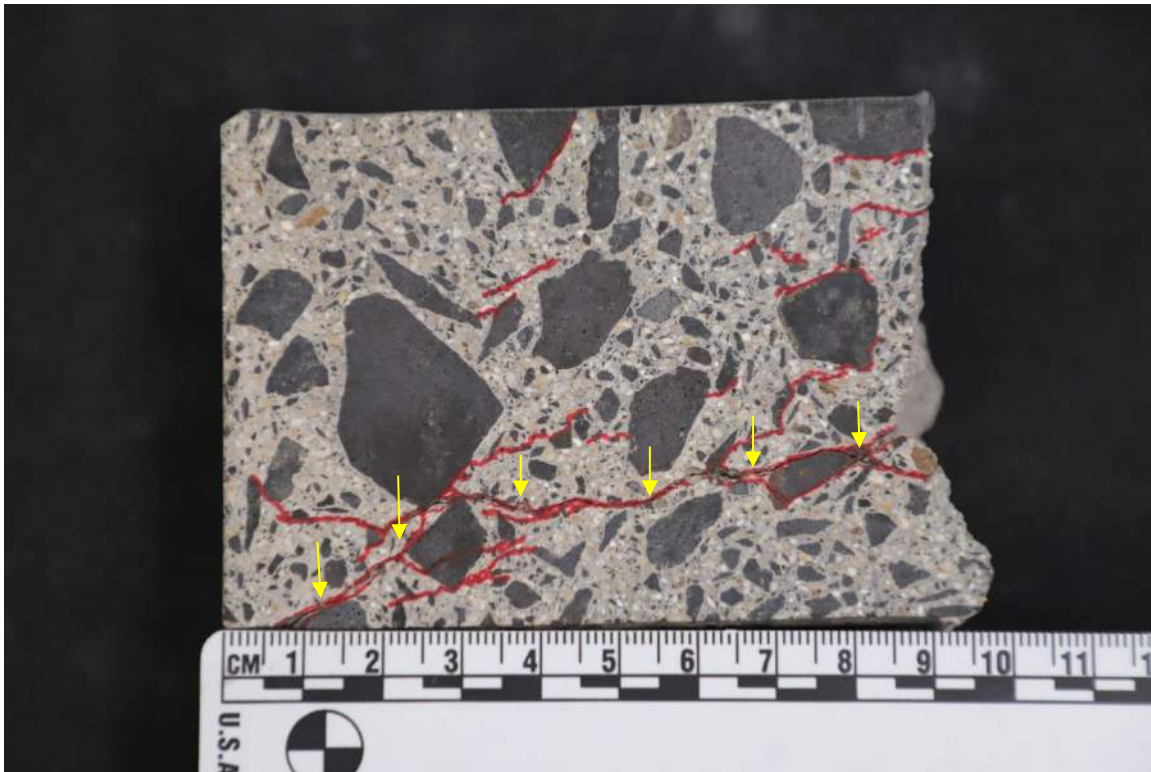
Core 1

Description: Saw cut and lapped cross section of the sample with the outer surface oriented to the left. Cracking was mapped in red ink. Yellow arrows indicate the macrocrack.

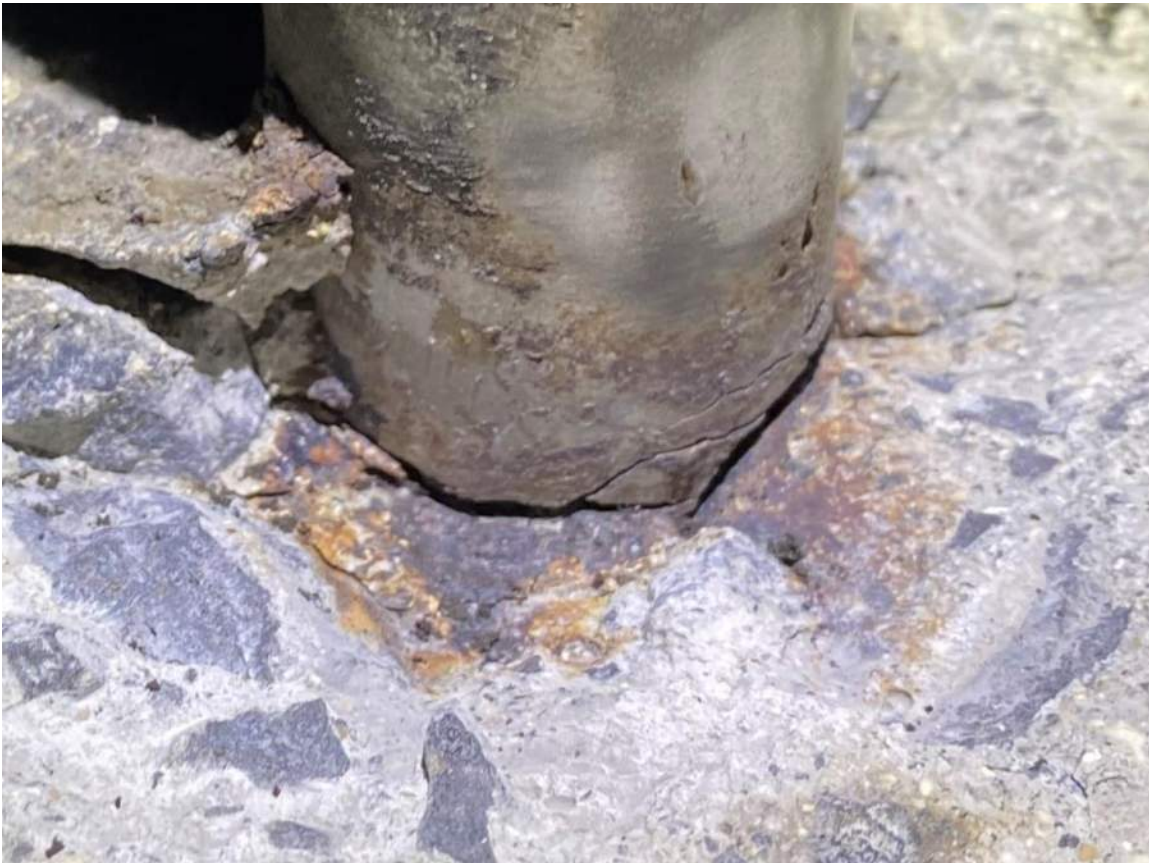
Severity level 3, interface fracture

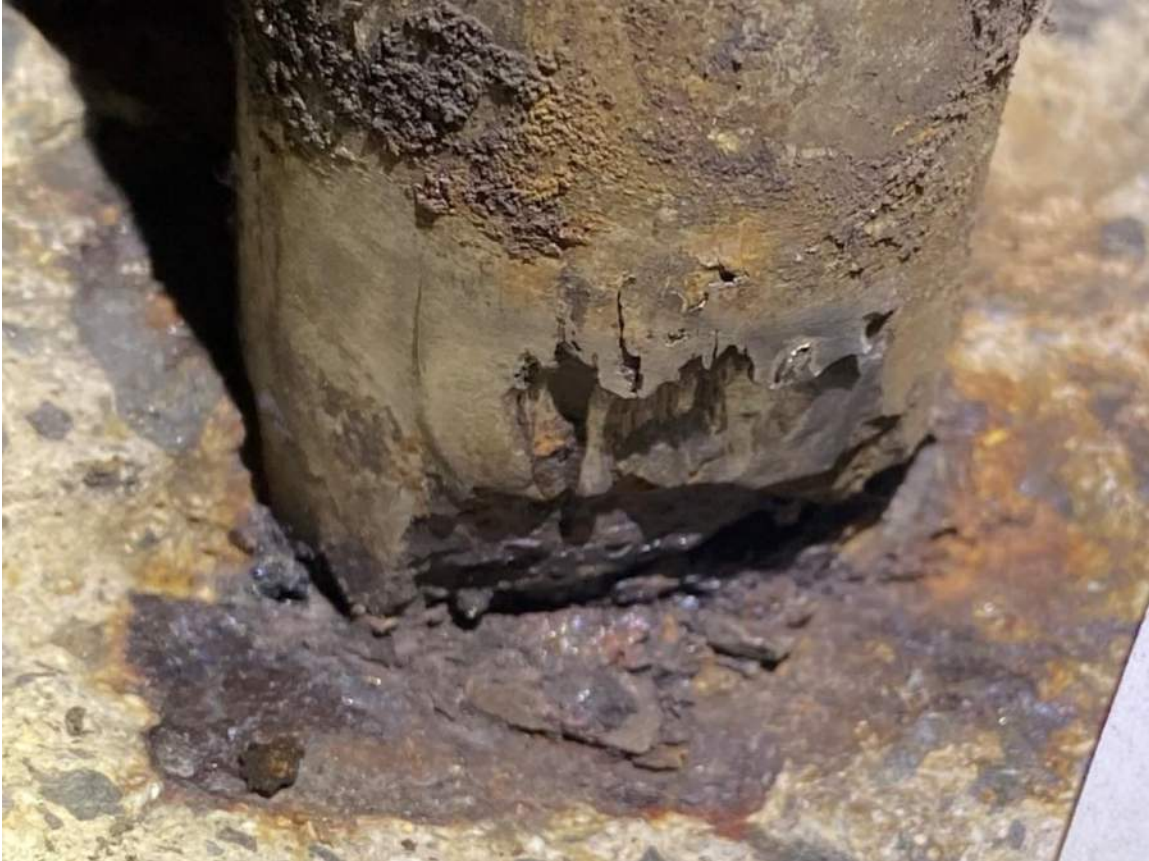
Severity level 3, interface fracture and severe corrosion

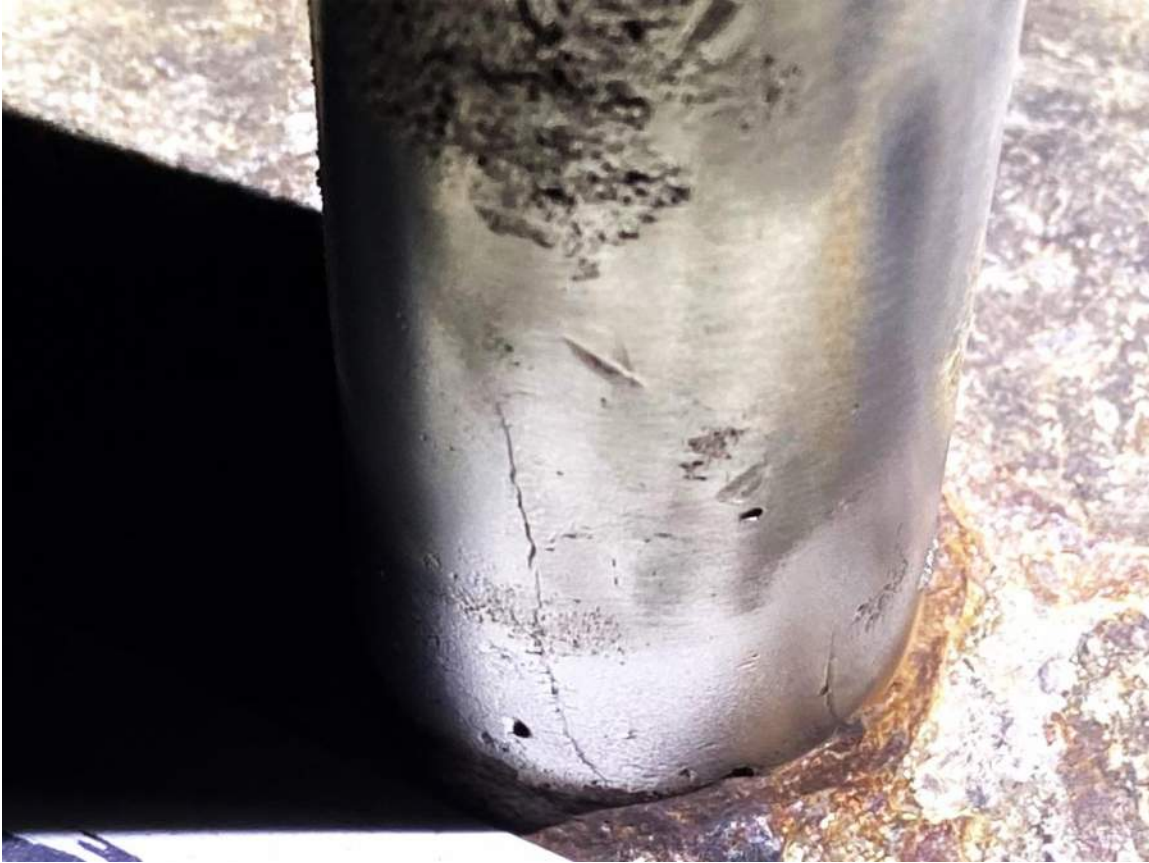
Severity level 3, visible cracking, and severe pitting

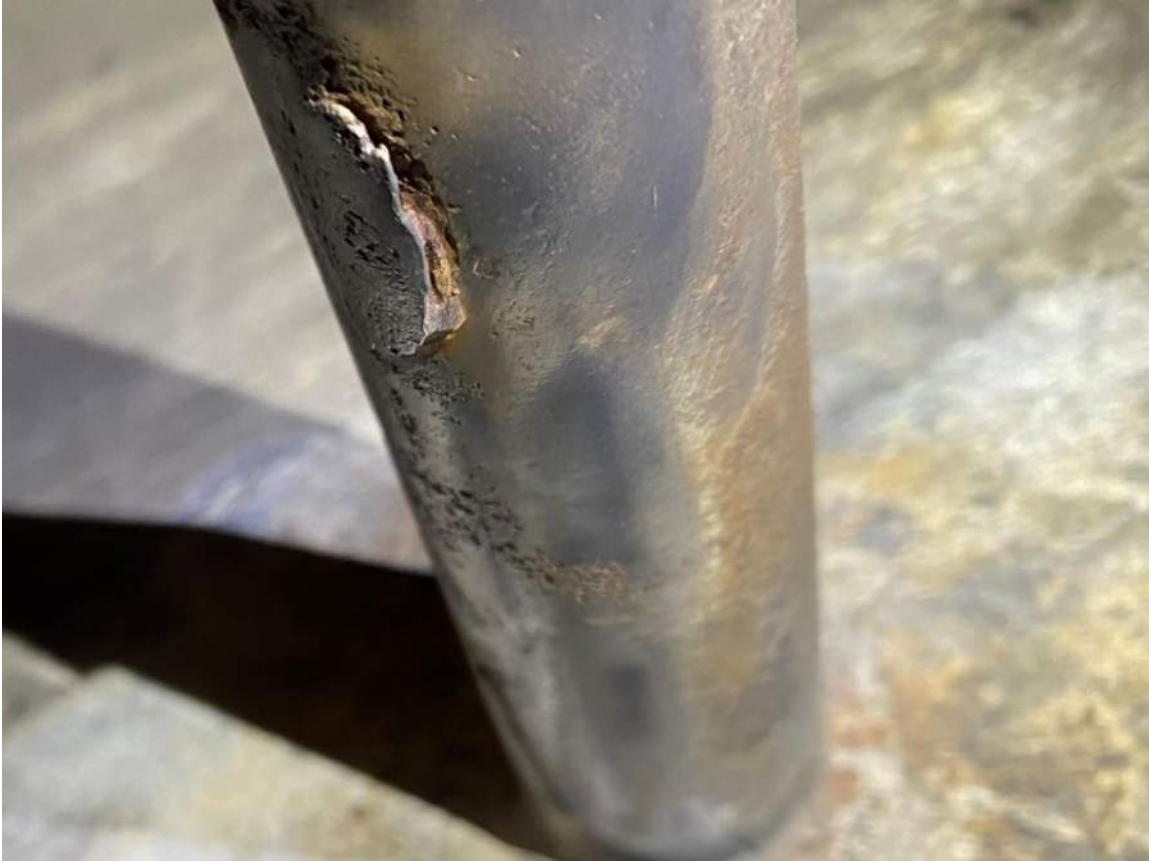
Severity level 3, visible cracking, and severe pitting

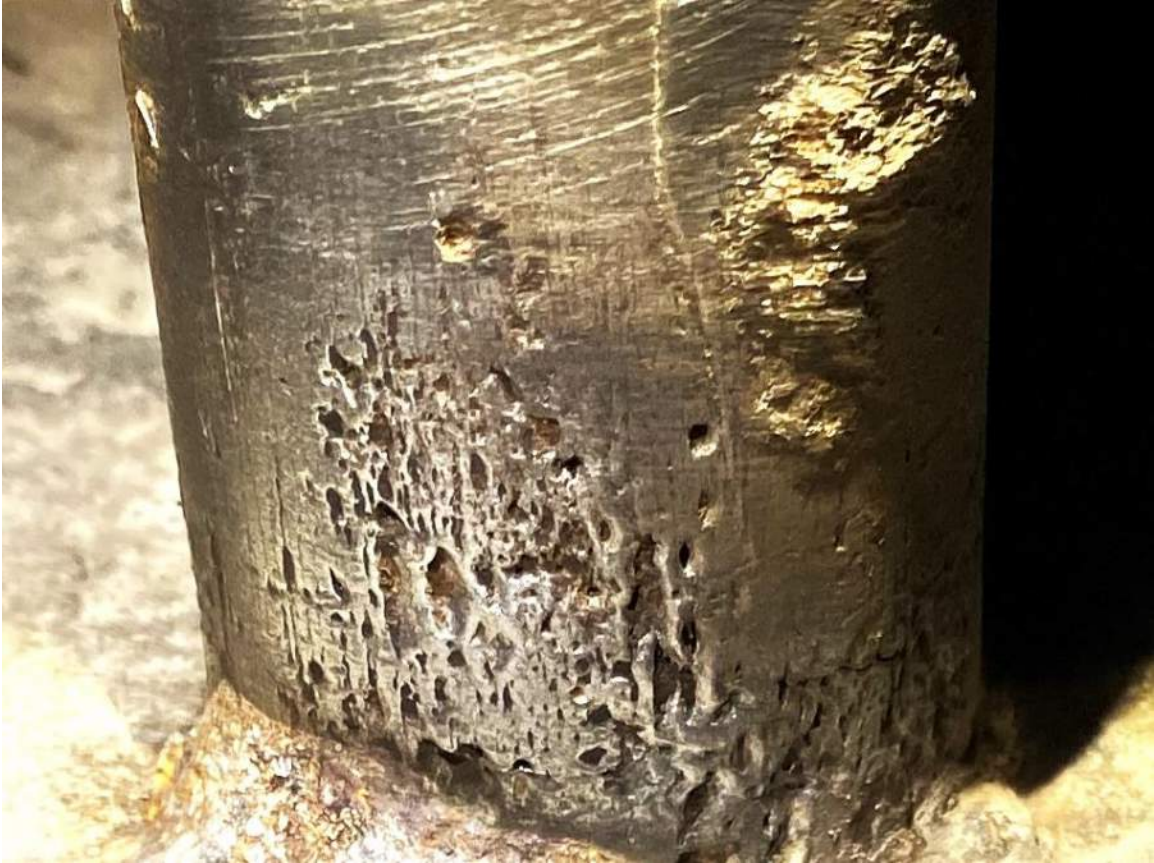
Severity level 3, visible cracking, and severe pitting

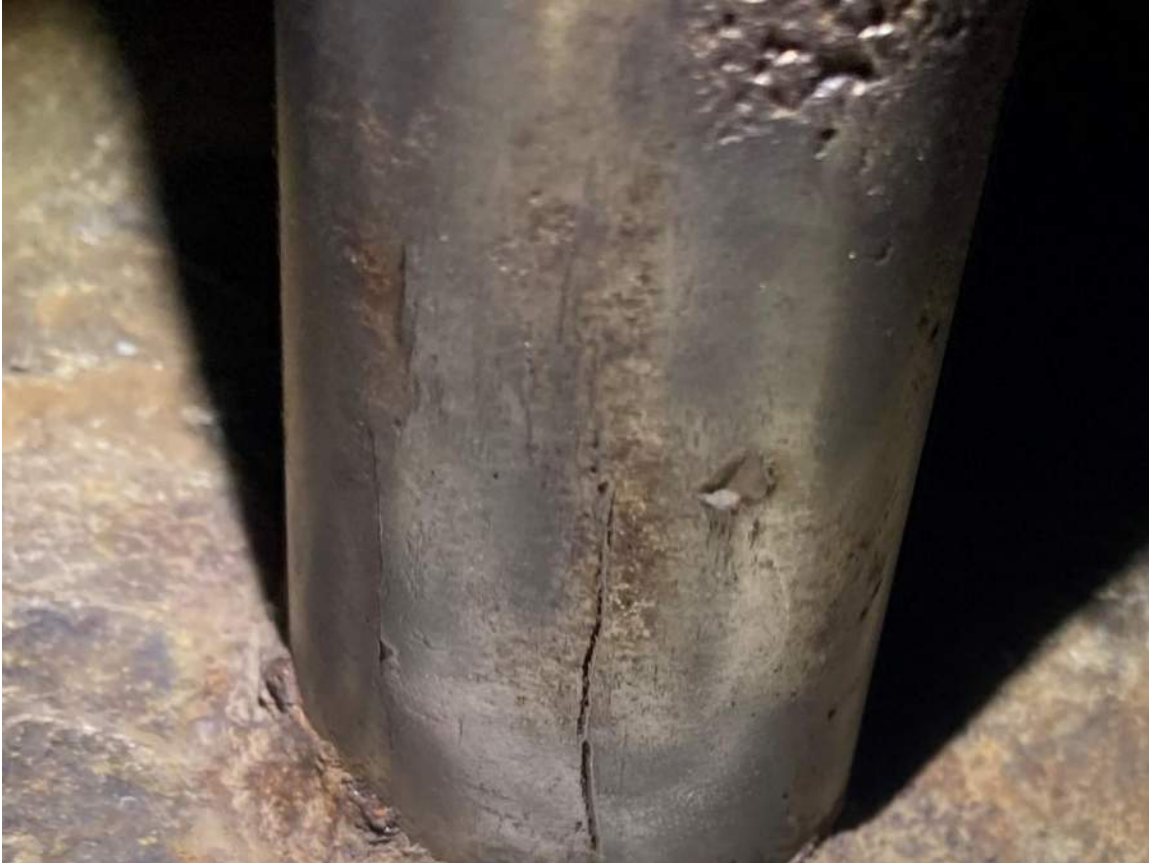
Severity level 3, visible cracking, and severe pitting

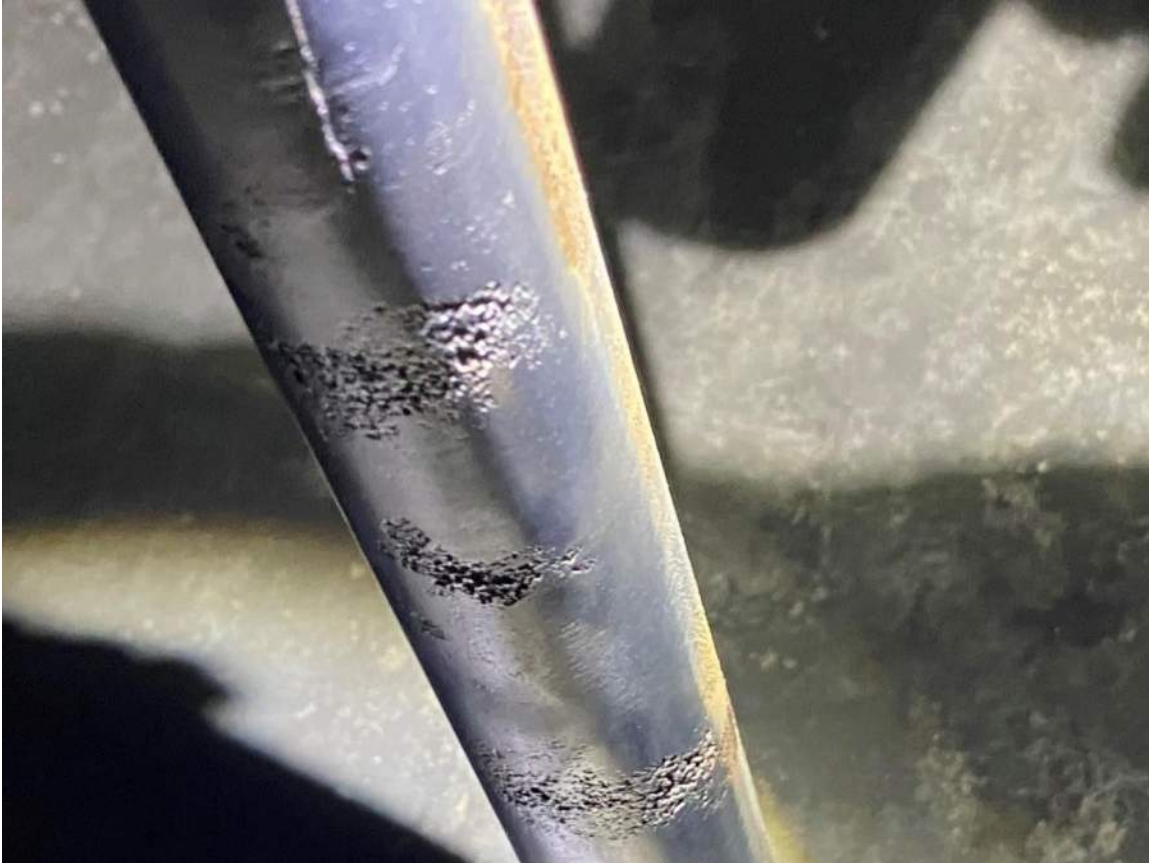
Severity level 3, visible cracking, and severe pitting

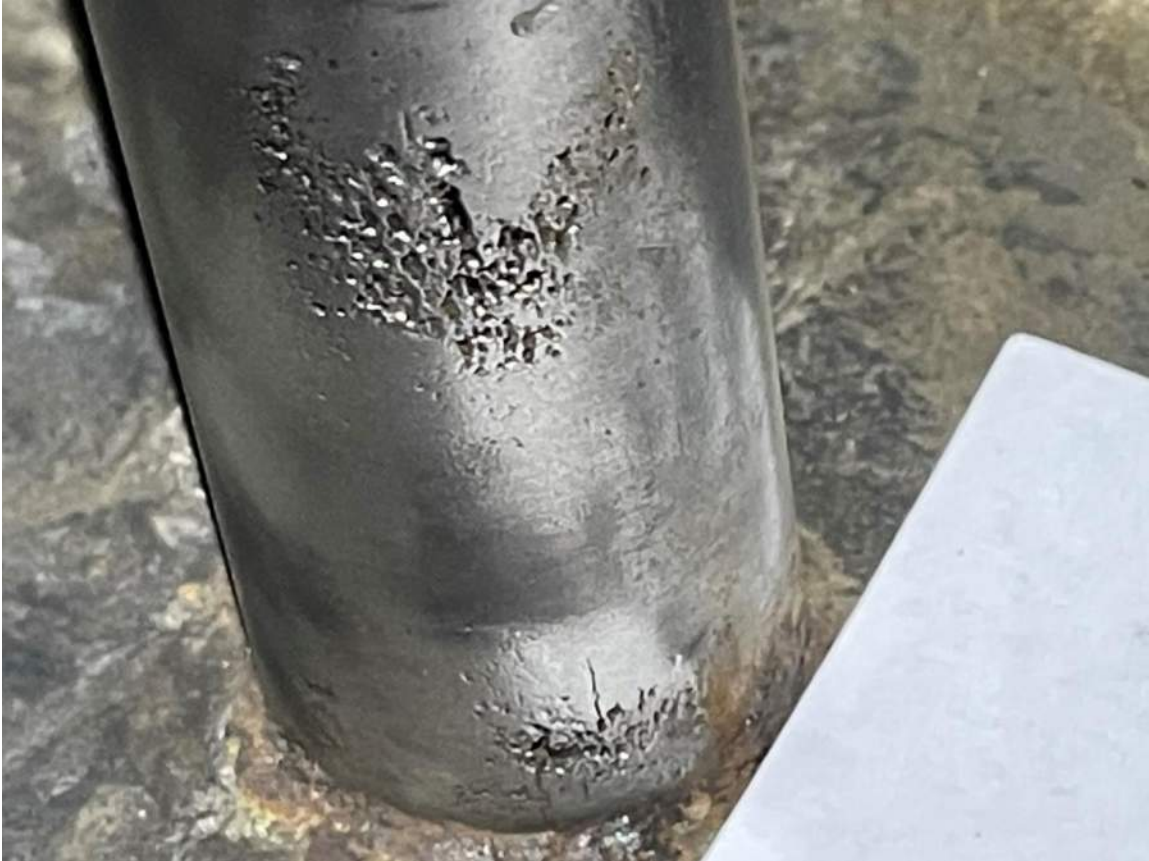
Severity level 3, visible cracking, and severe pitting

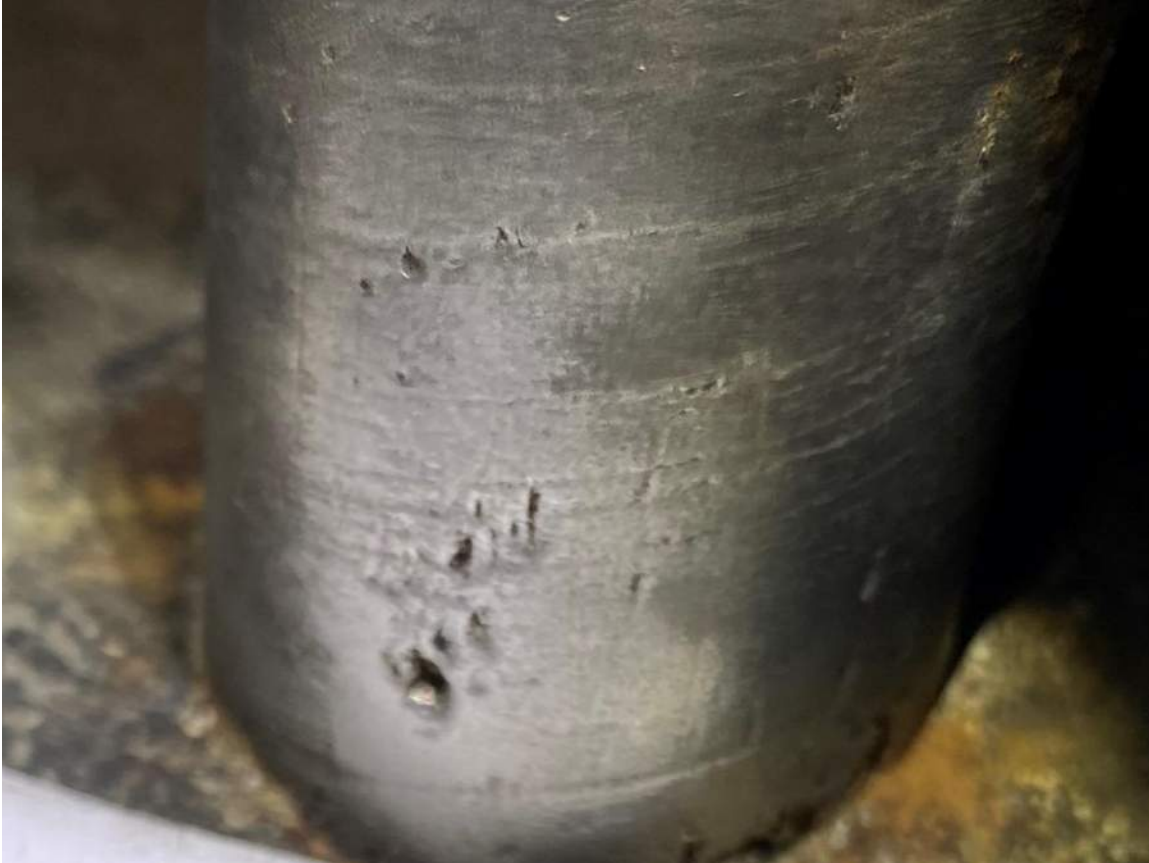
Severity level 2, moderate pitting

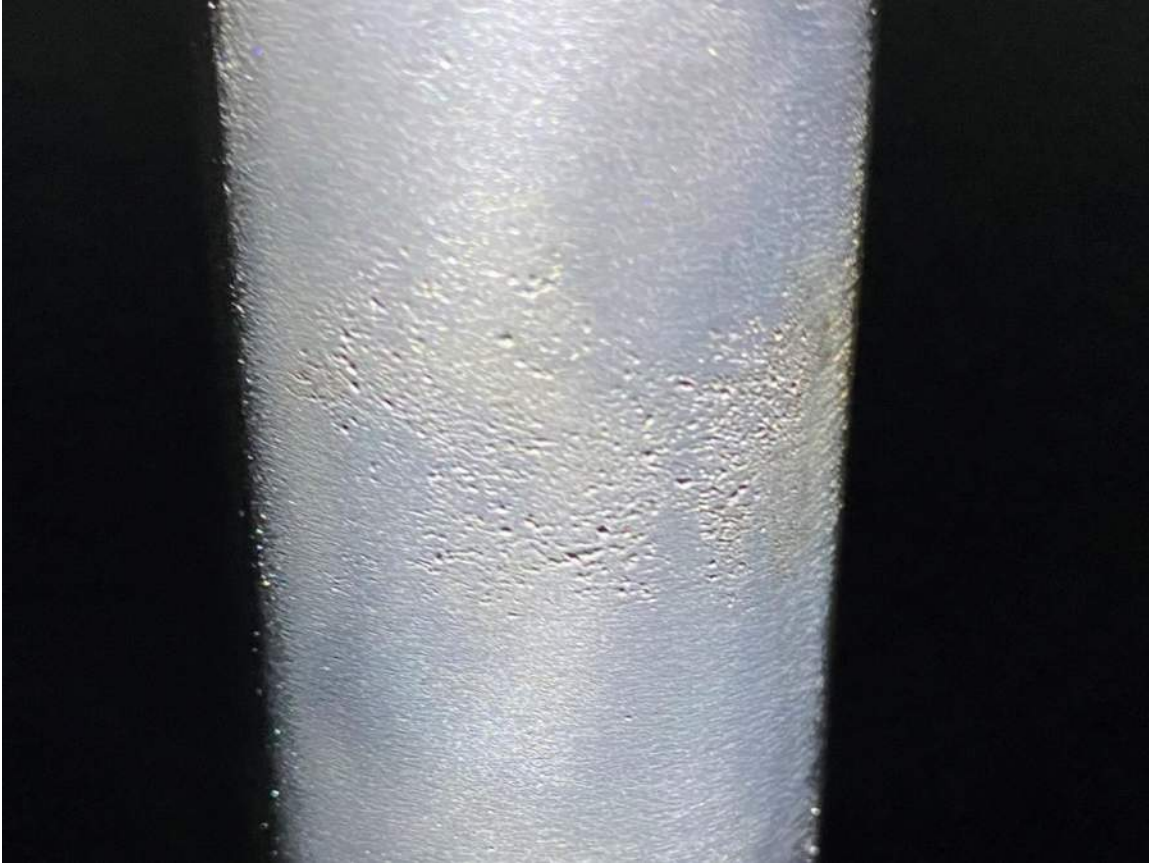
Severity level 1, mild pitting (new rod)

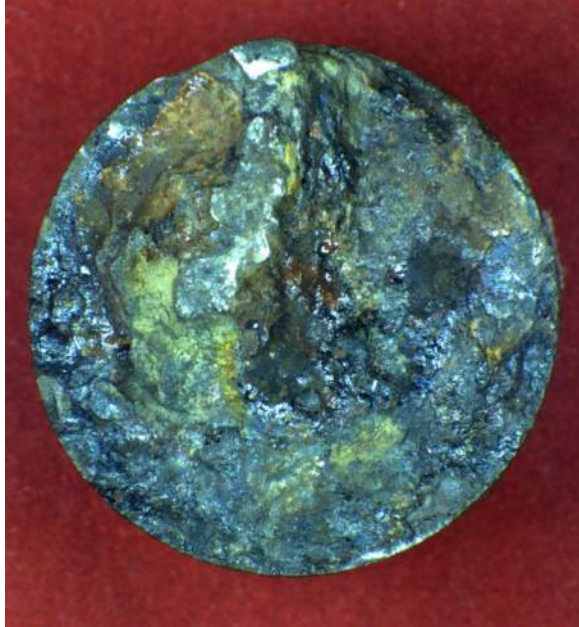
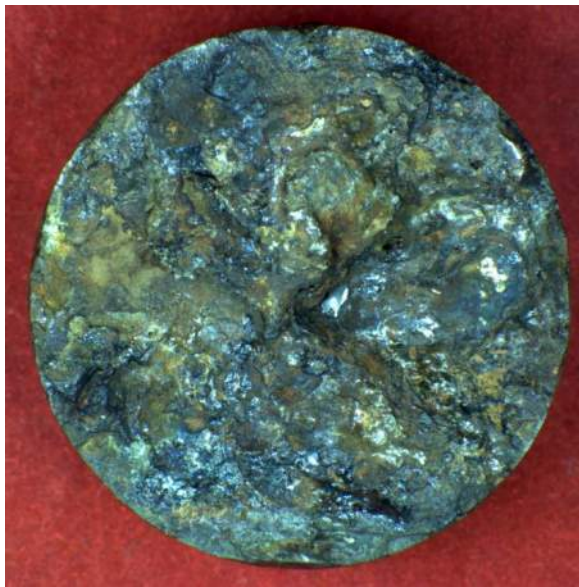
Pictures of the actual fracture surfaces on Rod 1 and 2 are shown in Figures 4 and 5 respectively. Each fracture surface was heavily corroded and no features were observable on the macroscale to determine if the fracture was brittle or ductile. However, since the rod was in direct tension and the fracture surface was generally flat and normal to the load, it was concluded that the fracture was brittle at the macroscale.

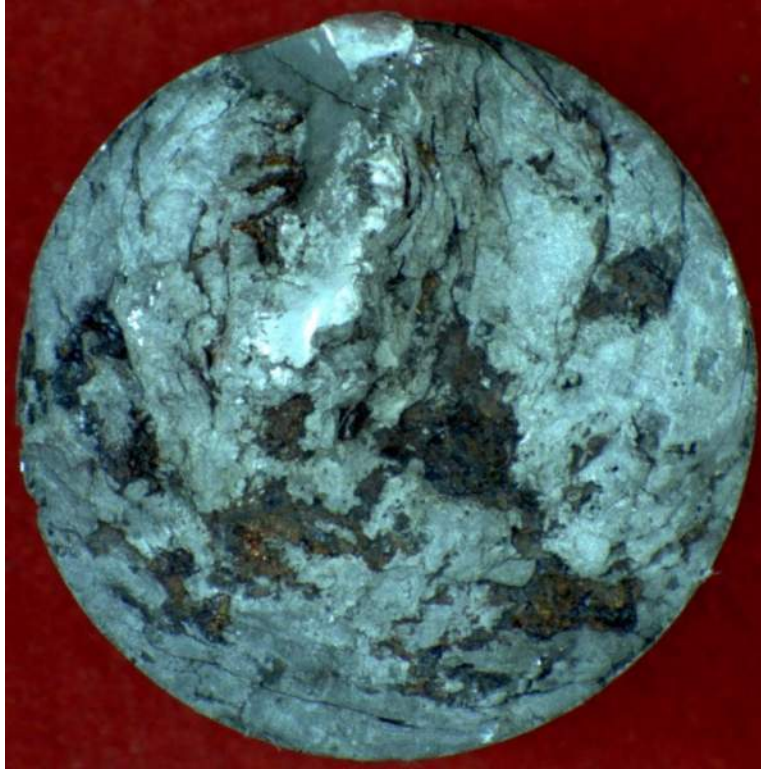
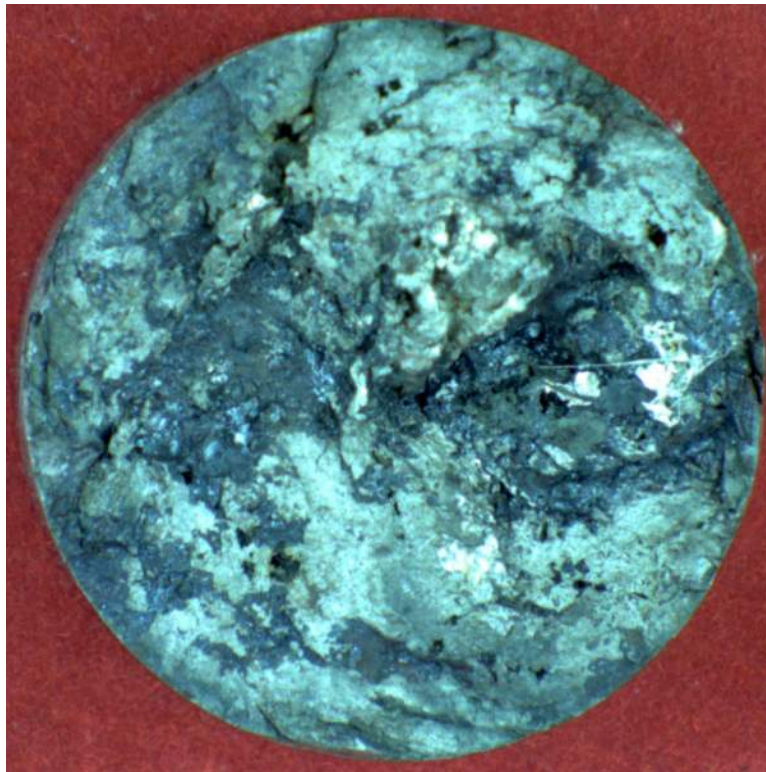
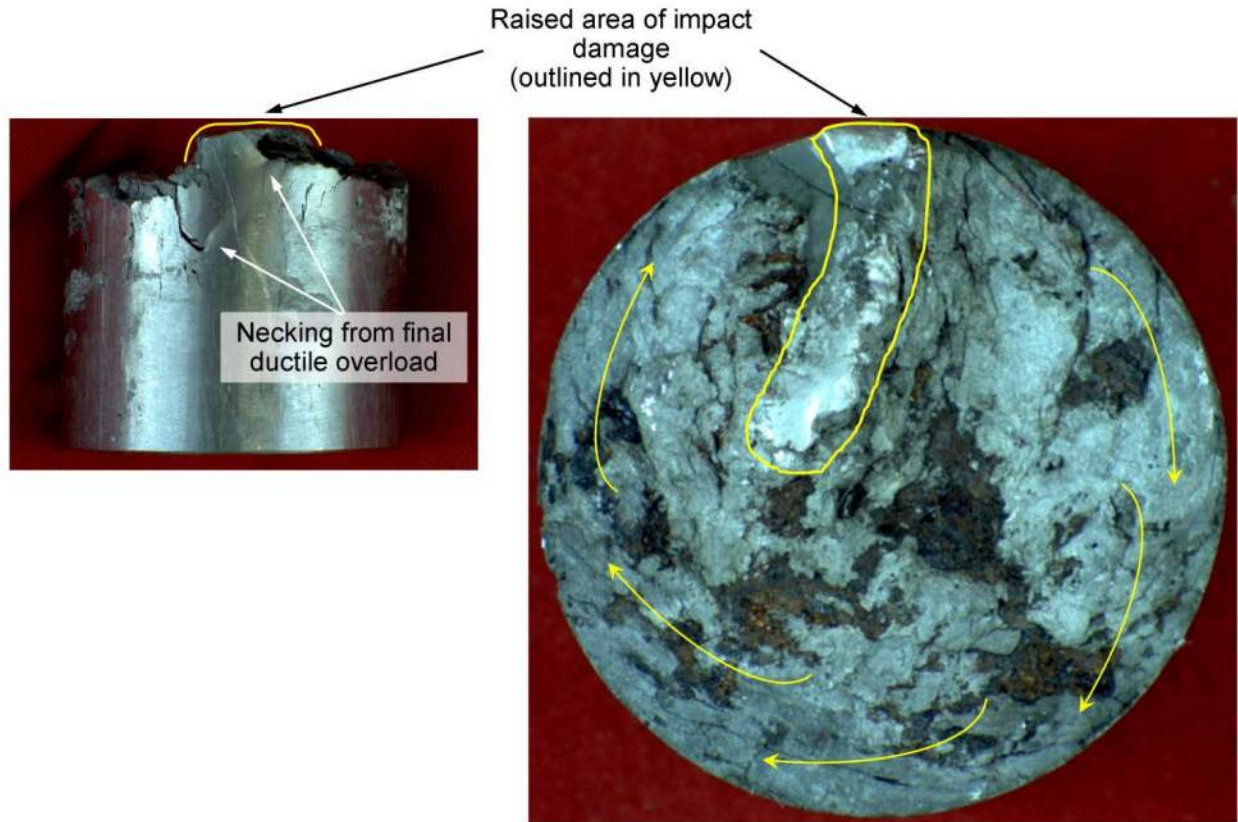
Both of the fracture surfaces appeared to be macroscopically brittle, but no clear initiation points could be identified. Since Rod 1 was cleaned better, it is easier to visualize the fracture surface having radial directionality. This can be further described with the assistance of Figure 16 which shows the cleaned fracture surface of Rod 1 and a side view of the Rod 1 fracture section. The fracture surface itself had obvious impact damage along one strip of the fracture surface outlined with a yellow line. The side view shows this area of impact damage that was likely the last ligament of the rod suffering final ductile overload. This is clear because of the obvious necking shown in the side view photo. As for the directionality of the fracture surface, there are no clear chevron marks pointing back to the initiation point, but overall the crack growth appeared to spiral around the center of the rod, beginning and ending from the ligament with the impact damage. The following sections will show that there were multiple cracks growing that likely coalesced, but it was the growth of the individualized cracks that appears to grow in a spiral that left this characteristic directionality on the fracture surface. The same directionality can be seen in Rod 2, though it is more difficult to see in Figure 15 since Rod 2 was not cleaned as thoroughly. There was also no evidence of a final overload or necking in Rod 2.

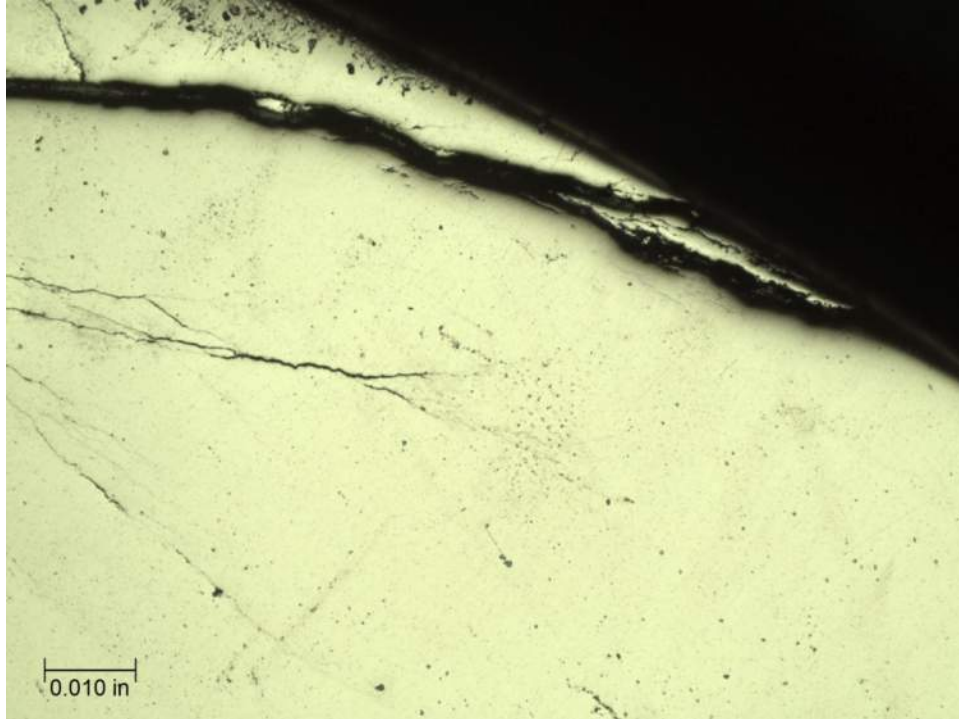
Figure 19. Photo. Rod 2 polished image showing major crack and smaller branching cracks.

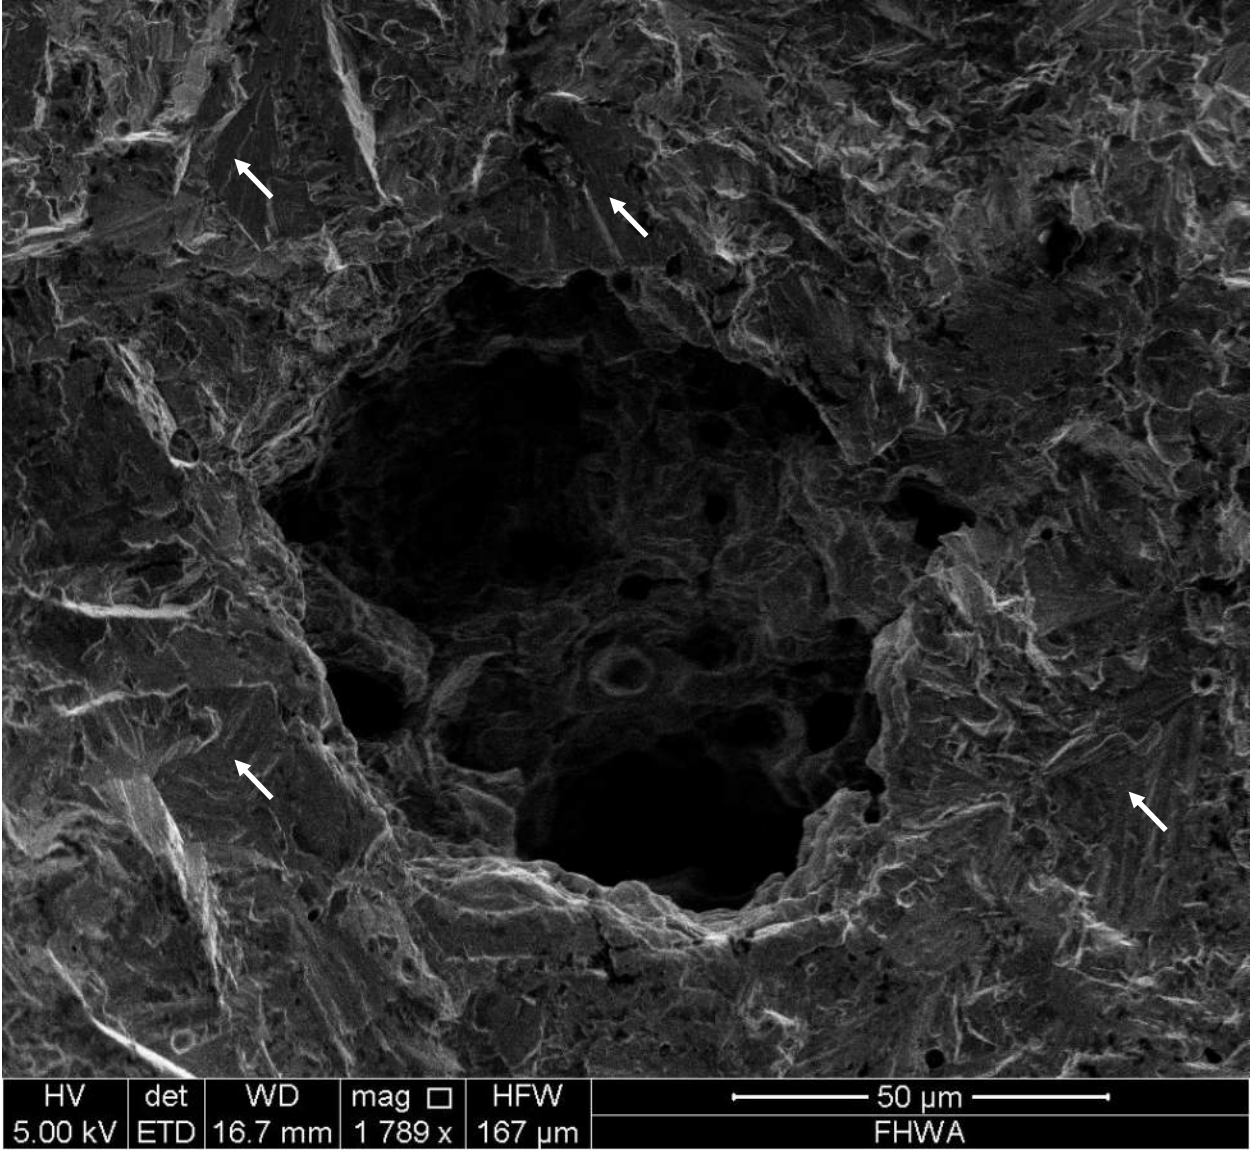
Figure 25. Rod 2 cleaned fracture surface showing more features of transgranular fracture.

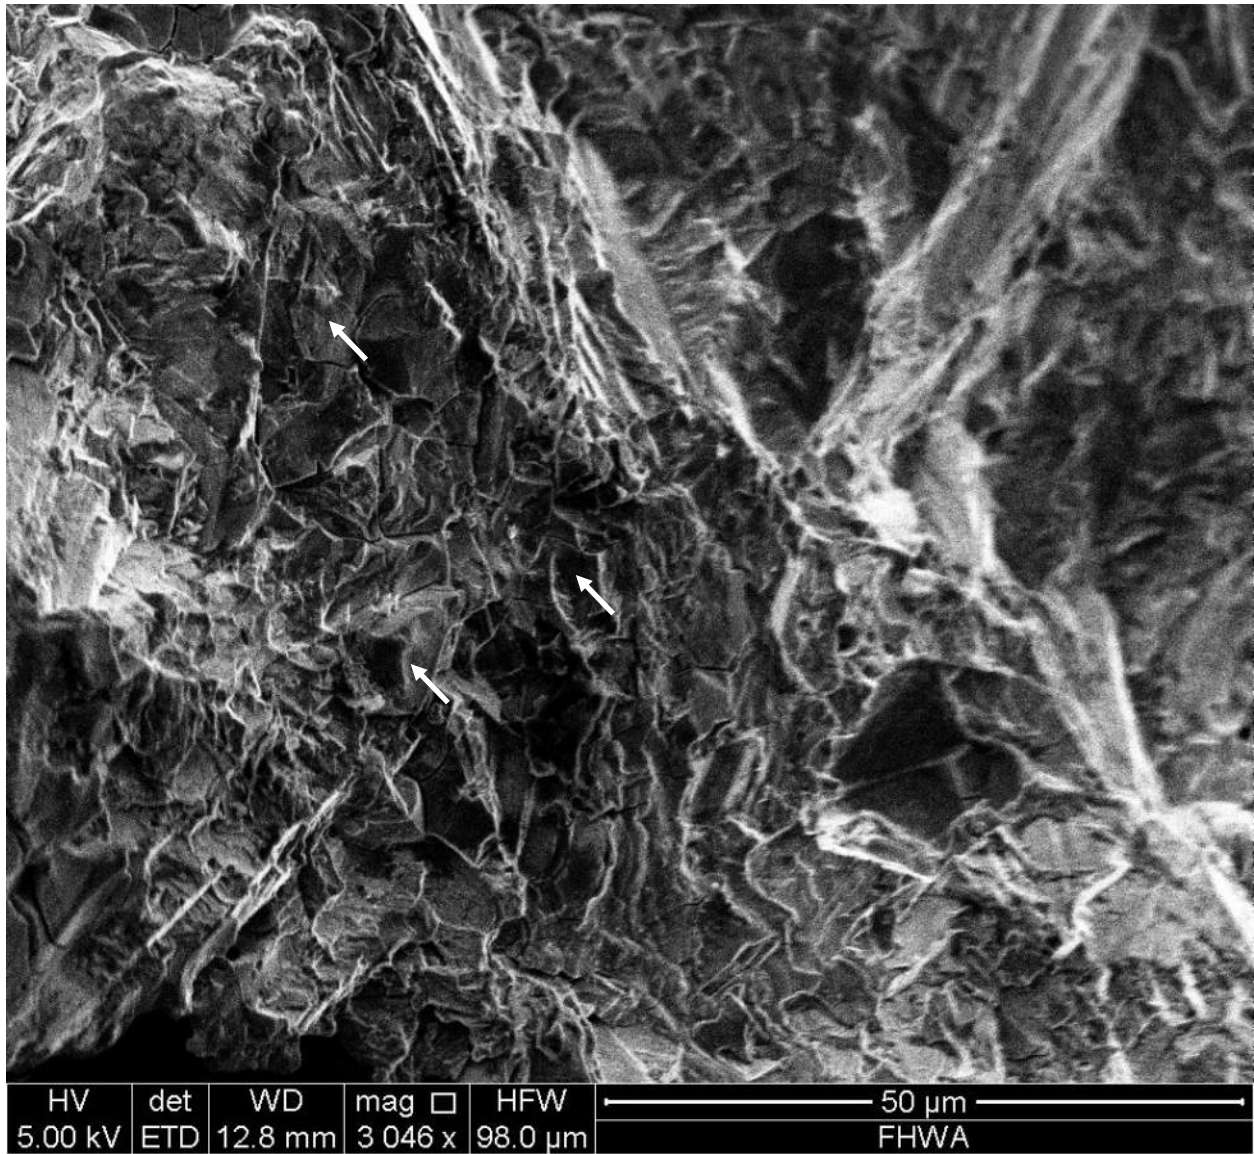
Figure 26. Rod 2 cleaned fracture surface showing more features of intergranular fracture.
