EXISTING CONDITIONS - ASBESTOS / LEAD / HAZARDOUS MATERIAL SURVEY

Wai'anapanapa State Park
Cabin Park Improvements
CABIN 1

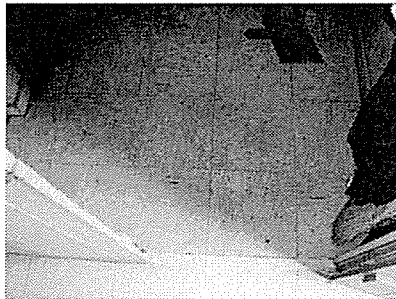
Photo #3
Storage. Asbestos containing 12"x12" tan with maroon and white specks tile.

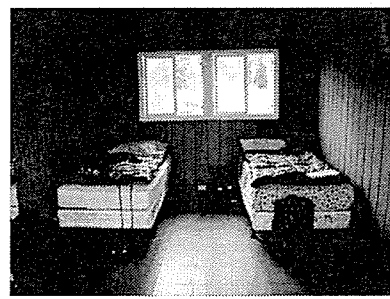
Photo #4
Bedroom by the kitchen area. Asbestos containing 12"x12" light-gray tile.

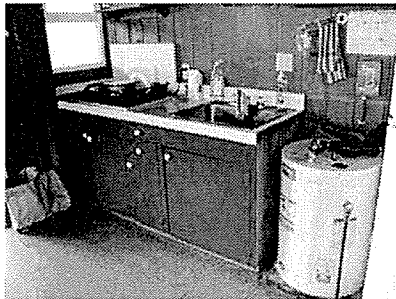
Photo #5
Non lead-based orange and green paint on the walls and kitchen cabinets.

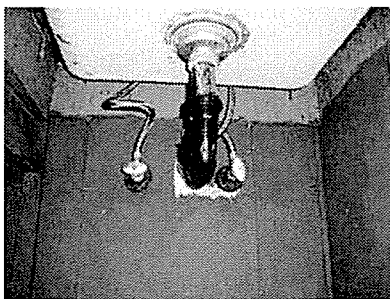
Photo #6
Asbestos containing gray undercoating sink mastic.

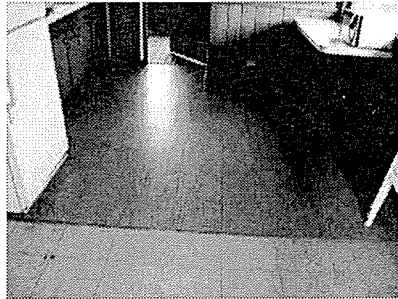
Photo #9
Kitchen. Asbestos containing tile and mastic under the 12"x12" brown speckled tile.

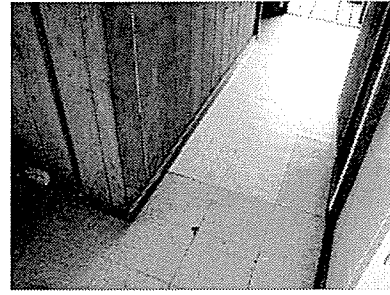
Photo #10
Hallway. Asbestos containing 12"x12" light-gray tile and brown mastic.

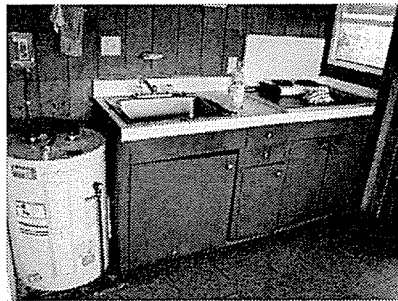
Photo #11
Non lead-based maroon paint on the kitchen cabinets.

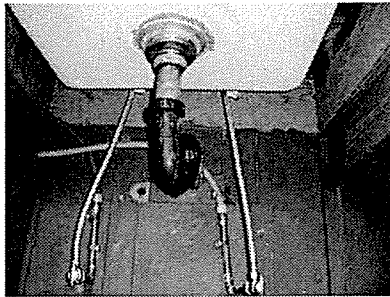
Photo #12
Asbestos containing gray undercoating sink mastic.

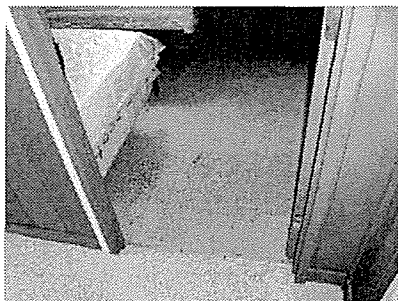
Photo #15
Bedroom. Asbestos containing 12"X12" light-gray tile with white specks.

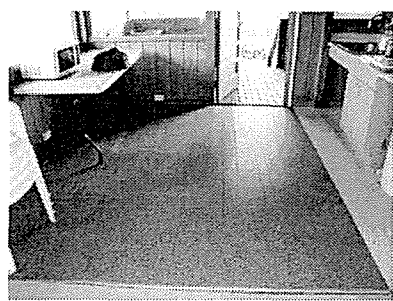
Photo #16
Kitchen. Asbestos containing tile and mastic under the 12"X12" brown speckled tile.

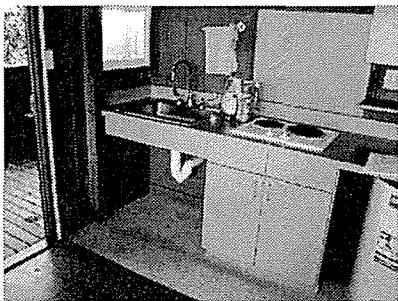
Photo #17
Non lead-based tan paint on the walls.

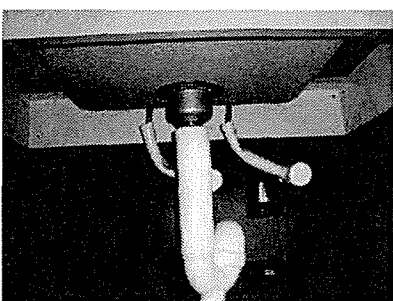
Photo #18
Asbestos containing gray undercoating sink mastic.

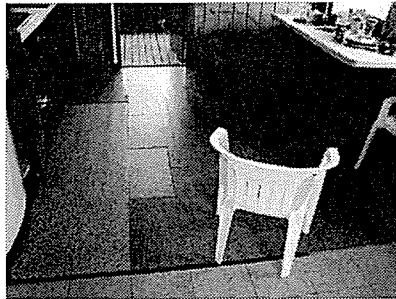
Photo #21
Kitchen. Asbestos containing tile and mastic under the 12"x12" brown speckled tile.

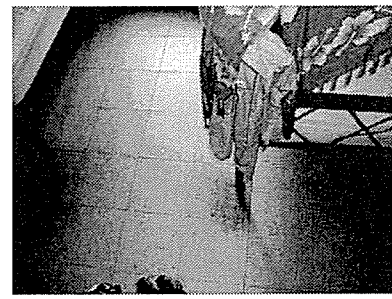
Photo #22
Asbestos containing 12"x12" light-gray tile with white and maroon specks.

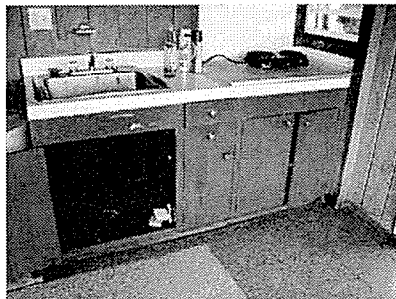
Photo #23
Non lead-based orange paint on the kitchen cabinets.

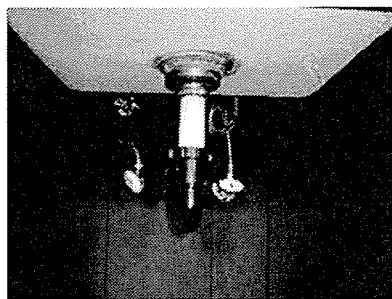
Photo #24
Asbestos containing gray undercoating sink mastic.

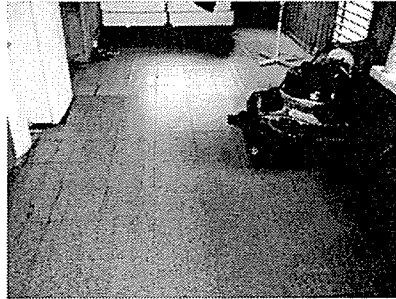
Photo #27
Kitchen. Asbestos containing tile and mastic under the 12"x12" brown speckled tile.

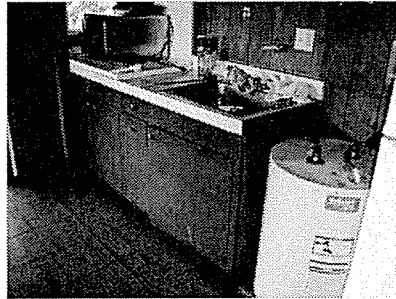
Photo #29
Non lead-based maroon paint on the cabinets.

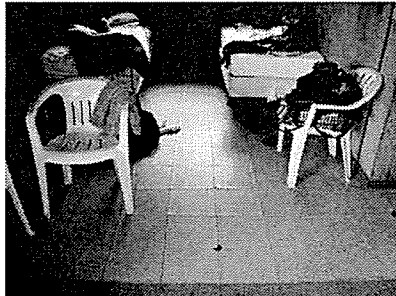
Photo #33
Asbestos containing 12"x12" light-gray tile with white specks.

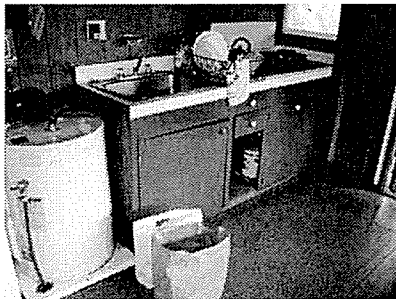
Photo #35
Non lead-based maroon paint on the kitchen cabinets.

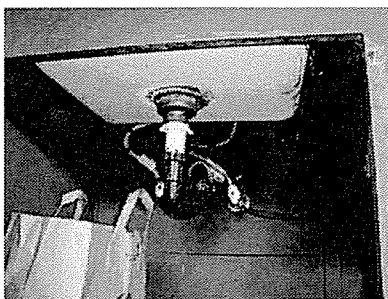
Photo #36
Asbestos containing gray undercoating sink mastic.

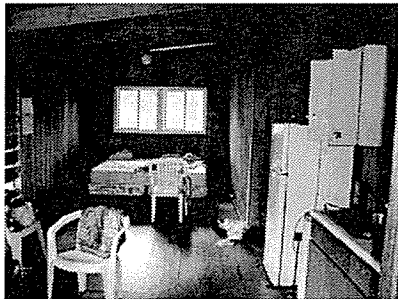
Photo #39
Kitchen. Asbestos containing tile and mastic under the 12"x12" brown speckled tile.

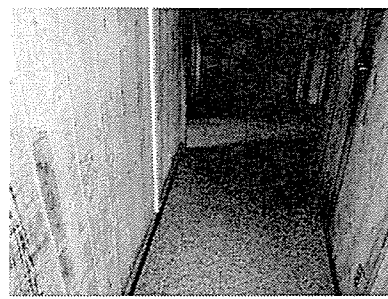
Photo #40
Asbestos containing black mastic under the 12"x12" tan tile.

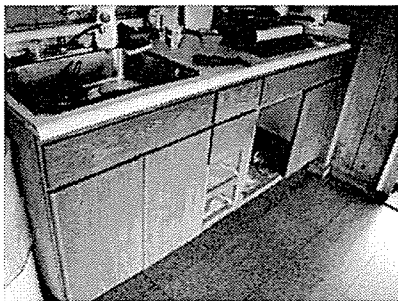
Photo #41
Unpainted wood kitchen cabinets.

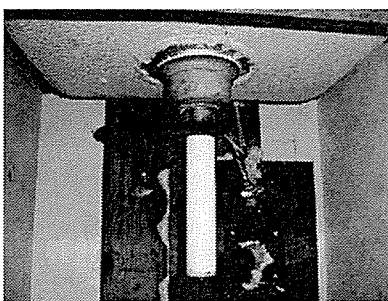
Photo #42
Asbestos containing gray undercoating sink mastic.

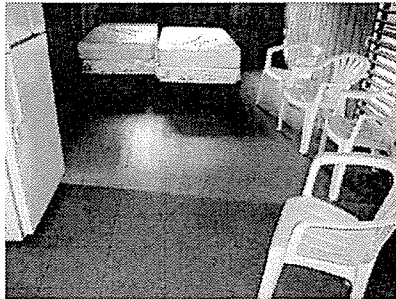
Photo #45
Bedroom by the kitchen. Asbestos containing tile and mastic under the 12'X12' cream tile with tan specks.

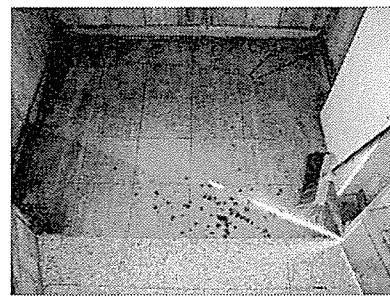
Photo #46
Storage. Asbestos containing 9'X9' tan tile and black mastic.

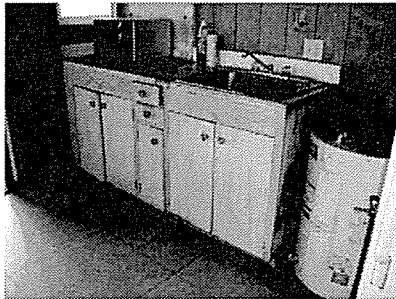
Photo #47
Non lead-based pink paint on the kitchen cabinets.

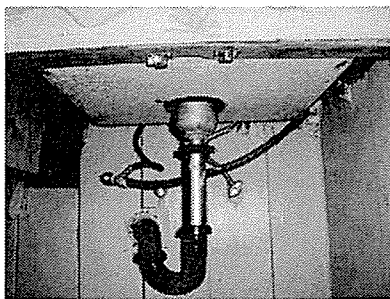
Photo #48
Asbestos containing gray undercoating sink mastic.

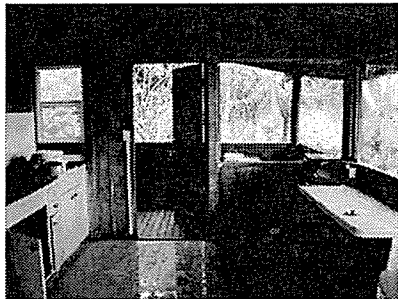
Photo #51
Kitchen. Asbestos containing black mastic under the 12"x12" cream colored tile.

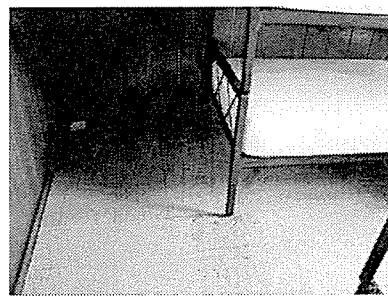
Photo #52
Bedroom. Asbestos containing black mastic under the 12"x12" cream colored tile.

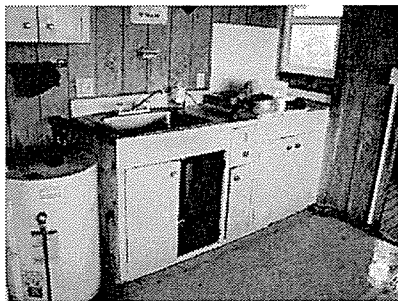
Photo #53
Non lead-based paint cream colored paint on the kitchen cabinets.

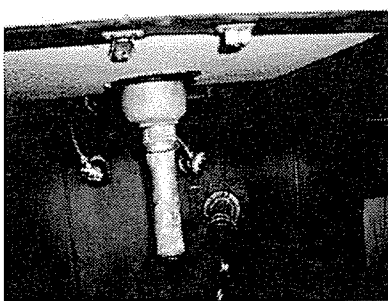
Photo #54
Asbestos containing gray undercoating sink mastic.

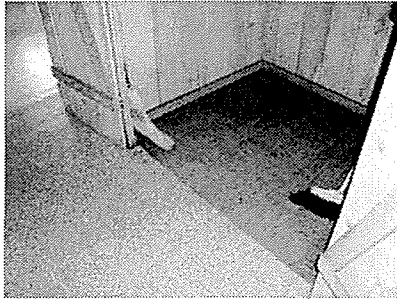
Photo #57
Asbestos containing 9"x9" tan tile with maroon and white specks and black mastic.

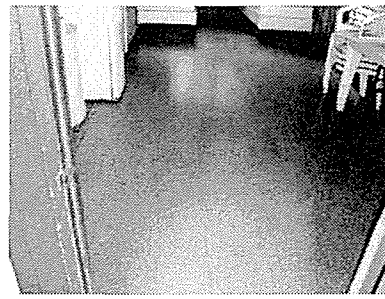
Photo #58
Asbestos containing black mastic under the 12"x12" cream colored tile with tan specks.

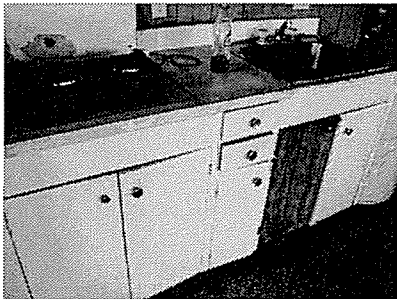
Photo #59
Non lead-based paint cream colored paint on the kitchen cabinets.

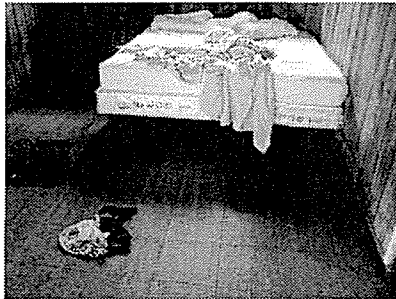
Photo #63
Bedroom by the kitchen area. Asbestos containing tile and mastic under the 12"x12" brown speckled tile.

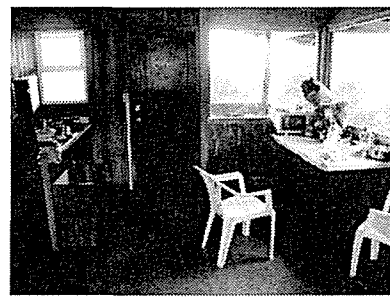
Photo #64
Kitchen. Asbestos containing tile and mastic under the 12"x12" brown speckled tile.

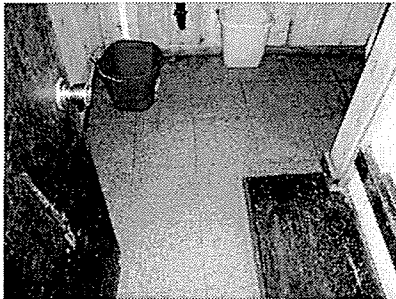
Photo #65
Bathroom. Asbestos containing tile and mastic under the 12"x12" brown speckled tile.

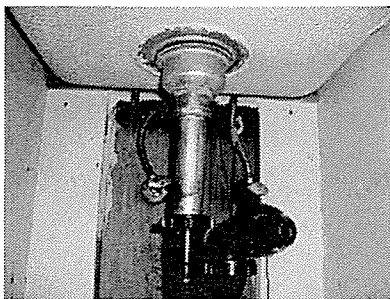
Photo #66
Non asbestos containing white undercoating sink mastic.
