**LIMITED HAZARDOUS MATERIALS  
SURVEY REPORT**

**DEPARTMENT OF LAND & NATURAL RESOURCES (DLNR)  
MAUI OFFICE ANNEX BUILDING  
MAUI, HAWAII**

ETC Project No. 15-4003

March 16, 2015

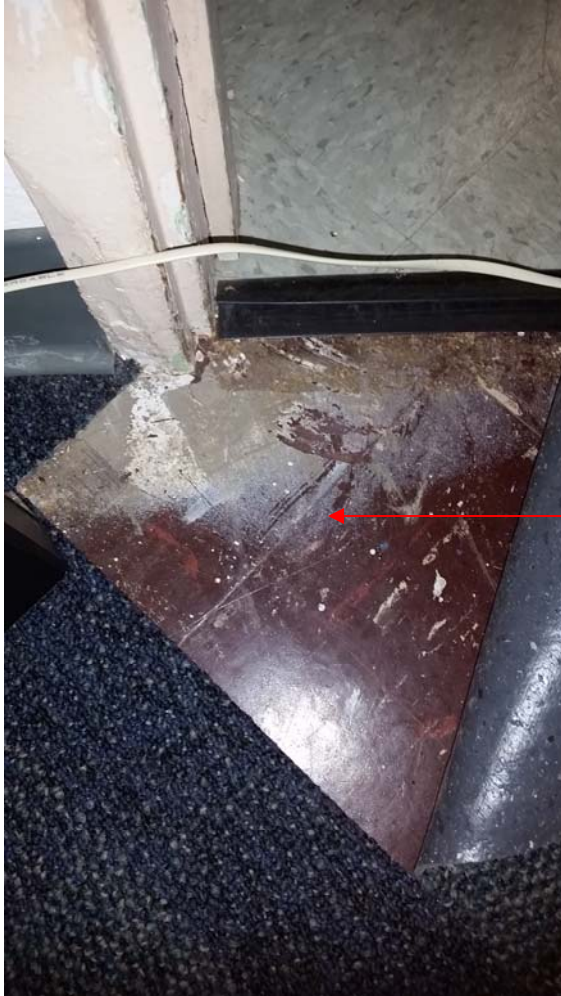
Homogenous Area	Material	Condition	Category	Friability	Estimated Quantity
Interior	9"x9" Brown Vinyl Floor Tile	Good	Misc.	Non Friable I	3,000 ft <sup>2</sup>

Photograph 1: 9"x9" Brown Vinyl Floor Tile (VFT) under carpet and 12"x12" Gray Speckled VFT.

- Any non-friable ACM which could be crumbled and pulverized during renovation/demolition activities must be removed and disposed of by a qualified asbestos abatement contractor.
