Asbestos and Lead Paint Sampling Report

***Demolish Structures on TMK 1-3-7-02:018 and 077,
5839 and 5841 Kalaniana'ole Highway,
Kalaupoho, Kuliouou, Oahu, Hawaii***

April 2016

Subject: **Asbestos and Lead Paint Sampling (E2 Project 160015)
Demolish Structures on TMK 1-3-7-02:018 and 077,
5839 and 5841 Kalaniana'ole Highway
Kalauhahai Fishpond (Lucas Spring), Kuliouou, Oahu, Hawaii**

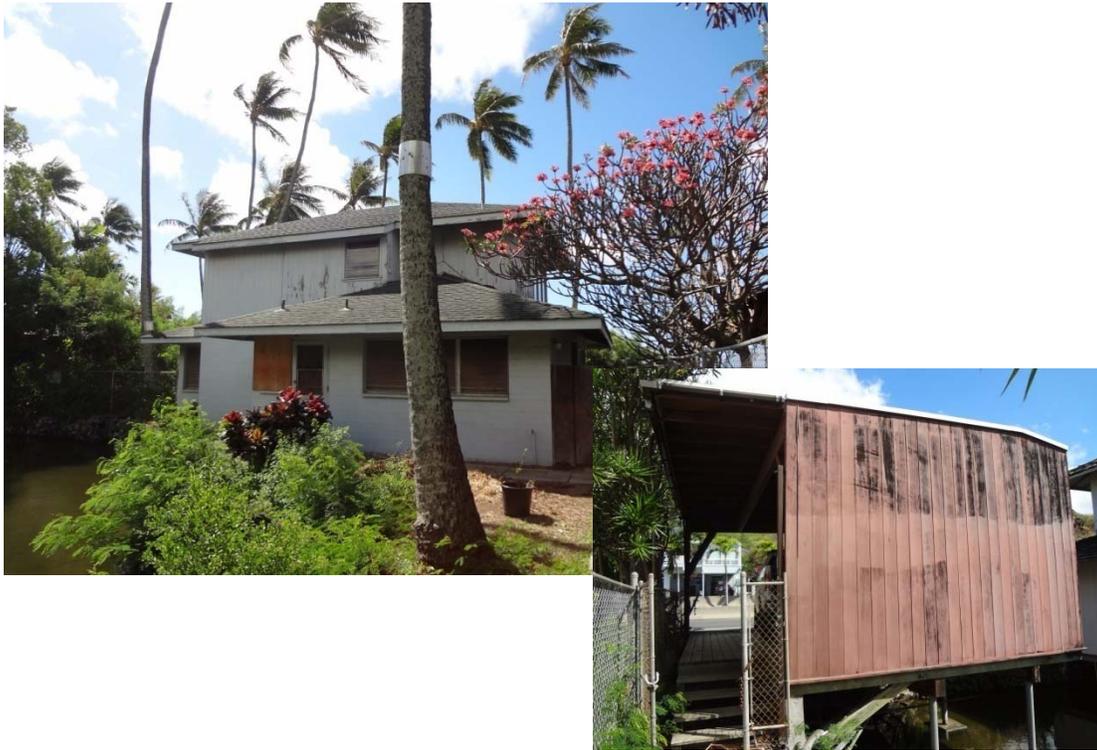
Photographs 1 and 2 – 5839 Kalaniana'ole Highway (2-story residence and garage). PACM tar/mastic on roof vent protrusions are visible on the residence on the left.

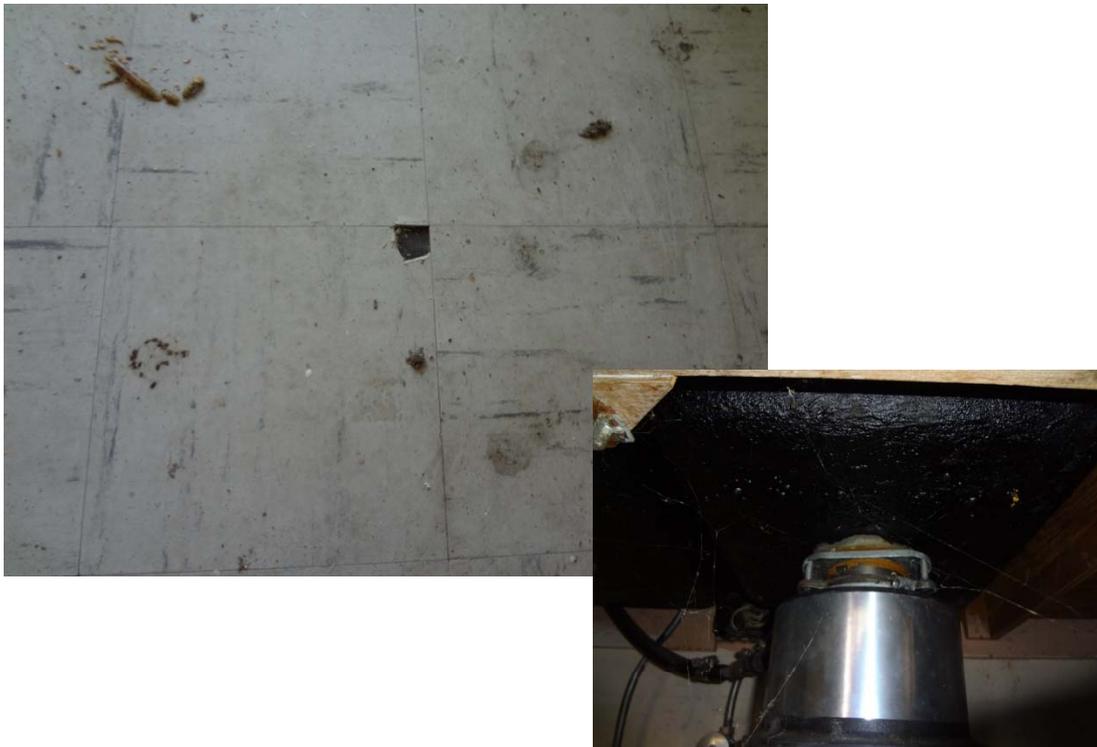
Photographs 3 and 4 – ACM 9"x9" light gray floor tile (HSA A1, mastic NAD) in the Living Room and ACM under-sink coating (HSA A5) in the Kitchen.

Non-ACM floor tiles with ACM mastic should be disposed of as ACM, as well, since the ACM mastic is probably still adhered to the tiles.

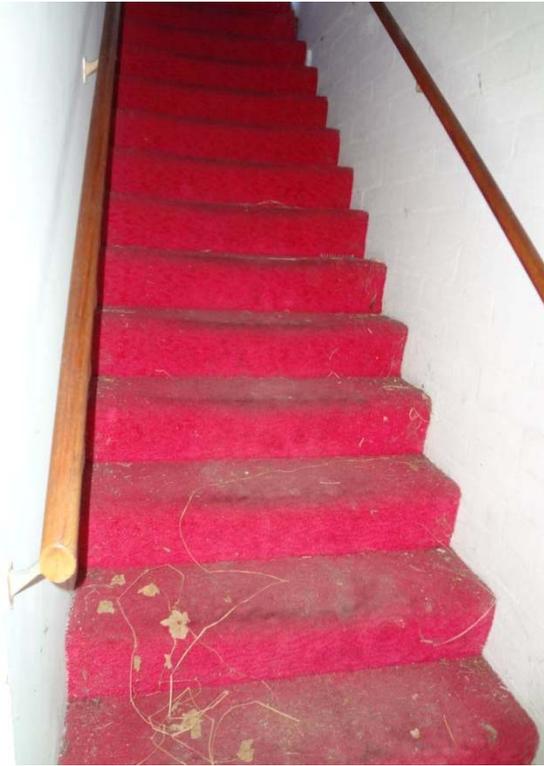
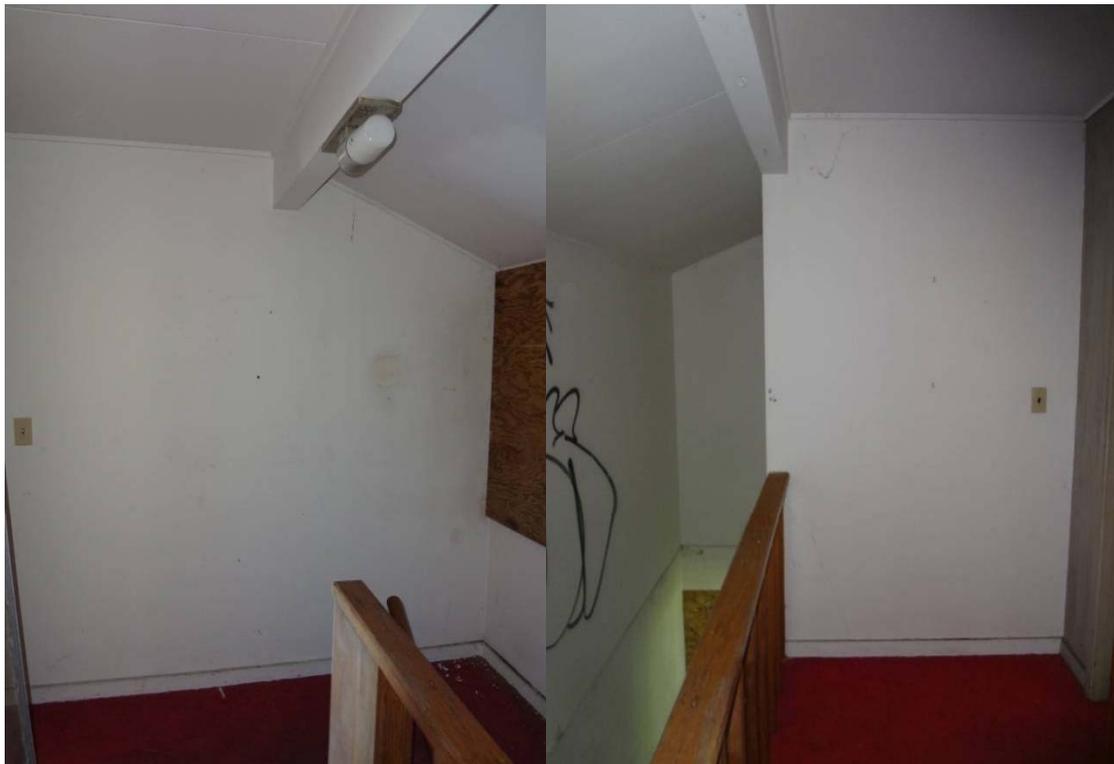
Photographs 5-7 – Non-ACM gypsum board wall system (with joint compound) (HSA A6) throughout the residence at 5839 Kalaniana'ole Highway confirmed to contain <1% Chrysotile asbestos by 400 Point-Count analyses ((non-ACM).

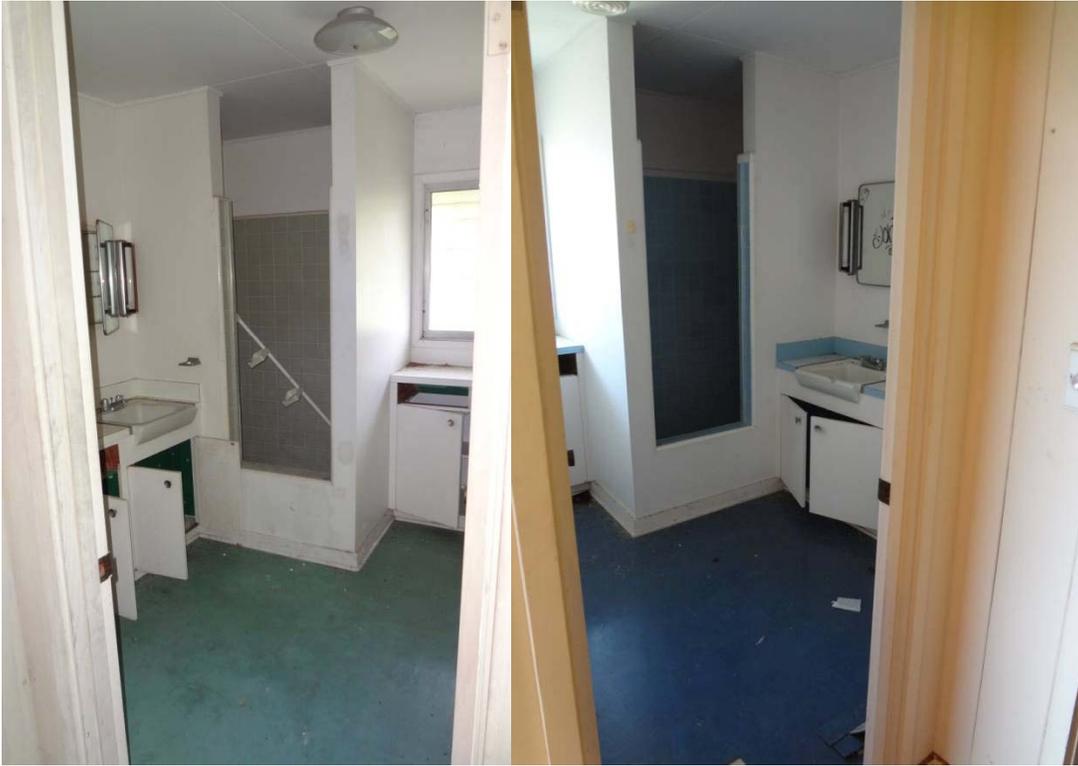
Photographs 8 and 9 – ACM mastic (trace Chrysotile) under the non-ACM 9"x9" floor tiles in both Bathrooms on the 2nd Floor (HSAs A8 and A9) at 5839 Kalaniana'ole Highway.

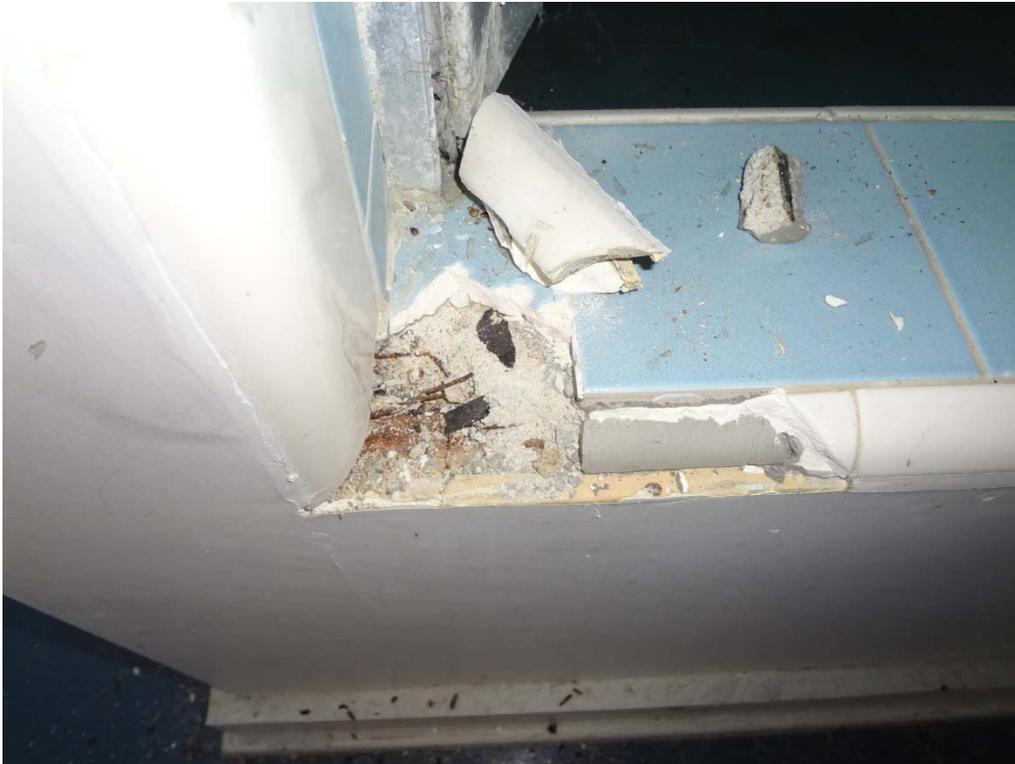
| Sample ID | Material Location | Sample Location | Type of ACM | Material | Description | Color | Friability | Physical Condition | Potential for Disturbance | ACM? | Total % Asbestos | Other Materials | Approx. Quantity |
|---|---|---|---|---|---|---|---|---|---|---|--|---|---|
| 5839-A11-1 | 2 nd Floor E and W Bathrooms | 2 nd Floor E Bathroom | Misc. | ceramic tile trim / grout / cement | shower | white / white / gray | Category I non-friable | damaged (from sampling) | high | Yes | off-white skim coat/joint compound – 2% Chrysotile, light gray cement Actinolite (trace) | cellulose (trace) | ~15 sf |
| 5839-A12-1+ | 2 nd Floor E and W Bathrooms | 2 nd Floor E Bathroom | Misc. | ceramic tile / grout / cement | shower | light blue / white / gray | Category I non-friable | damaged (from sampling) | high | No | light gray cement Actinolite <1% | cellulose (trace) | N/A |

Photograph 10 – ACM white ceramic tile trim (grout /cement/skim coat/joint compound) (HSA A11) in the Showers in both Bathrooms on the 2nd Floor. The non-ACM blue ceramic tile (HSA A12) contains <1% Actinolite by 400 Point-Count analyses.

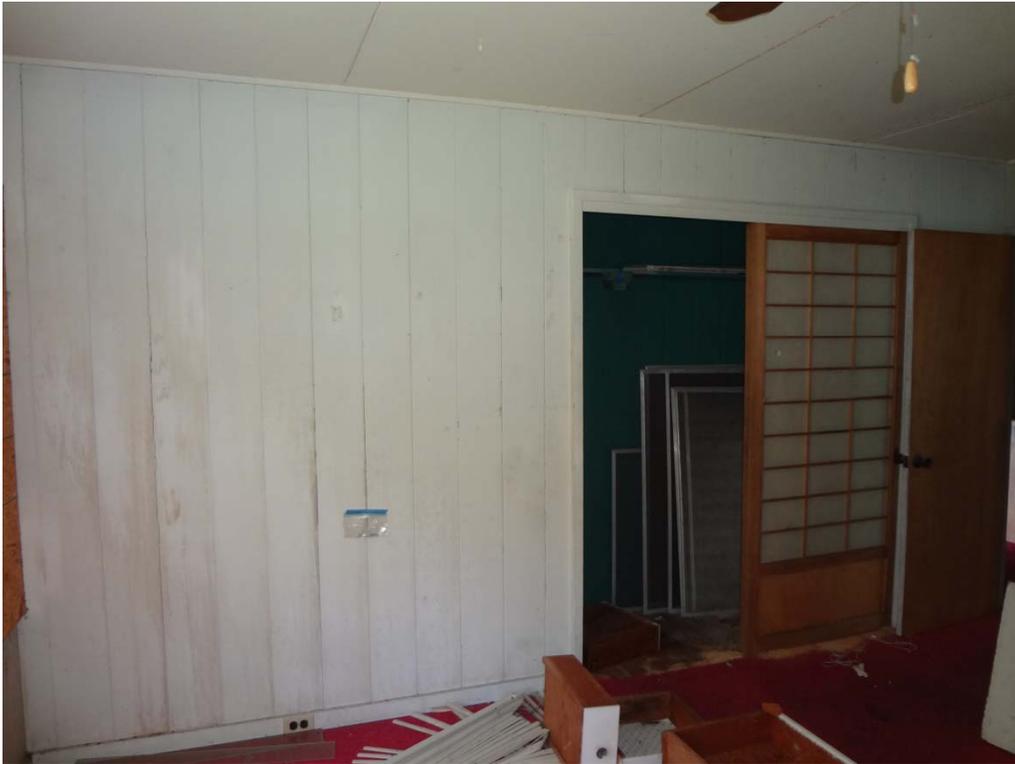
Photograph 11 – LBP samples L21 and L22 from the wall and closet shelf in the SE Bedroom at 5839 Kalaniana'ole Highway.

In addition, lead was found in some of the paint samples collected at the project site during this field effort. Lead that will be encountered at the project site will require proper handling, removal, and/or disposal in accordance with Federal and State regulations. Appropriate worker protection measures for lead should be taken during the lead removal and demolition work. Metal debris should be recycled when possible to decrease the amount of waste taken to the landfill and to possibly minimize the likelihood of the Toxicity Characteristic Leaching Procedure (TCLP) samples exceeding leaching criteria. A representative TCLP sample(s) of the remaining waste stream(s) will need to be collected and analyzed prior to landfill acceptance. Prior to repair work, the landfill should be consulted as to their requirements and procedures for the disposal of lead-contaminated waste and debris at their facility.

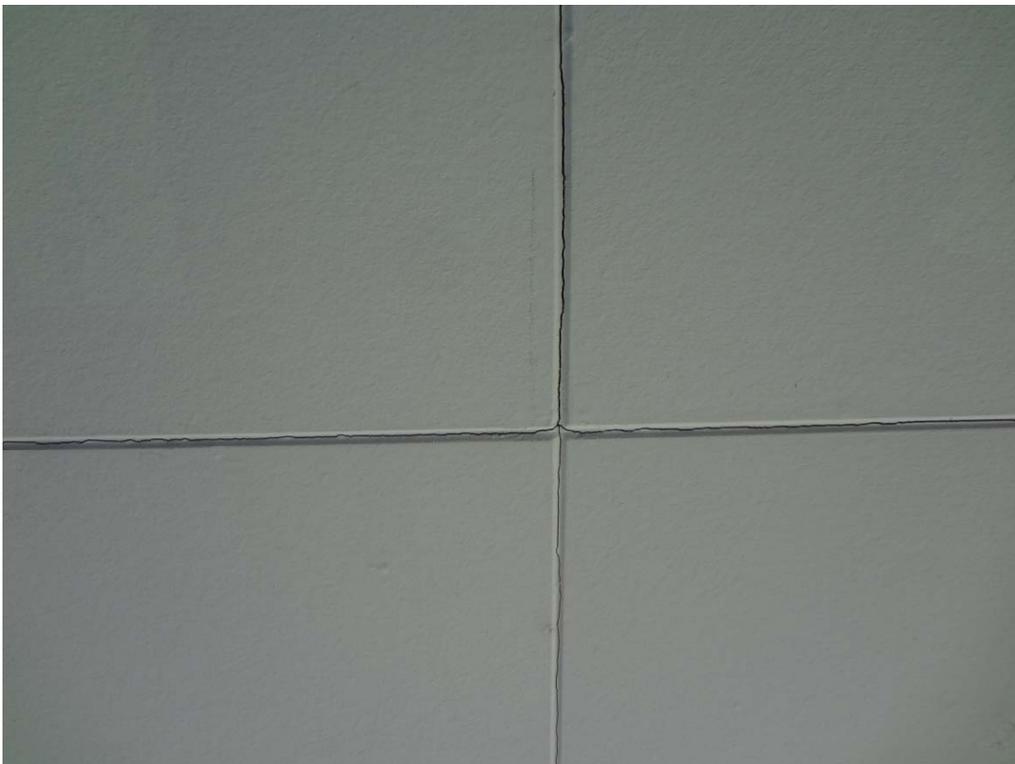
Photograph 12 – Example of arsenic-containing canec ceiling panels throughout the residence at 5839 Kalaniana'ole Highway .

Arsenic was found in the ceiling panels samples collected from both 5839 and 5841 Kalanianaʻole Highway. Inaccessible and/or hidden suspect materials not sampled during this field effort should be presumed arsenic-containing until sampled and proven otherwise. Prior to renovation and/or demolition, arsenic-containing canec should be removed whole, segregated, wrapped in plastic or placed in plastic bags during transportation and disposed of similarly to asbestos at a permitted landfill facility. Canec building materials are exempt from State laws requiring a hazardous waste determination to be made prior to disposal. As a result of this exemption, testing canec for arsenic content or leaching characteristics is not required by the state for disposal. The exemption applies whenever canec building materials are segregated from other building materials and disposed of separately. When canec is mixed with other building demolition waste, the combined waste could be subject to hazardous waste determination before disposal. The permitted landfill should be notified prior to disposal of canec materials so the canec can be appropriately segregated or handled in a manner to prevent landfill employees from being exposed during their operations.

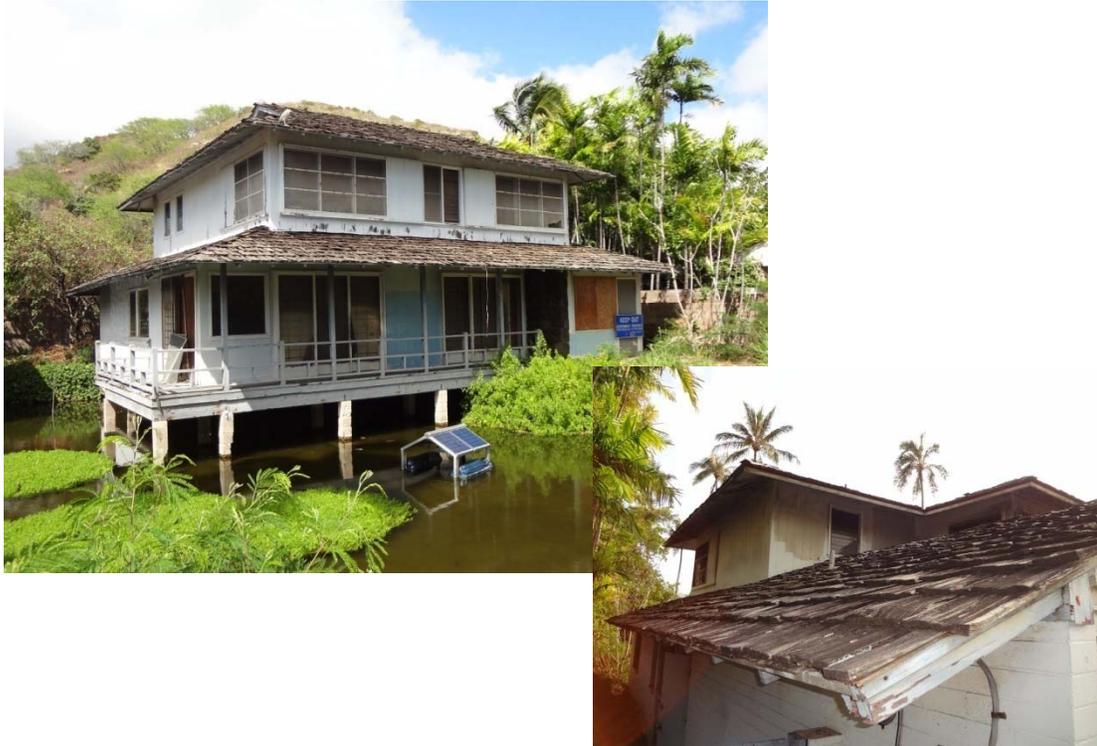
Photographs 13 and 14 – 5841 Kalaniana'ole Highway (2-story residence and garage). PACM tar/mastic on roof vent protrusions are visible on the right.

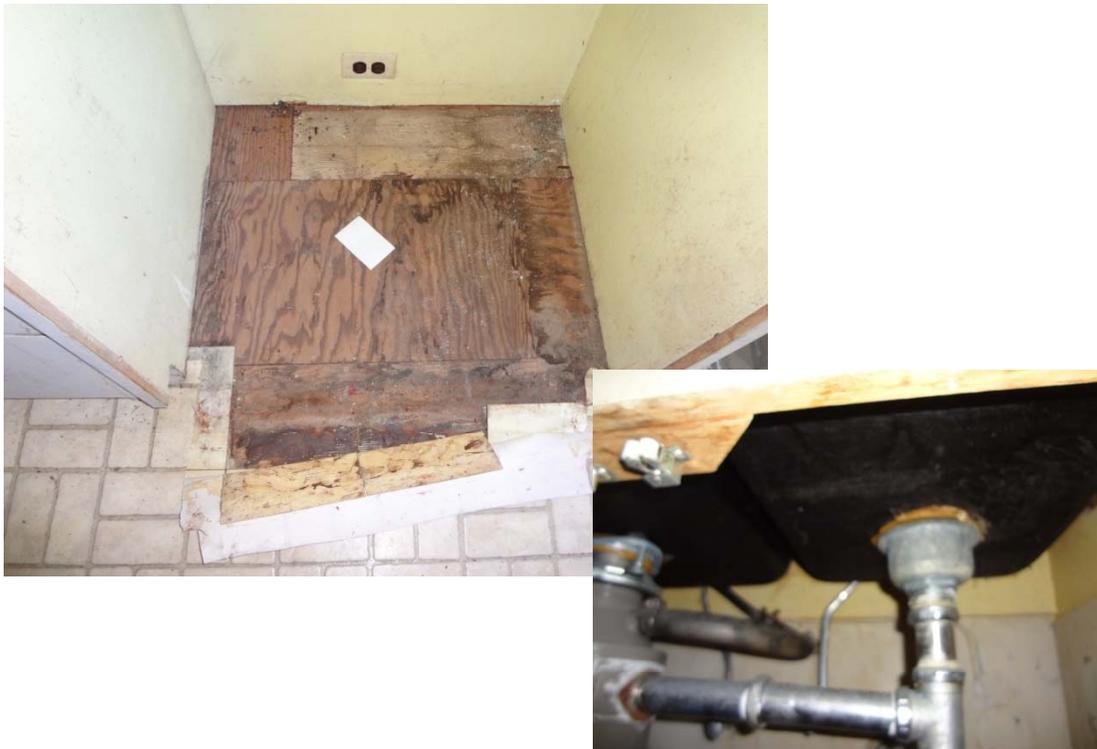
Photographs 15 and 16 – ACM tan mastic under the 9"x9" floor tile (HSA A4B, 2nd flooring layer under the sheet flooring) and ACM under-sink coating (HSA A5), both in the Kitchen.

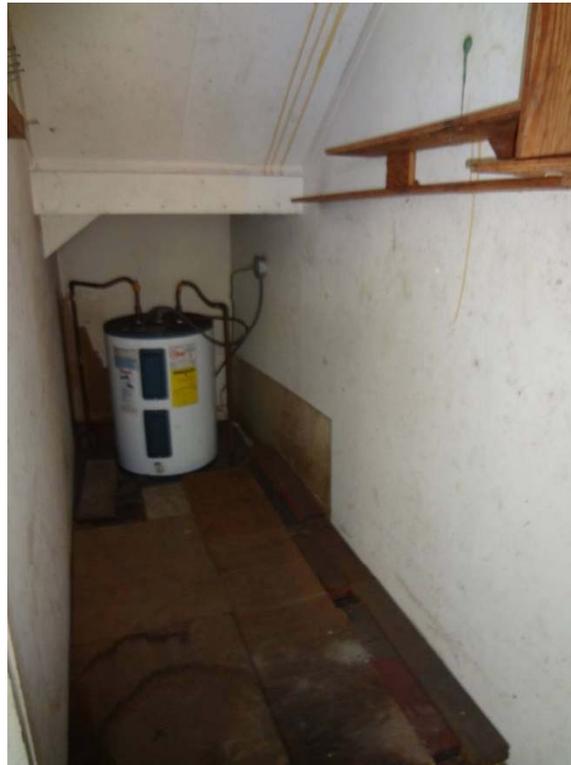
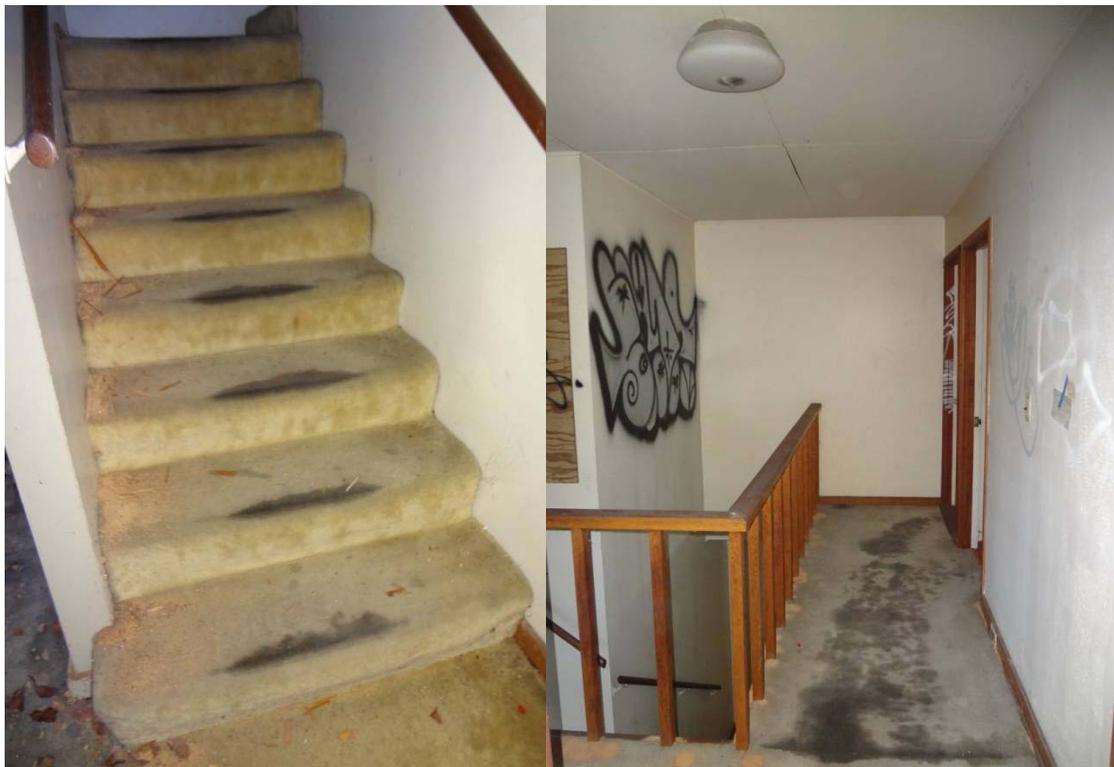
Photographs 17-19 – Non-ACM gypsum board wall system (with joint compound) (HSA A2) throughout the residence and garage at 5841 Kalaniana'ole Highway. Samples on the 2nd Floor confirmed to contain <1% Chrysotile asbestos by 400 Point-Count analyses (non-ACM).

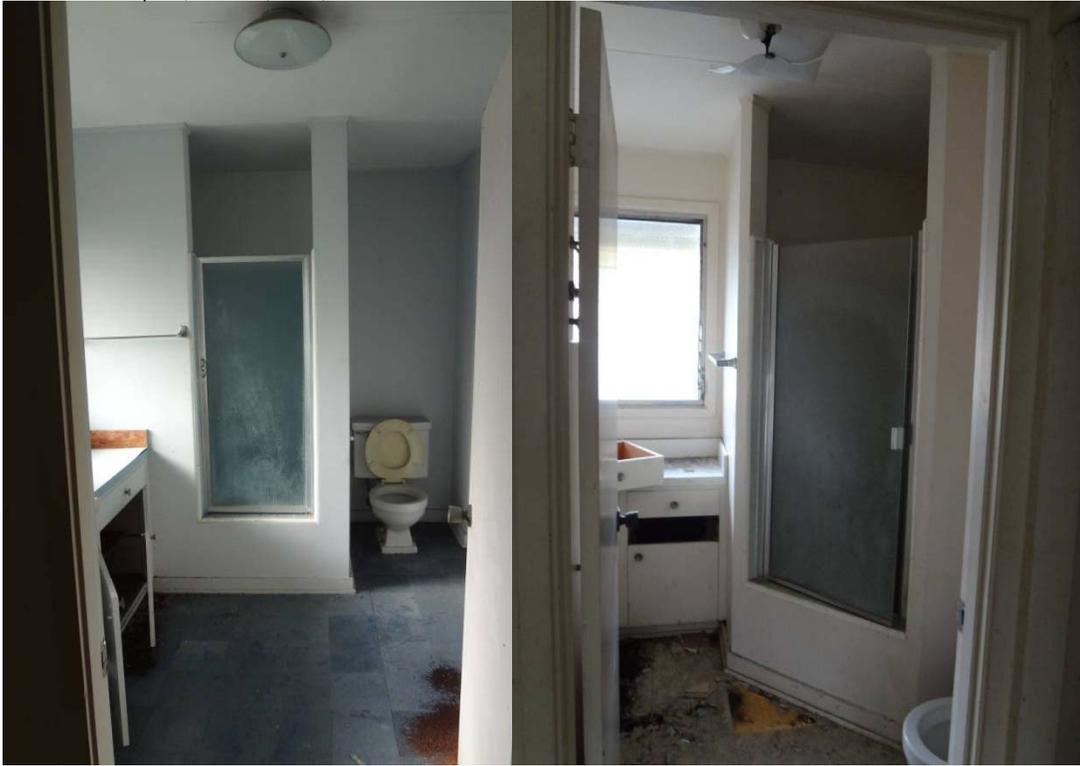
Photographs 20 and 21 – W and E Bathrooms with Showers on the 2nd Floor of
5841 Kalaniana'ole Highway.

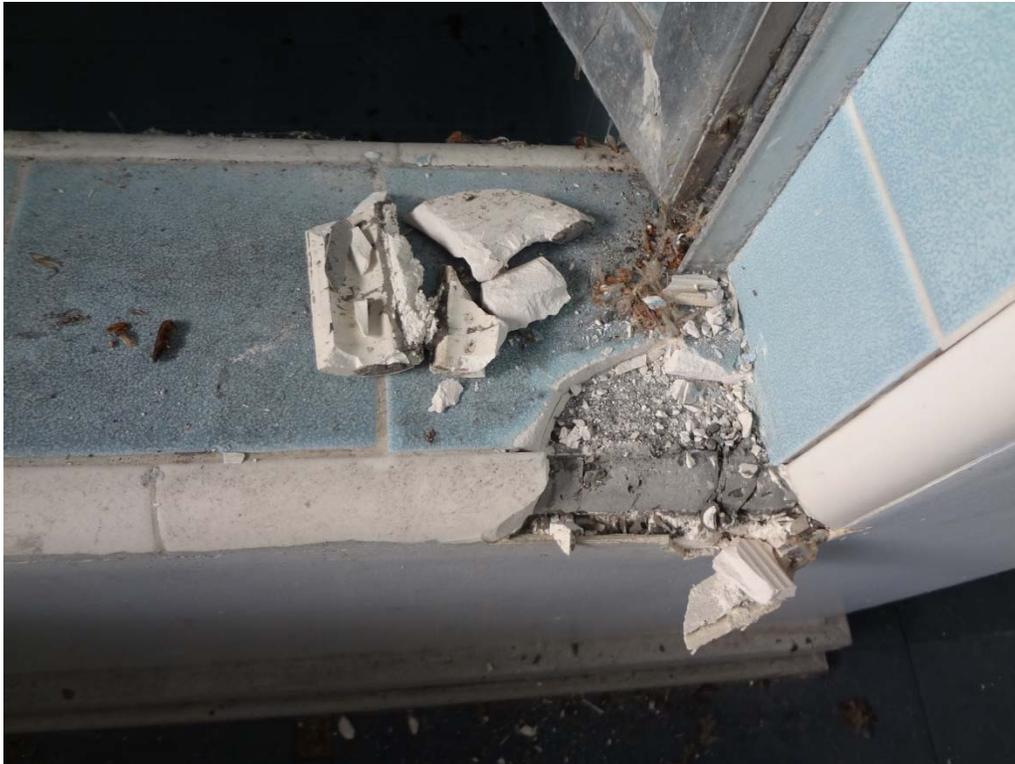
| Sample ID | Material Location | Sample Location | Type of ACM | Material | Description | Color | Friability | Physical Condition | Potential for Disturbance | ACM? | Total % Asbestos | Other Materials | Approx. Quantity |
|---|---|---|---|---|---|---|--|---|---|---|---|---|---|
| 5841-A12-1 | 2 nd Floor Bathrooms | W Bathroom | Misc. | ceramic tile / grout / cement | shower | light blue / white / gray | Category I non-friable | damaged (due to sampling) | high | No | NAD | cellulose (trace) | N/A |
| 5841-A13-1 | 2nd Floor Bathrooms | W Bathroom | Misc. | ceramic tile trim / grout / cement | shower | white / white / gray | Category I non-friable | damaged (due to sampling) | high | Yes | beige skim coat joint compound – 2% Chrysotile | cellulose (trace) | ~15 sf |

Photograph 22 – ACM white ceramic tile trim (with grout /cement/skim coat/joint
compound) (HSA A13) in the Showers in both Bathrooms on the 2nd Floor. The
blue ceramic tile (HSA A12) is non-ACM.

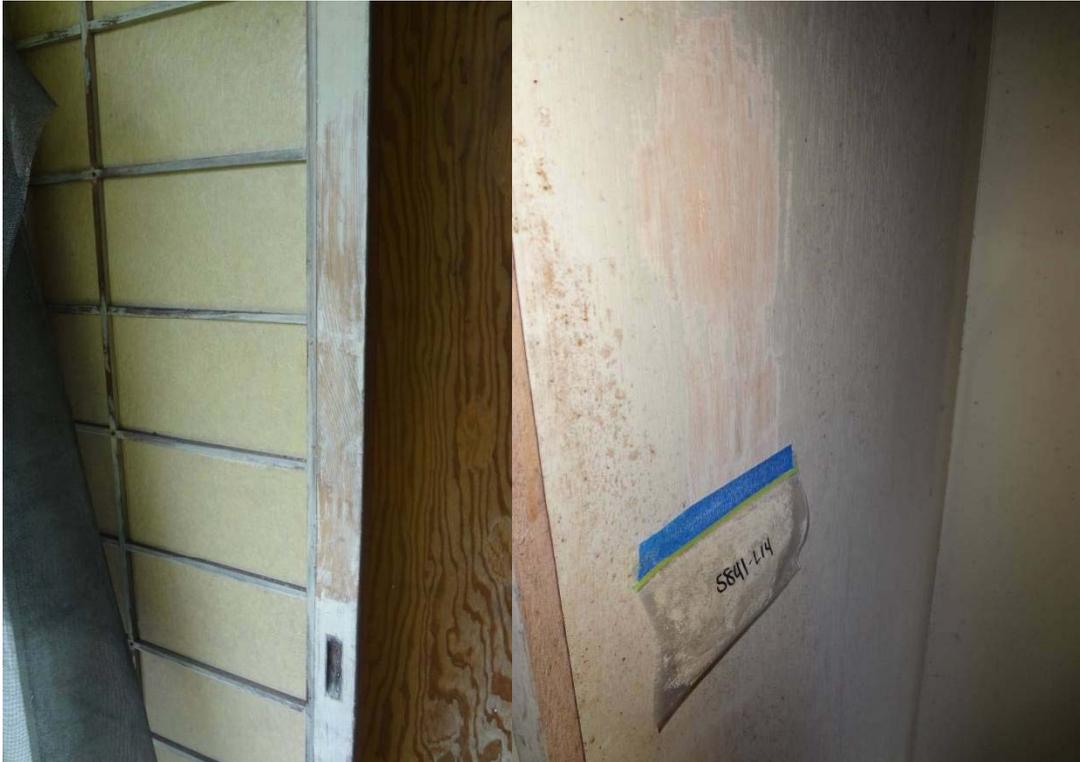
Photographs 23 and 24 – LBP samples L10 and L14 from the Living Room inner sliding door frame and Kitchen cabinet interior, respectively, at 5841 Kalaniana'ole Highway.

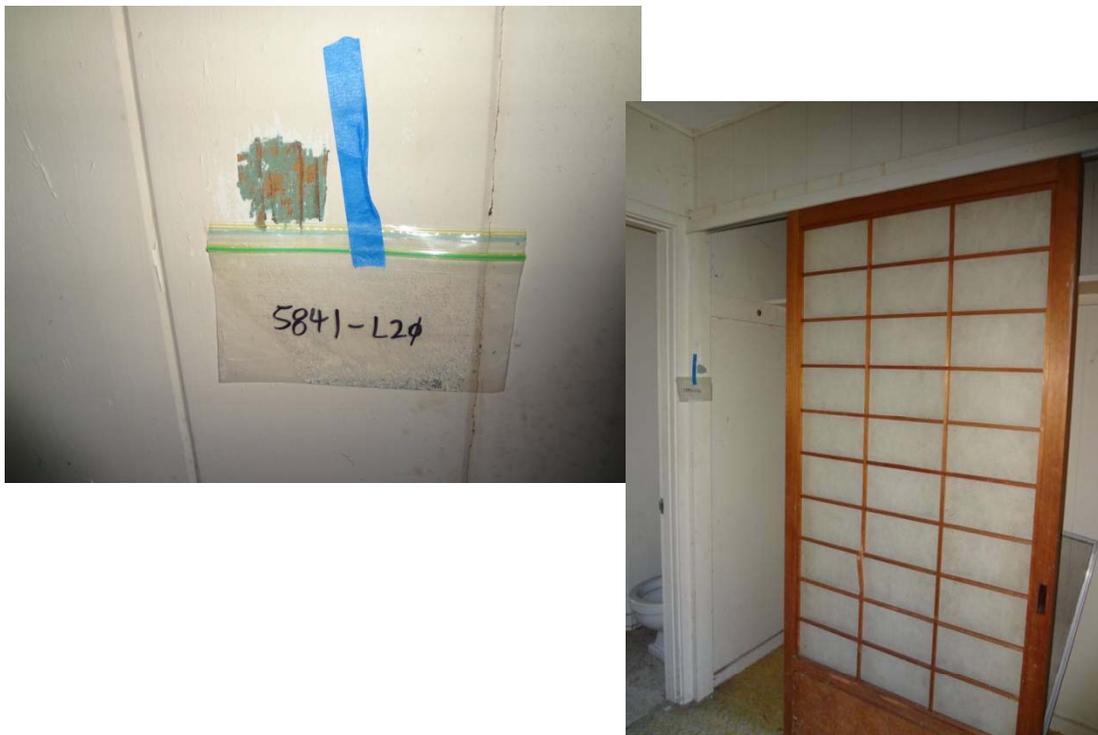
Photographs 25 and 26 – LBP samples L20 and L22 from the tongue and groove wood wall in the Middle Bedroom and the closet jamb in the SE Bedroom.

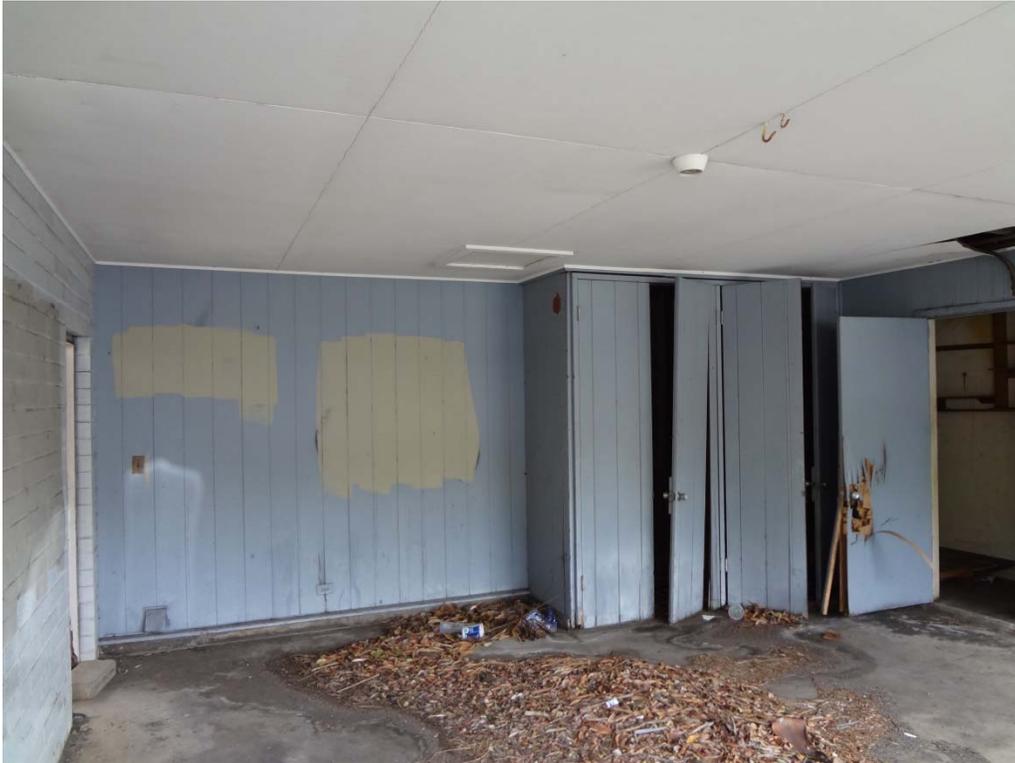
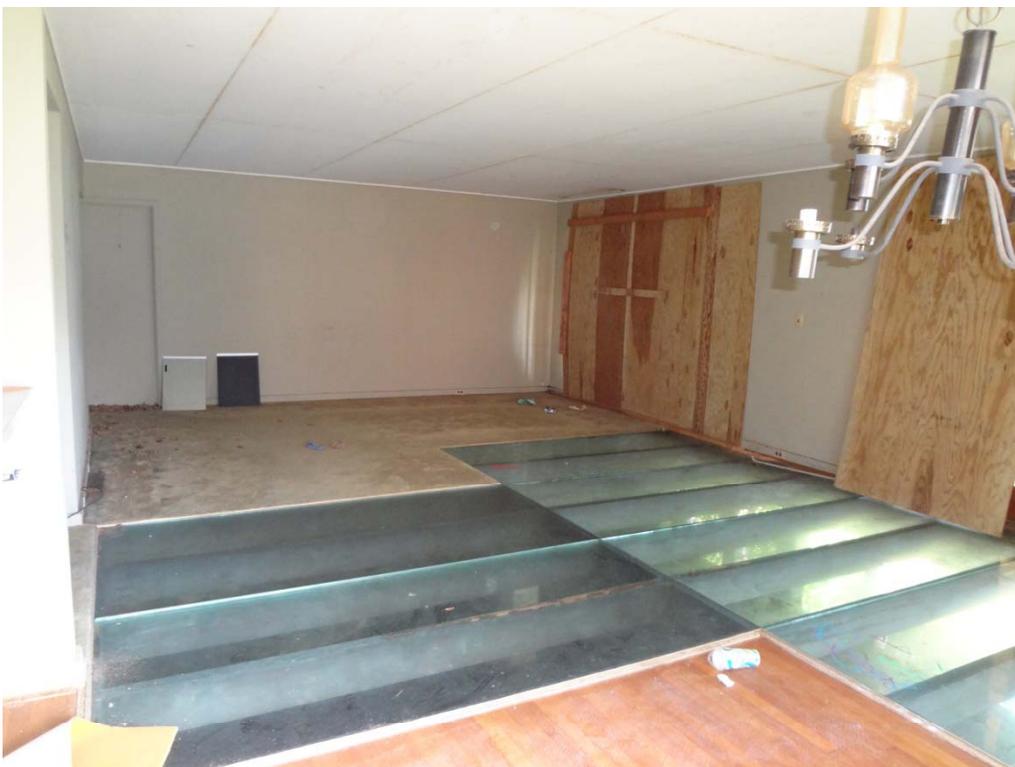
Photographs 27 and 28 – Examples of arsenic-containing canec ceiling panels throughout the residence and garage of 5841 Kalaniana'ole Highway.
