Kauhale Kakaako Parking Garage

Elevator Audit & Assessment Report

**Kauhale Kakaako Parking Garage
860 Halekauwila Street
Honolulu, HI 96813
Two (2) Passenger Elevators**

Re: Elevator Equipment Audit & Assessment

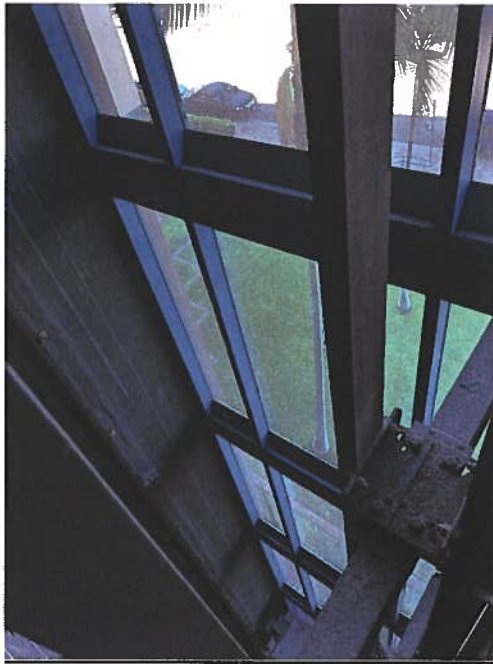
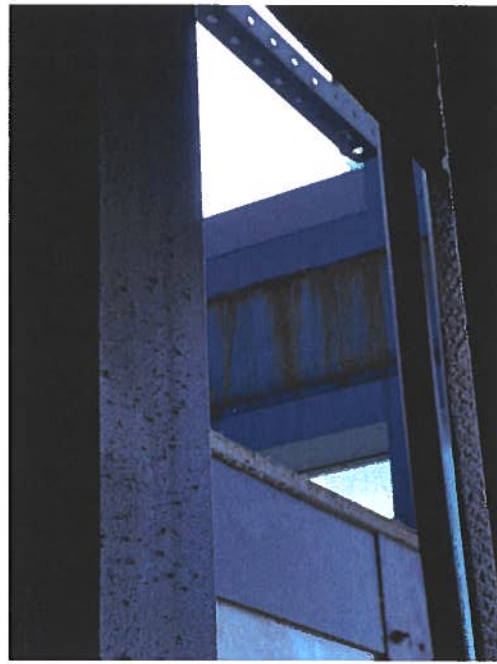
Elevator Glass Hoistways

We are addressing the hoistways as a separate item as work for them will have to be a coordinated effort. There are signs of water infiltration into the hoistway from various areas of the glass enclosure. Over time, with general weather impacts and sun light, the seals of the glass panels will need to be replaced and the entire hoistway resealed. This may also include rust abatement of the various metal framing around each glass panel. We highly recommend rust abatement along with electrostatic painting of all metal surfaces to extend the life of the steel hoistway structure.

The challenge will of course be access and working areas. There may be ways to work on the lower floors by raising the elevator and using ladders, etc. but safety evaluation and job hazard analysis' will be required to meet all OSHA requirements. We know for sure that an elevator contractor will be required to assist with elevator securing, running, and/or operating while work crews use the elevator car tops to conduct work.

More detailed discussions and planning will be required to address this either as a separate project, or coordination during the planned elevator modernization.

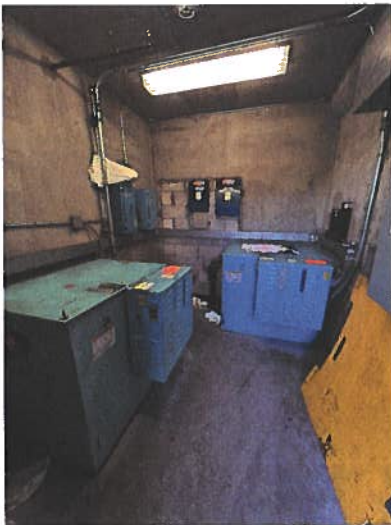
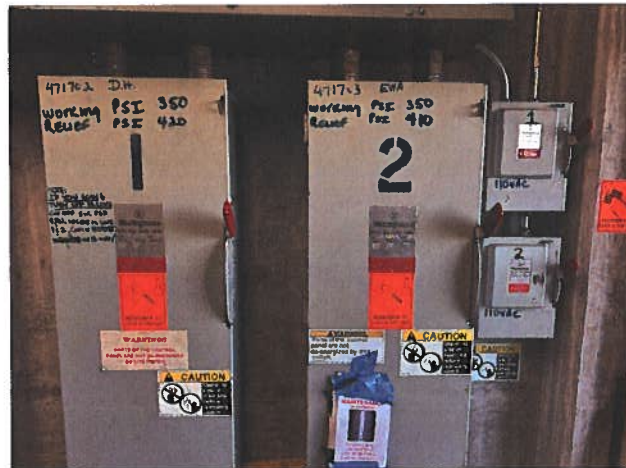
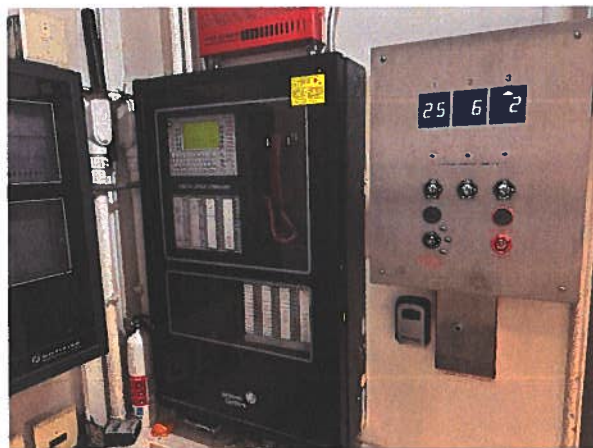
Elevator Machine Room

The elevator machine room is considered a remote machine room and is located approximately 20-30 feet from the elevator hoistways. While we understand the building design and location of the room, it does present a challenging issue with the hydraulic to and from piping. The current to and from piping is buried underground, and is running under the current sidewalk, into the grass area and then penetrated into the hoistway from the diamond head side. Both elevator's to and from piping can be seen from the underground penetration into the elevator pits. The largest concern

is the piping is not visible and the only method of monitoring any leak, is to constantly measure and monitor the oil levels in the hydraulic tanks and any scavenger pump and oil return lines to the machine room.

The machine room operating components are code compliant which includes compliant power disconnects, lighting, smoke fire recall systems. During the modernization, it will be an opportune time to make changes to the current fire panel operation and location since the current system is integrated with the condominium system. A separate operating and monitoring system for just these elevators should be installed at that time.

During modernization, the State Inspection Bureau will NOT require to and from piping to be re-installed above ground or visible, but we highly recommend this modification to ensure safe monitoring and maintenance of this line going forward. An underground leak, especially if not detected in a timely manner, will result in OSHA contamination reporting, clean-up, etc., including the unplanned disruption of the entire access to and from the garage. Again, this will should be addressed in further detail during the modernization planning stage.

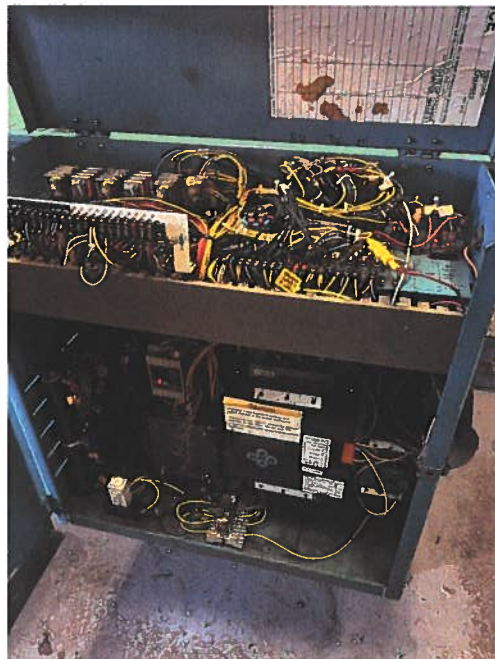
Elevator Controller

The controllers for these elevators are Otis Oildraulic. Otis installed numerous versions of this model throughout the world but quickly moved to a more updated and reliable system called an Otis 211M. These controllers are obsolete and replacement parts are refurbished versions. Otis has discontinued making original replacement parts due to high costs, so proper planning should be made for modernization. The control system is known to be reliable, and despite its age, it's still performing well and functional. Technical knowledge and resources are decreasing as many of the technicians who installed and worked on these are retiring but maintaining them in the short-term should not be an issue.

The controllers also contain a starter which receives the building's power and "starts" the elevator by transferring the power to the elevator. The current starters are an older model "soft-start", but we weren't able to verify its lifespan or longevity, so this will need to be monitored for replacement should failure occur prior to modernization. Starters are now designed and engineered as "soft start", which allows the power to be slowly ramped up the voltage and amperage needed to power the elevator based on the demand required. Much smoother, quieter and longer-lasting equipment operation is the result.

The control system also has a related component called an Automated Return Unit (ARU), which is a battery back-up system which will provide short term, temporary power, when there is a power loss to the elevator. This back-up system will provide enough power to allow the elevator to lower itself to the nearest, safest floor, and allow anyone inside to exit. This is a valuable feature for buildings and elevators, which are not tied into an emergency generator system. The current Otis Aut-o-safe is also obsolete but is compatible with the current control system. This can also be updated during the modernization.

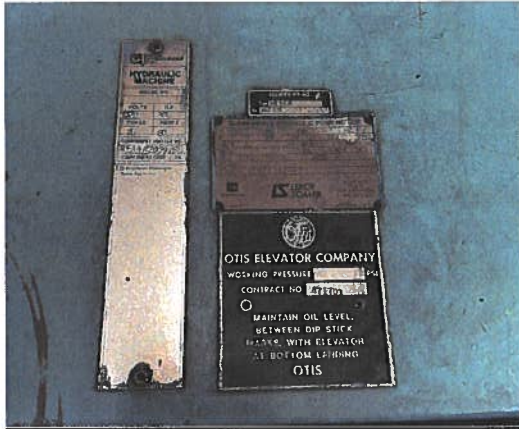
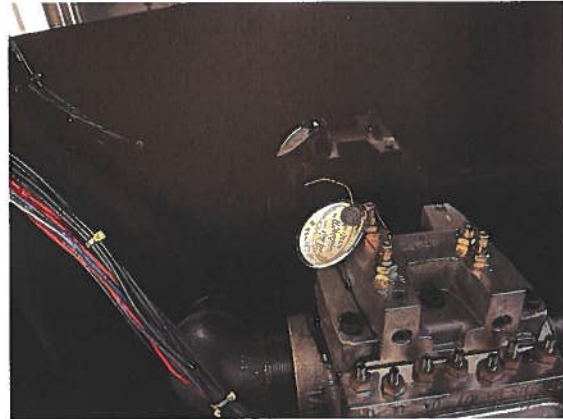
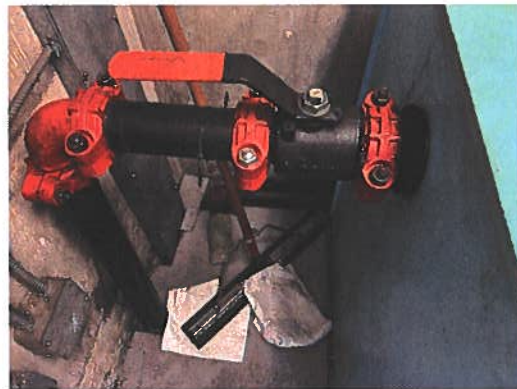
Elevator Power Unit

The current “machine” is a hydraulic Power Unit manufactured by Otis. The power unit is known as a submersible system with a pump motor, valve and muffler all self-contained in the hydraulic tank, with the oil which operates the system. There are numerous benefits to this set-up, all components are constantly lubricated, no external leaking of equipment and sound deadening within the tank unit. This power unit is operating well, and no signs of operating issues were present. The current valves on all elevators are Maxton (brand) valves and are known to be the top performing valve in the industry. The state approved and tested data tag showed the last safety test conducted in August 2021, so the test and inspections are up to date at this point.

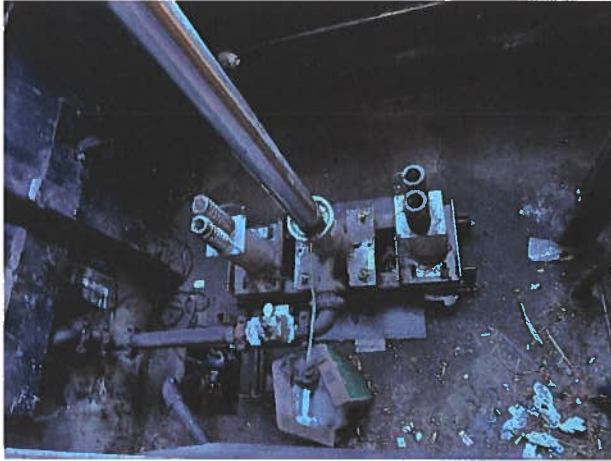
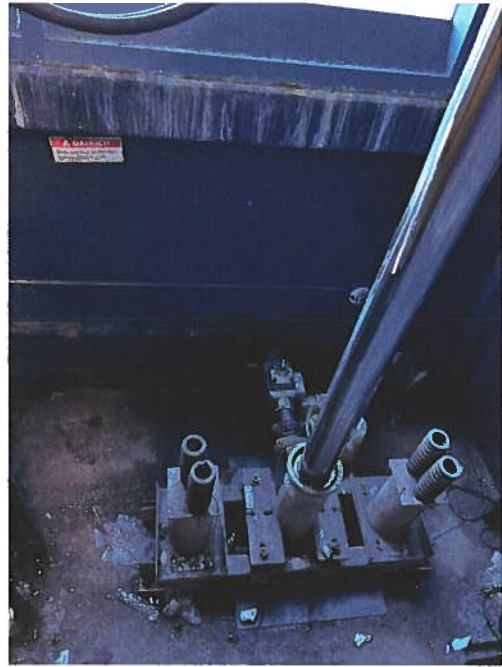
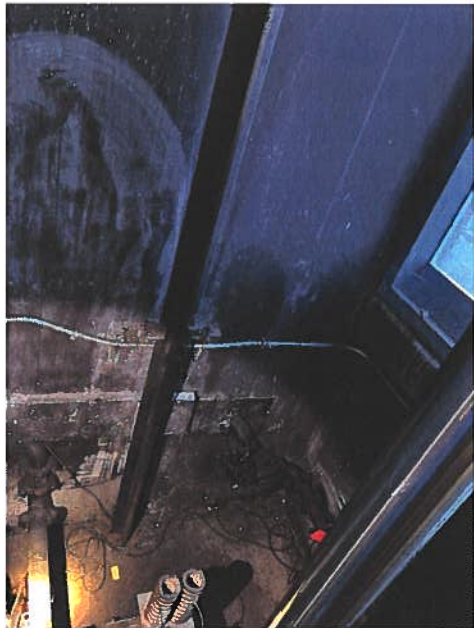
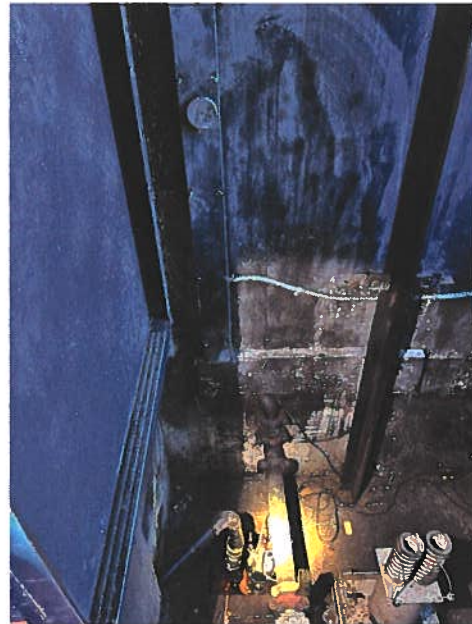
Elevator Hydraulic System

The existing hydraulic systems has an “in-ground”, single piston system. It utilizes a one-piece, piston which travels underground to the depth as far as it goes up to the top floor. In speaking with Elevator Services, both elevators experienced underground piston failures, and both were replaced with new undergrounds systems. The pistons appeared to be in good condition, is well-lubricated, with no scarring or leaking from the main packing.

However, we did notice some oil in the elevator pit and could not determine the exact source location, so we’ve asked Elevator Services to monitor the seals on the to and from piping, or the packing from each elevator for repair.

As part of maintenance servicing, there should be an oil log showing oil levels in the hydraulic tank, but we did not see or record them. This is another item we recommend Elevator Services keep in the machine room for reference and upkeep.

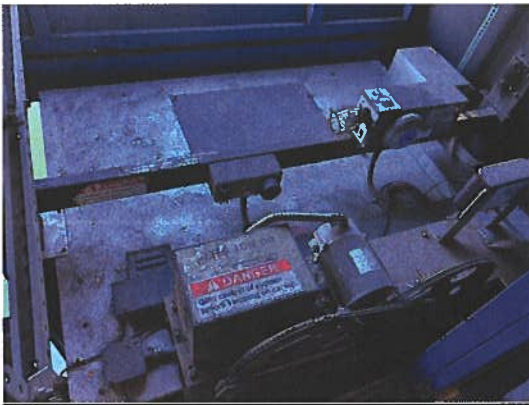
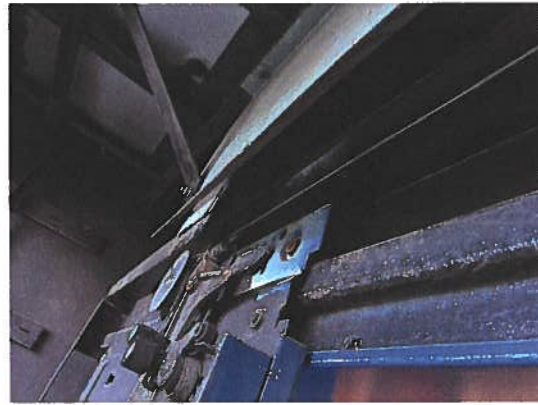
Door Components

The doors are operated by Otis i-Motion door operators and are well-suited for these types of elevators. Unfortunately, Otis has stopped manufacturing these operators and support for them from a parts perspective is rapidly decreasing. Thus, this is another component which should be monitored for replacement or may be replaced during the planned modernization. However, when this operator is coupled with robust, reliable door hardware components, door operation should be very reliable. The Otis door interlocks, integral hangers, closers, rollers and upthrusts make up a great door package, which in IEC's opinion, is the best in the industry. However, we did notice the chain linkage for both elevators are not in good condition and should be replaced prior to failure. We also noticed surface rust and corrosion setting in on the door components, so it would be a good idea to work on preventive repairs to remove the corrosion and paint the tracks to ensure a smooth operating surface for door travel. This work can also be addressed during modernization.

Unfortunately, the rust and corrosion has extended to the hoistway doors (doors on each floor) and the hoistway frames & returns (frames on each floor). There are multiple floors with visible rust and corrosion, some of which may be sanded, treated and painted. Some of the strike returns are beyond repair, so those will need to be replaced to provide a strong, rigid return for door closure. The doors on each floor have been painted on several occasions so they are hanging in there but may need a once over to remove corrosion scaling and repainting in the future.

The infrared door protection device monitors door opening and closing when the "beam" is broken to re-open the doors. The current models are Otis Lambda, which are obsolete. Thus, it may be a good idea to investigate upgrading this in the future to ensure users are kept safe and the opening device is working properly.

Door related problems make up approximately 70-80% of all elevator related issues. Thus, if maintenance and replacement of door components are performed on a normal, consistent basis, then you've just addressed the highest probable cause of elevator problems. During our survey we did notice several floors need to have door maintenance performed and we will enter that as punch-list items for Elevator Services to address.

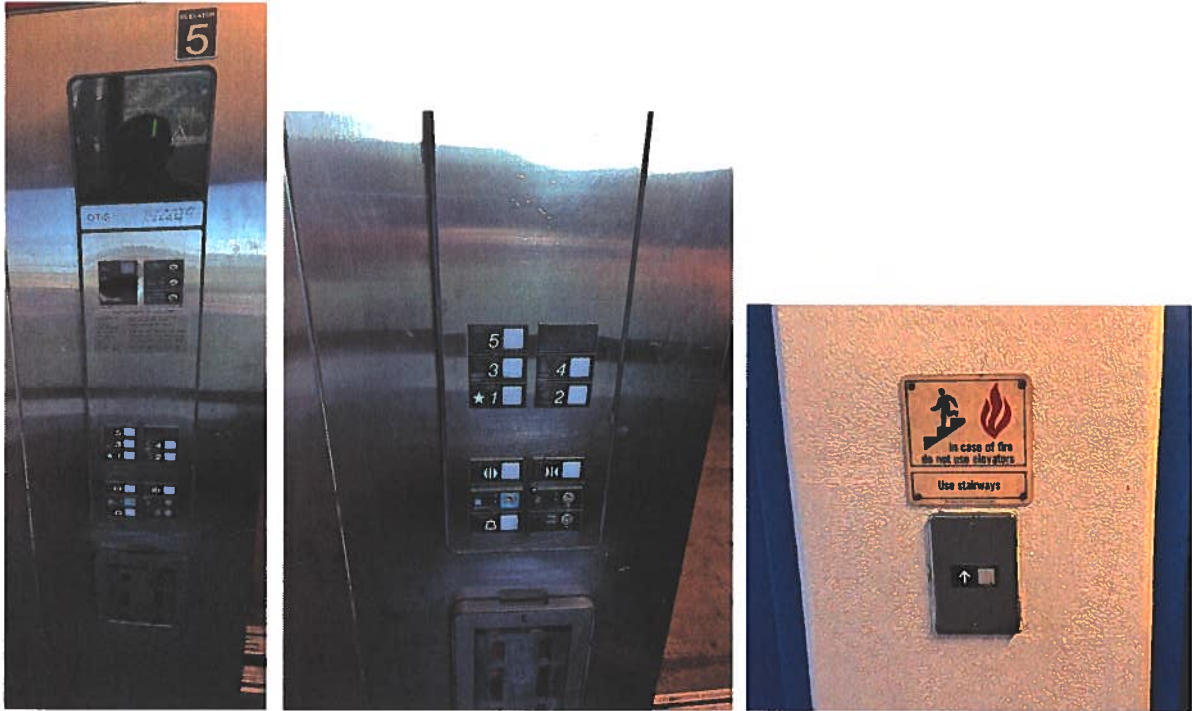
Elevator Car Enclosure & Signal Fixtures

The cab enclosure is the "box" that everyone rides in when using the elevator. As mentioned above, the current cab shell is a custom design and unique with a glass-back wall. While it is an upgraded model, it also presents a challenge with maintenance and ensuring the structure and seals are in

The signal fixtures are original Otis M2 models with plastic buttons. These are not the most conducive for the operating environment, so modernization will allow the installation of more robust and vandal-resistant versions of buttons, indicators and fixtures.

place to prevent any type of infiltration to the cab. When the elevator hoistways are addressed, we recommend doing the same to the cab shell and confirm its structural integrity and any seals are replaced.

The side interior walls may be replaced with new plastic laminated panels along with a new ceiling for a complete cab upgrade.
