GEOTECHNICAL CONSULTATION

MANA DRAG STRIP
REHABILITATION OF PAVEMENT
KAUAI RACEWAY PARK
KEKAHA, KAUAI, HAWAII

September 24, 2012

Pacific Geotechnical Engineers, Inc.

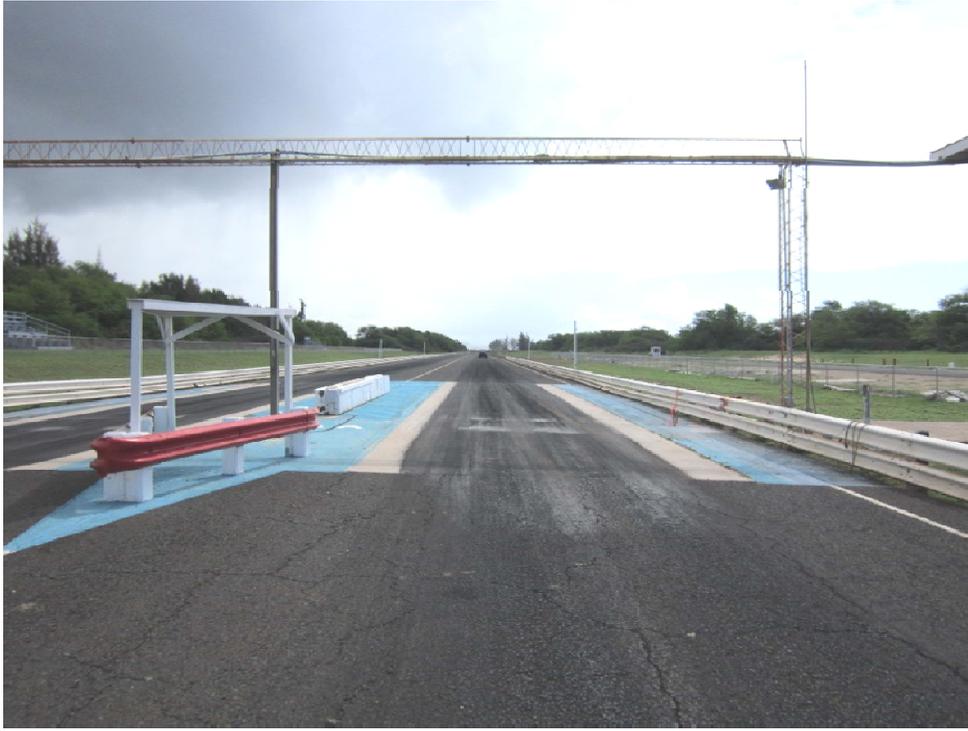
PHOTO 1 – Launch pad, looking east.

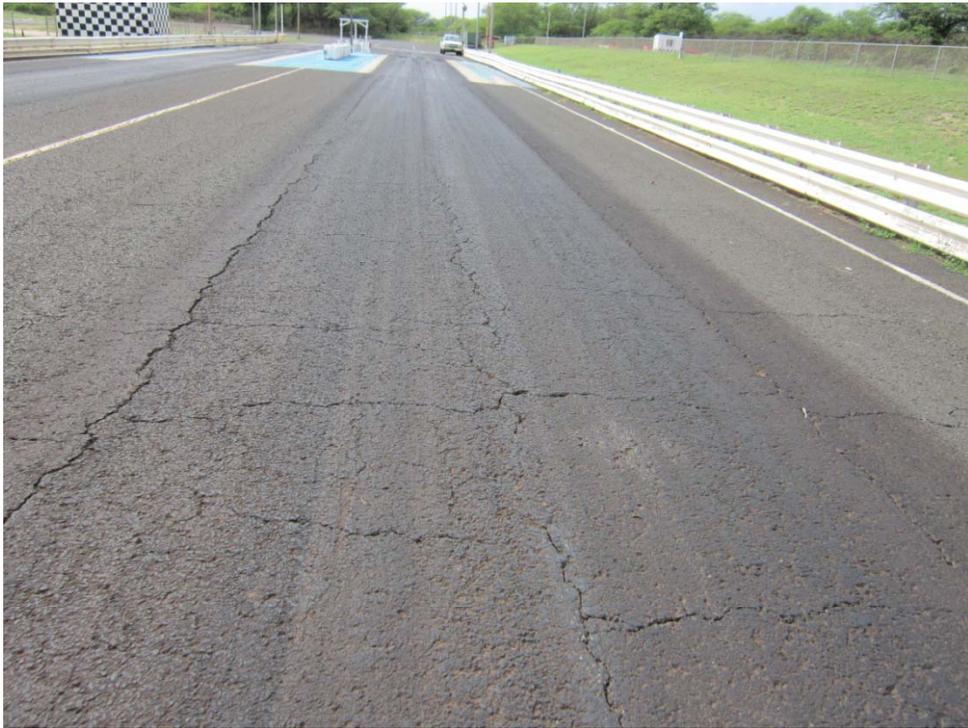
The existing pavement is in poor condition and exhibited moderate to high severity raveling and block cracking. As the pavement was constructed sometime in the 1970s, it is probably well beyond its original design life. A milling and resurfacing concept for pavement rehabilitation was initially considered for this project. Based on the results of the field exploration and PGE's analysis, milling and resurfacing does not appear to be feasible for the Mana Drag Strip due to insufficient thickness of the existing pavement and the deteriorated pavement condition. Based on the above considerations, it is recommended that a full-depth pavement reconstruction be performed.

PHOTO 2 – Moderate to high severity longitudinal and block cracking.

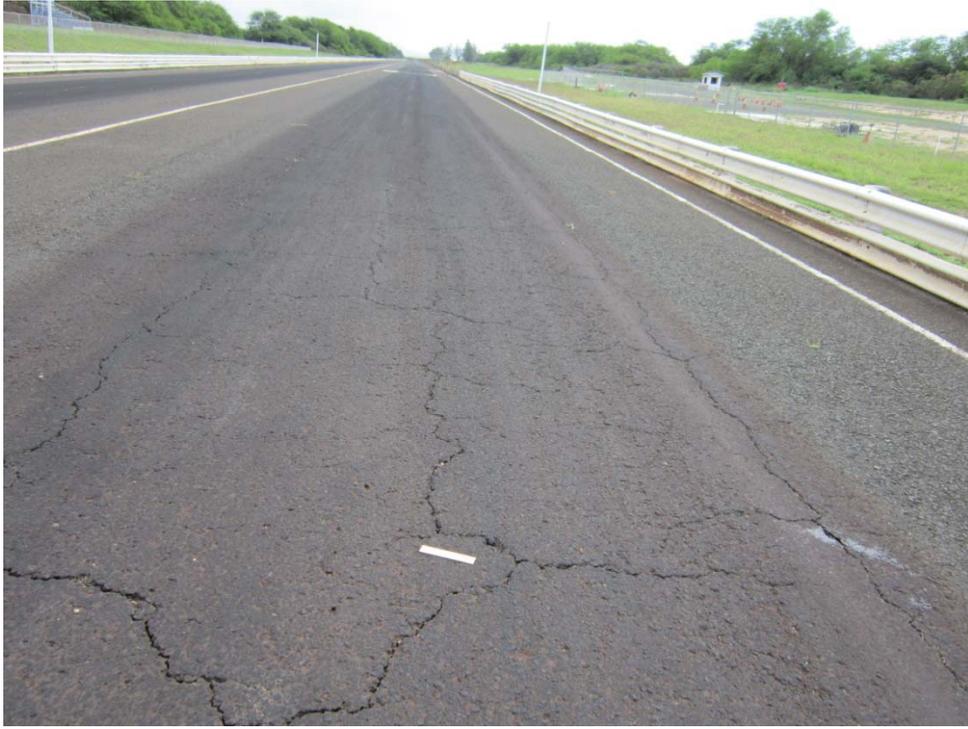
PHOTO 3 – Moderately severe block cracking.

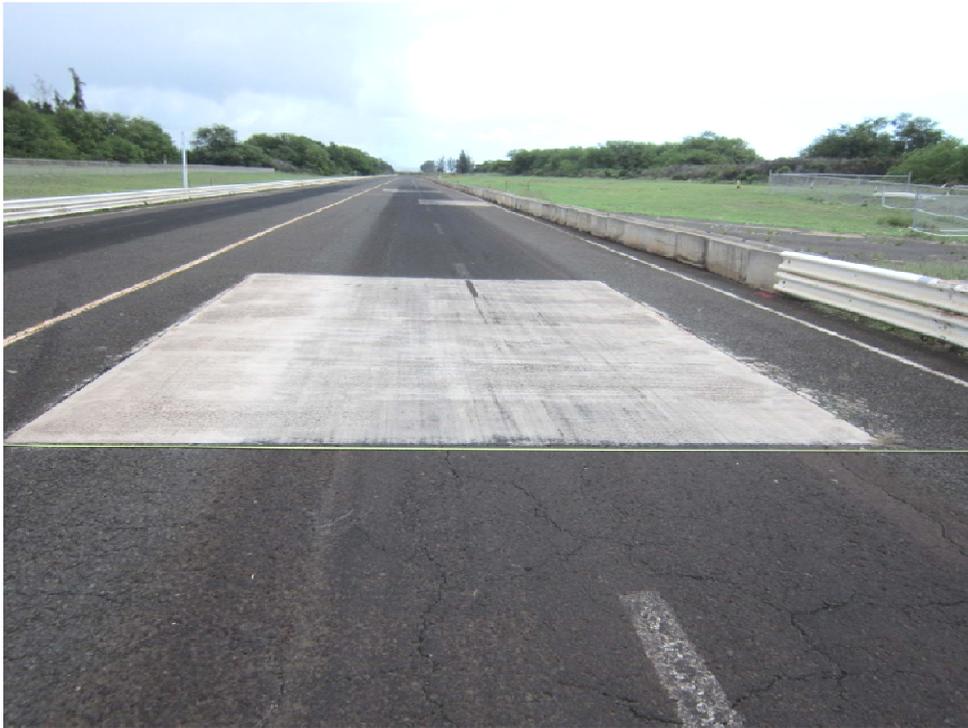
PHOTO 4 – Concrete pavement patch.

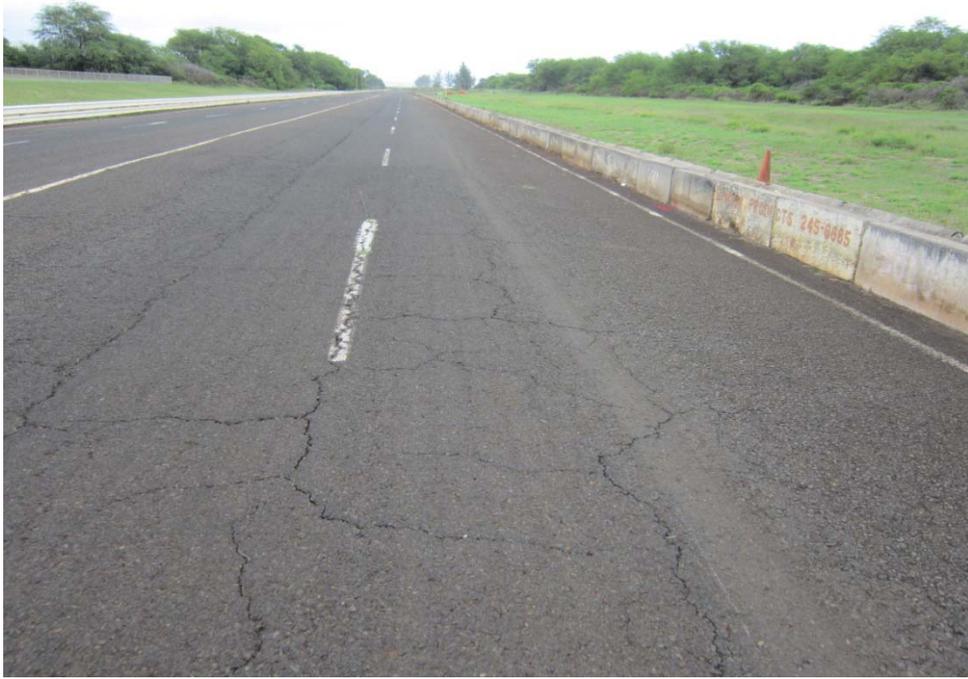
PHOTO 5 – Highly to moderately severe block cracking.

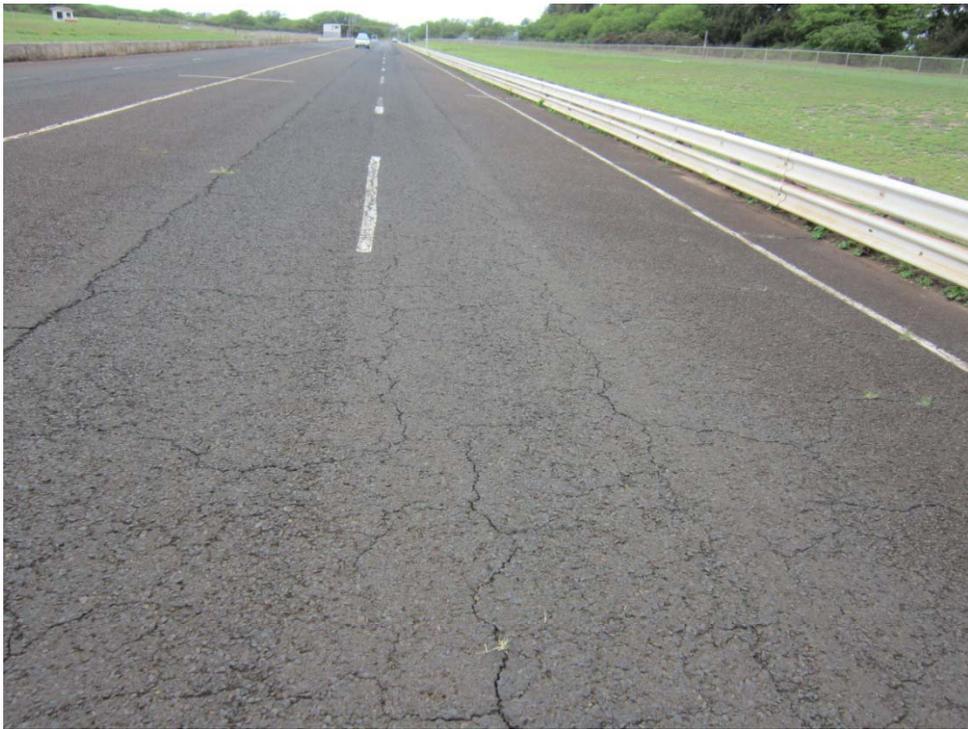
PHOTO 6 – High severity block cracking.

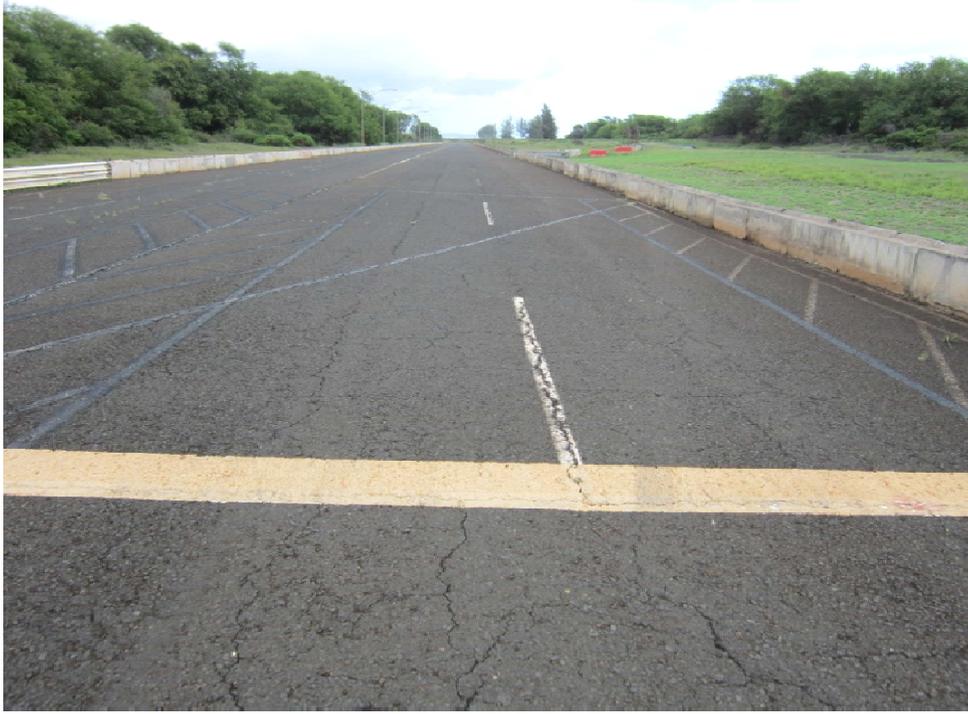
PHOTO 7 – Finish line at quarter mile.

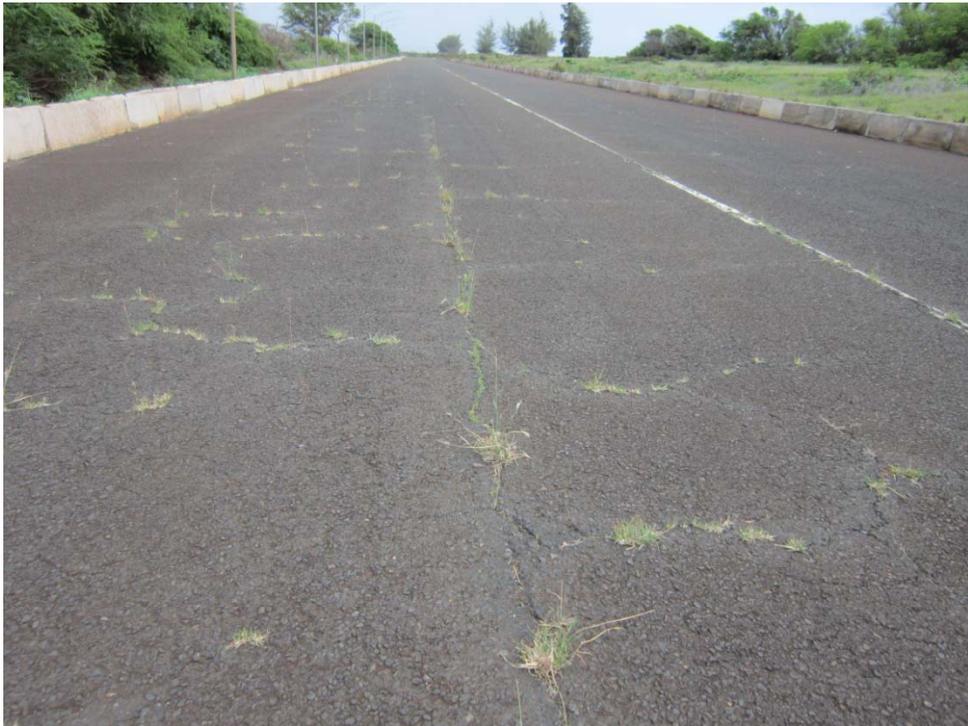
PHOTO 8 – Grass in cracks.

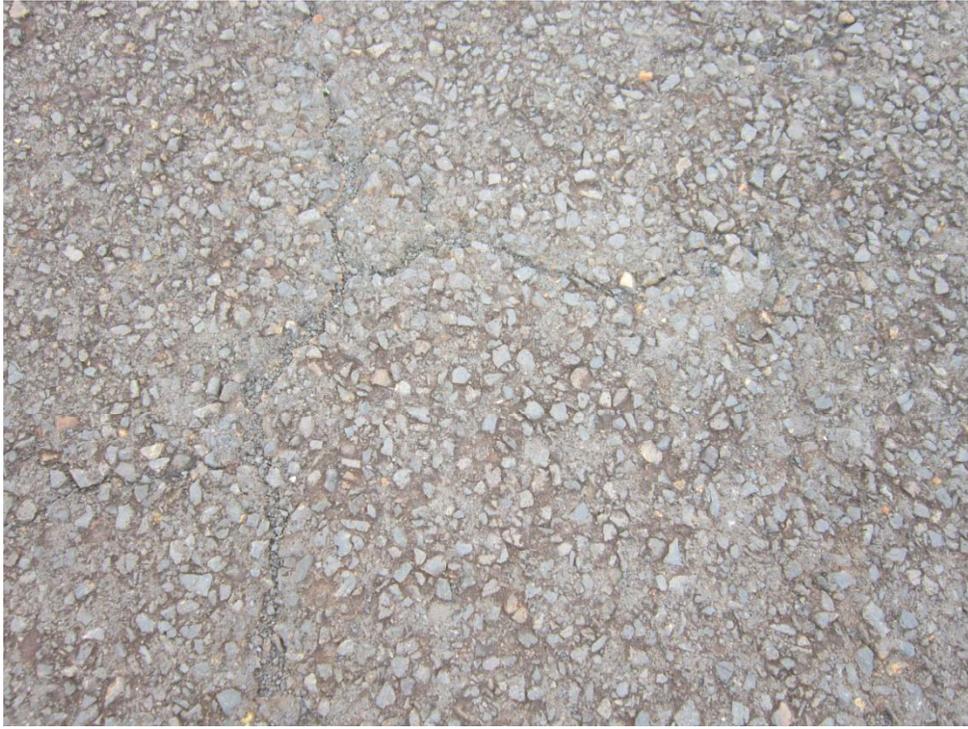
PHOTO 9 – Raveling and loss of aggregate.

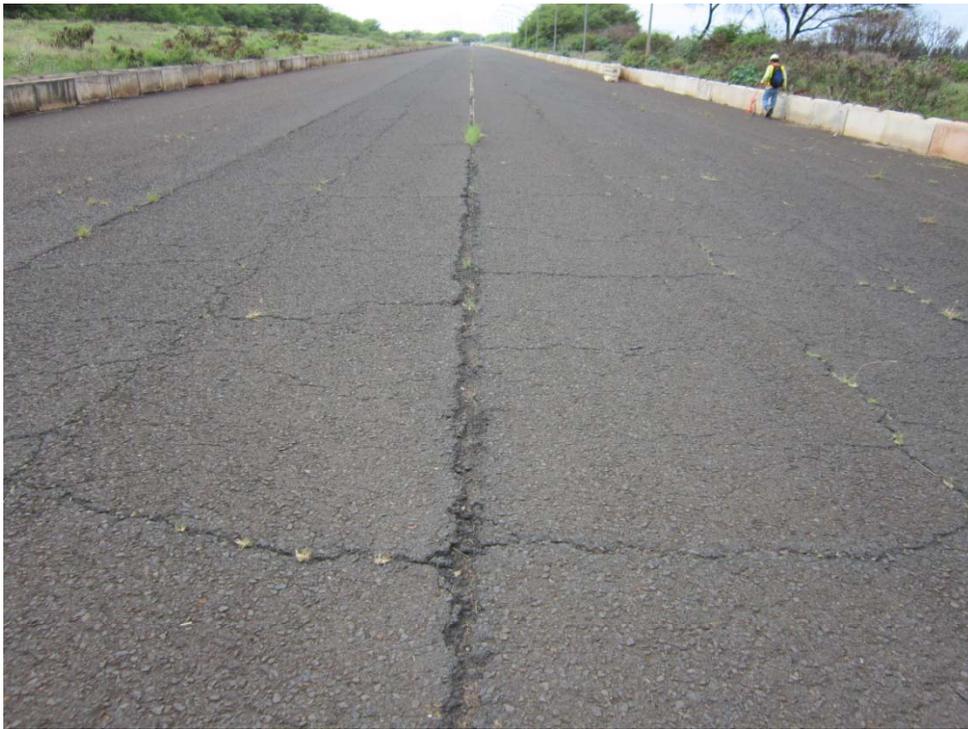
PHOTO 10 – Pavement crack at paving joint.

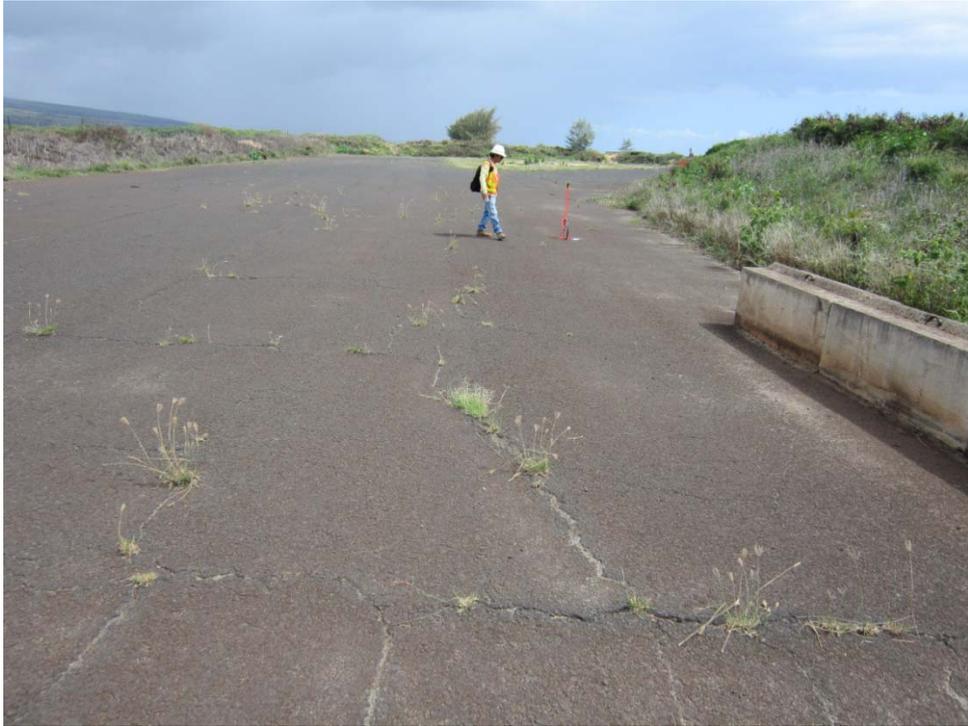
PHOTO 11 – Vegetation in cracks.

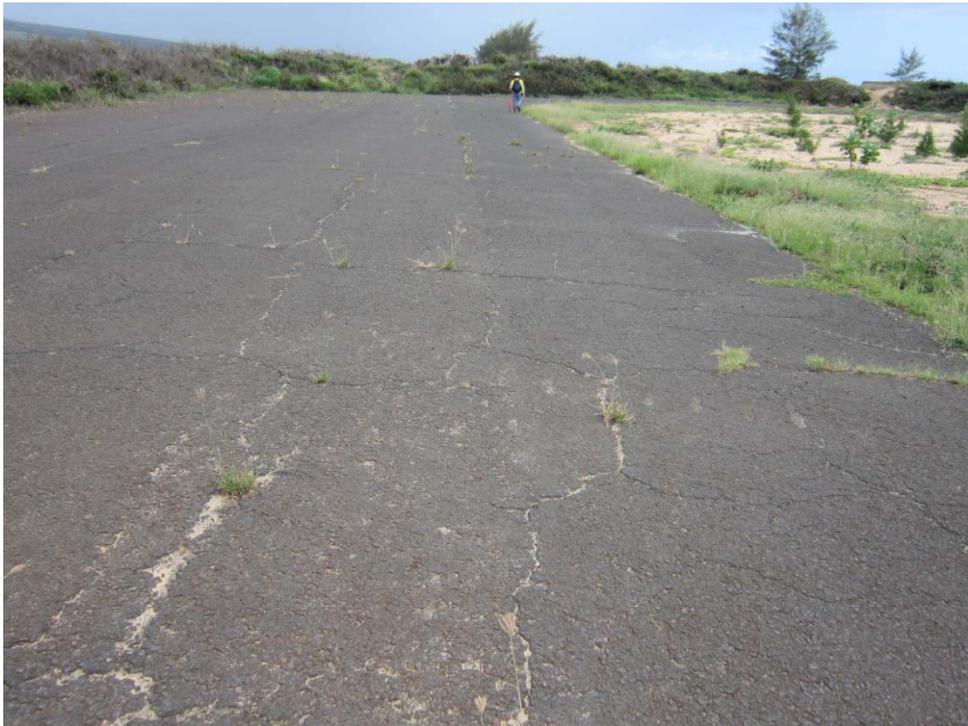
PHOTO 12 – Near end of raceway, looking east.
