TARGETED HAZARDOUS MATERIALS SURVEY REPORT

PROJECT:
GENERAL REPAIRS
DLNR JOB No.: 25-SPH-001

FACILITY SURVEYED:
KALŌPĀ STATE RECREATION AREA
44-3480 KALANIAI ROAD
HONOKAA, HAWAII 96727

DATE: JANUARY 2, 2025

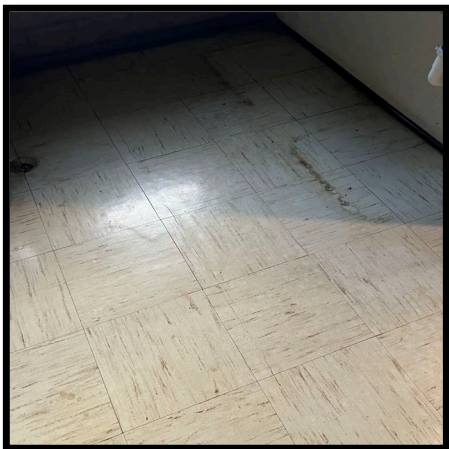
1A/B-A7: None Detected
1A/B-A8: None Detected
1A/B-A9: None Detected

Interior beige 12''x12'' vinyl floor tile and yellow/black mastic located in bathroom of cabin 1A/B.

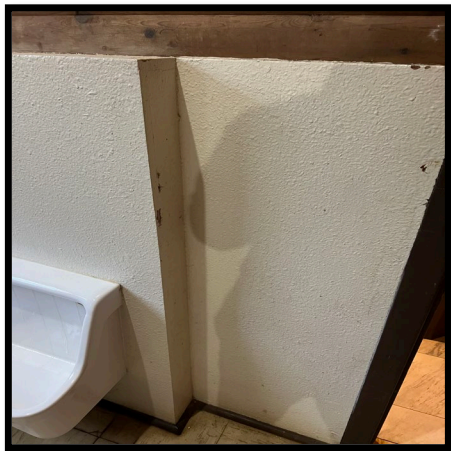
2A/B-A10: None Detected

2A/B-A11: None Detected

2A/B-A12: None Detected

Interior white/brown wood board plumbing chase located in bathroom of cabin 2A/B.

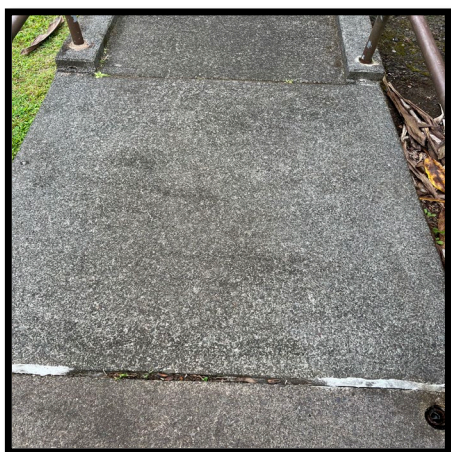
K/D-A1: None Detected

K/D-A2: None Detected

K/D-A3: None Detected

Exterior grey concrete walkway located in kitchen dining area.

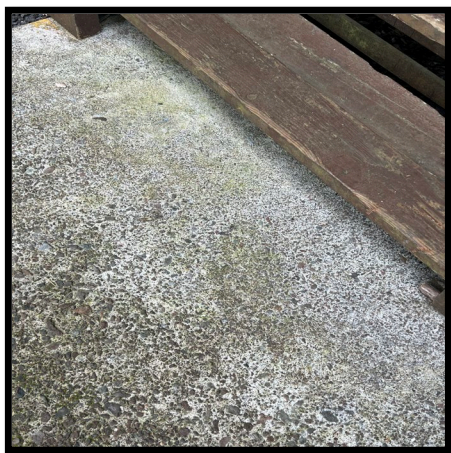
C2-A1: None Detected

C2-A2: None Detected

C2-A3: None Detected

Exterior grey concrete walkway located in exterior area of Cabin 2A/B.

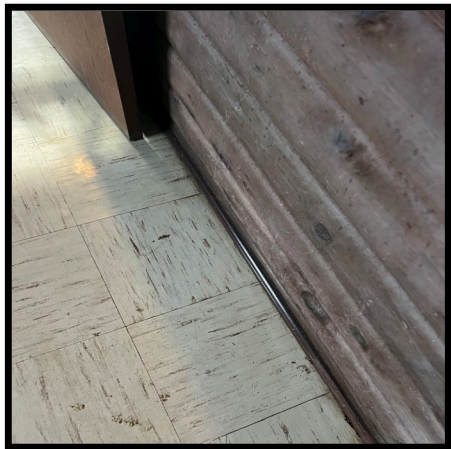
1A/B-L2: Does not contain lead above the laboratory detection limit (<52 mg/kg)

Interior brown wood wall trim located in cabin 1A/B.

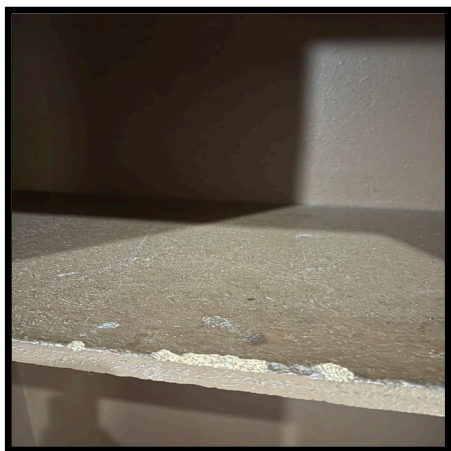
2A/B-L1: Does not contain lead above the laboratory detection limit (<40 mg/kg)

Interior brown wood shelves located in cabin 2A/B.

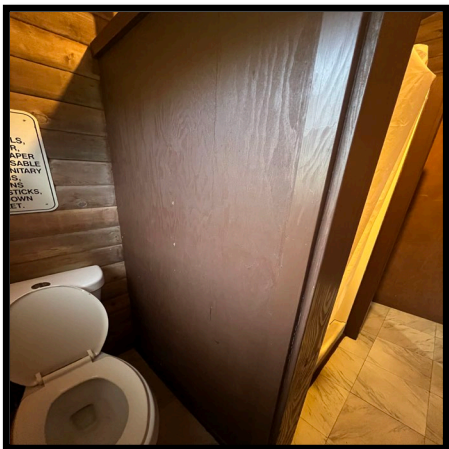
2A/B-L4: LCP (300 mg/kg)

Interior brown wood board plumbing chase located in cabin 2A/B.

- Spot remove and dispose of all LCP that may be disturbed or become dislodged during renovation activities in accordance with applicable local, state, and federal regulations.

- Spot remove and dispose of all loose and flaking (poor condition) LCP that may be disturbed or become dislodged during renovation activities in accordance with applicable local, state, and federal regulations.

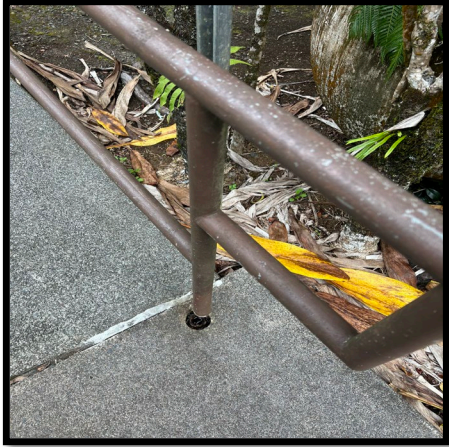
K/D-L1: LCP (280 mg/kg)

Exterior brown metal handrails located in kitchen/
dining area.

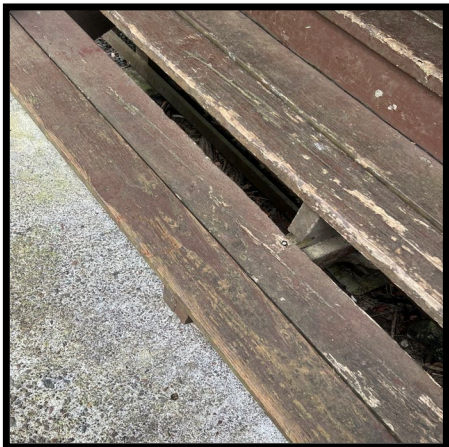
C2-L1: LCP (230 mg/kg)

Exterior brown wood stairs located in cabin 2A/B.

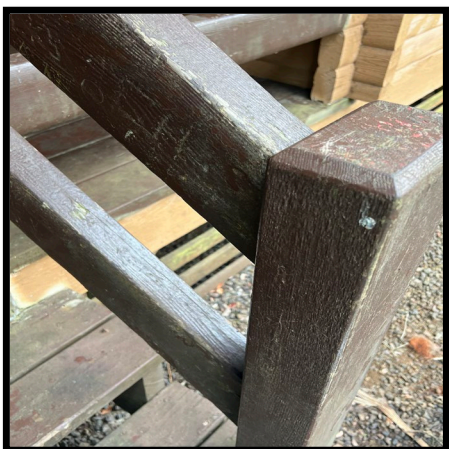
C2-L2: LCP (200 mg/kg)

Exterior brown wood stair railing located in cabin
2A/B.

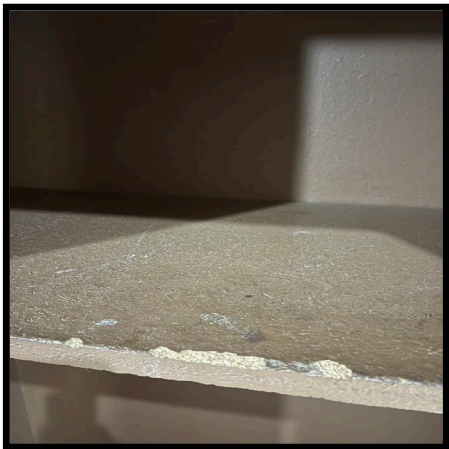
2A/B-ARS1: Does not contain arsenic above the laboratory detection limit (<42 mg/kg)

Interior brown wood shelves located in cabin 2A/B.
