DLNR Job #: 26-SPO-016

Site Pictures

Site Area: Pavilion #3

Keiwa Heiau State Recreation Area Comfort Stations General Repairs and Reroof

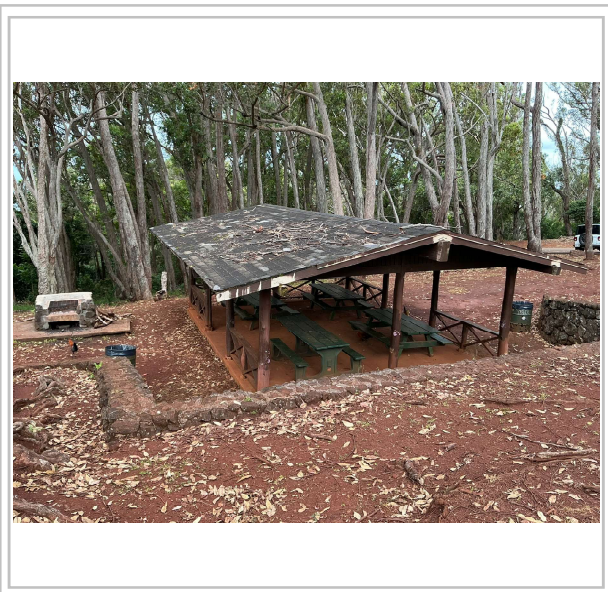
Pavilion roofing

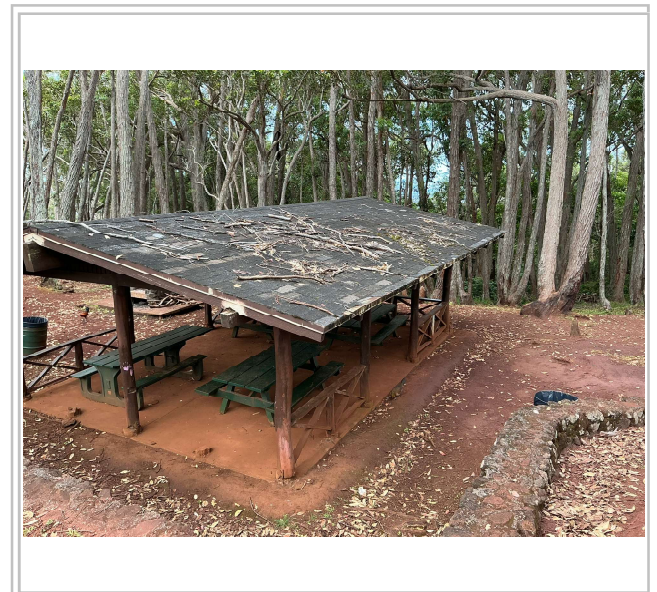
Pavilion roofing

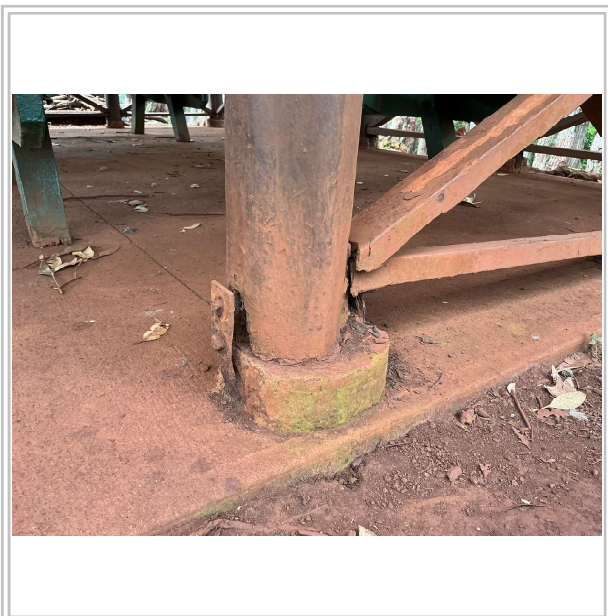
Corroded bracket and hardware example

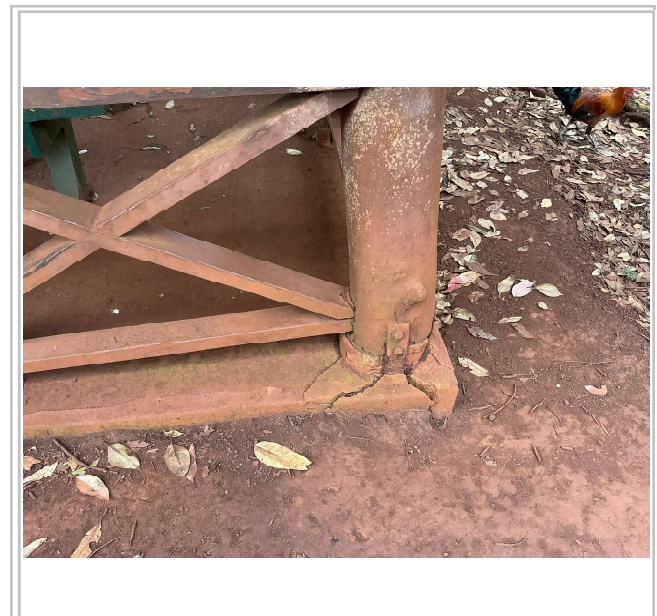
Concrete spall and corroded bracket example

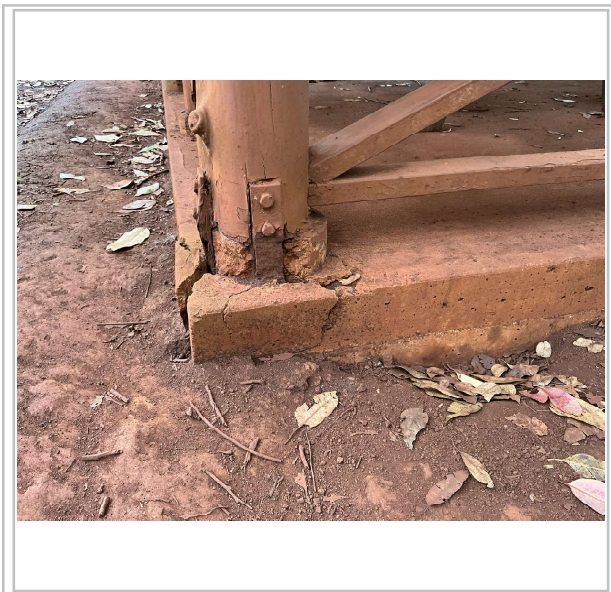
Concrete spall and corroded bracket example

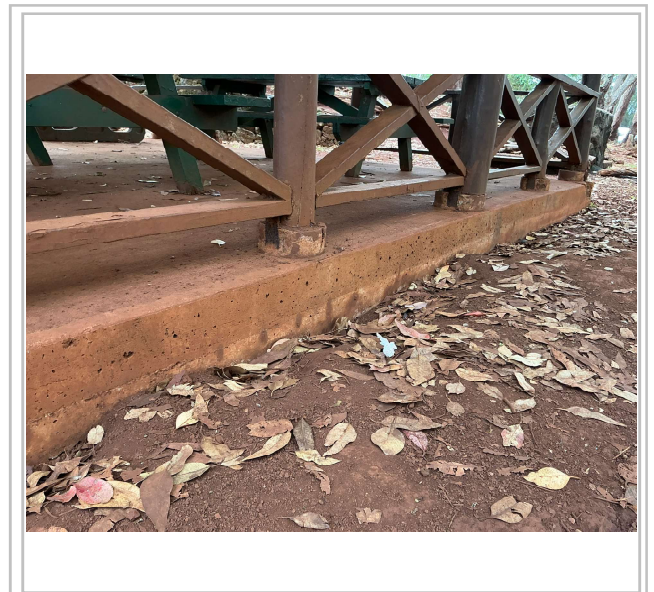
Corroded bracket example

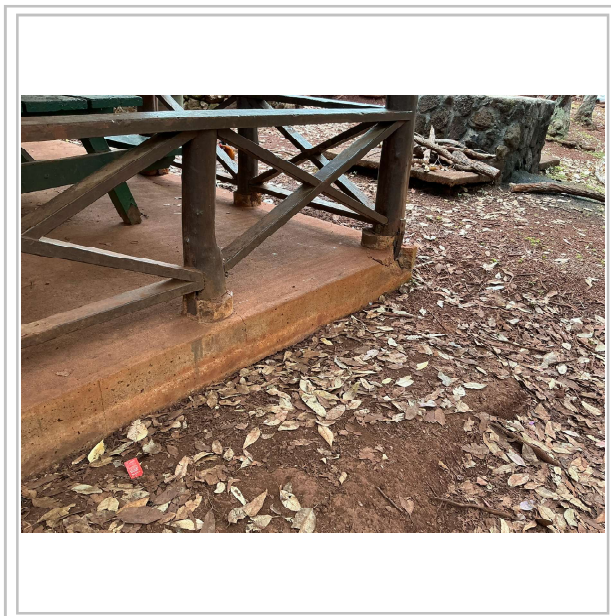
Concrete spall and corroded bracket example

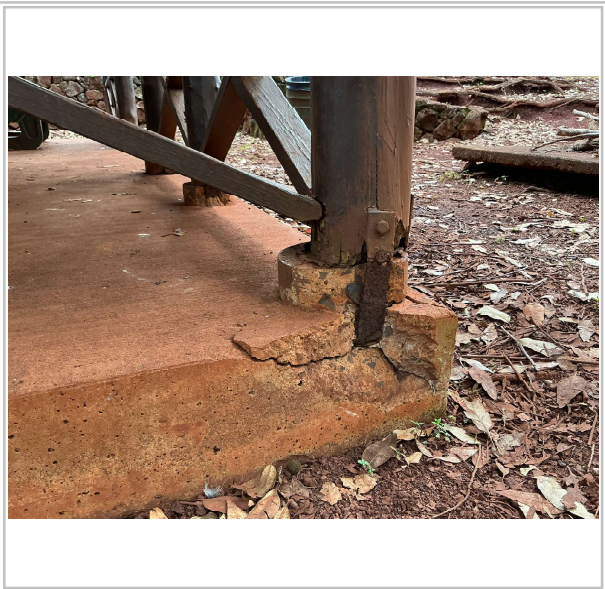
Concrete spall and corroded bracket example

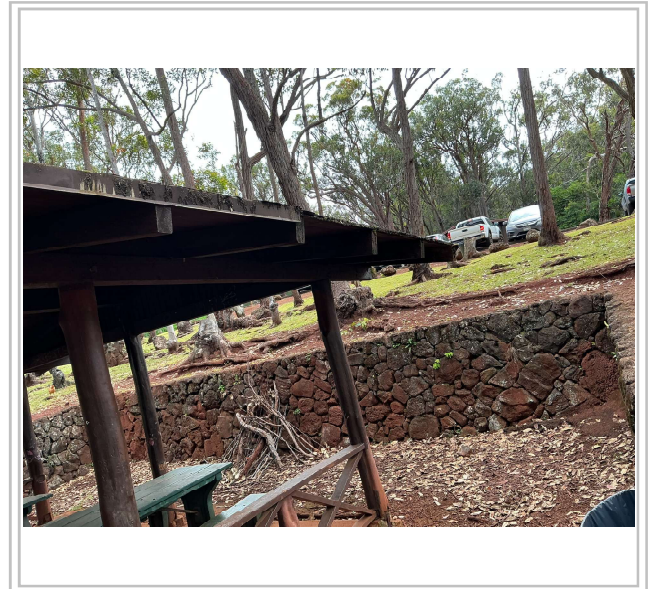
Concrete spall example

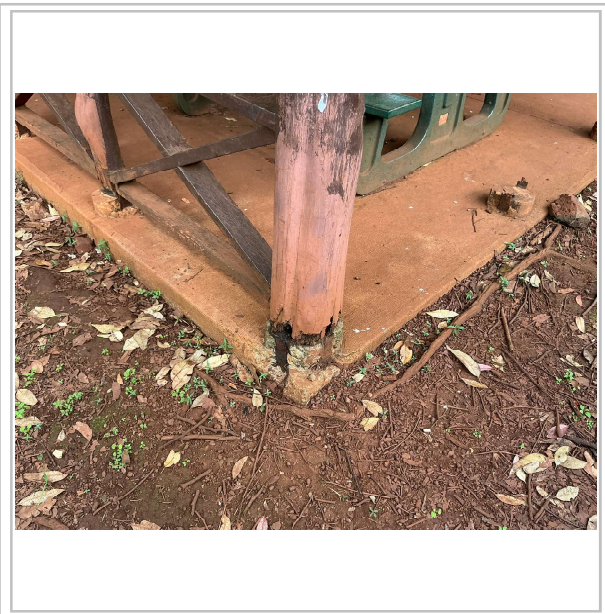
Concrete spall and corroded bracket example

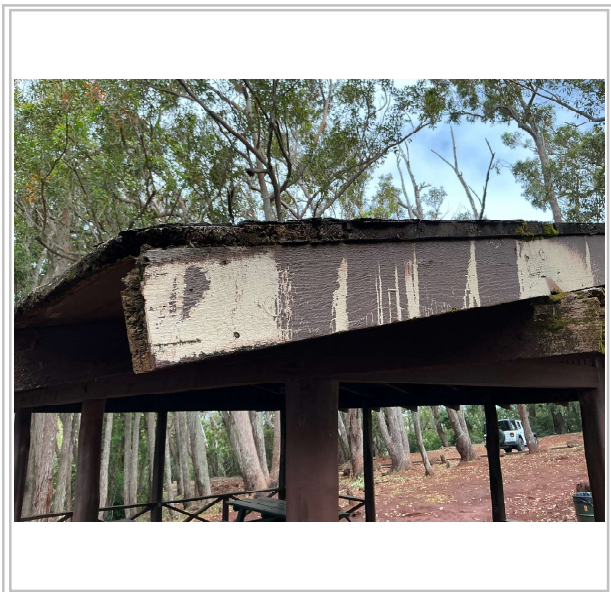
Rotting roof decking example

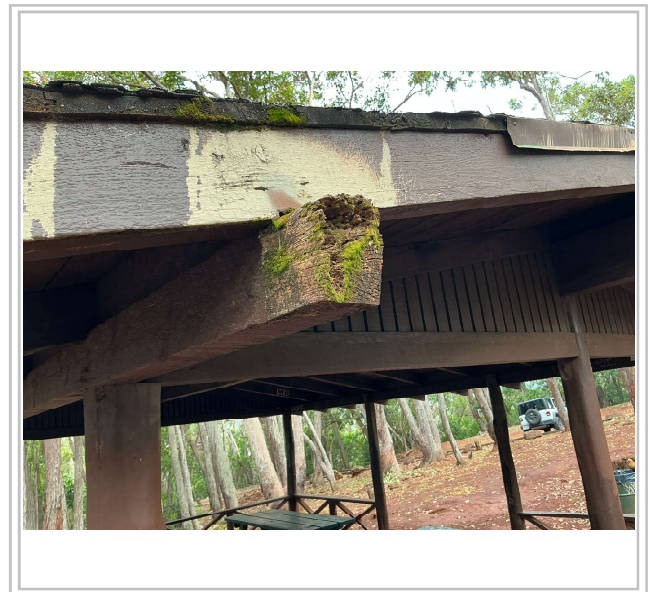
Wood rot example
