LIMITED INSPECTION REPORT FOR ASBESTOS, LEAD-BASED PAINT AND PCB'S

Foreign Trade Zone No.9
Pier 2 Warehouse and Office Improvement

September 2012

ENVIROQUEST Project 6611

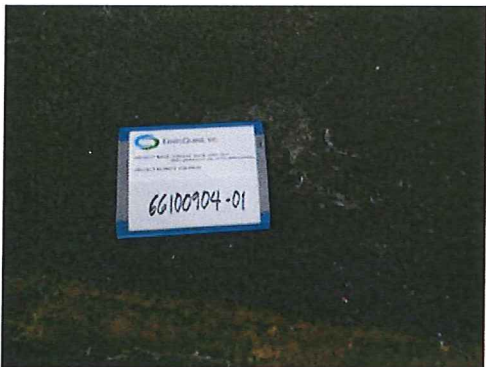
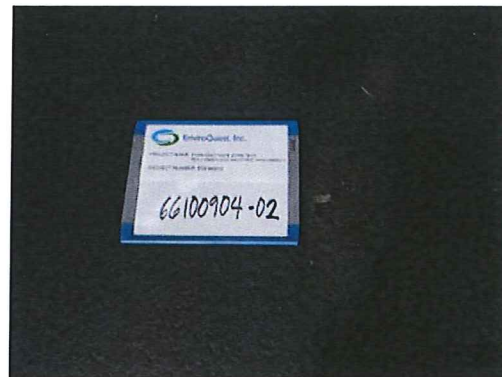
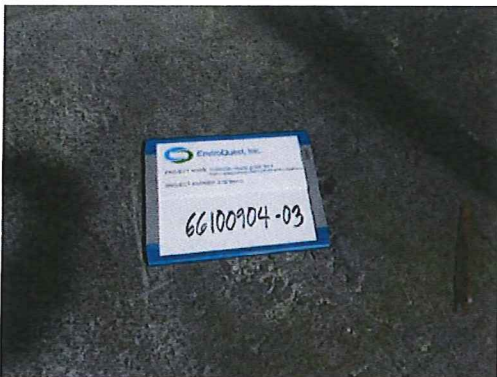
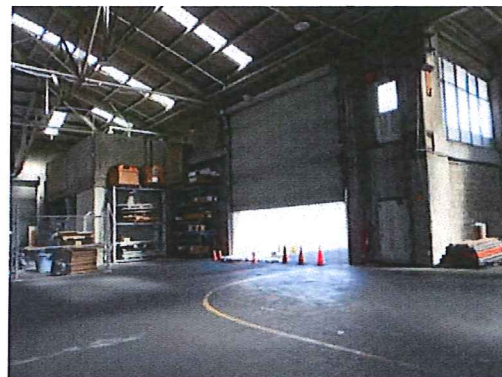
Photo #3: Ground floor. Non-asbestos containing black flooring (asphalt).

Photo #4: Ground floor. Non-asbestos containing black flooring (asphalt).

Photo #5: Ground floor. Non-asbestos containing black flooring (asphalt).

Photo #6: Ground floor. Non-asbestos containing black flooring (asphalt).

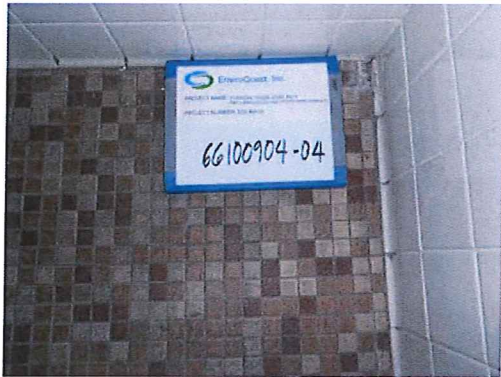
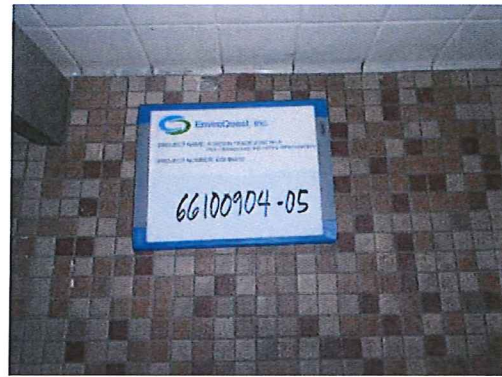
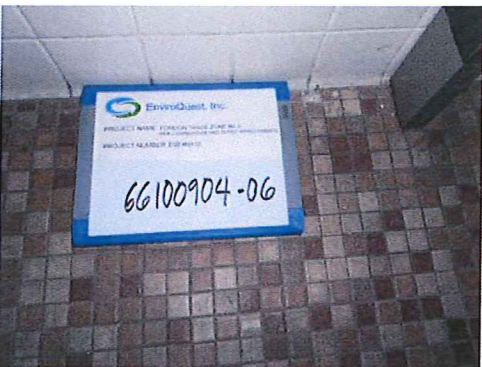
Photo #7: Ground floor, restroom.
Non-asbestos containing tan ceramic floor tile and grout.

Photo #8: Ground floor, restroom.
Non-asbestos containing tan ceramic floor tile and grout.

Photo #9: Ground floor, restroom.
Non-asbestos containing tan ceramic floor tile and grout.

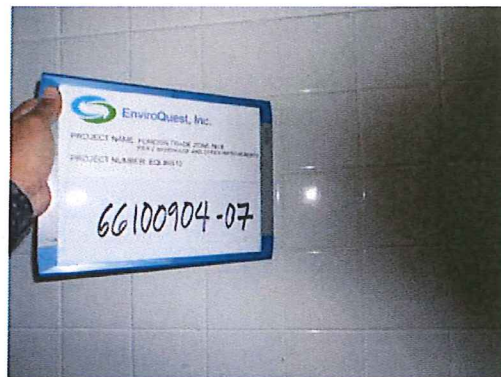
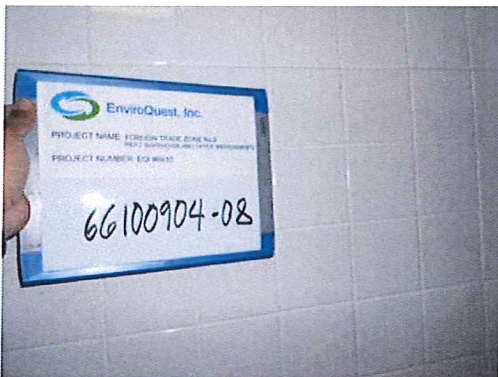
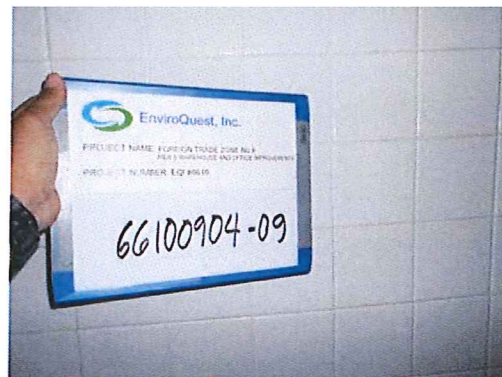
Photo #10: Ground floor, restroom.
Non-asbestos containing white ceramic wall tile and grout.

Photo #11: Ground floor, restroom.
Non-asbestos containing white ceramic wall tile and grout.

Photo #12: Ground floor, restroom.
Non-asbestos containing white ceramic wall tile and grout.

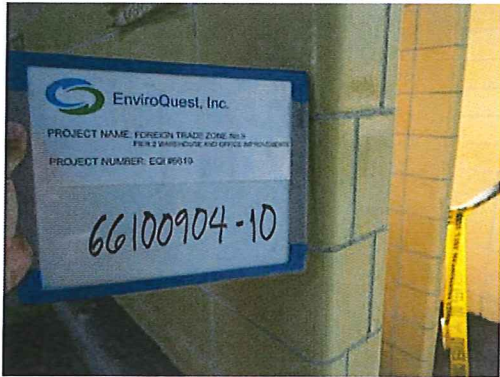
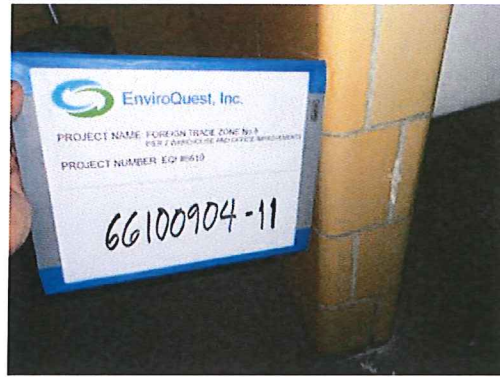
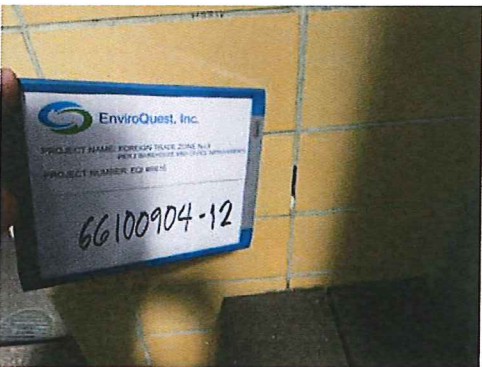
Photo #13: 2nd floor, urinal area.
Non-asbestos containing beige ceramic wall tile and grout.

Photo #14: 2nd floor, urinal area.
Non-asbestos containing beige ceramic wall tile and grout.

Photo #15: 2nd floor, shower room.
Non-asbestos containing beige ceramic wall tile and grout.

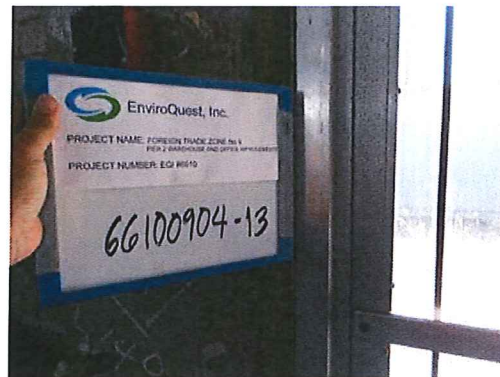
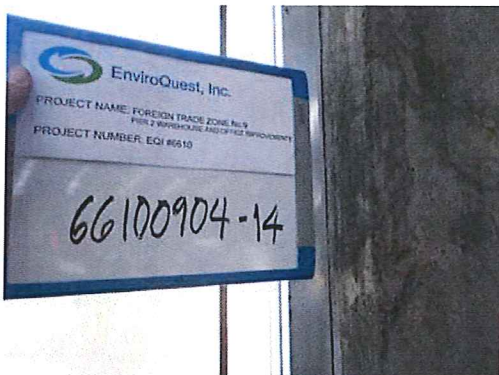
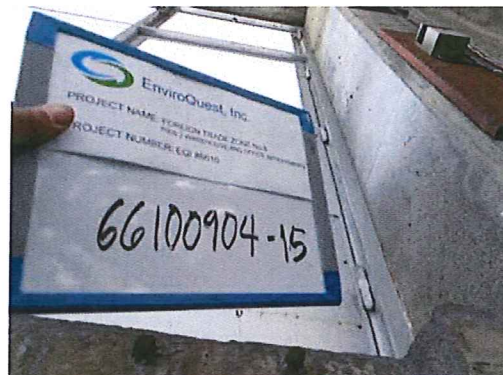
Photo #16: Ground floor, aluminum exit door frame.
Asbestos-containing tan door caulking.

Photo #17: Ground floor, aluminum exit door frame.
Asbestos-containing tan door caulking.

Photo #18: Aluminum window frame.
Asbestos-containing tan window caulking.

The damaged ACM should be repaired and or removed through abatement as part of the renovation work. Abatement must be completed by a certified asbestos abatement contractor under controlled conditions in accordance with EPA and HDOH regulations. Work should also be monitored by an independent industrial hygiene professional.

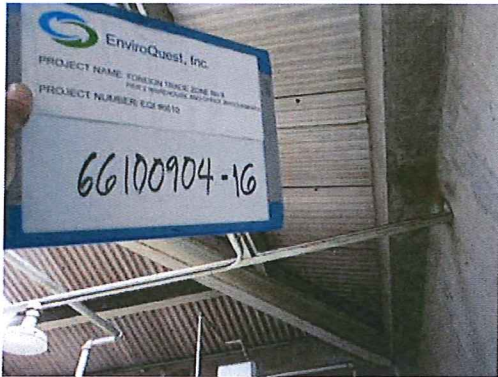
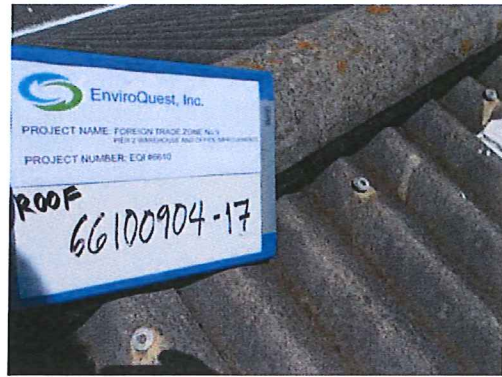
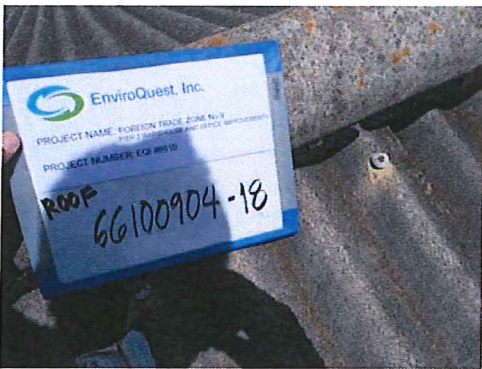
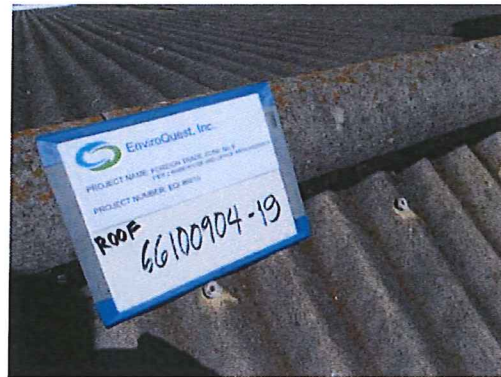
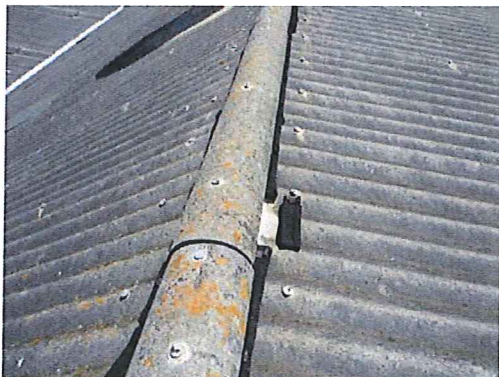
Photo #19:
Asbestos-containing corrugated roof panel.

Photo #20: Roof ridge.
Non-asbestos containing black sealant.
Asbestos-containing cementitious roof ridge.

Photo #21: Roof ridge.
Non-asbestos containing black sealant.
Asbestos-containing cementitious roof panel.

Photo #22: Roof ridge.
Non-asbestos containing black sealant.
Asbestos-containing cementitious roof panel.

Photo #23: Roof ridge.
Non-asbestos containing black sealant.
Asbestos-containing cementitious roof and ridge.

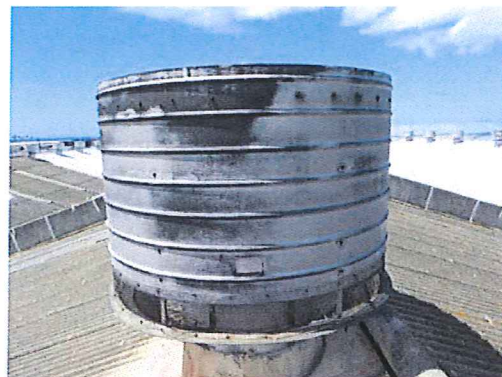
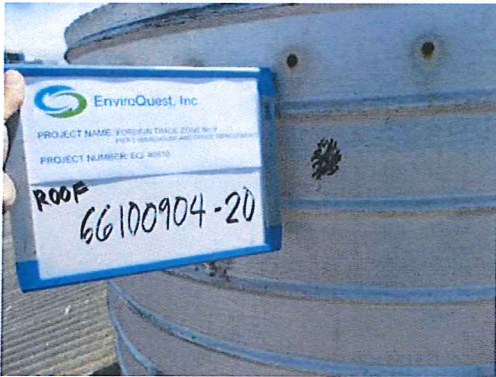
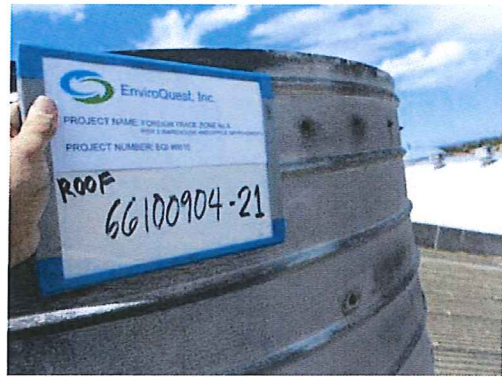
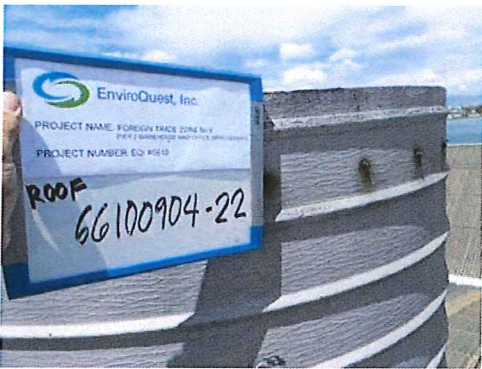
Photo #24: Roof exhaust fan.
Asbestos-containing black felt coating under silver paint and black tar.

Photo #25: Roof exhaust fan.
Asbestos-containing black felt coating under silver paint and black tar.

Photo #26: Roof exhaust fan.
Asbestos-containing black felt coating under silver paint and black tar.

Photo #27: Roof exhaust fan.
Asbestos-containing black felt coating under silver paint and black tar.

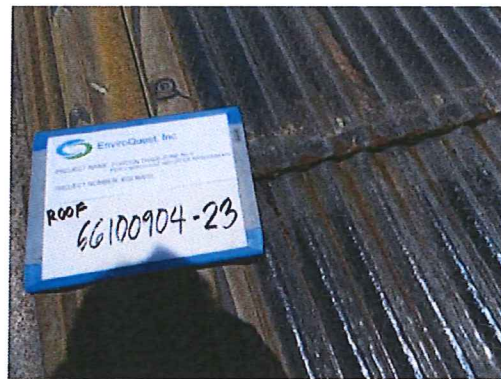
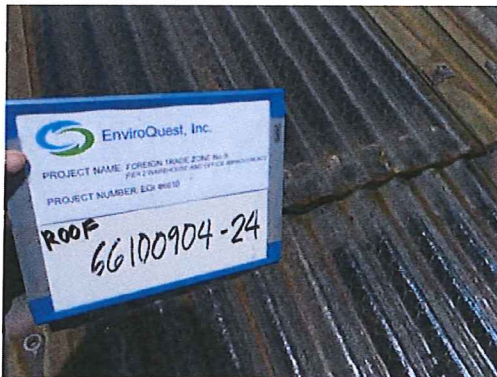
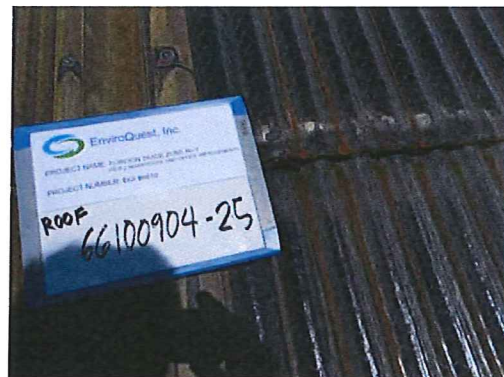
Debris from the cementitious panel on black filler material	Y	Debris visible on the roof side of the skylight joint	66100904-23 66100904-24 66100904-25	N	200 linear ft.	Damaged	28, 29, 30

Photo #28: Roof skylight.
Asbestos-containing debris from cementitious roof panel on the non-asbestos containing black sealant.

Photo #29: Roof skylight.
Asbestos-containing debris from cementitious roof panel on the non-asbestos containing black sealant.

Photo #30: Roof skylight.
Asbestos-containing debris from cementitious roof panel on the non-asbestos containing black sealant.

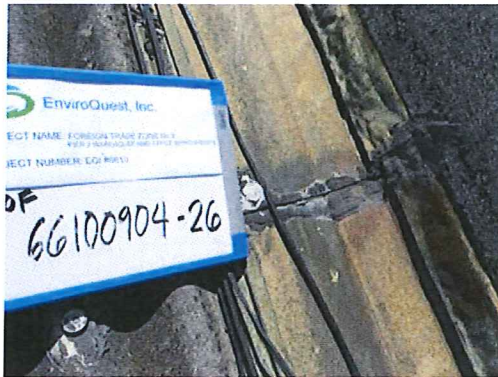
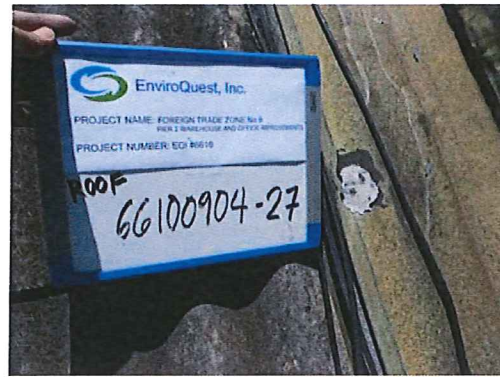
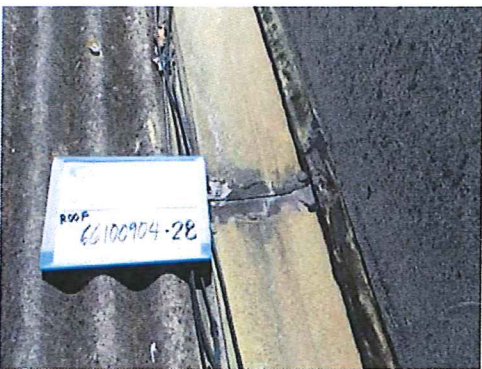
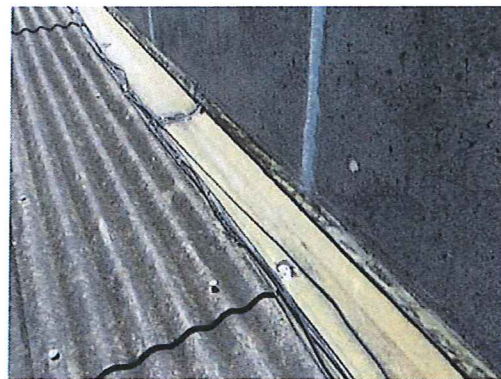
Photo #31: Roof flashing.
Non-asbestos containing black and white caulking.

Photo #32: Roof flashing.
Non-asbestos containing black and white caulking.

Photo #33: Roof flashing.
Non-asbestos containing black and white caulking.

Photo #34: Roof flashing.
Non-asbestos containing black and white caulking.

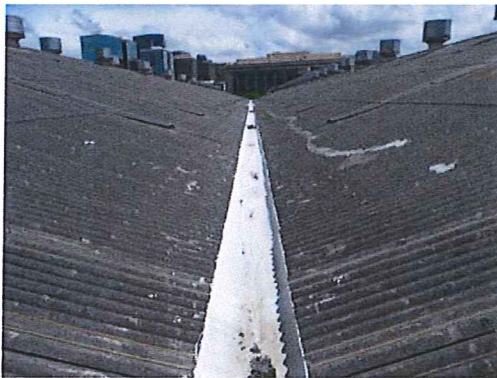
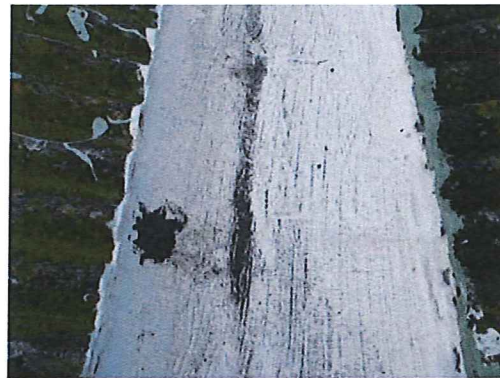
Photo #35: Roof gutter.
Asbestos-containing roofing felt under non-asbestos containing elastomeric coating and tar.

Photo #36: Roof gutter.
Asbestos-containing roofing felt under non-asbestos containing elastomeric coating and tar.

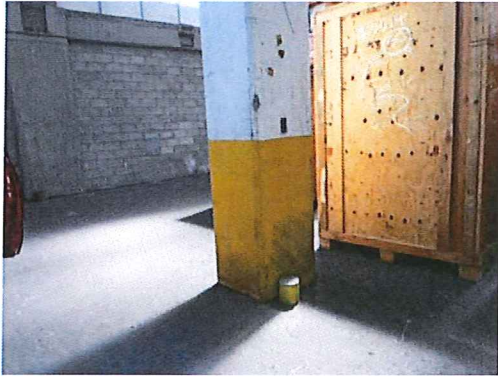
Photo #37: Ground floor.
Lead-based painted yellow concrete column (lower portion).

The lead paint/coating was found to be "intact" and no immediate action is necessary.

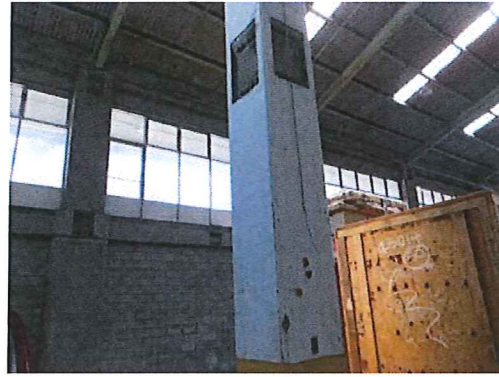
Photo #38: Ground floor.
Non-lead based painted white concrete column (upper portion).

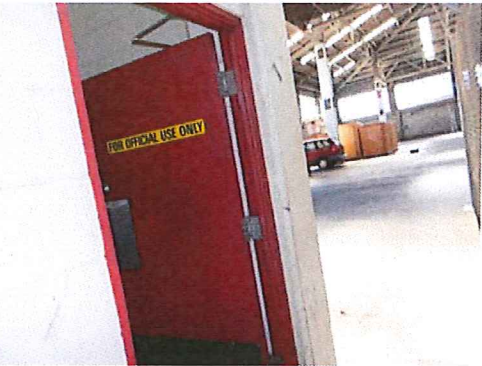
Photo #39: Ground floor, restroom.
Non-lead based painted red door and frame.

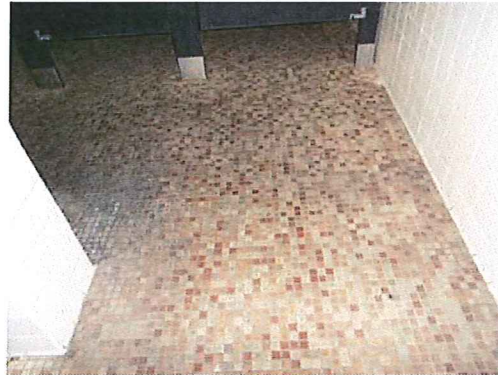
Photo #40: Ground floor, restroom.
Non-lead based paint coated glazed tan ceramic floor tile.

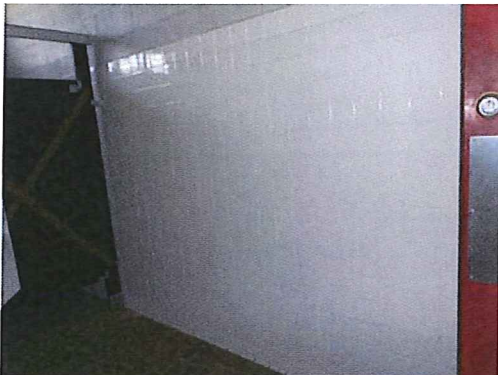
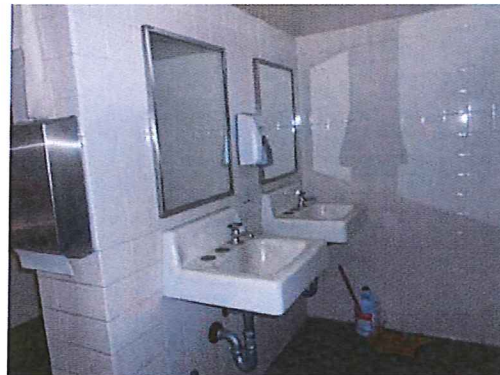
Photo #41: Ground floor.
Lead-based paint coated glazed white ceramic wall tile.

Photo #42: Ground floor.
Lead-based paint coated glazed white ceramic wall tile.

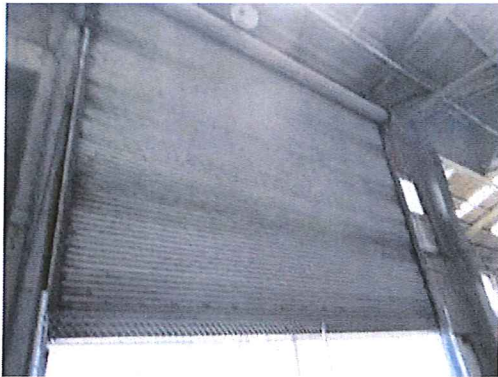
Photo #46: Ground floor.
Non-lead based painted light-green roll-up door.

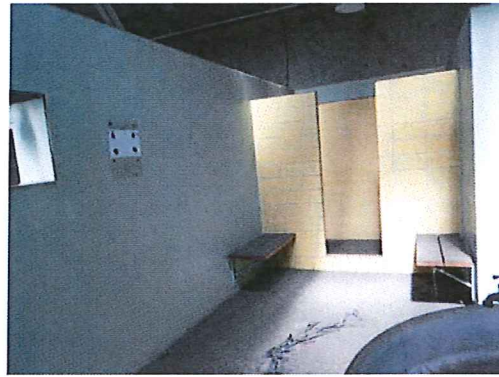
Photo #47: 2nd floor.
Non-lead based painted green wall.

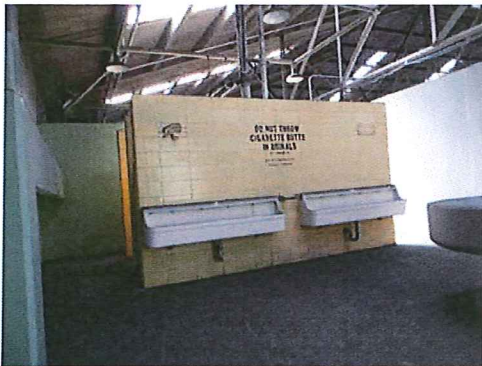
Photo #48: 2nd floor, urinal area.
Non-lead based paint coated glazed beige ceramic wall tile.

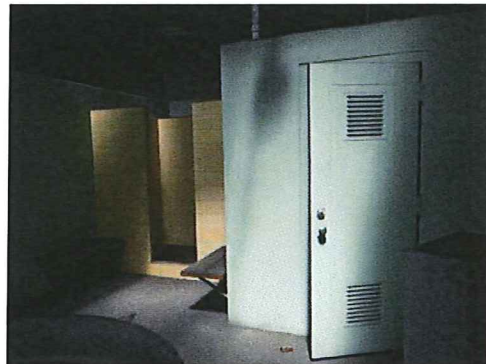
Photo #49: 2nd floor, storage room.
Non-lead based painted green wall and door.

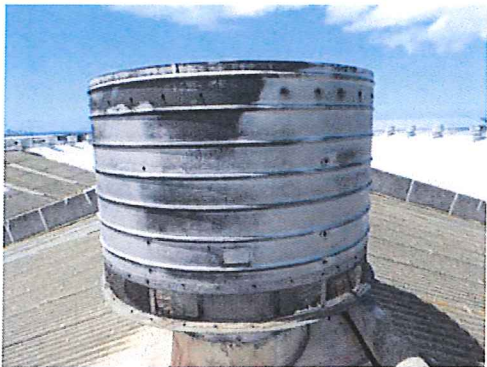
Photo #50: Roof.
Non-lead based painted silver exhaust fan.

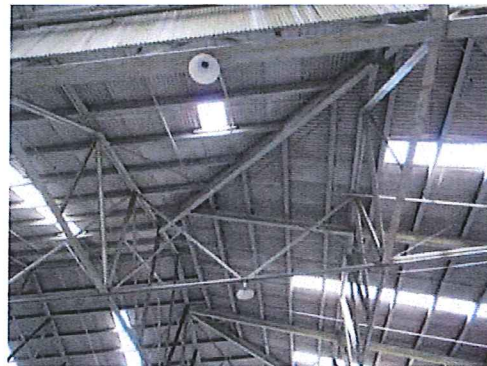
Photo #51: Roof trusses:
Lead-based painted light-gray metal trusses.

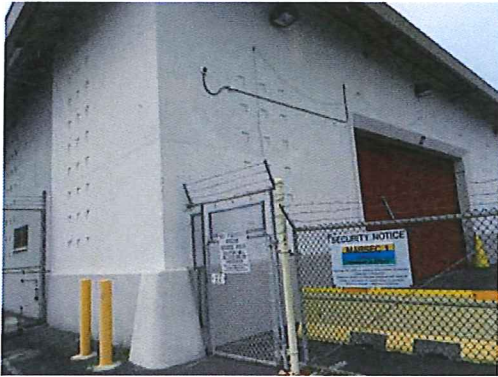
Photo #52:
Non-lead based painted off-white exterior wall.

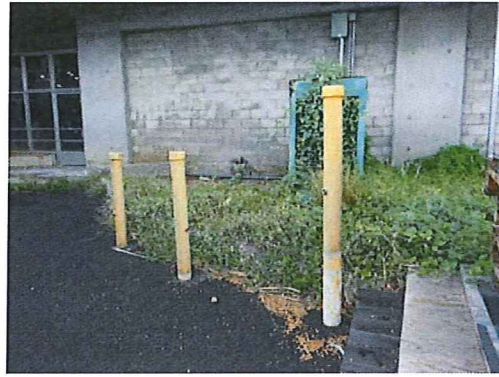
Photo #53:
Lead-based painted yellow bollards.

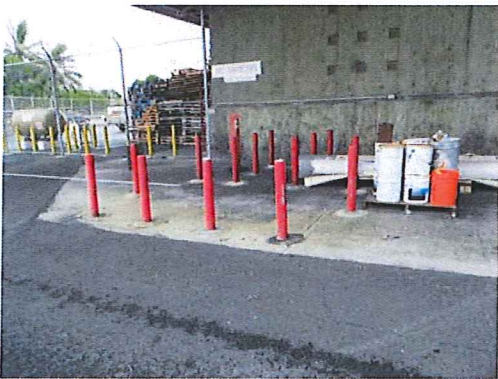
Photo #54:
Non-lead based painted red bollards.

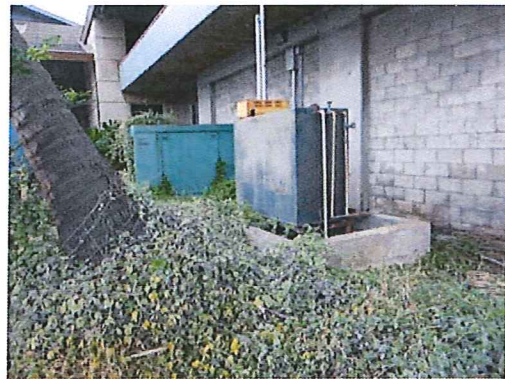
Photo #55:
Non-lead based painted blue and blue-green transformer.

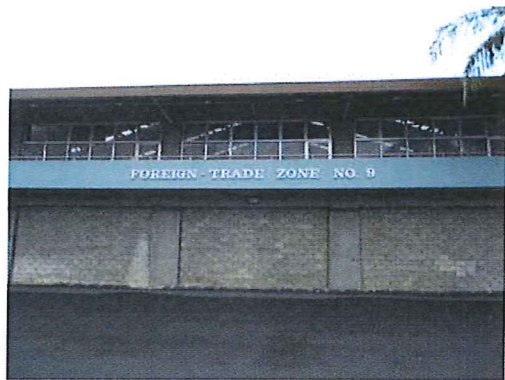
Photo #56:
Non-lead based painted gray canopy exterior wall.
