# TARGETED HAZARDOUS MATERIALS SURVEY REPORT

**PROJECT:**  
GENERAL REPAIRS  
DLNR JOB No.: 25-SPH-001

**FACILITY SURVEYED:**  
KALŌPĀ STATE RECREATION AREA  
44-3480 KALANIAI ROAD  
HONOKAA, HAWAII 96727

**DATE:** JANUARY 2, 2025

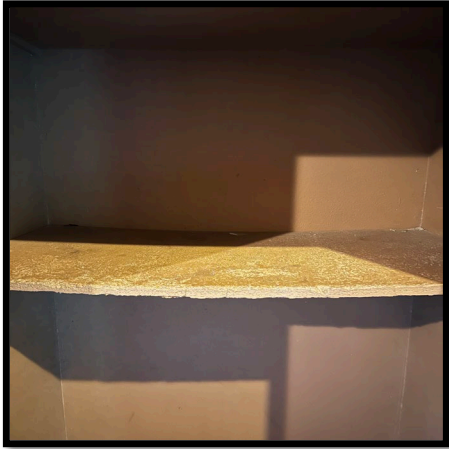
**1A/B-A1: None Detected**

**1A/B-A2: None Detected**

**1A/B-A3: None Detected**

Interior brown particle board shelves located in main area of cabin 1A/B.

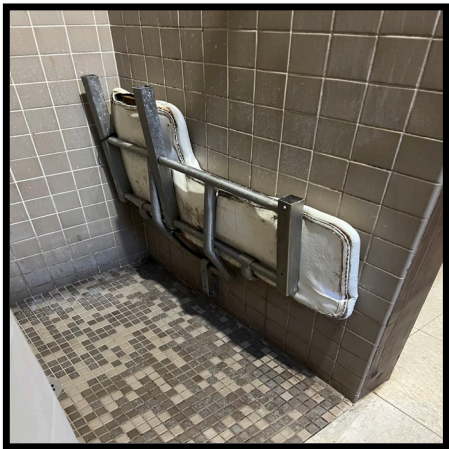
**1A/B-A4: None Detected**

**1A/B-A5: None Detected**

**1A/B-A6: None Detected**

Interior beige ceramic tile and grout located in shower of cabin 1A/B.

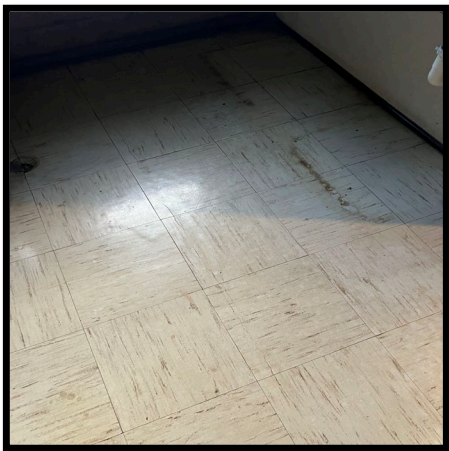
**1A/B-A7: None Detected**

**1A/B-A8: None Detected**

**1A/B-A9: None Detected**

Interior beige 12"x12" vinyl floor tile and yellow/black mastic located in bathroom of cabin 1A/B.

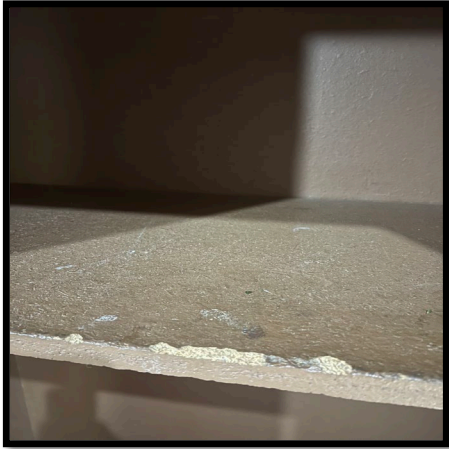
**2A/B-A1: None Detected**

**2A/B-A2: None Detected**

**2A/B-A3: None Detected**

Interior brown particle board shelves located in main area of cabin 2A/B.

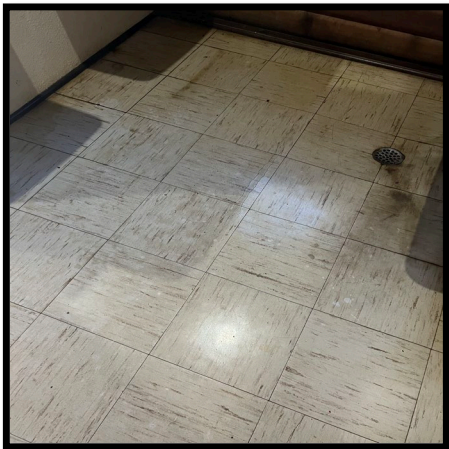
**2A/B-A4: None Detected**

**2A/B-A5: None Detected**

**2A/B-A6: None Detected**

Interior beige “12x12” vinyl floor tile and yellow/black mastic located in bathroom of cabin 2A/B.

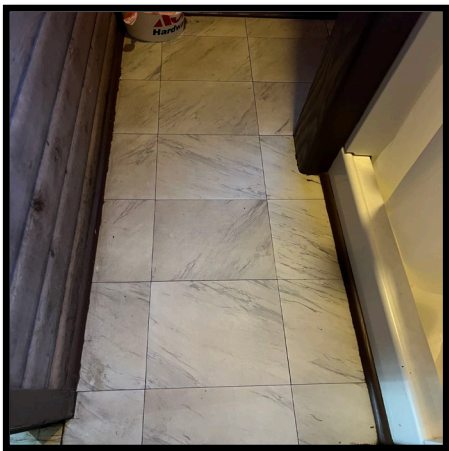
**2A/B-A7: None Detected**

**2A/B-A8: None Detected**

**2A/B-A9: None Detected**

Interior beige 12” x 12” vinyl floor tile and yellow/black mastic located in shower of 2A/B.

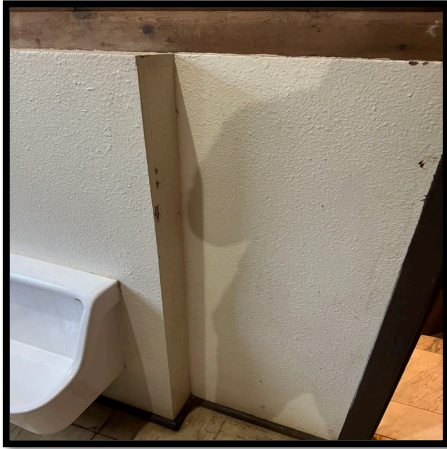
**2A/B-A10: None Detected**

**2A/B-A11: None Detected**

**2A/B-A12: None Detected**

Interior white/brown wood board plumbing chase located in bathroom of cabin 2A/B.

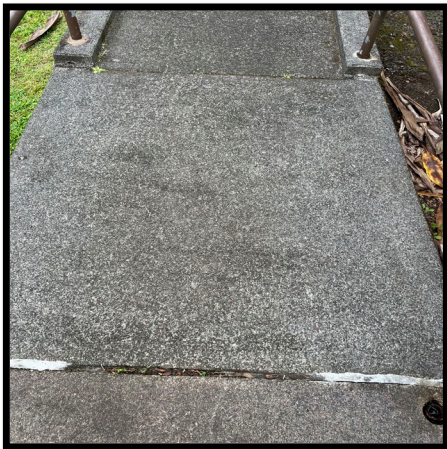
**K/D-A1: None Detected**

**K/D-A2: None Detected**

**K/D-A3: None Detected**

Exterior grey concrete walkway located in kitchen dining area.

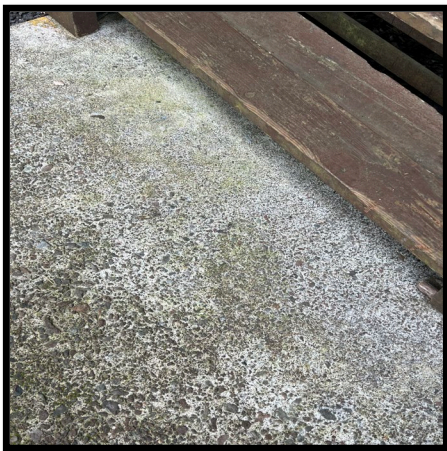
**C2-A1: None Detected**

**C2-A2: None Detected**

**C2-A3: None Detected**

Exterior grey concrete walkway located in exterior area of Cabin 2A/B.

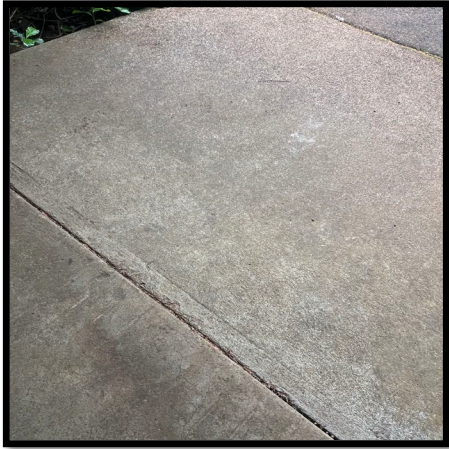
**DUP-A1: None Detected**

**DUP-A2: None Detected**

**DUP-A3: None Detected**

Exterior grey concrete walkway located in daily use pavilion.

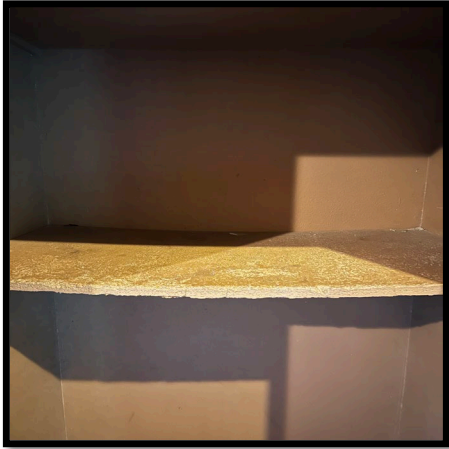
**1A/B-L1: Does not contain lead above the laboratory detection limit (56 mg/kg)**

Interior brown wood shelves located in cabin 1A/B.

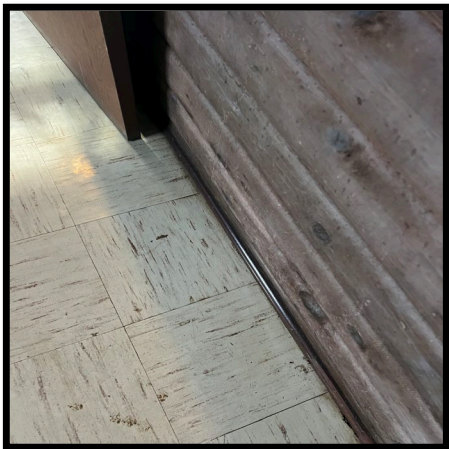
**1A/B-L2: Does not contain lead above the laboratory detection limit (<52 mg/kg)**

Interior brown wood wall trim located in cabin 1A/B.

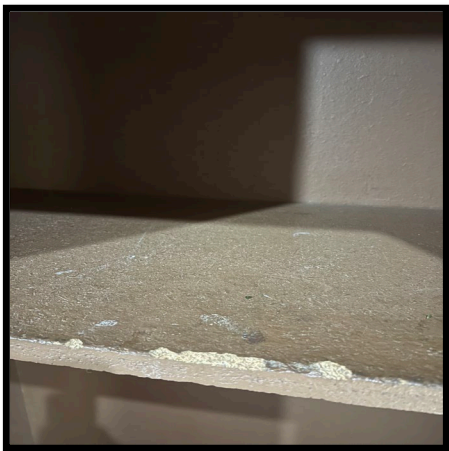
**2A/B-L1: Does not contain lead above the laboratory detection limit (<40 mg/kg)**

Interior brown wood shelves located in cabin 2A/B.

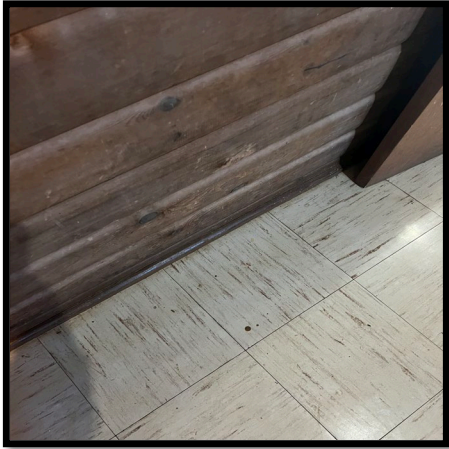
**2A/B-L2: Does not contain lead above the laboratory detection limit (<47 mg/kg)**

Interior brown wood wall trim located in cabin 2A/B.

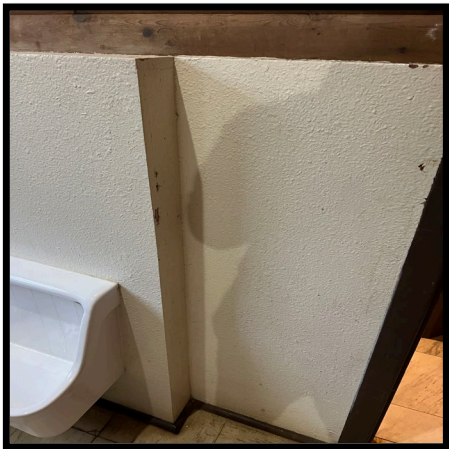
**2A/B-L3: Does not contain lead above the laboratory detection limit (<40 mg/kg)**

Interior white wood board plumbing chase located in cabin 2A/B.

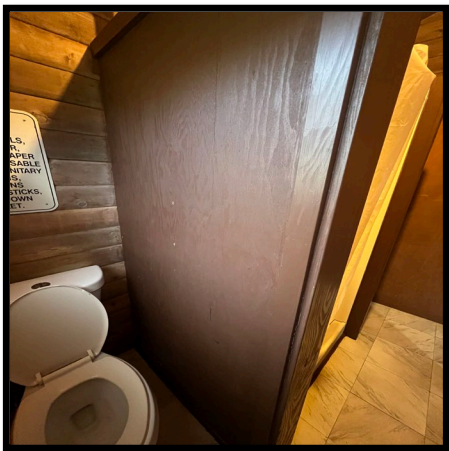
| <i>Int./<br/>Ext.</i> | <i>Cabin</i> | <i>Description</i> | <i>Color</i> | <i>Substrate</i> | <i>Cond.</i> | <i>Lead Conc.<br/>(mg/kg)</i> | <i>LCP<br/>or<br/>LBP?</i> | <i>Sample<br/>ID</i> |
|---|---|---|---|---|---|---|---|---|
| <b>Int.</b> | <b>2A/B</b> | <b>Plumbing<br/>Chase</b> | <b>Brown</b> | <b>Wood Board</b> | <b>Fair</b> | <b>300</b> | <b>LCP</b> | <b>2A/B-L4</b> |

**2A/B-L4: LCP (300 mg/kg)**

Interior brown wood board plumbing chase located in cabin 2A/B.

- Spot remove and dispose of all LCP that may be disturbed or become dislodged during renovation activities in accordance with applicable local, state, and federal regulations.

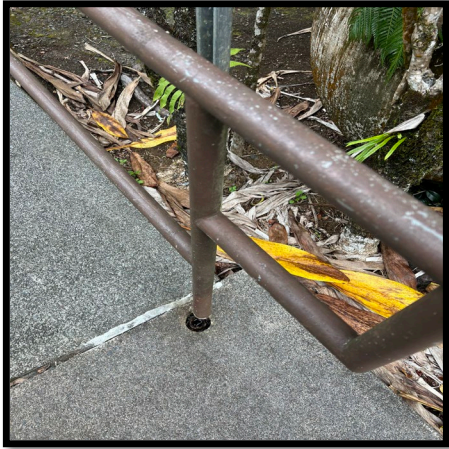
| <i>Int./<br/>Ext.</i> | <i>Cabin</i> | <i>Description</i> | <i>Color</i> | <i>Substrate</i> | <i>Cond.</i> | <i>Lead Conc.<br/>(mg/kg)</i> | <i>LCP<br/>or<br/>LBP?</i> | <i>Sample<br/>ID</i> |
|---|---|---|---|---|---|---|---|---|
| <b>Ext.</b> | <b>Kitchen/<br/>Dining</b> | <b>Handrails</b> | <b>Brown</b> | <b>Metal</b> | <b>Poor</b> | <b>280</b> | <b>LCP</b> | <b>K/D-L1</b> |

**K/D-L1: LCP (280 mg/kg)**

Exterior brown metal handrails located in kitchen/  
dining area.

- Spot remove and dispose of all loose and flaking (poor condition) LCP that may be disturbed or become dislodged during renovation activities in accordance with applicable local, state, and federal regulations.

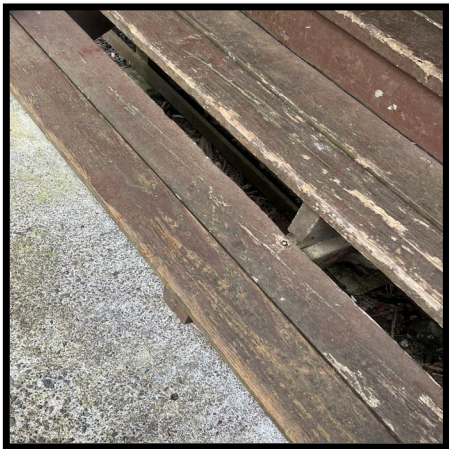
| <i>Int./<br/>Ext.</i> | <i>Cabin</i> | <i>Description</i> | <i>Color</i> | <i>Substrate</i> | <i>Cond.</i> | <i>Lead Conc.<br/>(mg/kg)</i> | <i>LCP<br/>or<br/>LBP?</i> | <i>Sample<br/>ID</i> |
|---|---|---|---|---|---|---|---|---|
| <b>Ext.</b> | <b>2A/B</b> | <b>Stairs</b> | <b>Brown</b> | <b>Wood</b> | <b>Poor</b> | <b>230</b> | <b>LCP</b> | <b>C2-L1</b> |

**C2-L1: LCP (230 mg/kg)**

Exterior brown wood stairs located in cabin 2A/B.

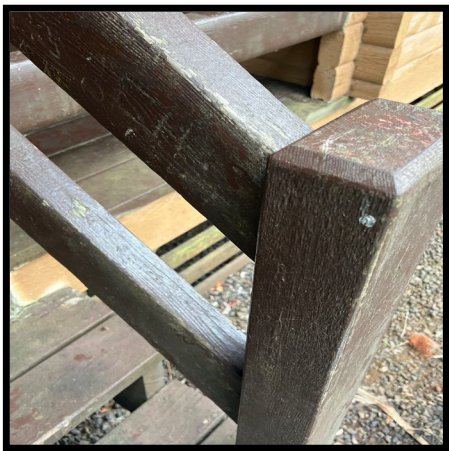
| <i>Int./<br/>Ext.</i> | <i>Cabin</i> | <i>Description</i> | <i>Color</i> | <i>Substrate</i> | <i>Cond.</i> | <i>Lead Conc.<br/>(mg/kg)</i> | <i>LCP<br/>or<br/>LBP?</i> | <i>Sample<br/>ID</i> |
|---|---|---|---|---|---|---|---|---|
| <b>Ext.</b> | <b>2A/B</b> | <b>Stair Railing</b> | <b>Brown</b> | <b>Wood</b> | <b>Poor</b> | <b>200</b> | <b>LCP</b> | <b>C2-L2</b> |

**C2-L2: LCP (200 mg/kg)**

Exterior brown wood stair railing located in cabin  
2A/B.

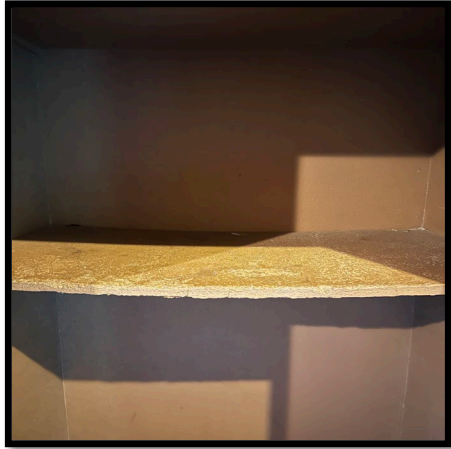
**1A/B- ARS1: Does not contain arsenic above the laboratory detection limit (<37 mg/kg)**

Interior brown wood shelves located in cabin 1A/B.

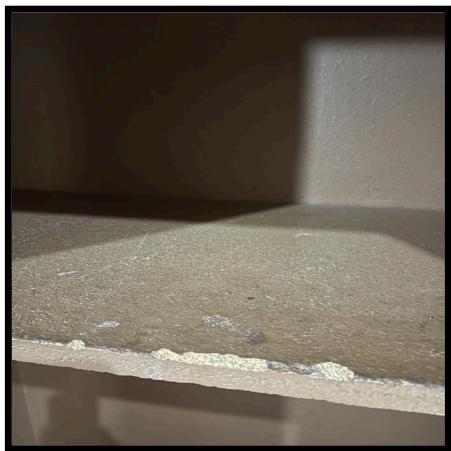
**2A/B-ARS1: Does not contain arsenic above the laboratory detection limit (<42 mg/kg)**

Interior brown wood shelves located in cabin 2A/B.
