# HAZARDOUS MATERIALS SURVEY REPORT

HAWAII ARMY NATIONAL GUARD  
KEAUKAHA MILITARY RESERVATION  
BUILDING NUMBERS: 501, 502, 629, 630 & 631 AND FIRING  
RANGE BUILDING NUMBERS: 636 & 638  
1304 KEKUANAOKA STREET  
HILO, HAWAII 96720

STATE OF HAWAII – DEPARTMENT OF DEFENSE  
3949 DIAMOND HEAD ROAD  
HONOLULU, HAWAII 96816-4495

**DATE:** MARCH 31, 2026

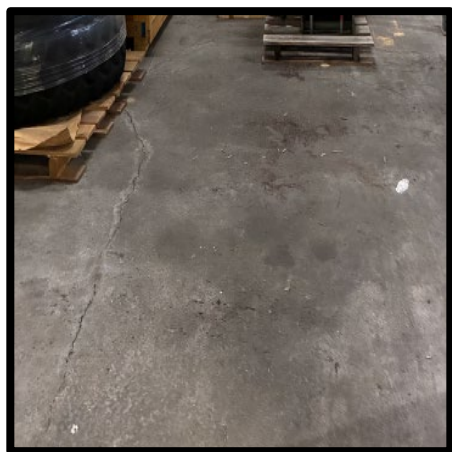
**B501 A16: None Detected**  
**B501 A17: None Detected**  
**B501 A18: None Detected**

Interior grey concrete floor located throughout building 501.

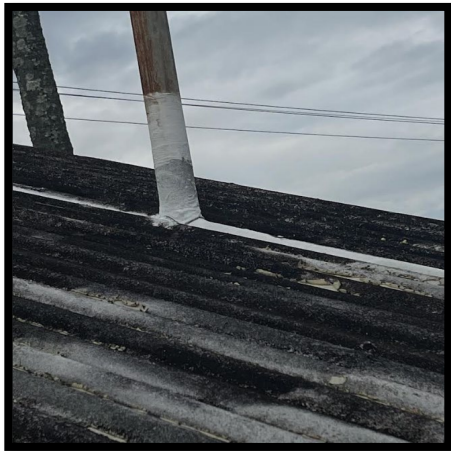
**B501 A22: None Detected**  
**B501 A23: None Detected**  
**B501 A24: None Detected**

Exterior white tape with black mastic located on the roof of building 501.

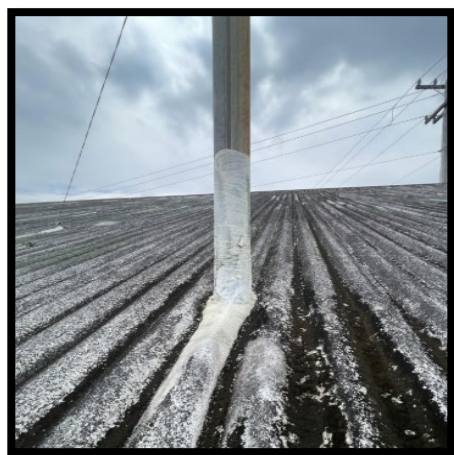
**B502 A25: 5% Chrysotile (Black mastic)**  
**B502 A26: Not Analyzed**  
**B502 A27: Not Analyzed**

Exterior white tape with black mastic located on the roof of building 502.

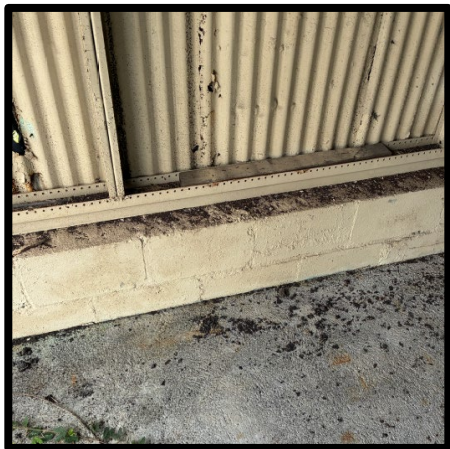
**B630 A4: None Detected**  
**B630 A5: None Detected**  
**B630 A6: None Detected**

| <i><b>Bldg.</b></i> | <i><b>Int./Ext.</b></i> | <i><b>Floor</b></i> | <i><b>Room</b></i> | <i><b>Homogeneous Materials</b></i> | <i><b>Color</b></i> | <i><b>Friable</b></i> | <i><b>Type</b></i> | <i><b>Cond.</b></i> | <i><b>Est. Amt. of Material (ft<sup>2</sup>)</b></i> | <i><b>Asbestos Content</b></i> | <i><b>Sample ID</b></i> |
|---|---|---|---|---|---|---|---|---|---|---|---|
| 630 | Int./Ext. | 1 | Throughout | CMU skim coat wall foundation | Beige | No | Surf. | Fair | 50 | None Detected | B630 A4 |

Interior/exterior beige CMU skim coat wall foundation located throughout building 630.

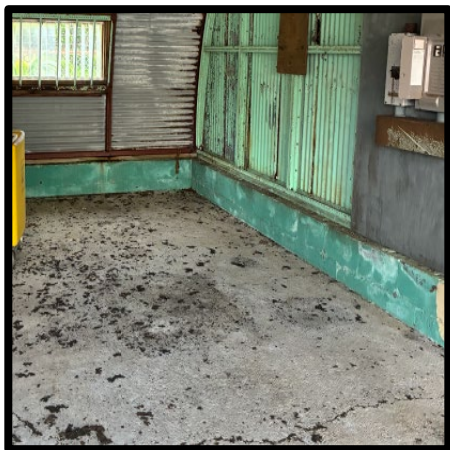
**B630 A7: None Detected**  
**B630 A8: None Detected**  
**B630 A9: None Detected**

| <i><b>Bldg.</b></i> | <i><b>Int./Ext.</b></i> | <i><b>Floor</b></i> | <i><b>Room</b></i> | <i><b>Homogeneous Materials</b></i> | <i><b>Color</b></i> | <i><b>Friable</b></i> | <i><b>Type</b></i> | <i><b>Cond.</b></i> | <i><b>Est. Amt. of Material (ft<sup>2</sup>)</b></i> | <i><b>Asbestos Content</b></i> | <i><b>Sample ID</b></i> |
|---|---|---|---|---|---|---|---|---|---|---|---|
| 630 | Int. | 1 | Throughout | CMU skim coat wall foundation | Green | No | Surf. | Fair | 60 | None Detected | B630 A7 |

Interior green CMU skim coat wall foundation located throughout building 630.

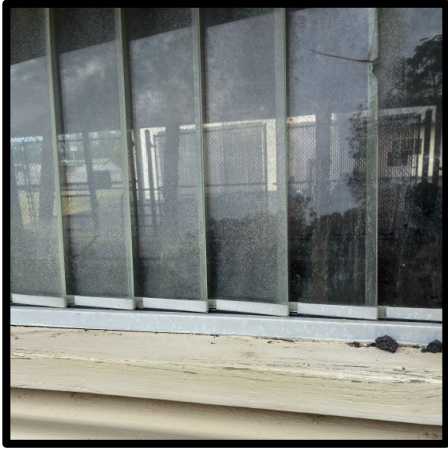
**B630 A10: None Detected**  
**B630 A11: None Detected**  
**B630 A12: None Detected**

Exterior beige window frame caulking located throughout building 630.

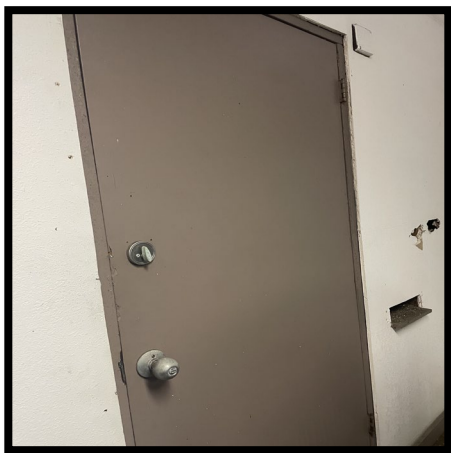
**B501 L6: LCP (380 mg/kg)**

Interior brown wood door, door frame and baseboards located in rooms 1 and 3 of building 501.

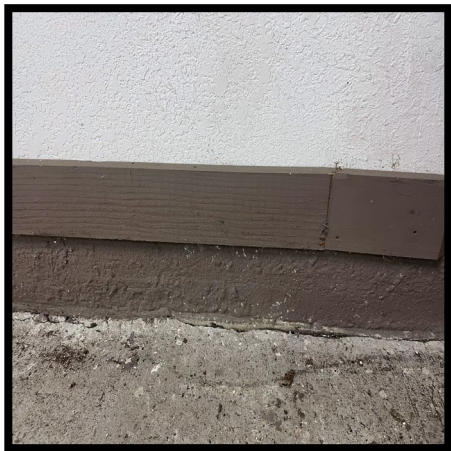
**B501 L9: LCP (640 mg/kg)**

Interior brown concrete baseboard located in room 2 of building 501.

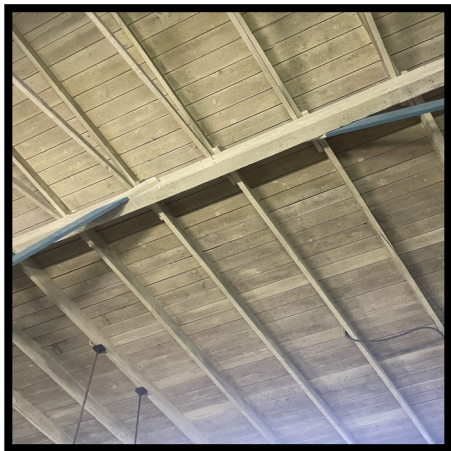
**B501 L12: LBP (20,000 mg/kg)**

Interior green wood rafters and ceiling located in room 3 of building 501.

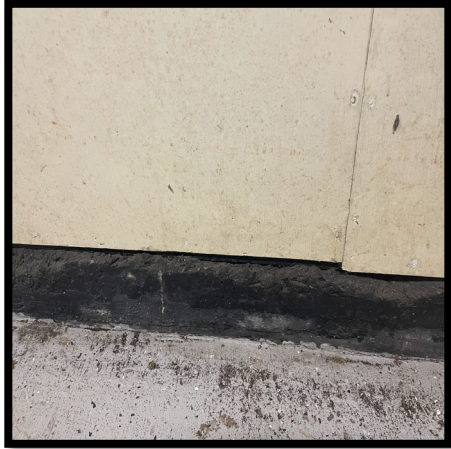
**B501 L13: LCP (1,500 mg/kg)**

| <i>Bldg.</i> | <i>Int./<br/>Ext..</i> | <i>Area</i> | <i>Description</i> | <i>Color</i> | <i>Substrate</i> | <i>Cond.</i> | <i>Lead<br/>Conc.<br/>(mg/kg)</i> | <i>LCP or<br/>LBP?</i> |
|---|---|---|---|---|---|---|---|---|
| 501 | Int. | Room 1 | Baseboard &<br>Foundation | Black | Concrete | Fair | 1,500 | LCP |

| <i>Bldg.</i> | <i>Int./<br/>Ext.</i> | <i>Area</i> | <i>Description</i> | <i>Color</i> | <i>Substrate</i> | <i>Cond.</i> | <i>Lead Conc.<br/>(mg/kg)</i> | <i>LCP or<br/>LBP?</i> | <i>Sample ID</i> |
|---|---|---|---|---|---|---|---|---|---|
| <b>501</b> | <b>Int.</b> | <b>Room 1</b> | <b>Baseboard &amp; Foundation</b> | <b>Black</b> | <b>Concrete</b> | <b>Fair</b> | <b>1,500</b> | <b>LCP</b> | <b>B501 L13</b> |

Interior black concrete baseboard and foundation located in room 1 of building 501.

- If planned renovation and/or demolition activities occur at the Subject Site, spot remove and dispose of all loose and flaking (poor condition) LBP and LCP that may be disturbed or become dislodged during renovation/demolition activities in accordance with applicable local, state, and federal regulations.
- Workers performing disturbance of LBP and LCP must take appropriate measures to comply with applicable OSHA and HIOSH regulations pertaining to the handling of lead containing materials, lead dust and worker protection. Note that OSHA and HIOSH regulate activities that disturb paint which contain any detectable concentration of lead.
- A qualified consultant should be obtained to conduct air monitoring and inspection activities to ensure compliance with applicable state and federal regulations pertaining to the handling of lead paint.

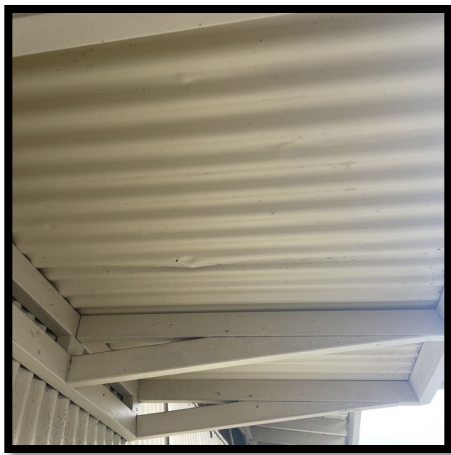
**B501 L14: Does not contain lead above the laboratory detection limit (<40 mg/kg)**

Exterior beige metal corrugated wall panels and overhang located throughout building 501.

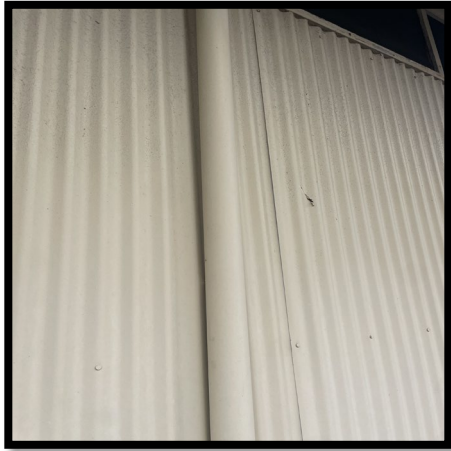
**B501 L16: LCP (47 mg/kg)**

Exterior beige PVC downspouts located throughout building 501.

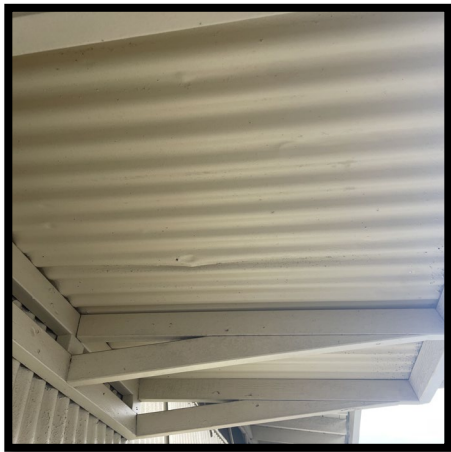
**B501 L17: LCP (130 mg/kg)**

Exterior beige wood rafters located throughout building 501.

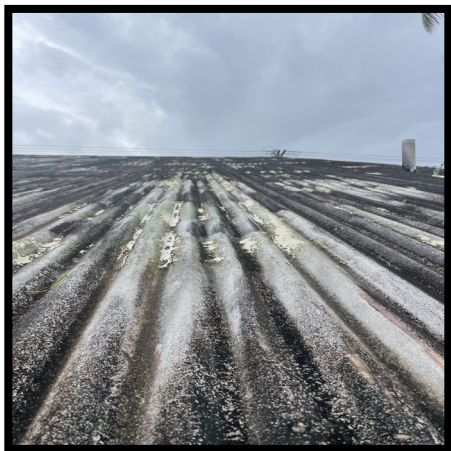
**B501 L18: Does not contain lead above the laboratory detection limit (< 40 mg/kg)**

Exterior off-white metal corrugated roof panels located throughout building 501.

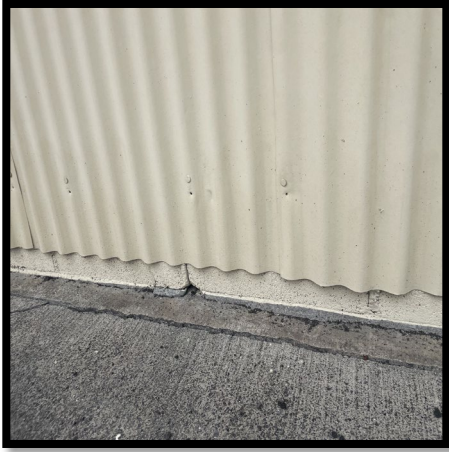
**B501 L19: LCP (1,900 mg/kg)**

| <i>Bldg.</i> | <i>Int./<br/>Ext..</i> | <i>Area</i> | <i>Description</i> | <i>Color</i> | <i>Substrate</i> | <i>Cond.</i> | <i>Lead<br/>Conc.<br/>(mg/kg)</i> | <i>LCP or<br/>LBP?</i> |
|---|---|---|---|---|---|---|---|---|
| 501 | Ext. | Throughout | Foundation | Beige | CMU | Fair | 1,900 | LCP |

| <i>Bldg.</i> | <i>Int./<br/>Ext.</i> | <i>Area</i> | <i>Description</i> | <i>Color</i> | <i>Substrate</i> | <i>Cond.</i> | <i>Lead Conc.<br/>(mg/kg)</i> | <i>LCP or<br/>LBP?</i> | <i>Sample ID</i> |
|---|---|---|---|---|---|---|---|---|---|
| <b>501</b> | <b>Ext.</b> | <b>Throughout</b> | <b>Foundation</b> | <b>Beige</b> | <b>CMU</b> | <b>Fair</b> | <b>1,900</b> | <b>LCP</b> | <b>B501 L19</b> |

Exterior beige CMU foundation located throughout building 501.

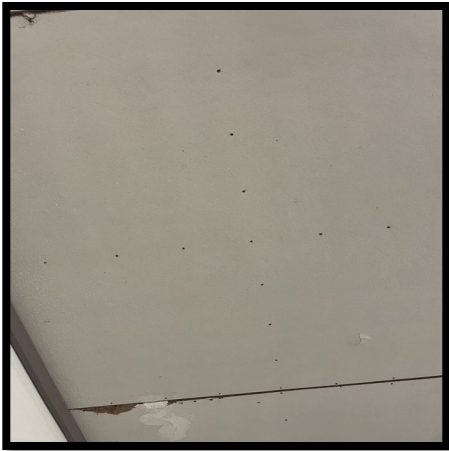
**B501 L20: Non-Detected Above Lab Detection Limit (< 40mg/kg)**

Interior white canec ceilings located in room 2 of building 501.

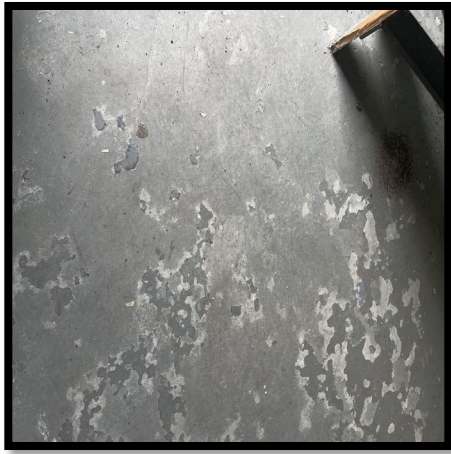
**B502 L2: LBP (6,600 mg/kg)**

| <i>Bldg.</i> | <i>Int./<br/>Ext..</i> | <i>Area</i> | <i>Description</i> | <i>Color</i> | <i>Substrate</i> | <i>Cond.</i> | <i>Lead<br/>Conc.<br/>(mg/kg)</i> | <i>LCP or<br/>LBP?</i> |
|---|---|---|---|---|---|---|---|---|
| 502 | Int. | Rooms 4, 5<br>& 6 | Floor &<br>Foundation | Grey | Concrete | Fair | 6,600 | LBP |

| <i>Bldg.</i> | <i>Int./<br/>Ext.</i> | <i>Area</i> | <i>Description</i> | <i>Color</i> | <i>Substrate</i> | <i>Cond.</i> | <i>Lead Conc.<br/>(mg/kg)</i> | <i>LCP or<br/>LBP?</i> | <i>Sample ID</i> |
|---|---|---|---|---|---|---|---|---|---|
| <b>502</b> | <b>Int.</b> | <b>Rooms 4, 5 &amp; 6</b> | <b>Floor &amp; Foundation</b> | <b>Grey</b> | <b>Concrete</b> | <b>Fair</b> | <b>6,600</b> | <b>LBP</b> | <b>B502 L2</b> |

Interior grey concrete floor and foundation located in rooms 4, 5 and 6 of building 502.

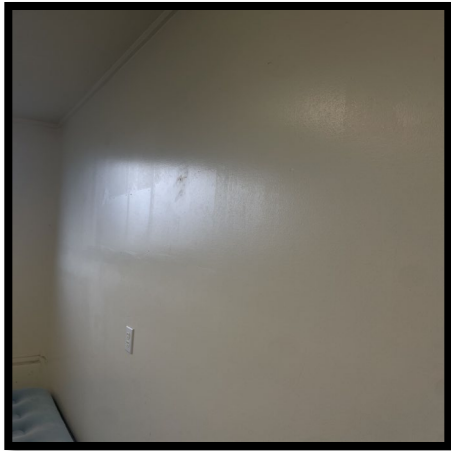
**B502 L3: Does not contain lead above the laboratory detection limit (< 40 mg/kg)**

Interior off white sheetrock wall and ceiling located in rooms 4, 5 and 6 of building 502.

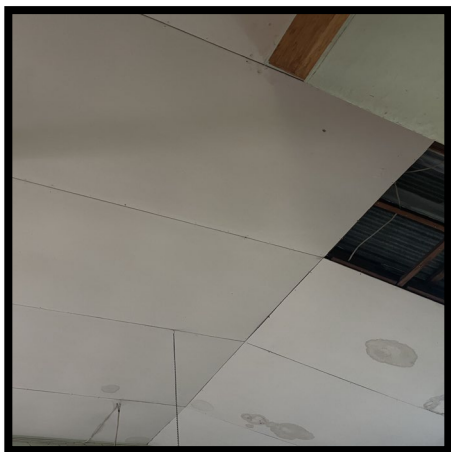
**B502 L4: Does not contain lead above the laboratory detection limit (< 40 mg/kg)**

Interior white canec ceiling located in rooms 4, 5 and 6 of building 502.

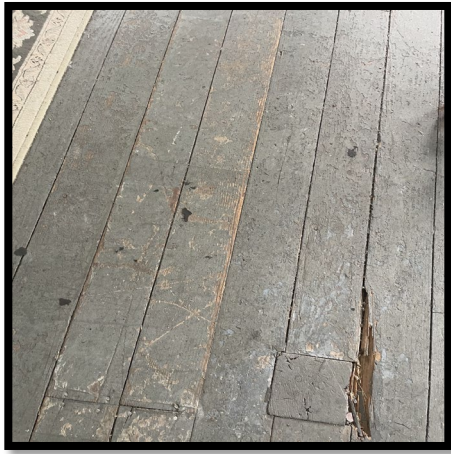
**B502 L5: LCP (3,200 mg/kg)**

Interior grey wood floors located in rooms 1, 2 and 3 of building 502.

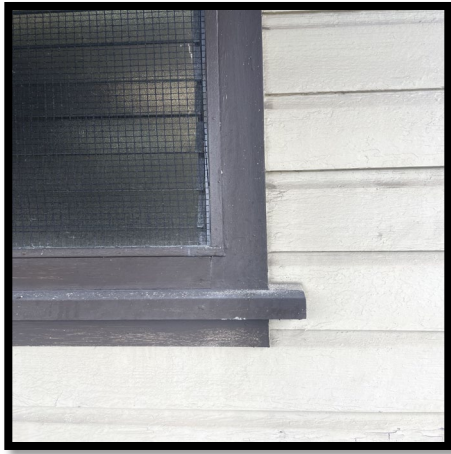
**B502 L8: LCP (170 mg/kg)**

Exterior brown wood window frames located throughout building 502.

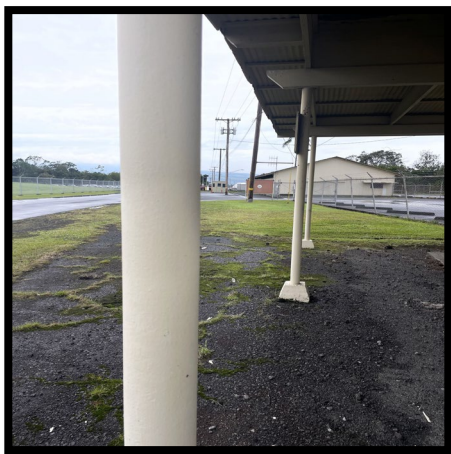
**B502 L10: LCP (390 mg/kg)**

Exterior beige metal post located throughout building 502.

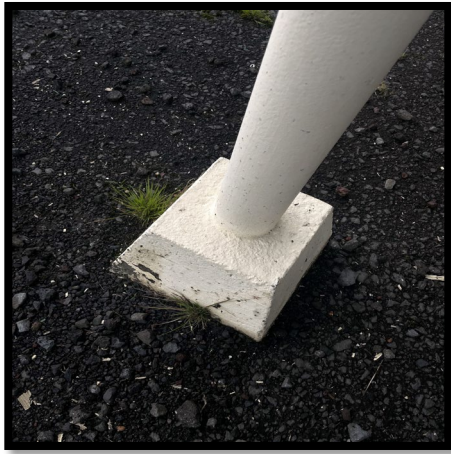
**B502 L11: LCP (270 mg/kg)**

| <i><b>Bldg.</b></i> | <i><b>Int./<br/>Ext..</b></i> | <i><b>Area</b></i> | <i><b>Description</b></i> | <i><b>Color</b></i> | <i><b>Substrate</b></i> | <i><b>Cond.</b></i> | <i><b>Lead<br/>Conc.<br/>(mg/kg)</b></i> | <i><b>LCP or<br/>LBP?</b></i> |
|---|---|---|---|---|---|---|---|---|
| 502 | Ext. | Throughout | Foundation & Post<br>Base | Beige | Concrete | Fair | 270 | LCP |

| <i>Bldg.</i> | <i>Int./<br/>Ext.</i> | <i>Area</i> | <i>Description</i> | <i>Color</i> | <i>Substrate</i> | <i>Cond.</i> | <i>Lead Conc.<br/>(mg/kg)</i> | <i>LCP or<br/>LBP?</i> | <i>Sample ID</i> |
|---|---|---|---|---|---|---|---|---|---|
| <b>502</b> | <b>Ext.</b> | <b>Throughout</b> | <b>Foundation &amp; Post Base</b> | <b>Beige</b> | <b>Concrete</b> | <b>Fair</b> | <b>270</b> | <b>LCP</b> | <b>B502 L11</b> |

Exterior beige concrete foundation and post base located throughout building 502.

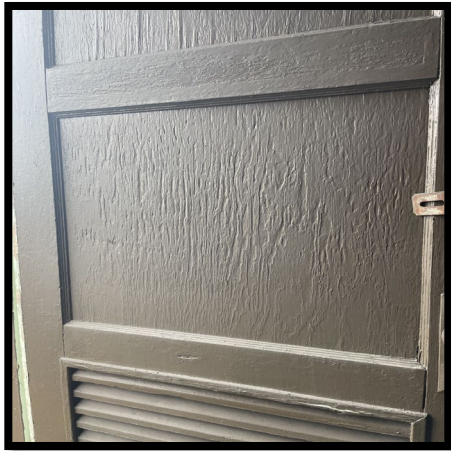
**B502 L12: LBP (5,200 mg/kg)**

Exterior brown wood door and door frame located throughout building 502.

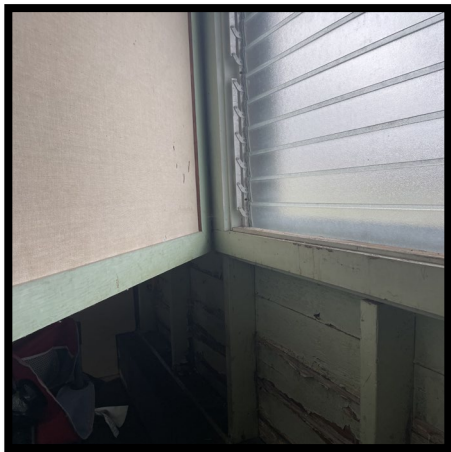
**B502 L13: LCP (1,600 mg/kg)**

Interior green wood window frame and shutters located throughout building 502.

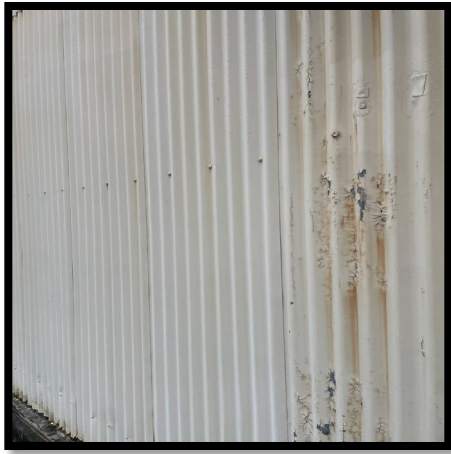
**B630 L3: LCP (3,300 mg/kg)**

Interior and exterior beige metal corrugated wall panels located throughout building 630.

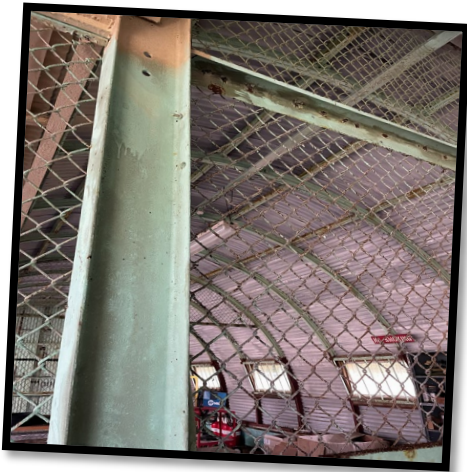
**B630 L4: LBP (62,000 mg/kg)**

Interior green metal framing located throughout building 630.

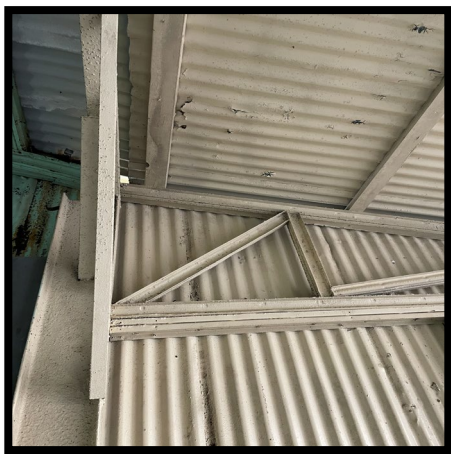
**B630 L5: LCP (800 mg/kg)**

Interior beige metal framing located throughout building 630.

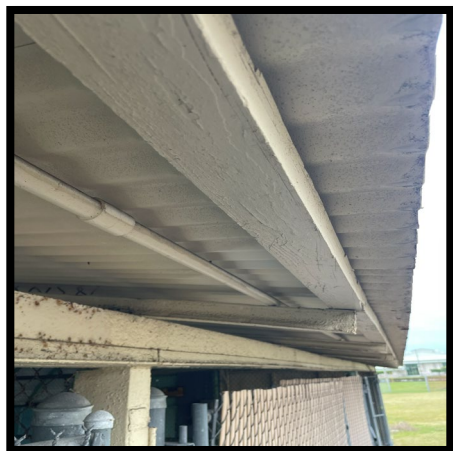
**B630 L9: LCP (1,600 mg/kg)**

Exterior beige wood rafters located throughout building 630.

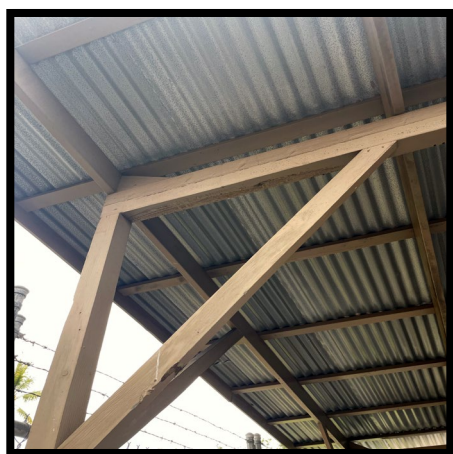
**B631 L1: LCP (170 mg/kg)**

Interior and exterior brown wood framing located throughout building 631.

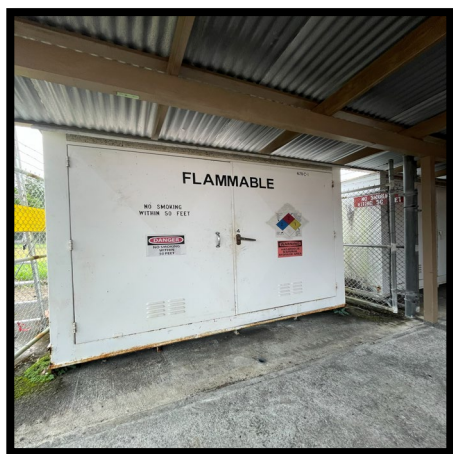
**B631 L2: Does not contain lead above the laboratory detection limit (< 40 mg/kg)**

Interior white metal storage container located in building 631.

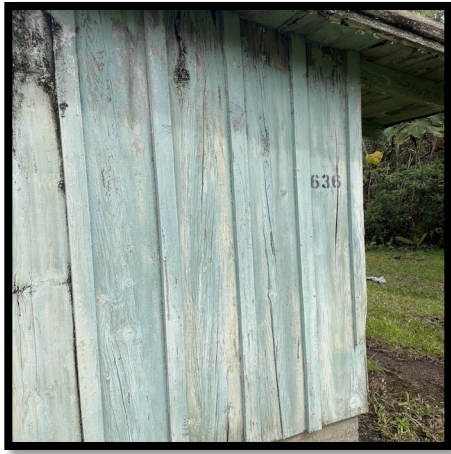
**B636 L1: LBP (33,000 mg/kg)**

Exterior green wood wall and rafters located throughout building 636.

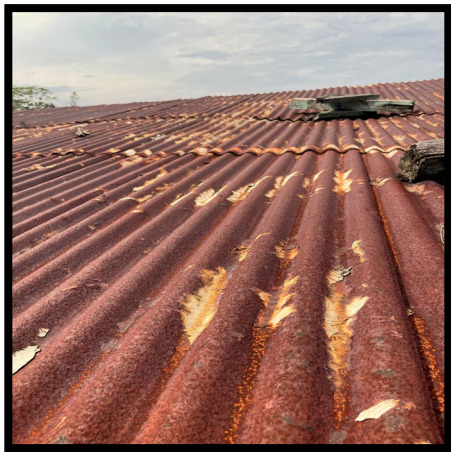
**B636 L3: LCP (180 mg/kg)**

Exterior red metal corrugated roof panels located throughout building 636.

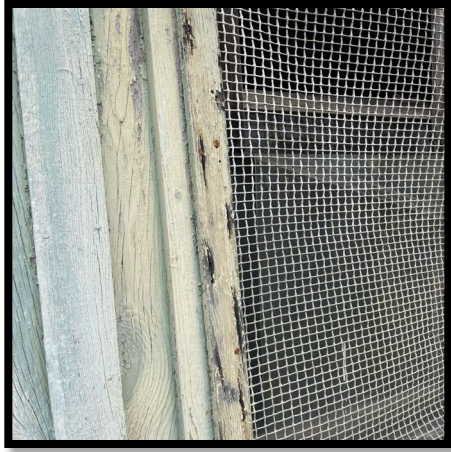
**B636 L4: LBP (18,000 mg/kg)**

Interior and exterior grey wood window frame located throughout building 636.

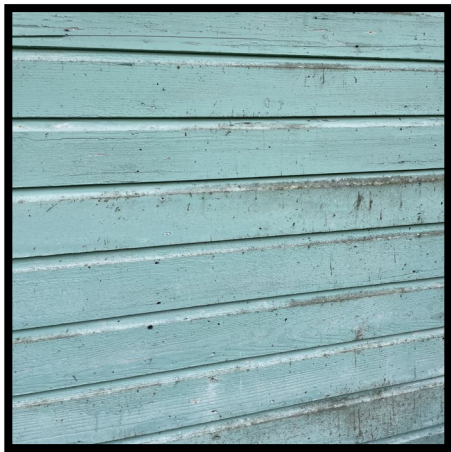
**B638 L1: LBP (250,000 mg/kg)**

Interior and exterior green wood walls located throughout building 638.

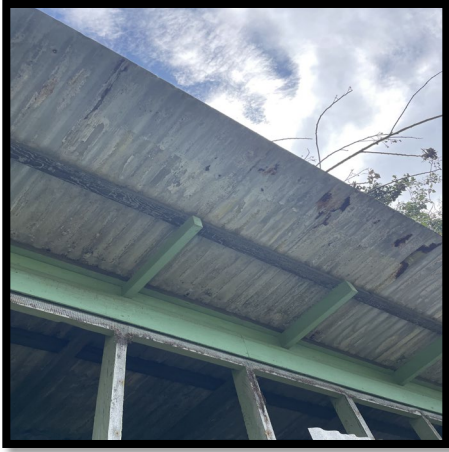
**B638 L2: LCP (3,000 mg/kg)**

| <i>Bldg.</i> | <i>Int./<br/>Ext..</i> | <i>Area</i> | <i>Description</i> | <i>Color</i> | <i>Substrate</i> | <i>Cond.</i> | <i>Lead<br/>Conc.<br/>(mg/kg)</i> | <i>LCP or<br/>LBP?</i> |
|---|---|---|---|---|---|---|---|---|
| 638 | Ext. | Throughout | Rafter, Framing &<br>Foundation | Silver | Wood | Poor | 3,000 | LCP |

| <i>Bldg.</i> | <i>Int./<br/>Ext.</i> | <i>Area</i> | <i>Description</i> | <i>Color</i> | <i>Substrate</i> | <i>Cond.</i> | <i>Lead Conc.<br/>(mg/kg)</i> | <i>LCP or<br/>LBP?</i> | <i>Sample ID</i> |
|---|---|---|---|---|---|---|---|---|---|
| 638 | Ext. | Throughout | Rafter, Framing &<br>Foundation | Silver | Wood | Poor | 3,000 | LCP | B638 L2 |

Exterior silver wood rafter, framing and foundation located throughout building 638.

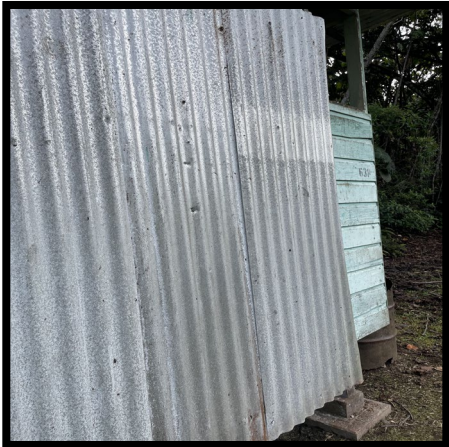
**B638 L3: LCP (1,100 mg/kg)**

Exterior silver metal corrugated roof panels located throughout building 638.

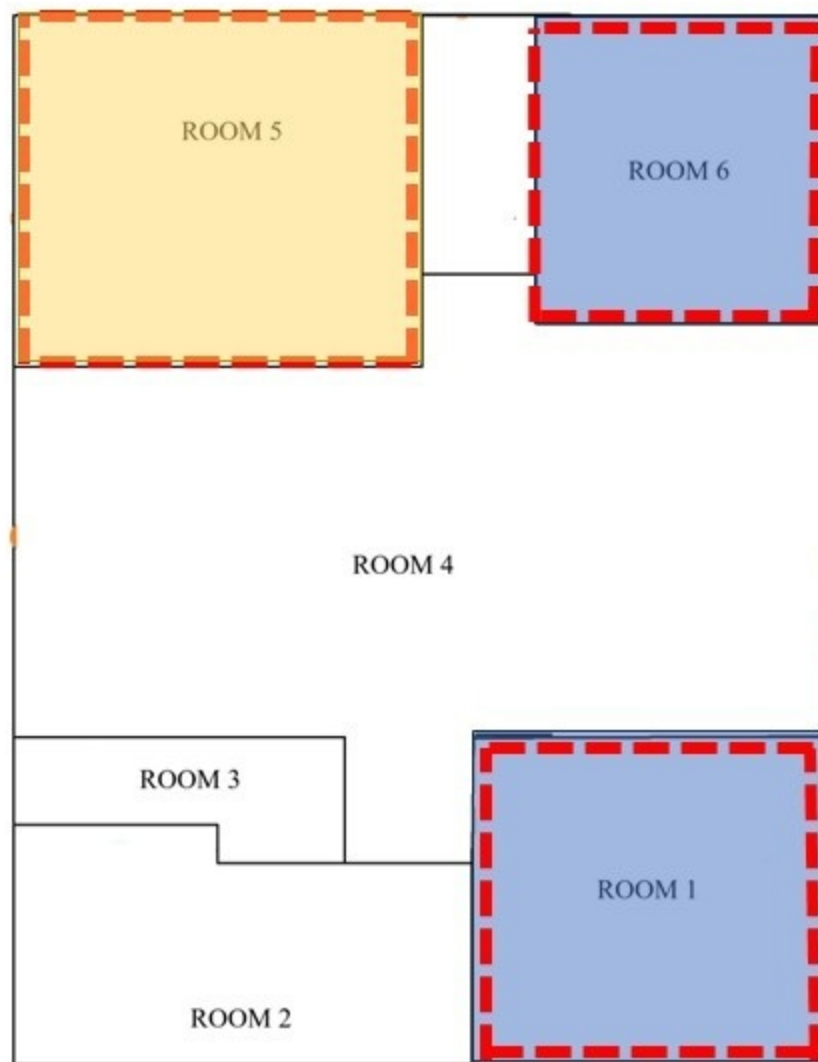
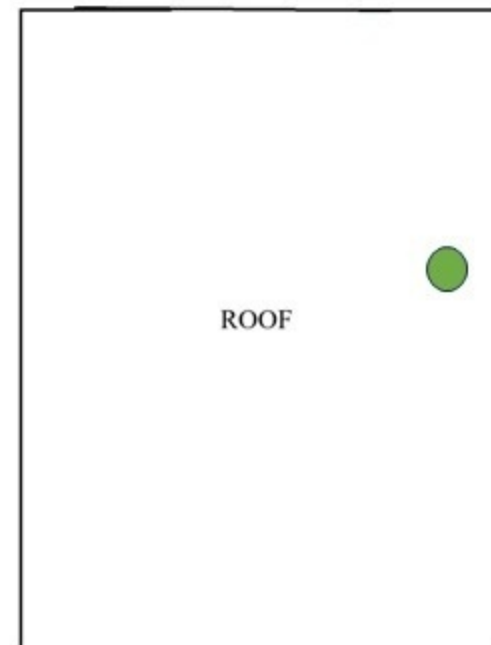
| | FIGURE<br>3A | BUILDNG 502 ACM Location<br>LOCATION MAP |

Identified ACM. Interior white sheetrock wall with joint compound
