**HAZARDOUS MATERIAL SURVEY REPORT
FOR
KEKAHA KAI STATE PARK
IMPROVEMENT PROJECT
KONA, HAWAI'I**

**MNA PROJECT 1522_2
STATE PROJECT NO. H-87C836D**

JUNE 5, 2013

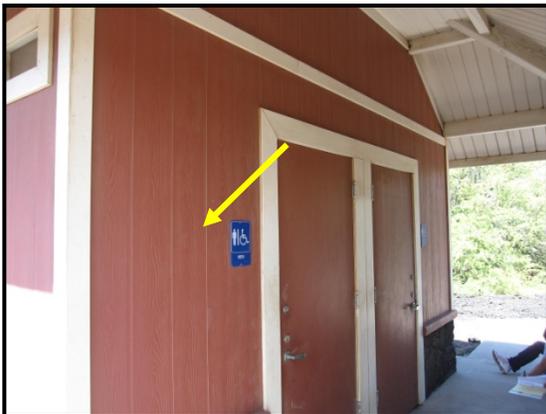
HM ID 2
Men's Restrooms
Floor 1

Exterior
Red paint on wood wall.

Non-LCP
1522-P2A: <100 mg/kg
1522-P2B: <130 mg/kg

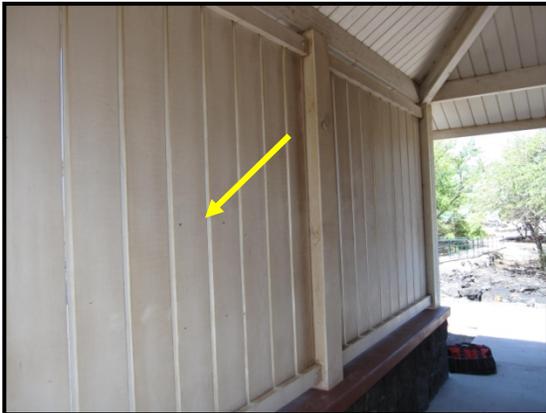
HM ID 5
Women's Restrooms
Floor 1

Exterior
White paint on wood wall.

Non-LCP
1522-P4A: <200 mg/kg
1522-P4B: <240 mg/kg

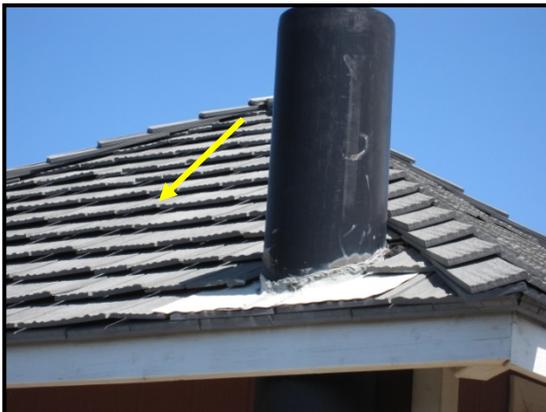
HM ID 9
Men's Restrooms
Roof
Roof
Black shingles on wood roof.

ACM
1522-A1A: ND
1522-A1B: ND
1522-A1C: ND

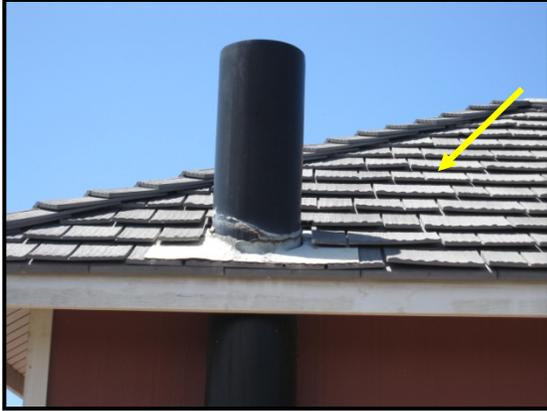
HM ID 10
Women's Restrooms
Roof

Roof
Black shingles on wood roof.

Non-ACM
1522-A2A: ND
1522-A2B: ND
1522-A2C: ND

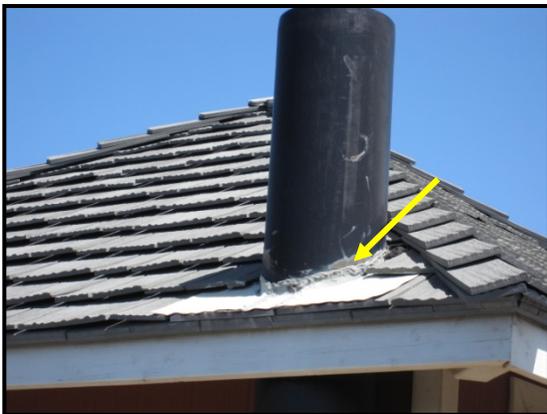
HM ID 11
Men's Restrooms
Roof

Roof
White caulking on wood roof.

Non-ACM
1522-A3A: ND
1522-A3B: ND
1522-A3C: ND

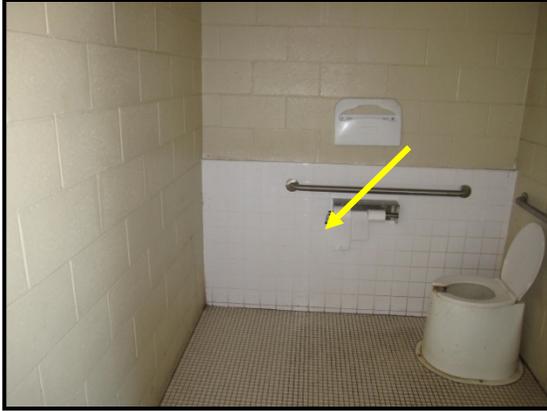
HM ID 16
Men's Restrooms
Floor 1

Men's Restroom 1
White grout on 4" x 4" ceramic tile wall.

Non-ACM
1522-A6A: ND
1522-A6B-Ceramic Tile: ND
1522-A6B-Grout: ND
1522-A6C: ND

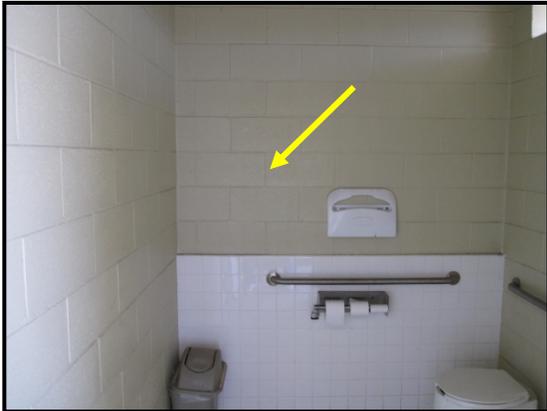
HM ID 17
Women's Restrooms
Floor 1

Women's Restroom 1
Off-white paint on concrete block wall.

Non-LCP
1522-P10A: <100 mg/kg
1522-P10B: <100 mg/kg

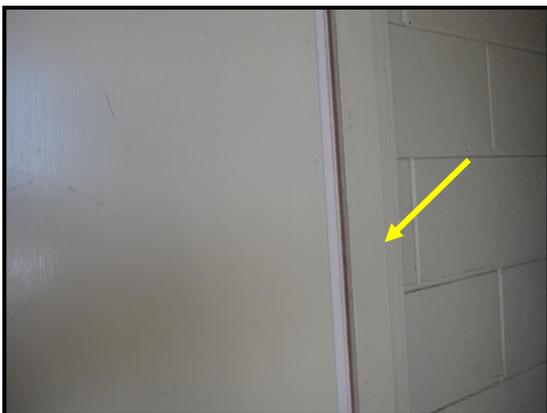
HM ID 18
Women's Restrooms
Floor 1

Women's Restroom 2
Off-white paint on wood door frame.

Non-LCP
1522-P11A: <190 mg/kg
1522-P11B: <100 mg/kg

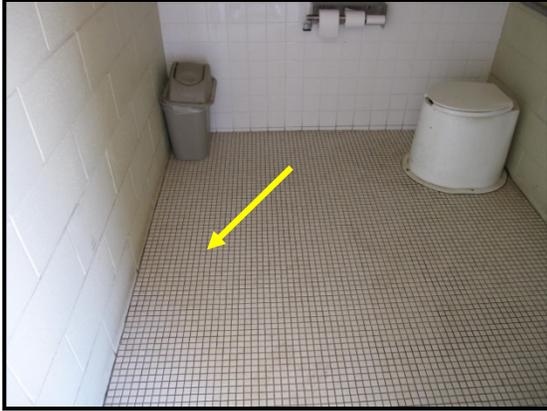
HM ID 19
Women's Restrooms
Floor 1

Women's Restroom 1
Brown grout on 1" x 1" ceramic tile floor.

Non-ACM
1522-A7A: ND
1522-A7B: ND
1522-A7C: ND

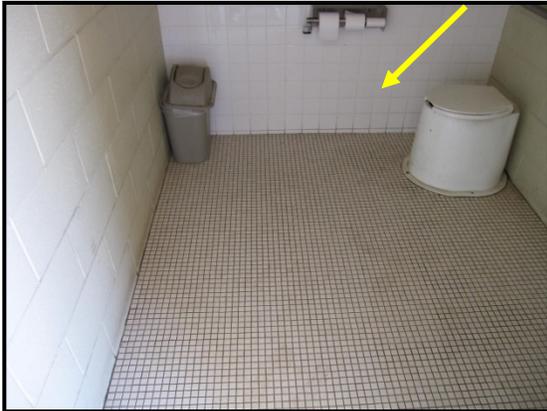
HM ID 20
Women's Restrooms
Floor 1

Women's Restroom 1
White grout on 4" x 4" ceramic tile wall.

Non-ACM
1522-A8A: ND
1522-A8B: ND
1522-A8C: ND

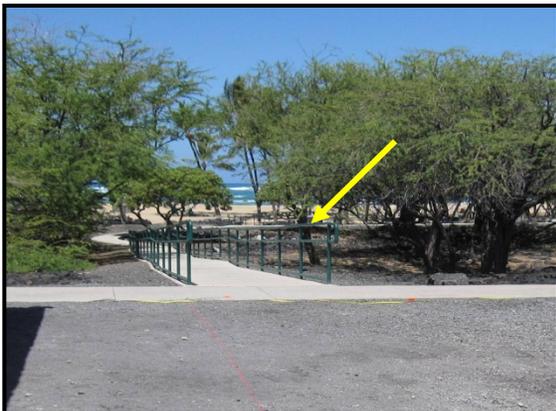
HM ID 21
Walkways
Exterior

Exterior
Green paint on metal railing.

Non-LCP
1522-P12A: <100 mg/kg
1522-P12B: <130 mg/kg

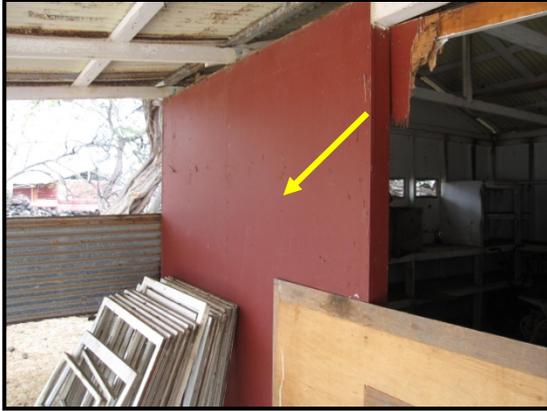
HM ID 22
House 1
Floor 1

Exterior
Red paint on wood wall.

LCP
1522-P13A: 380 mg/kg
1522-P13B: 380 mg/kg

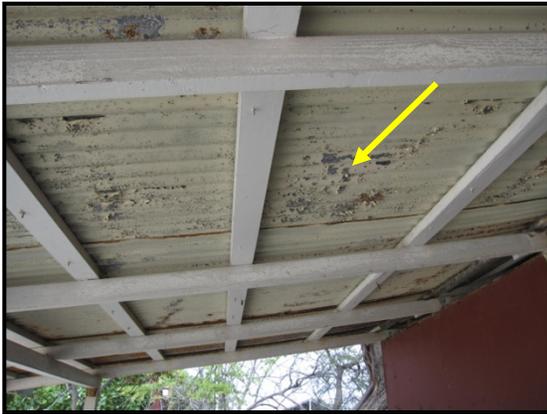
HM ID 26
House 1
Floor 1

Exterior
Off-white paint on metal awning.

LBP
1522-P17A: 13,000 mg/kg
1522-P17B: 13,000 mg/kg

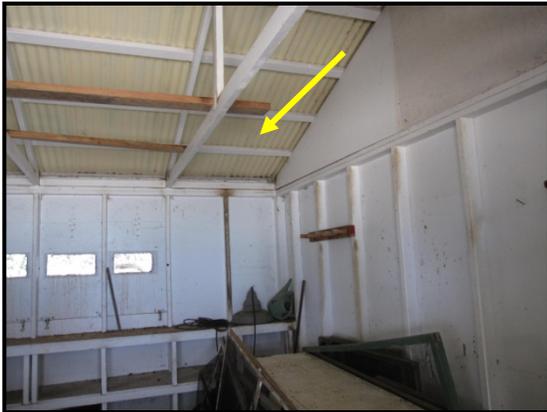
HM ID 29
House 1
Floor 1

Room 1
Off-white paint on metal ceiling.

LBP
1522-P20A: 14,000 mg/kg
1522-P20B: 13,000 mg/kg

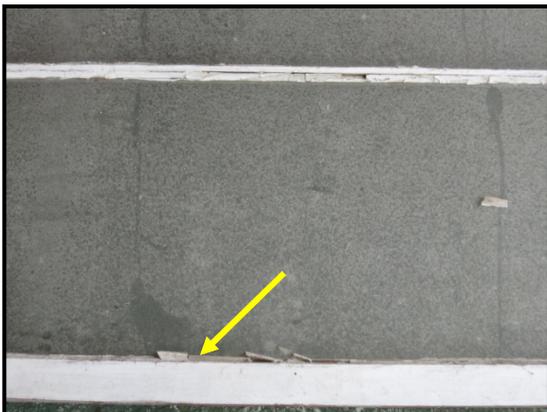
HM ID 30
House 1
Floor 1

One ACM was identified during the survey. Approximately 100 linear feet of white glazing in poor condition on glass windows in House 1, Kealemakule Housing Area, contained a measurable level of asbestos, 3% chrysotile. No ACM were identified in the Mahaiula Lagoon Area or the Kua Lagoon Area. The asbestos findings are summarized in Table 3. Suspect ACM descriptions and identifiers are provided in Appendix B. Sample and hazardous material location drawings are provided in Appendix C. Photographs of suspect materials are presented in Appendix D. Laboratory analytical reports, chain-of-custody, and field data forms are provided in Appendix E.

Exterior
White glazing on glass window.

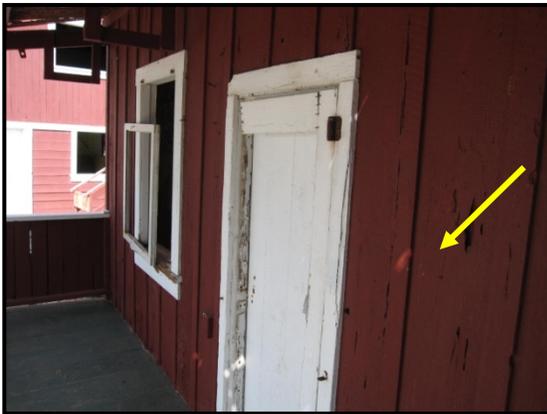
HM ID 32
House 2
Floor 1

Exterior
Red paint on wood wall.

LCP
1522-P22A: 230 mg/kg
1522-P22B: 340 mg/kg

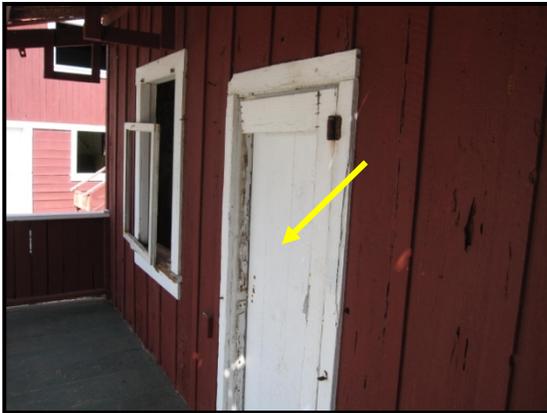
HM ID 35
House 2
Floor 1

Exterior
White paint on wood door.

Non-LCP
1522-P25A: <100 mg/kg
1522-P25B: <100 mg/kg

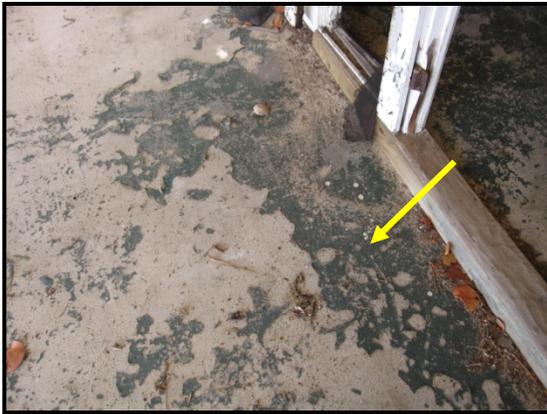
HM ID 45
House 3
Floor 1

Exterior
Green paint on concrete floor.

LBP
1522-P35A: 12,000 mg/kg
1522-P35B: 14,000 mg/kg

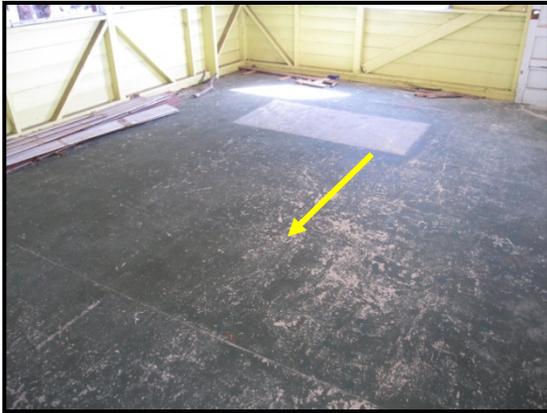
HM ID 48
House 3
Floor 1

Room 1
Green paint on concrete floor.

LBP
1522-P38A: 14,000 mg/kg
1522-P38B: 13,000 mg/kg

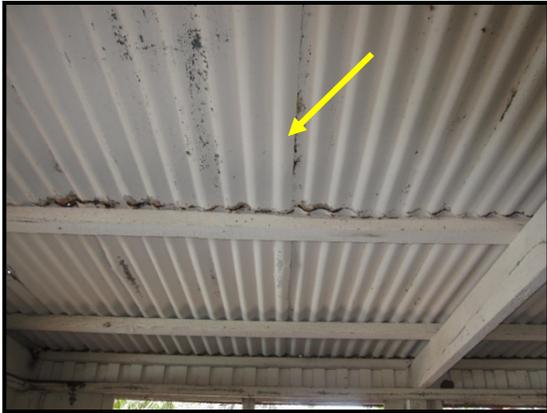
HM ID 51
House 3
Floor 1

Room 1
White paint on metal ceiling.

LCP
1522-P41A: 330 mg/kg
1522-P41B: 290 mg/kg

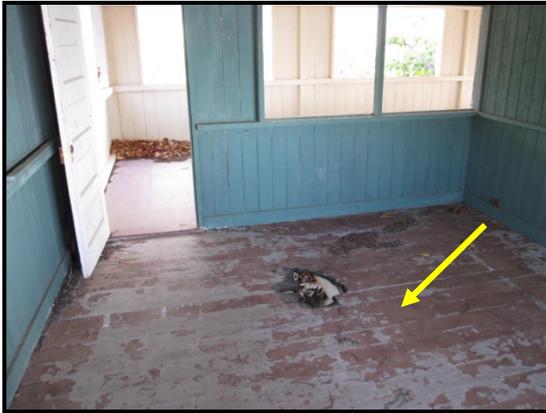
HM ID 54
House 3
Floor 2

Room 2
Red paint on wood floor.

LCP
1522-P44A: 2,800 mg/kg
1522-P44B: 4,500 mg/kg
