**DRAFT**  
**GEOTECHNICAL ENGINEERING EXPLORATION**  
**IAO VALLEY STATE MONUMENT FLOOD REPAIRS**  
**JOB NO. J45CM41A**  
**INTERIM REMEDIAL MEASURES**  
**WAILUKU, MAUI, HAWAII**

**W.O. 7417-00(A)    DECEMBER 1, 2016**

**WILSON OKAMOTO CORPORATION**

**STATE OF HAWAII**  
**DEPARTMENT OF LAND & NATURAL RESOURCES**

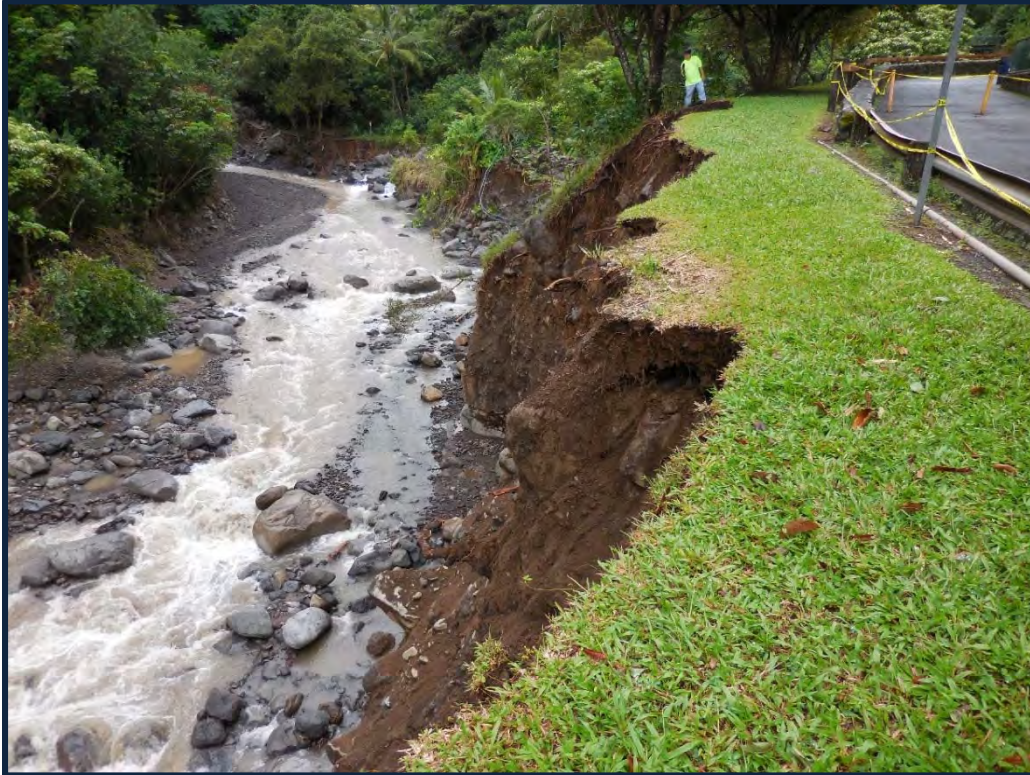
**Photograph No. 1:** View upstream of the parking lot slope failure site on September 13, 2016

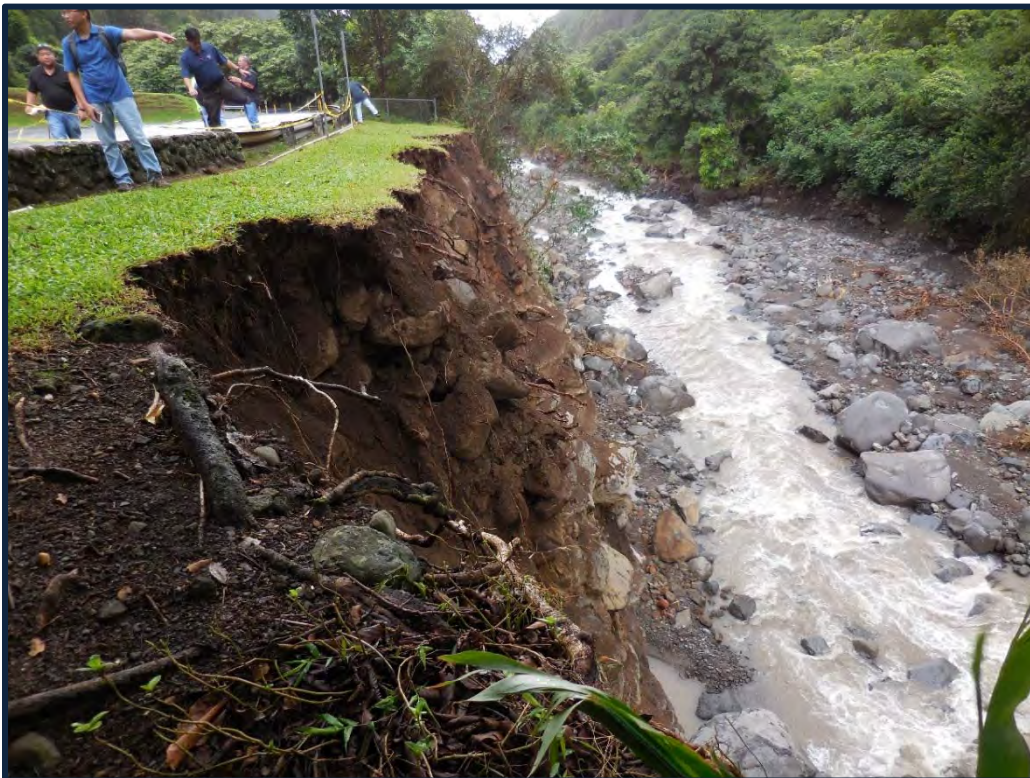
**Photograph No. 2:** View downstream of the parking lot slope failure site.

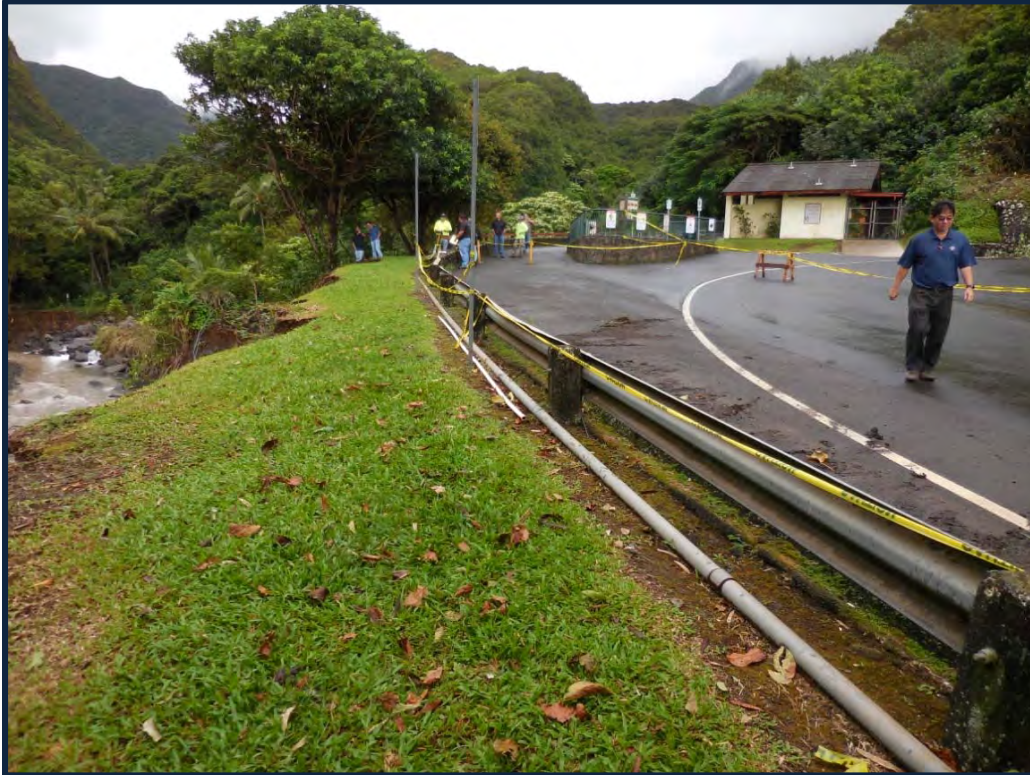
**Photograph No. 3:** Existing top of slope condition with view in the upstream direction.

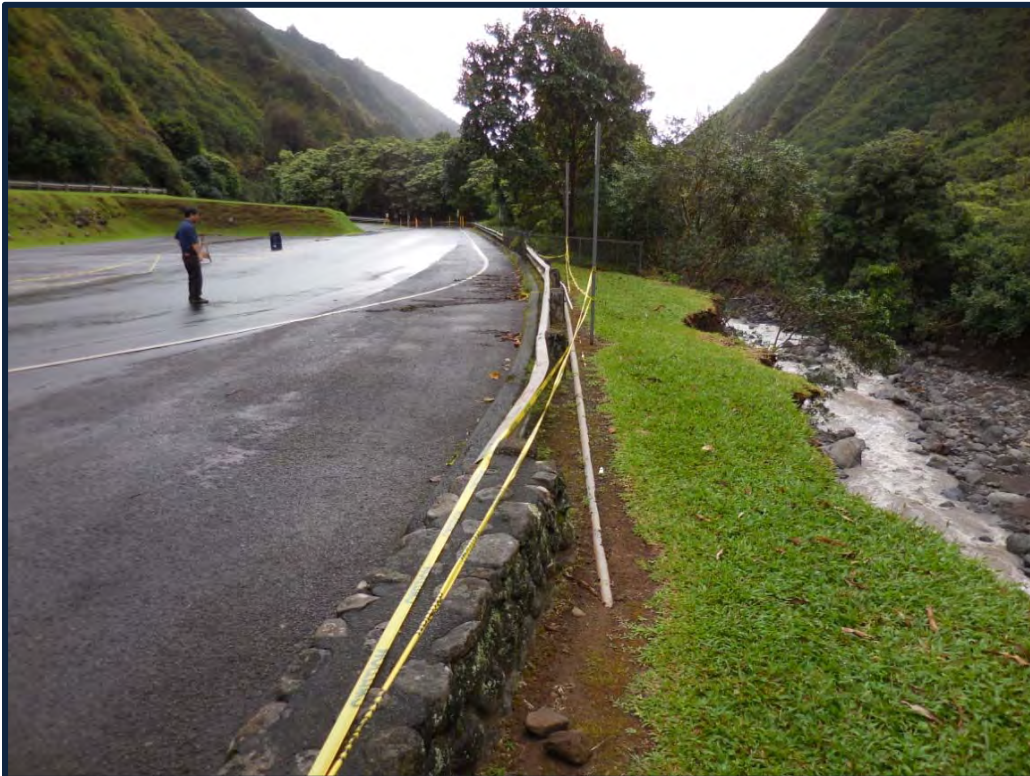
**Photograph No. 4:** Existing top of slope condition with view in the downstream direction.

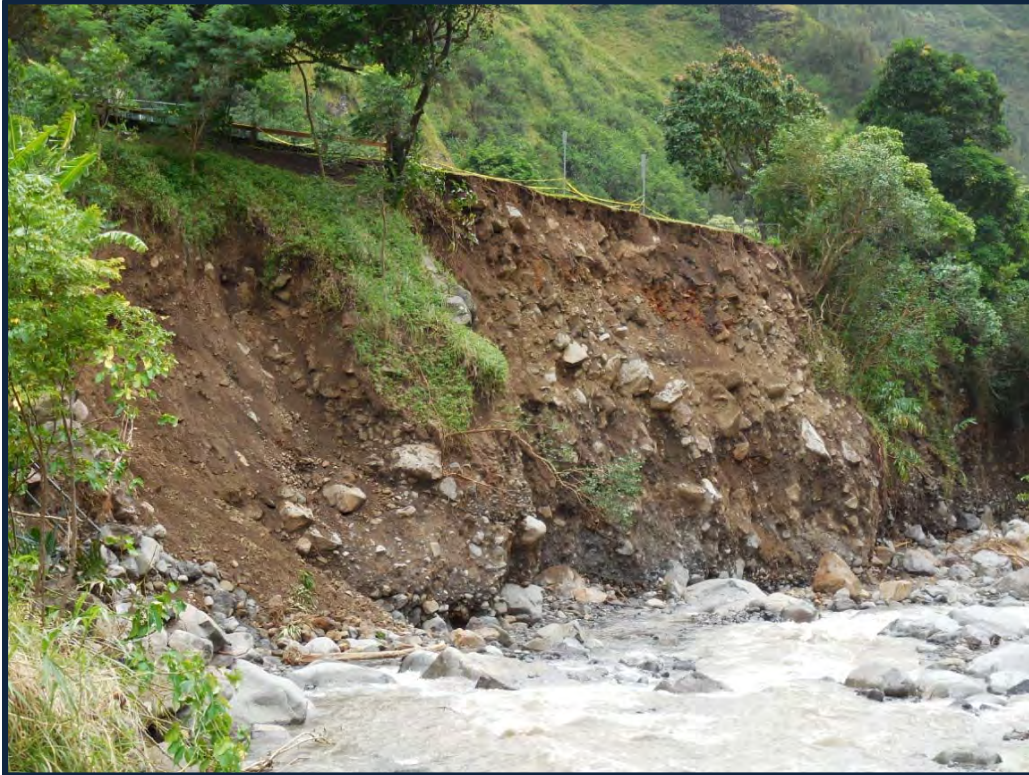
**Photograph No. 5:** Existing condition of the parking lot slope failure site from the stream elevation. Note the semi-consolidated character of the older colluvial deposits exposed in the lower portion of the slope, in contrast to the overlying unconsolidated overcast fill materials comprising the upper portion of the slope.

For temporary support of the slope face materials at the parking lot slope failure during the interim remedial repair, we recommend placing a minimum of 1-inch thick of shotcrete with fiber flash coating on the slope face. Prior to placing the shotcrete, the existing fill materials encountered on the slope face should be cut-back to a slope inclination of 0.5H:1V or flatter and scaling of the slope face should be performed to remove existing loose and unstable surface rocks. In addition, geocomposite drains should be placed on the face of the slope between the shotcrete to reduce the potential for the build-up of hydrostatic pressures. To reduce the potential for additional erosion at the slope toe from future flood events, we recommend installing a slope toe protection system consisting of a 19-foot wide by 10-foot high buttress fill covered with grouted rubble paving (GRP).

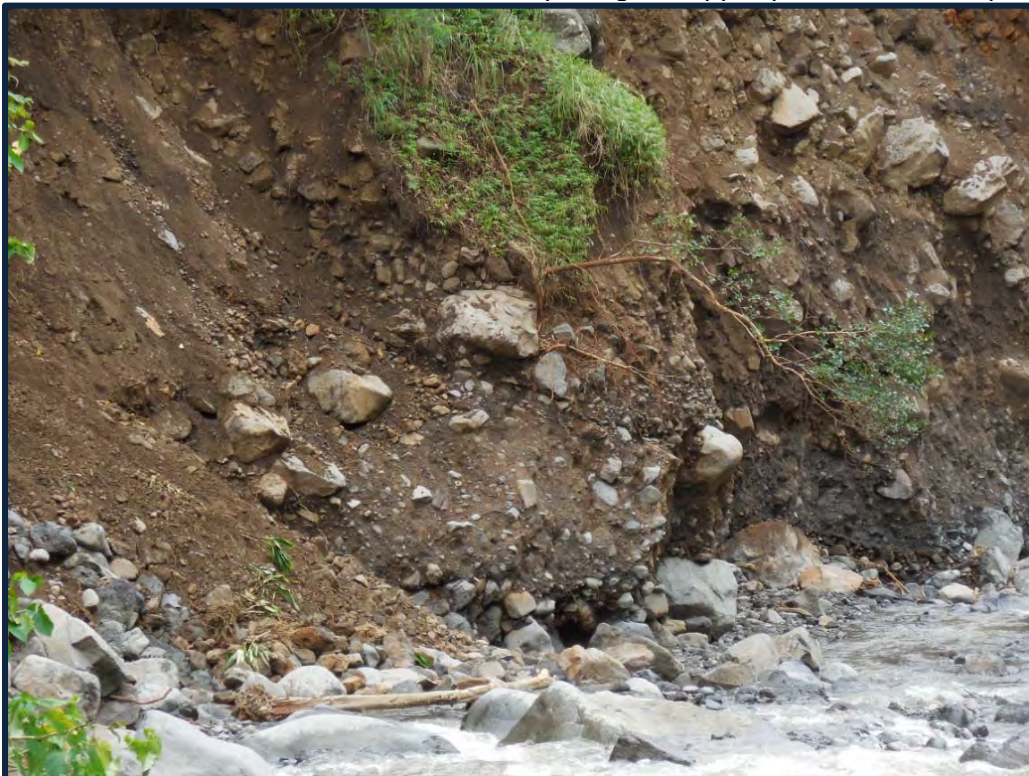
**Photograph No. 6:** Closer view of the semi-consolidated older colluvial materials comprising the lower slope at the parking lot slope failure site.

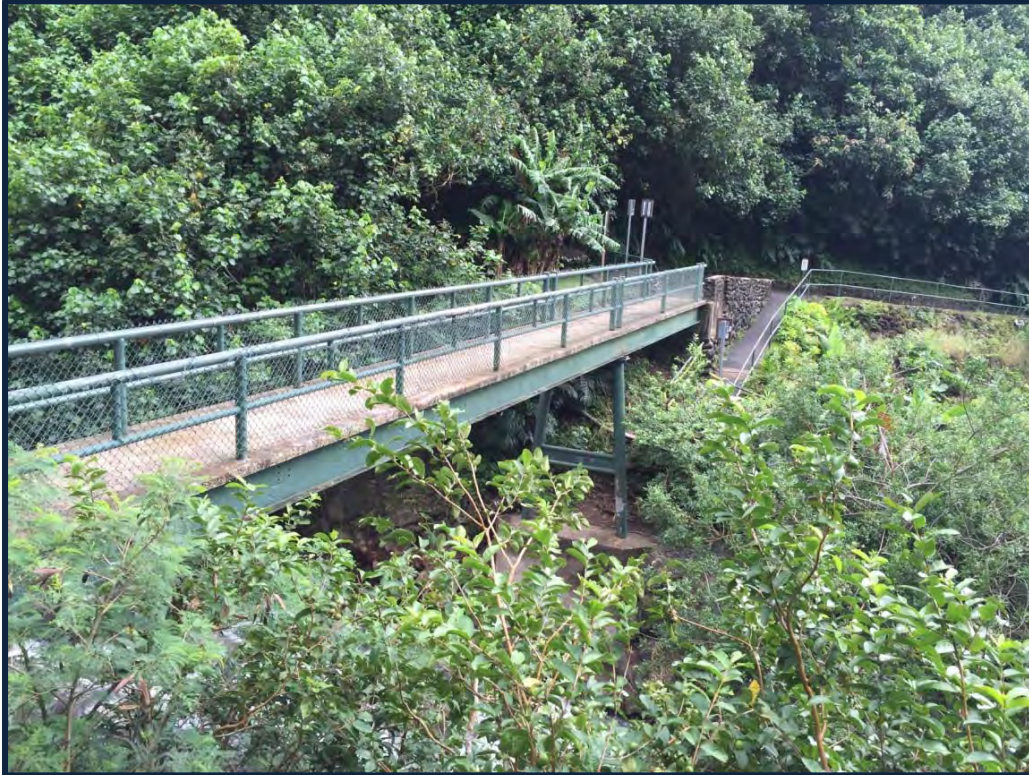
**Photograph No. 7:** Existing condition of the pedestrian bridge with view towards the north abutment.

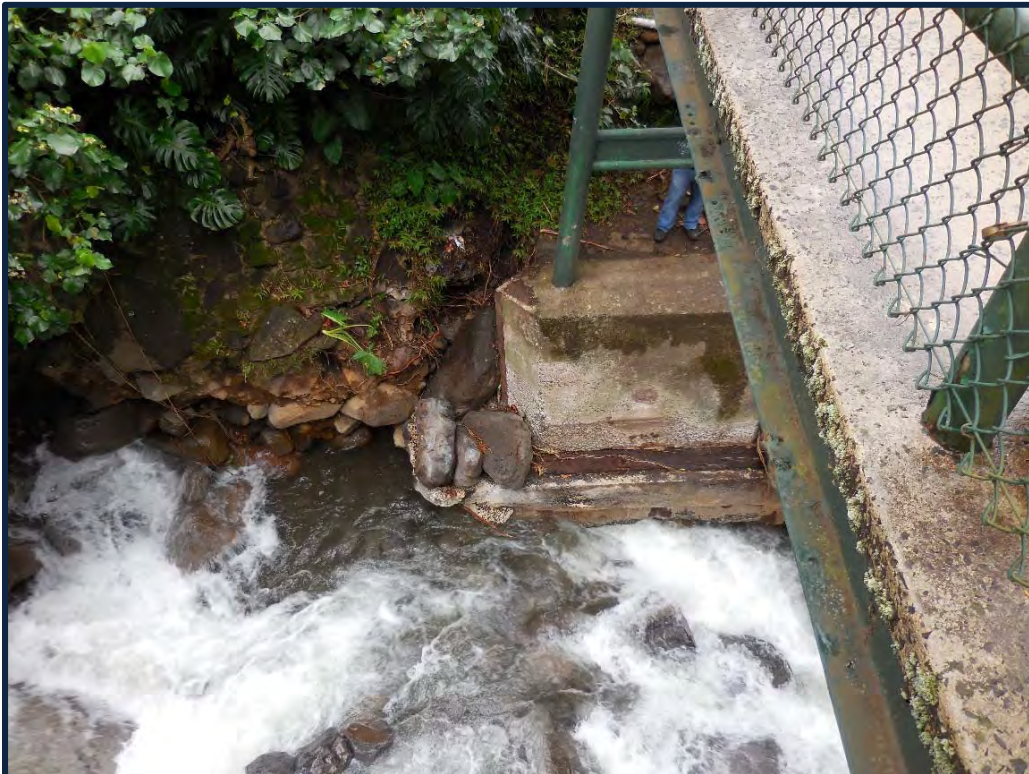
**Photograph No. 8:** Exposure by stream scour of the existing bridge pier foundation at the north abutment of the bridge.

The existing concrete footing supporting the intermediate pier on the eastern side of the pedestrian bridge appears to have been exposed and undermined by heavy stream flow scour. We understand it is desired to construct an additional pier support adjacent to the existing intermediate pier foundation. Based on the subsurface conditions anticipated at the location of the new pier foundation, we recommend utilizing a shallow spread and/or strip footings for foundation support of the new pier planned at the pedestrian bridge. Due to the apparent undermining of the existing intermediate pier footing, we recommend embedding the new footing to a depth equal to the depth of the existing intermediate pier footing, which we have estimated to be approximately 9.5 feet below the existing ground surface.

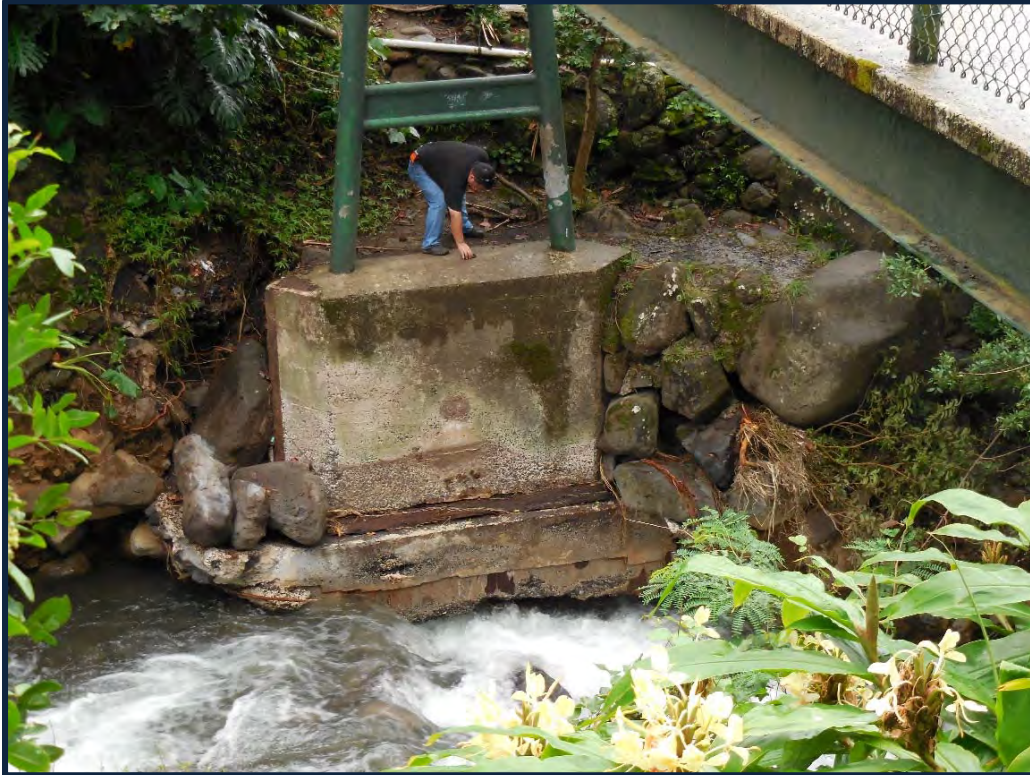
**Photograph No. 9:** Exposure by stream scour of the existing bridge pier foundation at the northern abutment of the bridge.

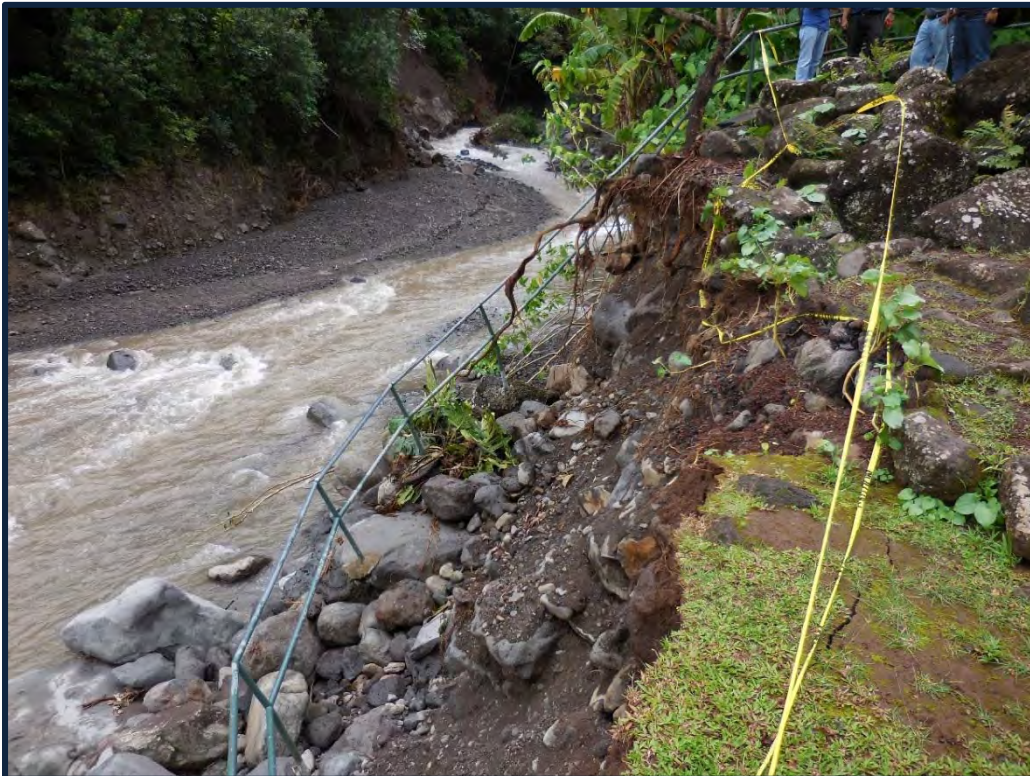
The Short Loop Trail failure is an approximate 40-foot length of streamside pathway composed of asphaltic concrete and steel railings that fully collapsed and were lost as a result of stream bank erosion by heavy stream flow. The failure occurred along a localized section of pedestrian pathway that parallels the stream in the lower rock garden adjacent to the parking lot. The path fell about 15 feet into the channel below leaving a near-vertical and irregular eroded scarp face composed of boulders and cobbles bordering the stream.

**Photograph No. 10:** Bank failure and loss of pathway and railings at the short loop trail.

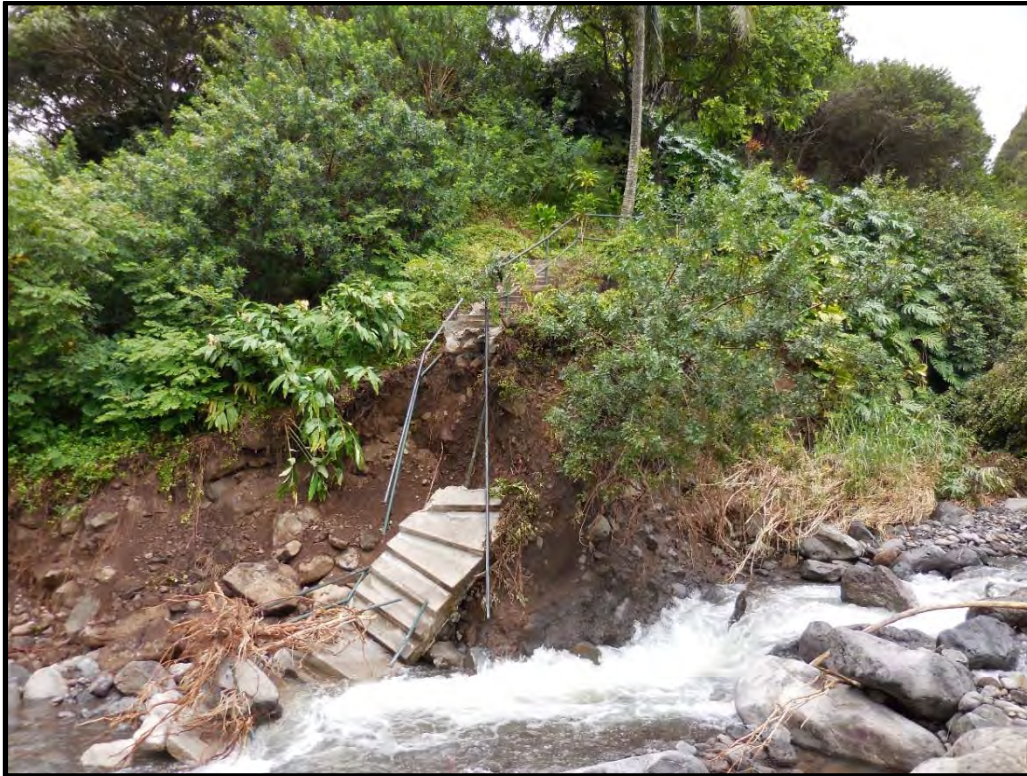
**Photograph No. 11:** Stream bank collapse truncating the northern portion of the long loop trail.

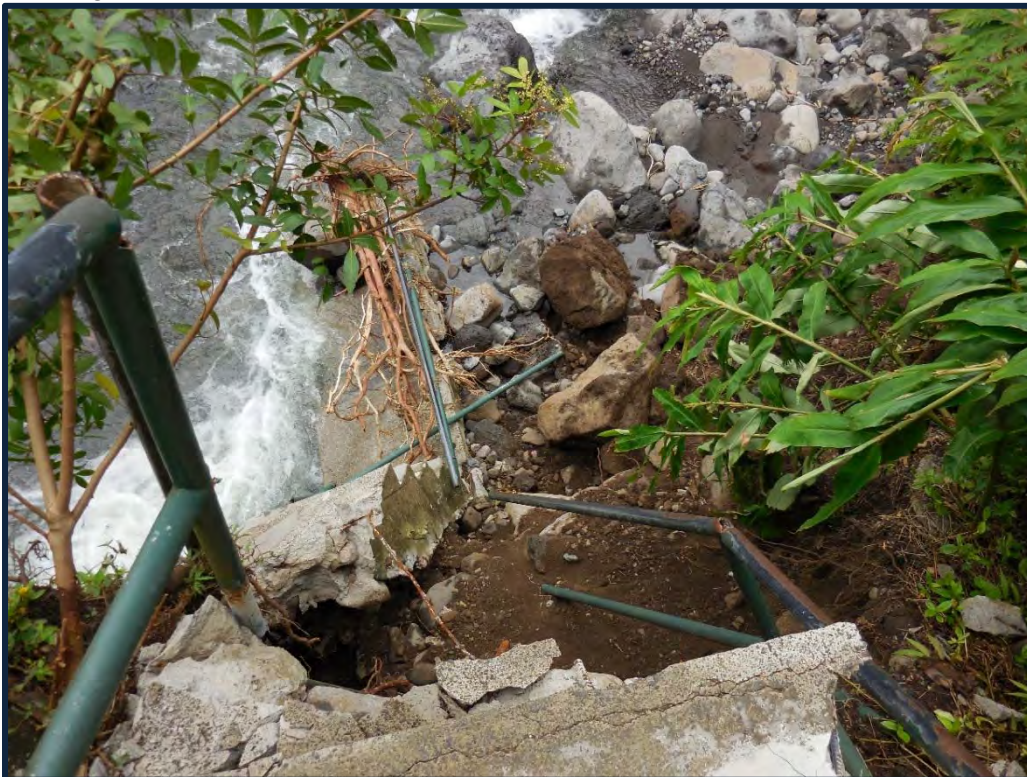
**Photograph No. 12:** Stream bank collapse truncating the northern portion of the long loop trail.

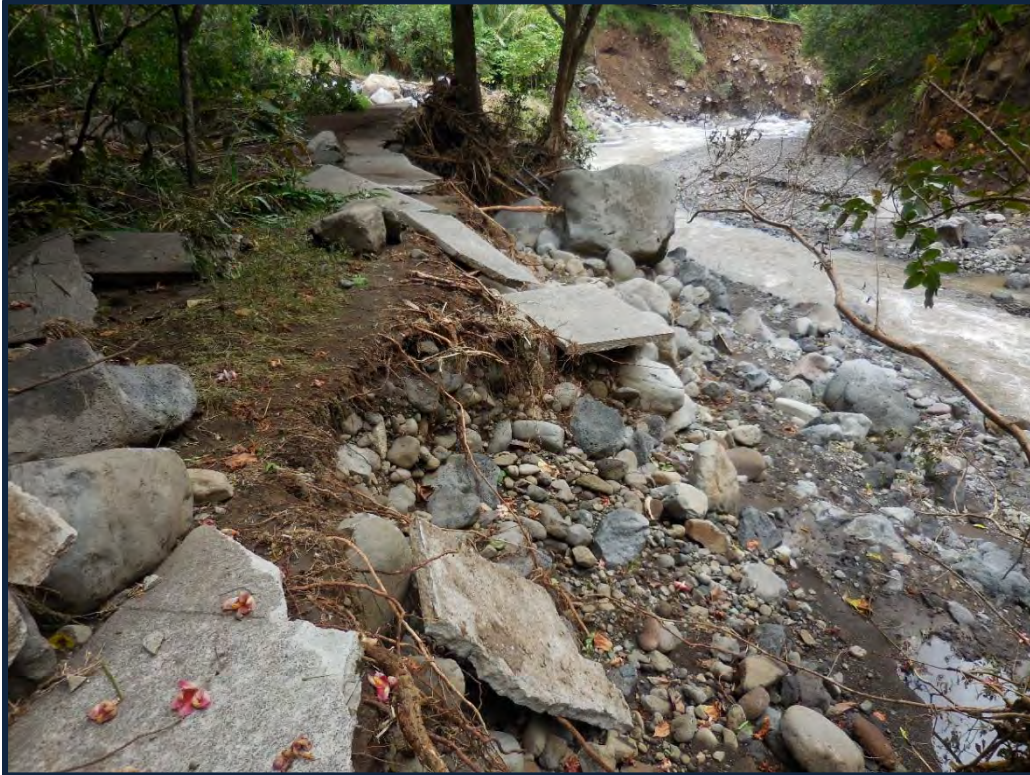
The Long Loop Trail failure is approximately 300 linear feet of concrete pathway and steel railings that were destroyed by flood water at the southwestern corner of the park where a streamside loop trail was established. The pedestrian pathway extends across a low-relief topographic plain adjacent to the main stream channel. It appears that heavy stream discharge overwhelmed the main channel and spread laterally across the low-lying terrain adjacent to the stream channel. Based on our observations, the concrete pathway was undermined adjacent to the main channel and broken into pieces by heavy flood runoff carrying debris such as boulders and vegetation.

**Photograph No. 13:** Portion of the concrete pathway on the long loop trail destroyed by floodwater.

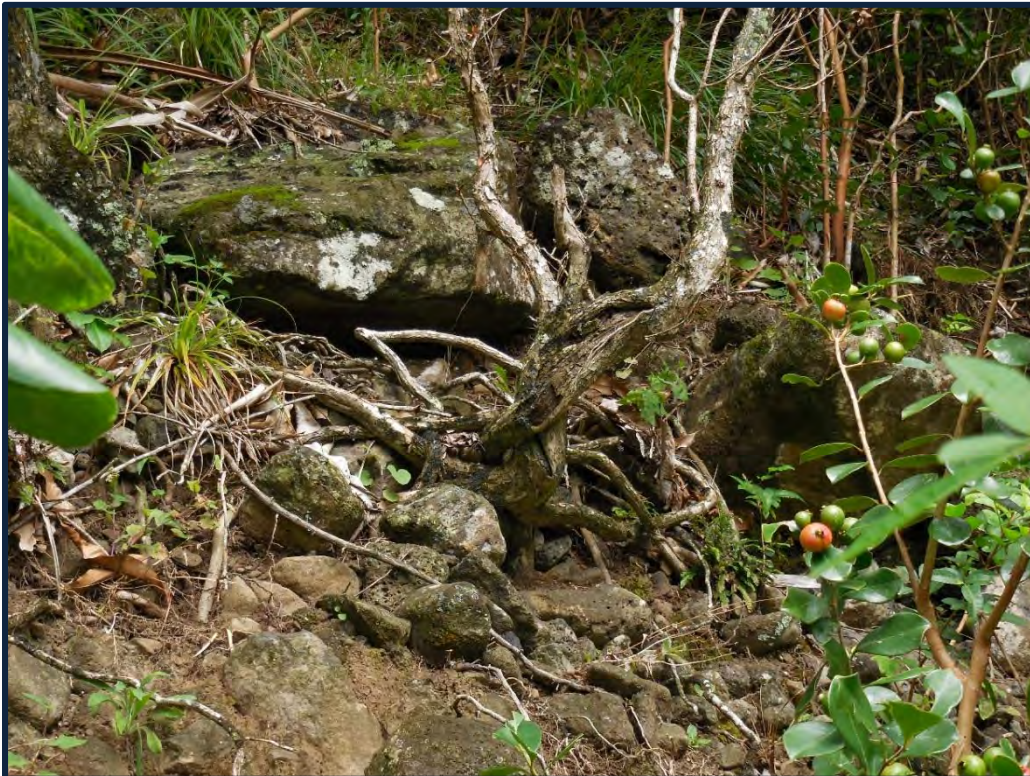
**Photograph No. 14:** Undermining and exposure of existing basaltic cobbles and boulders mantling the taller slopes adjacent to the pathway. Site of proposed slope scaling.

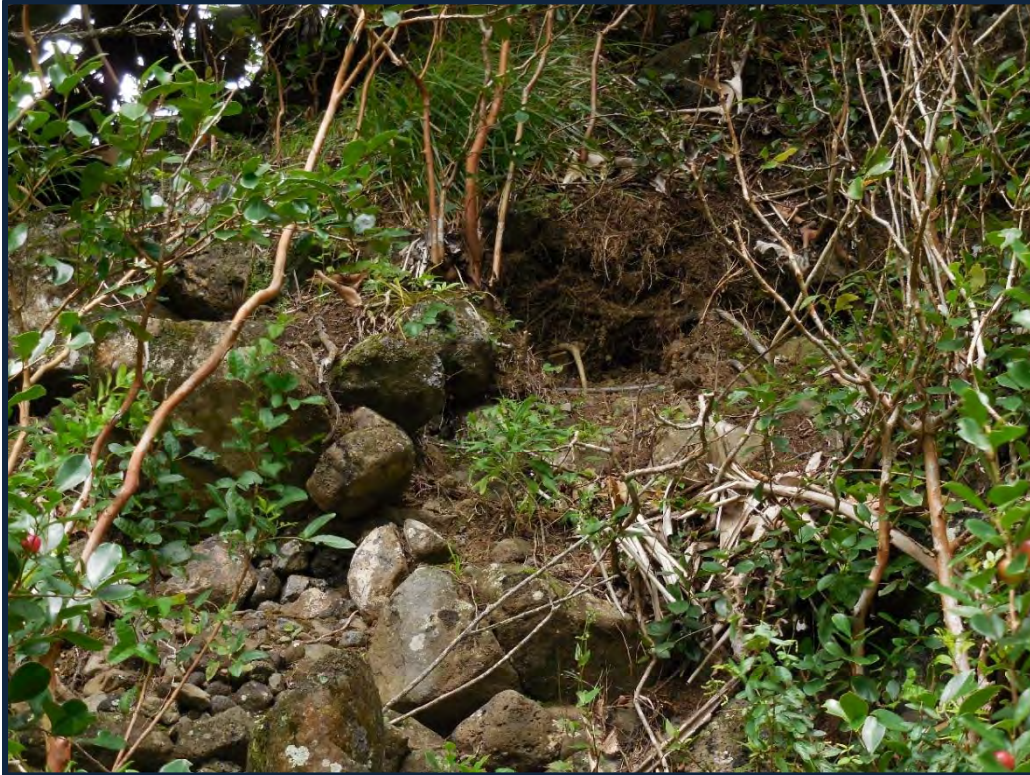
**Photograph No. 15:** Undermining and exposure of existing basaltic cobbles and boulders mantling the taller slopes adjacent to the pathway. Site of proposed slope scaling.

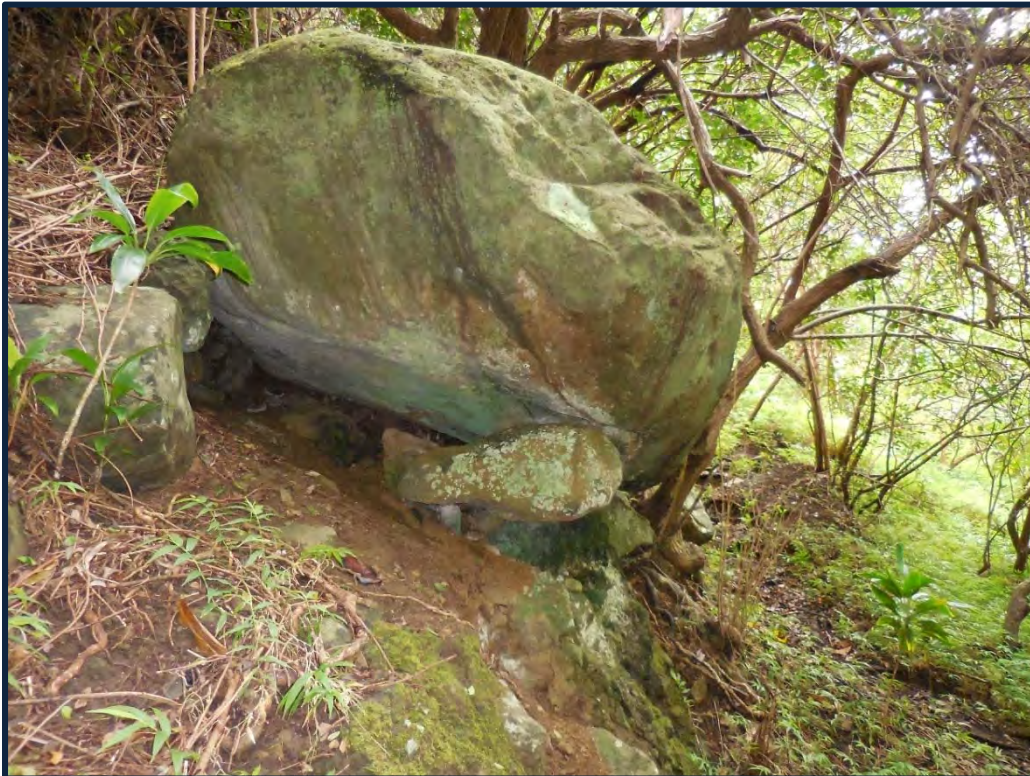
In addition, a large boulder of approximately 10 feet in diameter was observed to be perched precariously above a portion of the lower loop trail. Based on our observations, signs of runoff scour and removal of supporting material was observed at the base of the boulder.

**Photograph No. 16:** Single large boulder proposed for stabilization along a section of the remaining portion of the long loop trail.
