**ROUTINE BRIDGE INSPECTION REPORT
FEDERAL-AID PROJECT NO. BRIS-NBIS(080)
CONTRACT NO. SC-DDC-2200014**

**FARRINGTON HIGHWAY BRIDGE NO. 3 OVER PALEHUA STREAM
BRIDGE NO. 902
STRUCTURE NO. 003902001100001**

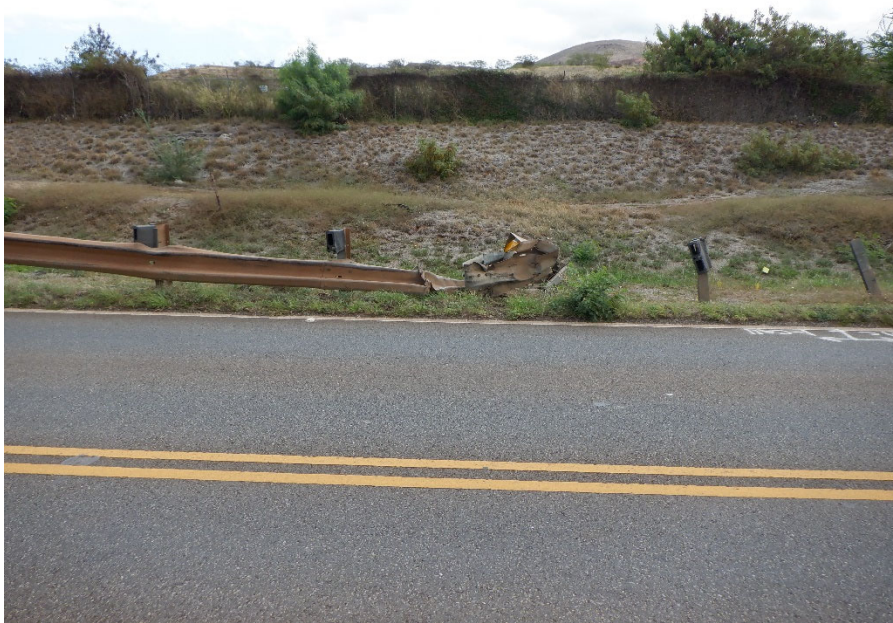
PHOTO 9 COLLISION DAMAGE TO UPSTREAM NORTH APPROACH
GUARDRAIL AND END TREATMENT

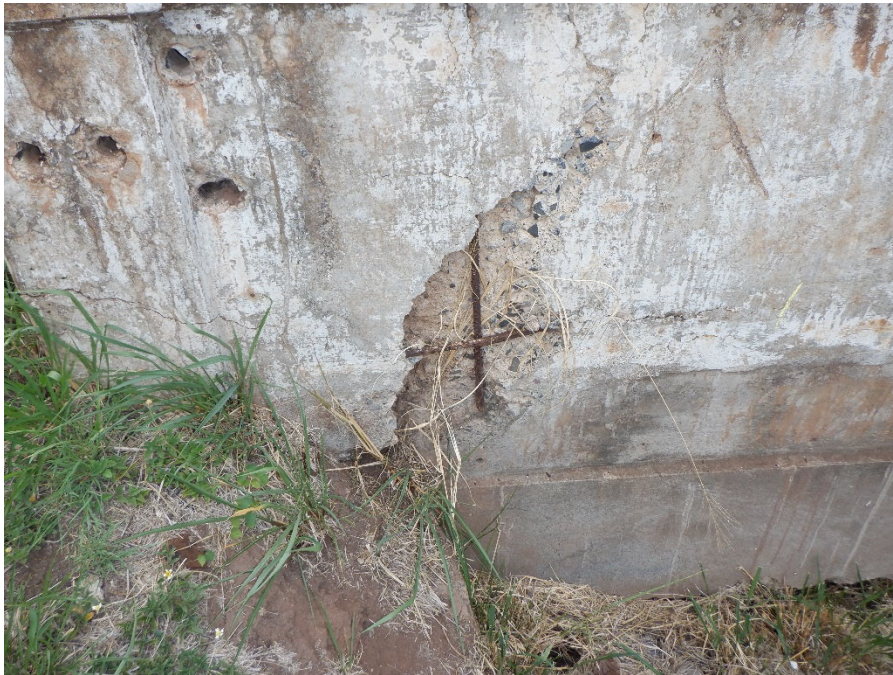
PHOTO 10 3'X3'X4" SPALL WITH EXPOSED REBAR (3FT 1080 CS3)
ON EXTERIOR FACE OF UPSTREAM RAILING, 2' FROM
NORTH END OF BRIDGE

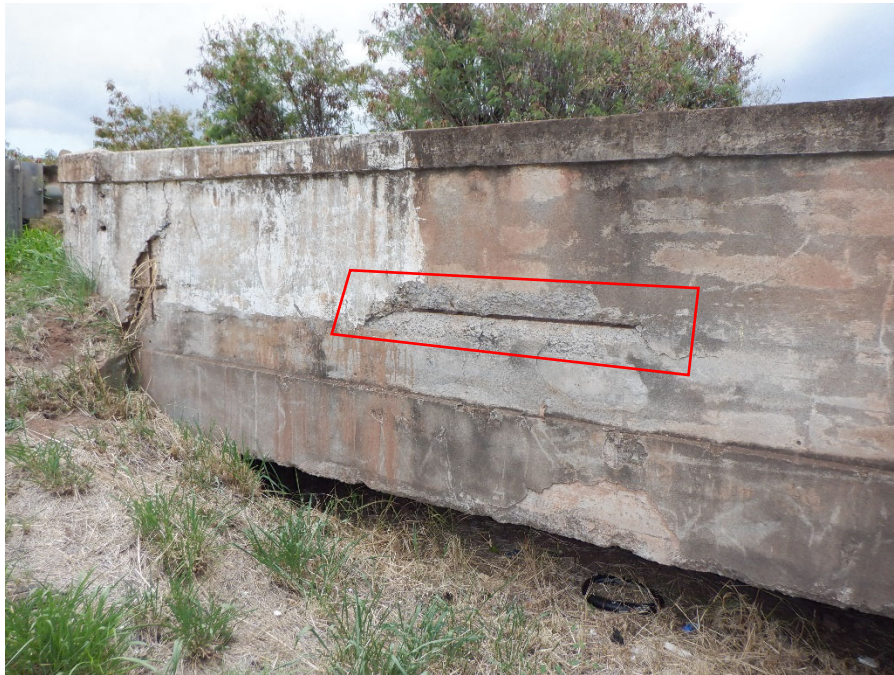
PHOTO 12 5'-3"X1'-6"X3" SPALL WITH EXPOSED REBAR (6FT 1080 CS3) ON EXTERIOR FACE OF UPSTREAM RAILING, 10' FROM NORTH END OF BRIDGE

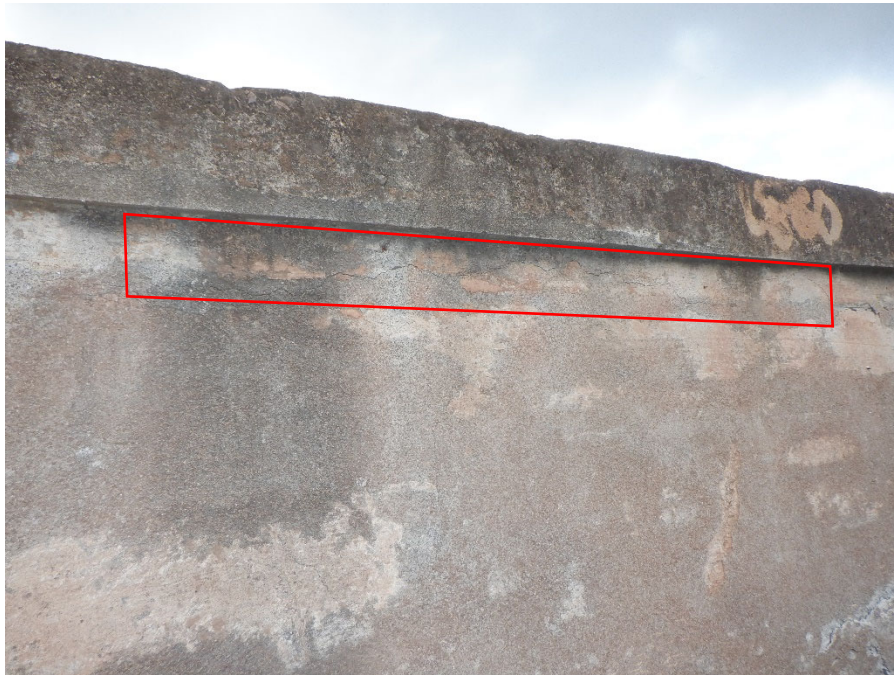
PHOTO 14 DELAMINATION (8FT 1080 CS2) ON EXTERIOR FACE OF
UPSTREAM RAILING

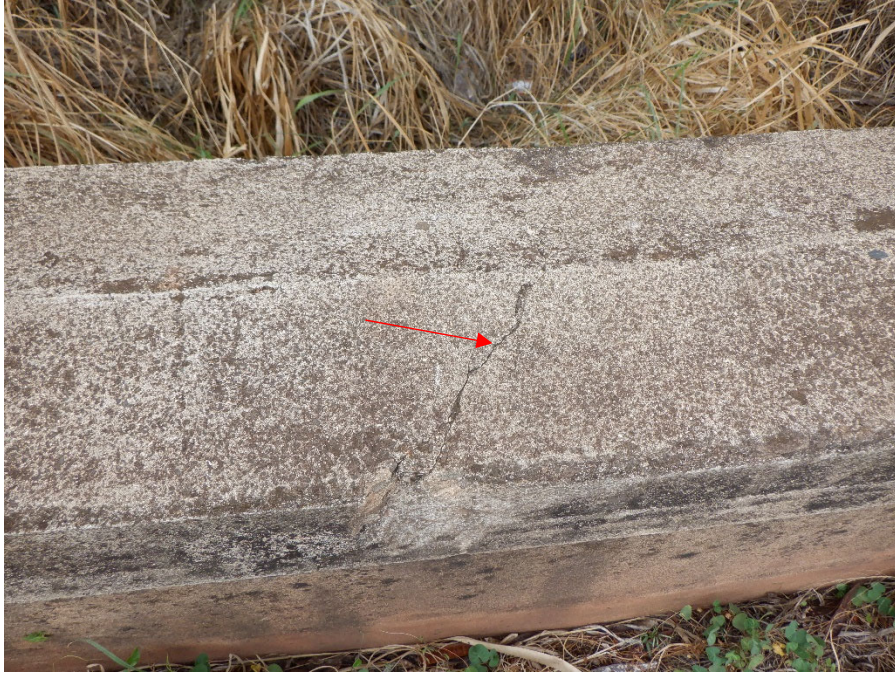
PHOTO 19 TYPICAL MODERATE WIDTH CRACK (1130 CS2) ON BOTH BRIDGE RAILINGS

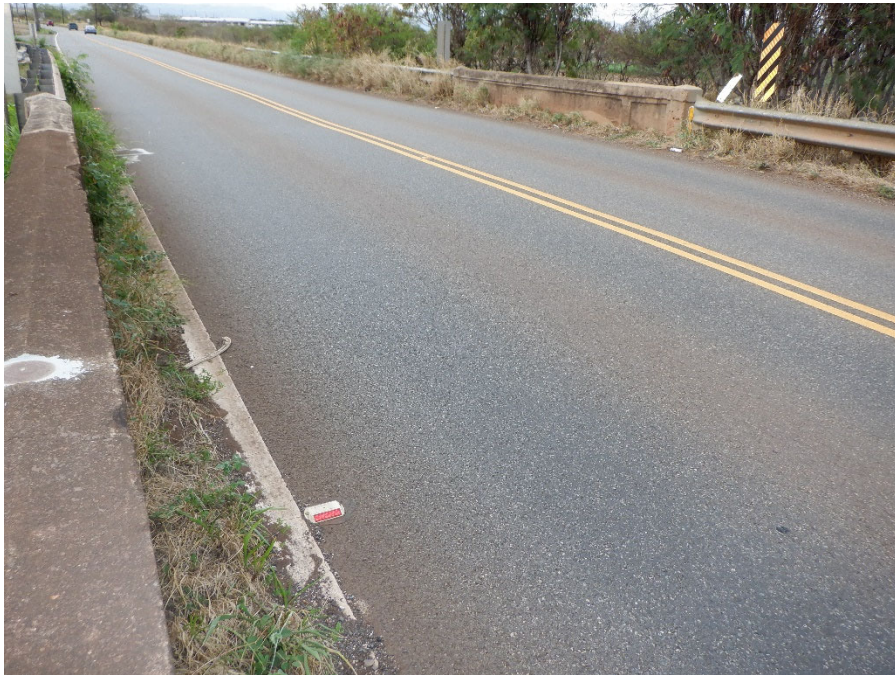
PHOTO 20 WEARING SURFACE

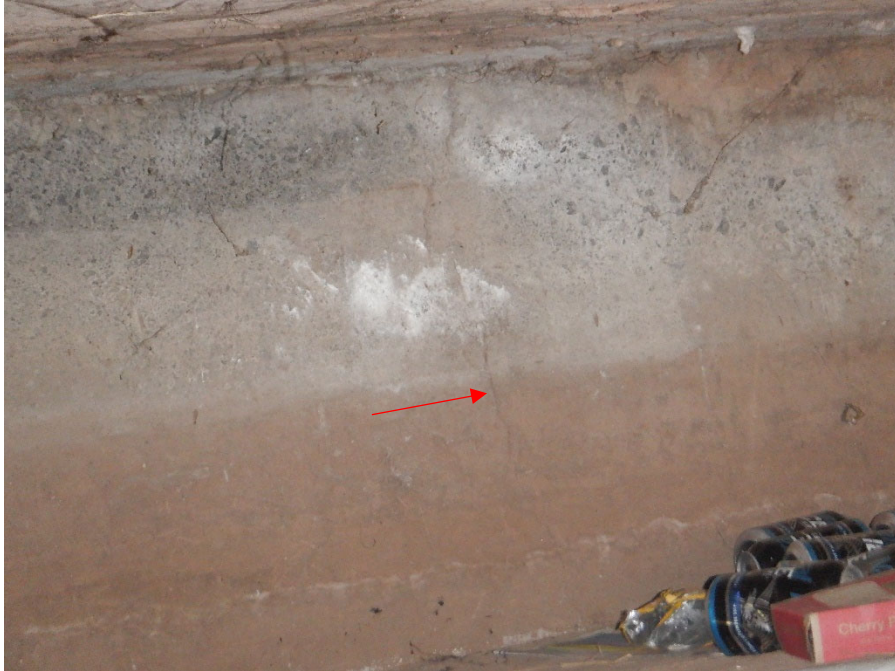
PHOTO 31 MODERATE WIDTH VERTICAL CRACK (1FT 1130 CS2) ON ABUTMENT 2

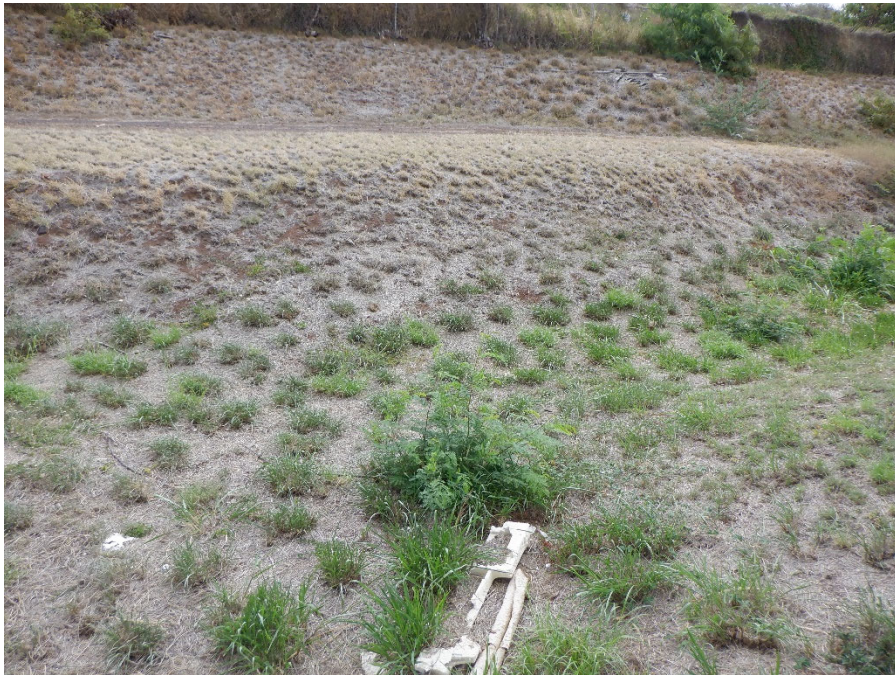
PHOTO 32 UPSTREAM CHANNEL

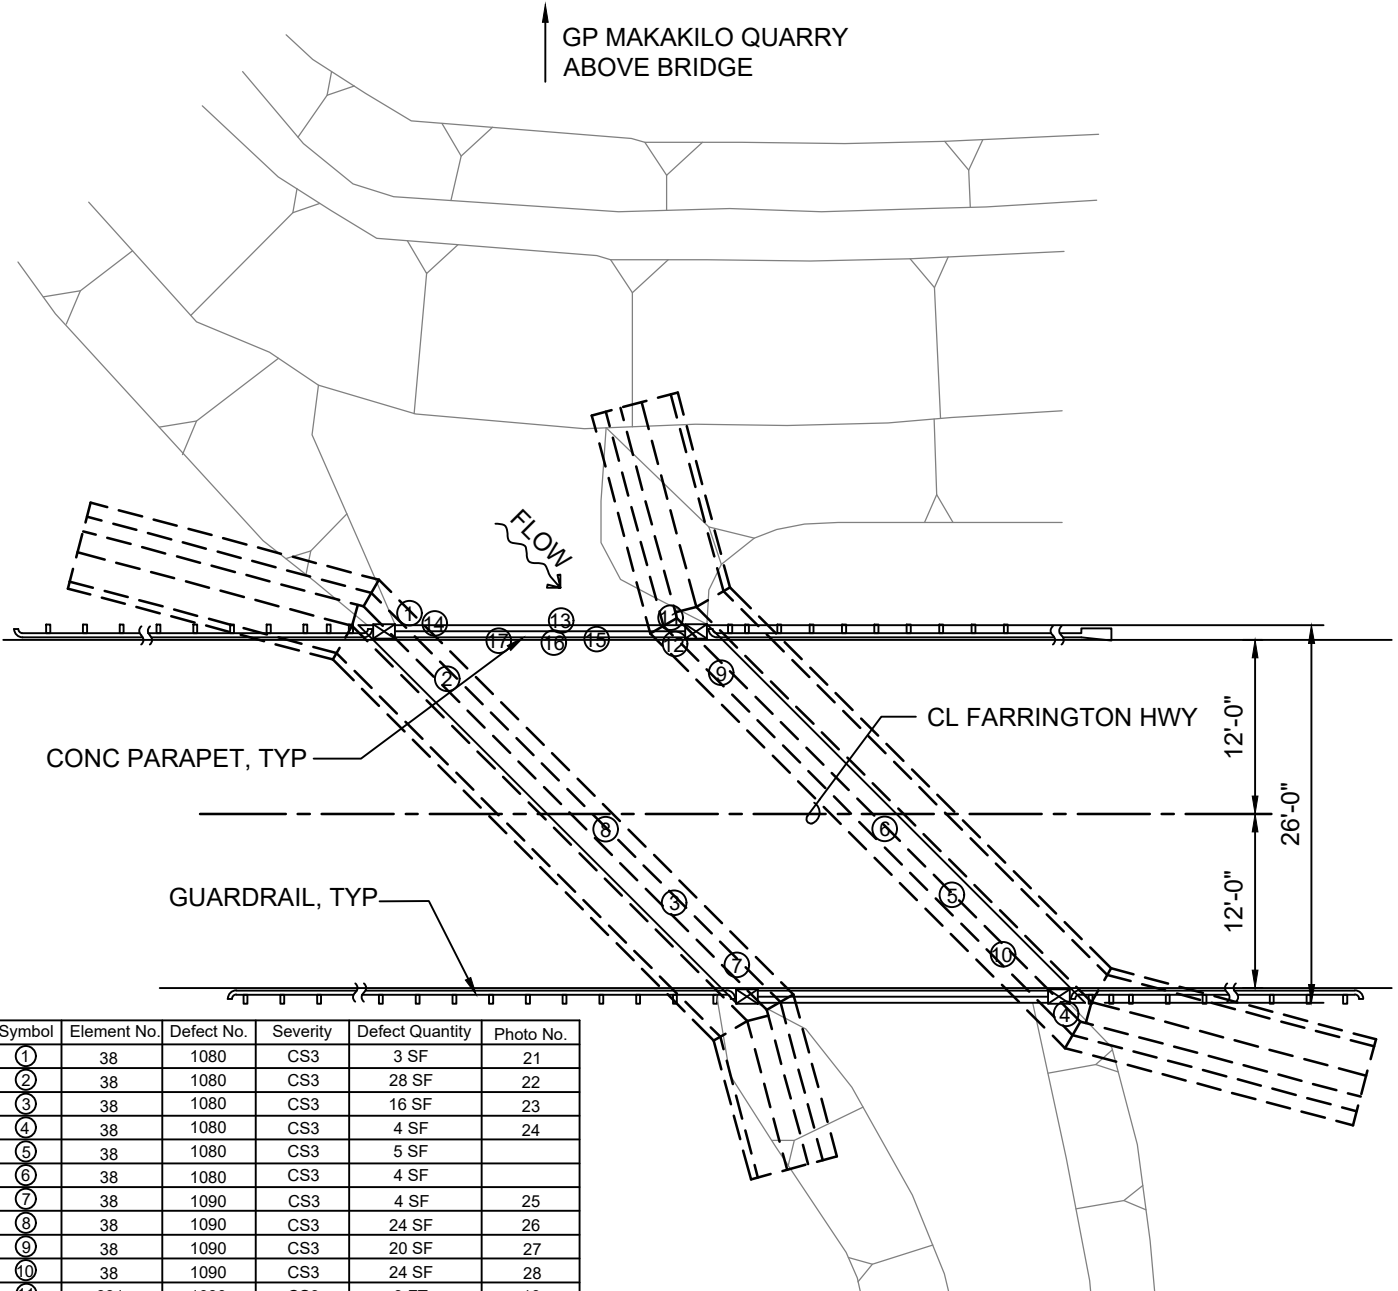
Symbol	Element No.	Defect No.	Severity	Defect Quantity	Photo No.
①	38	1080	CS3	3 SF	21
②	38	1080	CS3	28 SF	22
③	38	1080	CS3	16 SF	23
④	38	1080	CS3	4 SF	24
⑤	38	1080	CS3	5 SF	
⑥	38	1080	CS3	4 SF	
⑦	38	1090	CS3	4 SF	25
⑧	38	1090	CS3	24 SF	26
⑨	38	1090	CS3	20 SF	27
⑩	38	1090	CS3	24 SF	28
⑪	331	1080	CS3	3 FT	10
⑫	331	1080	CS3	1 FT	11
⑬	331	1080	CS3	6 FT	12
⑭	331	1080	CS3	4 FT	13
⑮	331	1090	CS3	1 FT	16
⑯	331	1090	CS3	1 FT	17
⑰	331	1090	CS3	1 FT	18

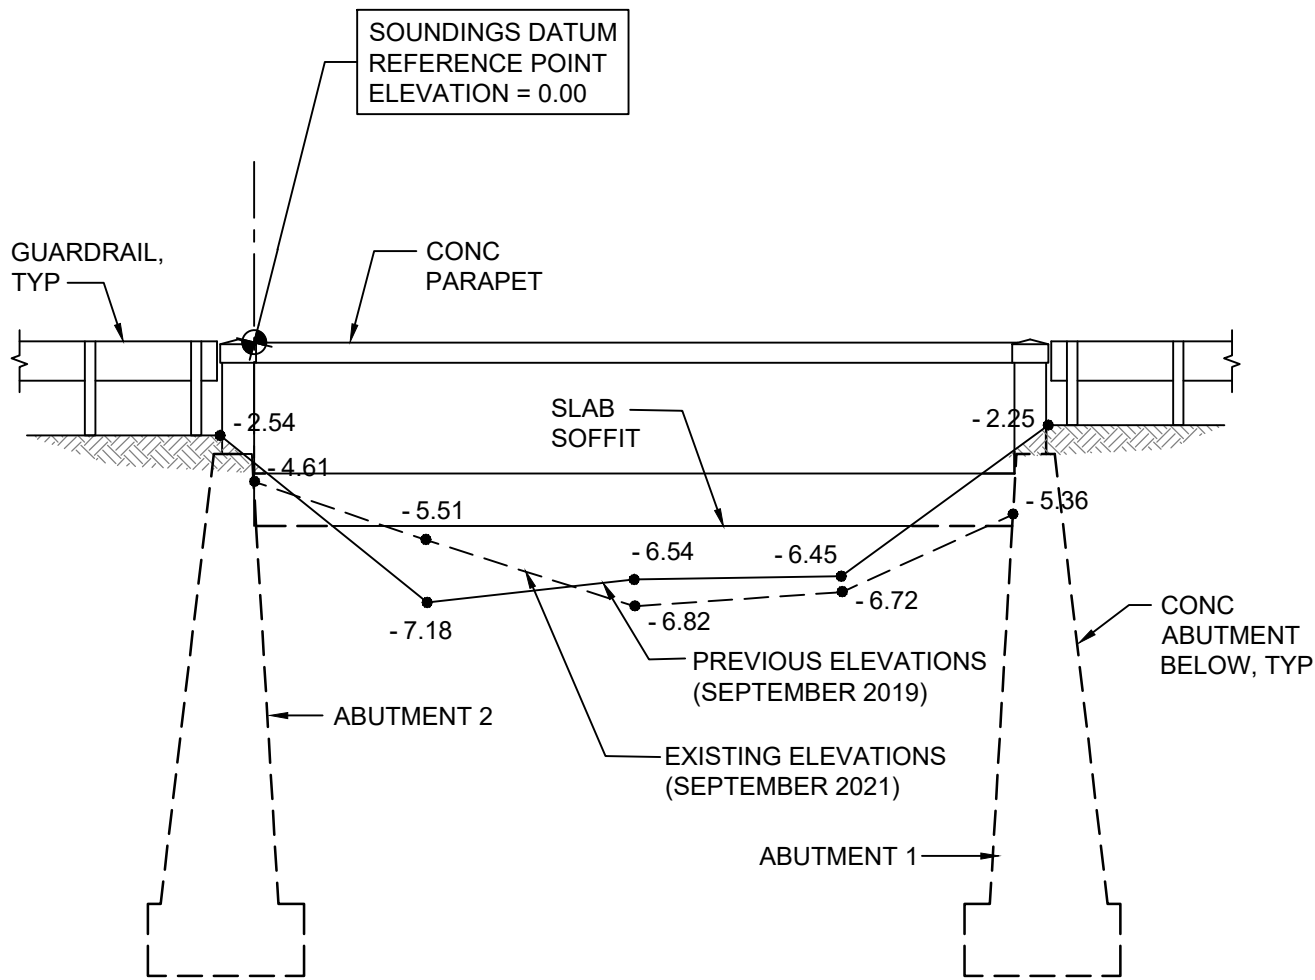
AS-BUILTS COULD NOT PROVIDE SUFFICIENT FOUNDATION INFORMATION. THEREFORE, BRIDGE FOUNDATION ELEVATIONS ARE UNKNOWN.
