LIMITED LEAD PAINT SURVEY State of Hawaii Laboratories Division 2725 Waimano Home Road Pearl City, Hawaii 96782

January 2025

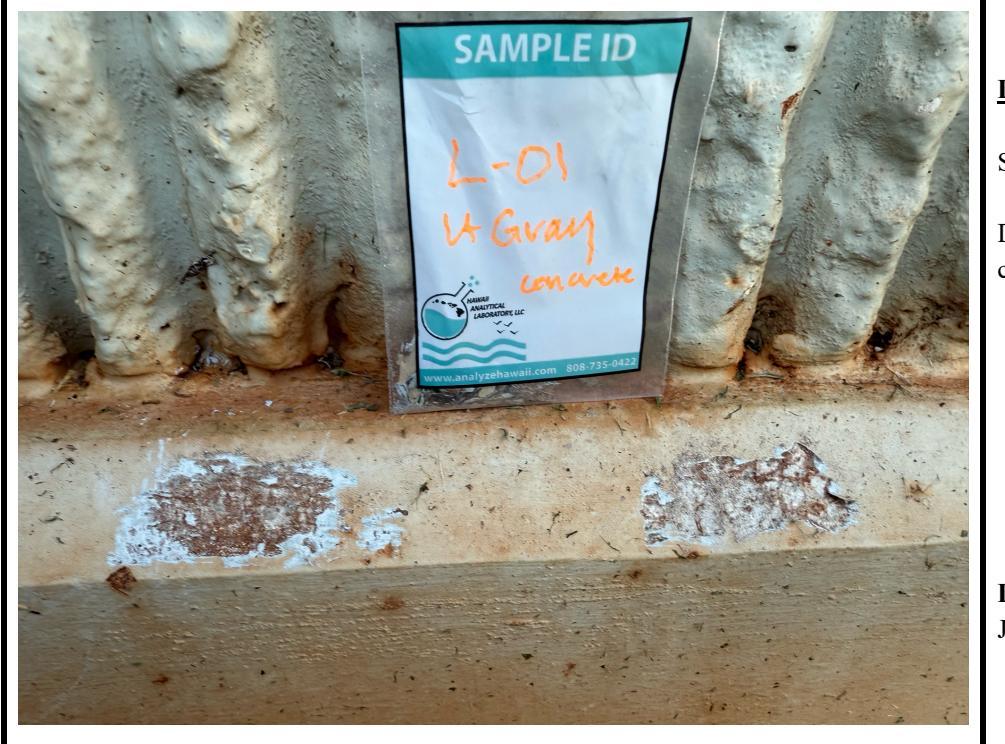
## Photograph #2

Sample L-01

Does not contain detectable concentrations of lead.

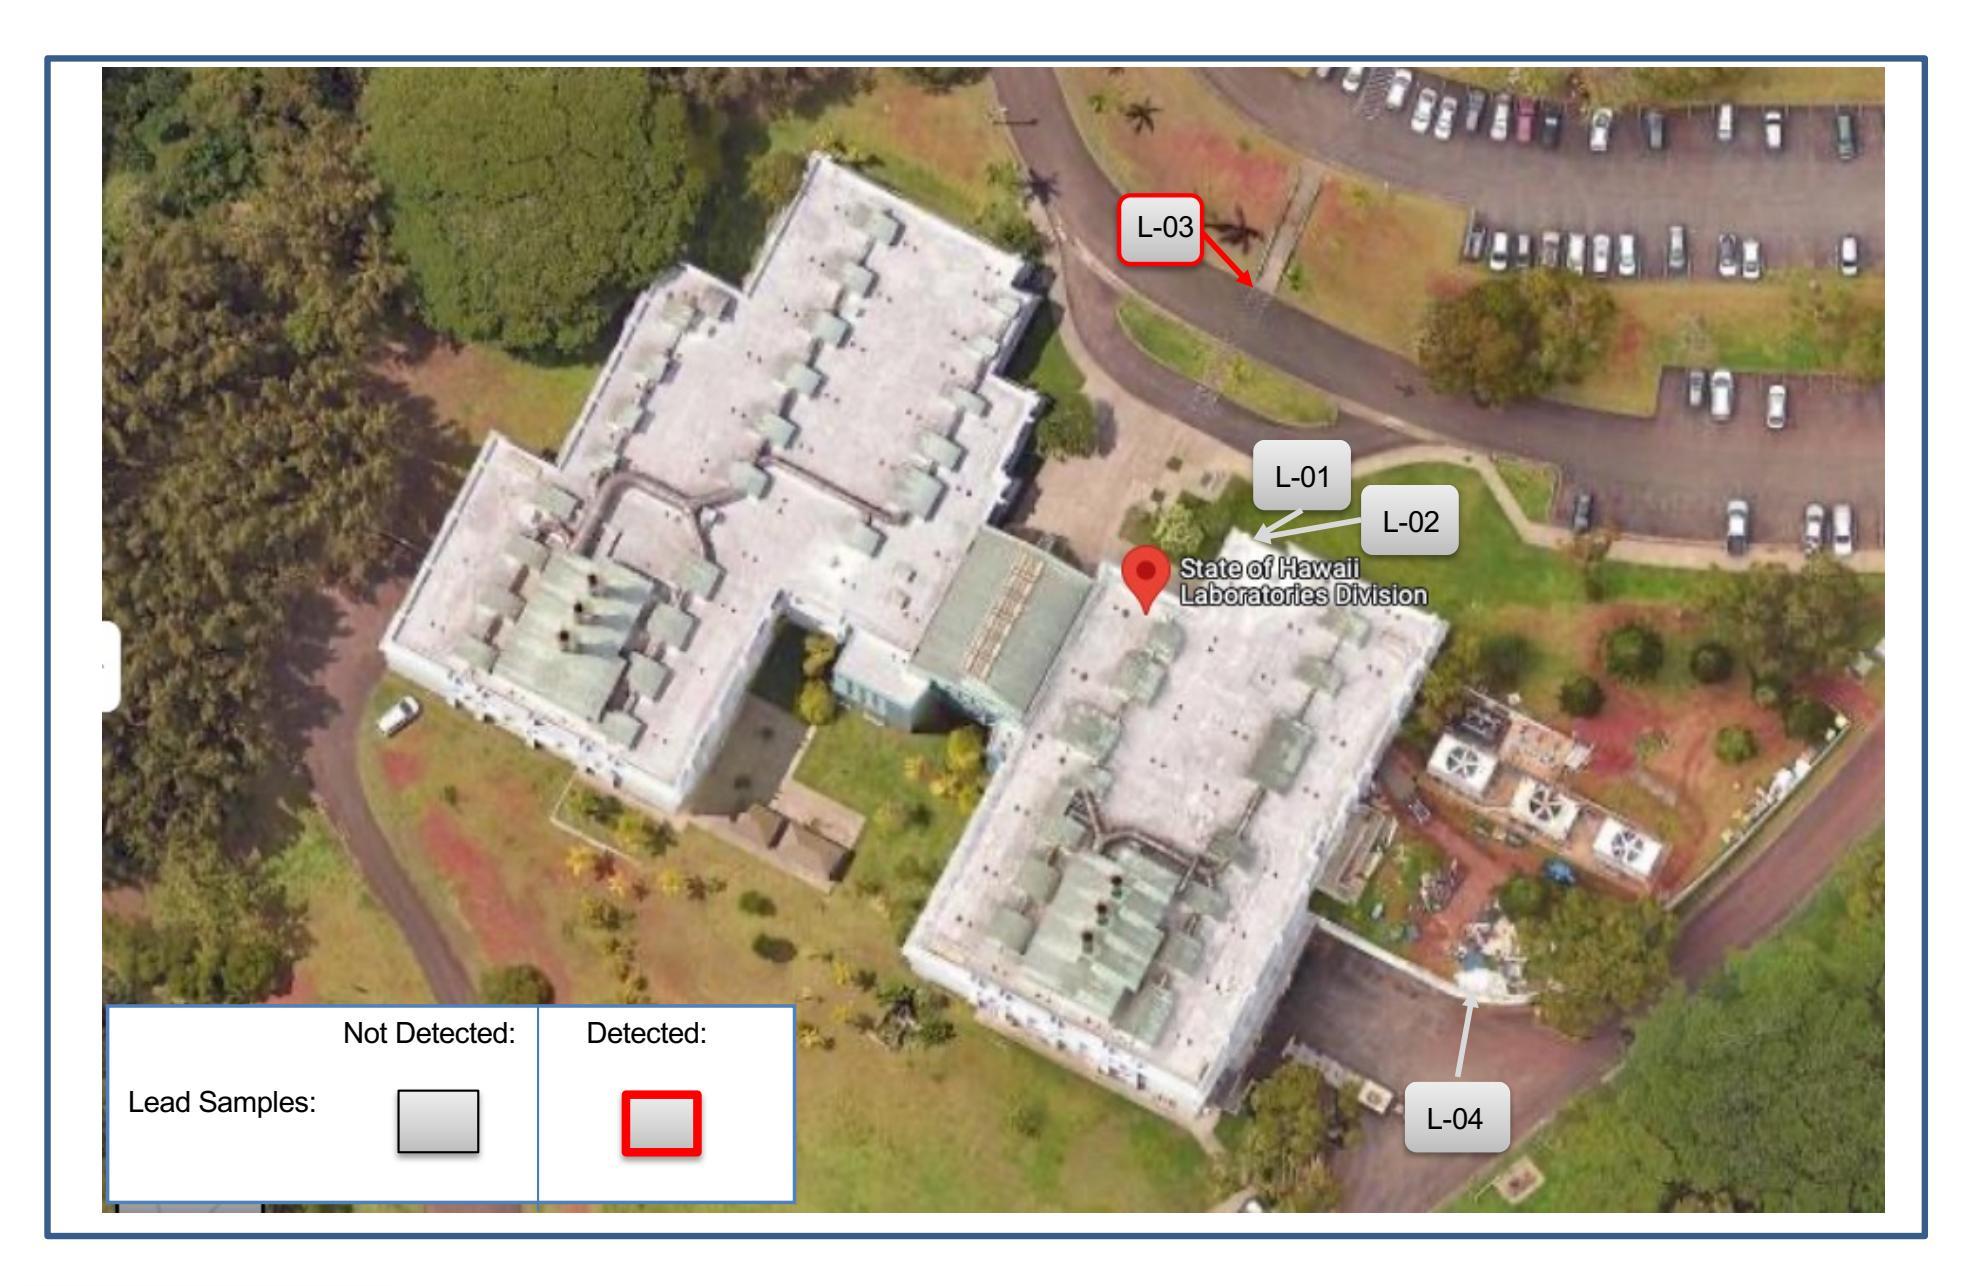
Figure 2

Sample Location Map 2725 Waimano Home Road Pearl City, Hawaii 96782
