**GEOTECHNICAL ENGINEERING EXPLORATION**  
**INTERSTATE ROUTE H-1 AND H-201**  
**DESTINATION SIGN UPGRADE/REPLACEMENT, PHASE 3**  
**FEDERAL-AID PROJECT NO. NH-0300(144)**  
**ISLAND OF OAHU, HAWAII**

**W.O. 7341-00    FEBRUARY 3, 2022**

**KSF, INC.**

**GEOLABS, INC.**  
Geotechnical Engineering and Drilling Services

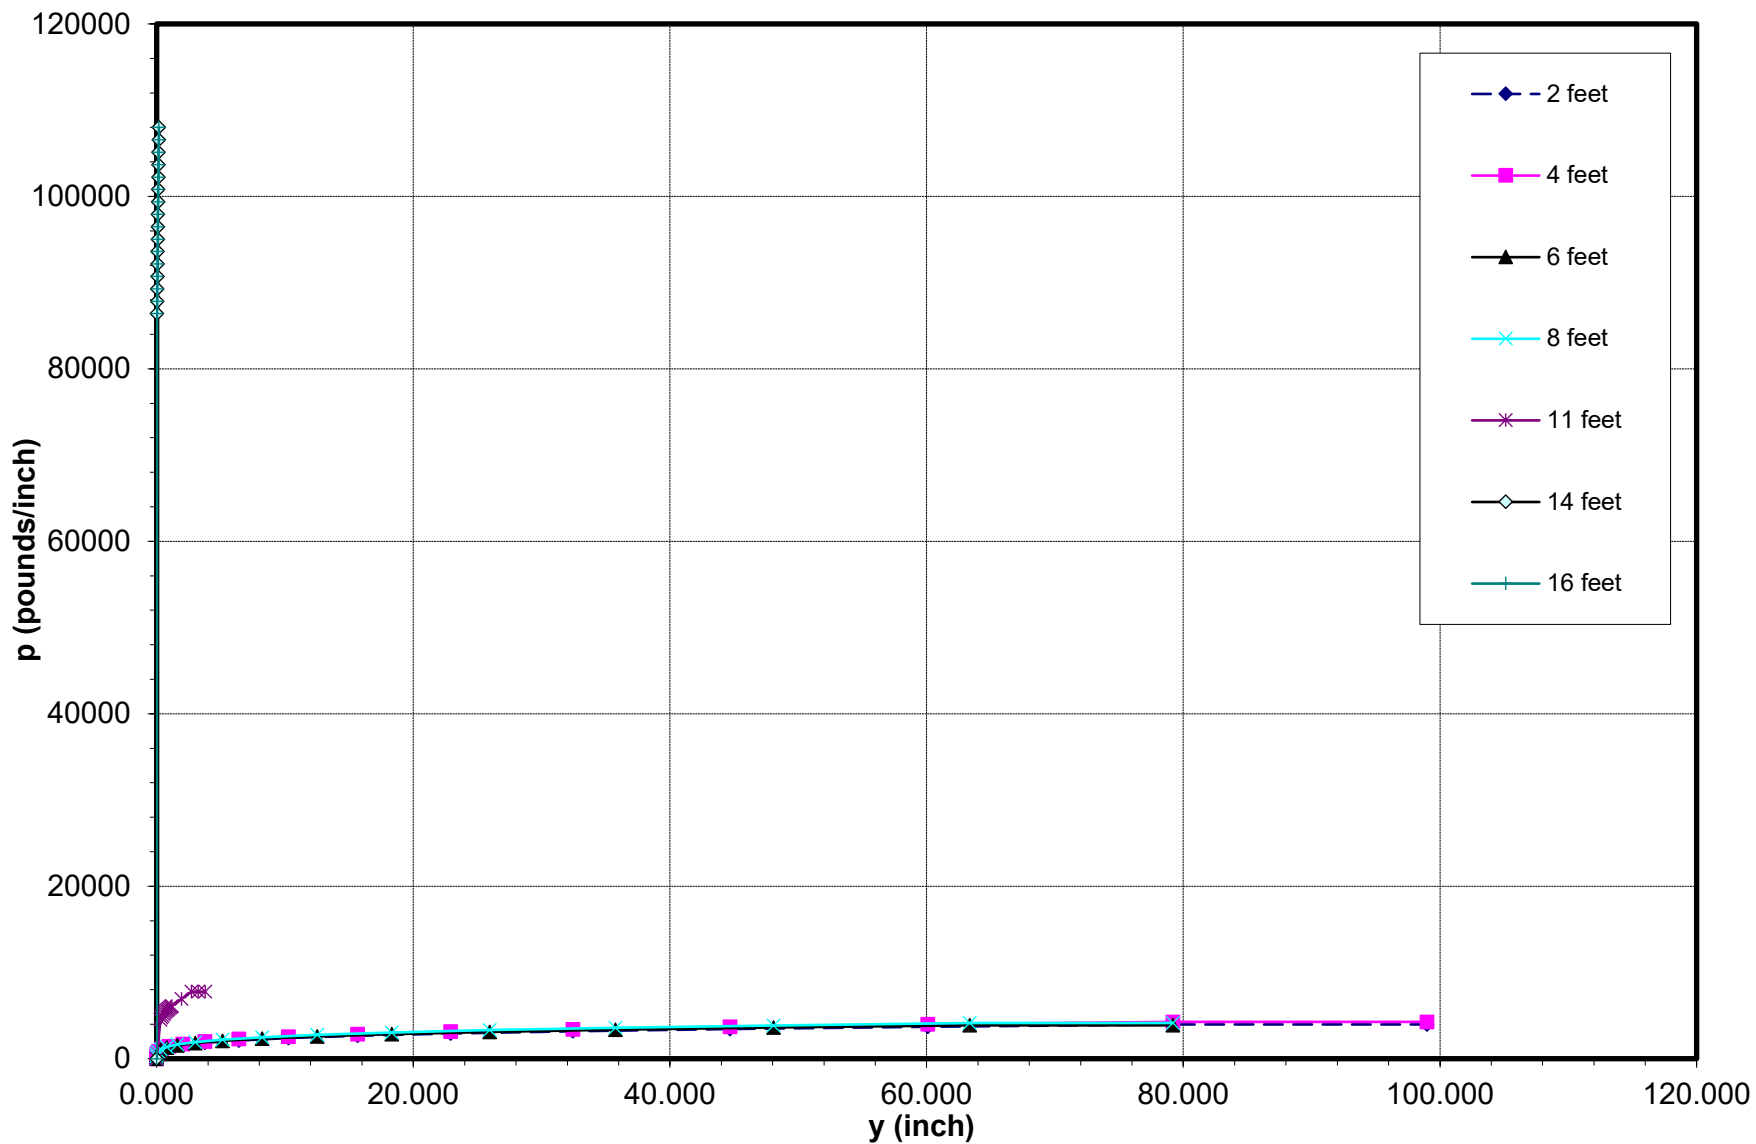
**SIGN H1EB-104 LATERAL LOAD ANALYSIS**  
**Interstate Route H-1 and H-201**  
**Destination Sign Upgrade/Replacement, Phase 3**  
**Island of Oahu, Hawaii**

P-Y Curves

In general, the sign structures may be subjected to torsional moments resulting in torsion on the drilled shaft foundations. Torsion may be resisted by the side shear along the drilled shaft surface and adjacent soils. Based on our analyses, we believe that the recommended diameter of drilled shafts extending to the depths recommended should be capable of resisting the torsional moment without significant movement of the foundations. It is our understanding that frequency analyses for modeling the foundation along with the structure for the two large cantilever signs structures under high torsional loads will be performed for Signs H1WB-421 and H1EB104. For the required analyses, “p-y” curves for the pile cap and the drilled shaft were estimated using the LPILE program for a composite pile with an upper pile section consisting of 7.5 feet by 7.5 feet by 5 feet thick with the top of the pile at 6 inches above the finish ground surface. The second pile section from the 5 feet below the top of the pile to the design bottom consists of a 72-inch diameter drilled shaft. Results of the generated non-linear “p-y” curves are summarized and present on Plates 3.1 through 4.2.

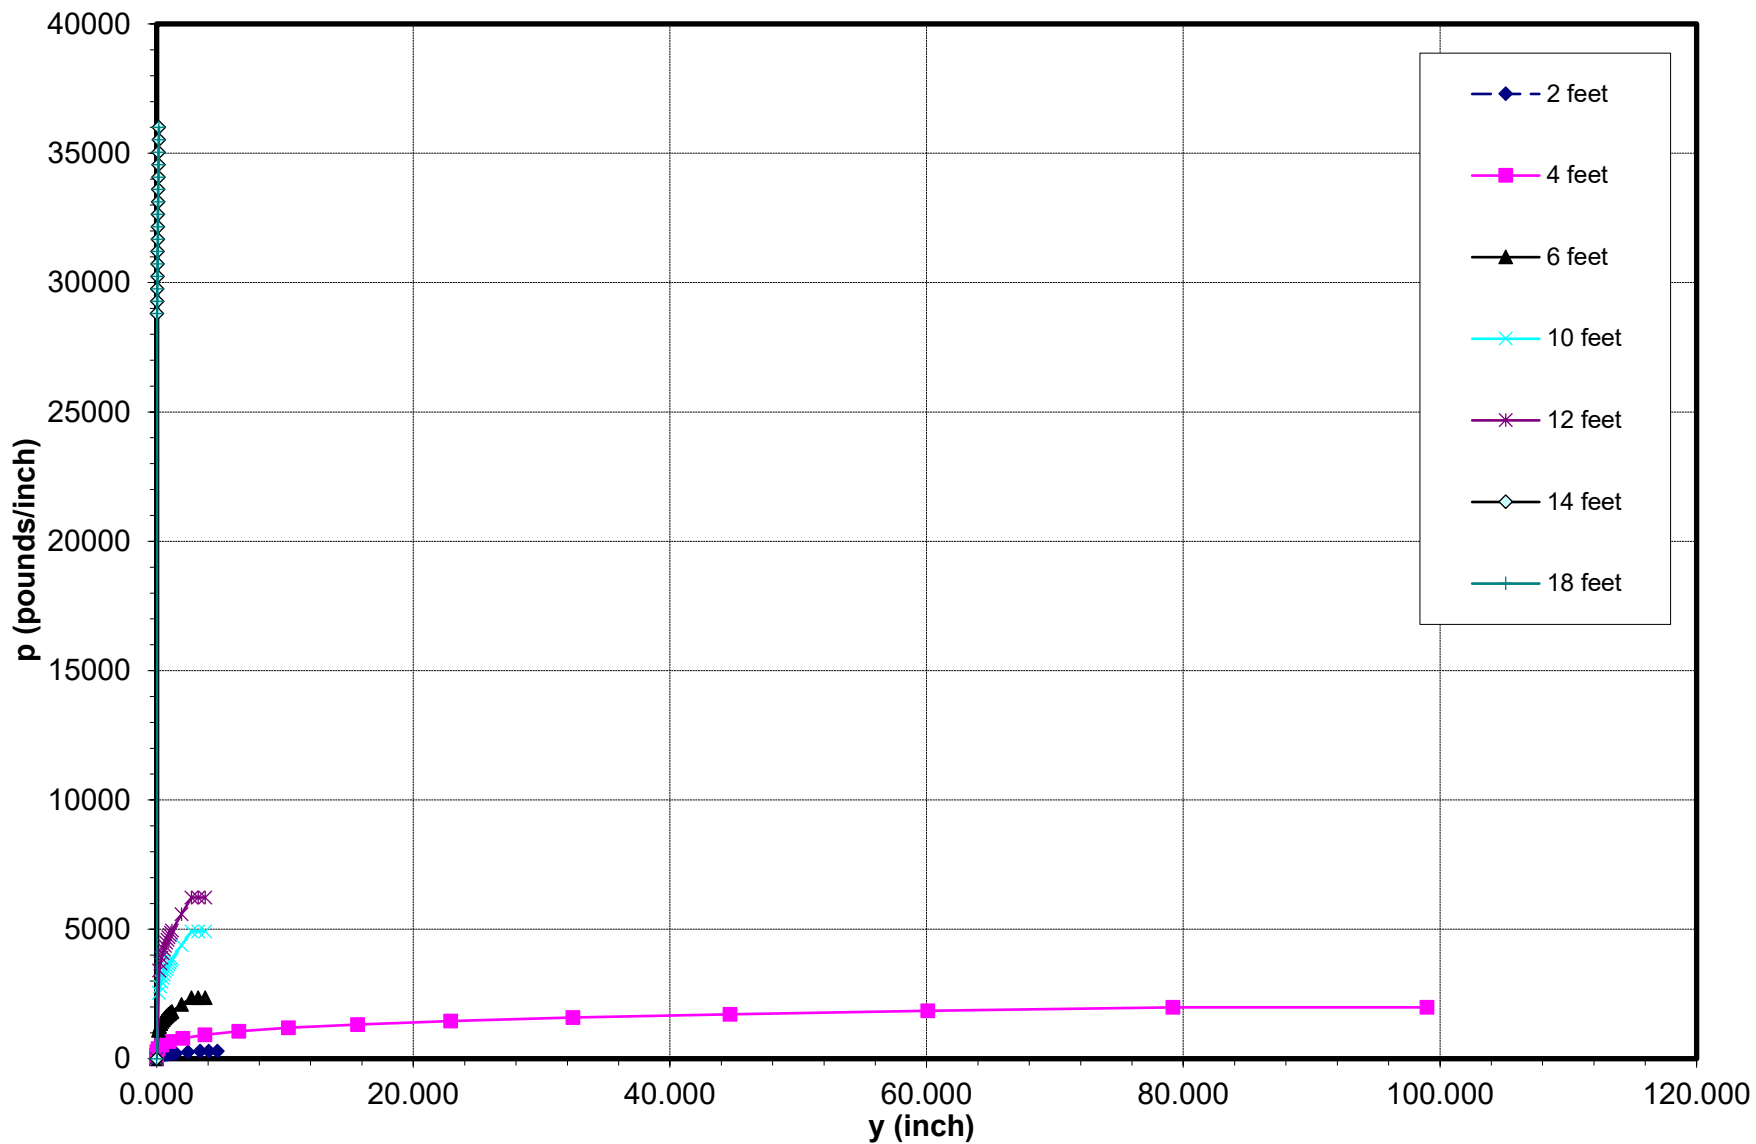
**SIGN H1EB-104 LATERAL LOAD ANALYSIS**  
**Interstate Route H-1 and H-201**  
**Destination Sign Upgrade/Replacement, Phase 3**  
**Island of Oahu, Hawaii**

P-Y Curves

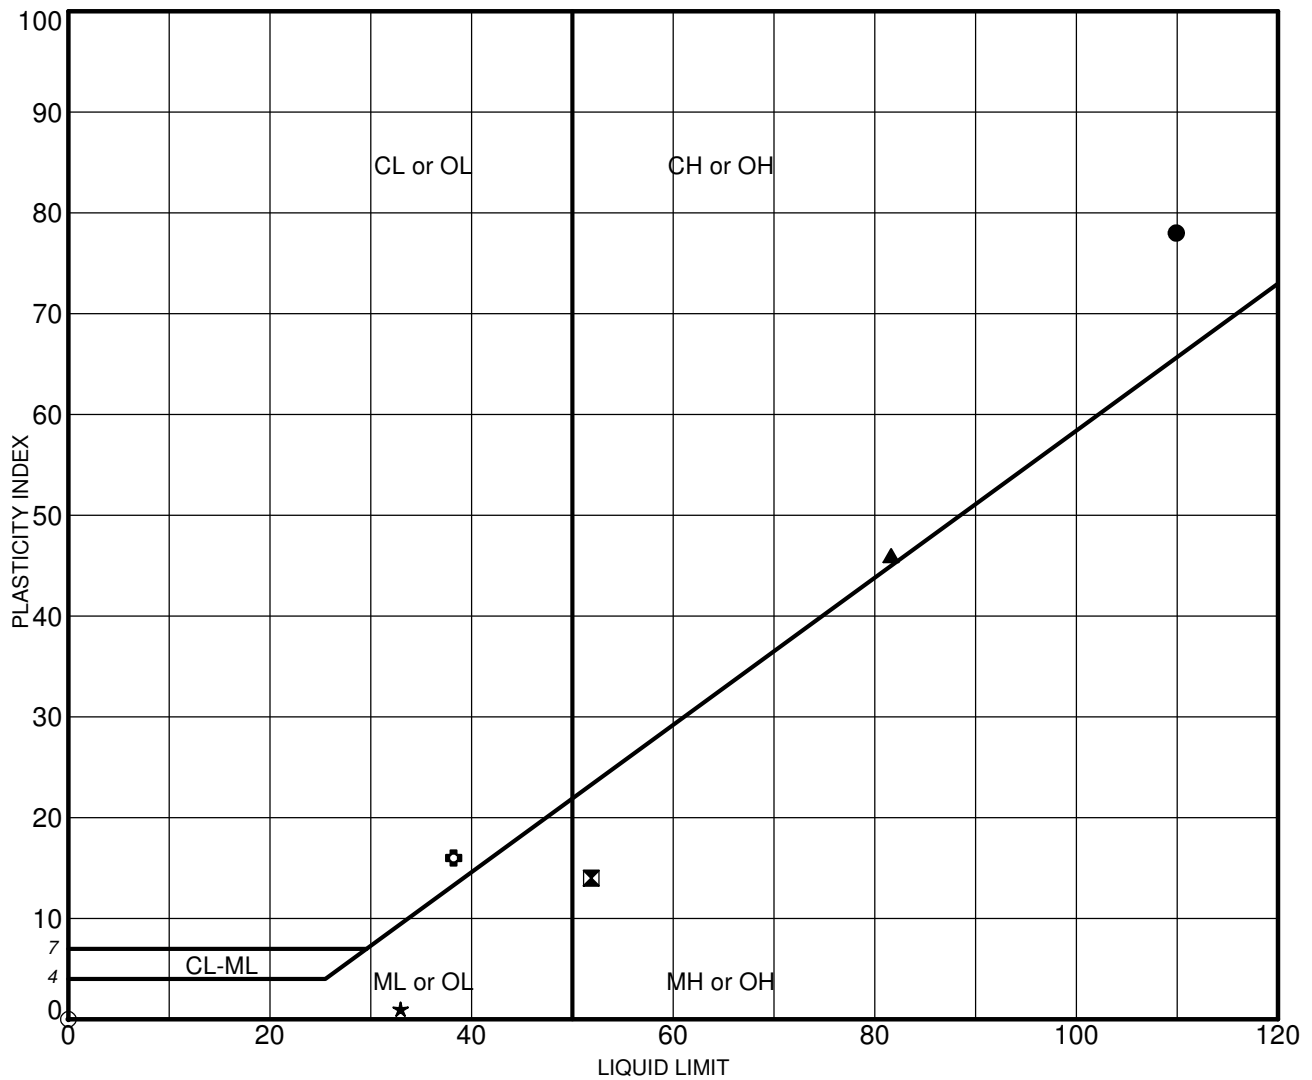
Plate  
**B - 1**

Sample	Depth (ft)	LL	PL	PI	Description
●	B-3	26.5-28.0	110	32	78	Gray with tan mottling silty clay (CH) with a little gravel
⊠	B-5	5.5-7.0	52	38	14	Reddish brown clayey silt (MH) with some decomposed gravel
▲	B-6	5.5-7.0	82	36	46	Brown silty clay (CH) with some sand and gravel
★	B-7	5.0-6.5	33	32	1	Brown sandy silt (ML) with some gravel
⊙	B-8	5.0-6.5	NP	NP	NP	Brown sandy silt
⊕	B-9	1.0-2.5	38	22	16	Reddish brown clayey sand (SC) with some gravel

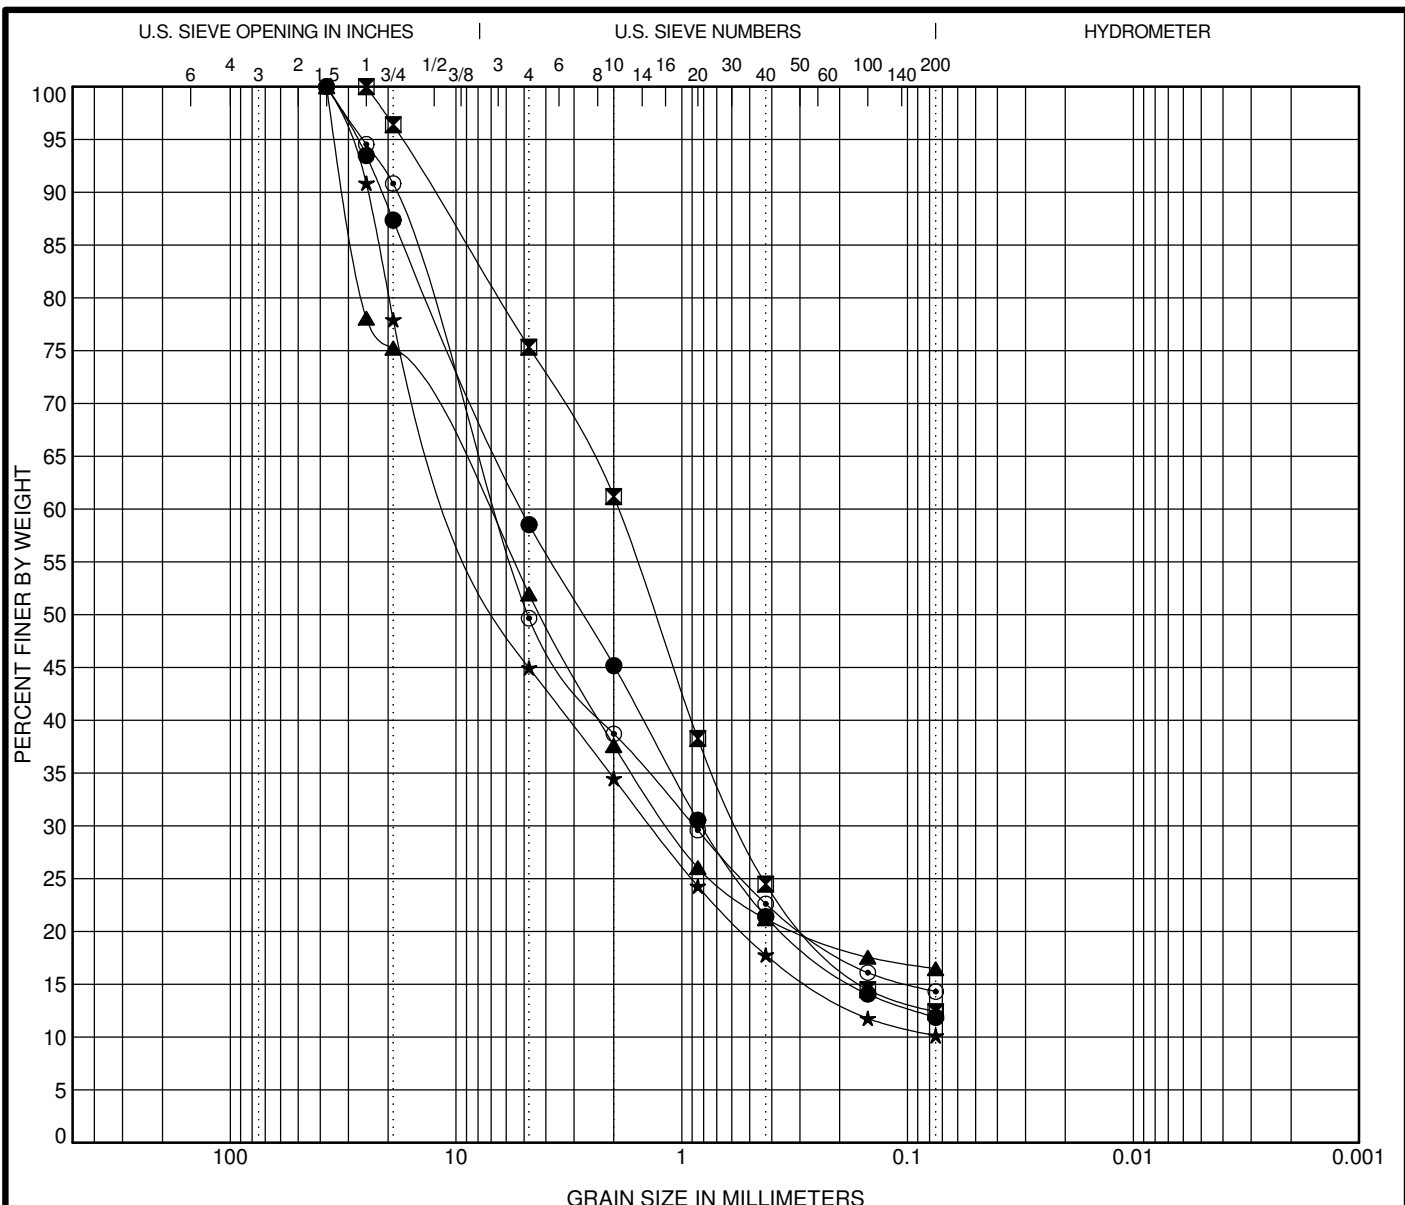
Sample	Depth (ft)	Description	LL	PL	PI	Cc	Cu
●	B-4	5.0-6.5				3.1	122.2
☒	B-7	15.0-16.5				4.8	56.2
▲	B-7	25.0-26.5					
★	B-8	15.0-16.5				3.0	125.4
◎	B-8	20.0-21.5

<b>GEOLABS, INC.</b> GEOTECHNICAL ENGINEERING	<b>GRAIN SIZE DISTRIBUTION - ASTM D6913</b> INTERSTATE ROUTE H-1 AND H-201 DESTINATION SIGN UPGRADE/ REPLACEMENT, PHASE 3 FAP NO. NH-0300 (144) ISLAND OF OAHU, HAWAII		Plate <b>B - 2</b>
	W.O. 7341-00

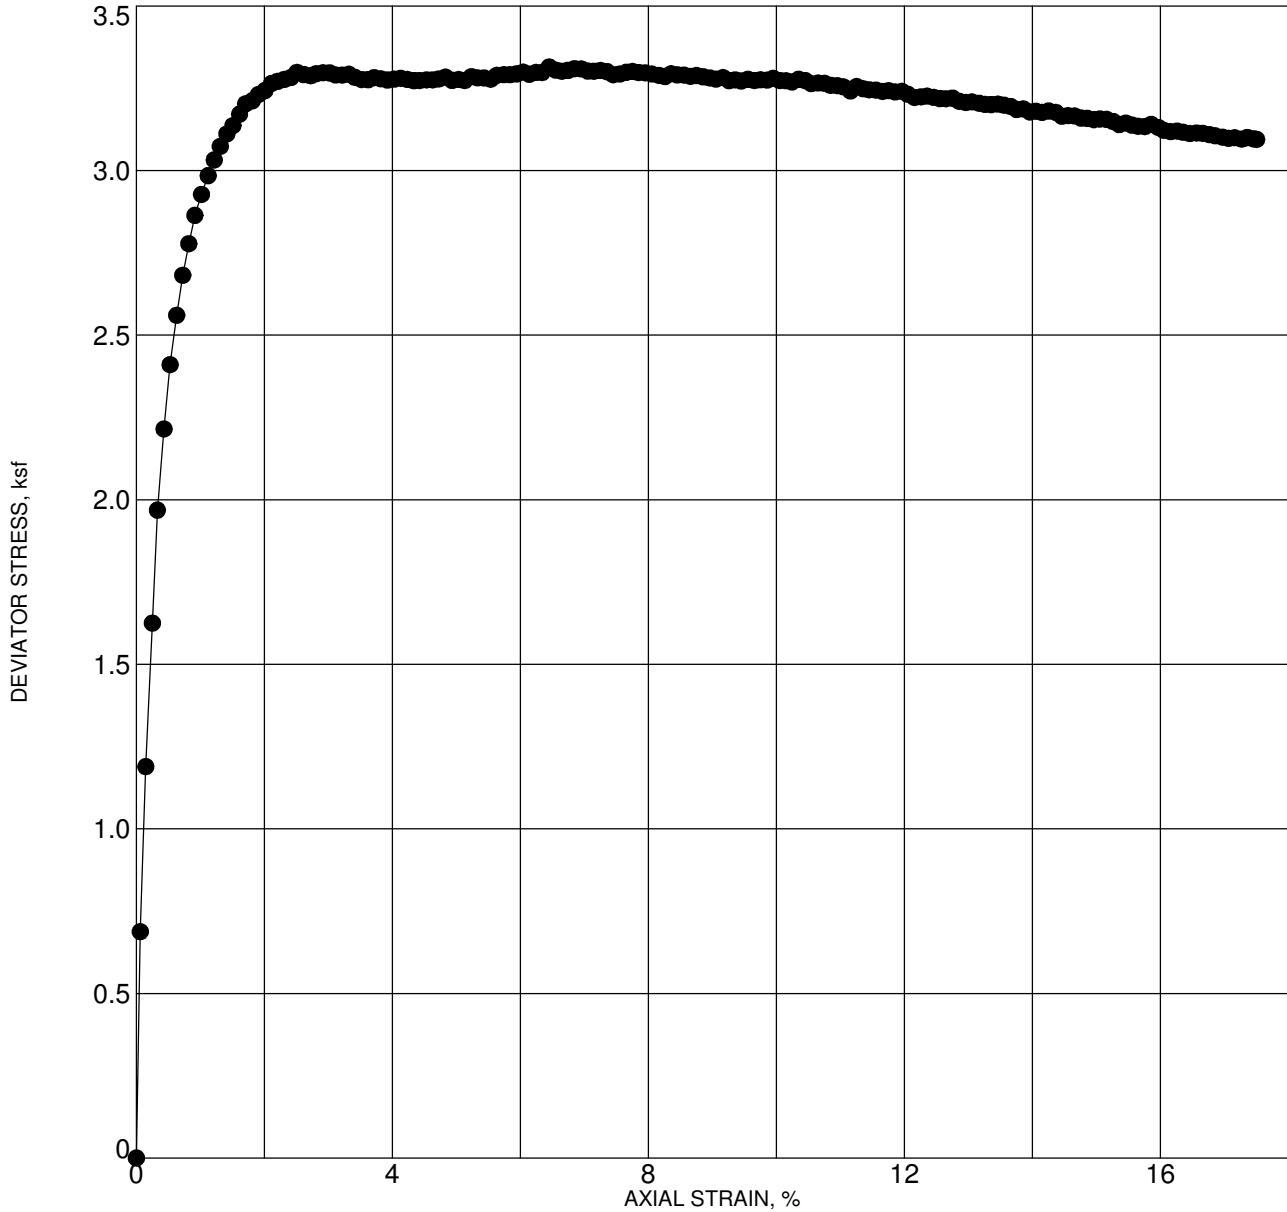
Plate  
**B - 5**

Max. Deviator Stress (ksf):	3.2
Confining Stress (ksf):	0.6

Location: B-3  
 Depth: 5.5 - 7.0 feet  
 Description: Dark brown silty clay  
 Test Date: 5/25/2018

Five Unconsolidated Undrained Triaxial Compression tests (ASTM D2850) were performed on selected soil samples to evaluate the undrained shear strength of the soils. The undrained shear strength test results along with the shear stress-strain curves are presented on Plates B-5 through B-9.

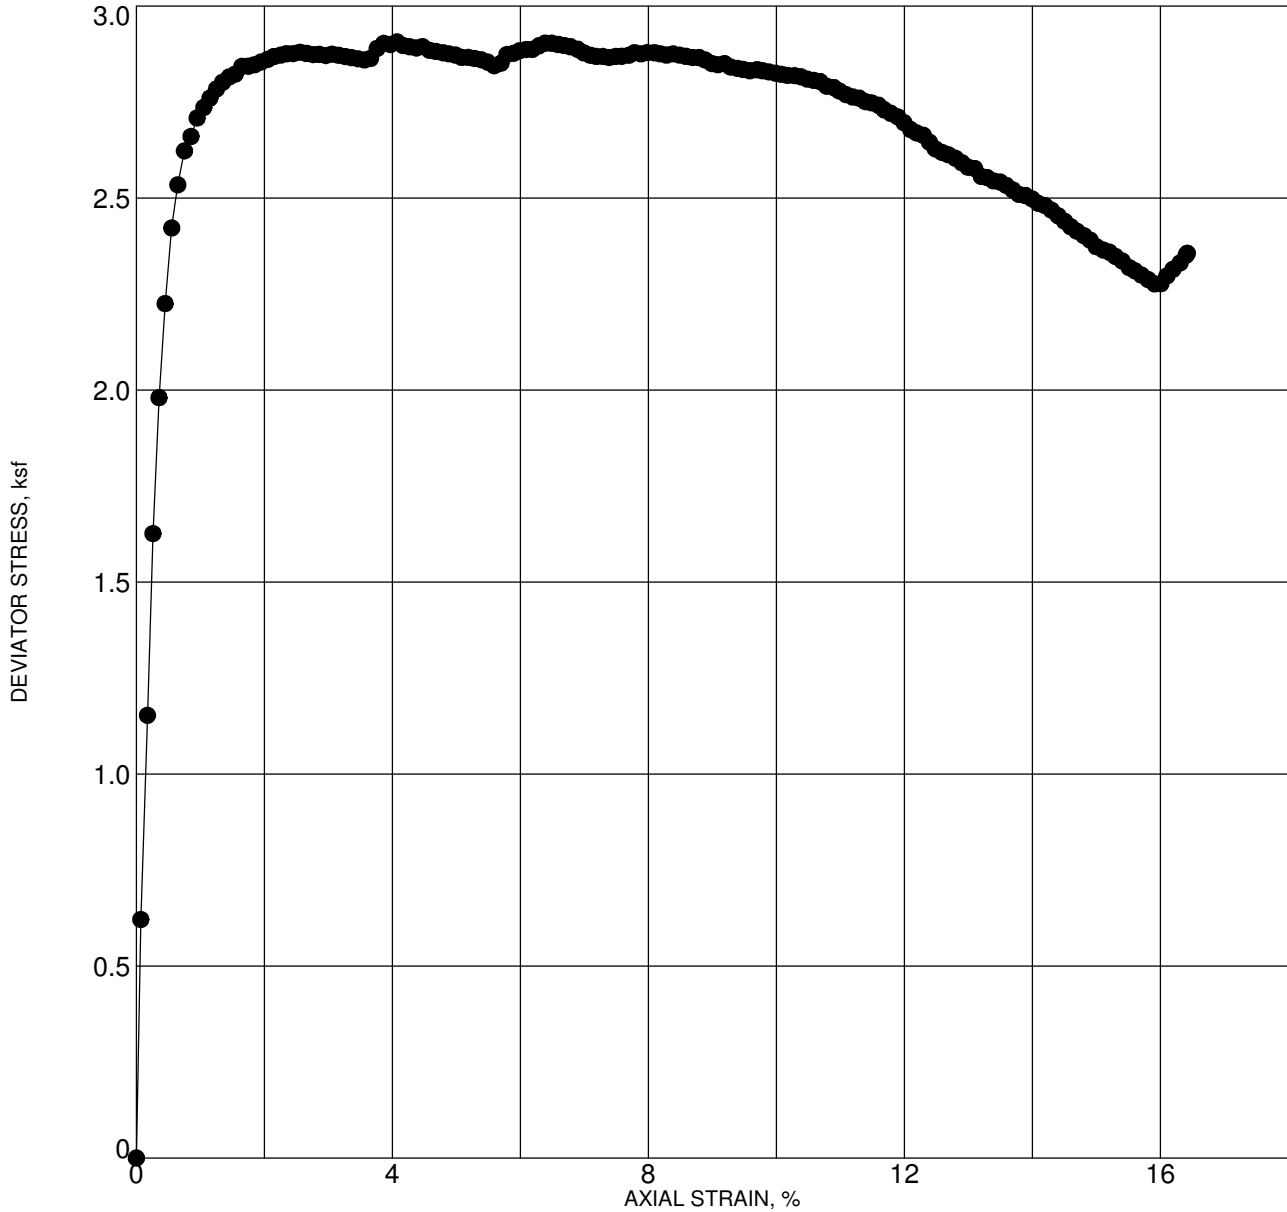
Plate  
**B - 6**

Max. Deviator Stress (ksf):	2.9
Confining Stress (ksf):	2.5

Location: B-3  
 Depth: 26.5 - 28.0 feet  
 Description: Gray with tan mottling silty clay (CH) with a little gravel  
 Test Date: 5/25/2018

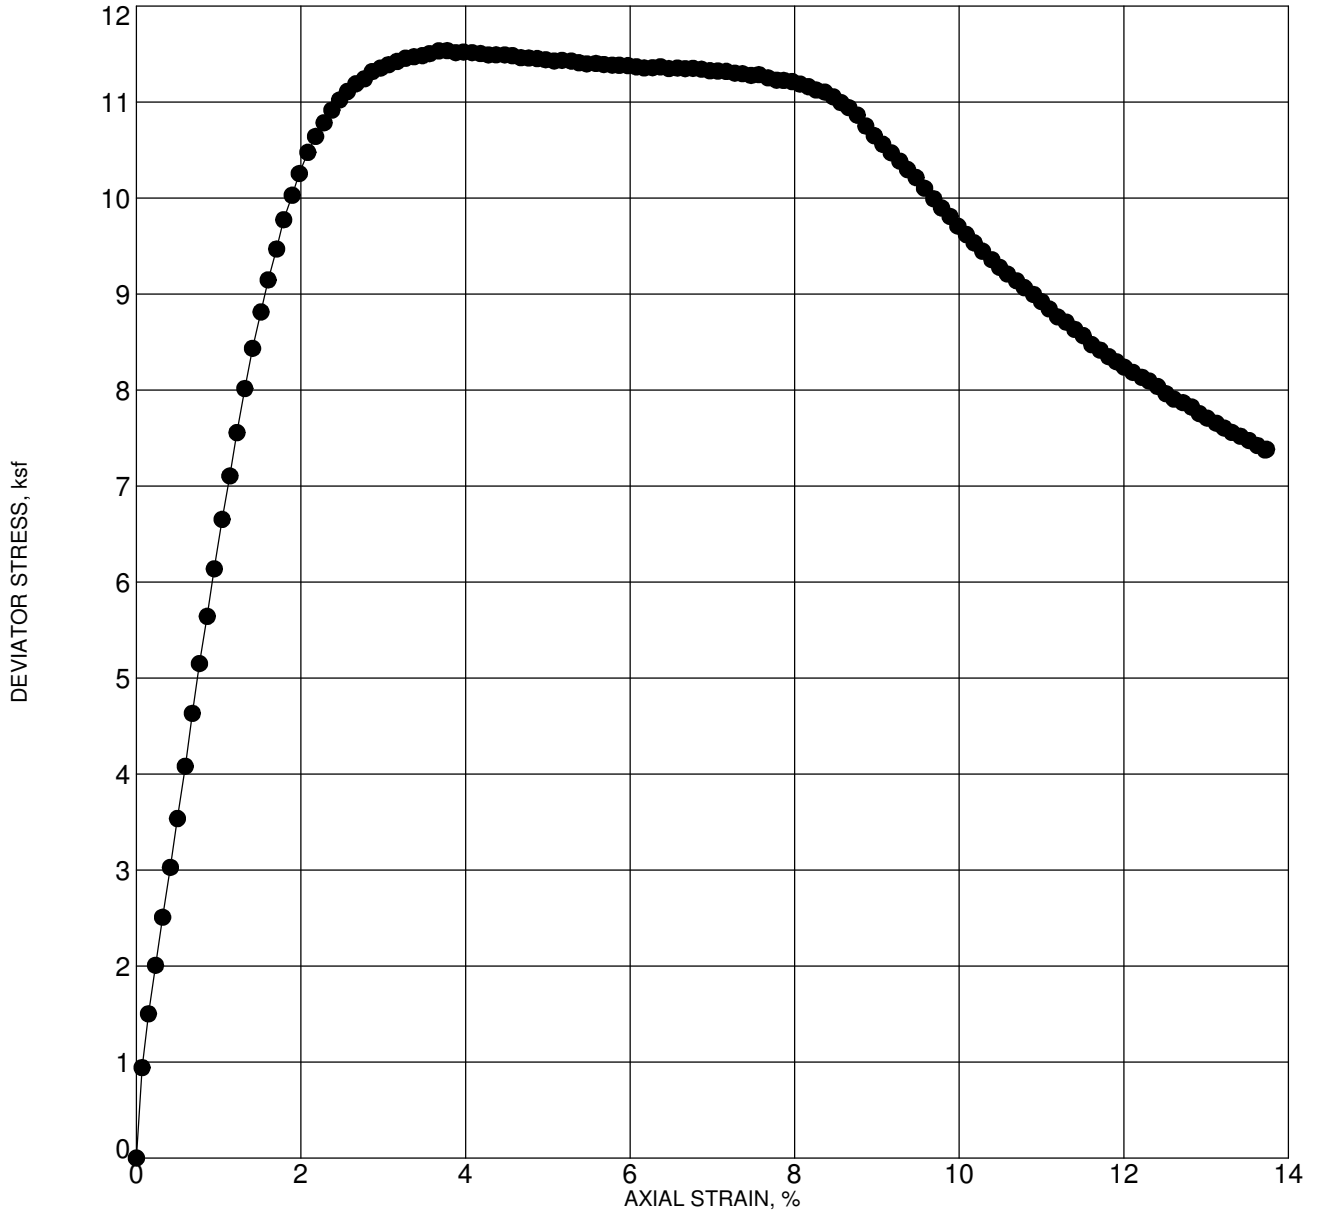
Plate  
**B - 7**

Max. Deviator Stress (ksf):	11.5
Confining Stress (ksf):	2.0

Location: B-4  
 Depth: 16.5 - 18.0 feet  
 Description: Dark brown silty clay with some decompose gravel  
 Test Date: 5/25/2018

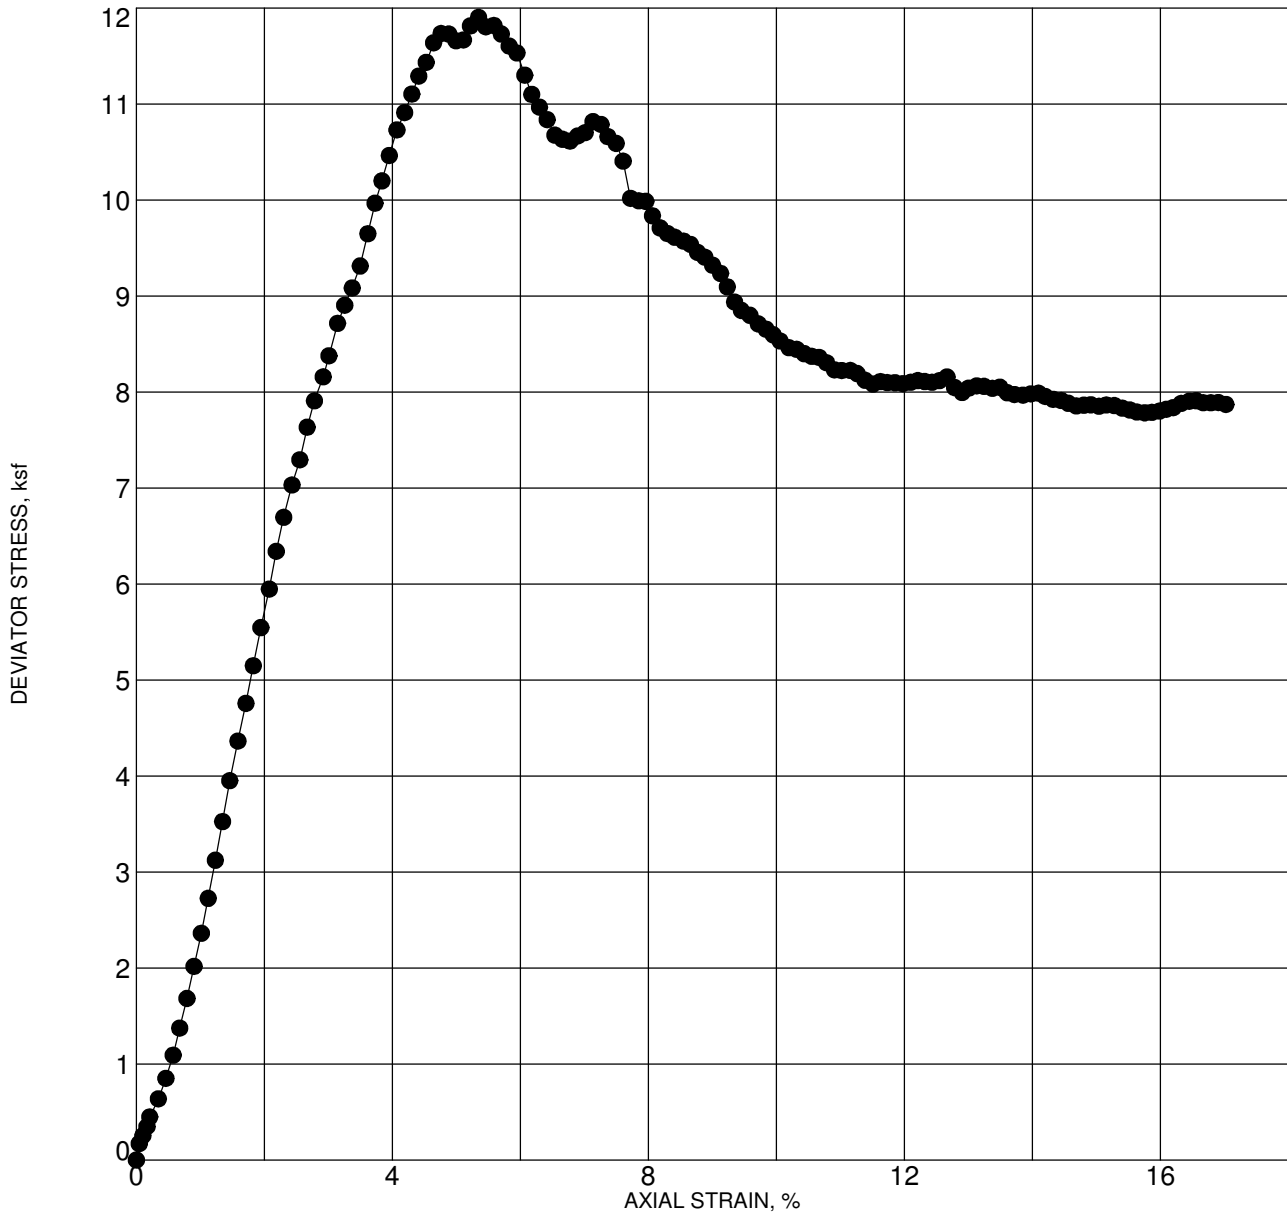
Max. Deviator Stress (ksf):	11.9
Confining Stress (ksf):	0.5

Location: B-7  
 Depth: 5.0 - 6.5 feet  
 Description: Brown sandy silt (ML) with some gravel  
 Test Date: 1/18/2022

<b>GEOLABS, INC.</b> GEOTECHNICAL ENGINEERING	<b>TRIAXIAL UU COMPRESSION TEST - ASTM D2850</b>	
	W.O. 7341-00	INTERSTATE ROUTE H-1 AND H-201 DESTINATION SIGN UPGRADE/ REPLACEMENT, PHASE 3 FAP NO. NH-0300 (144) ISLAND OF OAHU, HAWAII	
			Plate <b>B - 8</b>

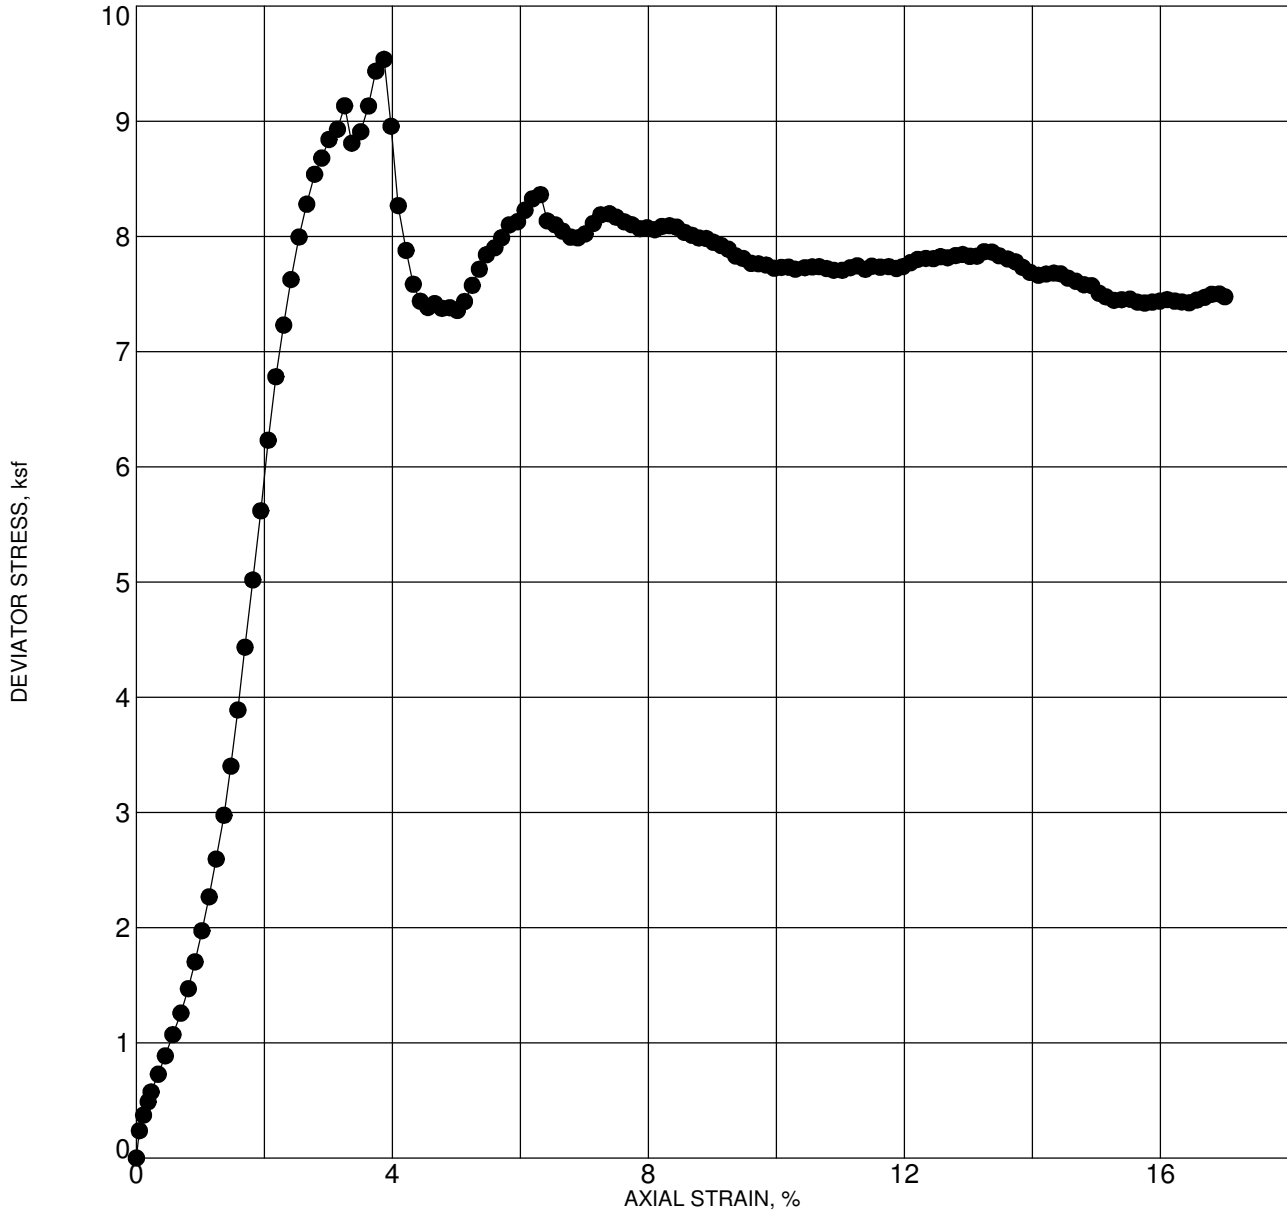
Max. Deviator Stress (ksf):	9.5
Confining Stress (ksf):	0.5

Location: B-8  
 Depth: 5.0 - 6.5 feet  
 Description: Brown sandy silt  
 Test Date: 1/19/2022
