EnviroQuest

August 21, 2024

Subject: Limited Lead Paint Sampling  
Nanue Bridge  
Hawaii County, Hawaii

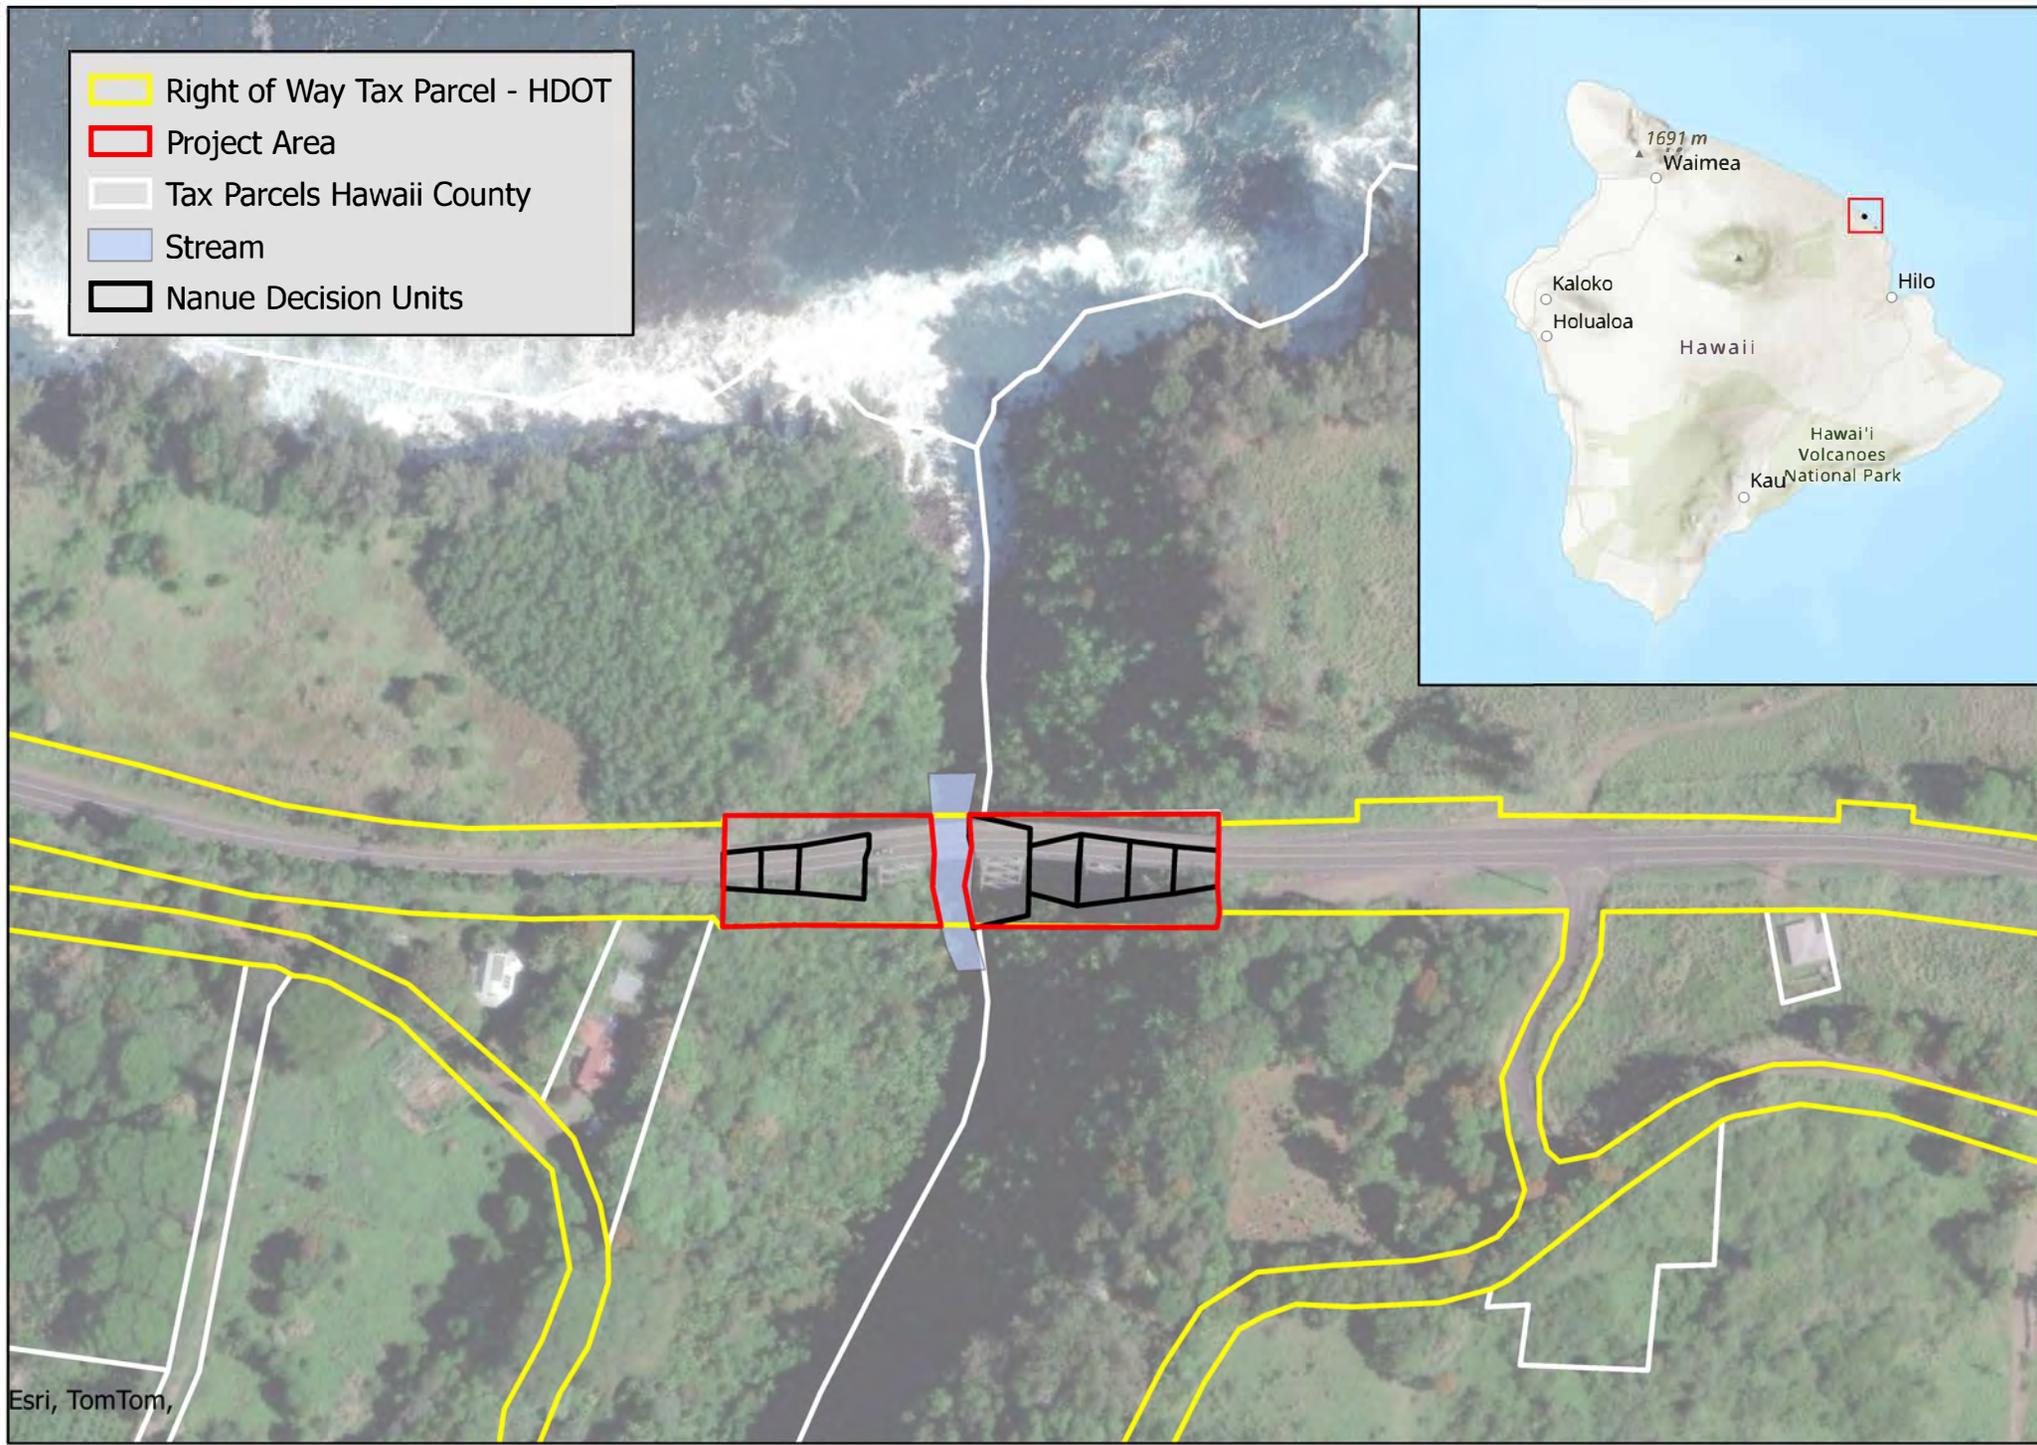
Figure 1  
Nanue Bridge Sample Area  
Nanue Stream Bridge, Hawaii County, HI

Figure 1 identifies the general site area of Nanue Bridge, and Figure 2 identifies the sample locations. The sample IDs (DU2, DU3, etc.) correspond to decision units from the Spring 2024 EQI soil sample site investigation at Nanue Bridge.

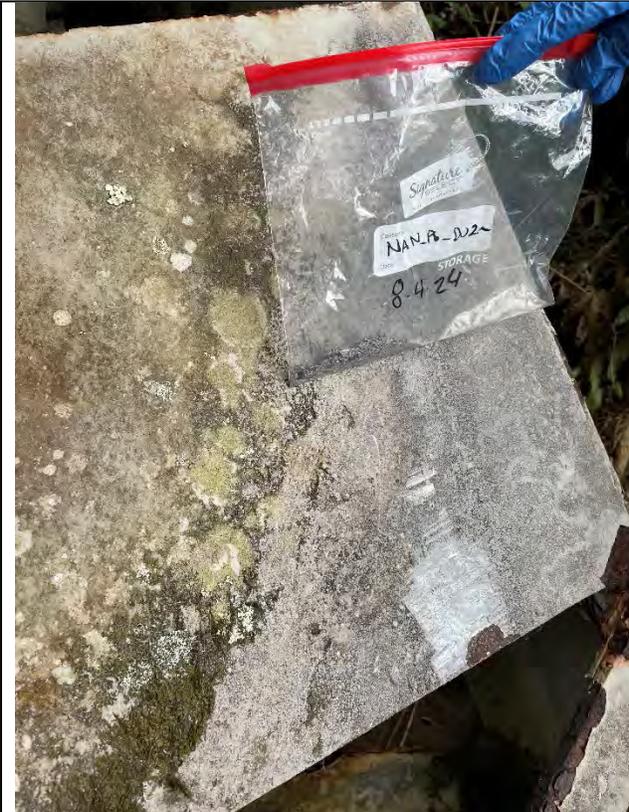
Sample NAN\_PB\_DU2a

Sample No.	Sample Location/Description	Result (wt. %)	LBP <sub>1</sub> (Y/N)	LCP <sub>2</sub> (Y/N)
NAN_Pb_DU2a	N. Embankment, DU2, eastern support girder	0.14	N	Y
NAN_Pb_DU2b	N. Embankment, DU2, middle	0.041	N	Y
NAN_Pb_DU2c	N. Embankment, DU2, western support	0.021	N	Y
NAN_Pb_DU3a	N. Embankment, DU3, middle	0.0087	N	Y
NAN_Pb_DU3b	N. Embankment, DU3, western beam	0.066	N	Y
NAN_Pb_DU9	S. Embankment, DU9, southeastern footing	0.019	N	Y
NAN_Pb_DU10a	S. Embankment, DU10, southeastern footing	0.094	N	Y
NAN_Pb_DU10a2	S. Embankment, DU10, southwestern footing	0.047	N	Y
NAN_Pb_DU10b	S. Embankment, DU10, northeastern footing	0.055	N	Y
NAN_Pb_DU10b2	S. Embankment, DU10, northwestern footing	0.031	N	Y

Prior to the disturbance of any LCP, the contractor's employees disturbing the painted materials must be informed that it contains lead and must conduct all lead paint disturbance work in accordance with Occupational Safety and Health Administration (OSHA) 29 CFR 1926.62 *Lead*.

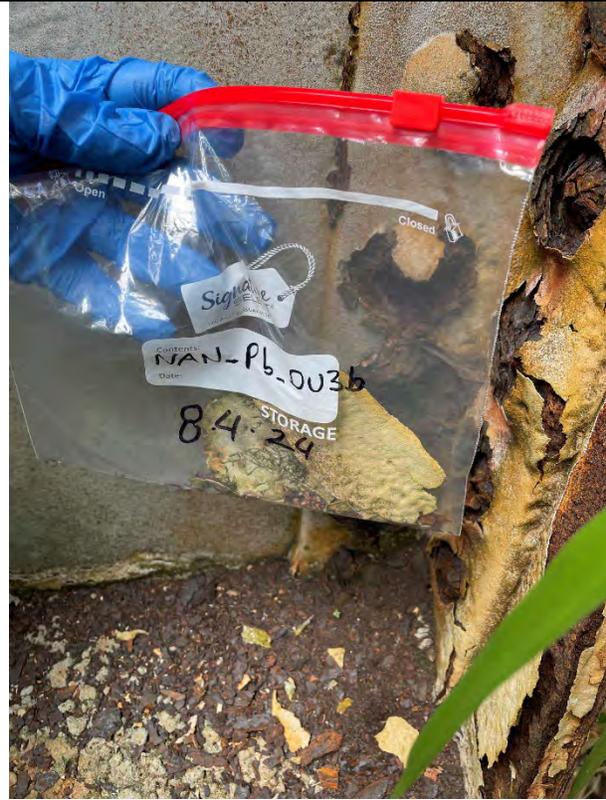
Sample NAN\_PB\_DU3b

Sample No.	Your Sample ID / Description	Results	Units	Date Analyzed
202454285	NAN_Pb_DU3b	0.066	wt %	8/7/2024
Comments

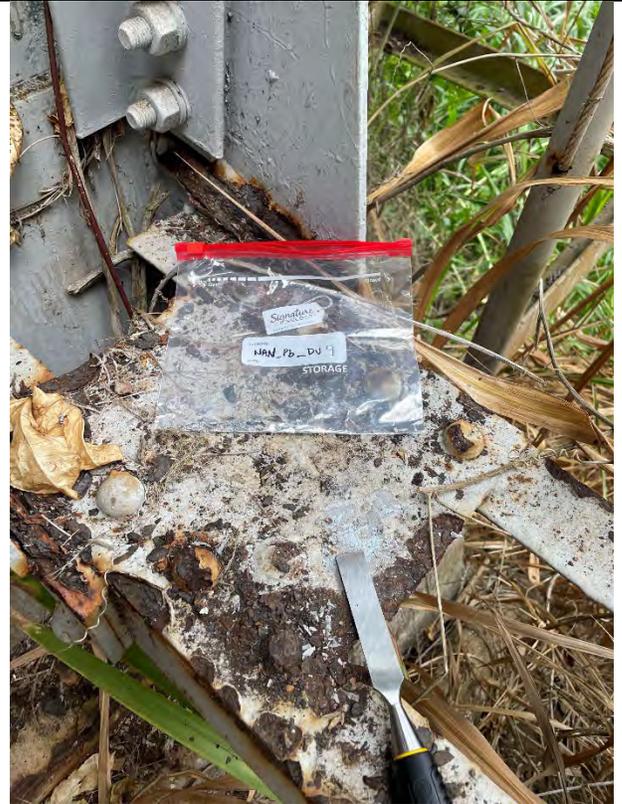
Sample NAN\_PB\_DU9a

Sample No.	Your Sample ID / Description	Results	Units	Date Analyzed
202454276	NAN_Pb_DU9	0.019	wt %	8/7/2024
Comments				
202454277	NAN_Pb_DU10a	0.094	wt %	8/7/2024
Comments				
202454278	NAN_Pb_DU10a2	0.047	wt %	8/7/2024
Comments				
202454279	NAN_Pb_DU10b	0.055	wt %	8/7/2024
Comments				
202454280	NAN_Pb_DU10b2	0.031	wt %	8/7/2024
Comments				
202454281	NAN_Pb_DU2a	0.14	wt %	8/7/2024
Comments				
202454282	NAN_Pb_DU2b	0.041	wt %	8/7/2024
Comments				
202454283	NAN_Pb_DU2c	0.021	wt %	8/7/2024
Comments				
202454284	NAN_Pb_DU3a	0.0087	wt %	8/7/2024
Comments
