**STATE OF HAWAII
DEPARTMENT OF TRANSPORTATION**

**ADDENDUM NO. 2
FOR
HAWAII BELT ROAD
NANUE STREAM BRIDGE REHABILITATION
VICINITY OF HILO
DISTRICT OF HILO, ISLAND OF HAWAII
FEDERAL-AID PROJECT NO. BR-019-2(077)**

December 13, 2024

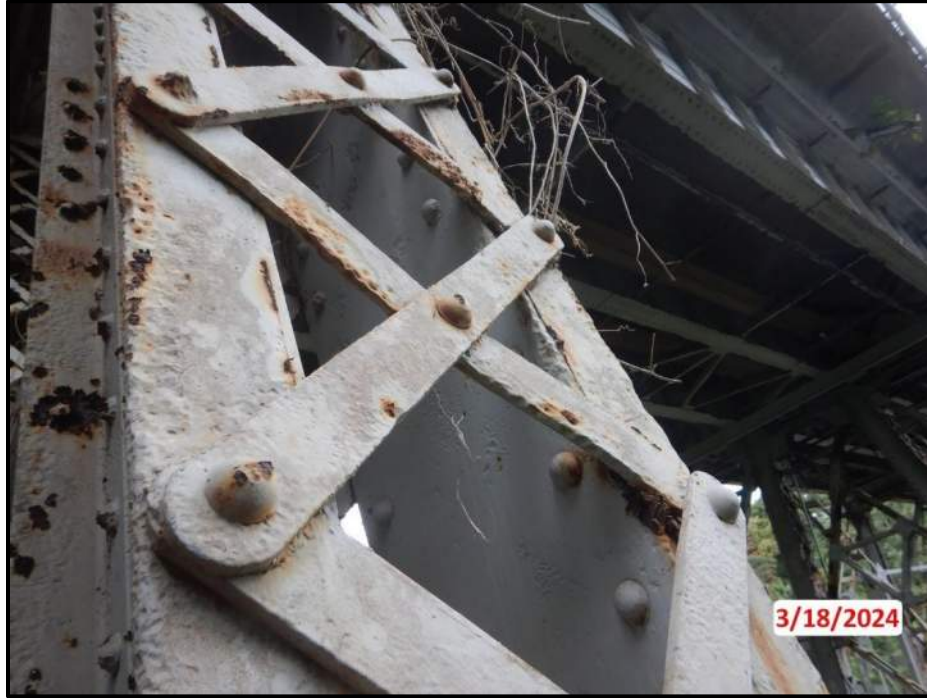
Photograph 9. Bent 1, Level 1, lower section, Column A, looking northwest. Typical pitting, pack rust and laminar corrosion, CS3.

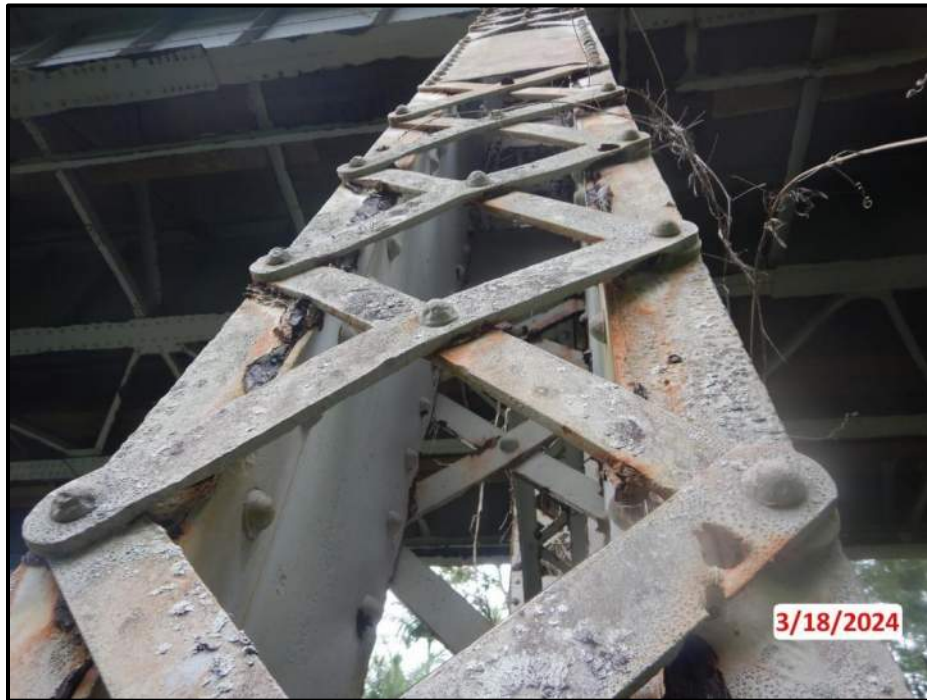
Photograph 10. Bent 1, Level 1, lower section, Column D, west face, lacing bars, looking east. (2) with corrosion holes, up to 2" diameter, CS3.

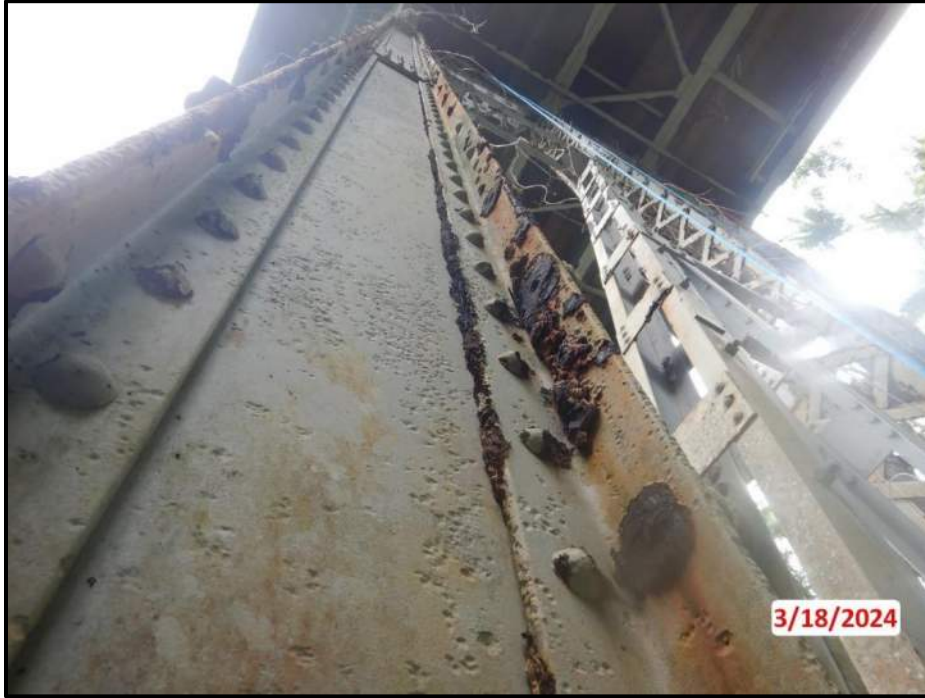
Photograph 11. Bent 1, Level 1, Column D, south face, looking north. Scattered rivets with up to 100% section loss, CS3.

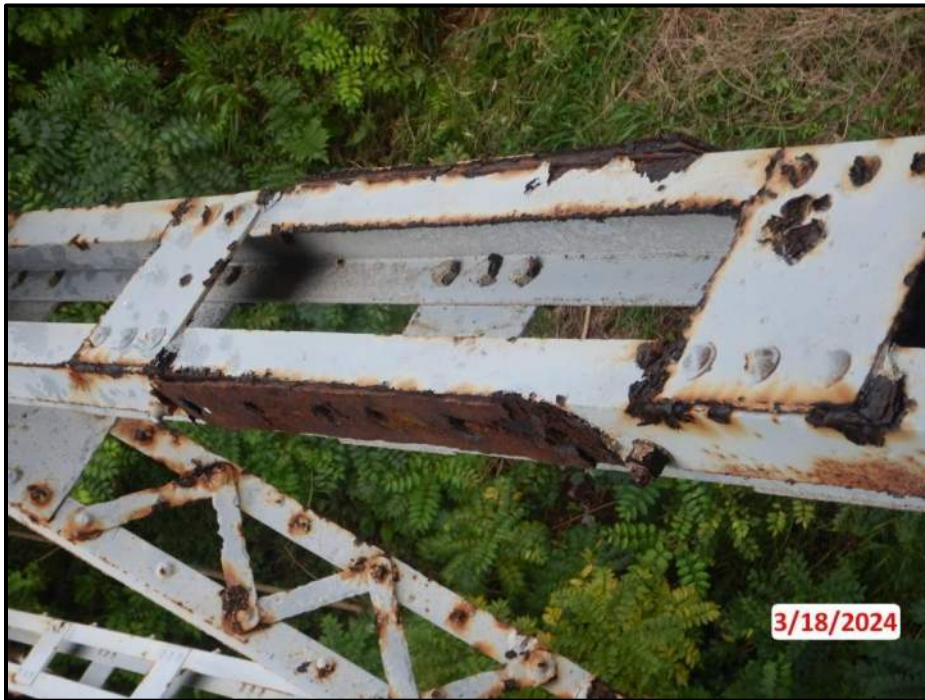
Photograph 12. Bent 2, Level 1, upper section, between Columns A and B, diagonal bracing, both cover plates at mid-length, looking north. Pack rust up to 3/4" thick causing separation of plate and one broken rivet on both cover plates, CS3.

Defect ID	Caption
6	Bent 2, Level 1, upper section, between Columns A and B, diagonal bracing, both cover plates at mid-length: Pack rust up to 3/4" thick causing separation of plate and one broken rivet on both cover plates, CS3, (See Photo 12).
7	Bent 2, Level 1, upper section, between Columns B and C, horizontal bracing, west face, lacing bars: (3) with 50% section loss and (1) with 90% section loss, CS3, (See Photo 13).
8	Bent 2, Level 1, upper section, Column C, west face, (1) lacing bar: (1) area of 90% section loss, CS3, (Similar to Photo 55).
9	Bent 2, Level 1, upper section, Column D, west face, (2) lacing bars: Completely severed with areas of laminar corrosion and pack rust throughout, CS3, (Similar to Photo 55).
10	Bent 2, Level 1, lower section, between Columns B and C, upper west diagonal bracing near Column C, north angle: 3" L x up to 1" W area of 100% section loss, CS3, (Similar to Photo 116).

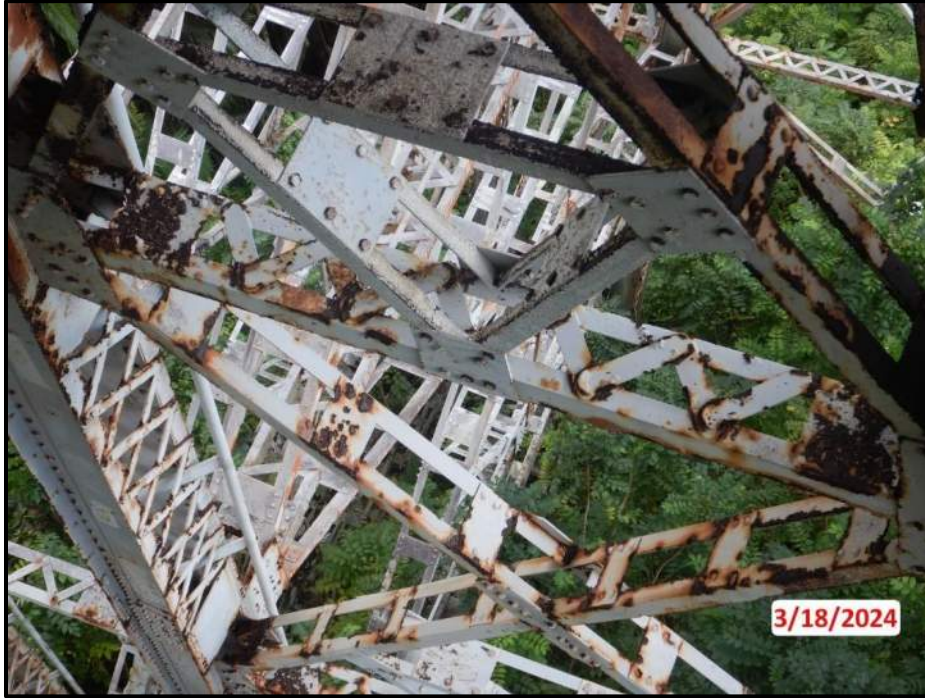
Photograph 13. Bent 2, Level 1, upper section, between Columns B and C, horizontal bracing, west face, lacing bars, looking north. (3) with 50% section loss and (1) with 90% section loss, CS3.

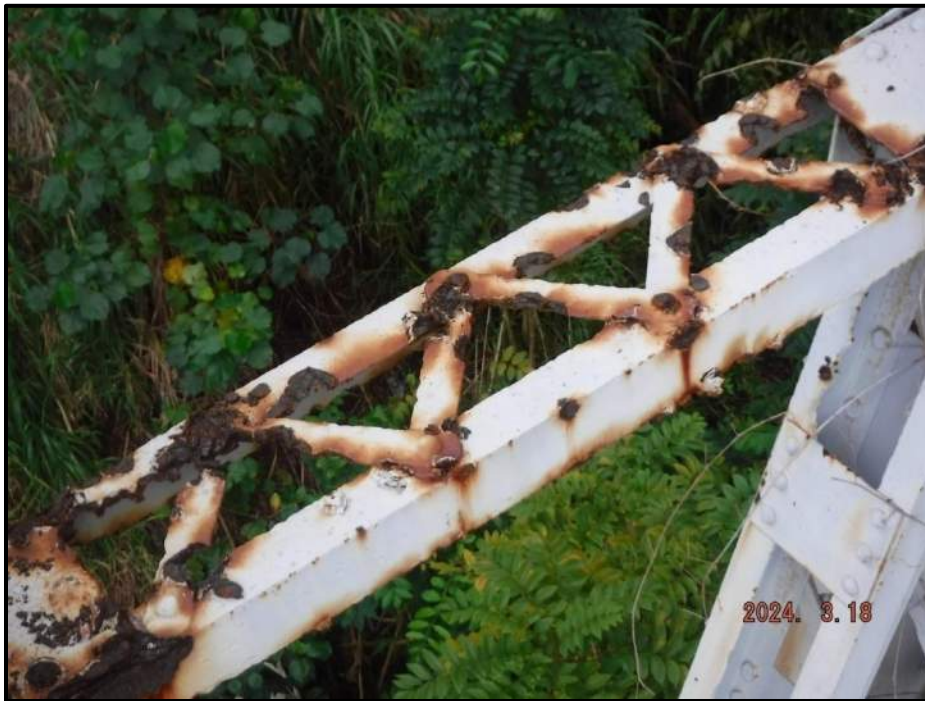
Photograph 14. Bent 2, Level 1, lower section, between Columns A and B, horizontal bracing, south face of angle, looking north. 1' 8" L x 1" H area of up to 100% section loss, with (3) lacing bars up to 75% section loss. The south angle has approximately 30% section loss near Column A. Angle original section is 3" x 4-1/2", remaining is 1-1/2" x 3-3/4", CS3.

11	Bent 2, Level 1, lower section, between Columns C and D, diagonal bracing near Column C, (2) batten plates: (3) of (6) rivet heads with up to 80% section loss, CS3, (Similar to Photo 17).
12	Bent 2, Level 1, lower section, between Columns B and C diagonals, mid-horizontal bracing: Members have 1" knife-edging typical along entire length, CS3, (Similar to Photo 41).
13	Bent 2, Level 1, lower section, Column C, cover plate: Up to 2" diameter corrosion holes, CS3, (Similar to Photo 79).
14	Bent 2, Level 1, lower section, between Columns B and C, horizontal and diagonal bracing, south face, adjacent to Column B: Knife edging and holes in flanges throughout, CS3, (Similar to Photo 50).
15	Bent 2, Level 1, lower section, between Columns A and B, horizontal bracing, south face of angle: 1' 8" L x 1" H area of up to 100% section loss, with (3) lacing bars up to 75% section loss. The south angle has approximately 30% section loss near Column A. Angle original section is 3" x 4-1/2", remaining is 1-1/2" x 3-3/4", CS3, (See Photo 14).

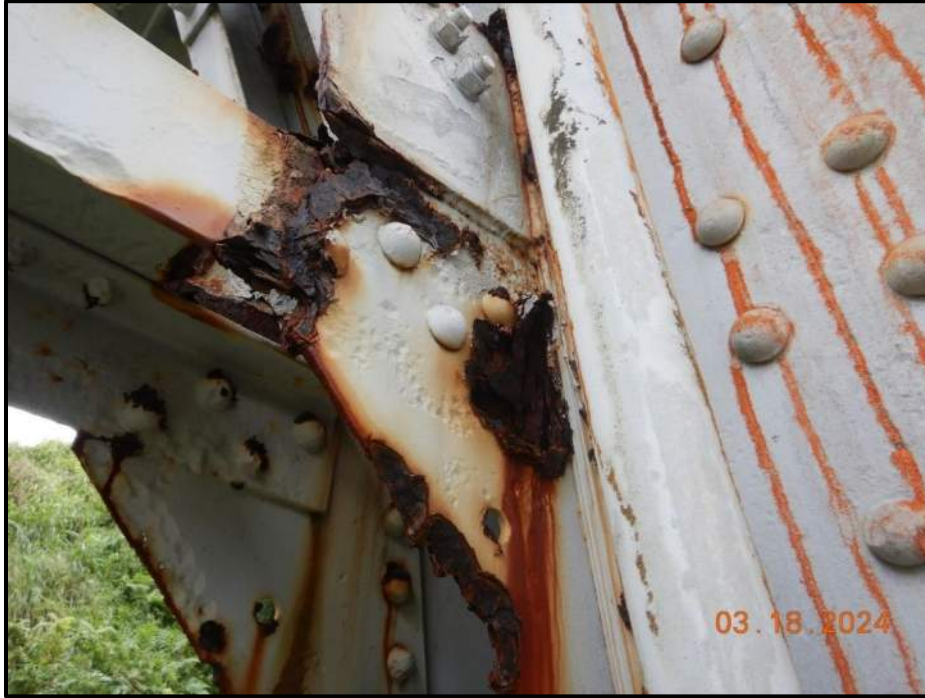
Photograph 15. Bent 2, Level 1, lower section, Column D, lower horizontal gusset plate, looking south. Laminar corrosion up to 100% section loss with knife edging, painted over pitting, and 4" corrosion hole, CS3.

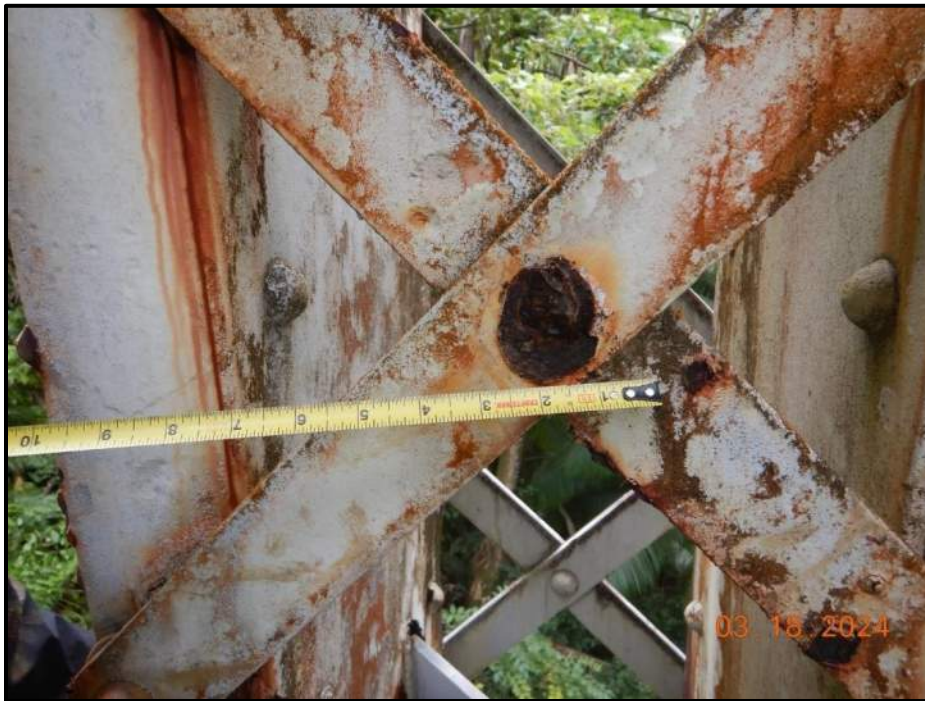
Photograph 16. Bent 2, Level 2, Column D, 7' from Level 1, east face, lacing bar, center rivet head, looking west. 100% section loss, CS3.

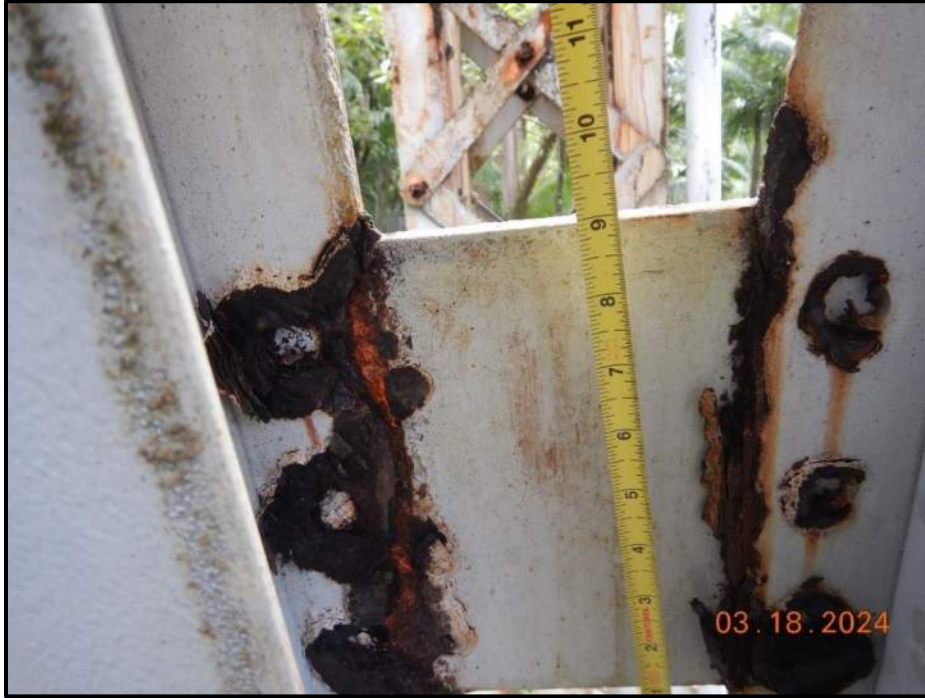
Photograph 17. Bent 2, Level 2, between Columns C and D, diagonal bracing, near short horizontal, batten plate, interior rivet heads, looking west. All have 100% section loss, CS3.

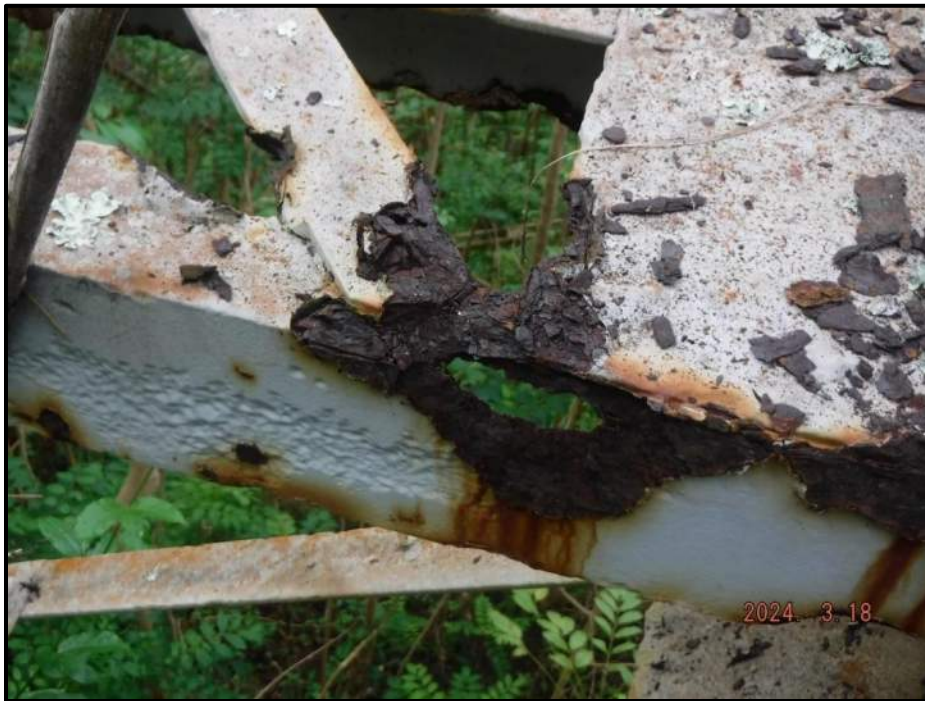
Photograph 18. Bent 2, Level 2, between Columns B and C, horizontal bracing near Column B, along flanges, looking north. Knife-edging with up to 1-1/2" L x 1" W corrosion holes, CS3.

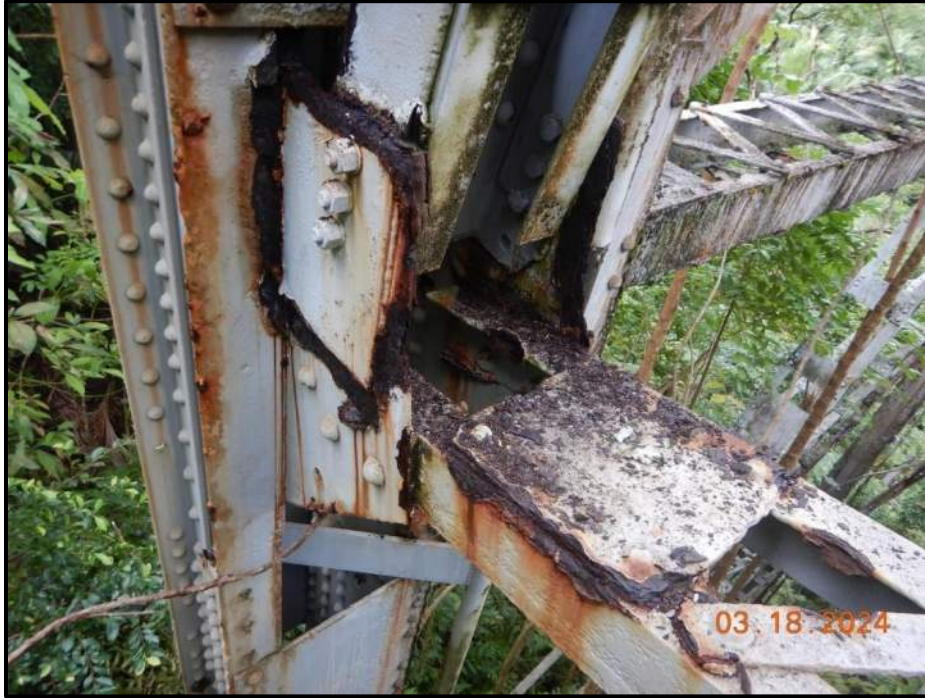
Photograph 19. Bent 2, Level 2, east of Column D, horizontal and diagonal bracing gusset plates, looking northwest. Typical heavy laminar corrosion and knife edging, CS3.

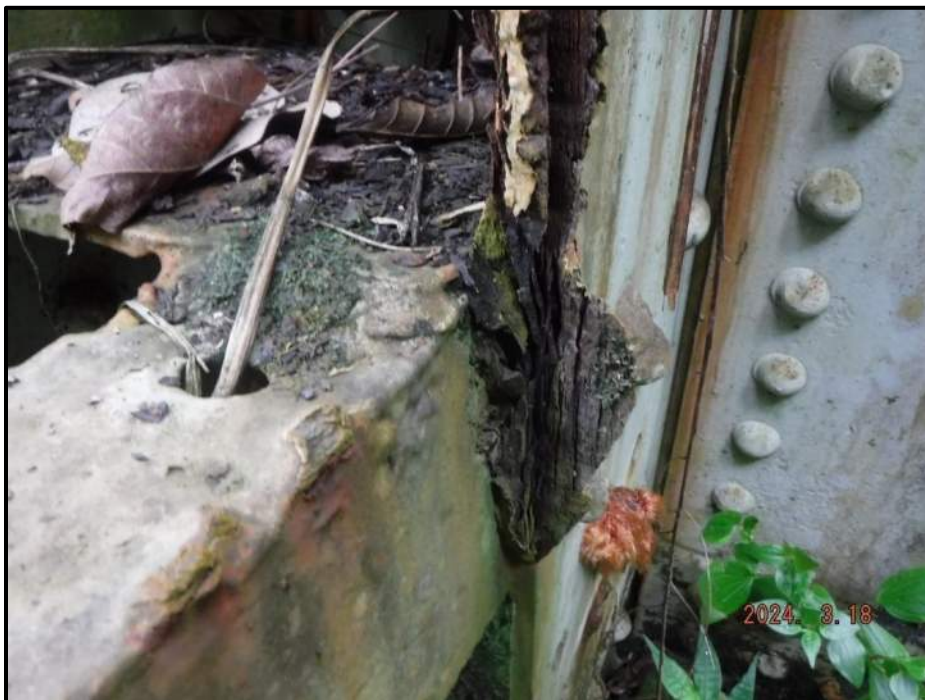
Photograph 20. Bent 2, Level 3, north of Column A, west gusset plate, looking south. Pack rust up to 1/4" thick, CS3.

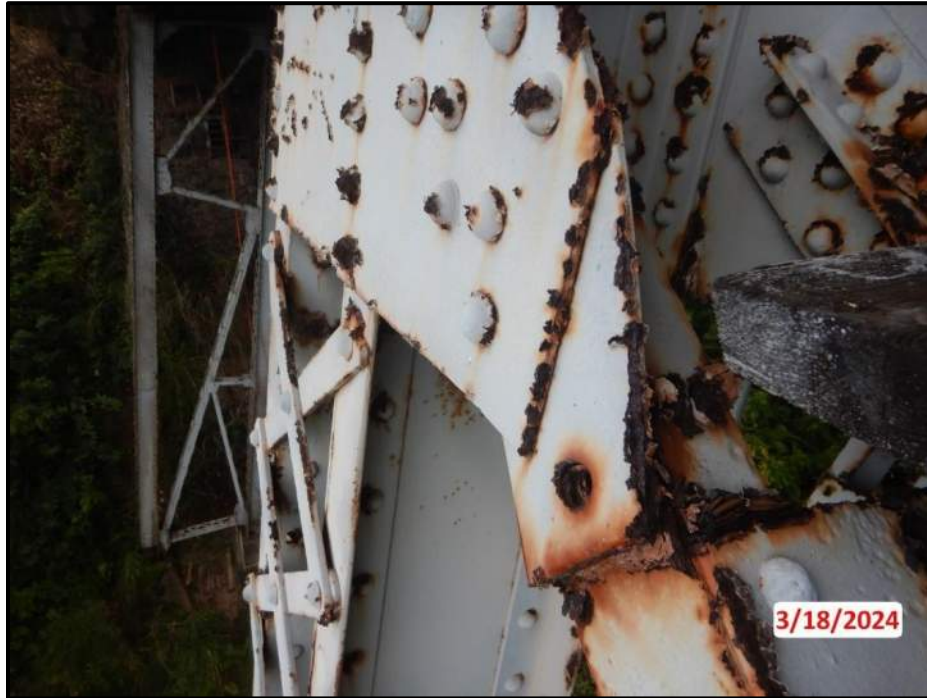
Photograph 21. Tower 2, Level 1, north of Column A, diagonal bracing gusset plate, looking southwest. (1) missing rivet with pack rust up to 1/2" thick, CS3.

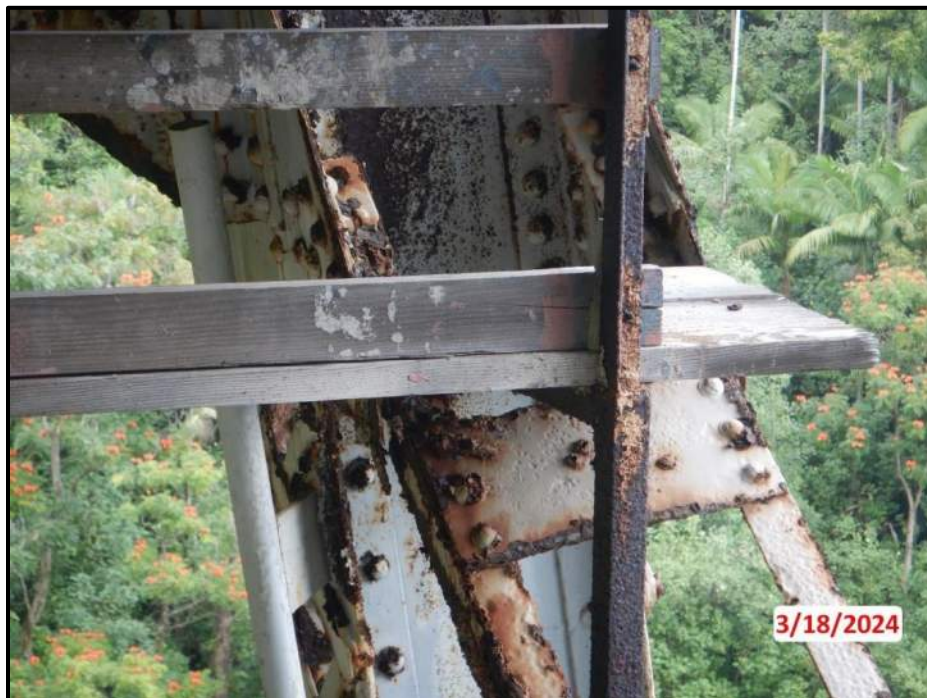
Photograph 22. Tower 2, Level 1, Column A , upper north diagonal bracing, near Bent 3, looking north. Vertical leg of interior angle near Column A connection, 6" L x 2" H corrosion hole. Exterior leg has area of pack rust causing separation of gusset plate up to 1". Rest of this member has multiple areas of knife-edging along interior angle over 8' length with individual areas up to 1" x 6" exhibiting 100% section loss, CS3.

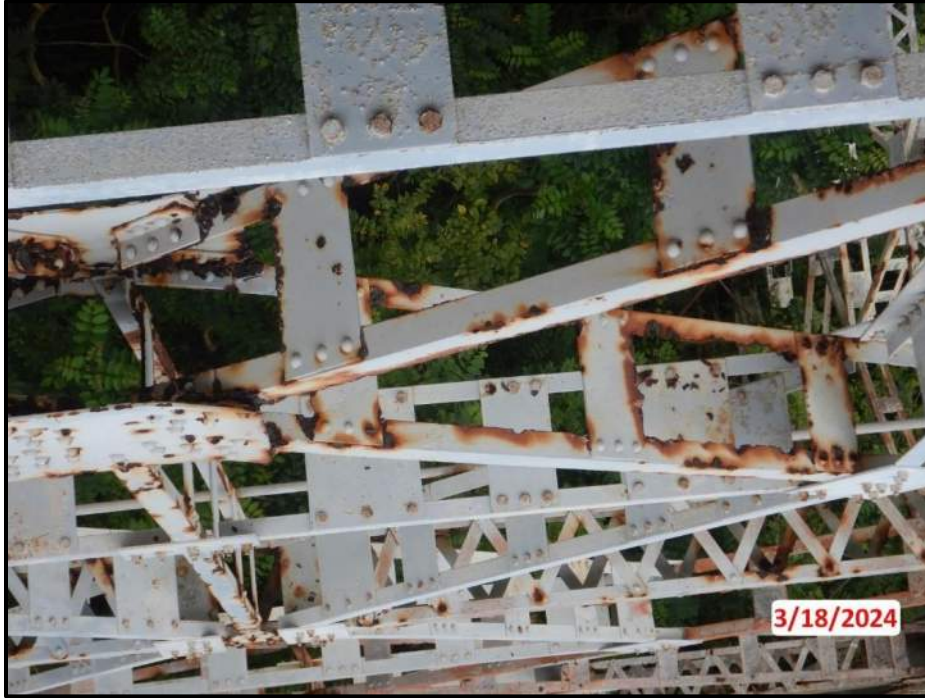
Photograph 23. Tower 2, Level 1, Column B, lower north diagonal bracing, both angle legs, looking west. Up to 1' L x 1-1/2" W isolated areas of 100% section loss along full member length, CS3.

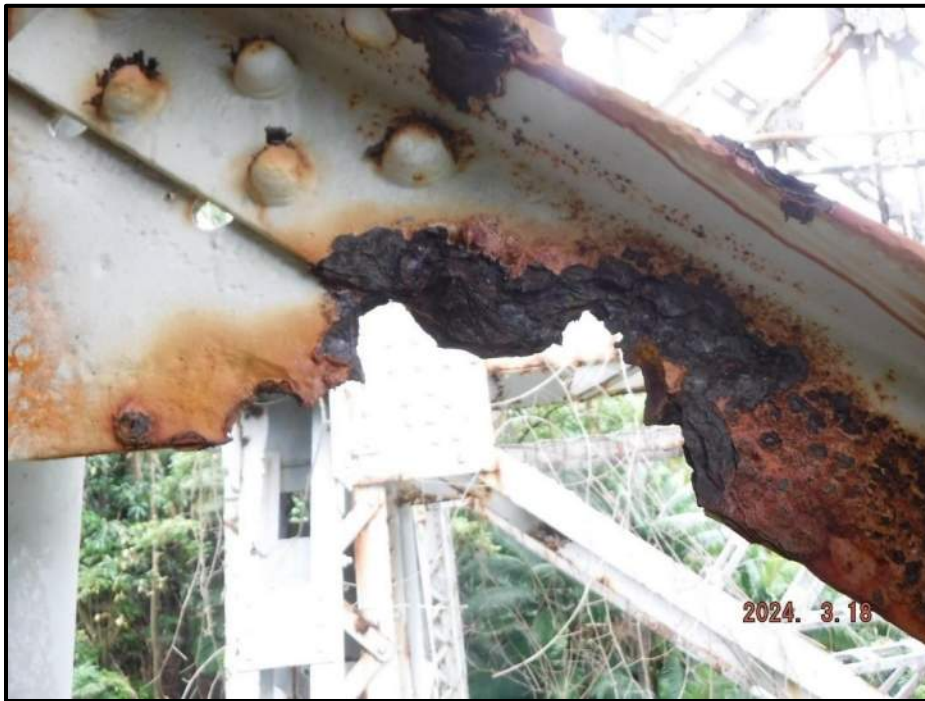
Photograph 24. Tower 2, Level 2, Column A, upper south diagonal and gusset plate at Column A connection, looking west. Interior angle, 8" L x 3" W area of 100% section loss, CS3.

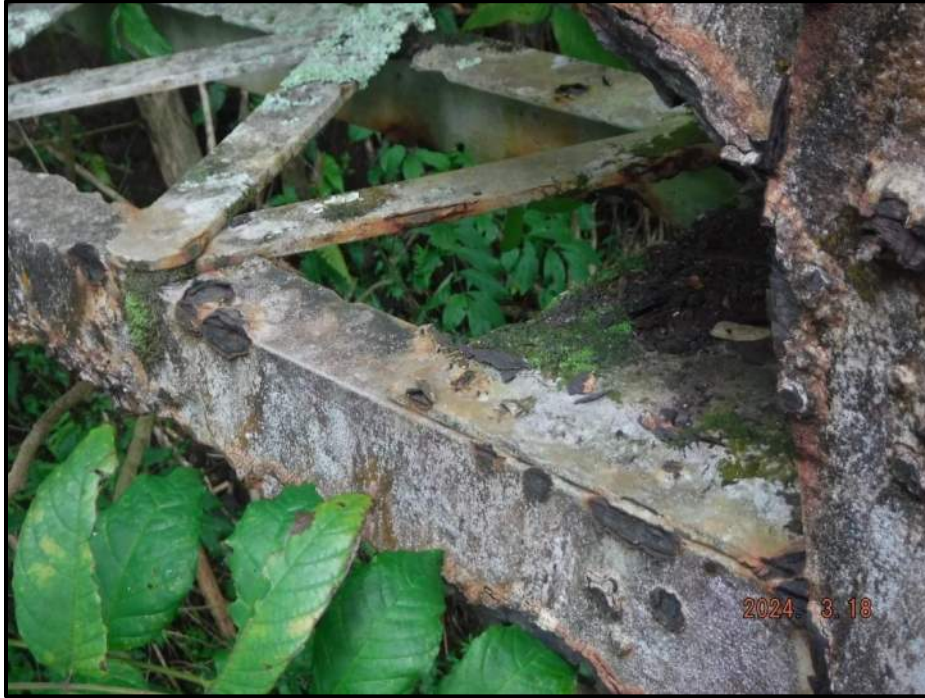
Photograph 25. Tower 2, Level 3, Column B, horizontal bracing, looking northeast. Numerous rivet heads with up to 100% section loss, CS3.

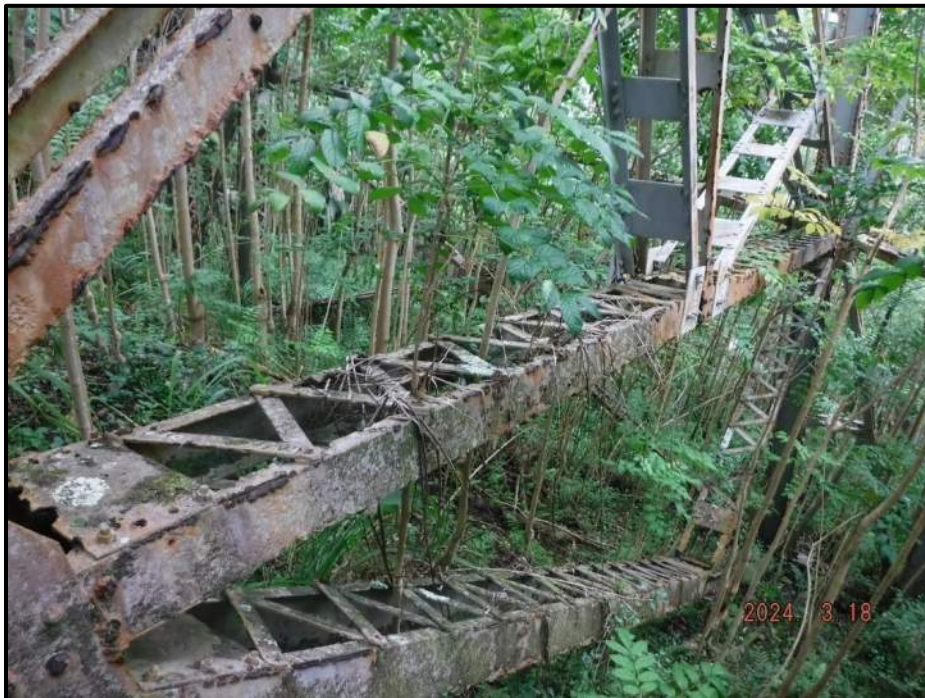
Photograph 26. Tower 2, Level 3, Column B, horizontal bracing, looking northwest. Multiple up to 3/4" diameter corrosion holes throughout, and covered in vegetation, CS3.

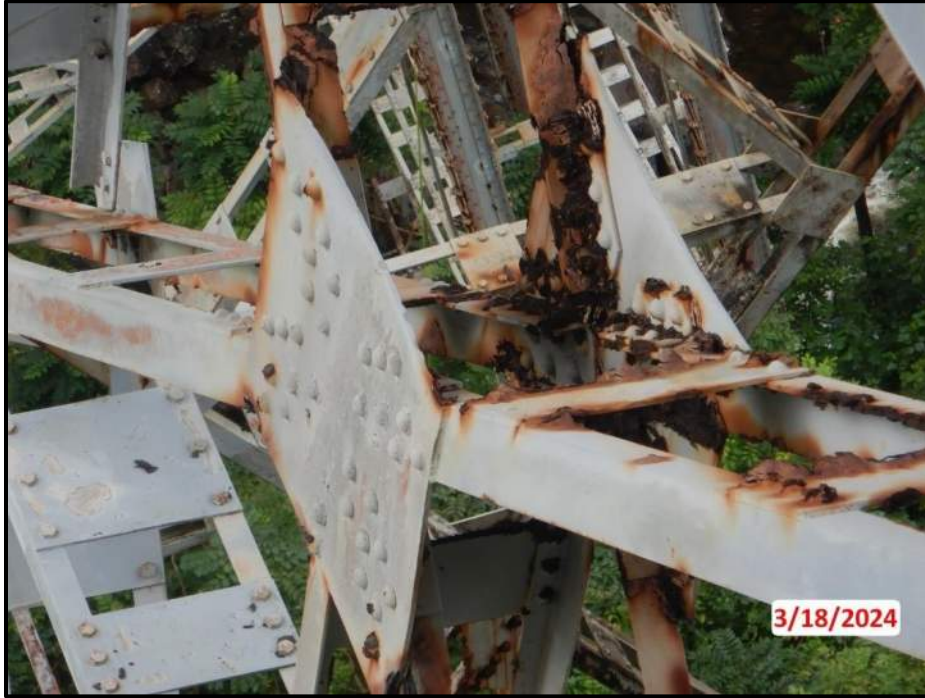
Photograph 27. Tower 2, Level 1, Column C, both center gusset plates, looking northeast. Pack rust at the incoming angles up to 1/2" thick; Laminar corrosion adjacent to angles throughout with up to 1" diameter x 100% section loss, CS3.

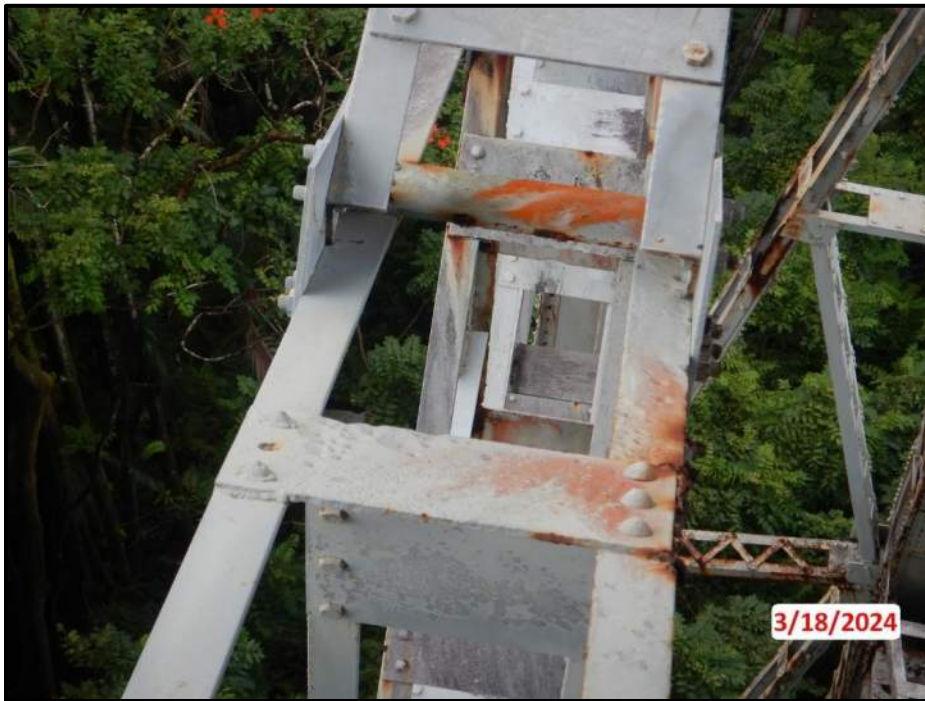
Photograph 28. Tower 2, Level 1, Column D, upper north diagonal bracing, top face of batten plate, west rivet heads, looking north. (1) of (3) missing, CS3.

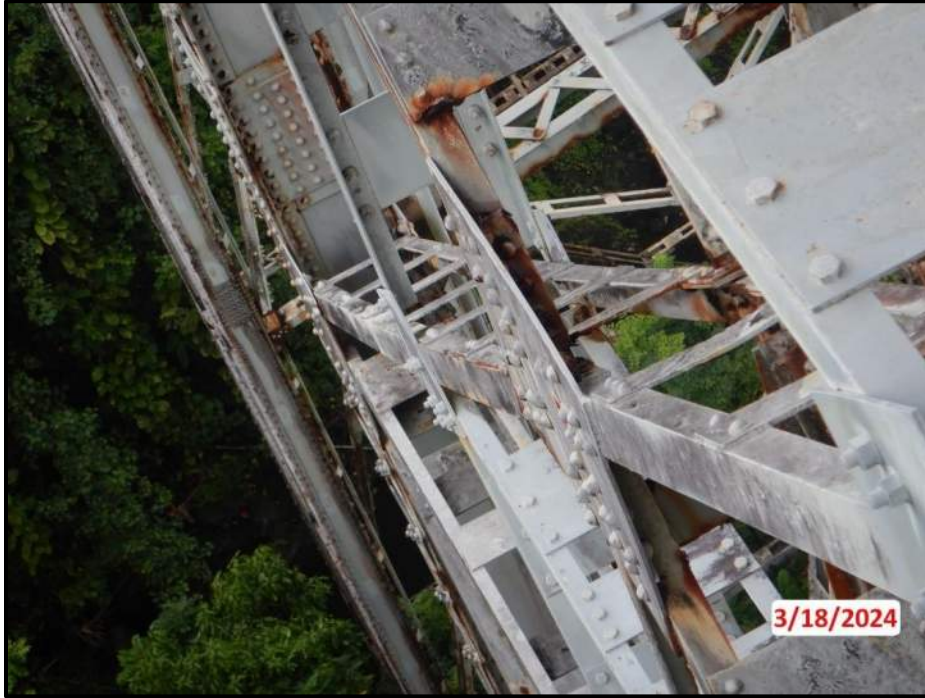
Photograph 29. Tower 2, Level 1, Column D, center west gusset plate, looking north. (1) missing rivet, CS3.

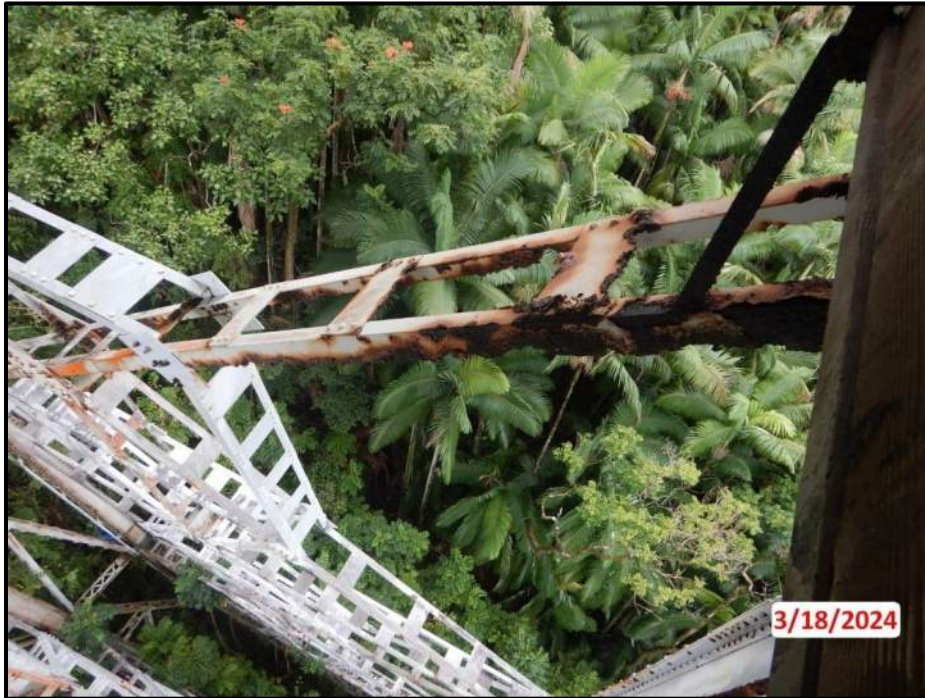
Photograph 30. Tower 2, Level 1, Column D, upper north diagonal bracing, looking west. Heavy knife-edging and up to 6" L x 2" H corrosion holes, CS3.

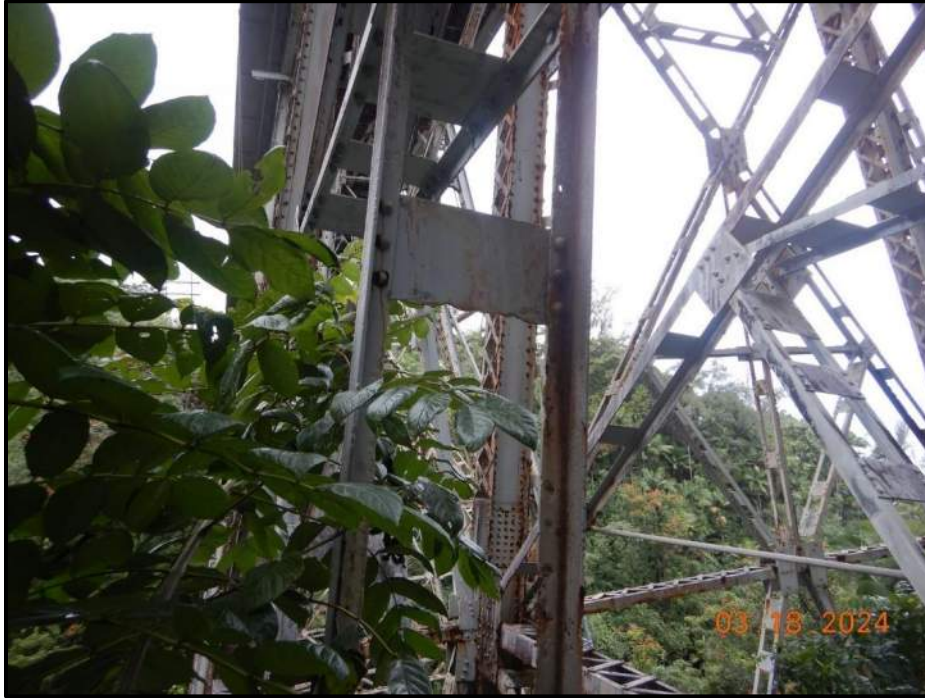
Photograph 31. Tower 2, Level 2, Column D, vertical bracing, looking north. Up to 1/8" deep pitting with scattered areas of knife-edging, CS3.

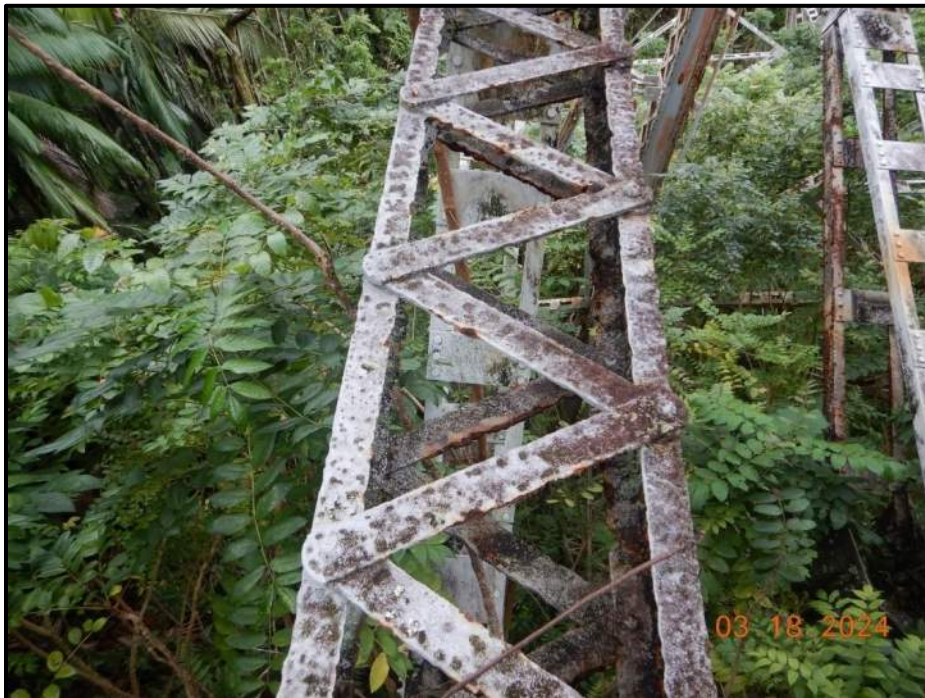
Photograph 32. Tower 2, Level 2, Column D, horizontal bracing, looking north. Pinholes (corrosion holes) throughout the length, CS3.

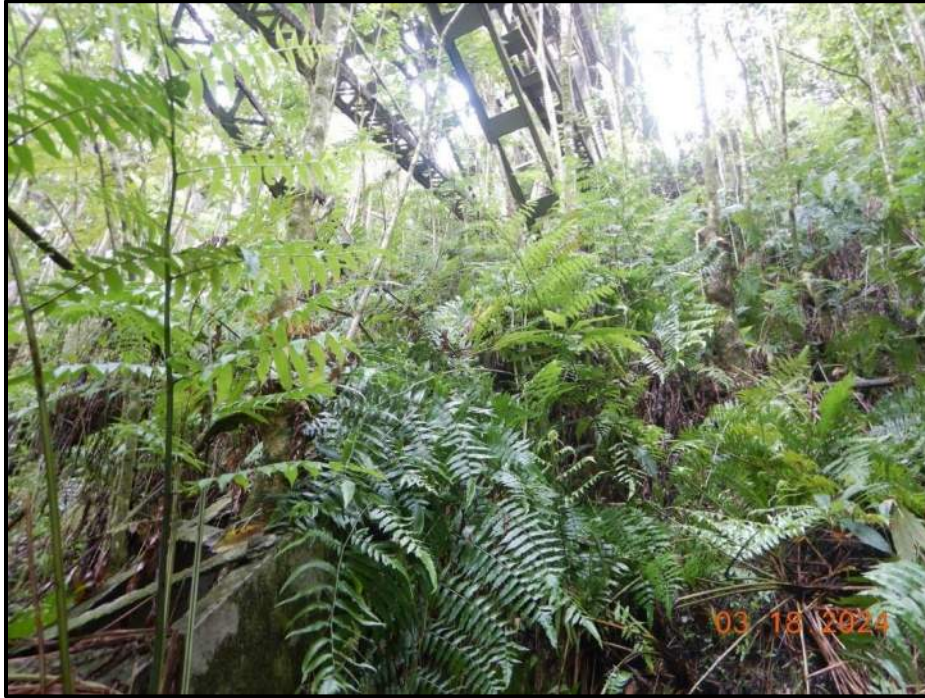
Photograph 33. Tower 2, Level 4, Column D, lower diagonal bracing, looking south. Heavy growth with trees growing through the members.

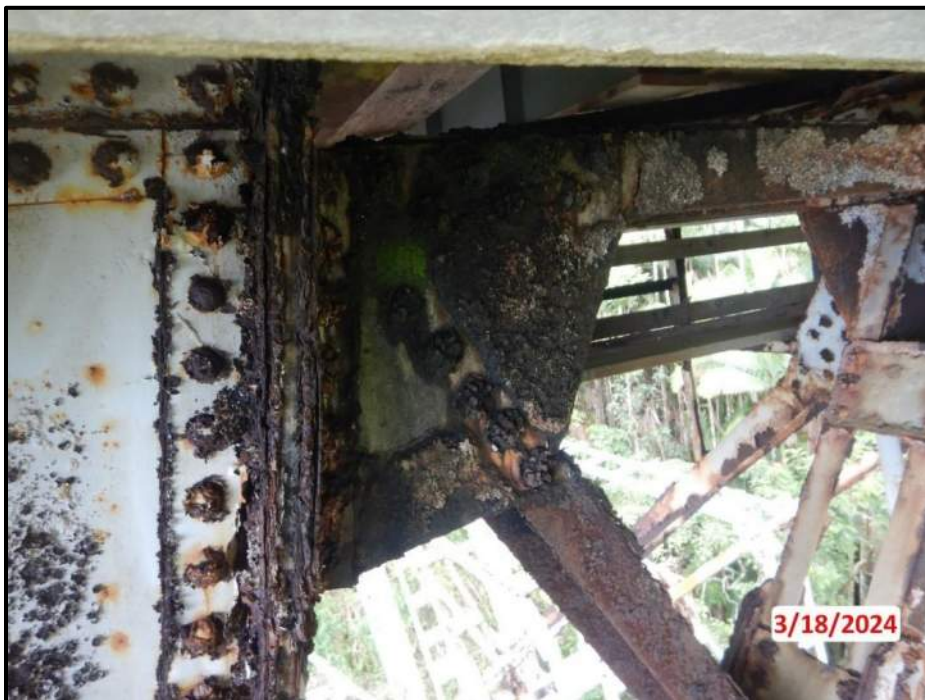
Photograph 34. Bent 3, Level 1, upper section, Column B, top gusset plate and longitudinal bracing, looking southeast. Laminar corrosion and areas of section loss on members and rivet heads due to active water leakage from the bridge, CS3.

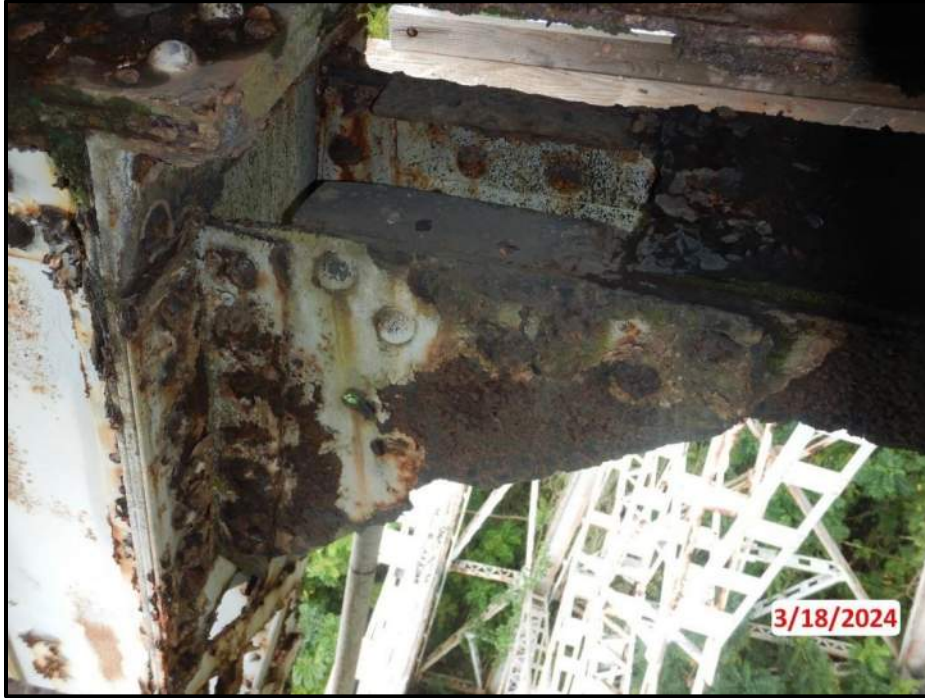
Photograph 35. Bent 3, Level 1, upper section, west of Column A, north gusset plate, looking south. Knife edging and corrosion holes up to 3" x 2" along bottom edge of gusset plate, CS3.

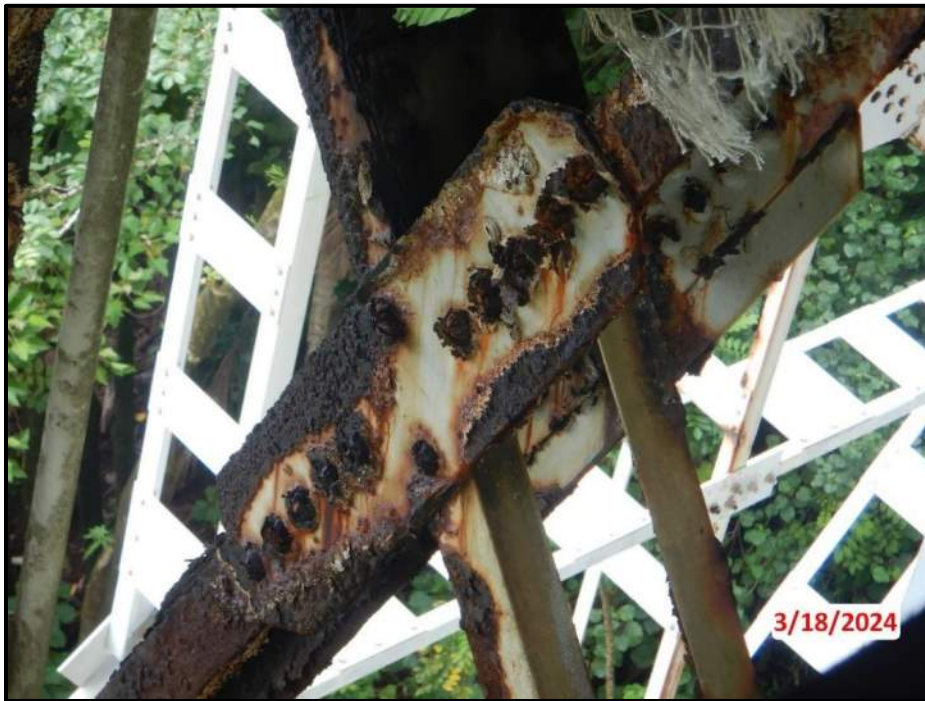
Photograph 36. Bent 3, Level 1, upper section, between Columns B and C, center gusset plates, looking southeast. Laminar corrosion on plates and transverse bracing members, CS3.

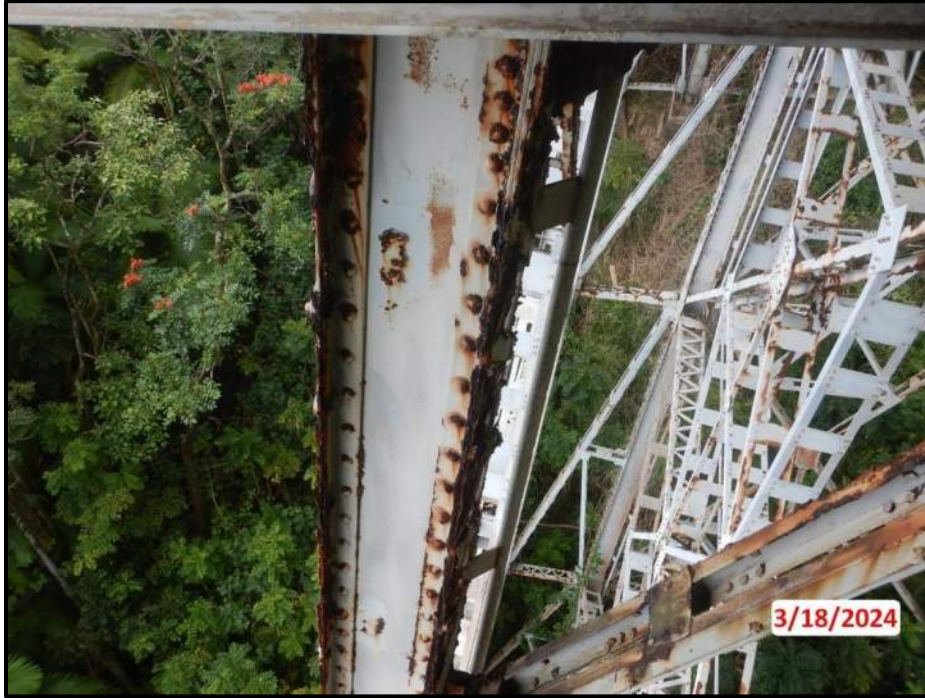
Photograph 37. Bent 3, Level 1, upper section, Column A, exterior face edges over top 12', looking south. Widespread laminar corrosion, CS3.

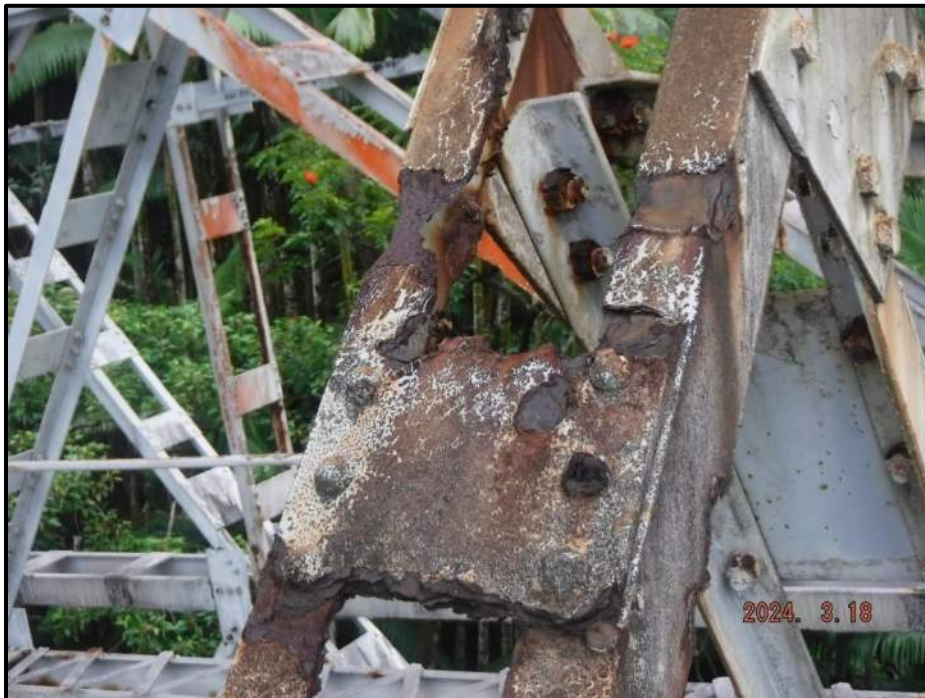
Photograph 38. Bent 3, Level 1, lower section, between Columns B and C, lower east diagonal bracing near Column B, adjacent to batton plates top flange of angles, looking west. Knife-edging with areas of 4" L x 2" W of up to 100% section loss, CS3.

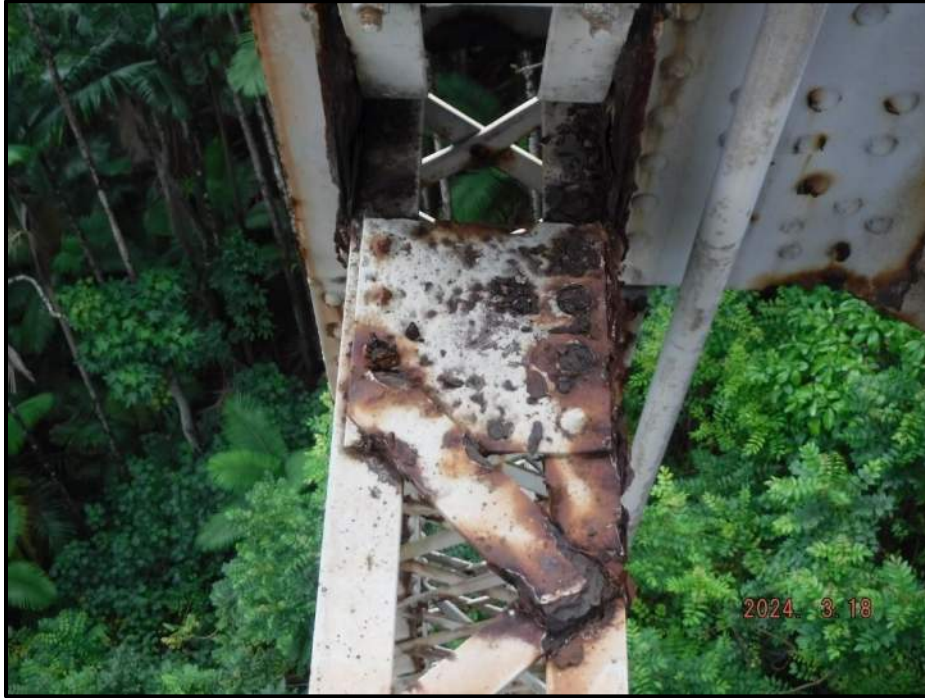
Photograph 39. Bent 3, Level 1, lower section, Columns A and B, horizontal bracing, looking east. Pack rust up to 1-1/2" thick with section loss up to 30% to gusset plates and 100% loss to rivet heads of batten plate, CS3.

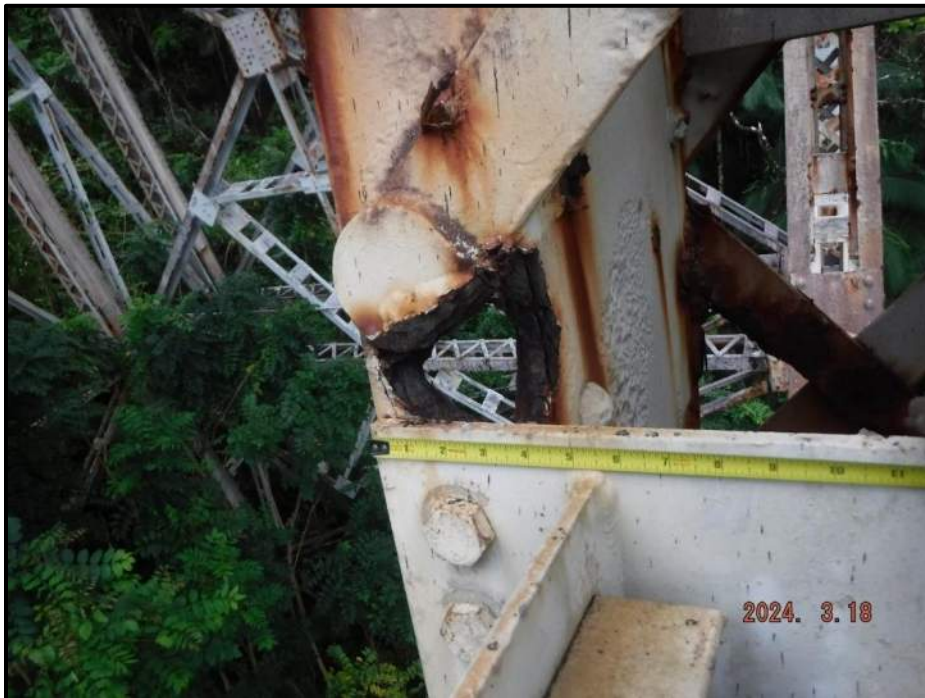
Photograph 40. Bent 3, Level 2, Column B, looking west. 2-1/2" diameter corrosion hole in southeast angle above horizontal brace connection, CS3.
