**STATE OF HAWAII
DEPARTMENT OF TRANSPORTATION**

**ADDENDUM NO. 2
FOR
HAWAII BELT ROAD
NANUE STREAM BRIDGE REHABILITATION
VICINITY OF HILO
DISTRICT OF HILO, ISLAND OF HAWAII
FEDERAL-AID PROJECT NO. BR-019-2(077)**

December 13, 2024

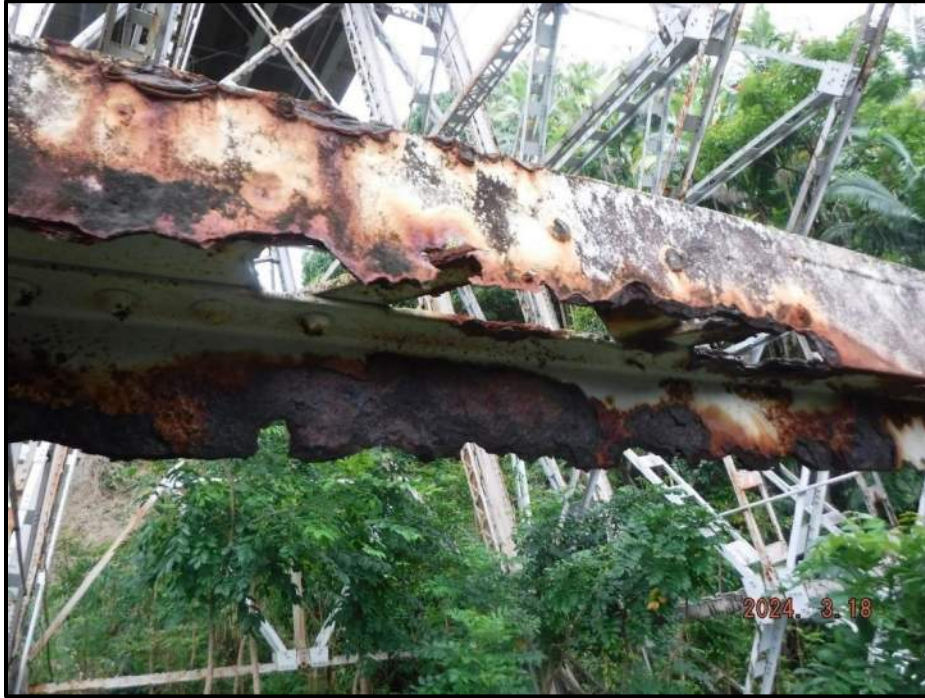
Photograph 41. Bent 3, Level 2, between Columns B and C, horizontal bracing, looking south. Knife-edging with up to 1-1/2" diameter corrosion holes on both flanges, CS3.

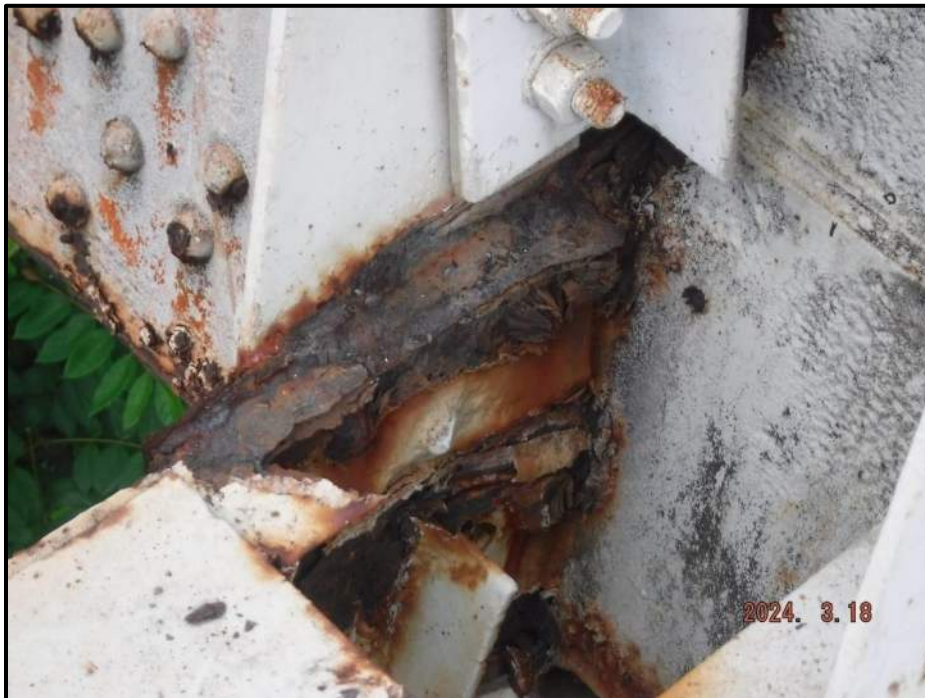
Photograph 42. Bent 3, Level 2, between Columns A and B, horizontal bracing, south flange, horizontal leg, looking north. 9" L x full-width of angle area of 100% section loss, CS3.

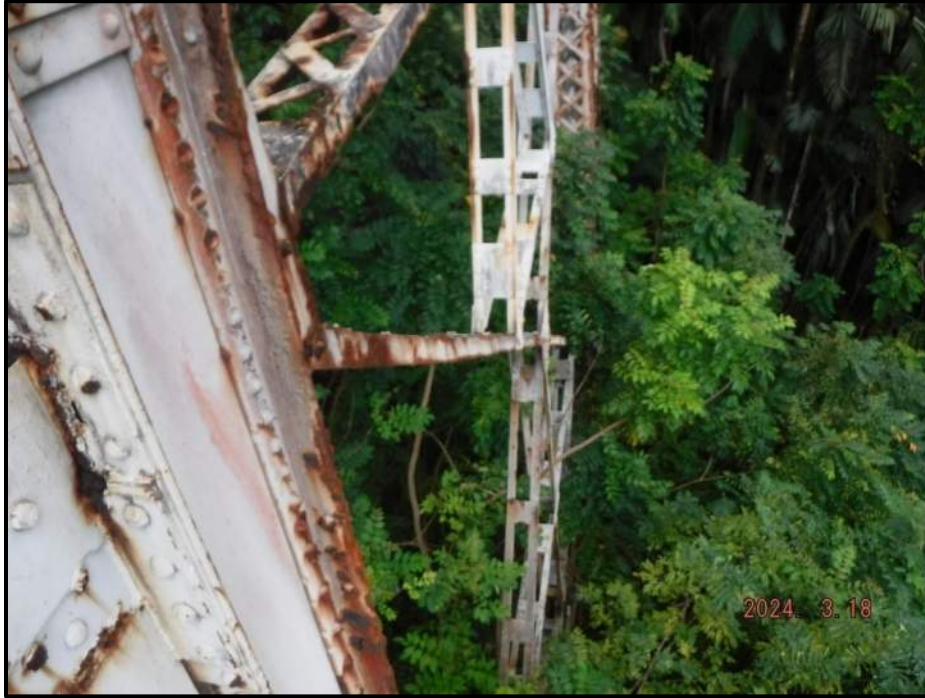
Photograph 43. Bent 3, Level 3, between Columns B and C, upper east diagonal, looking west. Bowed up to 1" out of plane over full length, CS3.

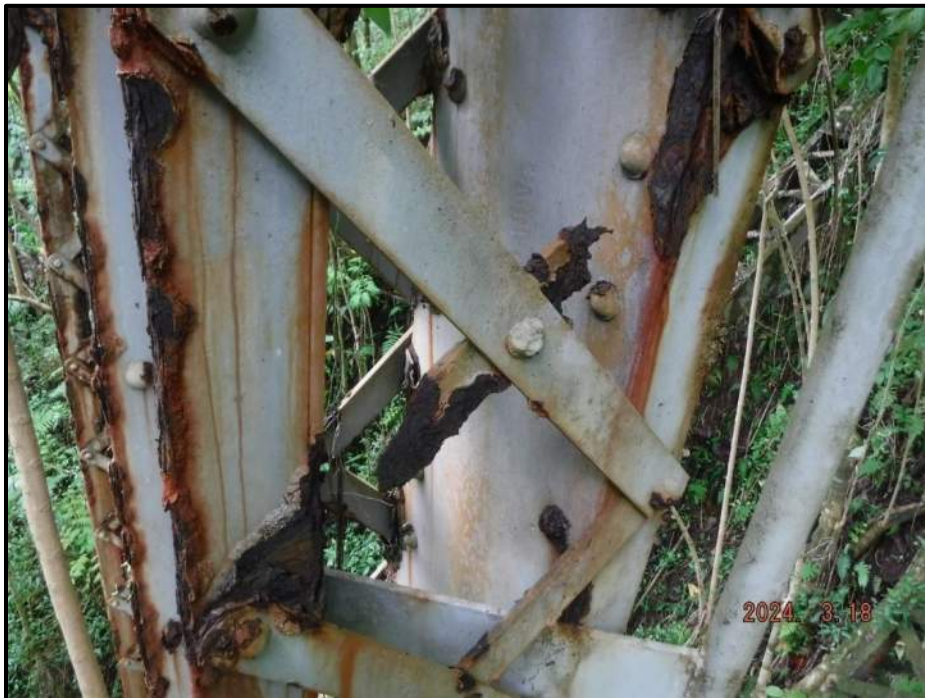
Photograph 44. Bent 3, Level 4, Column B, (1) lacing bar, looking east. 100% section loss on both ends on the west column face, CS3.

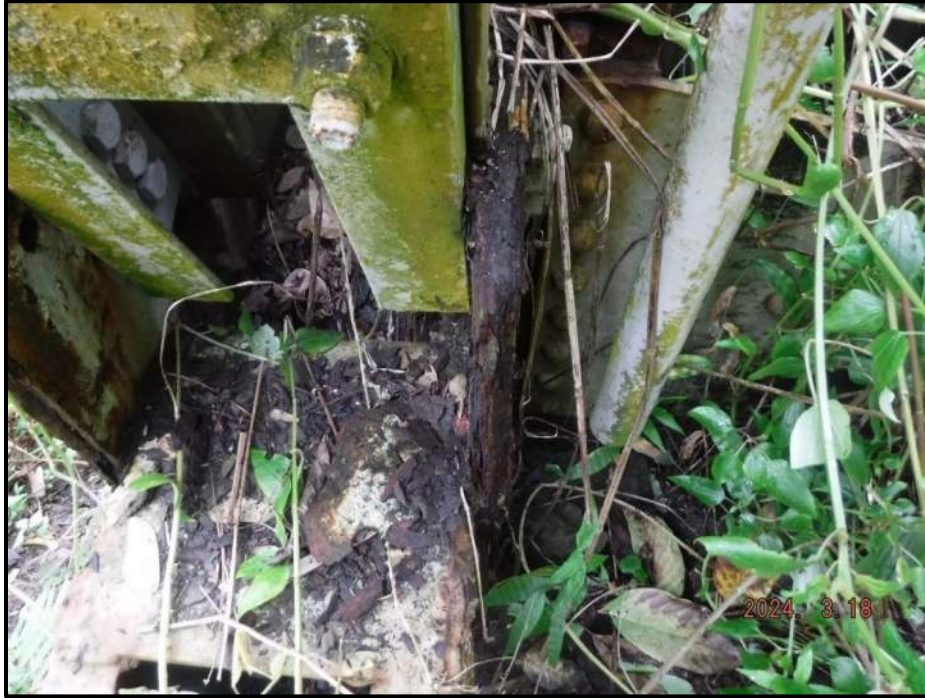
Photograph 45. Bent 3, Level 4, Column A, just above bearing, gusset plates, looking east. Plates have minor distortion and bowed to the south less than 1/8" due to laminar corrosion, CS3.

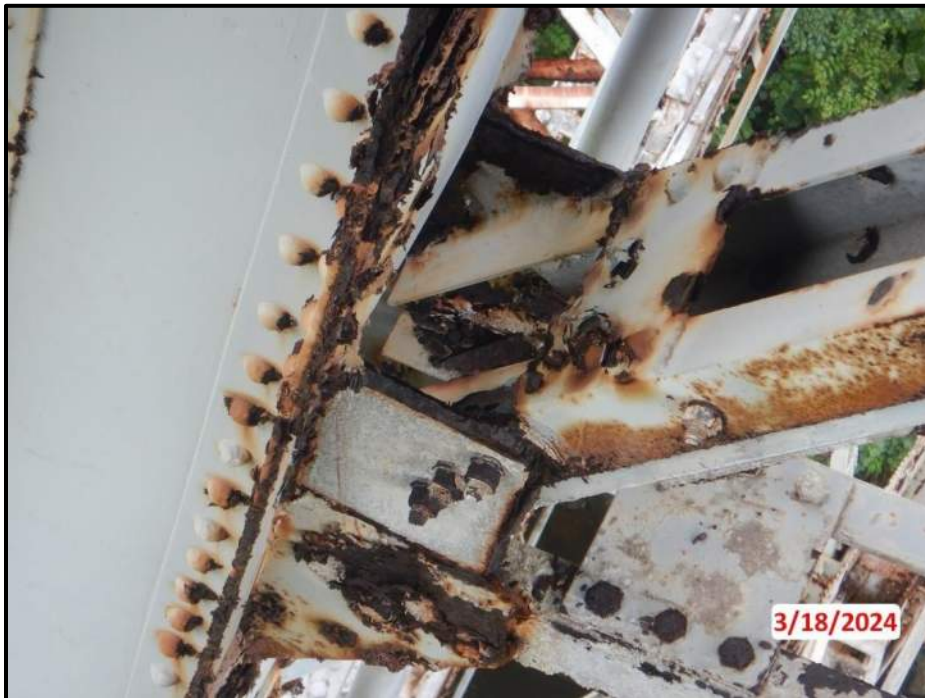
Photograph 46. Bent 4, Level 1, upper section, Column D, upper gusset plates, looking northwest. Heavy laminar corrosion and approximately 1/4" to 3/8" remaining section on gusset plate between diagonal and horizontal bracing member, CS3.

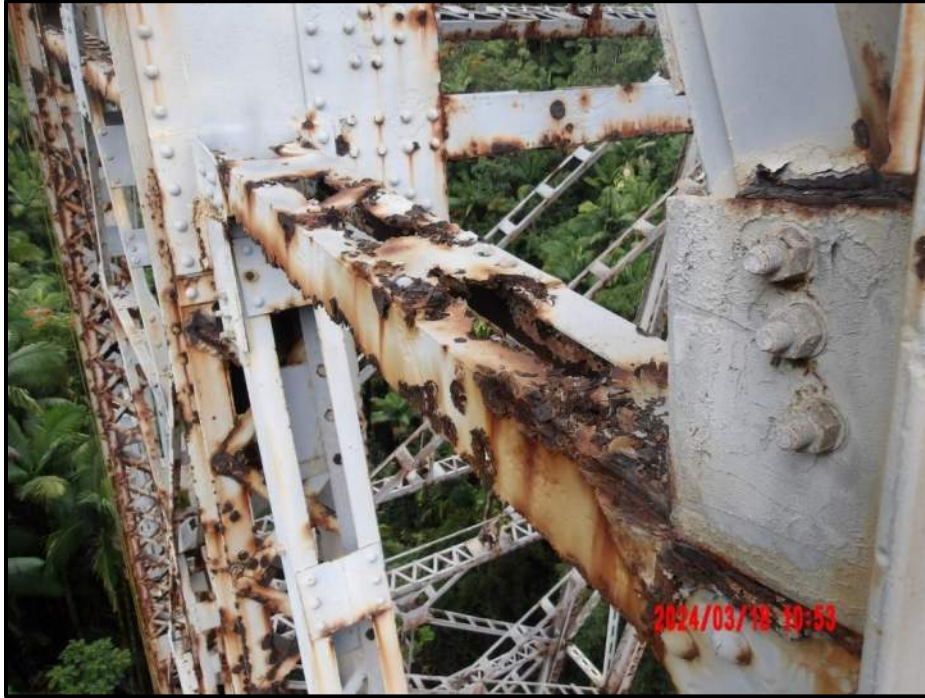
Photograph 47. Bent 4, Level 1, lower section, between Columns A and B, horizontal bracing, looking west. Vertical legs have knife-edging with areas of up to 100% section loss and corrosion holes up to 1" diameter. (1) lacing bar has 100% section loss and batten plate has area of 100% loss, CS3.

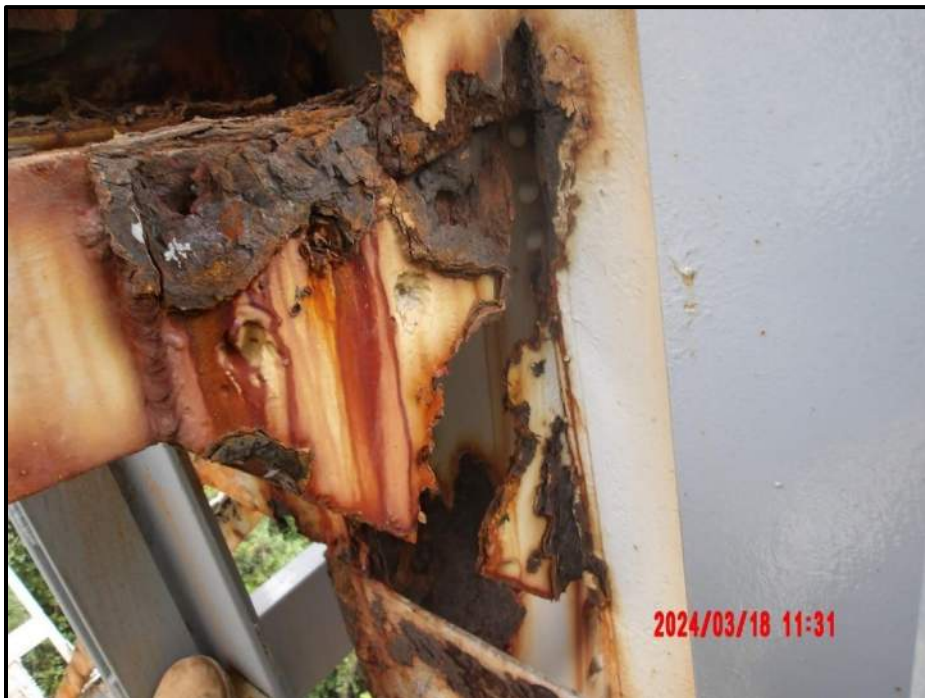
Photograph 48. Bent 4, Level 2, Column A, exterior gusset plate, looking northeast. Corrosion, pack rust up to 1" thick with areas of up to 100% loss and only retrofit gusset plate remaining, CS3.

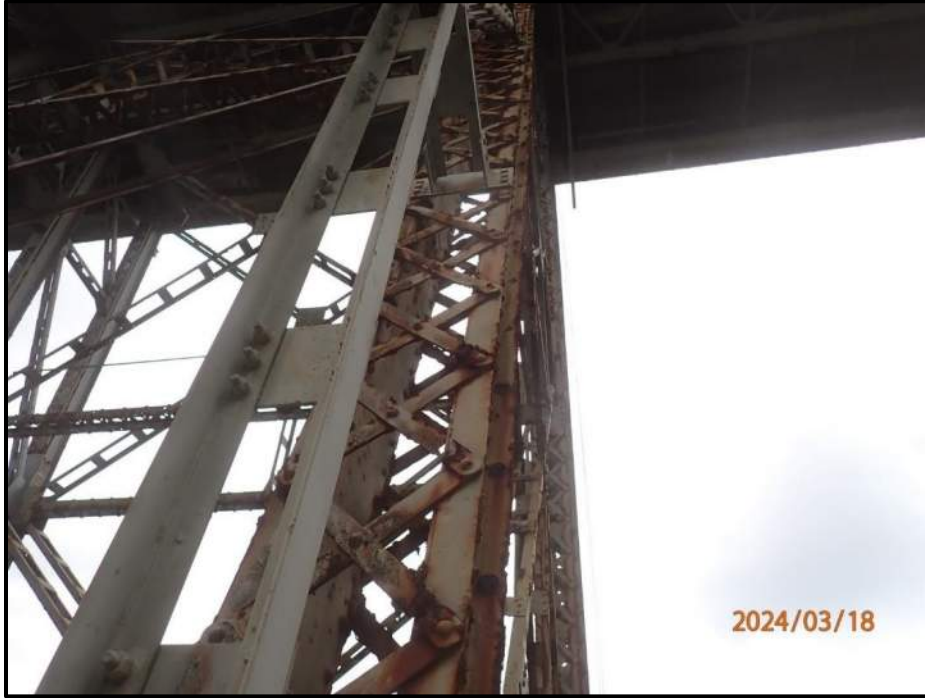
Photograph 49. Bent 4, Level 2, Column C, looking north. 50% of lacing bars on west face have 100% section loss, remaining bars on both faces have average 30% section loss, CS4.

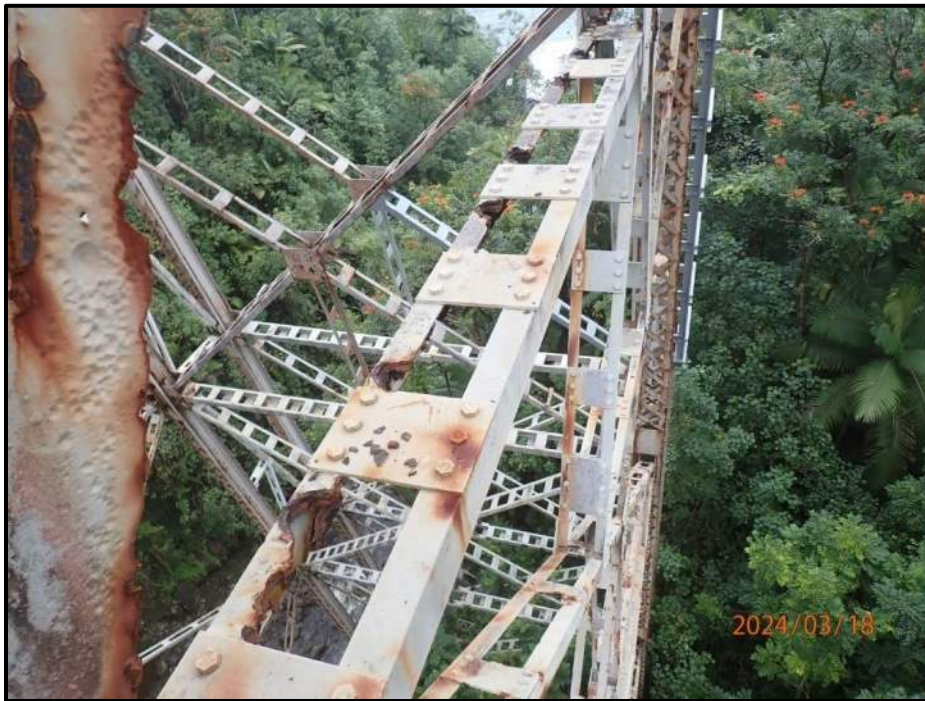
Photograph 50. Bent 4, Level 2, between Columns B and C, horizontal bracing adjacent to Column C, vertical connection, interior top flange along member, looking east. (7) corrosion holes, up to full width of top flange x 5" L, CS3.

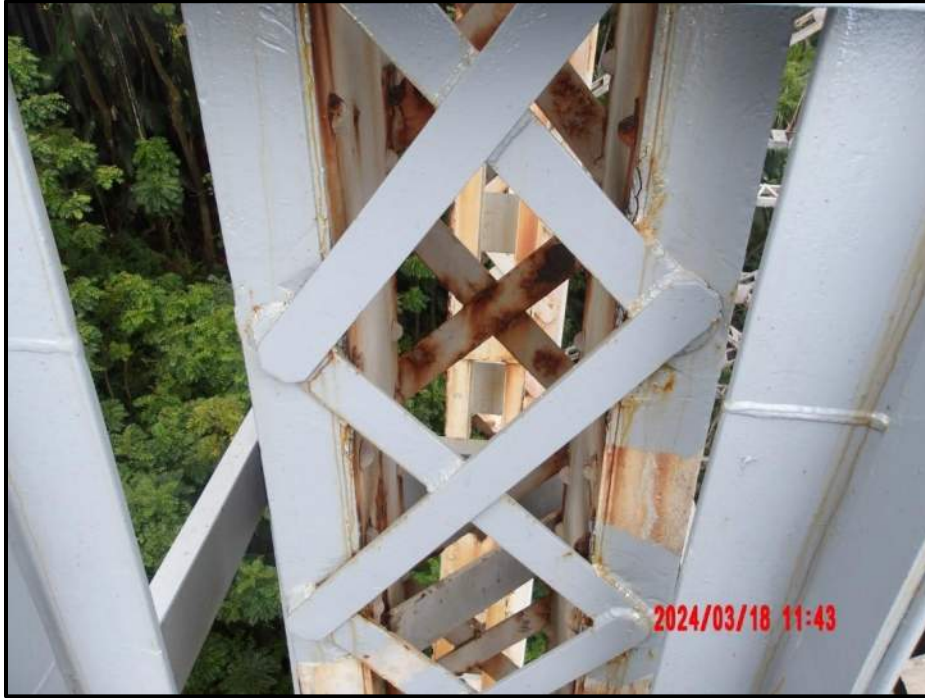
Photograph 51. Bent 4, Level 3, Column A above lower connection, looking west. Retrofit, four interior and three exterior lacing bars cut or removed, (CS3). - Repaired.

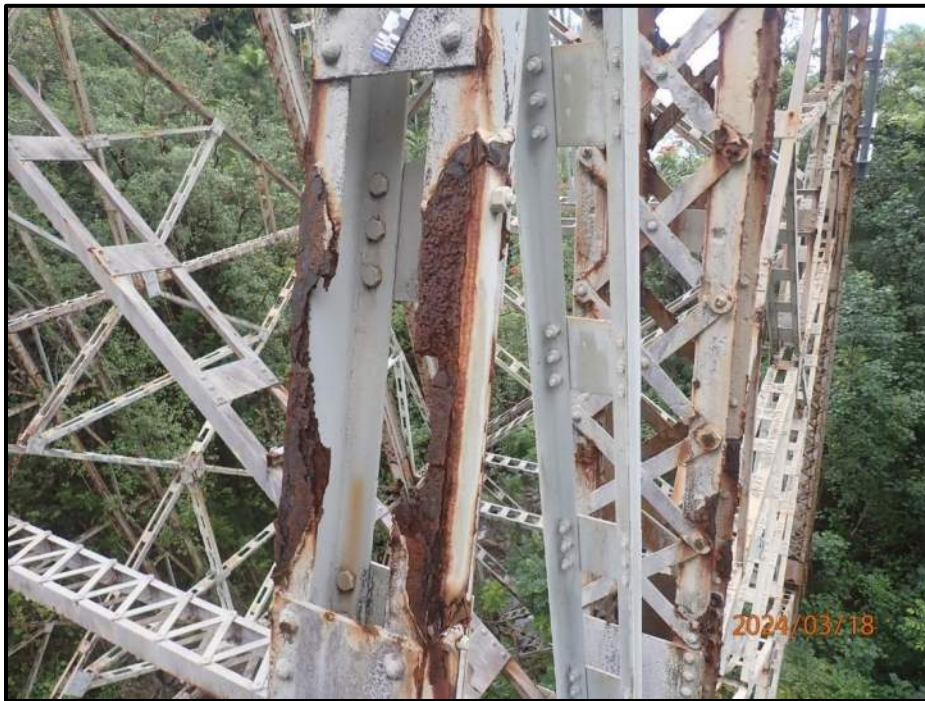
Photograph 52. Bent 4, Level 3, between Columns C and D, diagonal bracing, looking northeast. 3' L x full width of angle area of up to 100% section loss to top flanges, CS3. -Note this member has been retrofitted and retrofit is in good condition.

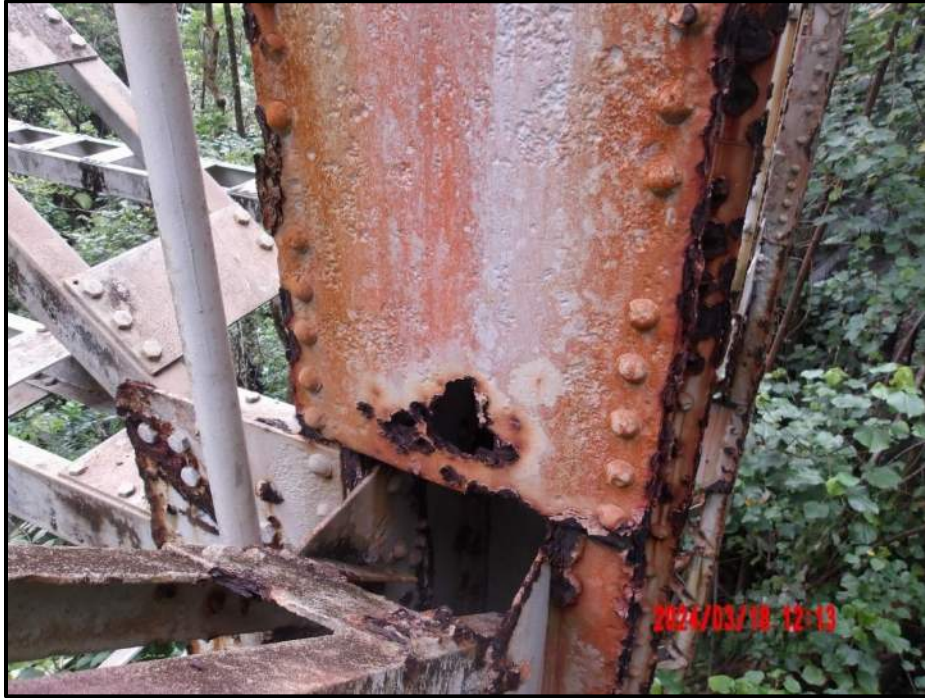
Photograph 53. Bent 4, Level 4, Column B, west face, cover plate, looking east. Corrosion hole, 8" W x 5" H, CS3.

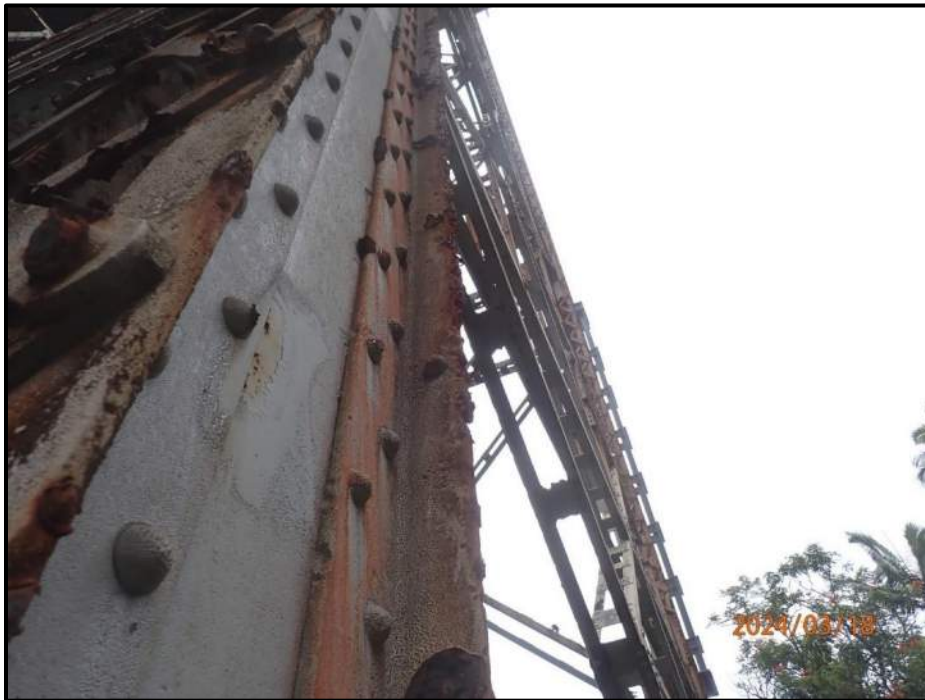
Photograph 54. Bent 4, Level 4, Column C, flanges, looking east. Knife-edging, CS3.

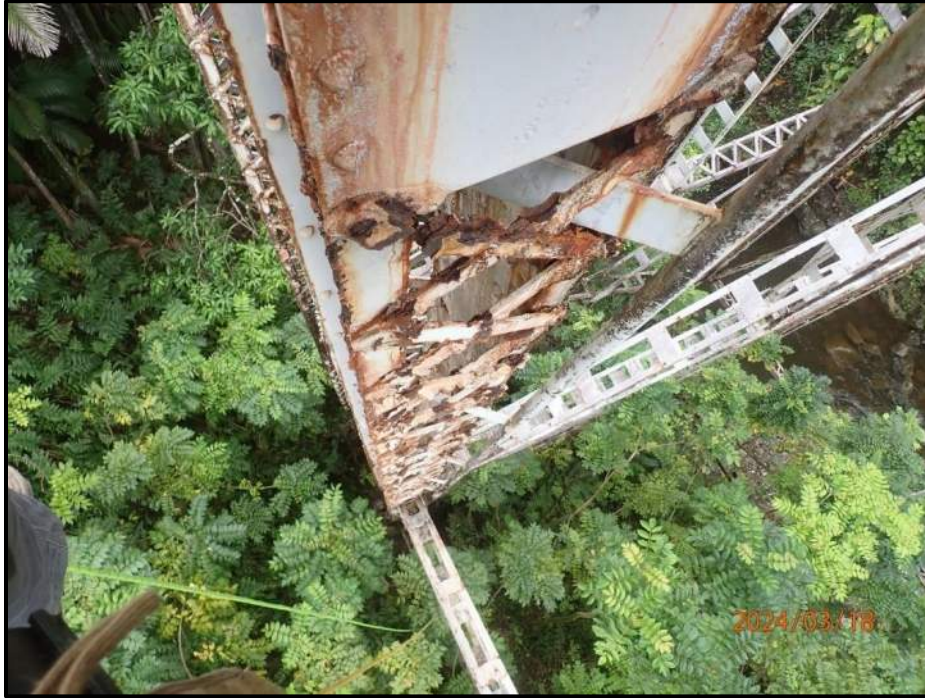
Photograph 55. Bent 4, Level 5, Column C, west face, (6) lacing bars, looking east. 100% section loss, CS3.

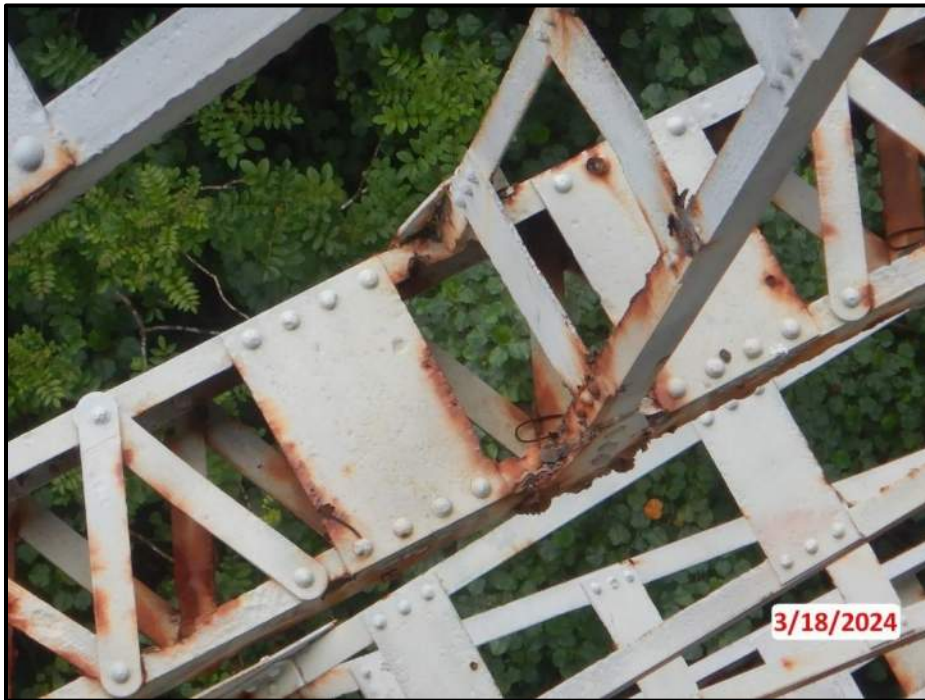
Photograph 56. Tower 3, Level 1, Column A, horizontal and vertical bracing gusset plate, looking southeast. Up to 85% section loss, full length x 2" H, CS3.

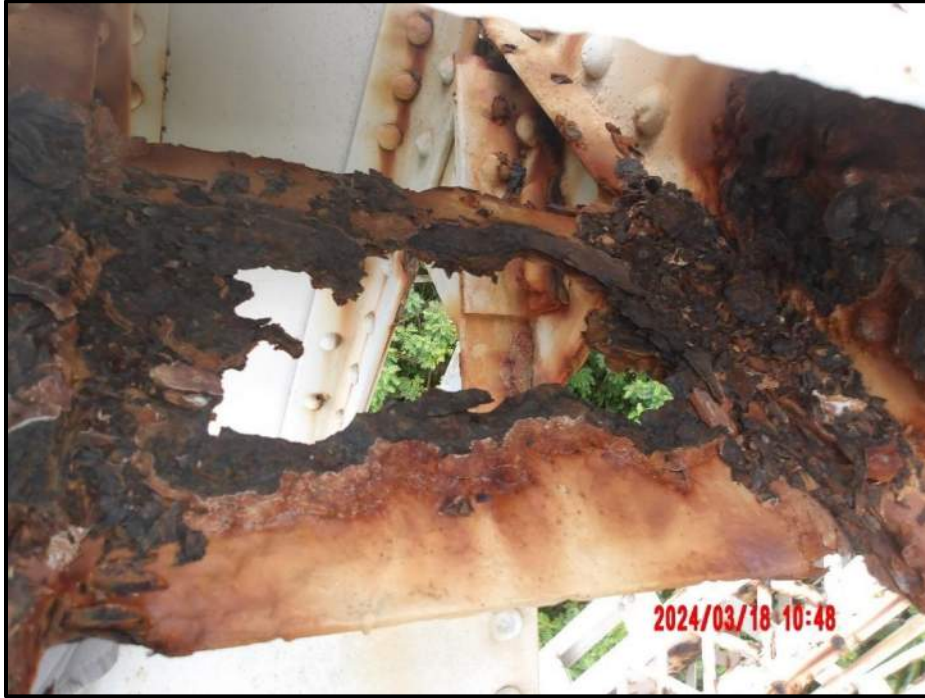
Photograph 57. Tower 3, Level 1, Column A, horizontal bracing, lower batten plate, looking south. Corrosion hole, 5" L x 10" W, CS3.

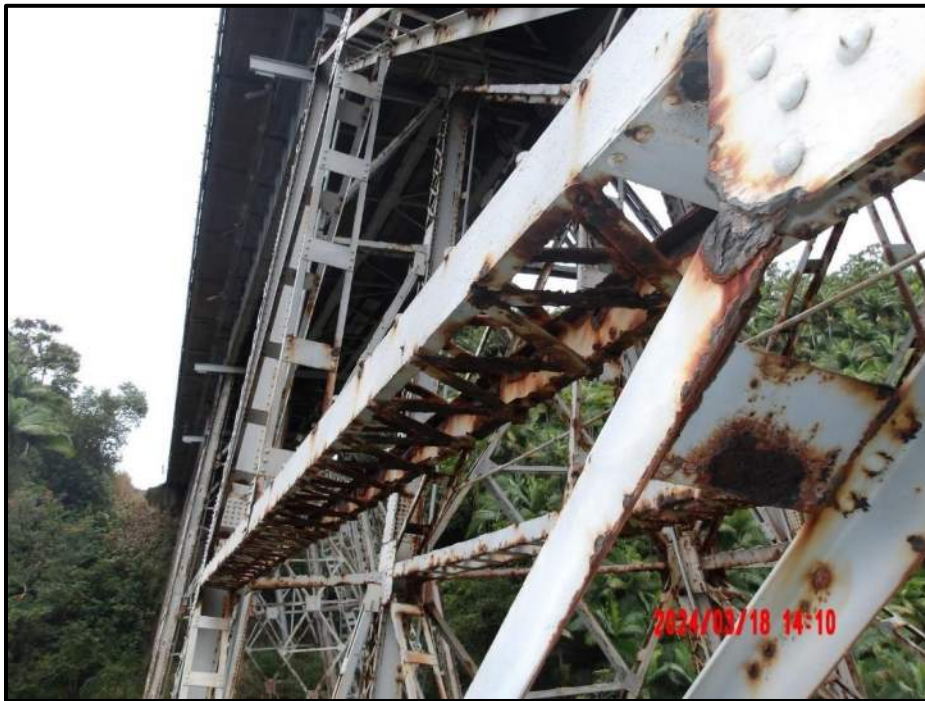
Photograph 58. Tower 3, Level 1, Column A, horizontal bracing, looking south. Heavy pitting and laminar corrosion with up to 80% section loss. Few lacing bars exhibit 100% section loss and knife-edging. Channel legs exhibit scattered knife-edging, CS3.

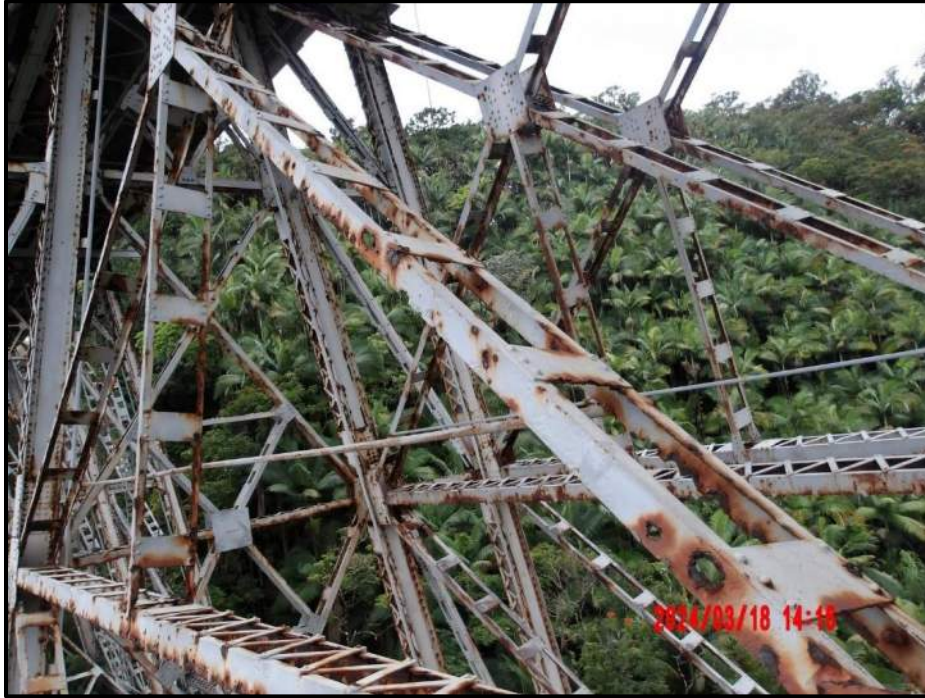
Photograph 59. Tower 3, Level 1, Column B, lower north diagonal bracing, looking southwest. Worst case is a 4" diameter corrosion hole near center gusset plate. Approximately 40% loss in cross sectional area, CS3.

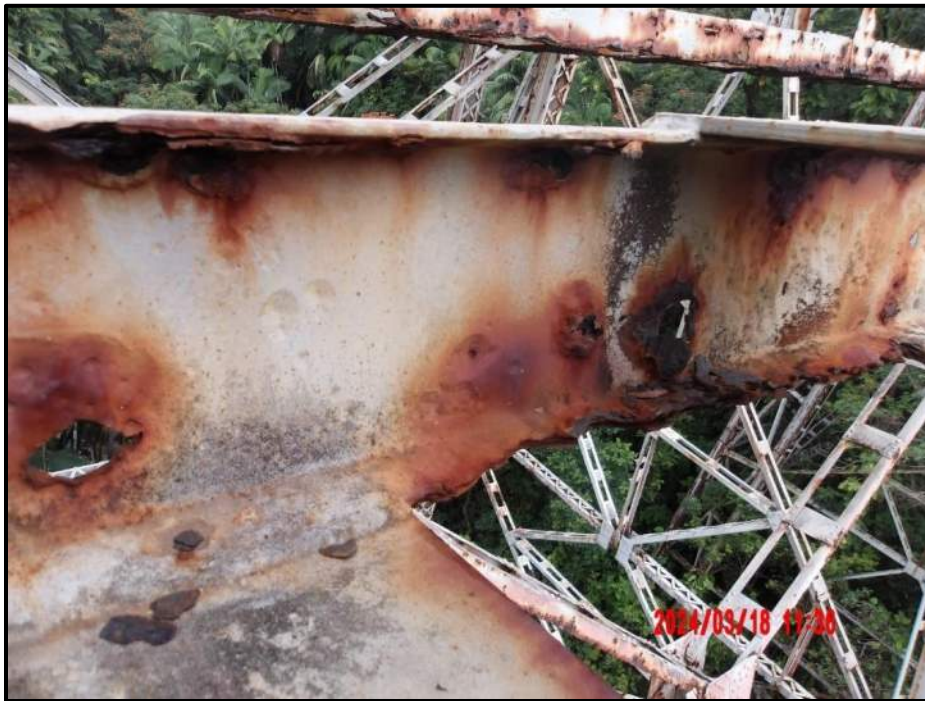
Photograph 60. Tower 3, Level 2, Column A, horizontal bracing, near Bent 4, looking northwest. 50% section loss to entire member with holes throughout, CS4.

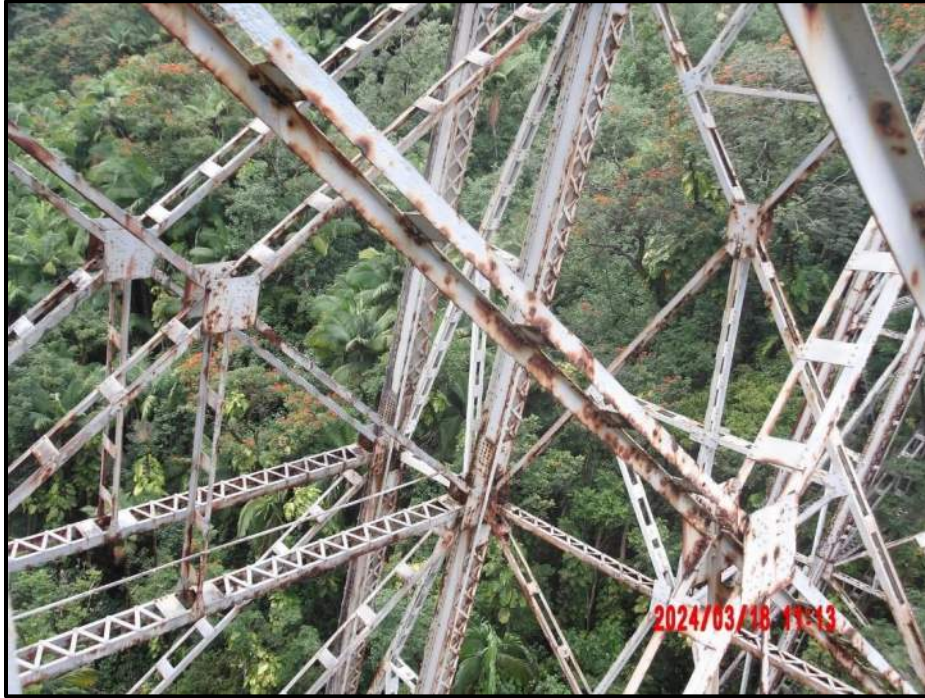
Photograph 61. Tower 3, Level 2, Column A, upper south to lower north diagonal bracing, looking north. Global distortion to the diagonal members within level. Upper south diagonal bracing, east leg has corrosion holes, up to 1" diameter, CS3.

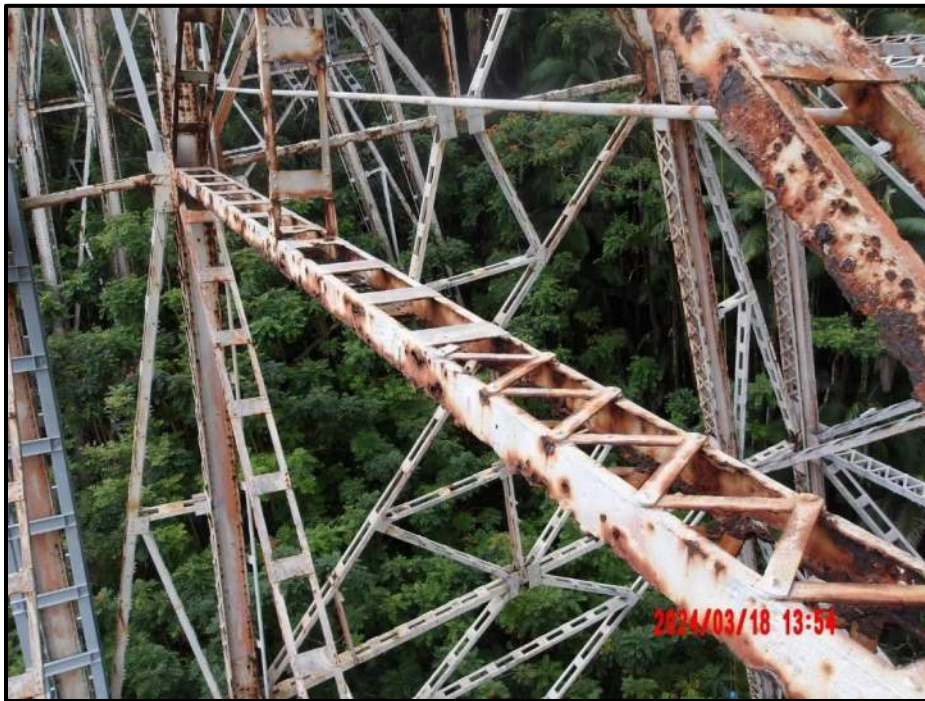
Photograph 62. Tower 3, Level 2, Column B, horizontal bracing, looking southwest. Numerous corrosion holes, up to 6" L x 3" H throughout full length of both channels, CS3.

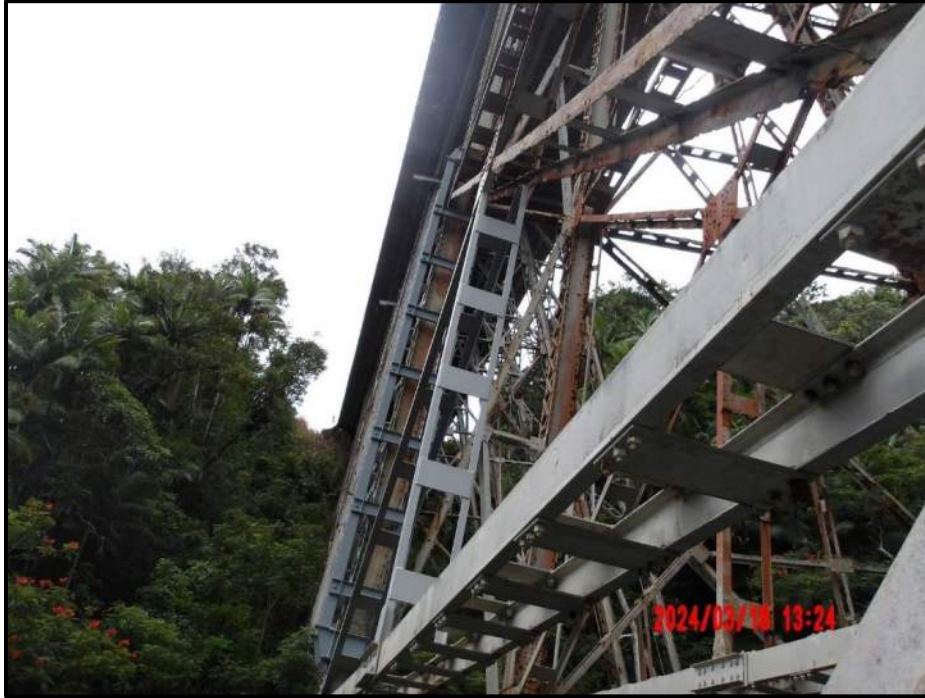
Photograph 63. Tower 3, Level 3, Column A, lower south diagonal, and vertical bracing, looking southeast. Repair in good condition.

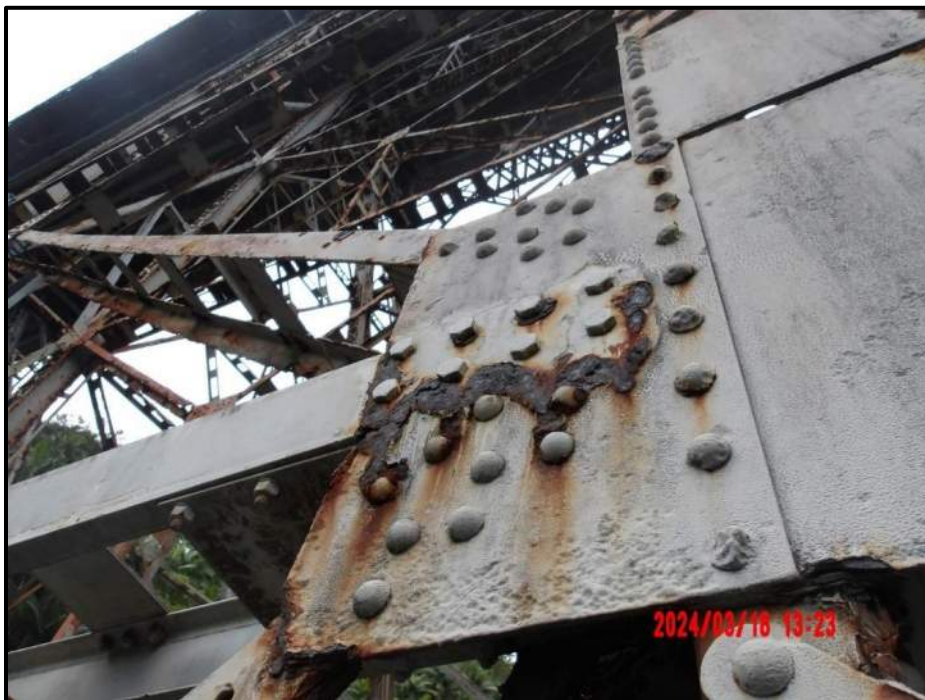
Photograph 64. Tower 3, Level 3, Column A, Bent 5, interior and exterior gusset plates, between horizontal and lower diagonal bracing, looking west. Pack rust with section loss, CS3.

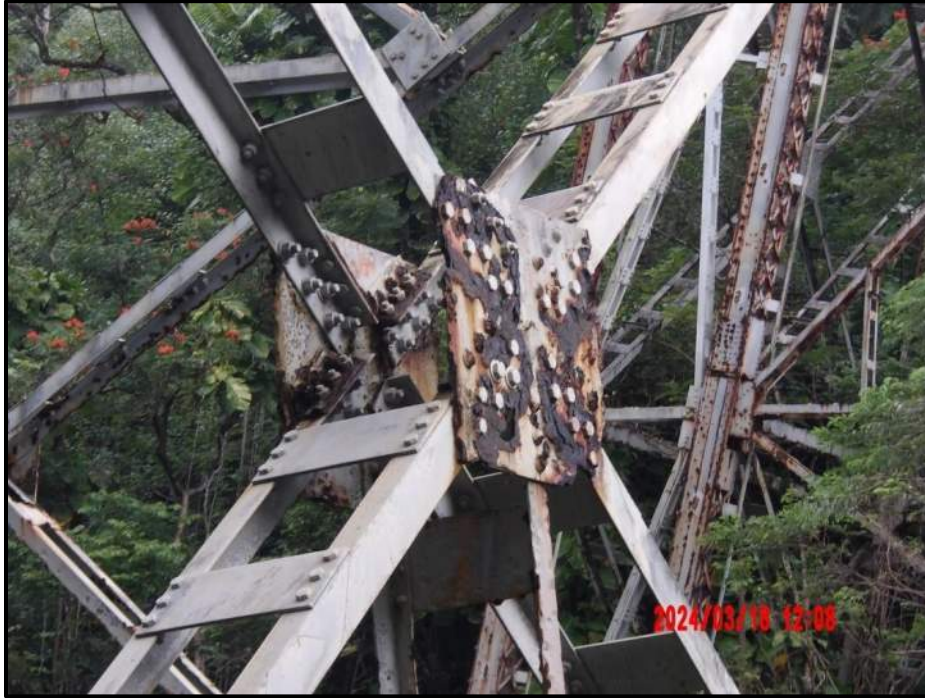
Photograph 65. Tower 3, Level 4, Column B, center gusset plate, looking northwest. Numerous corrosion holes on both gusset plates, CS3.

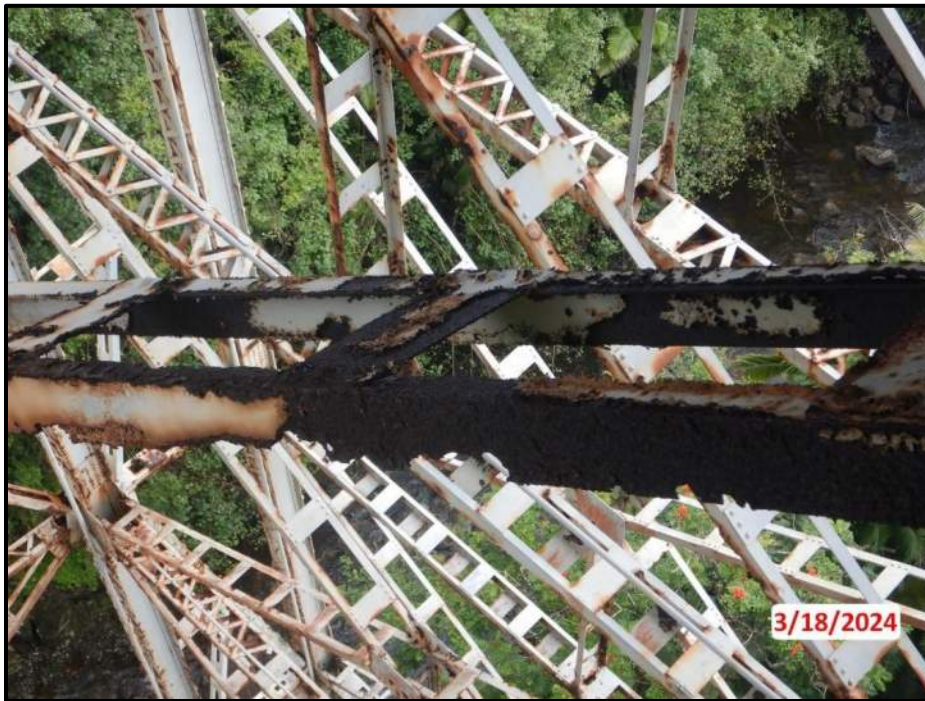
Photograph 66. Tower 3, Level 1, Column C, upper south to lower north diagonal bracing, looking northeast. Up to 6" L x 2" H corrosion holes with knife edging throughout both angles, CS3.

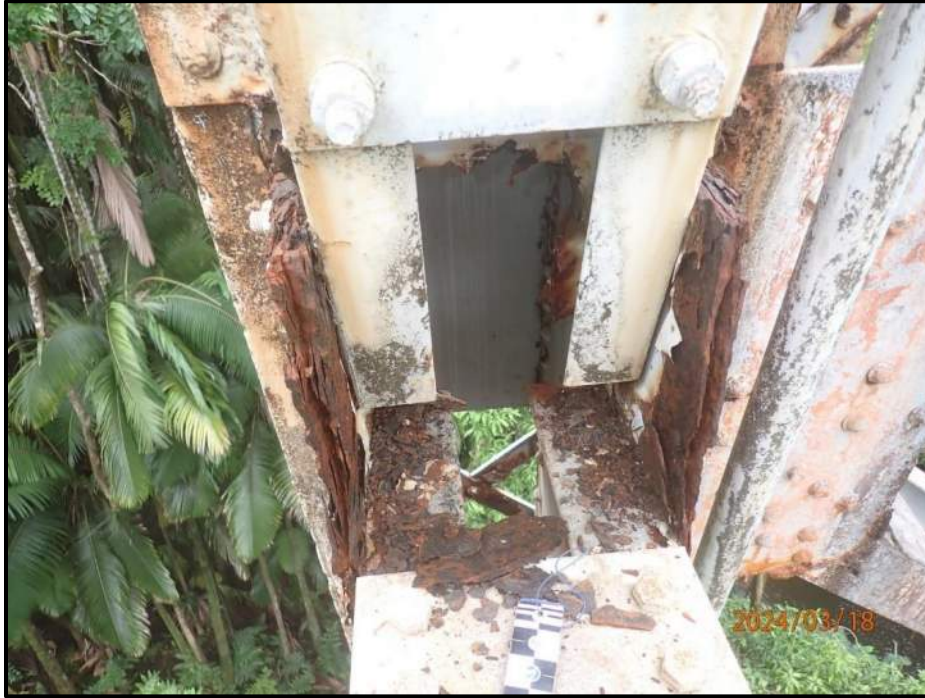
Photograph 67. Tower 3, Level 3, Column D, Bent 4 gusset plate, looking south. Heavy laminar corrosion with up to 50% section loss, CS3.

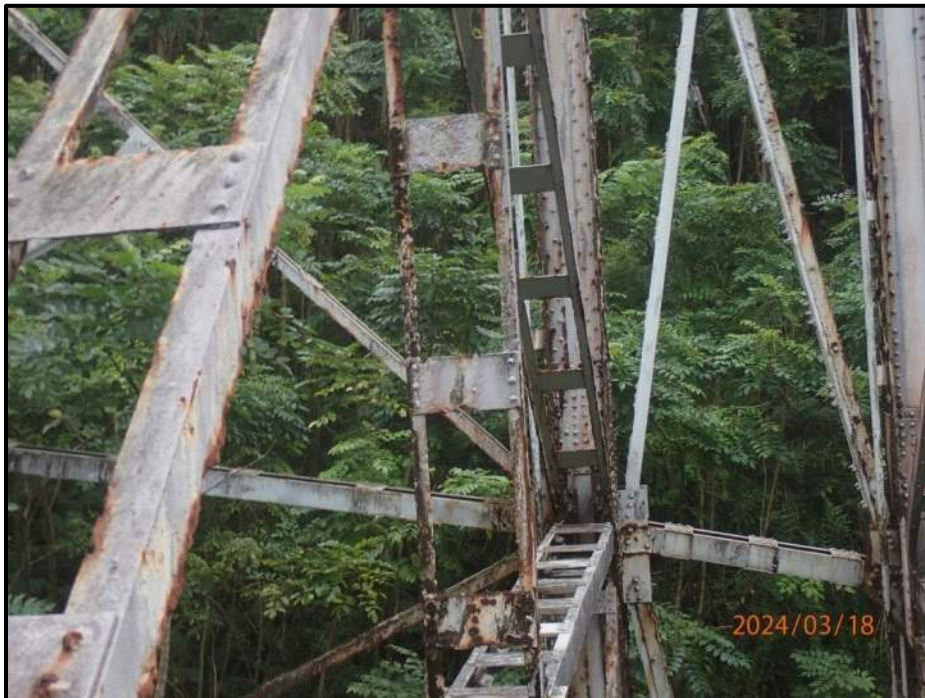
Photograph 68. Tower 3, Level 4, Column C, vertical bracing, looking east. Heavy corrosion of angles and batten plates on vertical with knife-edging, pitting up to 3/16" deep and corrosion holes up to 5" diameter, CS3.

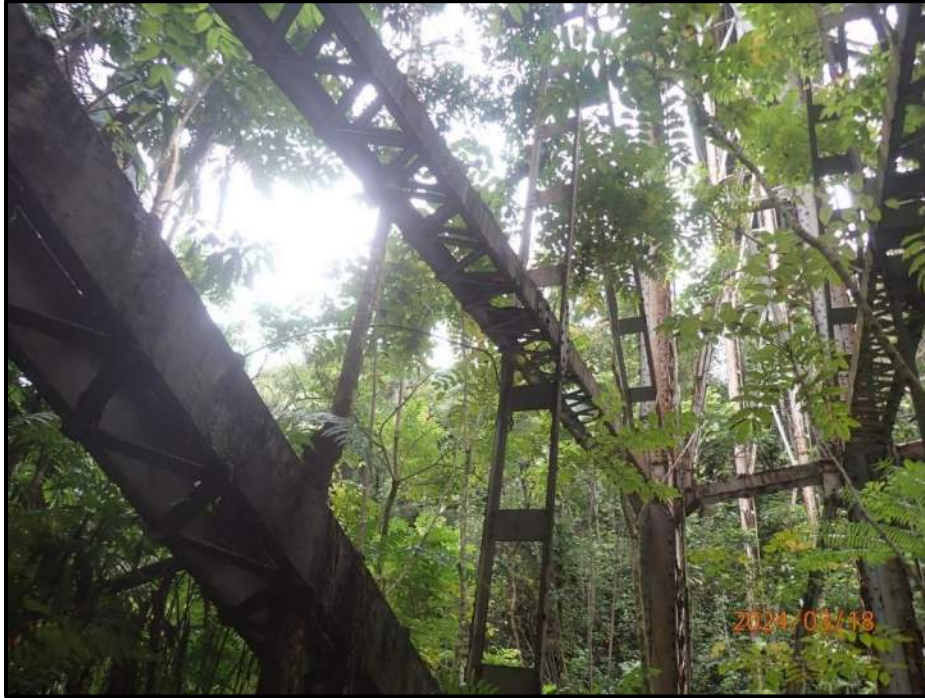
Photograph 69. Tower 3, Level 6, Column D, upper horizontal bracing, looking northwest. Vegetation, tree growing through members.

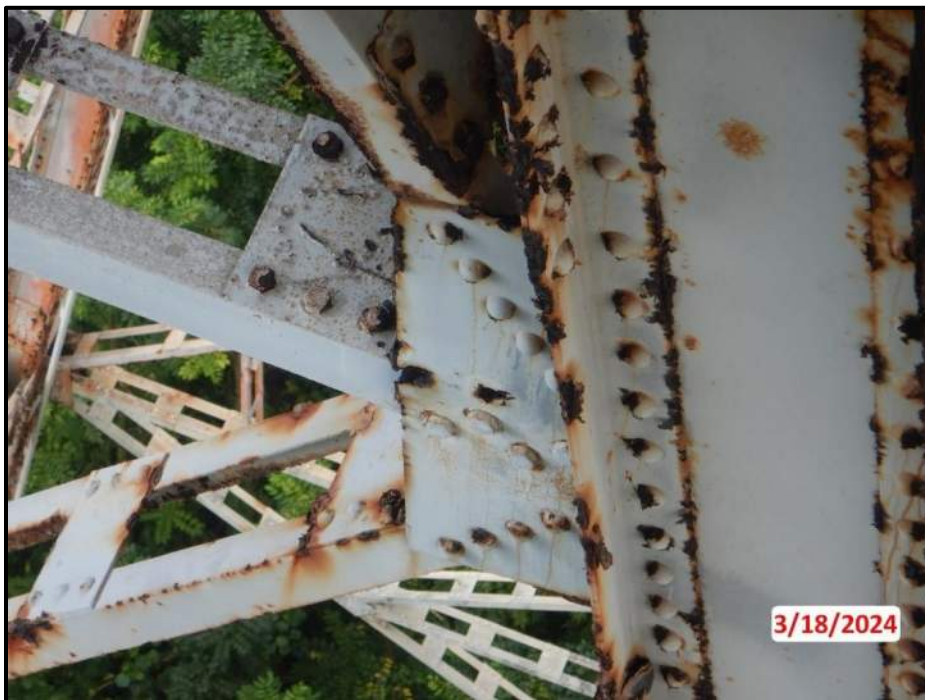
Photograph 70. Bent 5, Level 1, upper section, Column C, north gusset plate, looking southeast. (1) 1" diameter and (1) 2" diameter corrosion hole, CS3.

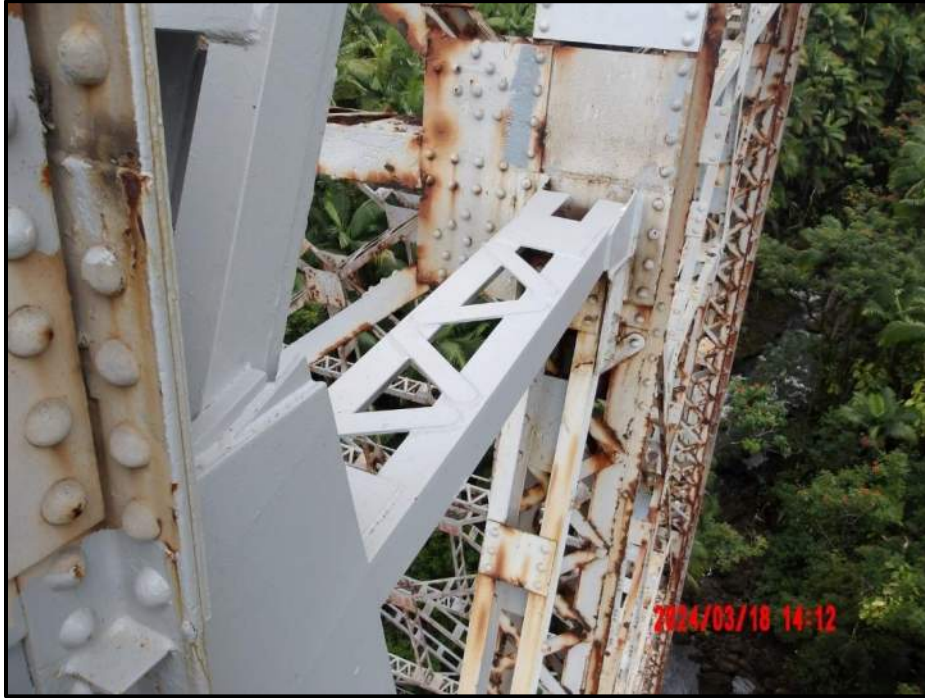
Photograph 71. Bent 5, Level 1, lower section, between Columns A and B, lower horizontal bracing, looking west. Column A lower gusset plates exhibit up to 100% section loss above and below horizontal member with 5" L segments of 25% section left holding members. - Repaired

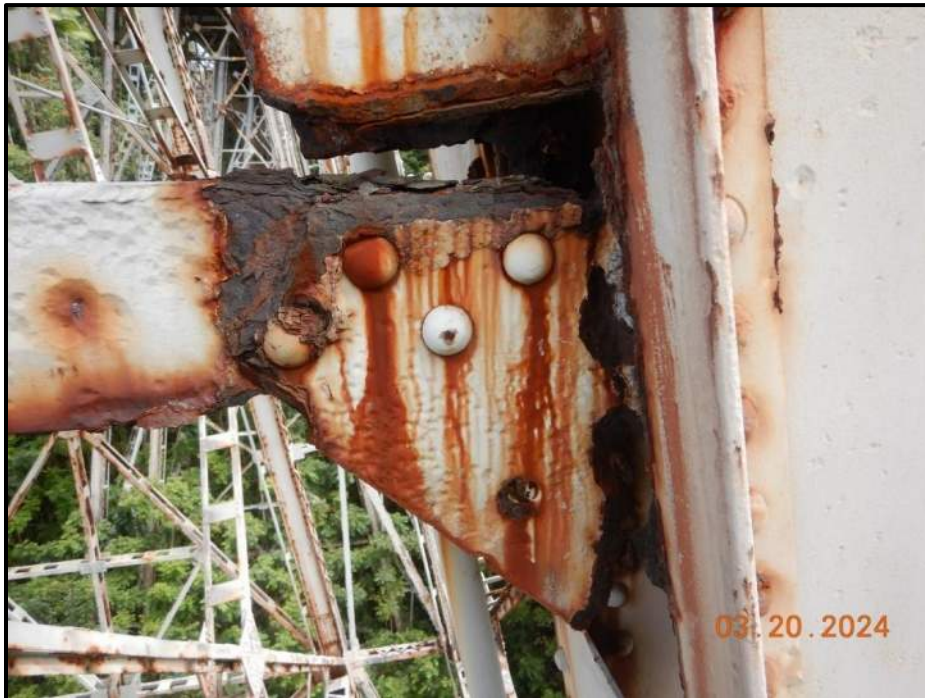
Photograph 72. Bent 5, Level 1, lower section, Column D, horizontal bracing, gusset plate, looking south. North gusset plate has 9" H x up to 3" W area of 100% section loss at connection to Column D, CS4. South gusset plate (6) corrosion holes up to 2" diameter and (1) on north gusset plate, CS3.

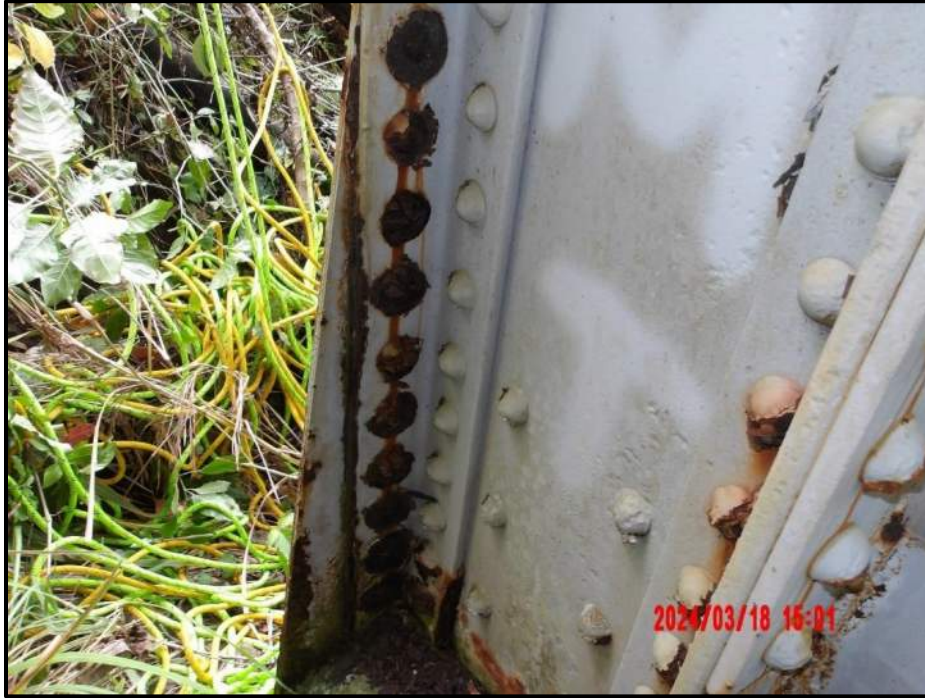
Photograph 73. Bent 5, Level 2, Column B, exterior gusset plate, looking south. Multiple corrosion holes up to 5" x 2-1/2" and pitting up to 1/16" deep in exterior gusset plate; interior rivet heads at connection to column typically have up to 100% section loss in this location, CS3.
