**STATE OF HAWAII
DEPARTMENT OF TRANSPORTATION**

**ADDENDUM NO. 2
FOR
HAWAII BELT ROAD
NANUE STREAM BRIDGE REHABILITATION
VICINITY OF HILO
DISTRICT OF HILO, ISLAND OF HAWAII
FEDERAL-AID PROJECT NO. BR-019-2(077)**

December 13, 2024

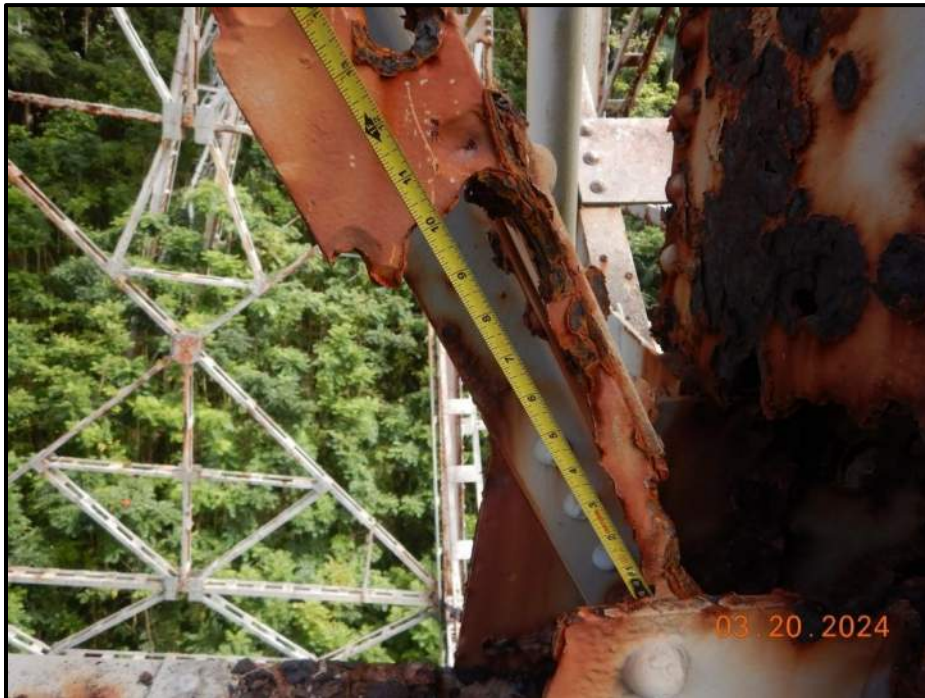
Photograph 74. Bent 5, Level 2, between Columns B and C, lower west diagonal bracing, connection to Column C, looking south. North angle exhibits (2) 10" L x up to 4" H holes with 1" x 3" remaining section. Remaining length of diagonal exhibits knife-edging and pitting, CS4.

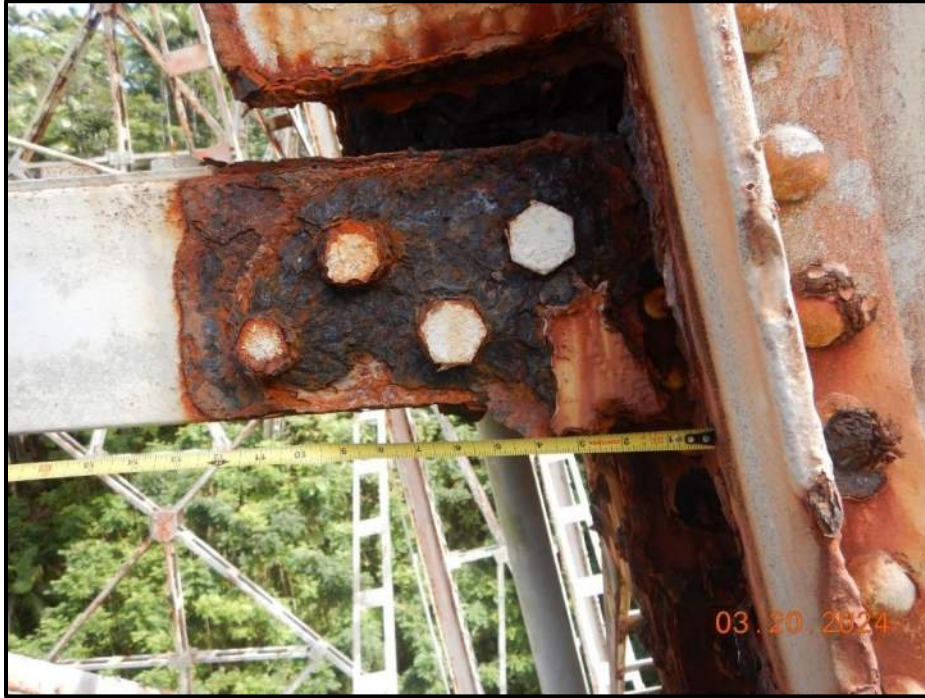
Photograph 75. Bent 5, Level 2, Column D, horizontal bracing gusset plates, looking south. Heavy laminar corrosion with up to 100% section loss with 15% section remaining of the north gusset plate and repair plates becoming ineffective. The gusset plate is completely detached from the column, CS4.

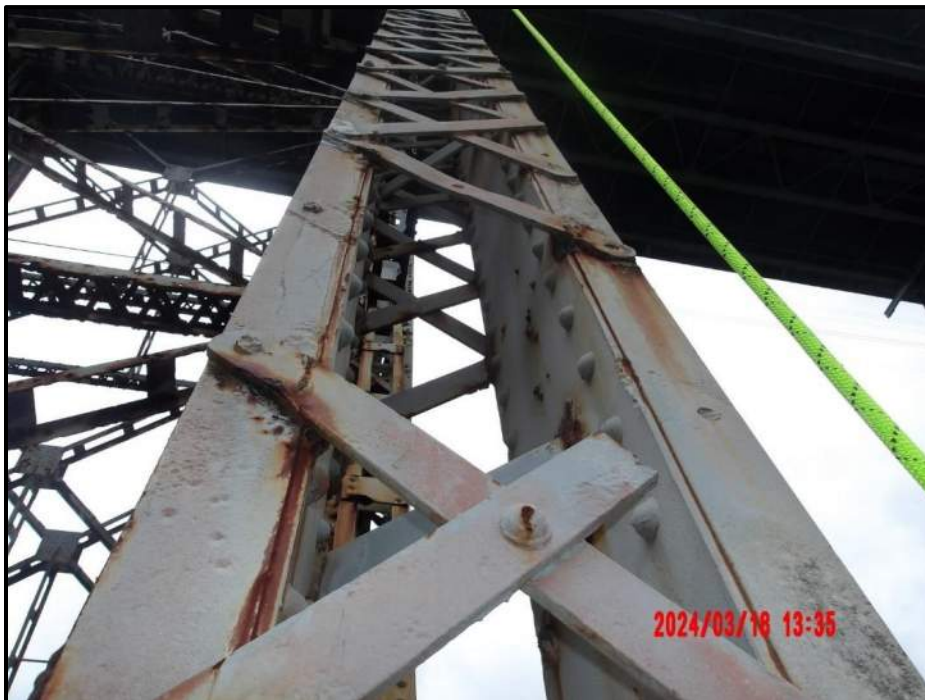
Photograph 76. Bent 5, Level 3, Column A, (9) lacing bars, looking west. Removed from column, CS3.

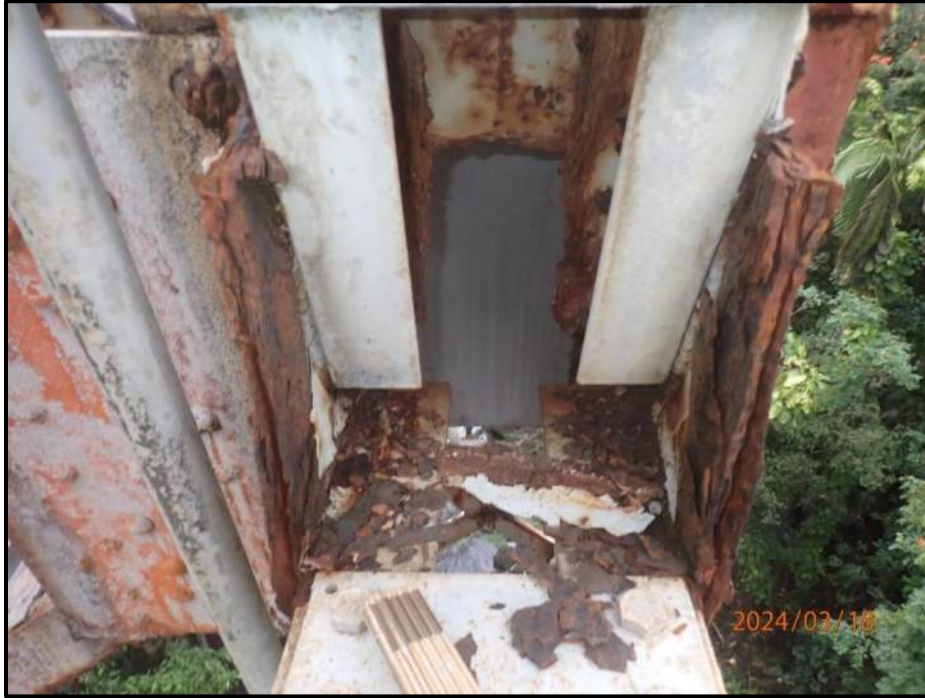
Photograph 77. Bent 5, Level 3, between Columns C and D, diagonal bracing, outboard angles, looking south. 10" L x up to full height section loss with adjacent corrosion holes, extreme deterioration up to 90% cross section reduction having no change from previous inspection, CS4.

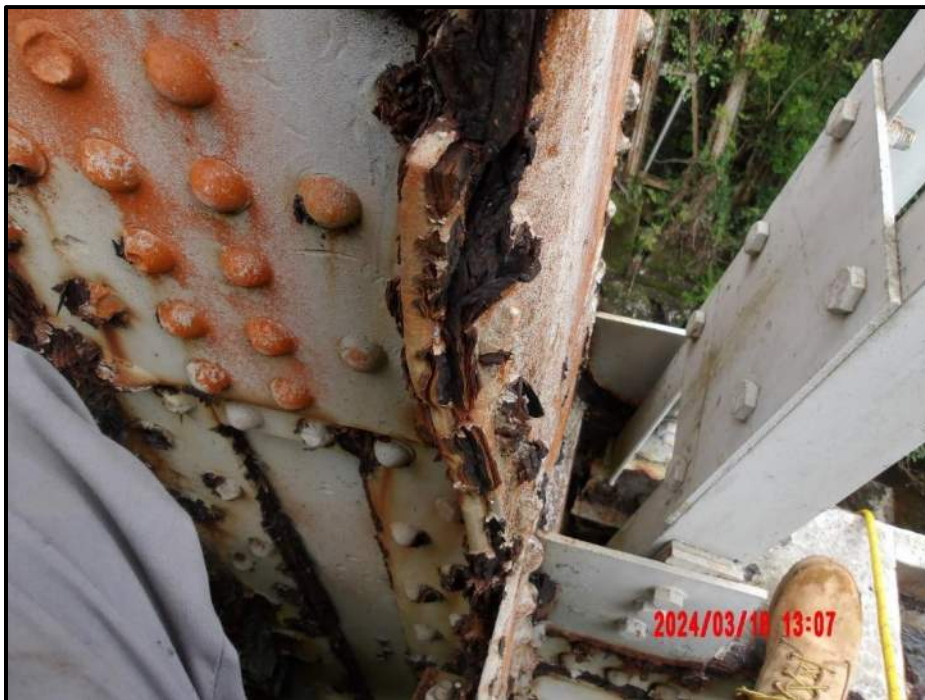
Photograph 78. Bent 5, Level 4, Column B, vertical at southeast flange splice, looking north. Column is deformed, 1' 10" L x 1" deflection, CS3.

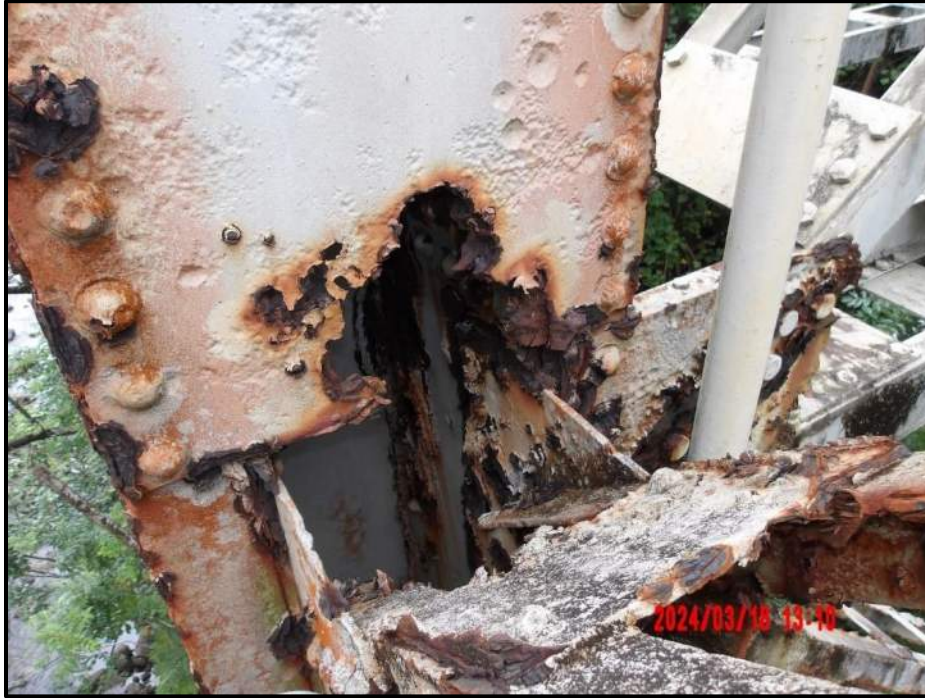
Photograph 79. Bent 5, Level 4, Column B, west cover plate, looking east. Corrosion hole, 9" diameter, CS3.

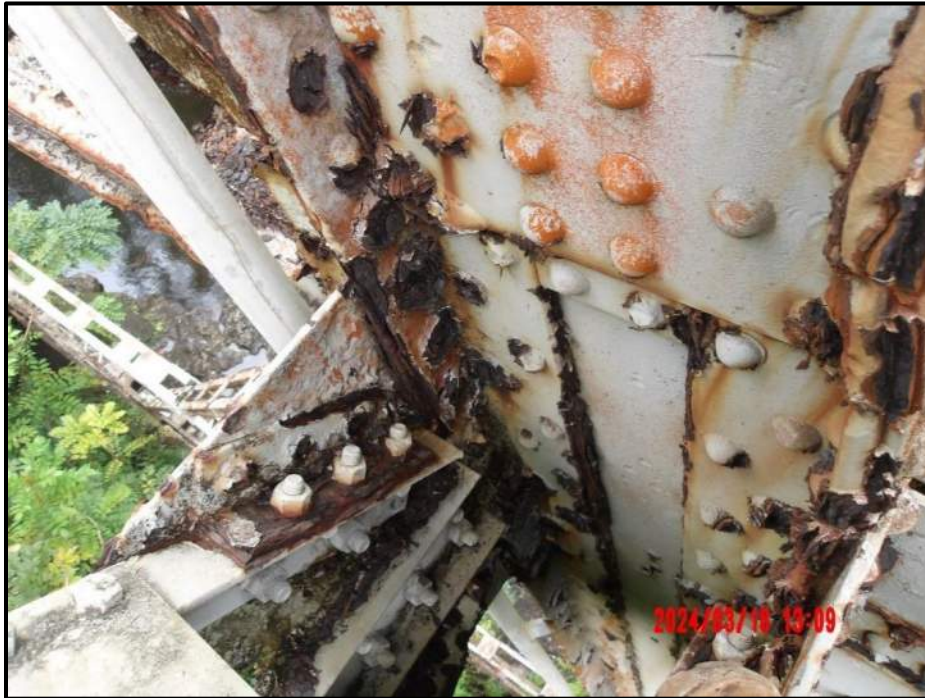
Photograph 80. Bent 5, Level 5, Column B interior splice plate rivets, looking northwest. Up to 100% section loss, corrosion, CS3.

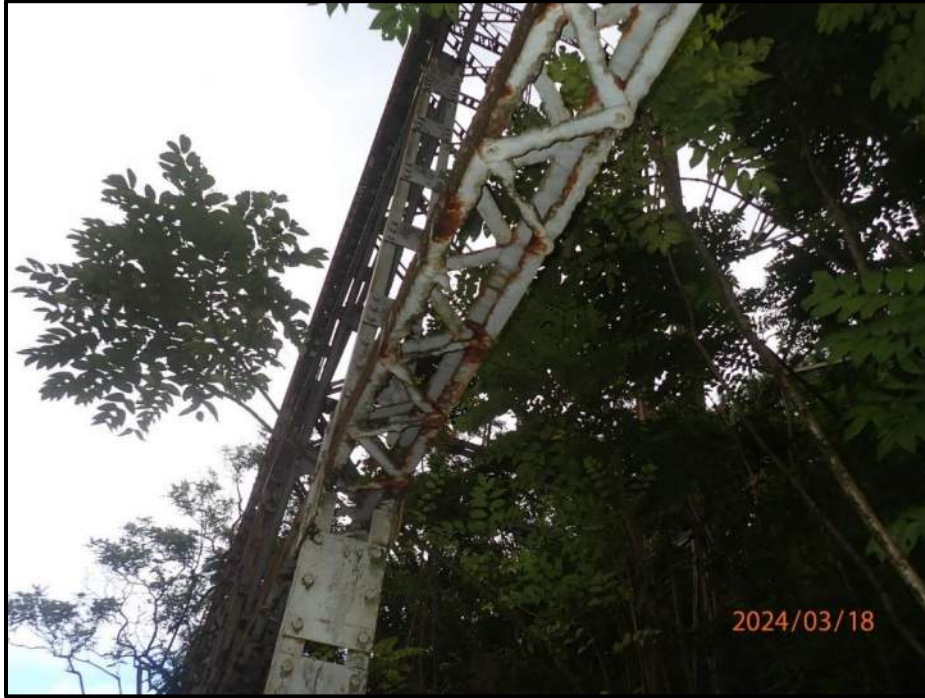
Photograph 81. Bent 5, Level 5, between Columns B and C, horizontal bracing, top and bottom lacing bars, looking east. Up to 100% section loss, CS3.

16	Bent 2, Level 1, lower section, Column A, interior gusset plates: Up to 1" W x full length section loss where all members frame in, CS3, (Similar to Photo 19).
17	Bent 2, Level 1, lower section, between Columns B and C, horizontal bracing, lacing bars: (2) with 75% section loss, CS3, (Similar to Photo 81).
18	Bent 2, Level 1, lower section, Column C, interior face of south web cover plate: Painted-over pitting up to 3" diameter x 1/4" deep, CS3, (Similar to Photo 123).

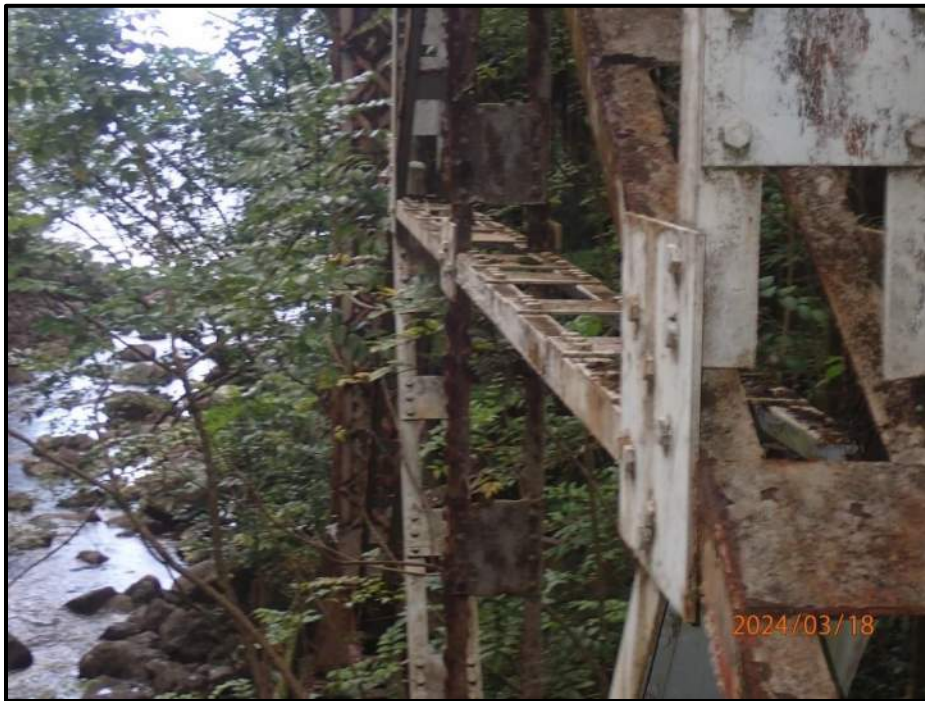
Photograph 82. Bent 5, Level 6, between Columns B and C, vertical bracing, looking east. Up to 25% section loss and pitting up to 1/8" deep, CS3.

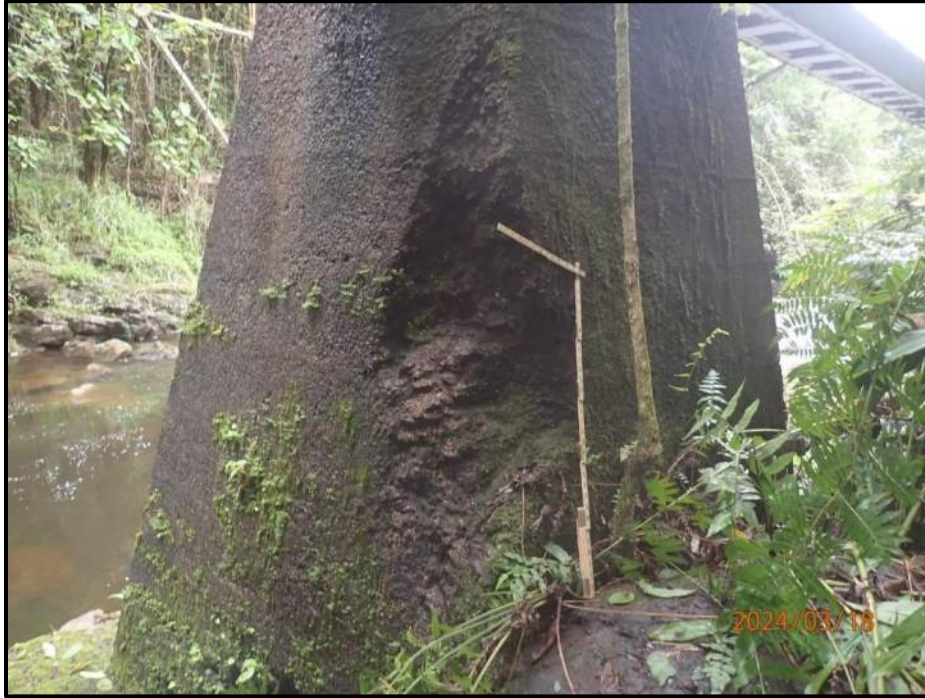
Photograph 83. Bent 5, Level 6, Column C, footing, southwest corner, looking east. Spall, 5' H x 1' 4" W x up to 10" deep, CS3.

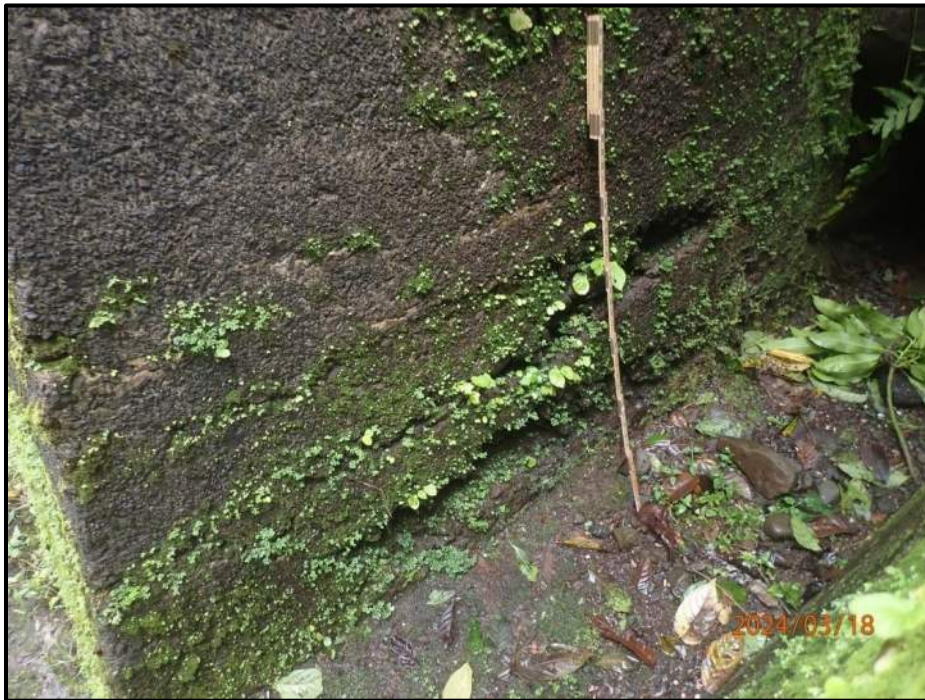
Photograph 84. Bent 5, Level 6, Column C, footing, base of pedestal on west side, looking east. 6' x 2' area of abrasion with course aggregate exposed and missing up to 4" deep, CS3.

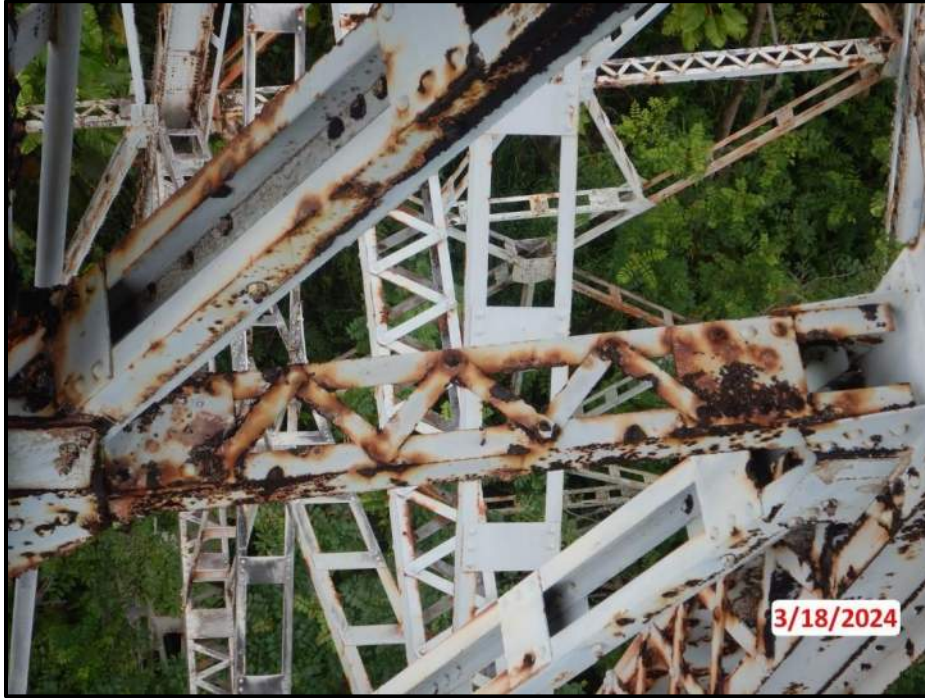
Photograph 85. Bent 6, Level 1, upper section, between Columns C and D, horizontal bracing, looking north. Heavy pitting with 1' 6" L x 2" H area of 100% section loss, CS3.

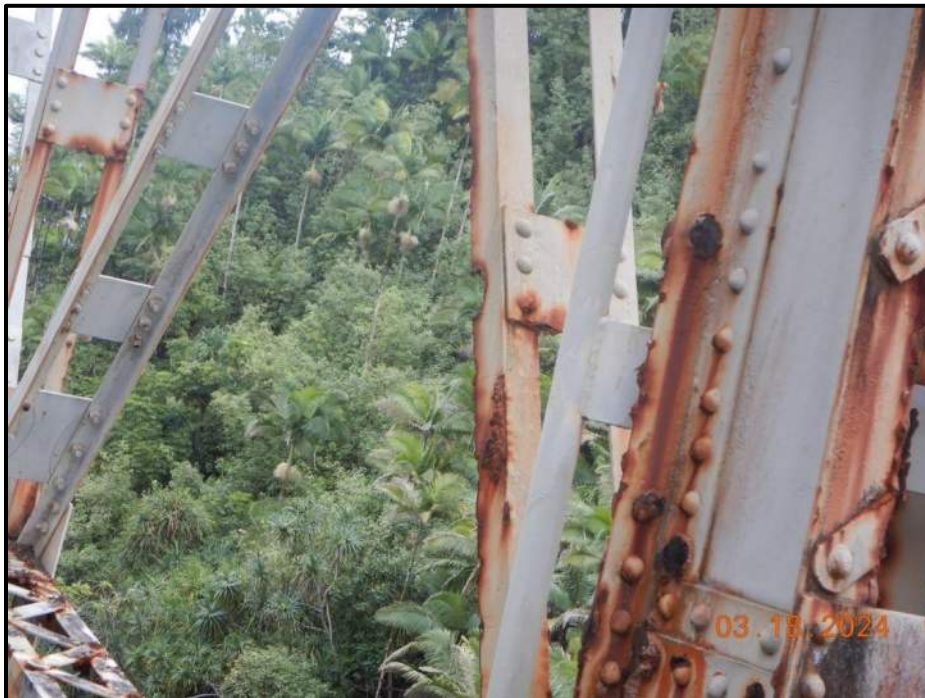
Photograph 86. Bent 6, Level 2, between Columns B and C, lower west diagonal bracing near Column C, north angle vertical leg, looking southeast. Corrosion hole, 3" L x 2" H, CS3.

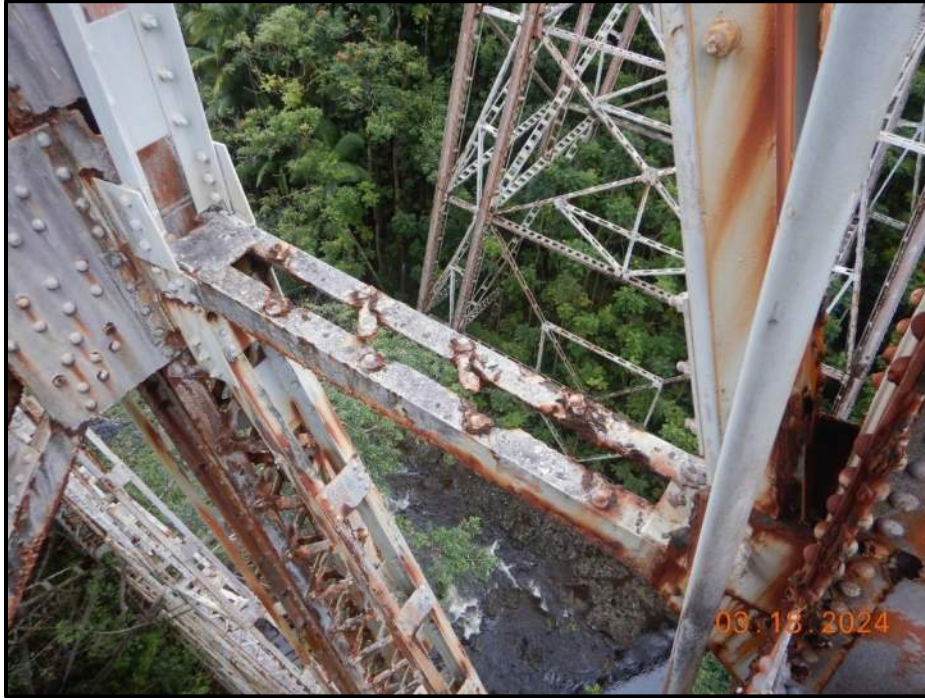
Photograph 87. Bent 6, Level 2, between Columns C and D, horizontal bracing, all (4) lacing bars, looking southeast. 100% section loss, CS3.

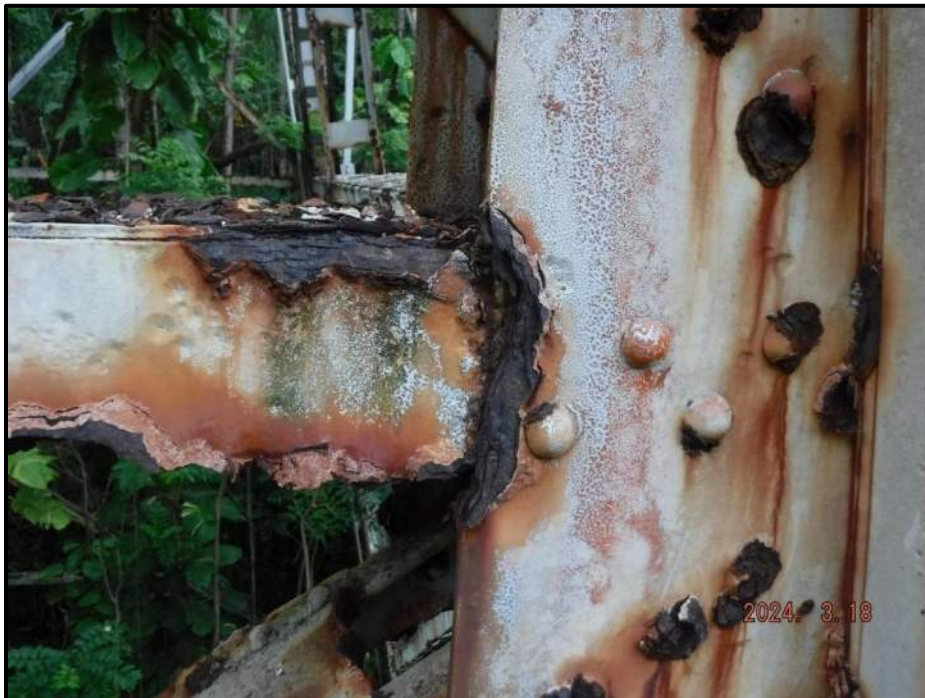
Photograph 88. Bent 6, Level 3, west of Column B, south gusset plate, looking north. 1-1/2" W x 8" H area of 100% section loss, CS3.

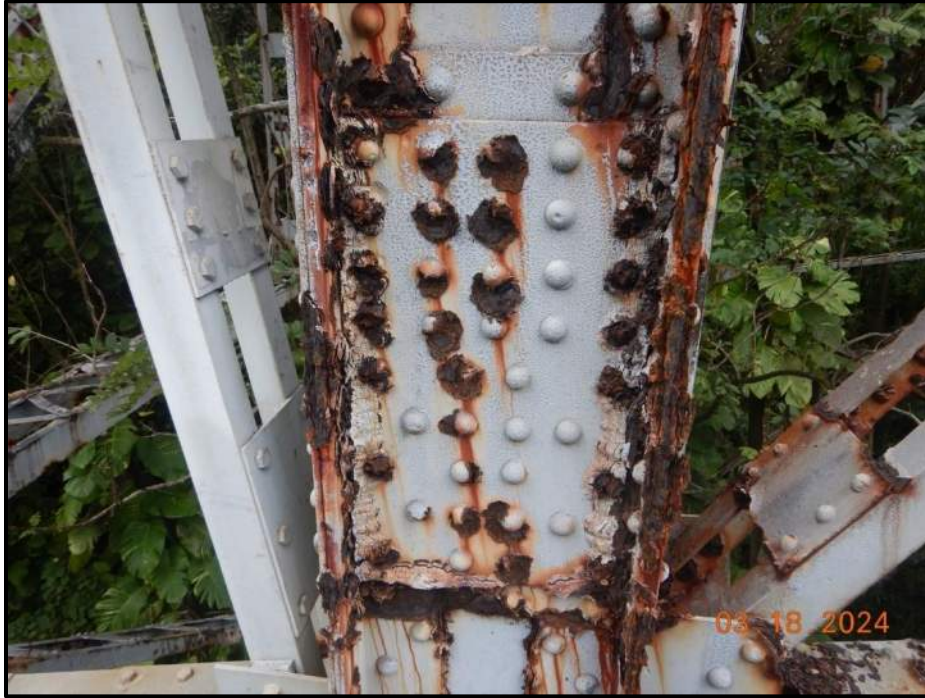
Photograph 89. Bent 6, Level 3, Column C, south face cover plate, looking north. 50% of rivet heads have up to 20% remaining section, CS3.

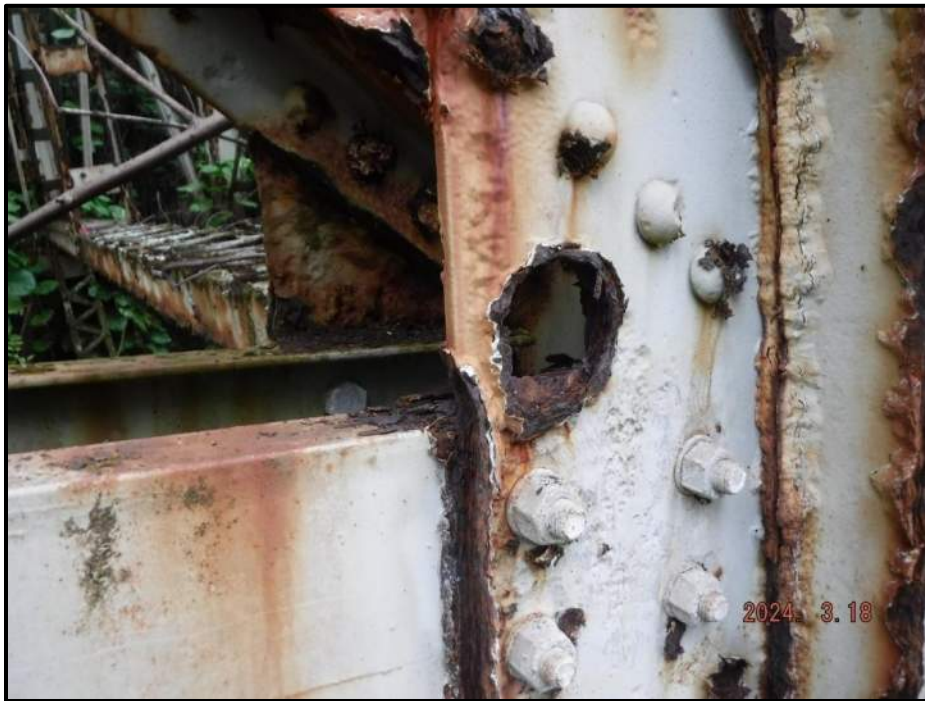
Photograph 90. Bent 6, Level 4, Column B, exterior gusset plate at horizontal bracing, looking south. 3-1/2" diameter corrosion hole, CS3.

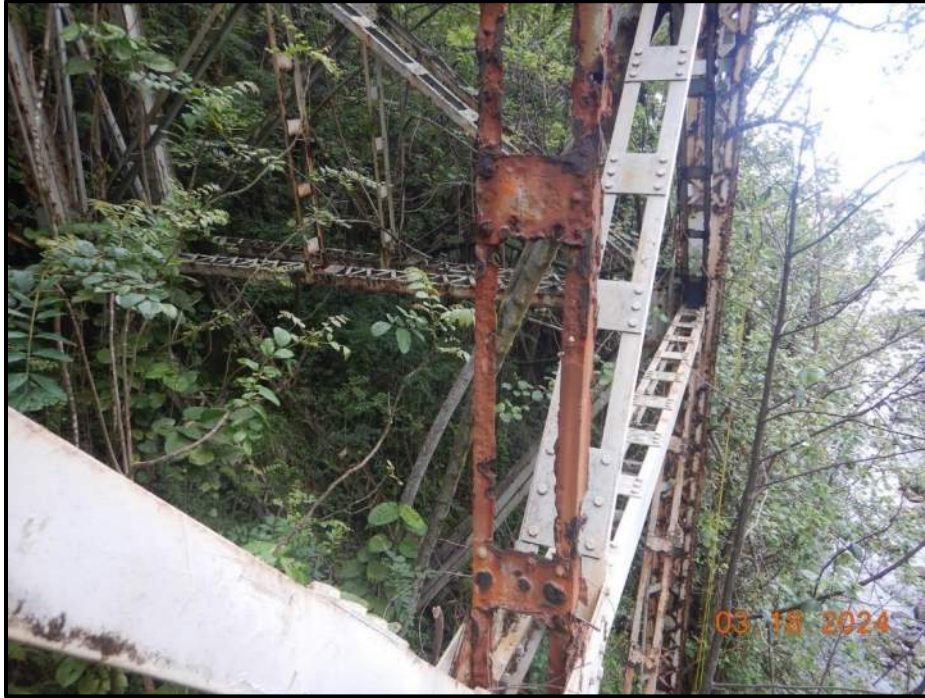
Photograph 91. Bent 6, Level 4, between Columns B and C, vertical bracing, looking east. Severe corrosion throughout this member with up to 60% cross sectional loss, CS4.

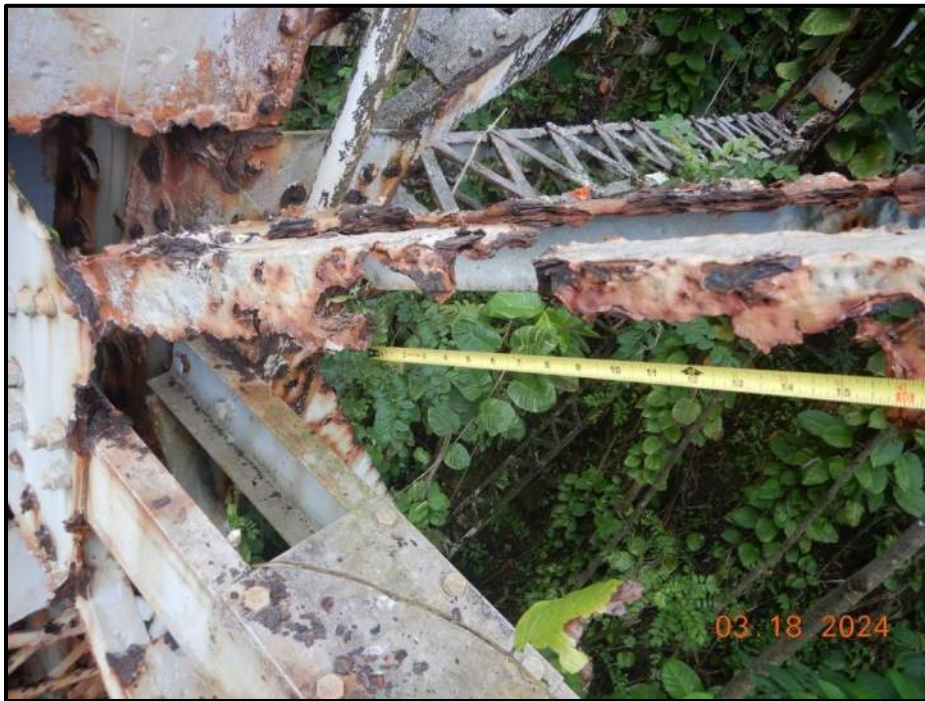
Photograph 92. Bent 6, Level 4, between Columns B and C, lower west diagonal adjacent to Column C, looking northwest. Corrosion holes and knife-edging at exterior vertical flange and section of missing vertical flange at lower end for 1' 6" L, CS3.

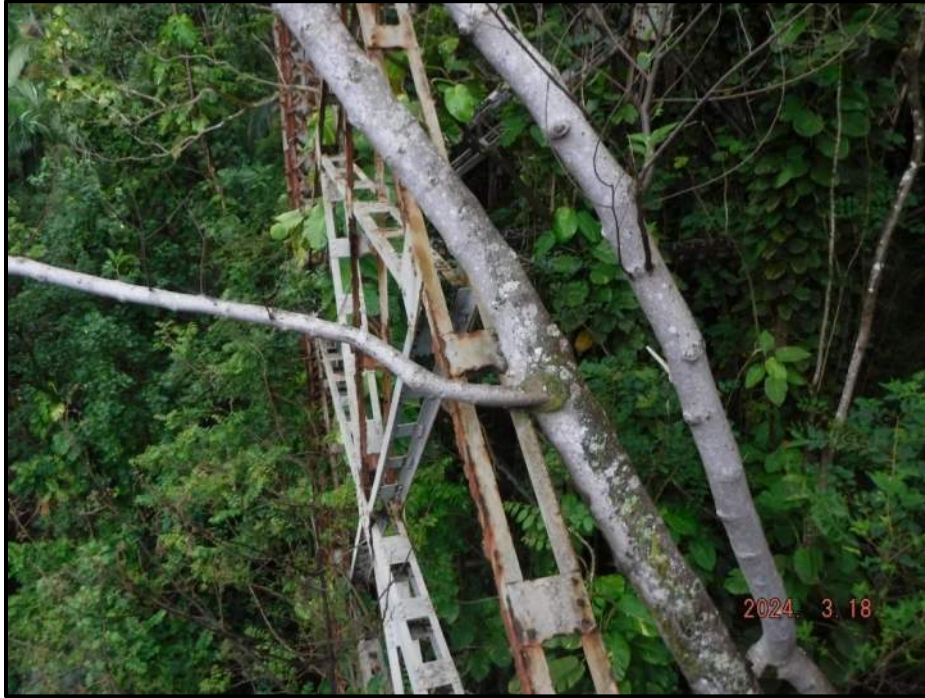
Photograph 93. Bent 6, Level 4, between Columns B and C, lower east diagonal bracing, looking west. Large tree leaning heavily on bracing, CS3.

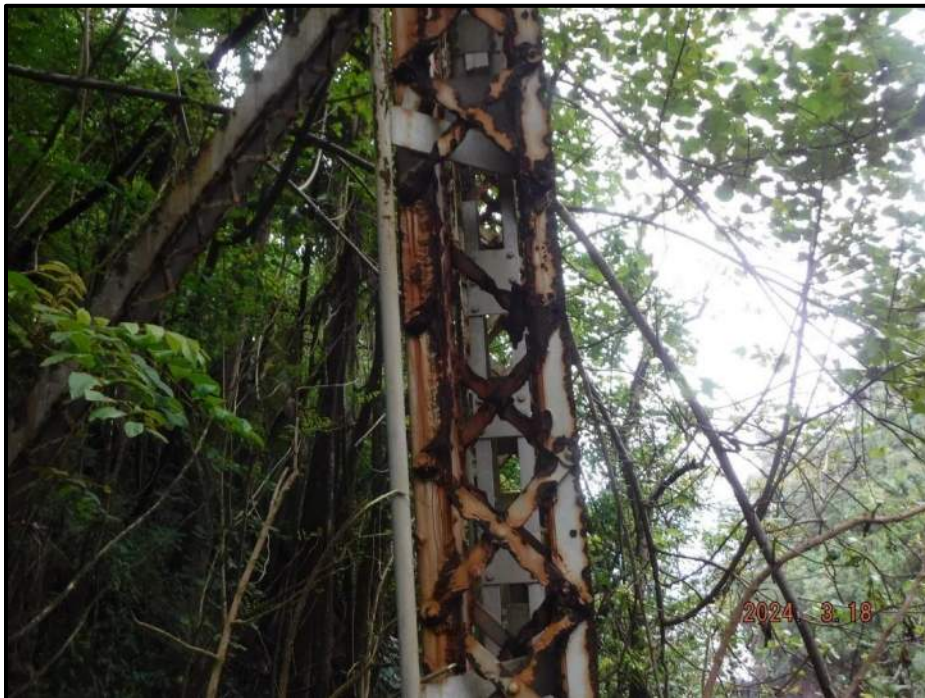
Photograph 94. Bent 6, Level 5, Column B, looking east. Almost all lacing bars on the west side of the column have 100% section loss; (6) bars remaining intact at time of inspection, CS4.

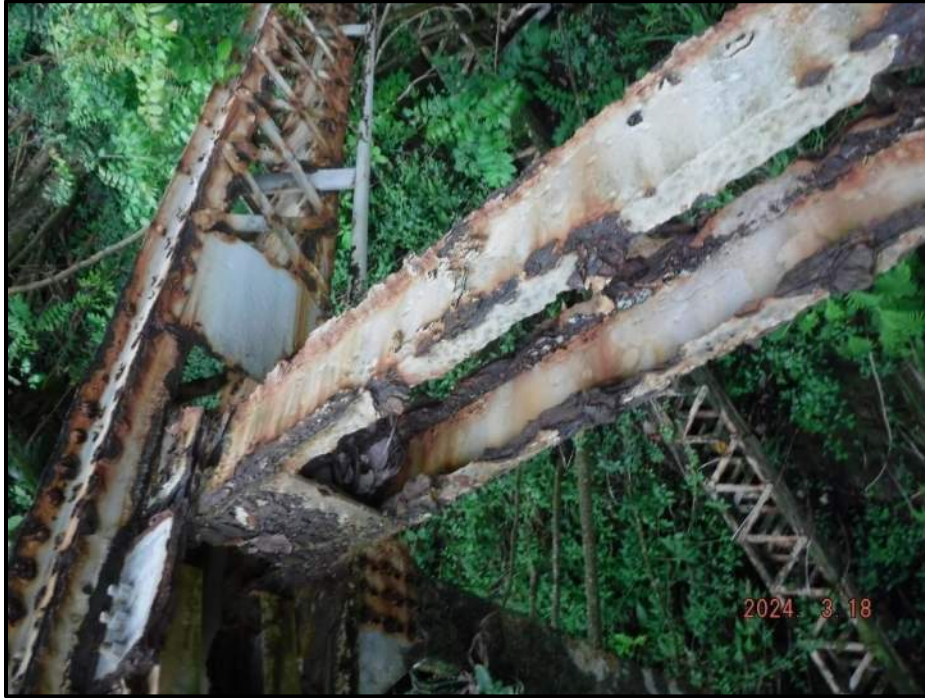
Photograph 95. Bent 6, Level 5, between Columns A and B, horizontal bracing web members, looking southeast. Up to 75% section loss throughout, CS4.

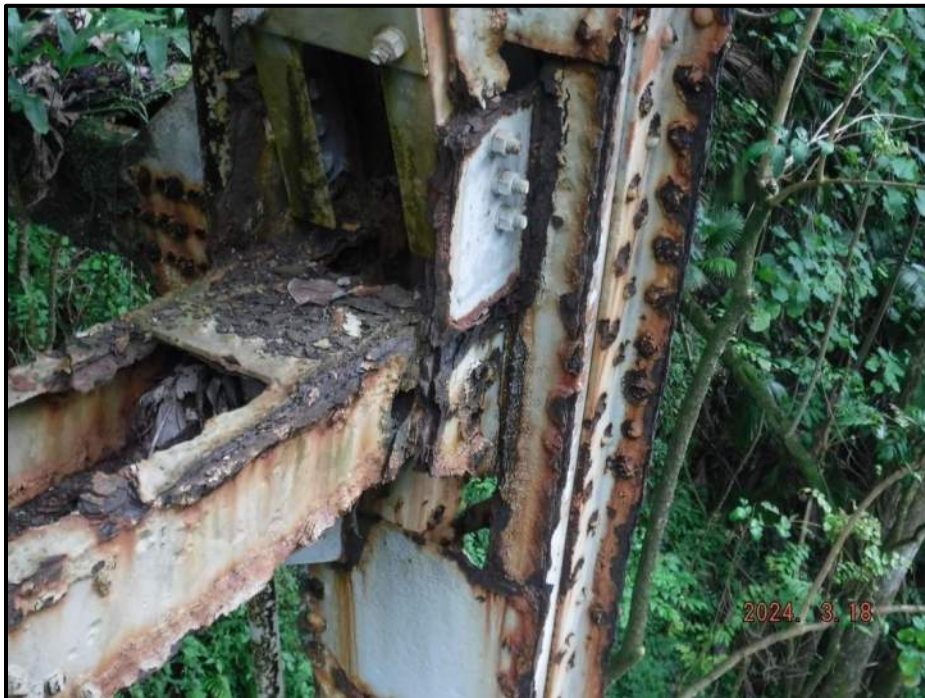
Photograph 96. Bent 6, Level 5, Column A, gusset plate at horizontal bracing, looking northeast. 75% section loss with corrosion holes, CS3.

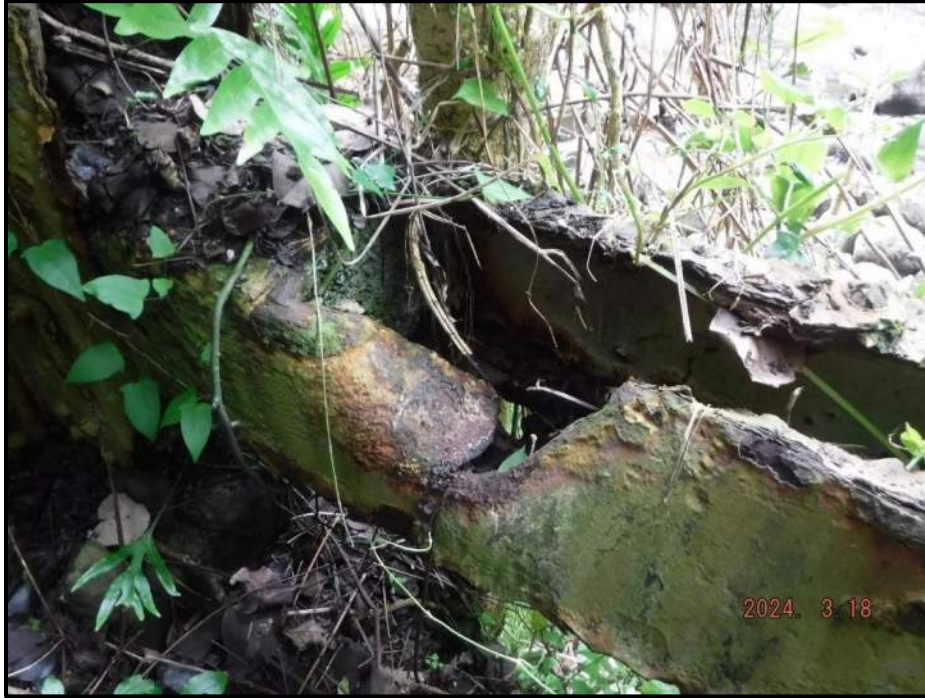
Photograph 97. Bent 6, Level 6, between Columns A and B, horizontal bracing, looking northeast. Damage, member impacted by falling rocks, CS3.

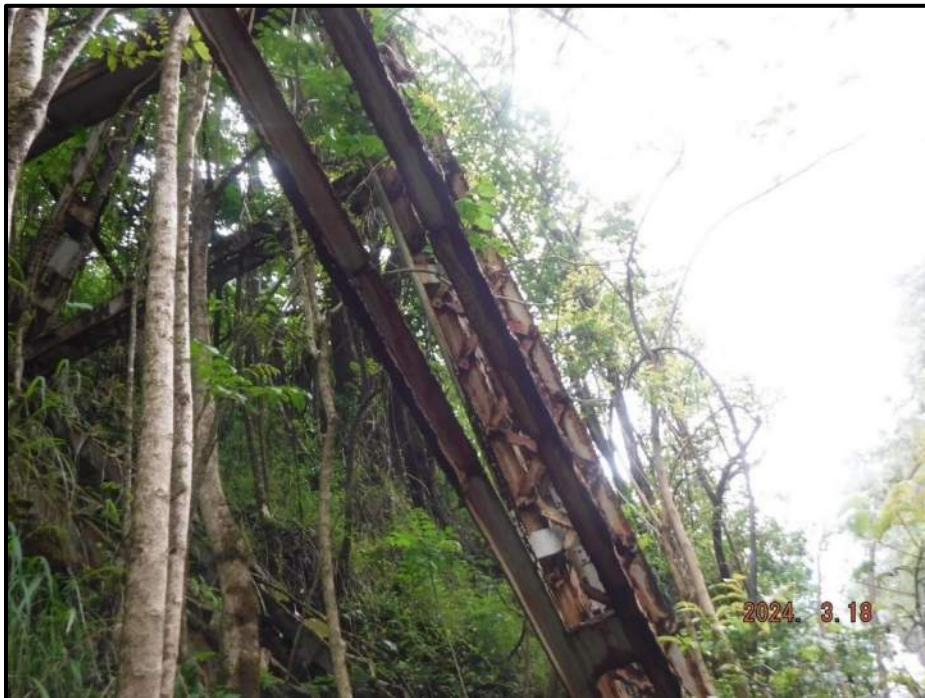
Photograph 98. Bent 6, Level 6, between Columns B and C, lower east diagonal at third point closest to Column B, looking east. Missing batten plate, CS3.

-Tower 3, Bent 4 to 5, Column A, Level 3 - Vertical in Level 3 is completely detached from the upper horizontal member of Level 4. - Repaired, (See Photo 98).

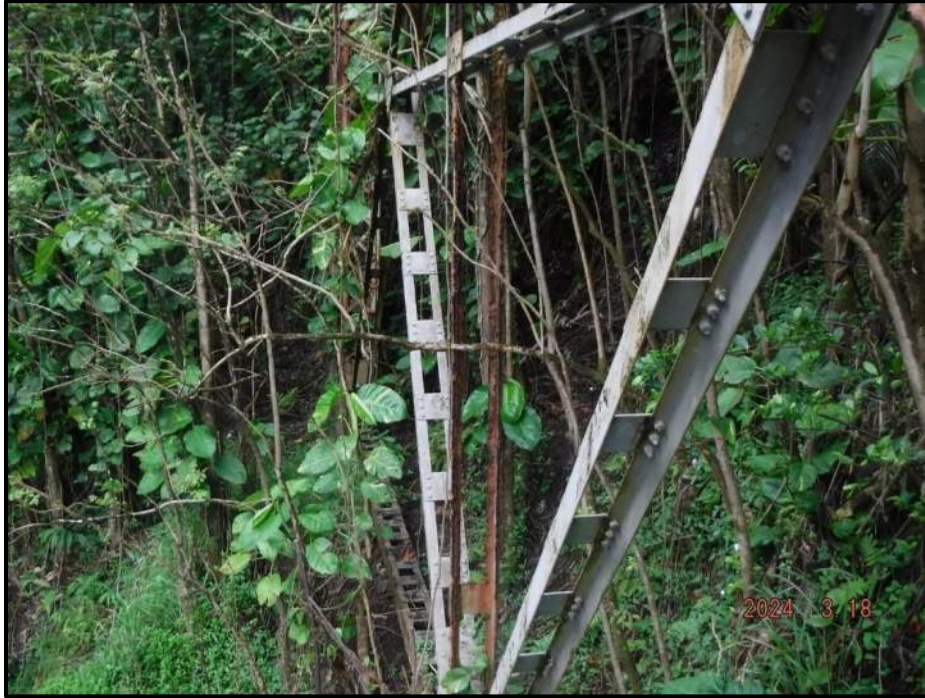
Photograph 99. Bent 6, Level 6, between Columns B and C, mid-length vertical bracing above crossing horizontal, looking west. Detached batten plate, CS3.

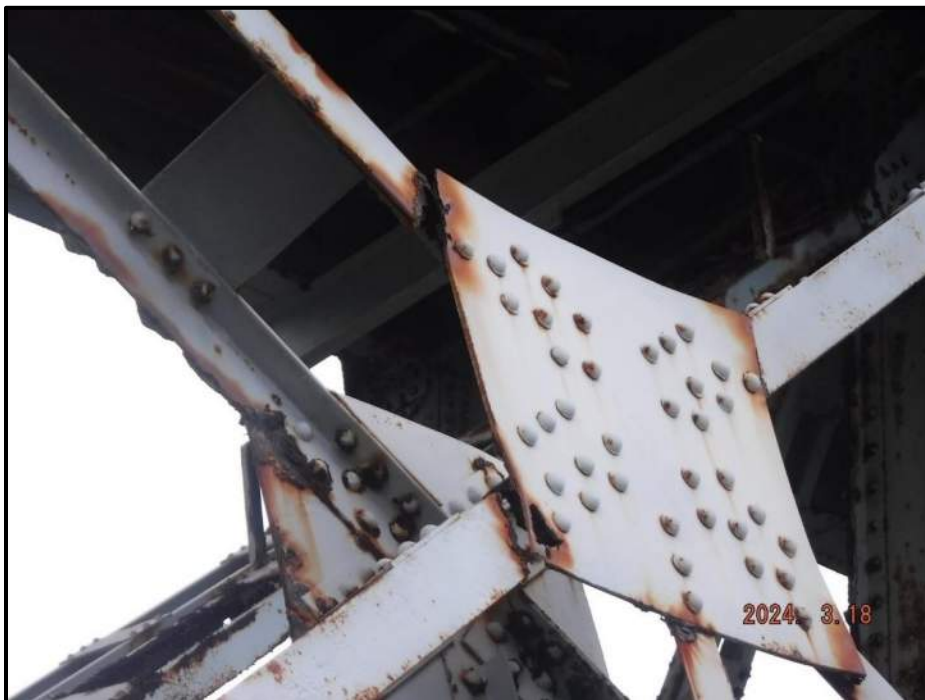
Photograph 100. Tower 4, Level 1, Column B, lower south diagonal bracing, looking northwest. Exterior angle of diagonal has 100% section loss to vertical leg and only 2-1/2" of section remaining on horizontal leg; angle is deformed 1/4" over 10" near section loss; gusset plate has 3" diameter corrosion hole, CS4.

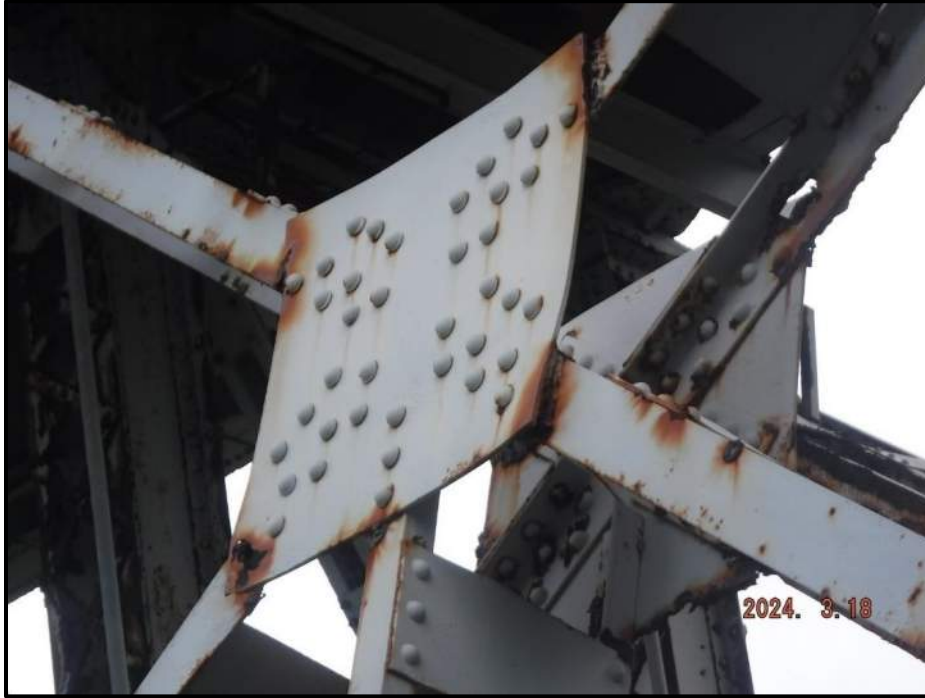
Photograph 101. Tower 4, Level 1, Column B, upper north diagonal bracing, looking southwest. Interior angle of diagonal has 3" diameter corrosion hole in vertical leg of angle at connection, CS4.

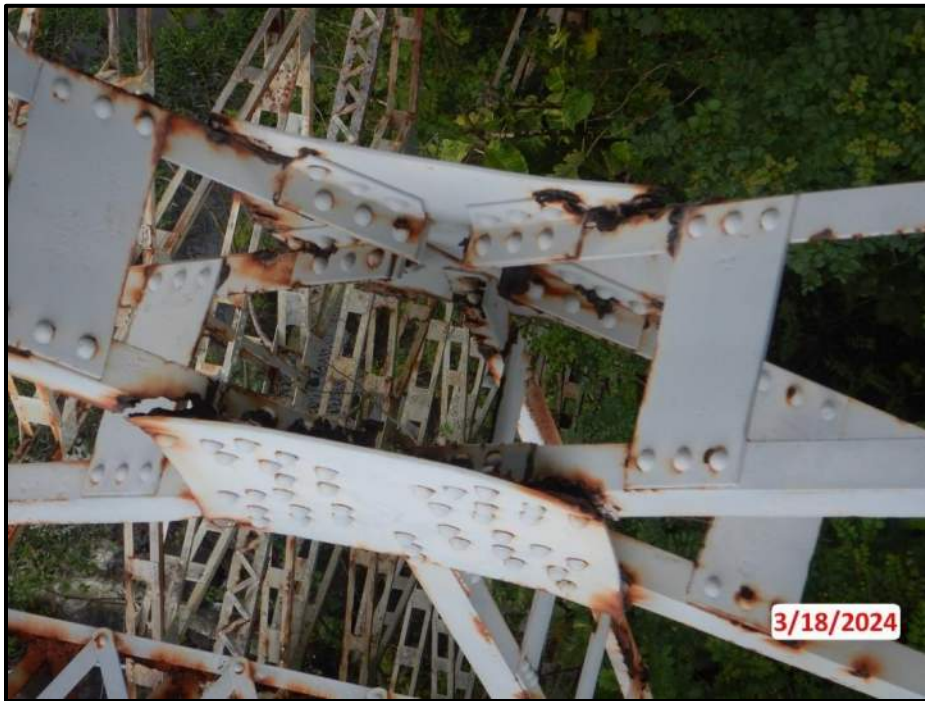
Photograph 102. Tower 4, Level 1, Column B, upper south diagonal bracing, looking west. Exterior angle of diagonal has 100% section loss to vertical leg and only 2" of section remaining on horizontal leg; angle is deformed 1/4" over 10" near section loss, CS4.

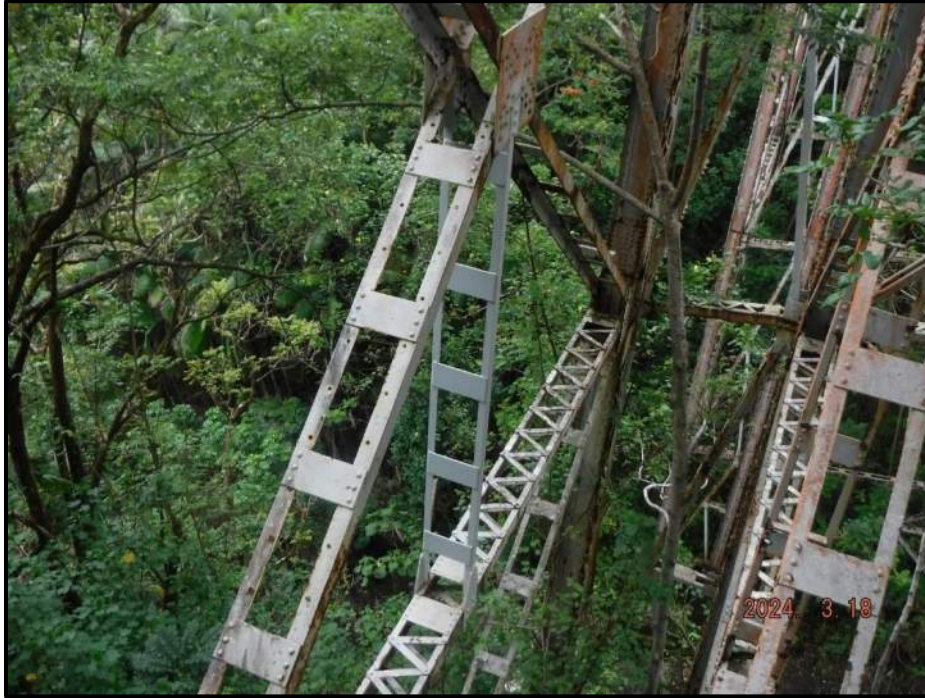
Photograph 103. Tower 4, Level 3, Column A, vertical bracing, looking southeast. Section loss, exterior leg with 80% loss. - Repaired. Top connection bolts of repaired section is not painted and exhibits surface corrosion, CS2.

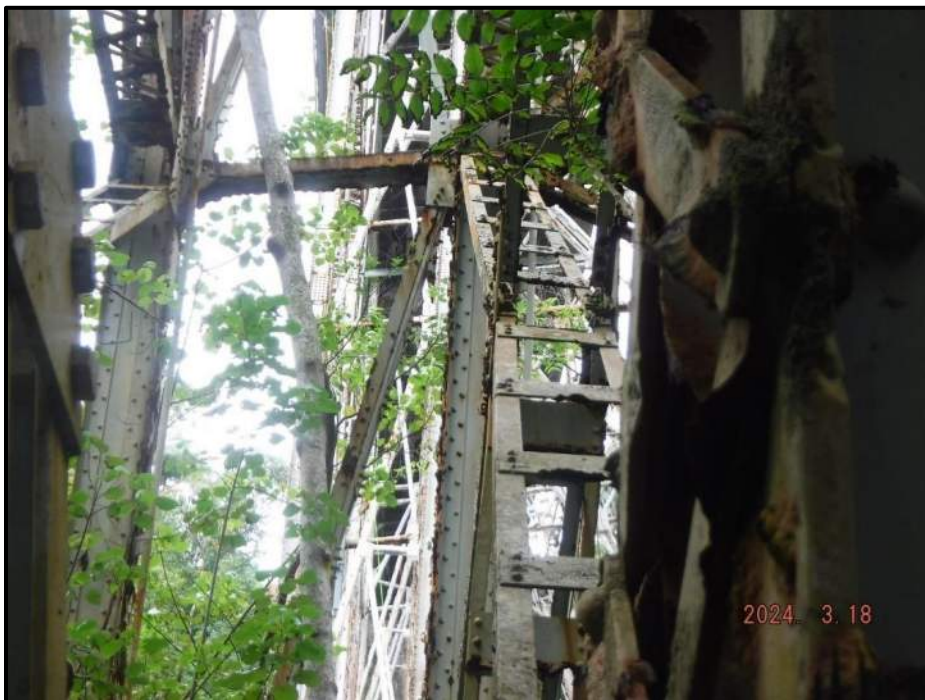
Photograph 104. Tower 4, Level 4, Column B, looking south. All bracing in this level bowed up to 6" inwards (west); vertical member angles have deformations up to 1" over 2', CS3.

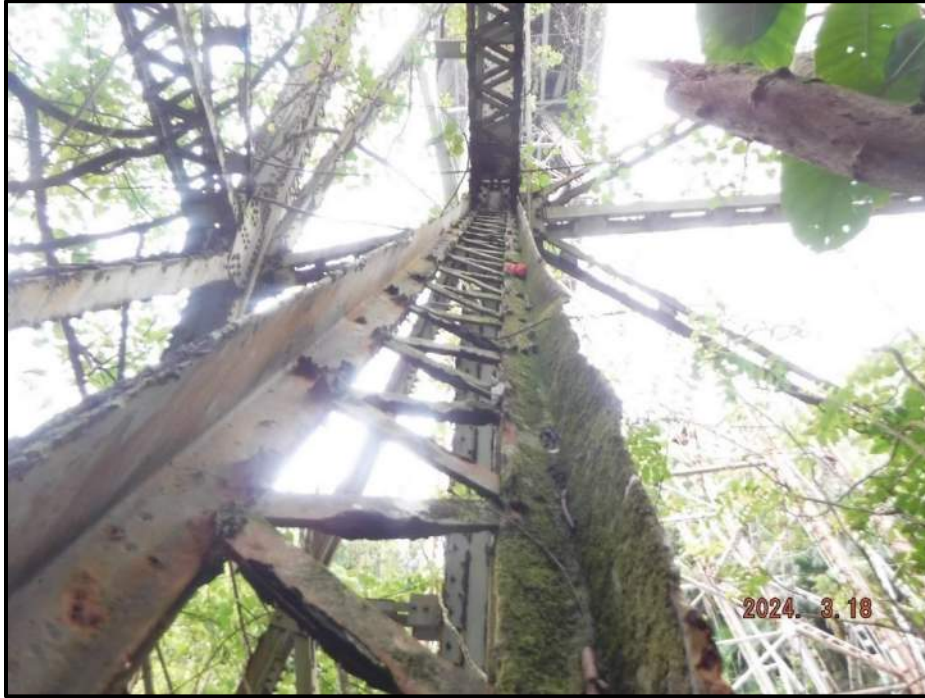
Photograph 105. Tower 4, Level 5, Column B, mid-diagonal bracing, interior angle, looking south. Twisted over full length with deformation up to 6" over 2' 6", CS3.

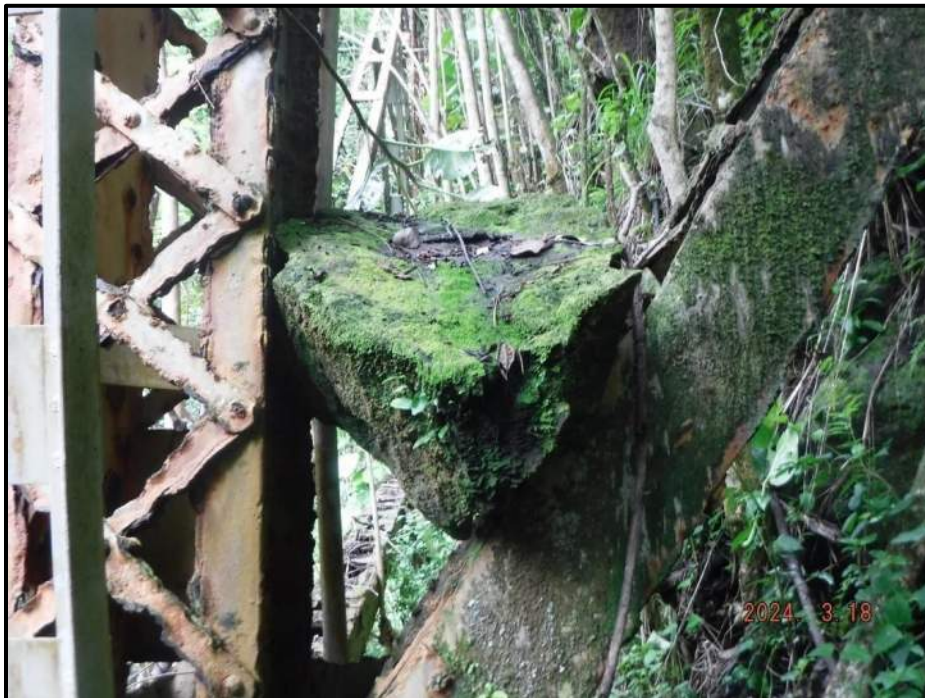
Photograph 106. Tower 4, Level 6, Column B, looking west. 3' diameter boulder on top of diagonal member at bottom connection; member appears to be deformed as a result.
