**STATE OF HAWAII
DEPARTMENT OF TRANSPORTATION**

**ADDENDUM NO. 2
FOR
HAWAII BELT ROAD
NANUE STREAM BRIDGE REHABILITATION
VICINITY OF HILO
DISTRICT OF HILO, ISLAND OF HAWAII
FEDERAL-AID PROJECT NO. BR-019-2(077)**

December 13, 2024

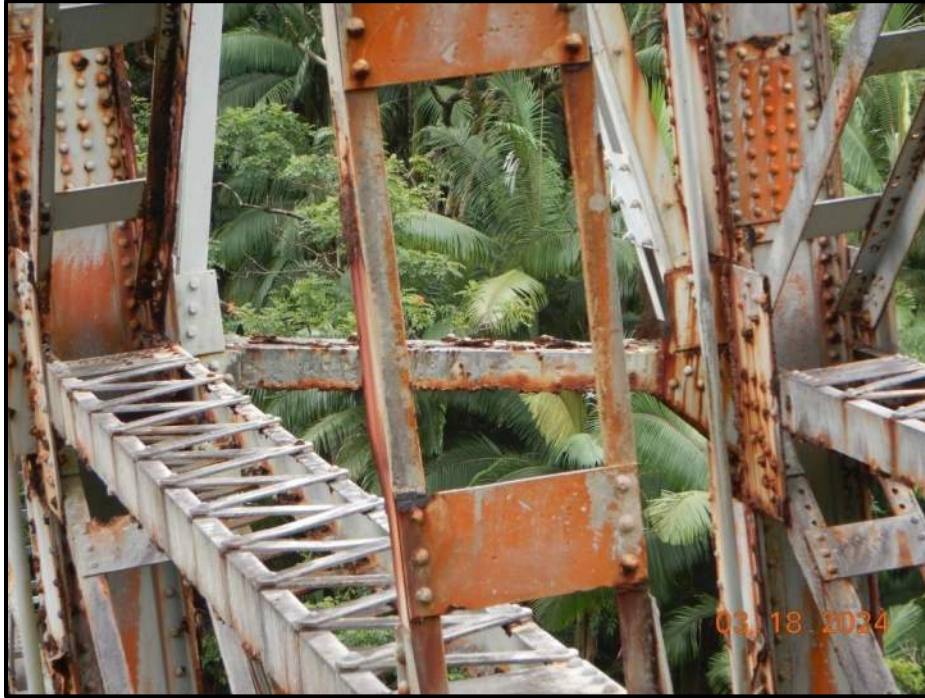
Photograph 107. Tower 4, Level 2, Column C, vertical bracing, looking south. East angles bent out-of-plane 1/2" and west angle, (3) rivets have 90% section loss, CS3.

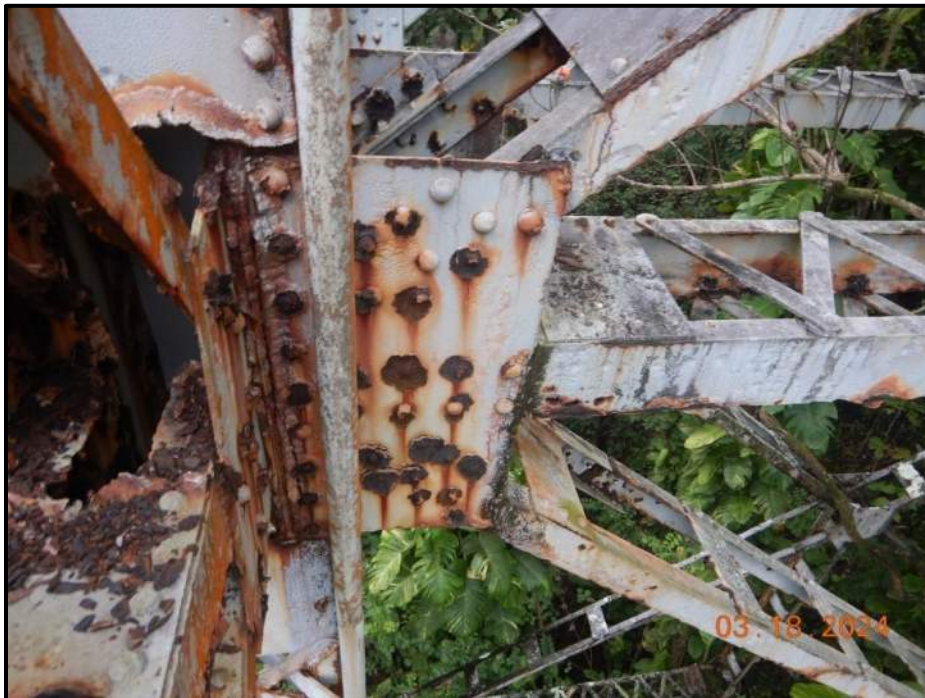
Photograph 108. Tower 4, Level 3, Column C, gusset plate connecting bracing to Bent 6, looking west. (14) of (18) rivet heads connecting the gusset plate to the column have 20% remaining on the inside face. East channel of bracing has more severe section loss at this location with (5) corrosion holes in the web up to 1" diameter, CS4.

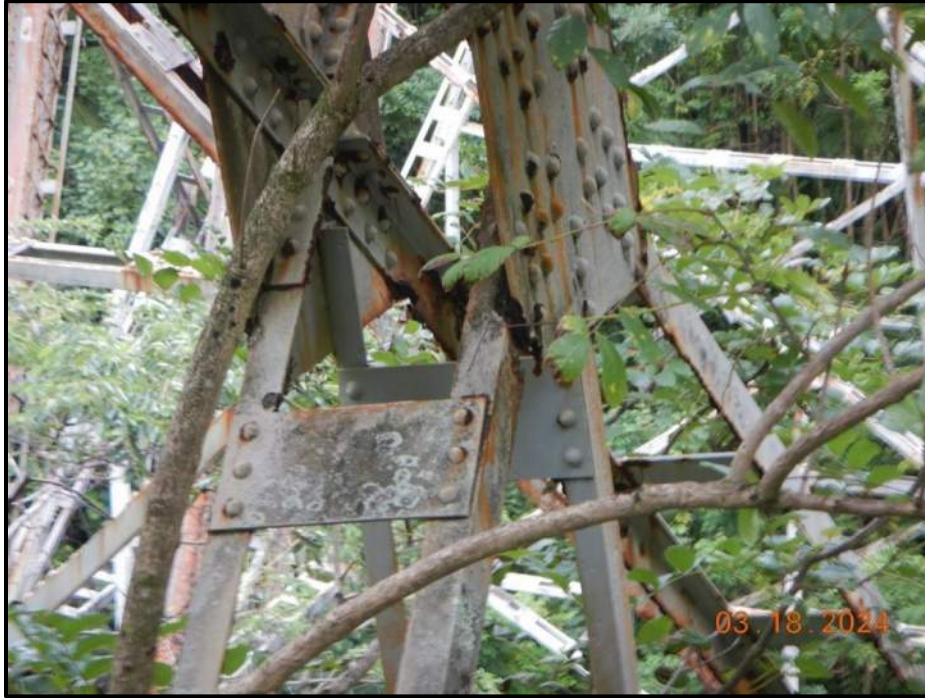
Photograph 109. Tower 4, Level 3, Column C, lower north diagonal bracing, looking southeast. West angle has 4" H x 2" L area of 100% section loss adjacent to the gusset plate, and the east angle has 1/4" loss in same location. Combined for 50% loss of member cross sectional area, CS4.

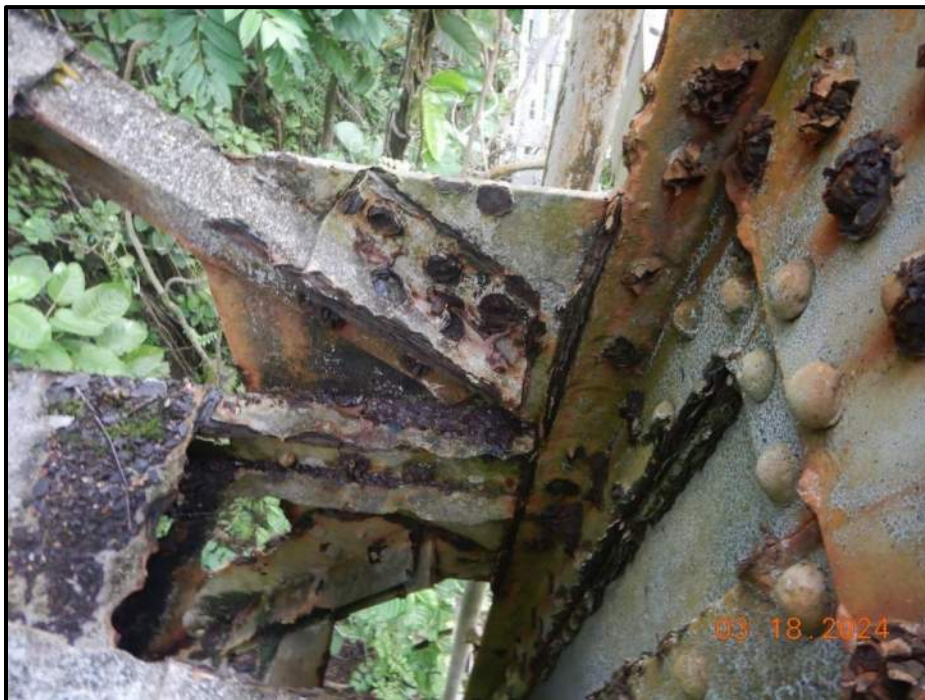
Photograph 110. Tower 4, Level 4, Column C, gusset plate at Bent 6, looking east. (9) of (18) rivet heads connecting the gusset plate to the column have 10% remaining on the inside face, CS3.

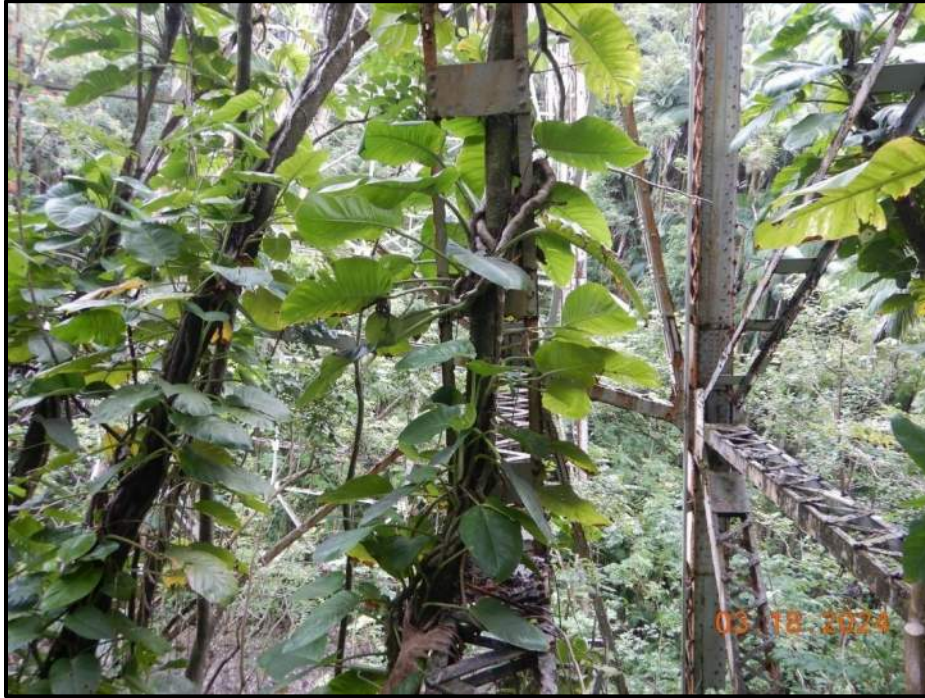
Photograph 111. Tower 4, Level 4, Column C, horizontal bracing, near center, looking south. Large tree growing through the structure (incidental).

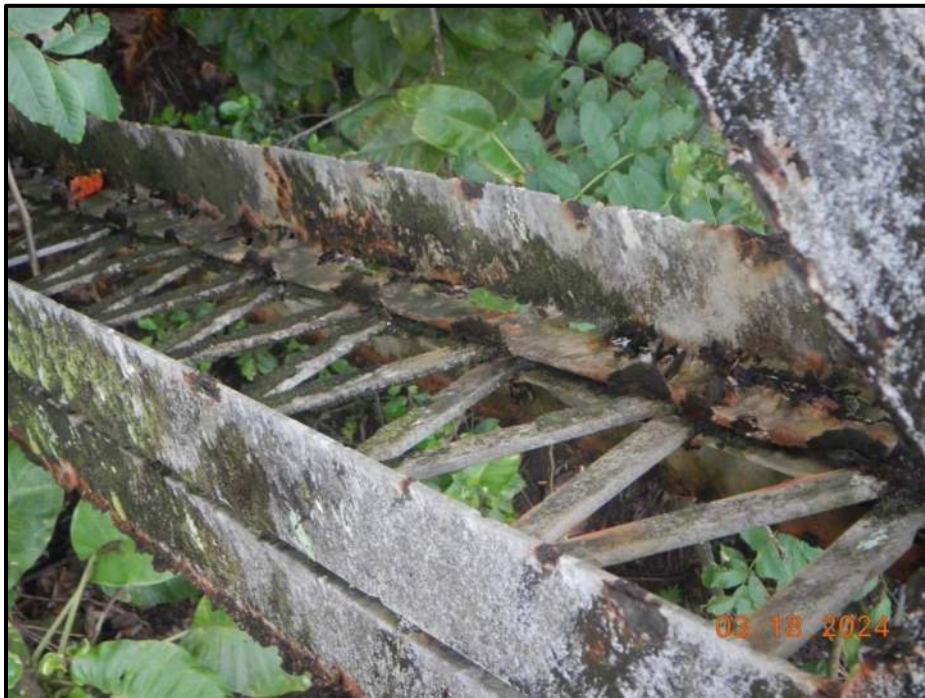
Photograph 112. Tower 4, Level 5, Column C, mid-diagonal mid-length, interior top angle, looking north. 100% section loss for most of length of horizontal flange. Approximately 20% loss of cross sectional area, CS3.

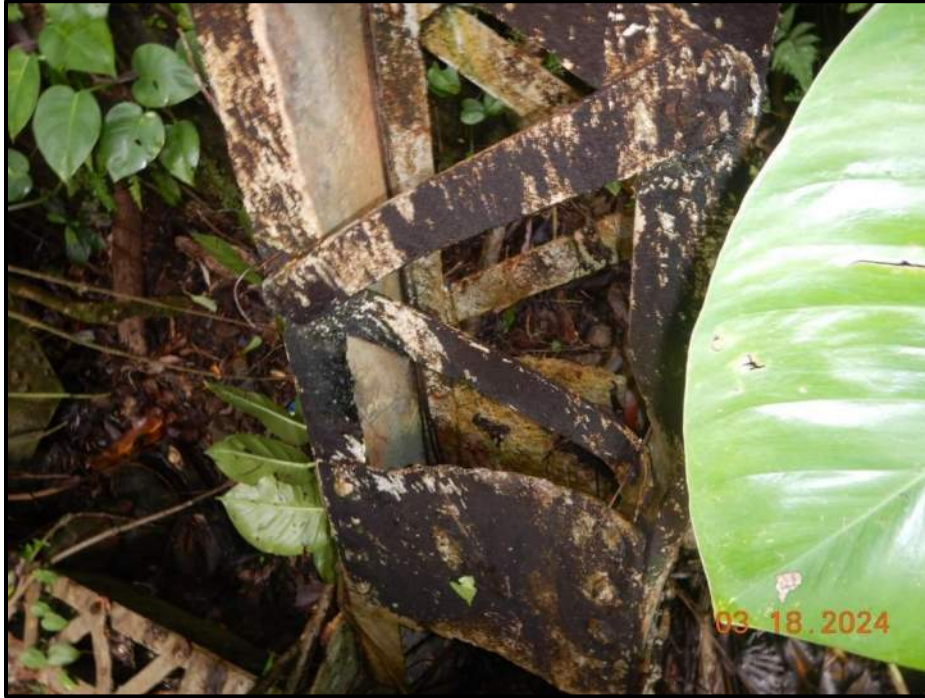
Photograph 113. Tower 4, Level 6, Column C, adjacent to Bent 6 pedestal, interior channel, looking north. 3" downward deformation over 1' 6" L, CS3.

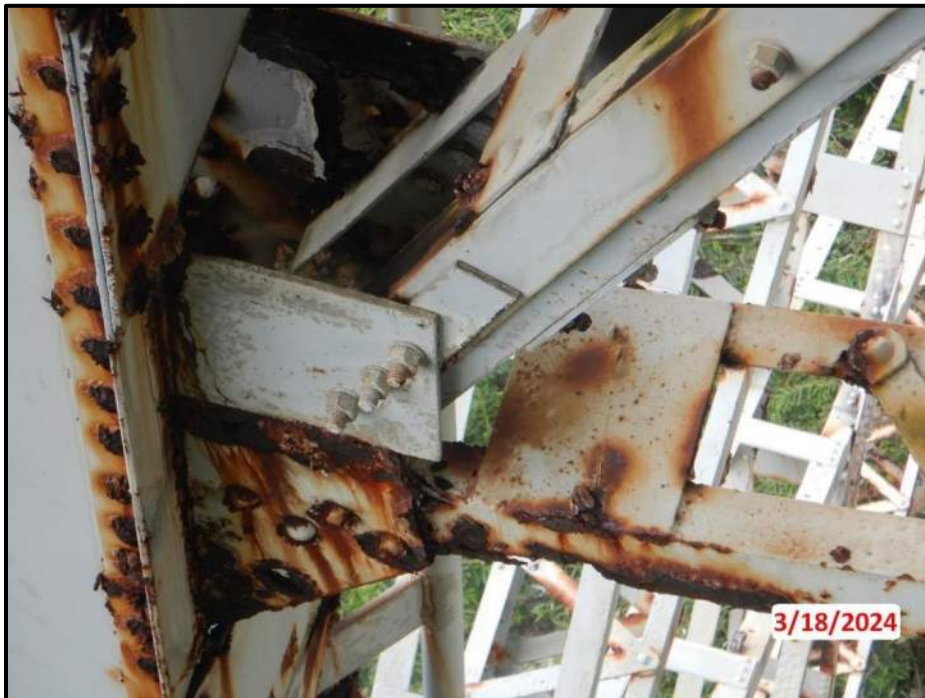
Photograph 114. Bent 7, Level 1, upper section, Column A, gusset plate, looking south. (2) corrosion holes up to 1" diameter, CS3.

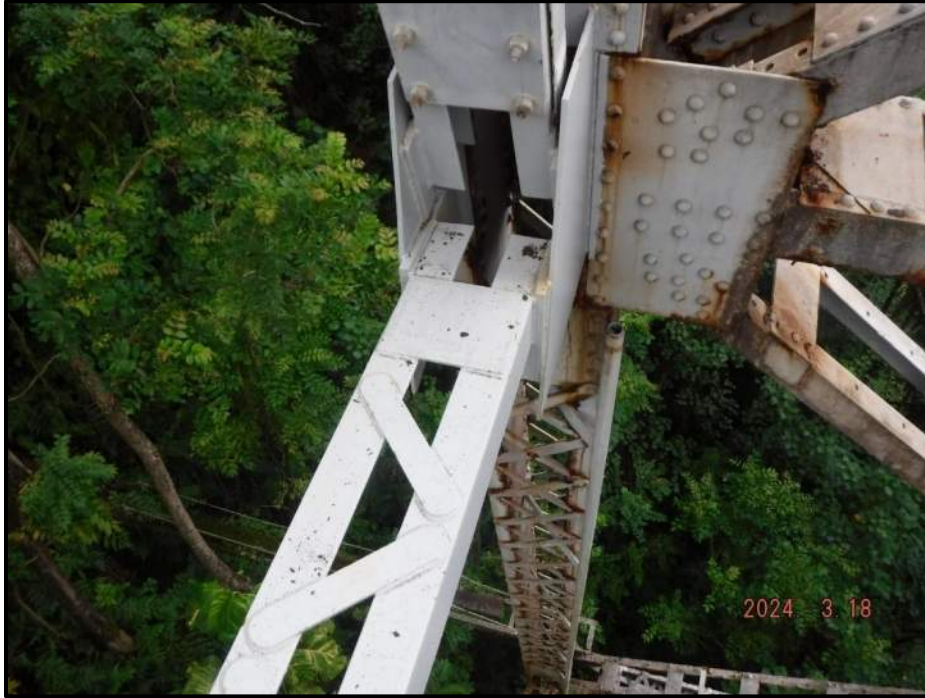
Photograph 115. Bent 7, Level 2, between Columns A and B, horizontal bracing and gusset plate at Column A, looking east. - Repaired and repair is in good condition.

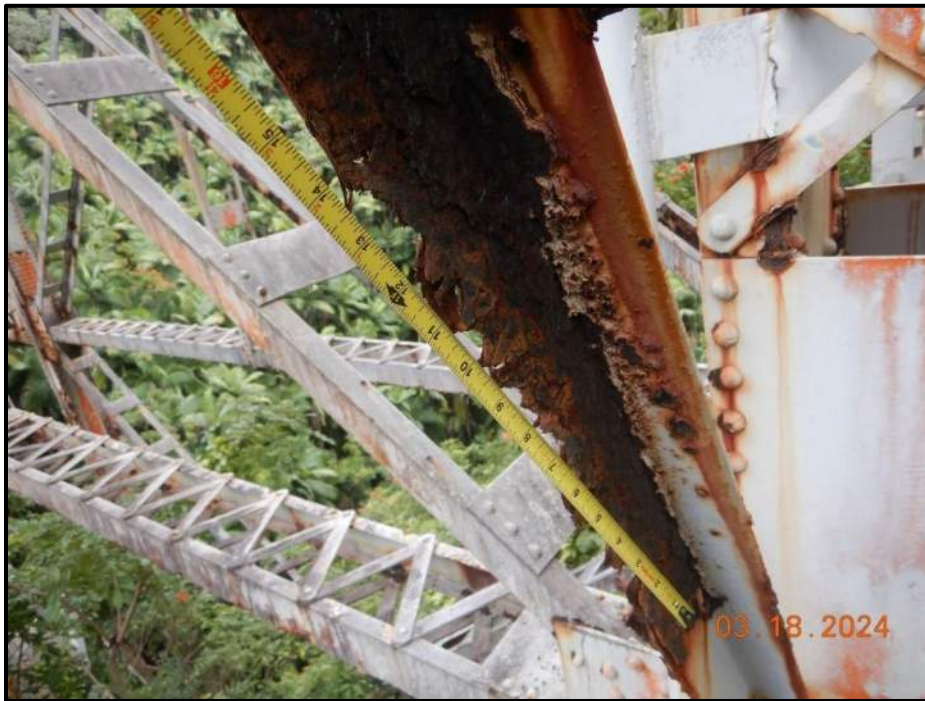
Photograph 116. Bent 7, Level 2, between Columns B and C, lower west diagonal bracing, south angle, looking southwest. Heavy laminar corrosion and knife-edging over 4' L, CS3.

Defect ID	Caption
6	Bent 2, Level 1, upper section, between Columns A and B, diagonal bracing, both cover plates at mid-length: Pack rust up to 3/4" thick causing separation of plate and one broken rivet on both cover plates, CS3, (See Photo 12).
7	Bent 2, Level 1, upper section, between Columns B and C, horizontal bracing, west face, lacing bars: (3) with 50% section loss and (1) with 90% section loss, CS3, (See Photo 13).
8	Bent 2, Level 1, upper section, Column C, west face, (1) lacing bar: (1) area of 90% section loss, CS3, (Similar to Photo 55).
9	Bent 2, Level 1, upper section, Column D, west face, (2) lacing bars: Completely severed with areas of laminar corrosion and pack rust throughout, CS3, (Similar to Photo 55).
10	Bent 2, Level 1, lower section, between Columns B and C, upper west diagonal bracing near Column C, north angle: 3" L x up to 1" W area of 100% section loss, CS3, (Similar to Photo 116).

40	Tower 2, Level 2, Column B, upper south diagonal bracing, inner west angle vertical flange: 1' L x 3" W of 100% loss, CS3, (Similar to Photo 23).	72	Bent 3, Level 1, lower section, Column B, southeast flange: Corrosion hole, 1-1/2" W x 1" H, CS3, (Similar to Photo 40).
41	Tower 2, Level 2, Column B, diagonal gusset plate connection, lower diagonals: Corrosion holes, up to 4" L x 2" H, CS3, (Similar to Photo 30).	73	Bent 3, Level 1, lower section, Columns A and B, horizontal bracing: Pack rust up to 1-1/2" thick with section loss up to 30% to gusset plates and 100% loss to rivet heads of batten plate, CS3, (See Photo 39).
42	Tower 2, Level 2, Column B, lower north diagonal and gusset plate at Column B connection: Exterior angle, up to 3/16" loss to full section and a 1" diameter corrosion hole at gusset plate, CS3, (Similar to Photo 24).	74	Bent 3, Level 1, lower section, between Columns B and C, lower west diagonal bracing: Laminar corrosion with knife-edging and holes up to 1" diameter near center gusset plate, CS3, (Similar to Photo 116).

Defect ID	Caption
108	Bent 4, Level 2, Column A, east side lacing bar: 90% section loss, CS3, (Similar to Photo 55).
109	Bent 4, Level 2, Column A, exterior gusset plate: Corrosion, pack rust up to 1" thick with areas of up to 100% loss and only retrofit gusset plate remaining, CS3, (See Photo 48).
110	Bent 4, Level 2, between Columns B and C, upper west diagonal and horizontal bracing near Column C: Heavy laminar corrosion throughout with up to 25% section loss, CS3, (Similar to Photo 116).
111	Bent 4, Level 2, Column C: 50% of lacing bars on west face have 100% section loss, remaining bars on both faces have average 30% section loss, CS4, (See Photo 49).
112	Bent 4, Level 2, between Columns B and C, lower west diagonal bracing: Heavy laminar corrosion throughout with up to 25% section loss, CS3, (Similar to Photo 116).

Defect ID	Caption	Defect ID	Caption
113	Bent 4, Level 2, between Columns B and C, lower west diagonal bracing, near Column C: Knife-edging and 80% section loss to the interior angle, CS3, (Similar to Photo 116).	145	Tower 3, Level 3, Column A, upper north diagonal bracing, at connection: Heavy corrosion and laminar corrosion up to 50% section loss, CS3, (Similar to Photo 59).
114	Bent 4, Level 2, between Columns B and C, horizontal bracing adjacent to Column C, vertical connection, interior top flange along member: (7) corrosion holes, up to full width of top flange x 5" L, CS3, (See Photo 50).	146	Tower 3, Level 3, Column A, lower south diagonal, and vertical bracing: Repair in good condition, (See Photo 63).
115	Bent 4, Level 3, Column A above lower connection: Retrofit, four interior and three exterior lacing bars cut or removed, (CS3). - Repaired, (See Photo 51).	147	Tower 3, Level 3, Column A, Bent 5, interior and exterior gusset plates, between horizontal and lower diagonal bracing: Pack rust with section loss, CS3, (See Photo 64).

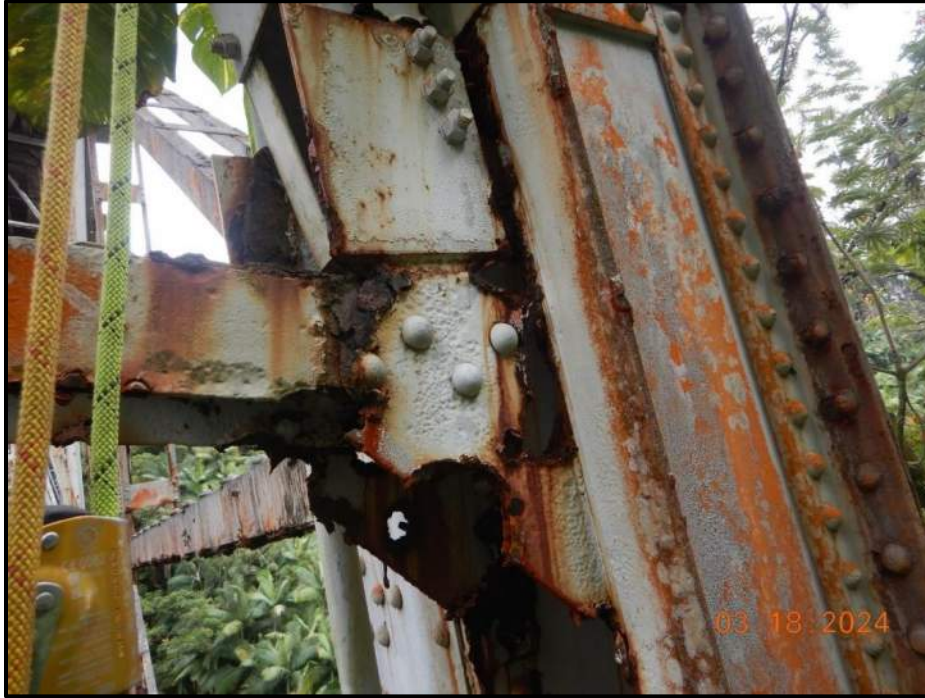
Photograph 117. Bent 7, Level 2, Column D, gusset plates, looking south. Corrosion, heavy laminar corrosion with diagonal lateral bracing corroded away and detached, CS4.

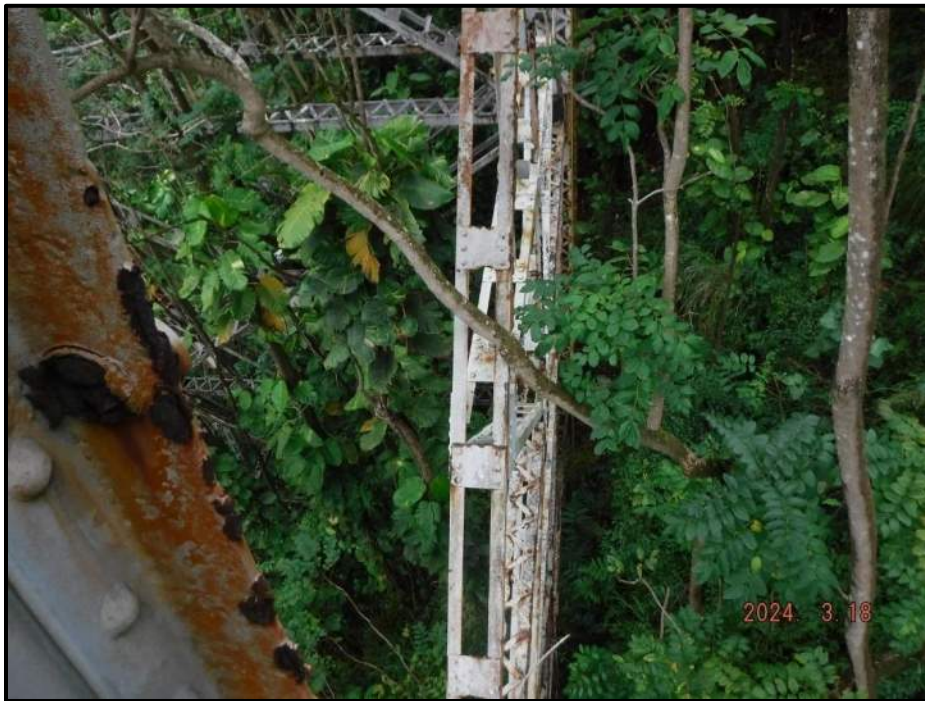
Photograph 118. Bent 7, Level 3, between Columns C and D, lower east diagonal, looking west. Tree growing against structure.

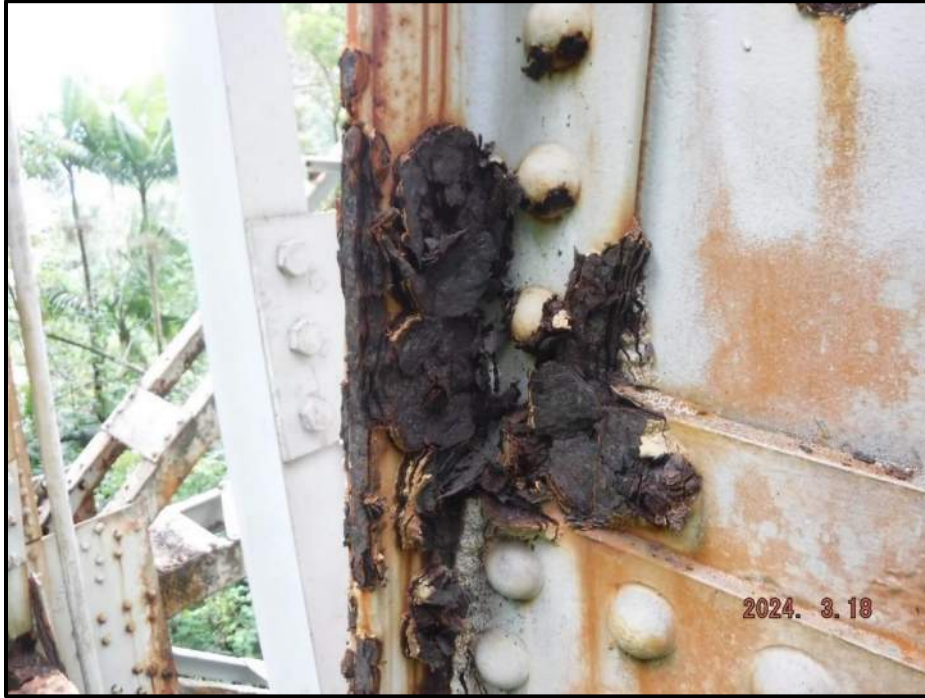
Photograph 119. Bent 7, Level 3, Column B splice plate, looking south. Majority of connection rivets for Column B have section loss and corrosion, CS3.

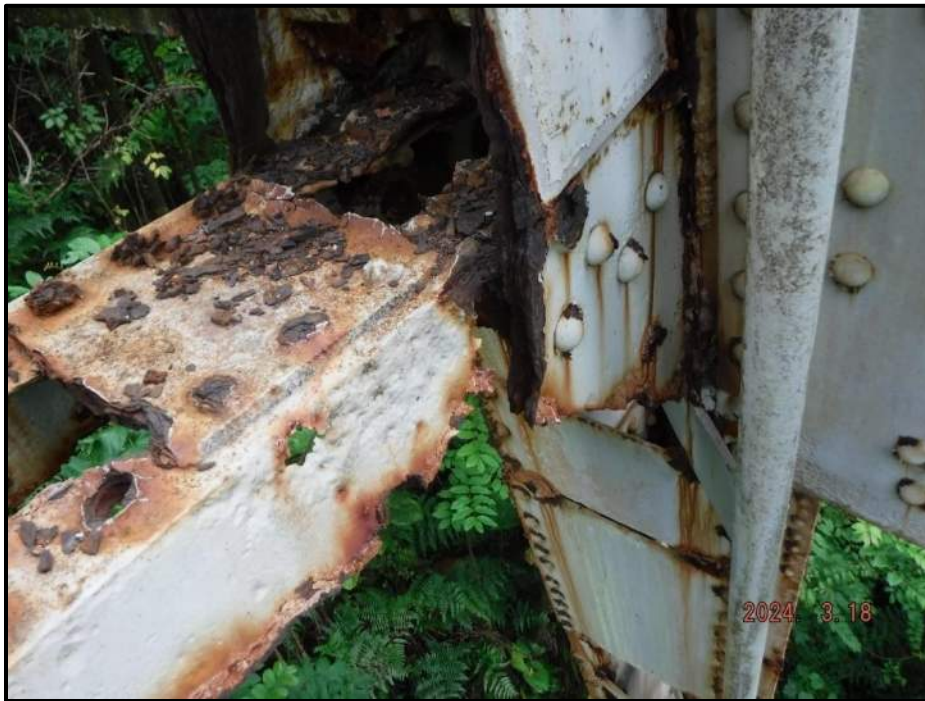
Photograph 120. Bent 7, Level 3, Column A, south horizontal bracing angle, looking northeast. 3" W x 4" H corrosion hole in vertical angle, CS3.

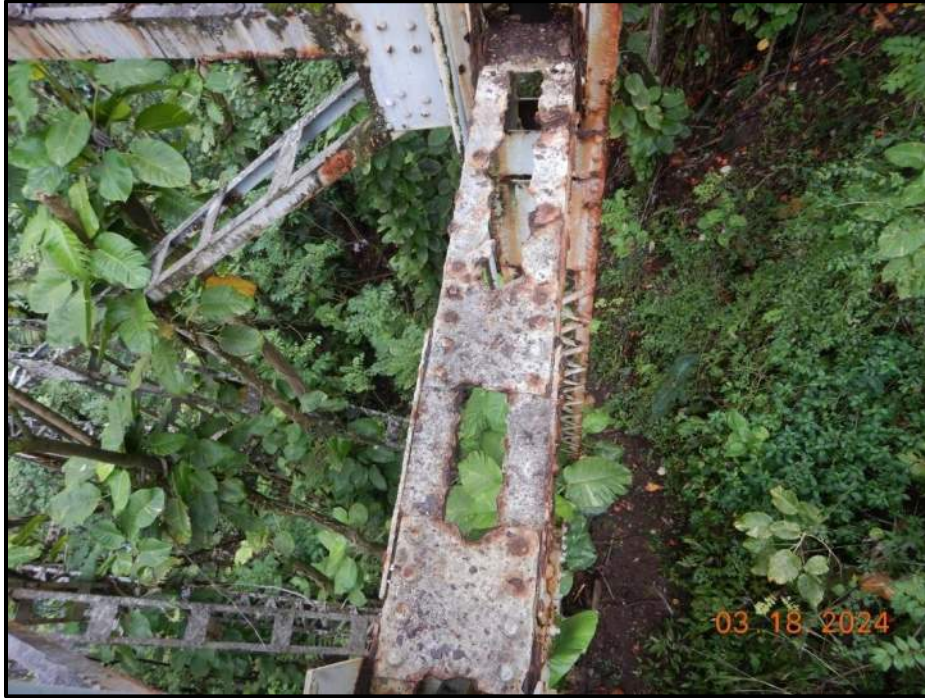
Photograph 121. Bent 7, Level 3, between Columns C and D, horizontal bracing, looking west. Up to 100% section loss to batten plates, knife edging on top flange angles, and missing lacing bars, CS3.

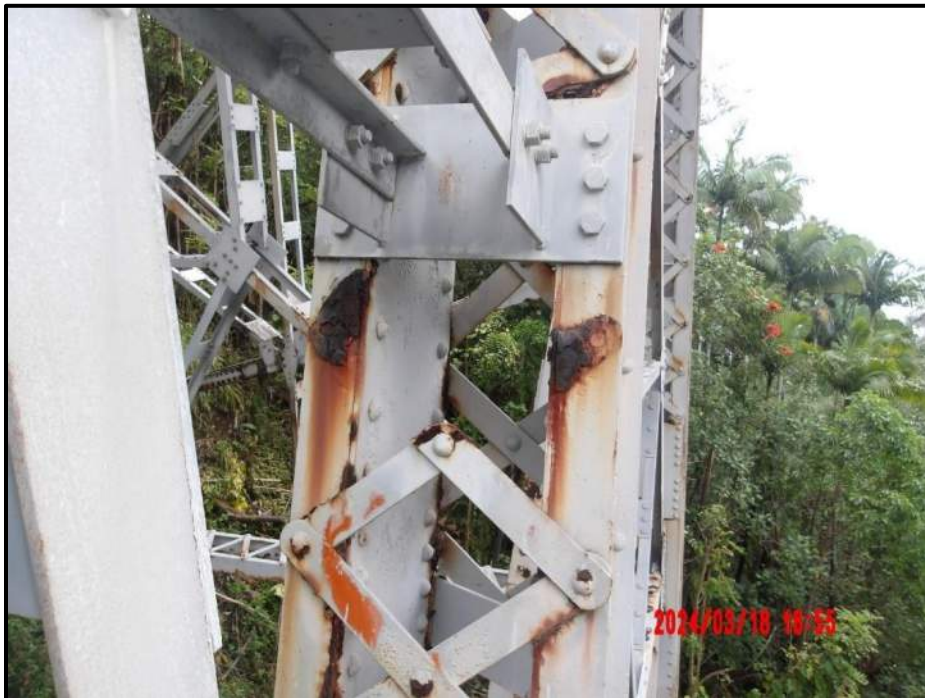
Photograph 122. Bent 8, Level 1, lower section, Column C, west face, (2) lacing bars, looking east. 100% section loss, CS3.

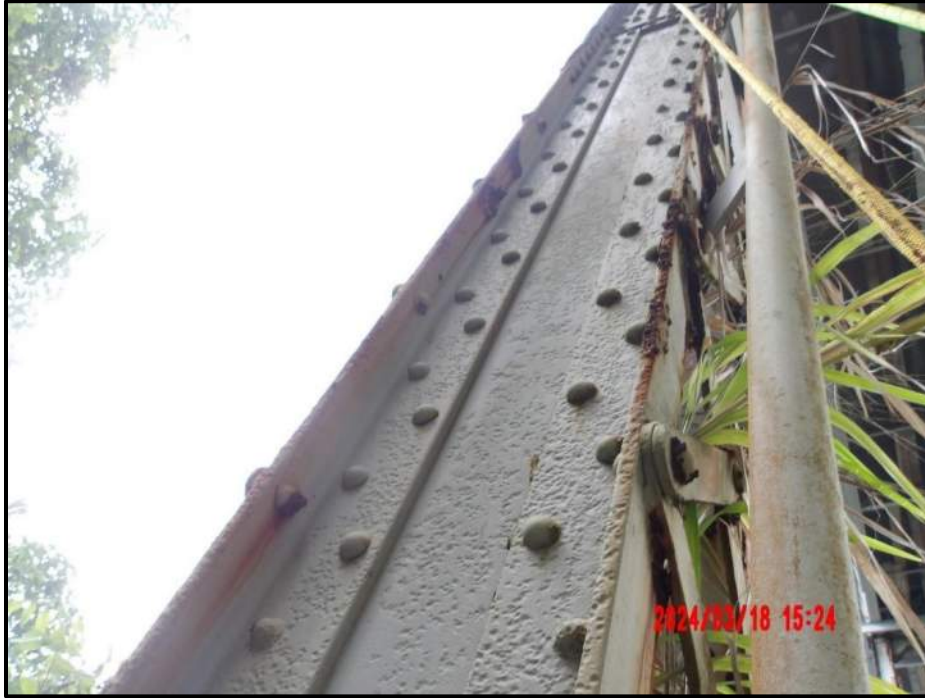
Photograph 123. Bent 8, Level 2, Column A, bottom section, north face angles and web, looking southeast. Painted over pitting, full height x up to 3/16" deep, CS3.

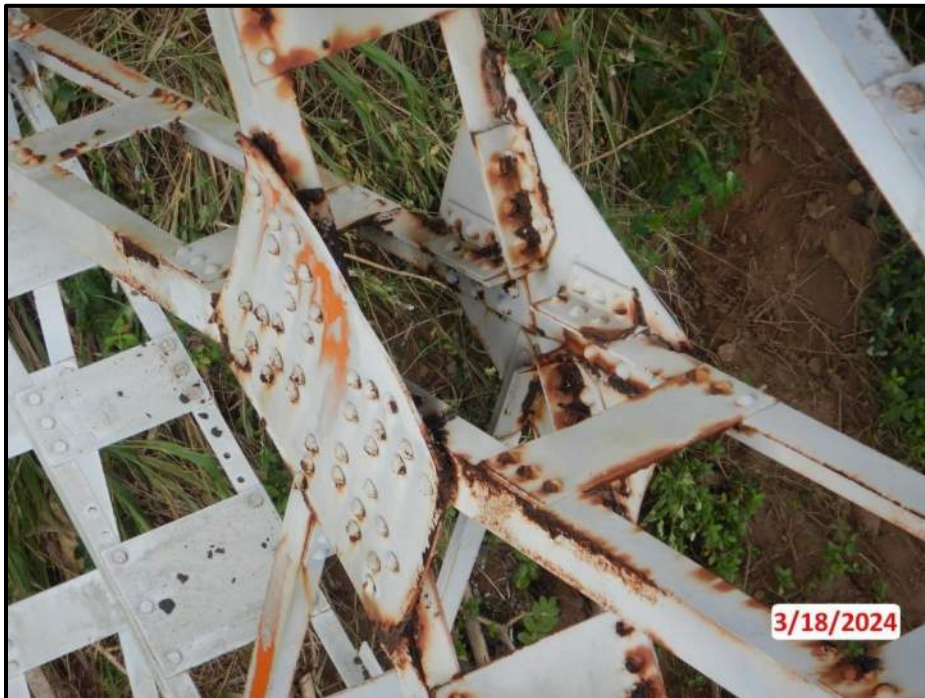
Photograph 124. Tower 5, Level 1, Columns C and D, center gusset, looking northeast. Pack rust up to 1" thick, CS3.

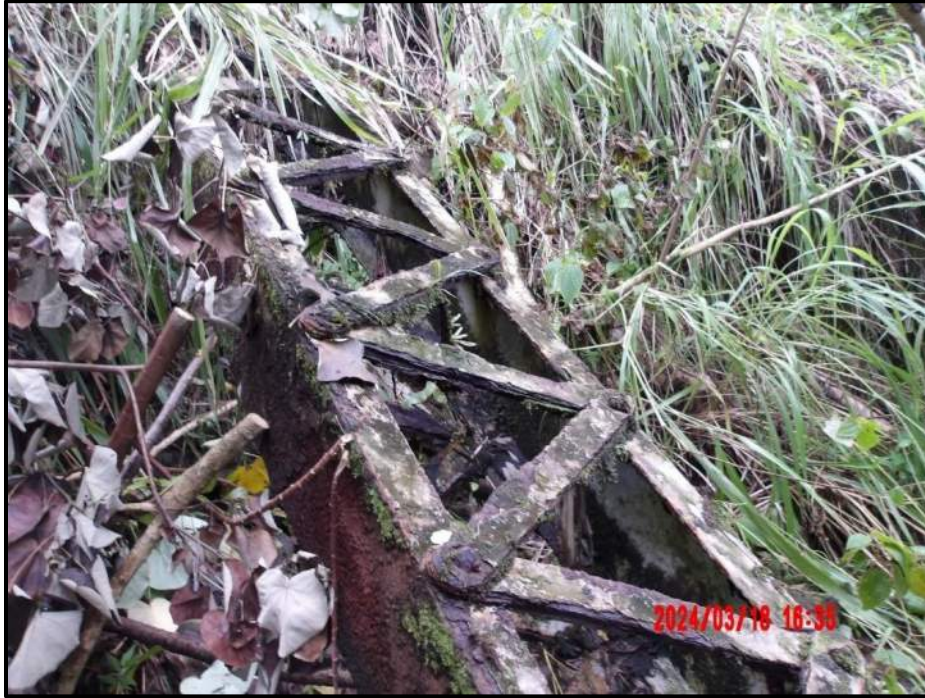
Photograph 125. Tower 5, Level 2, Column D, diagonal bracing, lacing bars, looking east. Heavy laminar corrosion (similar as Bent 8, Column D), CS3.

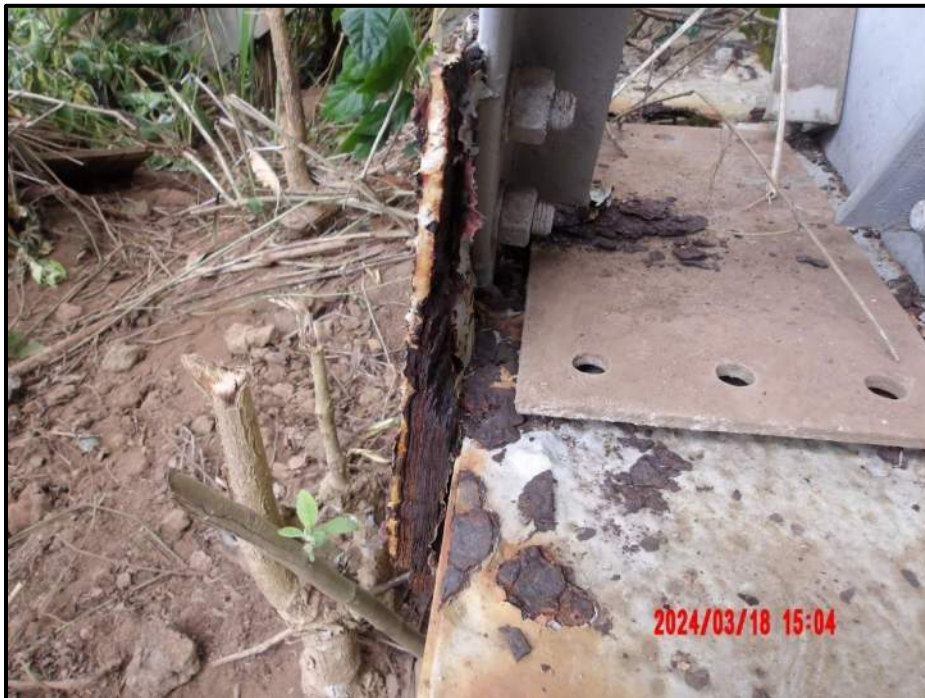
Photograph 126. Bent 9, Level 1, lower section, between Columns B and C, lower horizontal bracing center gusset plate, looking west. Heavy laminar corrosion, up to 1-1/4" W with up to 50% section loss, CS3.

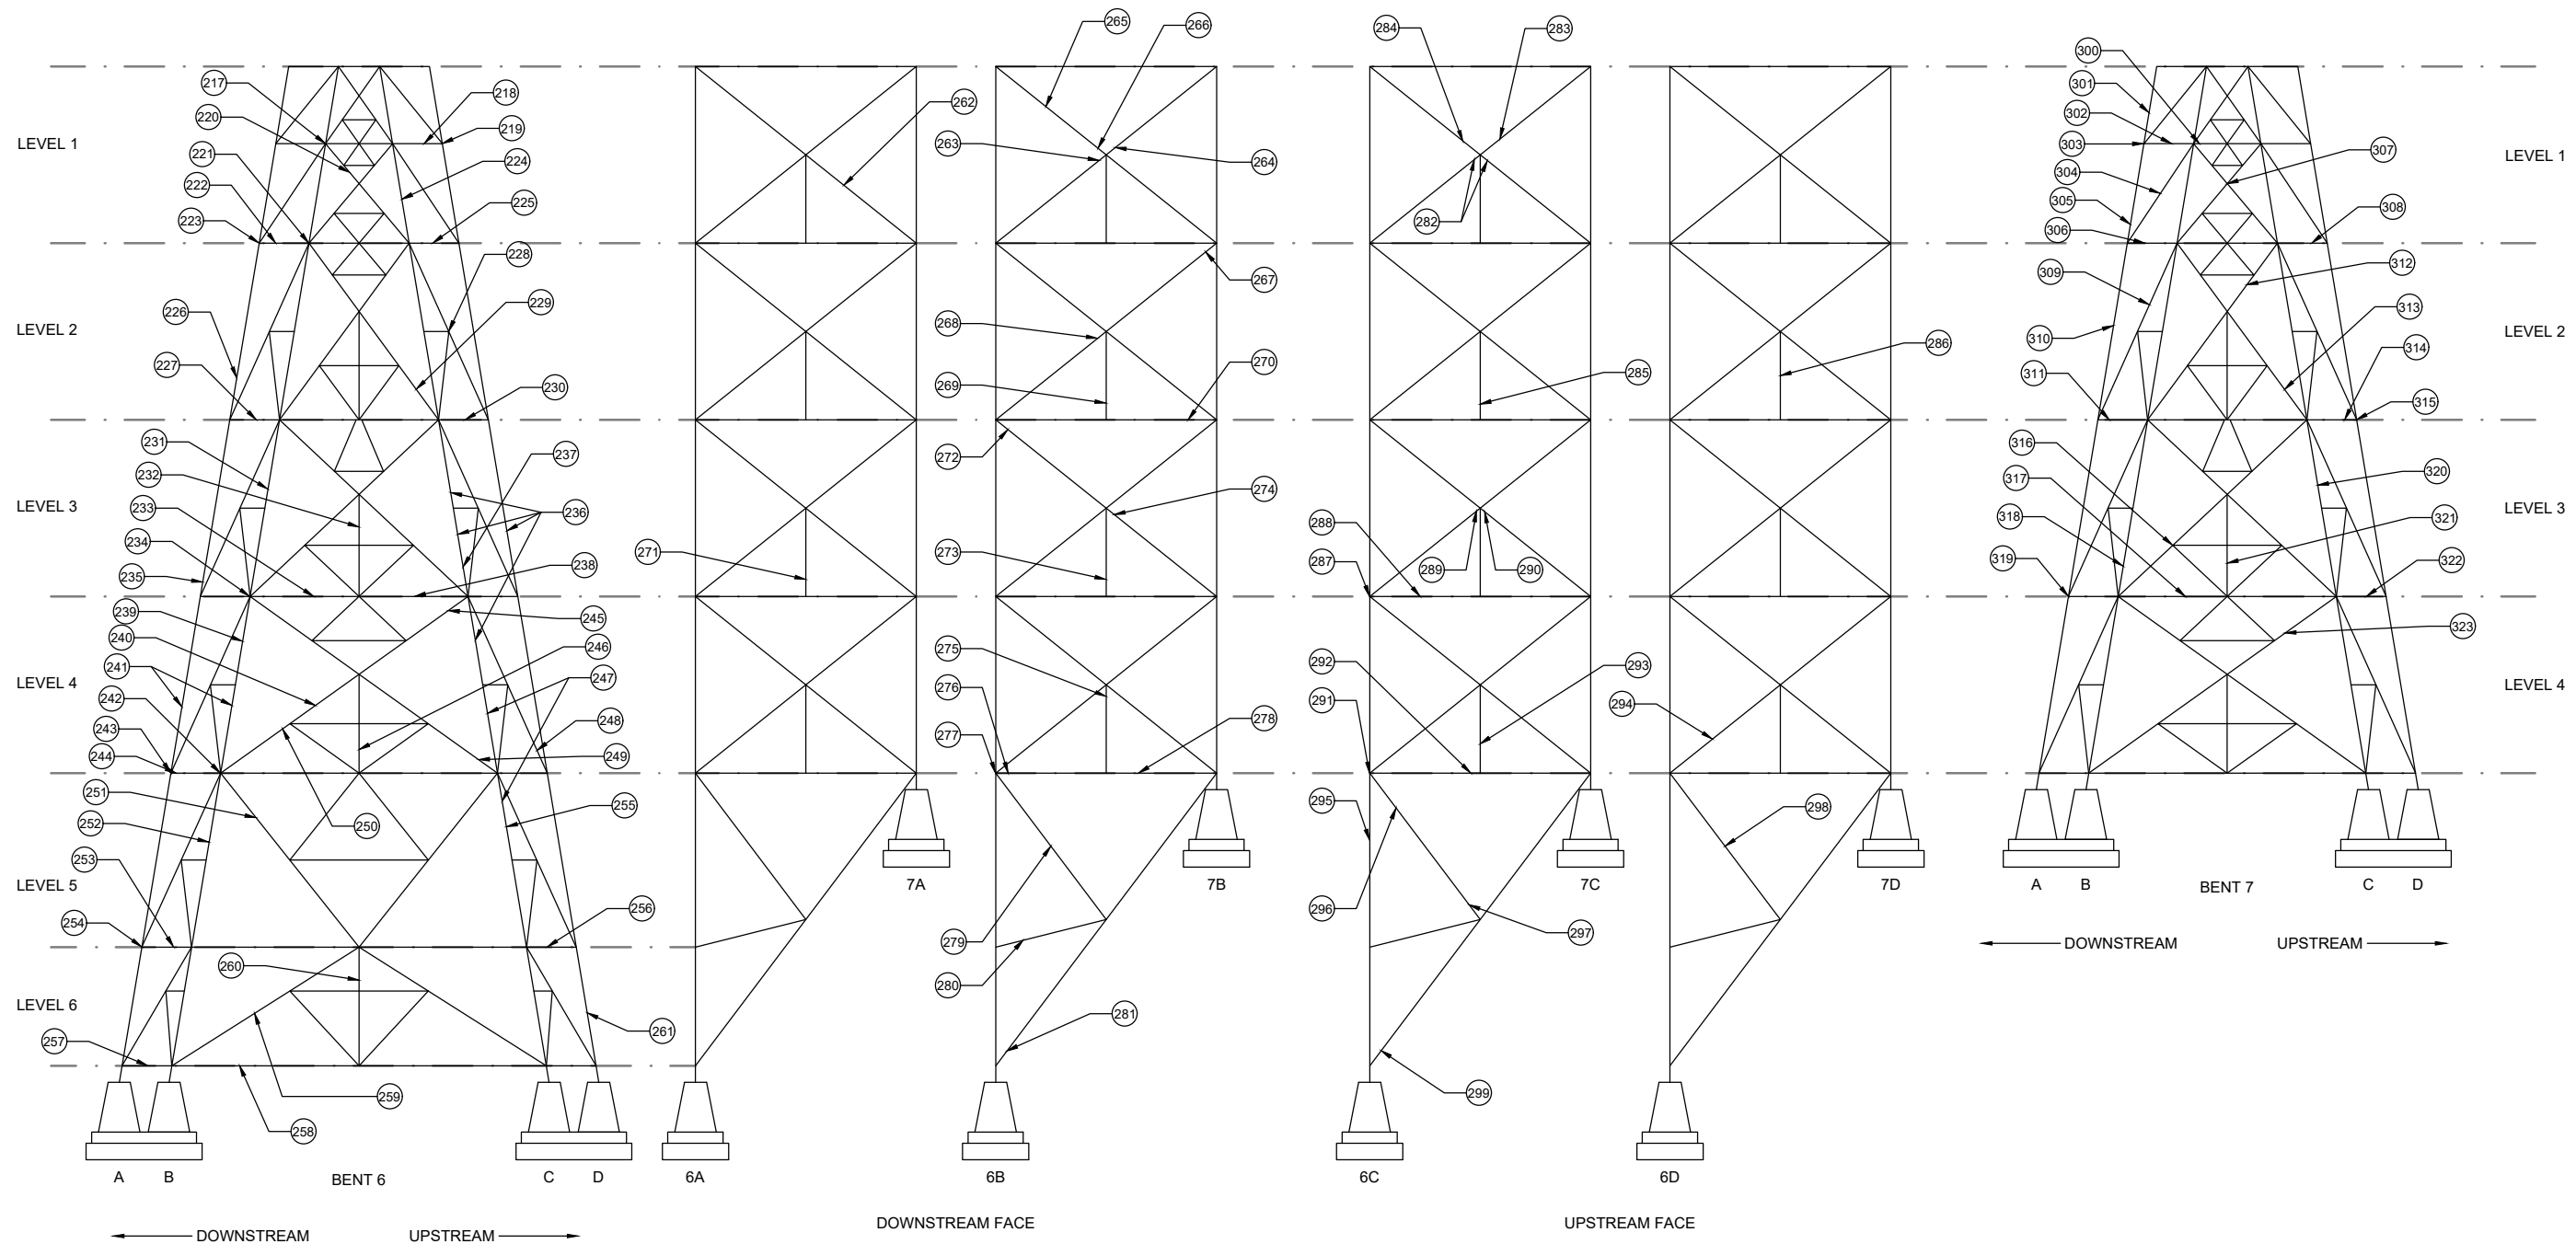
Defect ID	Caption
217	Bent 6, Level 1, upper section, Column B, lower gusset plates west of Column B: Knife-edging with areas of 100% section loss up to 1" W x 2" H, CS3, (Similar to Photo 88).
218	Bent 6, Level 1, upper section, between Columns C and D, horizontal bracing: Heavy pitting with 1' 6" L x 2" H area of 100% section loss, CS3, (See Photo 85).
219	Bent 6, Level 1, upper section, Column D, lower gusset plates: Heavy laminar corrosion with repair plates present, CS3, (Similar to Photo 19).
220	Bent 6, Level 1, lower section, between Columns B and C, upper east diagonal bracing, vertical leg of exterior angle: 1-1/2" W area of 100% section loss, typical along full length, CS3, (Similar to Photo 66).
221	Bent 6, Level 1, lower section, Column B, west side bottom north diagonal between angle and gusset plate: Corrosion hole, 3" L x 2" W, with pack rust up to 1/2" thick, CS3, (Similar to Photo 70).

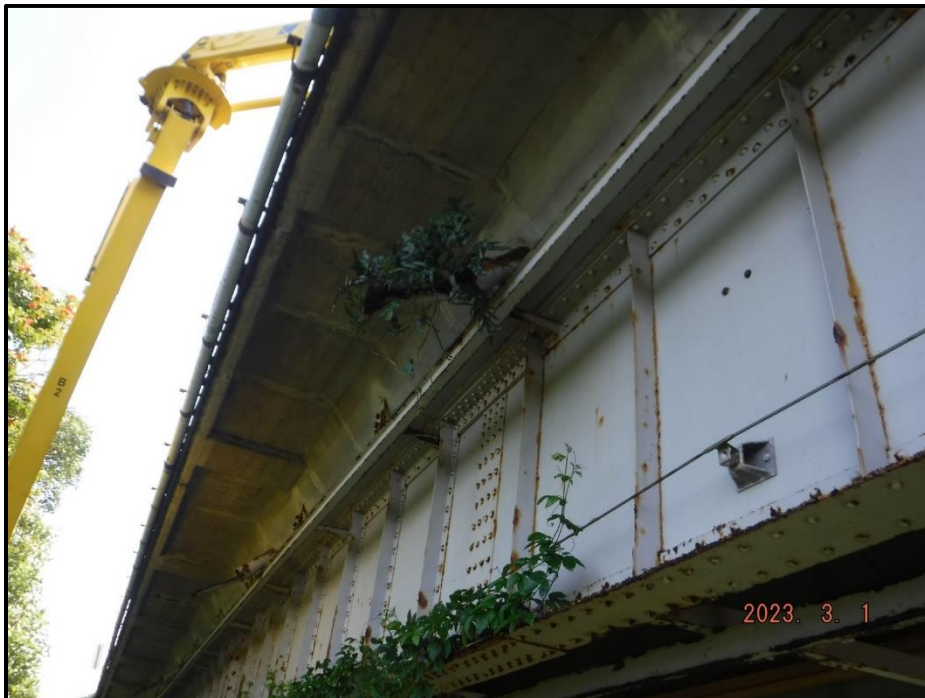
Photograph 14. Span 2, east overhang, 1st scupper south of Bent 2, looking west. Vegetation growth and almost full of debris.

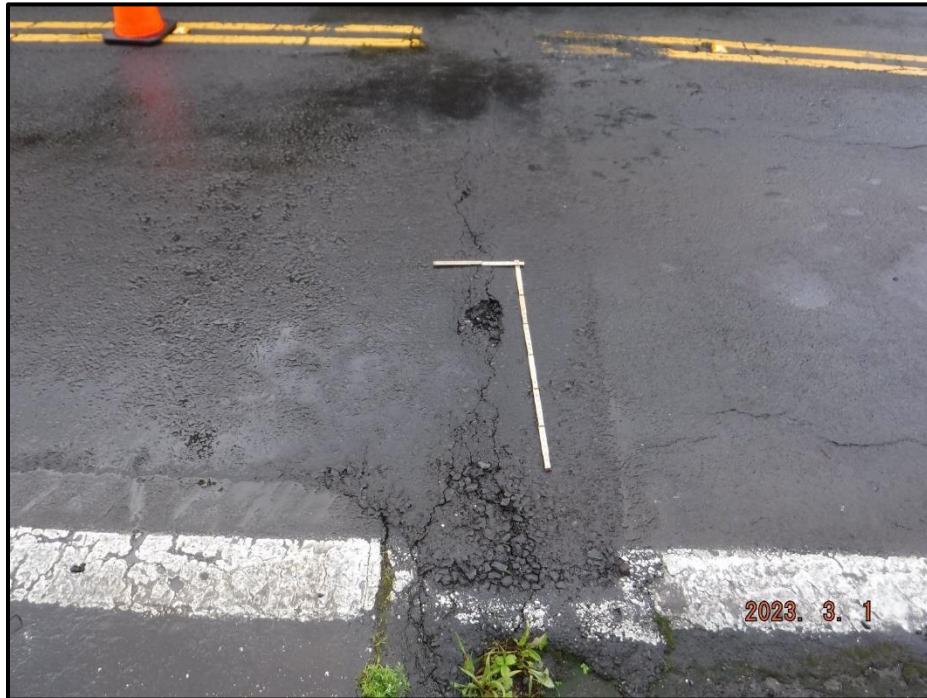
- South Abutment Joint, NB lane, 6" diameter x 1" deep spall adjacent to crack, 1 SF CS3, (See Photo 15).
- Bent 3 Joint, both lanes, 2' 4" L x 4' W area of settled patches with a 6" Dia. x 1" D spall within. The rest of the paved over joint is rutted up to 1" deep, 8 SF CS3, (See Photo 16).

Photograph 15. South Abutment Joint, NB Lane, looking west. 6" diameter x 1" deep spall adjacent to crack, CS3.

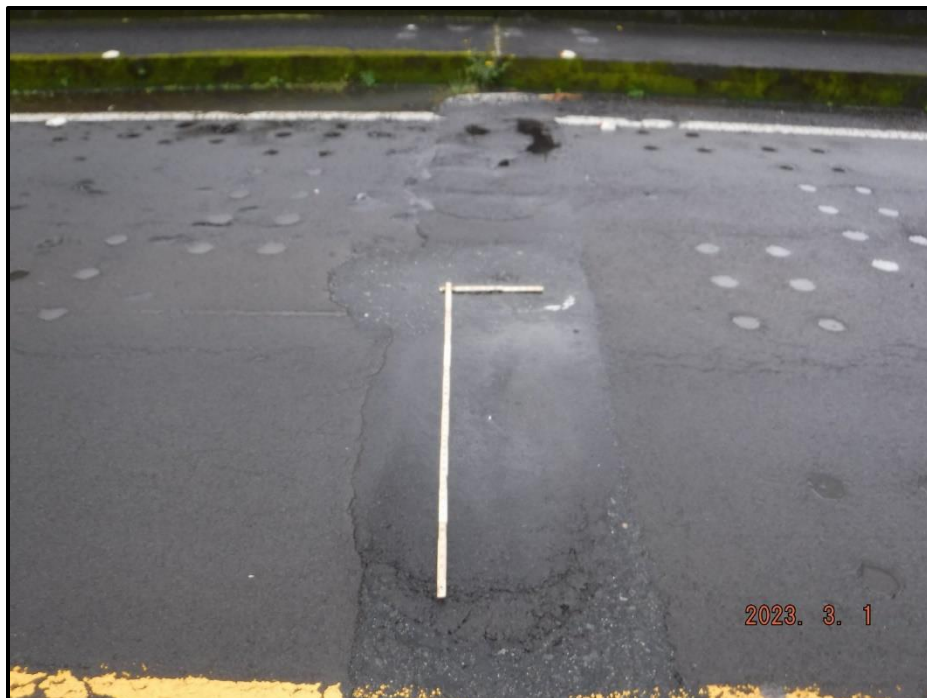
Photograph 16. Bent 3 Joint, both lanes, looking west. 2' 4" L x 4' W area of settled patches with a 6" Dia. x 1" D spall within. The rest of the paved over joint is rutted up to 1" deep, CS3

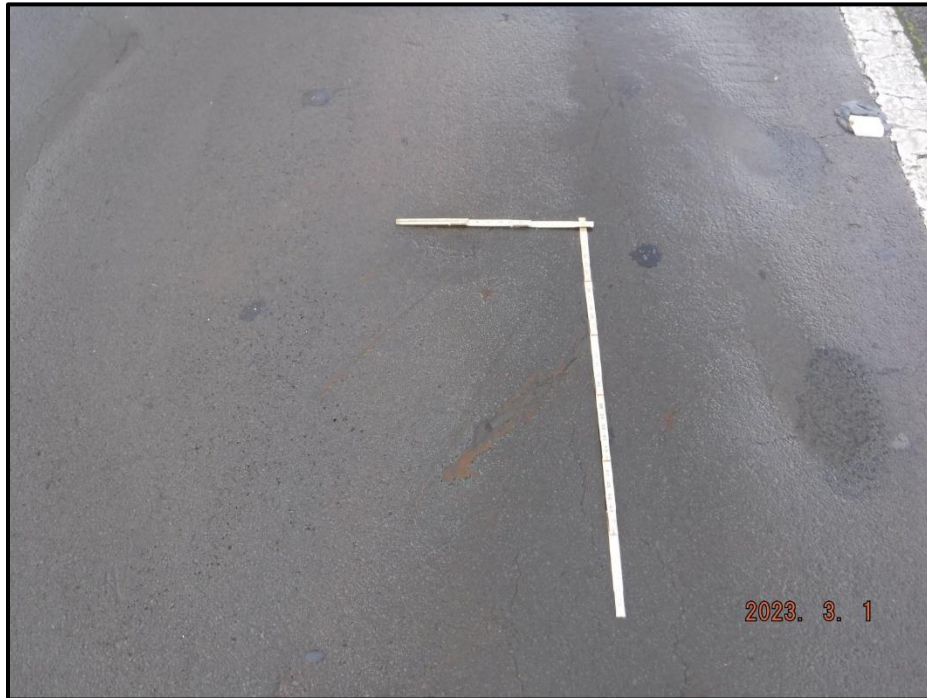
Photograph 17. Span 4, NB Lane, 20' north of Bent 3, looking north. 3' L x 3' W area of gouges (largest is 1' 1" L x 2' W x 1/2" deep), CS3.

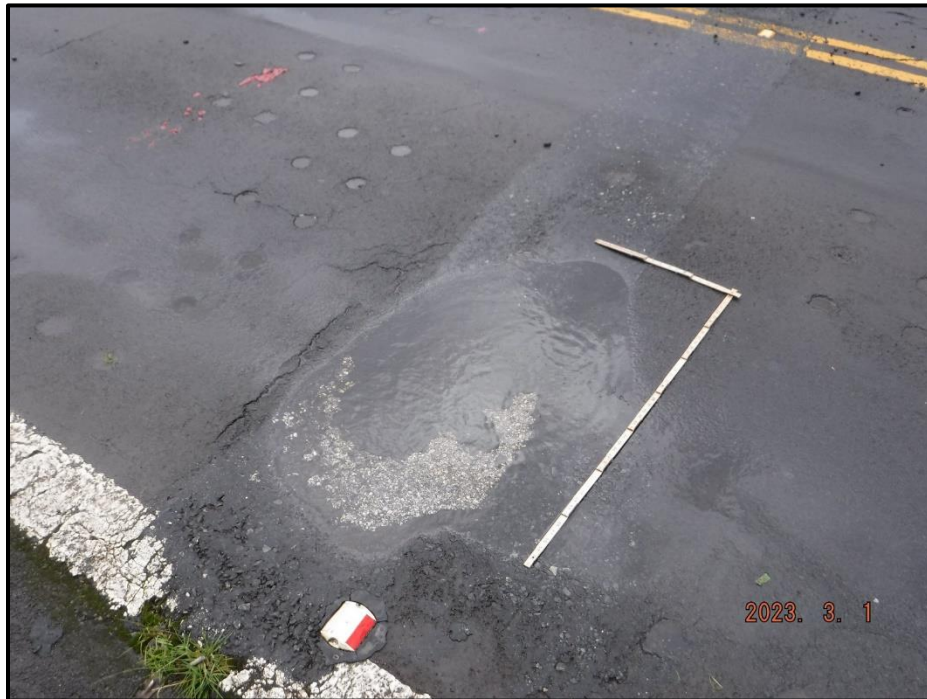
Photograph 18. Bent 5 Joint, NB lane, looking southwest. 2' 4" L x 4' W x 1/2" deep cracked and settled pothole with ponding water, CS3.

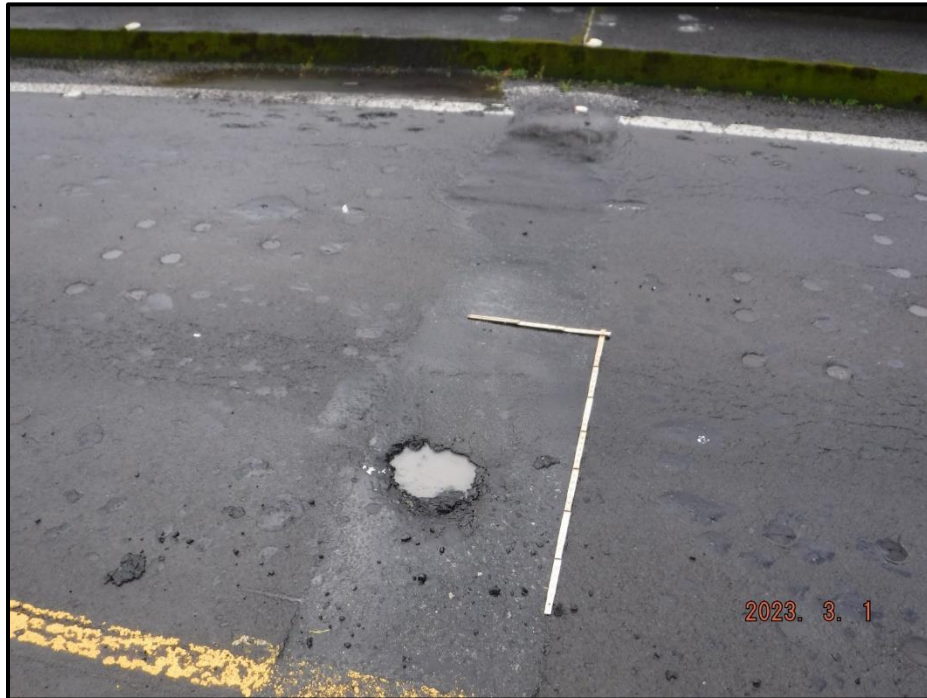
- Bent 5 Joint, SB lane, 2' L x 4' 5" W x 2" deep settled patch with a 11" L x 11" W x 1" deep spall within with exposure of deck and joint, 1 SF CS3, 1 SF CS4 (See Photo 19).

Photograph 19. Bent 5 Joint, SB lane, looking southwest. 2' L x 4' 5" W x 2" deep settled patch with a 11" L x 11" W x 1" deep spall within with exposure of deck and joint, CS3, CS4.
