**STATE OF HAWAII
DEPARTMENT OF TRANSPORTATION**

**ADDENDUM NO. 2
FOR
HAWAII BELT ROAD
NANUE STREAM BRIDGE REHABILITATION
VICINITY OF HILO
DISTRICT OF HILO, ISLAND OF HAWAII
FEDERAL-AID PROJECT NO. BR-019-2(077)**

December 13, 2024

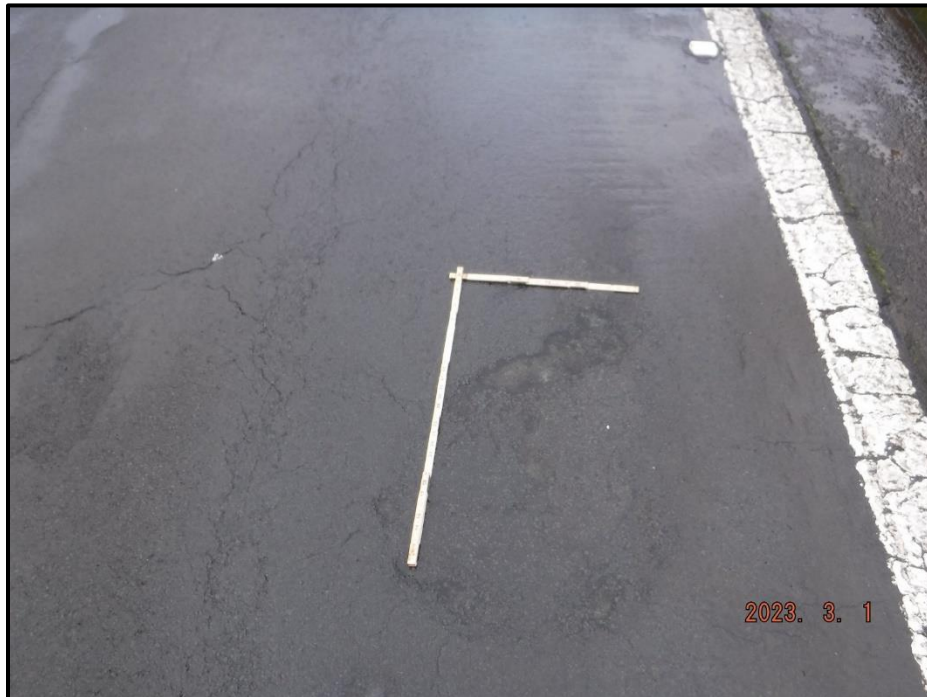
Photograph 20. Span 8, NB lane, 15' north of Bent 7 joint, looking north. 8" L x 1' 3" W x 1/2" deep patched pothole that is failing and has ponding water, CS3.

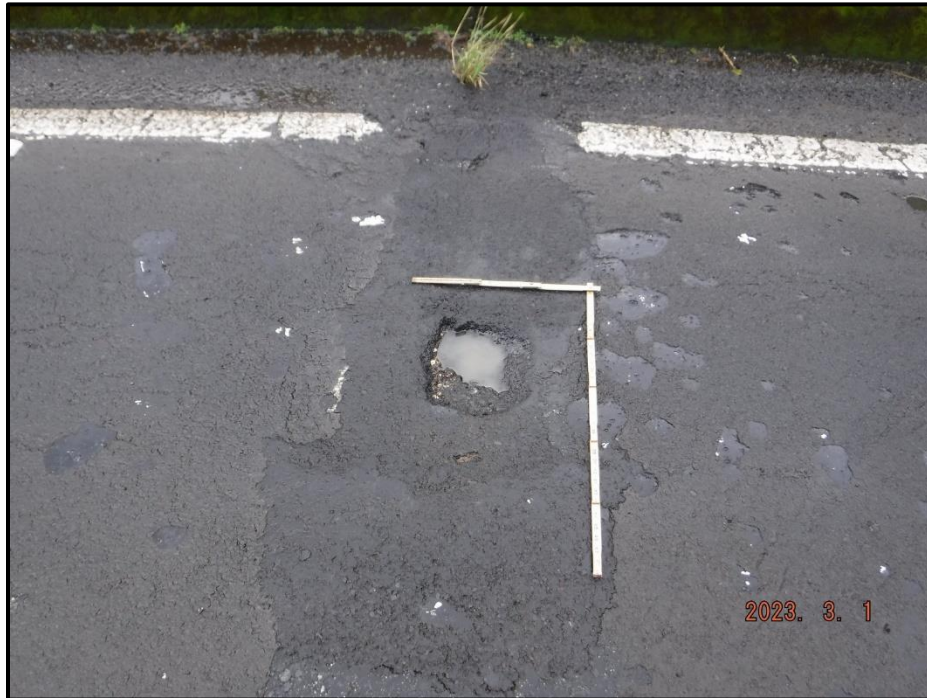
Photograph 21. Bent 9 Joint, SB lane, wearing surface, looking west. 1' 4" L x 1' 9" W x 1" deep cracked and settled patch with 5" L x 11" W x 1" deep pothole within with exposure of steel plate and joint material, CS2, CS4.

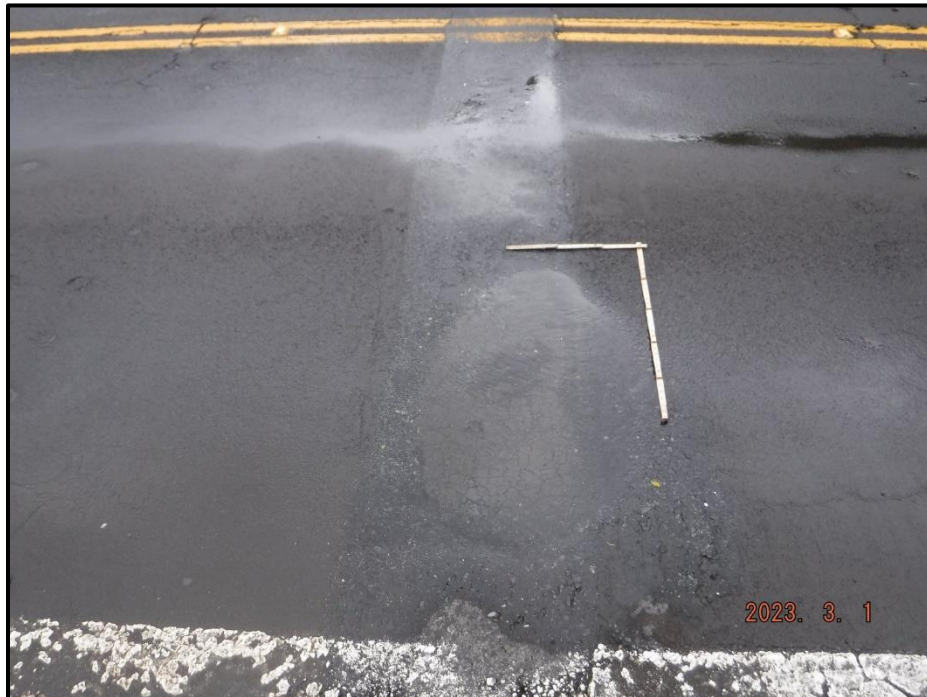
Photograph 22. Bent 9 Joint, NB right wheel line, looking west. Cracked and settled potholes with ponding water, CS3.

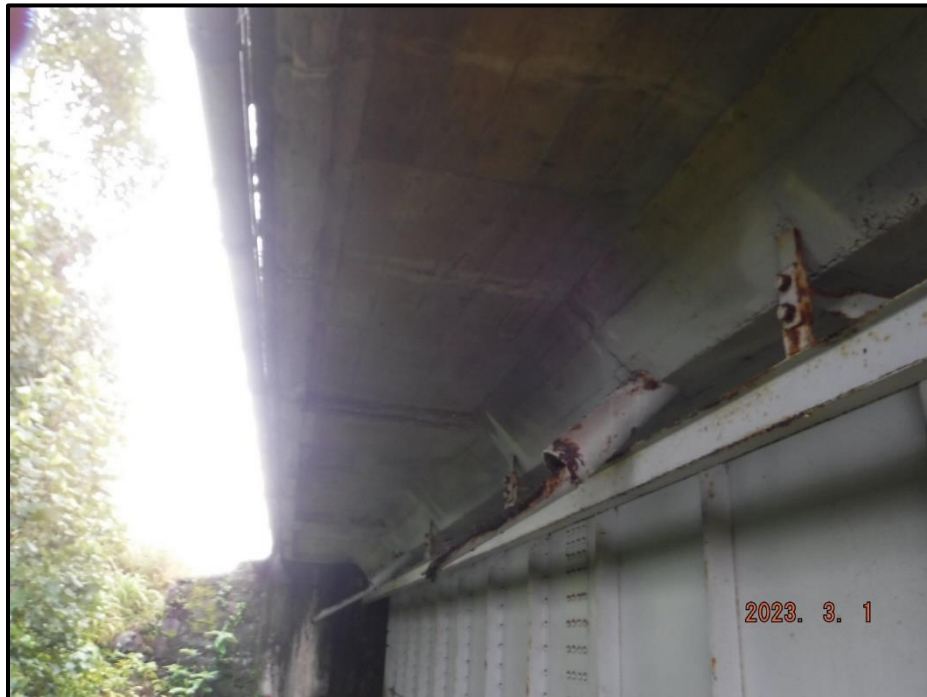
-All spans, both overhangs, transverse cracking with efflorescence throughout, typically 3'-4' apart x up to 1/8" W, 85 SF CS3, (See Photo 24).

Photograph 24. Span 1, underside of deck, east overhang, 5' south of Bent 1, looking south. Transverse cracking with efflorescence throughout, typically 3'-4' apart x up to 1/8" W, CS3.

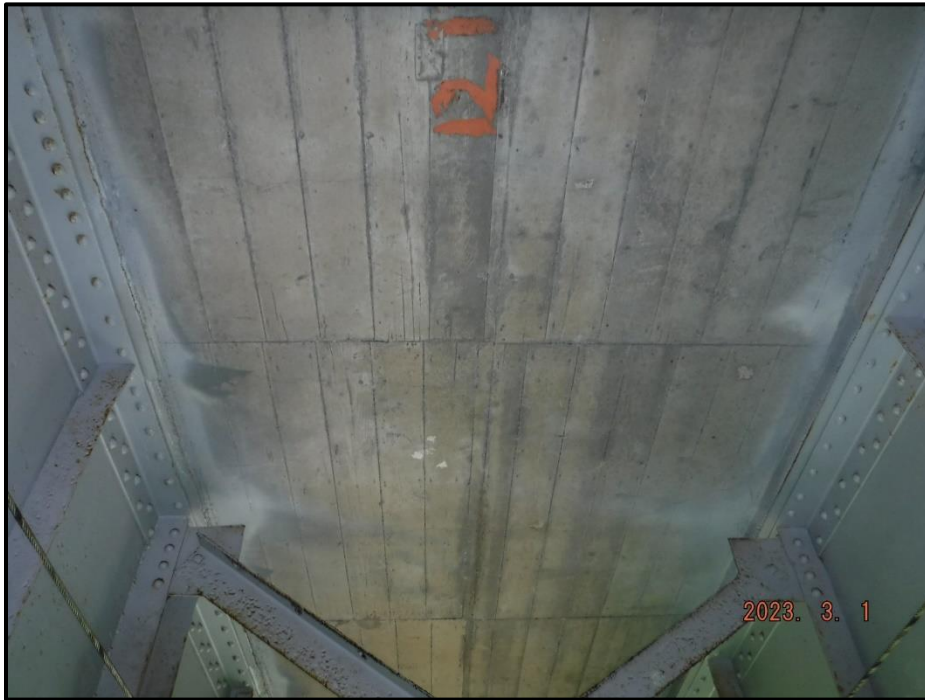
-All spans, Bay 2, map cracking throughout, up to 1/16" W, 128 SF CS3, (See Photo 25).

Photograph 25. Span 2, underside of deck, Bay 2, looking north. Map cracking throughout up to 1/16" W, CS3.

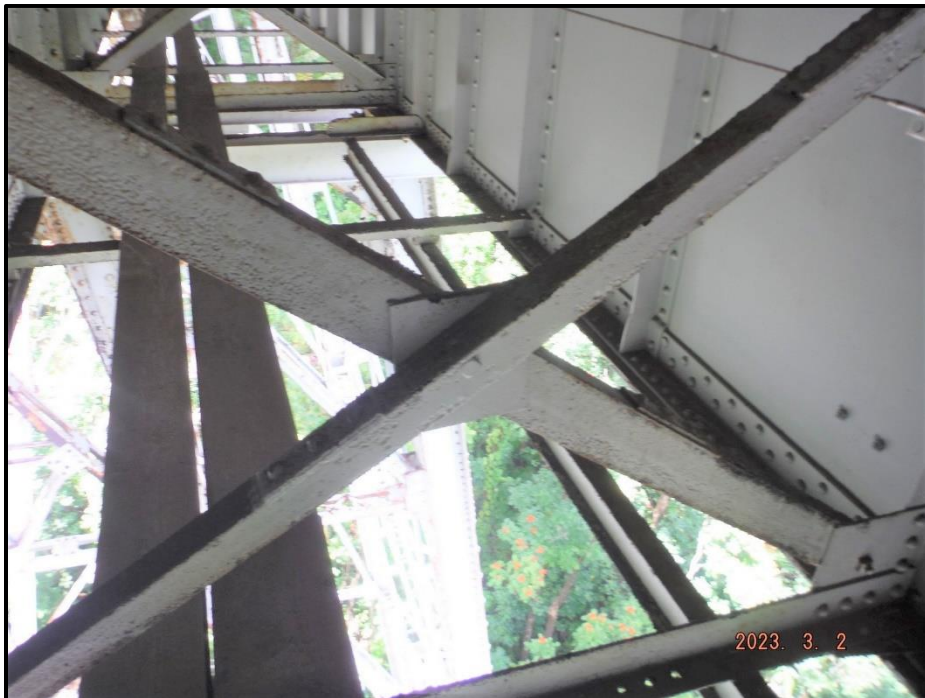
-The cross frames typically have painted over pitting 1/16" deep with isolated areas up to 1/4" deep and areas of corrosion, (See Photo 26).

Photograph 26. Span 6, Bay 1, near Bent 6, looking north. Cross frames typically have painted over pitting 1/16" D with isolated areas up to 1/4" D and areas of reactivating corrosion.

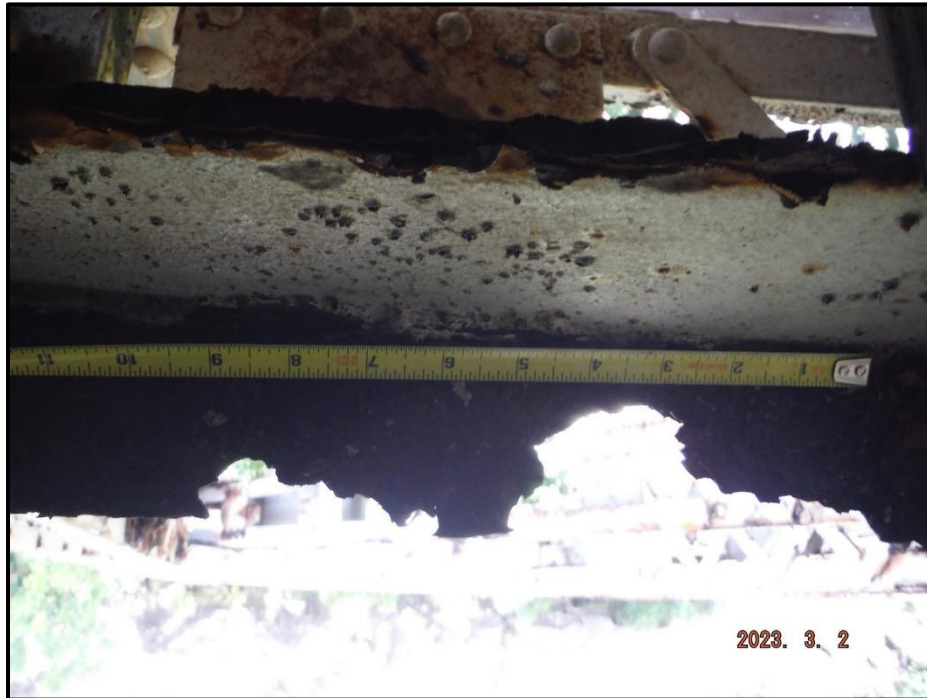
-Span 6, Bay 1 at Bent 5, adjacent to Girder 1, lower lateral bracing (wind bracing), 100% section loss on bottom flange over 10" L x up to 1 1/2" deep, (See Photo 27).

-Span 9, Bay 1 at Bent 9, adjacent to Girder 1, lower bracing, 100% section loss on bottom flange over 1' L x up to 1" W, (Similar to Photo 27).

Photograph 27. Span 6, Bay 1 at Bent 5, adjacent to Girder 1, lower bracing (wind bracing), looking north. 100% section loss on bottom flange over 10" L x up to 1 1/2" deep.

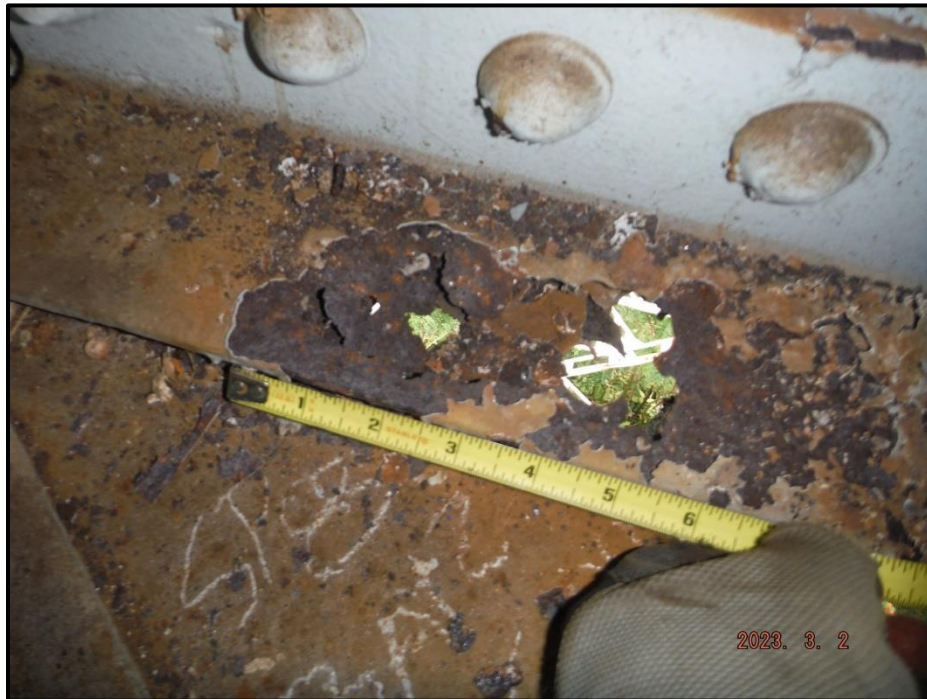
-Span 8, Bay 2, 2nd lower strut, (2) missing bolts and (1) corrosion hole, 5" L x 2" W, (See Photo 28).

-Span 8, Bay 2, 3rd lower strut, missing bolts and (1) corrosion hole, 4" L x 1 1/2" W, (Similar to Photo 28).

Photograph 28. Span 8, Bay 2, 2nd lower strut, looking south. (2) missing bolts and (1) corrosion hole, 5" L x 2" W.

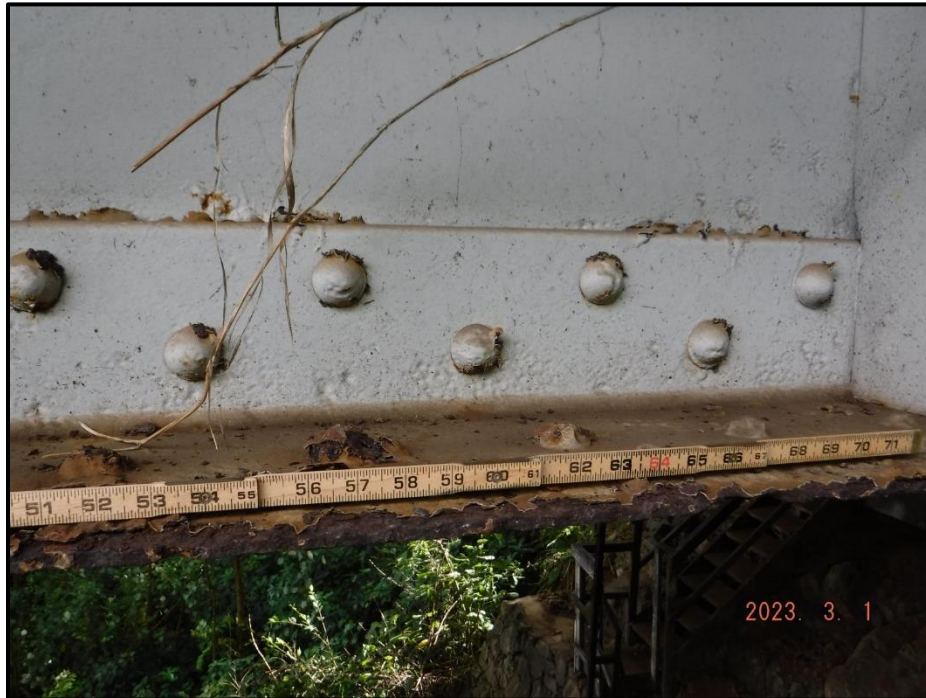
Photograph 29. Span 1, Girder 4 bottom flange (top and bottom faces), at midspan, looking east. Typical peeling paint and moderate corrosion along the ends of all exterior girders , typically 4' L x 5' W, with up to 3/16" deep section loss, CS3.

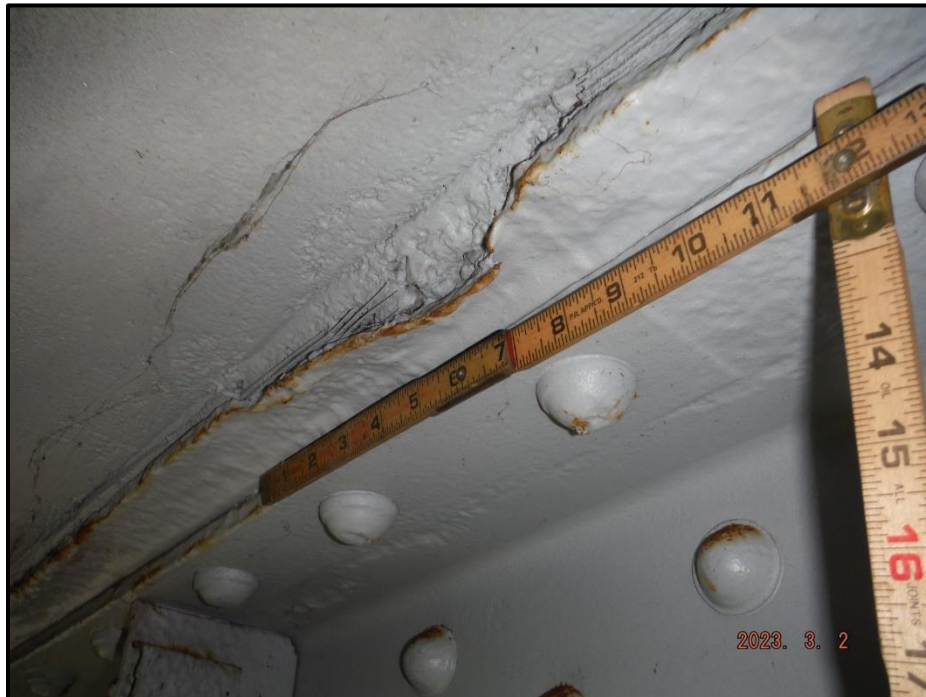
Photograph 30. Span 2, Bay 1, top flange plate of Girder 1, looking northeast. Intermittent areas of up to 2' L x 2" W x 1/2" deep painted over pitting, CS3.

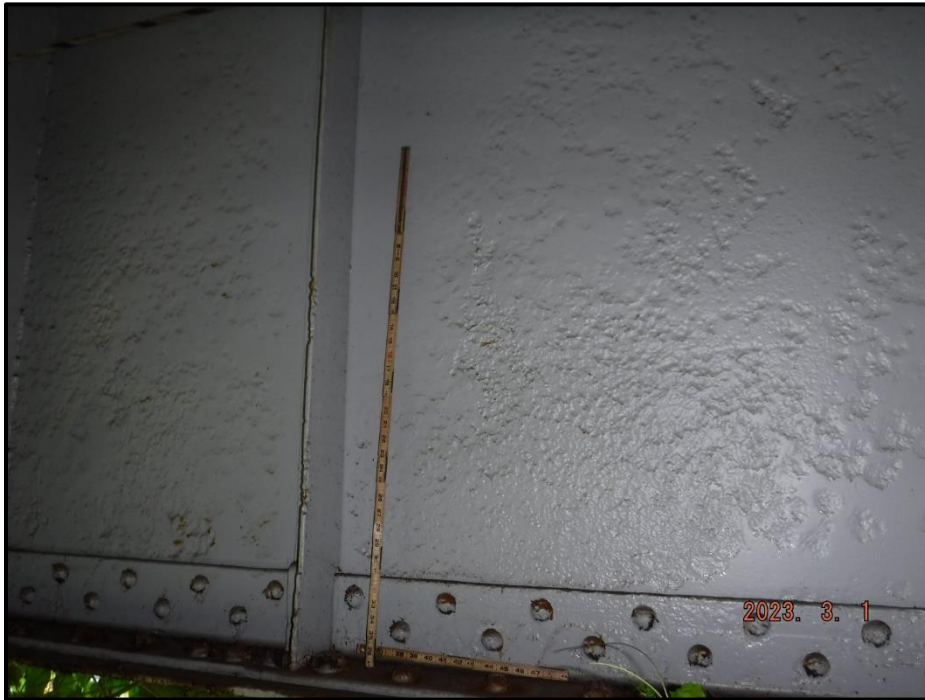
Photograph 31. Span 2, Girder 1, west face, looking east. 25' L section of painted over pitting up to 1/8" deep, CS3.

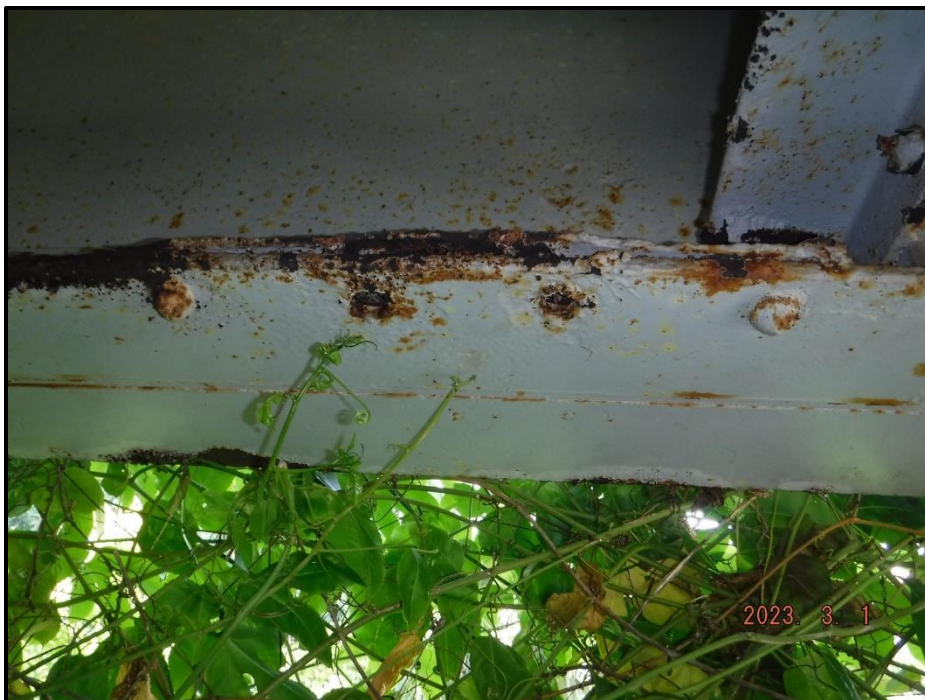
Photograph 32. Span 2, Girder 3, east face bottom flange, 5' north of Bent 1, looking west. (2) missing rivets in 1' L area of up to 1" thick pack rust, CS3.

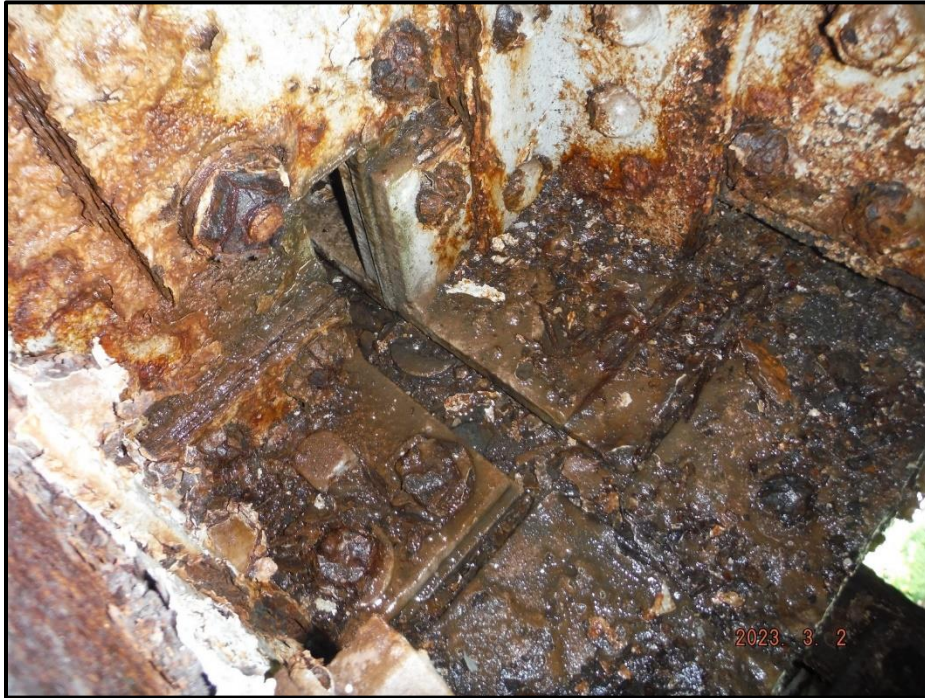
Photograph 33. Bent 3, Bay 1, Girder 1 and 2 bottom flange connection, looking northwest. Rivet heads have corrosion with up to 50% section loss, CS3.

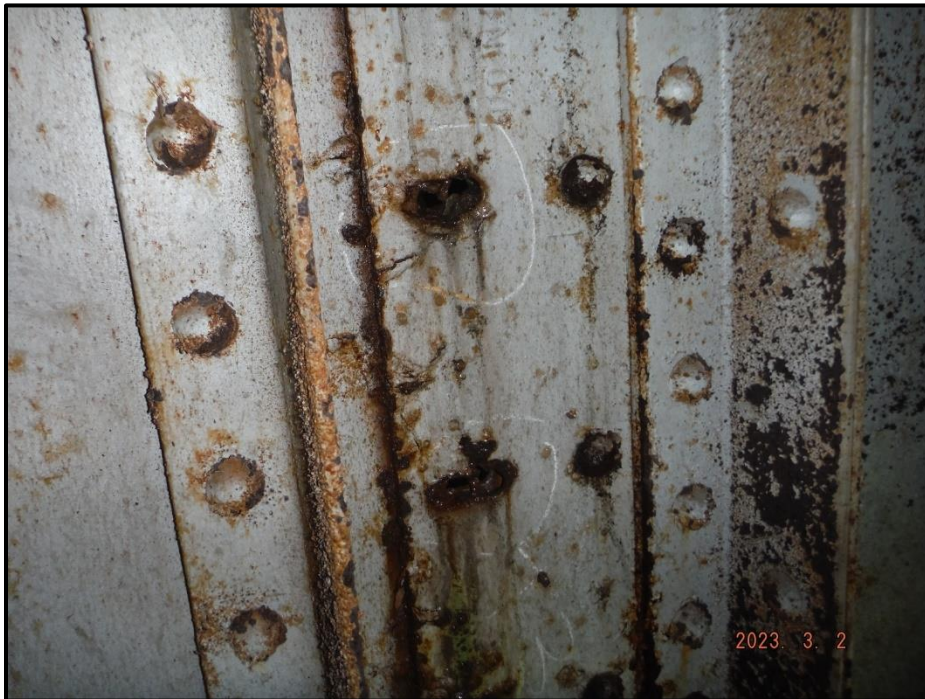
Photograph 34. Bent 3, Bay 1, Girder 2, web sliding plate, looking west. (3) missing bolts with heavy laminar corrosion, CS3.

Defect ID	Caption
1	South Abutment bearings, moderate corrosion with minor section loss, 4 EA CS3, (See Photo 47).
2	All spans, Bay 2, map cracking throughout, up to 1/16" W, 128 SF CS3, (See Photo 25).
3	All spans, both overhangs, transverse cracking with efflorescence throughout, typically 3'-4' apart x up to 1/8" W, 85 SF CS3, (See Photo 24).
4	Span 2, Bay 1, top flange plate of Girder 1, intermittent areas of up to 2' L x 2" W x 1/2" deep painted-over pitting, 10 LF CS3, (See Photo 30).
5	Span 2, Girder 1, west face, 25' L section of painted-over pitting up to 1/8" deep, 25 LF CS3, (See Photo 31).
6	Span 2, Girder 3, east face bottom flange, 5' north of Bent 1, (2) missing rivets in 1' L area of up to 1" thick pack rust, 1 LF CS3, (See Photo 32).
7	Bent 3, Bay 1, Girder 1 and 2 bottom flange connection, rivet heads have corrosion with up to 50% section loss, 2 LF CS3, (See Photo 33).
8	Bent 3, Bay 1, Girder 2, web sliding plate, (3) missing bolts with heavy laminar corrosion, 1 LF CS3, (See Photo 34).

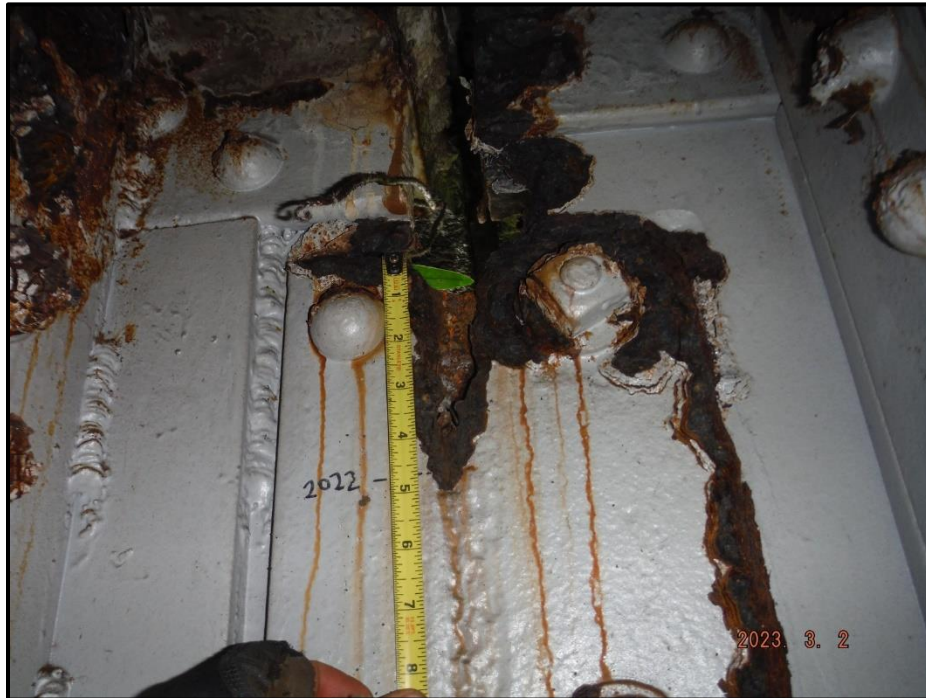
Photograph 35. Bent 3, Girder 1, top of sliding web plate, looking east. 5" H x 2" W area of 1/8" to 100% section loss, area of 100% loss is 1" W, CS3.

9	Bent 3, Bay 2, both cross frames, laminar corrosion throughout with up to 25% section loss of member.
10	Bent 3, Girder 1, top of sliding web plate, 5" H x 2" W area of 1/8" to 100% section loss, area of 100% loss is 1" W, 1 LF CS3, (See Photo 35).
11	Bent 3, Girder 2 web sliding plate, missing bolts and nuts and heavy laminar corrosion, 1 LF CS3, (Similar to Photo 40).
12	Bent 3, Girder 4 web sliding plate, heavy corrosion at the bolt slots and (2) missing bolts at the bottom, with a 2" H x 3" W area of 100% section loss, 1 LF CS3, (See Photo 40).
13	Bent 3, Span 3, Girder 2 bearing, missing south anchor bolt, 1 EA CS3.

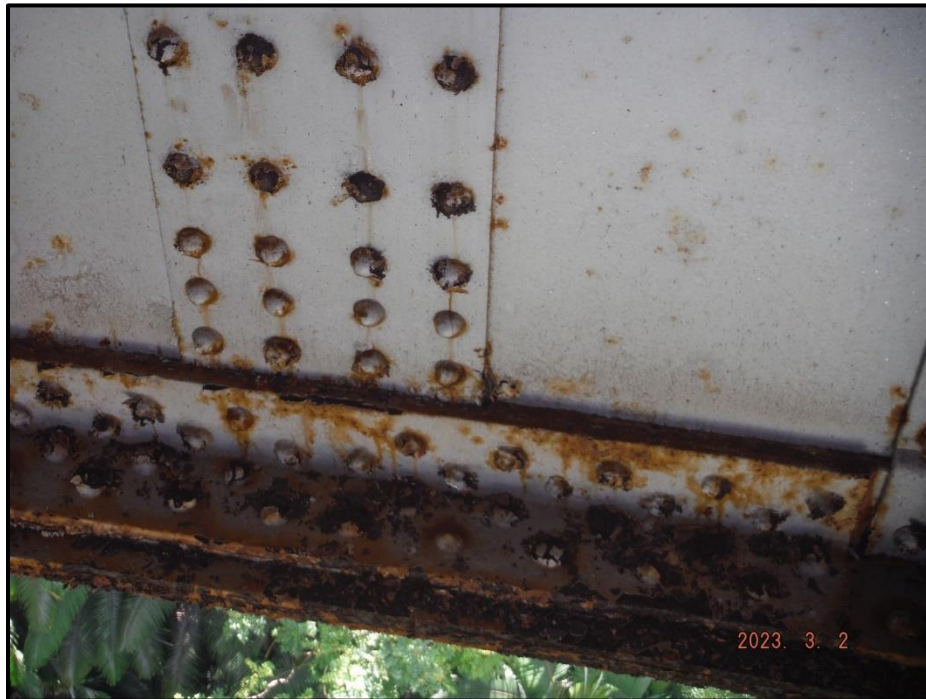
Photograph 36. Span 4, Girder 3 splice and bottom flange, looking west. 3' L x up to 1/8" W pitting and rivet head corrosion with up to 25% section loss, as well as peeling paint, CS3.

21	Span 4, Bay 2, lower gusset plates at 2nd and 3rd cross frames, pack rust and corrosion holes up to 6" L x 2" W adjacent to Girder 3.
22	Span 4, Girder 3 splice and bottom flange, 3' L x up to 1/8" W pitting and rivet head corrosion with up to 25% section loss, as well as peeling paint, 3 LF CS3, (See Photo 36).

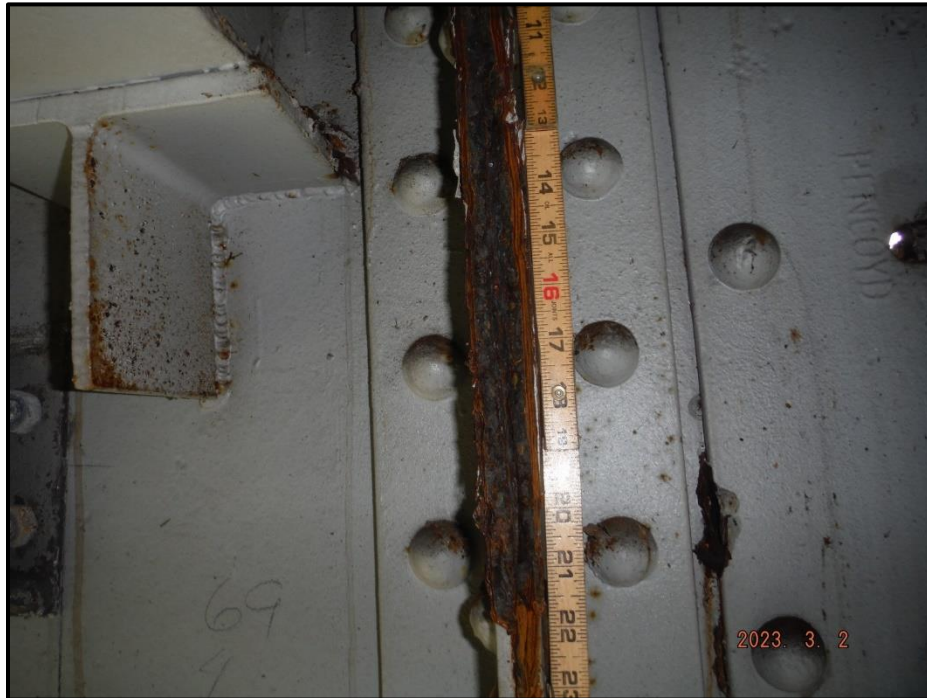
Photograph 37. Span 6, Bent 5, web stiffener above Girder 1 bearing, looking east. 3/16" thick pack rust causing a 1' 11" H x 1" deflection, CS3.

Defect ID	Caption
23	Span 4, Girder 4 east face, near Bent 3, bearing stiffener, pack rust up to 1" thick at the base with four missing rivets, 1 LF CS3, (Similar to Photo 37).
24	Bent 4, Girder 4 bearing, heavy corrosion on the anchor bolts with up to 30% section loss, 1 EA CS3.
25	Bent 4, Span 5, Girder 1 bearing, peeling paint and heavy corrosion throughout. The bottom plates have 10% section loss, 1 EA CS3, (Similar to Photo 50).
26	Bent 5, Girder 1 web sliding plate, corrosion induced crack at the top 1" with heavy laminar corrosion around the crack, 1 LF CS3, (Similar to Photo 35).
27	Bent 5, Girder 2 web sliding plate, (1) missing connection bolt, 1 LF CS3, (Similar to Photo 40).
28	Span 6, Bay 1 at Bent 5, adjacent to Girder 1, lower bracing, 100% section loss on bottom flange over 10" L x up to 1-1/2" deep, (See Photo 27).
29	Span 6, Bent 5, web stiffener above Girder 1 bearing, 3/16" thick pack rust causing a 1' 11" H x 1" deflection, 1 LF CS3, (See Photo 37).

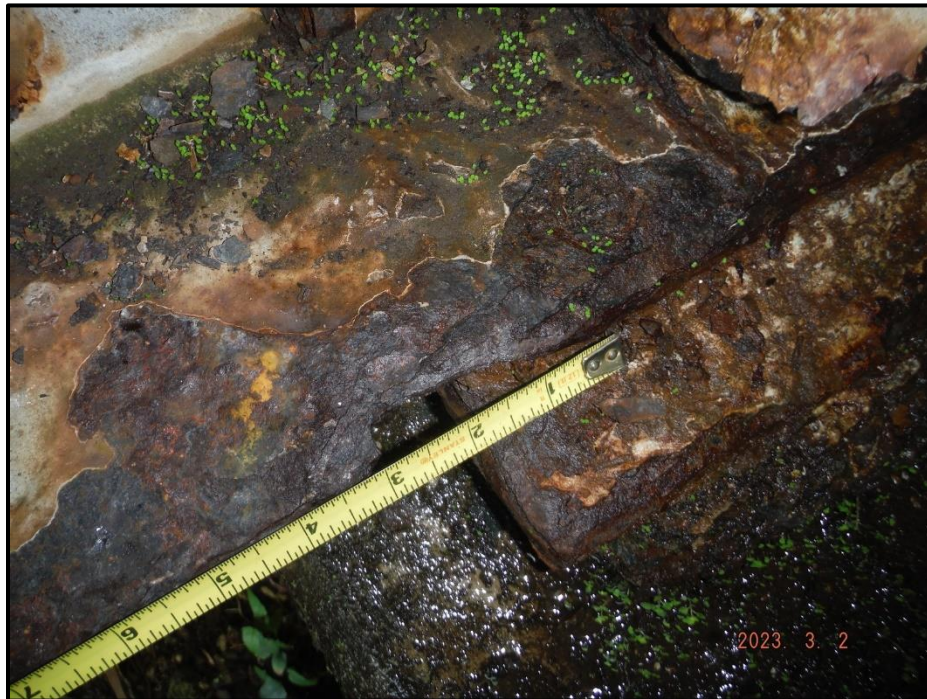
Photograph 38. Span 10, Girder 1, east face at North Abutment, looking west. 3" L x 1/2" W area of 100% section loss, CS3.

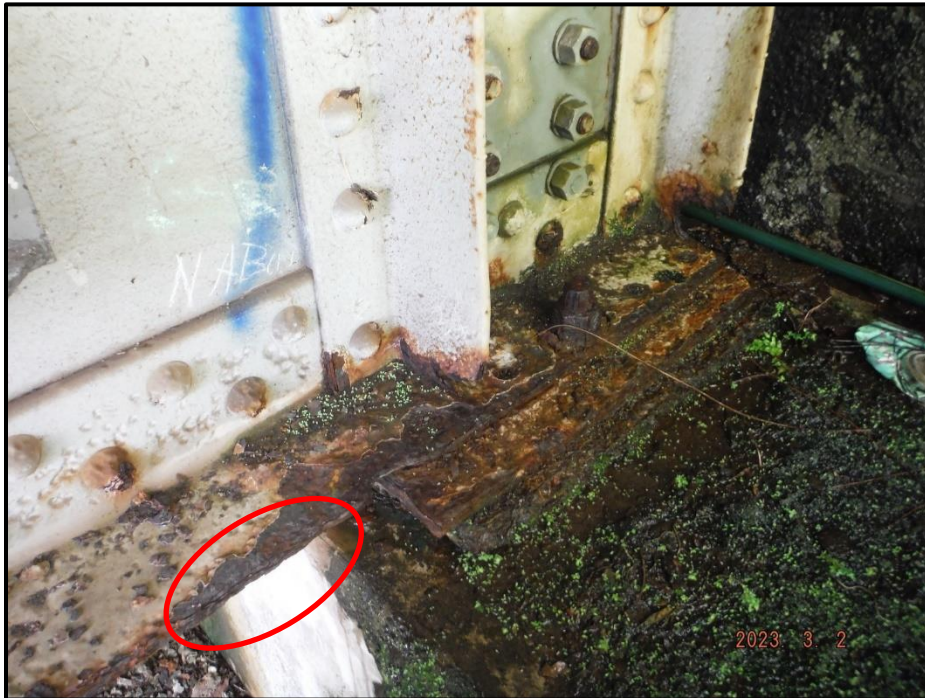
Photograph 39. Span 10, Girder 1, east face at North Abutment, looking northwest. (2) bearing stiffeners have effectively no remaining section at the lower 2" at the base. The eastern bottom flange has 2" W knife-edging, CS3.

Defect ID	Caption
40	Span 10, Girder 1, east face at North Abutment, (2) bearing stiffeners have effectively no remaining section at the lower 2" at base. The eastern bottom flange has 2" W knife-edging. This condition is similar at the Girder 4 East face, 2 LF CS3, (See Photo 39).
41	Span 10, Girder 1, east face at North Abutment, 3" L x 1/2" W area of 100% section loss, 1 LF CS3, (See Photo 38).
42	North Abutment bearings, up to 1/8" thick laminar corrosion, 4 EA CS3, (Similar to Photo 50).
43	North Abutment, Girder 3, Bay 2, lateral bracing has (3) missing/ loose anchor bolts and a deformed gusset plate.

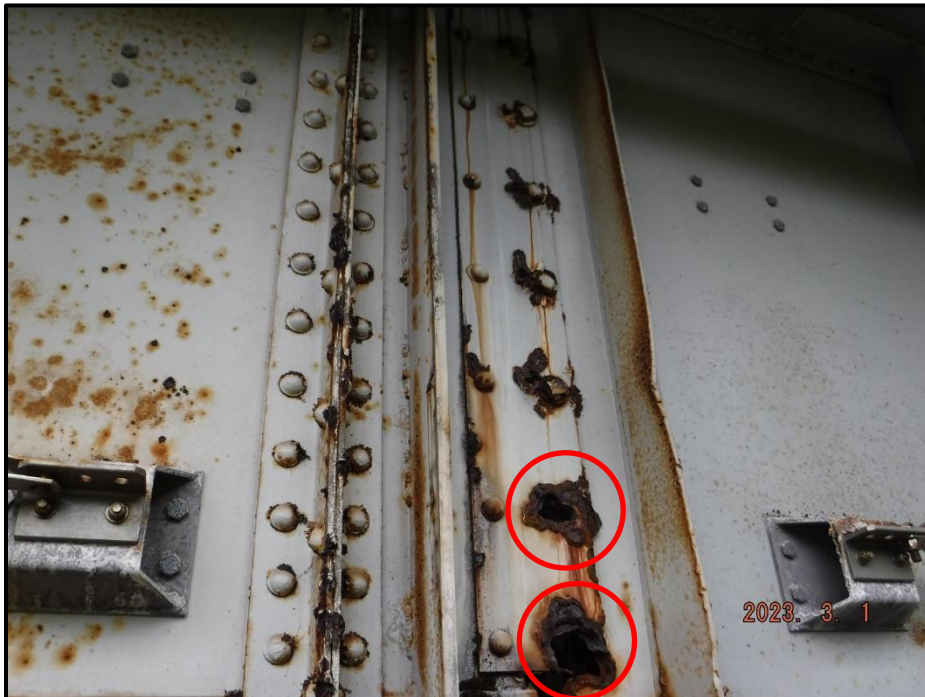
Photograph 40. Bent 3, Girder 4 web sliding plate, looking east. Heavy corrosion at the bolt slots and (2) missing bolts at the bottom, with a 2" H x 3" W area of 100% section loss, CS3.

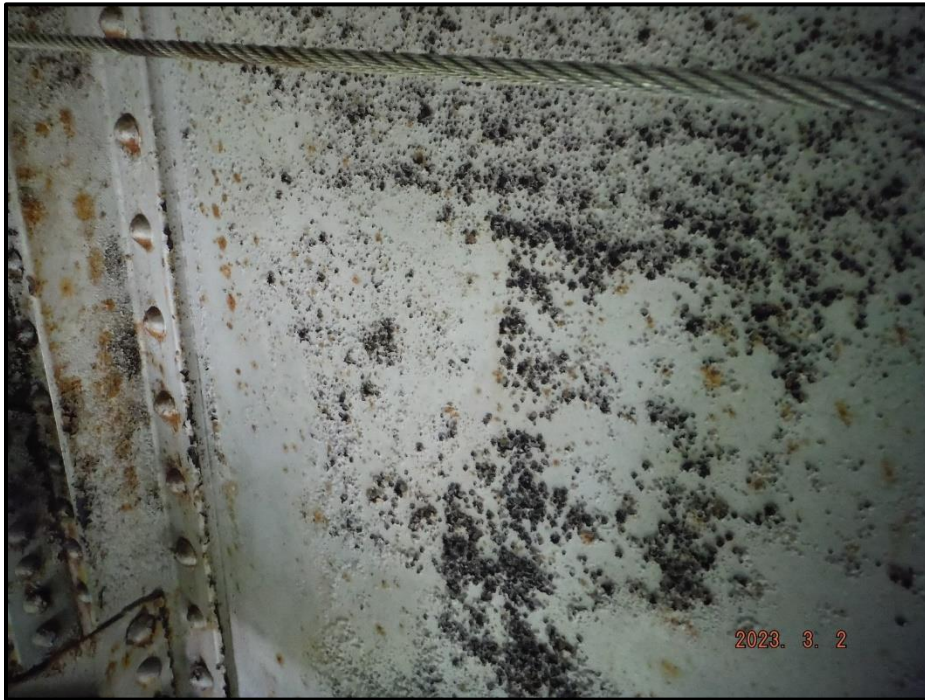
Photograph 41. Span 5, Bent 4, Girder 2, looking west. Steel protective coating exhibits peeling/ bubbling, CS3.

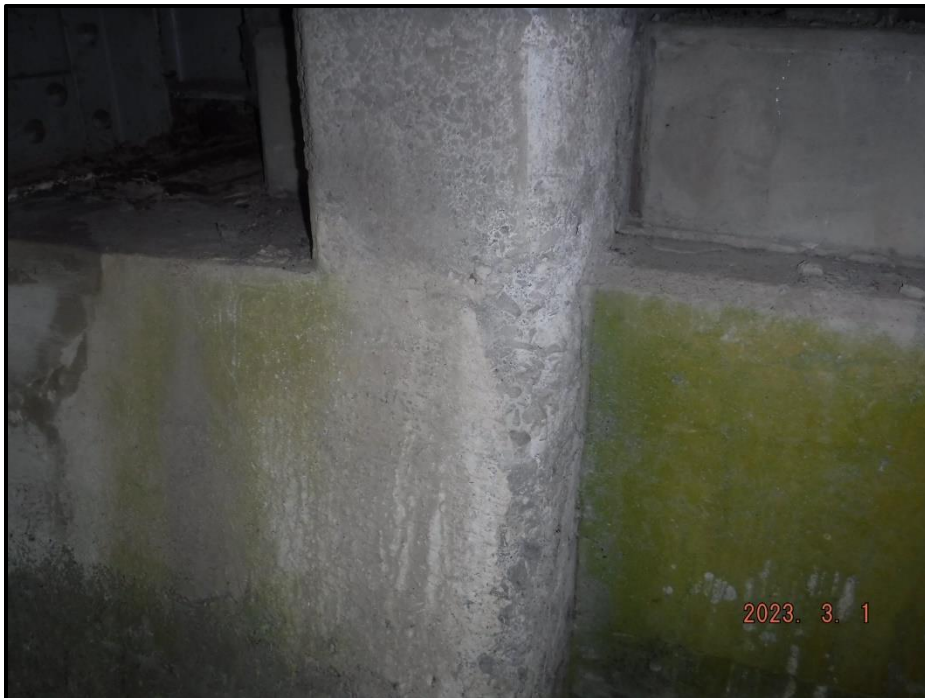
Photograph 42. South Abutment, Bay 3, center section, looking south. Spall, 1' 4" H x 8" W x 1" deep, CS3.

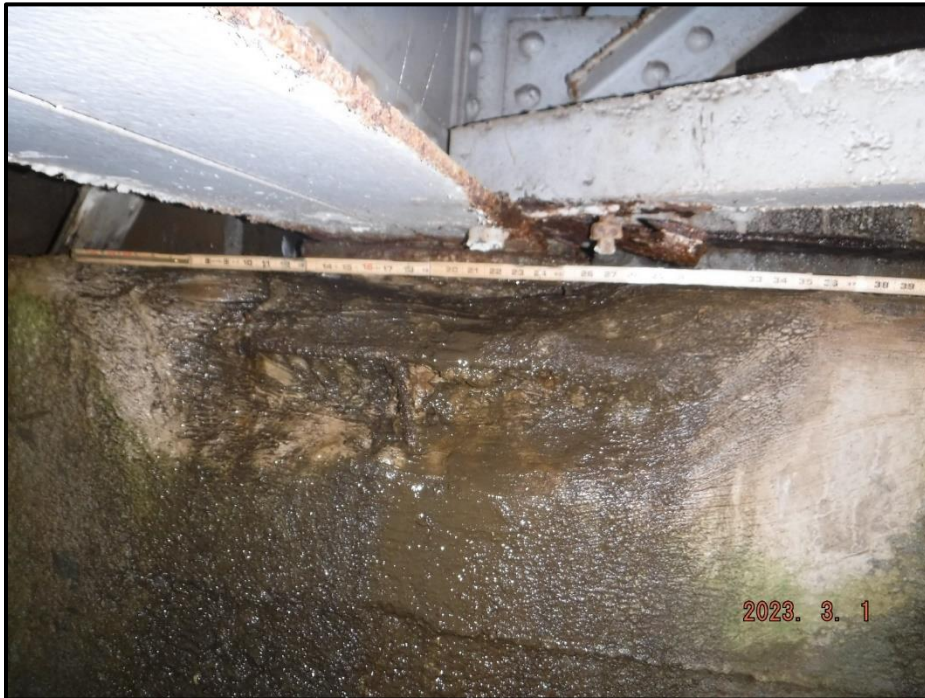
Photograph 43. North Abutment, Girder 3 seat, looking north. Failed repair, 2' 11" L x 10" H x 3" deep exposing (2) reinforcing bars with no section loss, CS3.

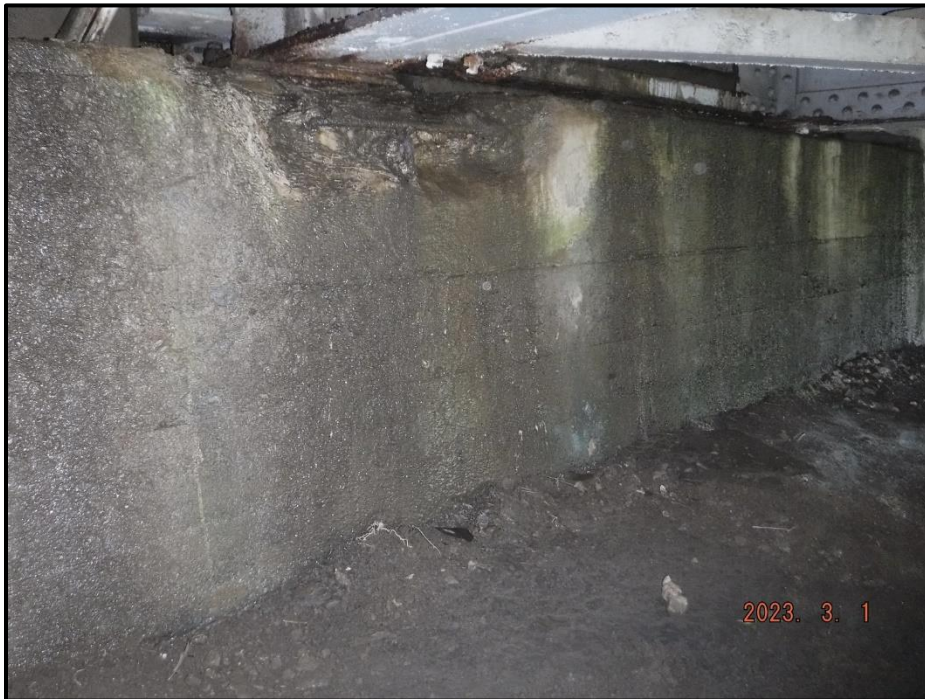
Photograph 44. North Abutment, west end of center section, looking northeast. Honeycombing, up to 2' H x 1' W x 1" deep, CS3.

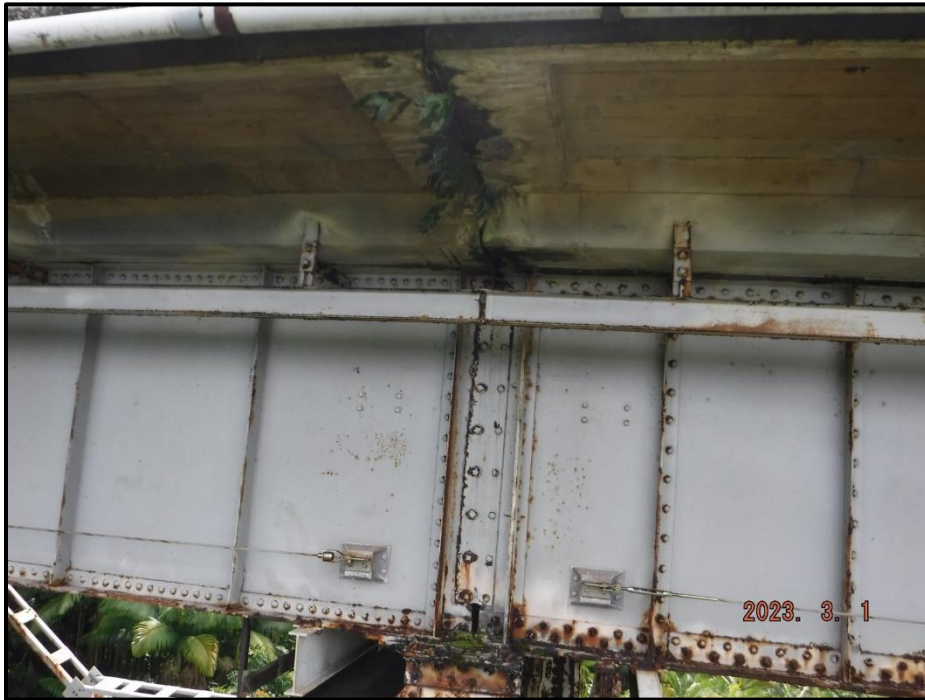
Photograph 45. Bent 3, center joint, looking west. Vegetation growth into the joint from the underdeck at the east overhang.

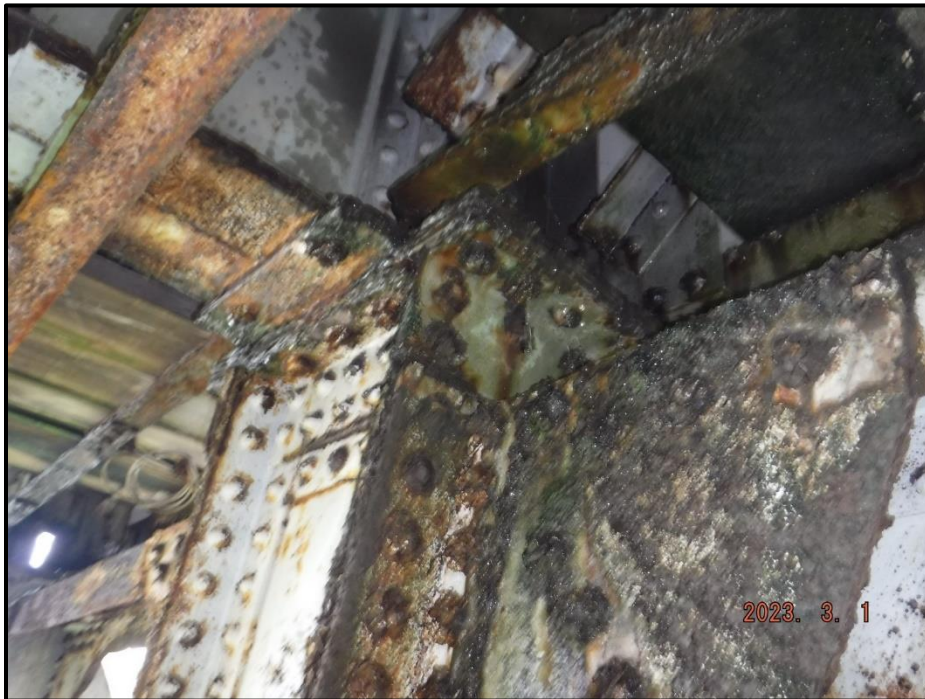
Photograph 46. Bent 3 Joint, Bay 2, looking southeast. Active leakage, CS3.

-Bent 3 Joint, Bay 2, active leakage, 8 LF CS3, (See Photo 46).

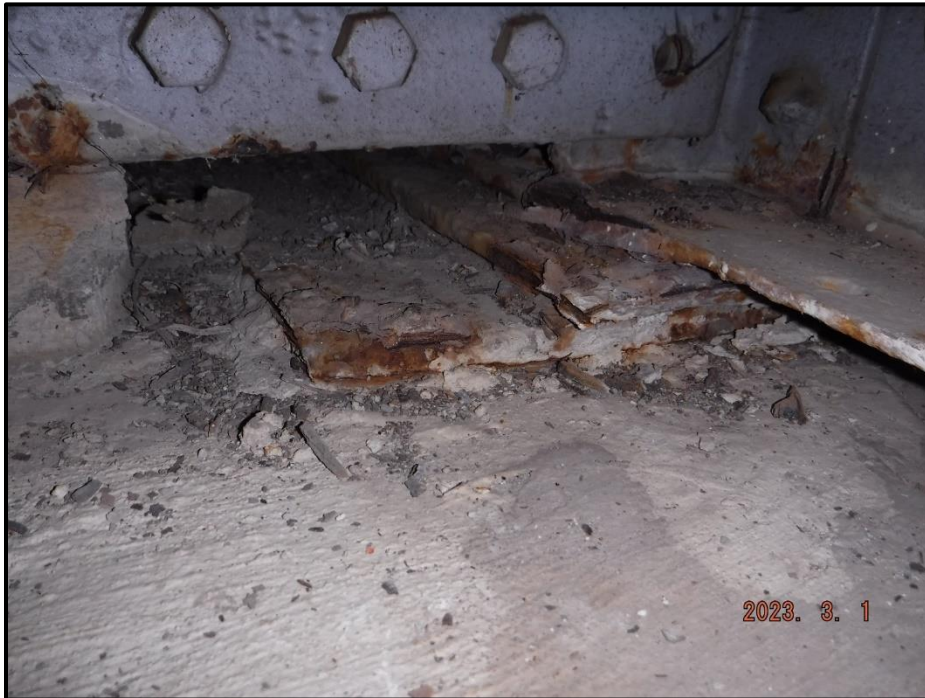
Photograph 47. South Abutment, Girder 3 bearing, looking southwest. Moderate corrosion with minor section loss, CS3.

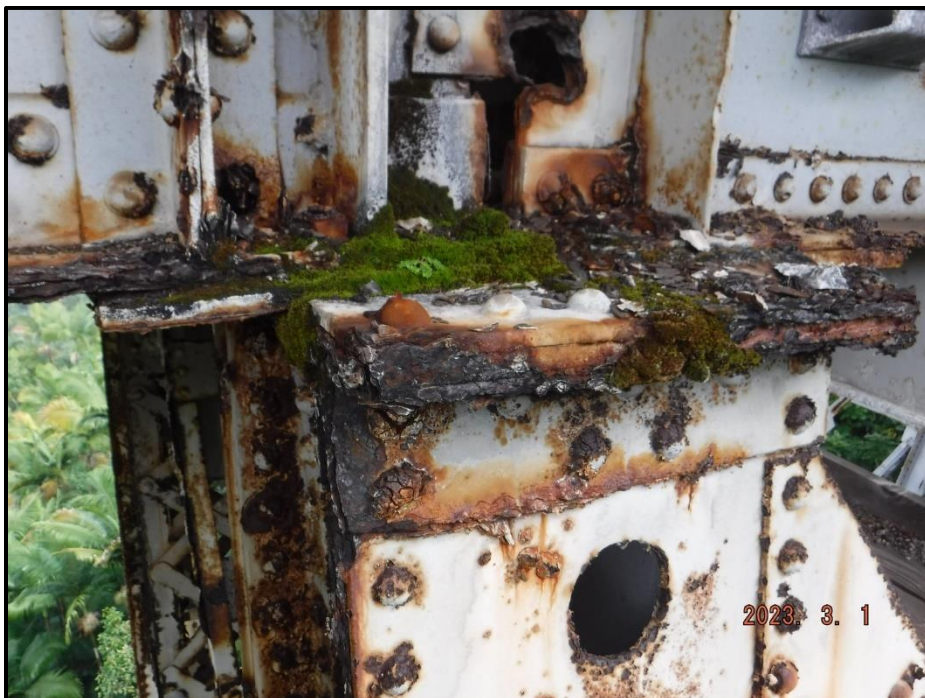
Photograph 48. Bent 3, Span 4, Girder 4 bearing, looking west. Peeling paint and heavy corrosion throughout. The bottom plate has 10% section loss along the edges and pack rust on the north side, CS3.

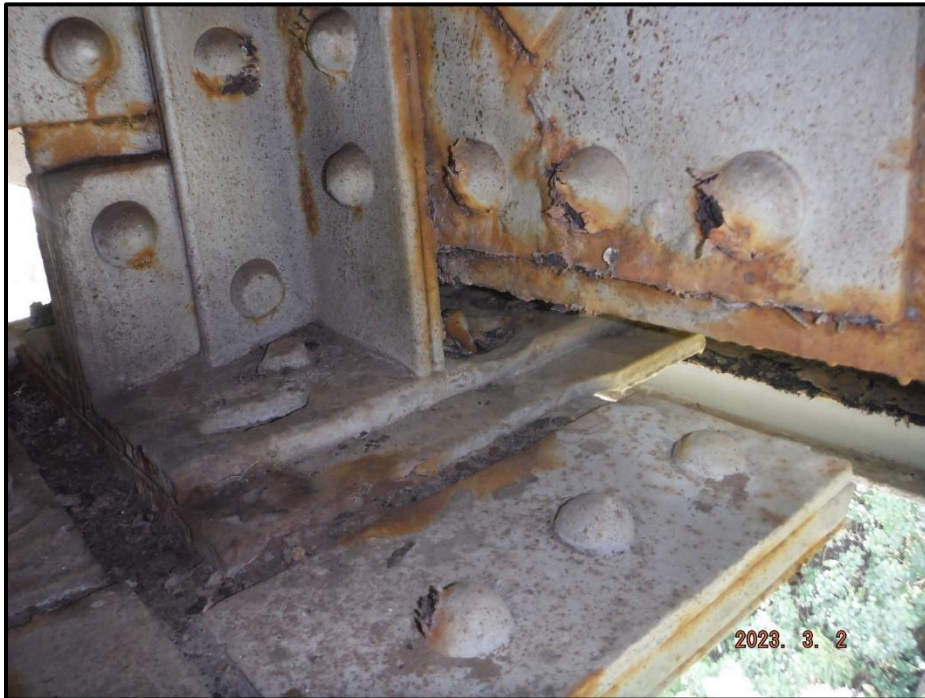
Photograph 49. Bent 7, Span 8, Girder 3 Bearing, looking northwest. Missing southeast, southwest, and northwest anchor bolts, missing northeast anchor nut, CS3.

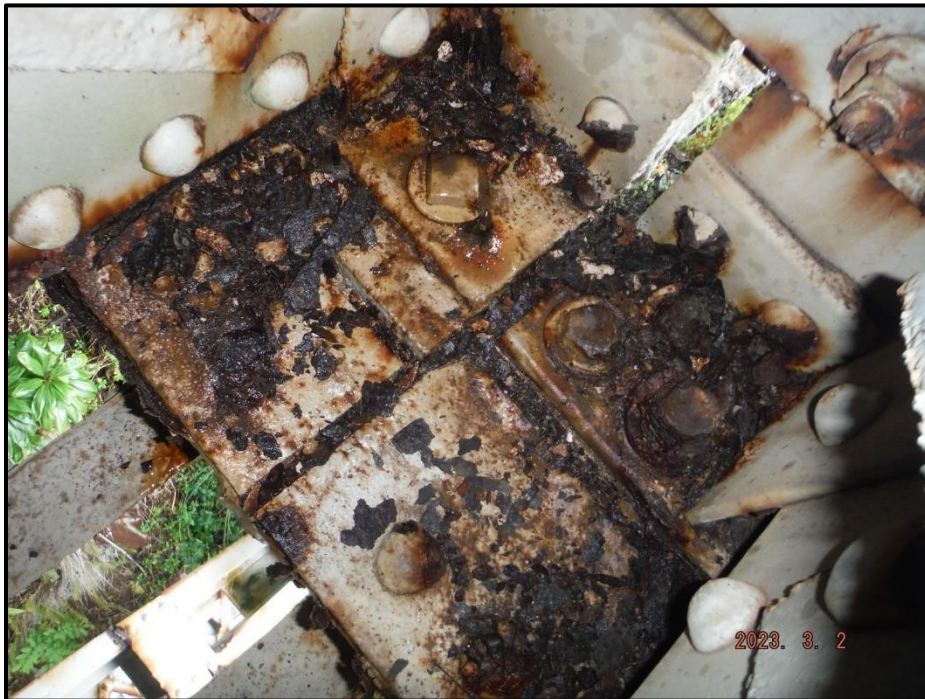
Photograph 50. Bent 9, Span 9, Girder 1 bearing, looking east. Up to 1/4" thick laminar corrosion, CS3.

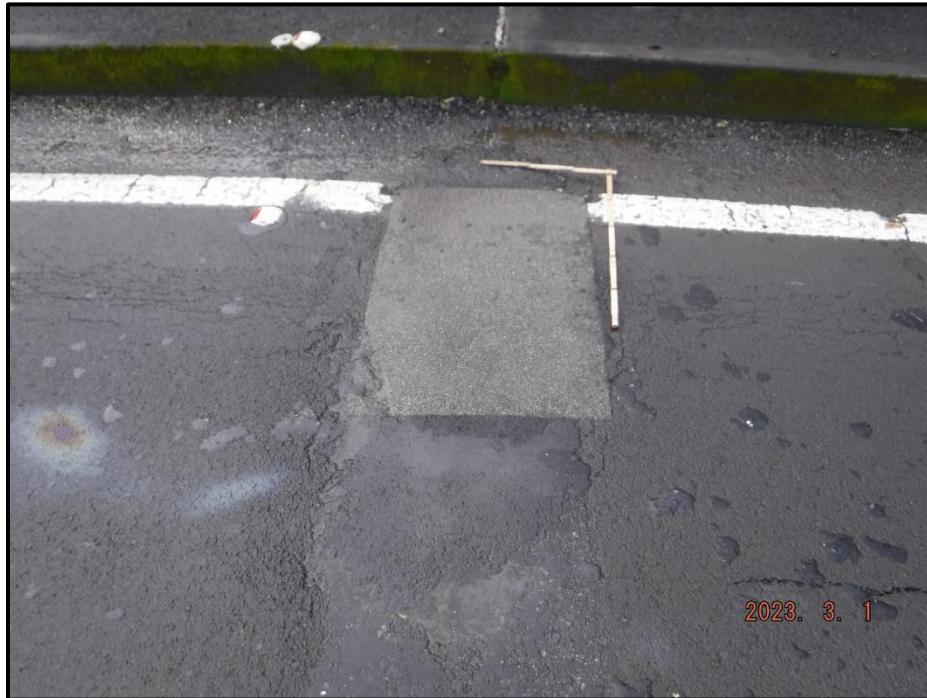
Photograph 51. Bent 7 Joint, SB lane, looking west. Previous cracked and settled patch has been re-patched.

- Bent 7 Joint, SB lane, previous cracked and settled patch has been re-patched, (See Photo 51).
- North Abutment Joint, NB lane, exposure of steel plate with minor corrosion through pothole has been patched.
