**STATE OF HAWAII
DEPARTMENT OF TRANSPORTATION**

**ADDENDUM NO. 2
FOR
HAWAII BELT ROAD
NANUE STREAM BRIDGE REHABILITATION
VICINITY OF HILO
DISTRICT OF HILO, ISLAND OF HAWAII
FEDERAL-AID PROJECT NO. BR-019-2(077)**

December 13, 2024

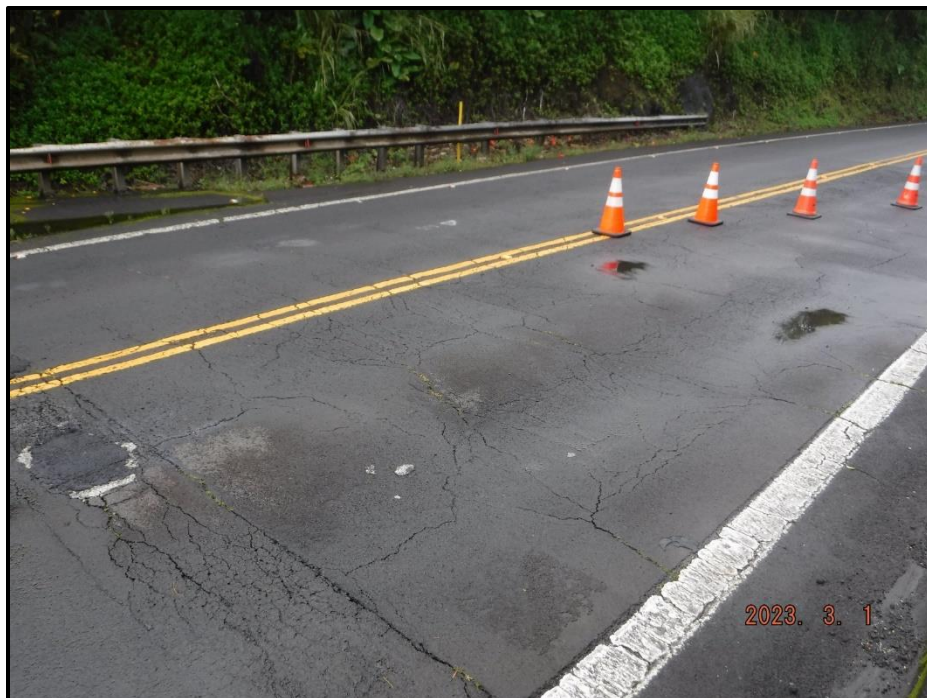
Photograph 52. North and south approach roadways, looking northwest. Depressed and worn surface in wheel lines of both lanes, up to 1/2" wide map cracks throughout, some with vegetation growth.

-North and south approach roadways, depressed and worn surface in wheel lines of both lanes; up to 1/2" wide map cracks throughout, some with vegetation growth, (See Photo 52).

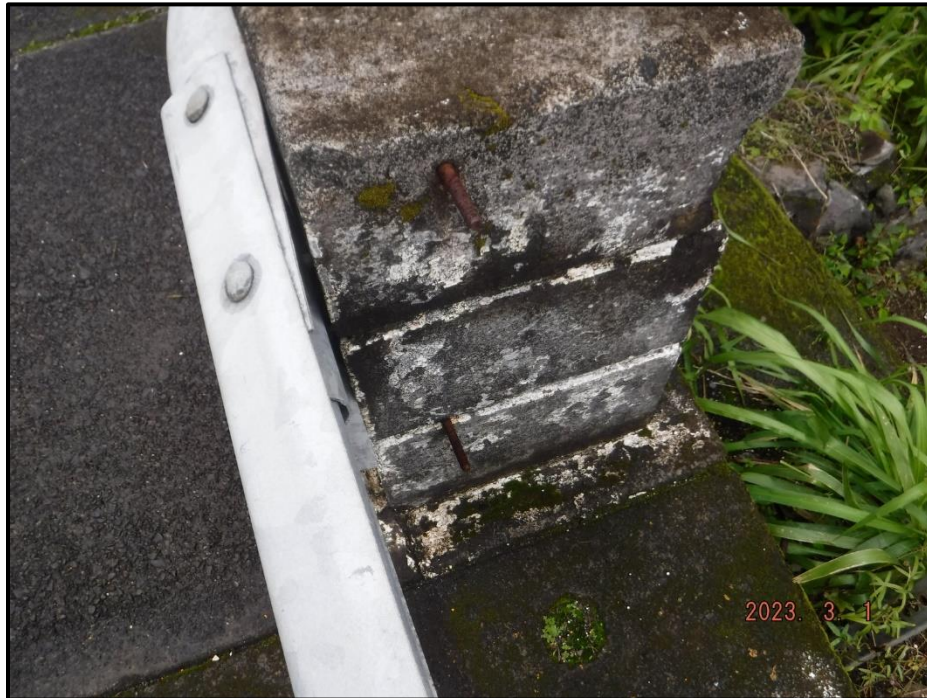
Photograph 53. East railing, south end, looking north. (2) reinforcing bars sticking out of concrete towards NB traffic.

-East railing, south end, (2) reinforcing bars sticking out of concrete towards NB traffic, (See Photo 53).

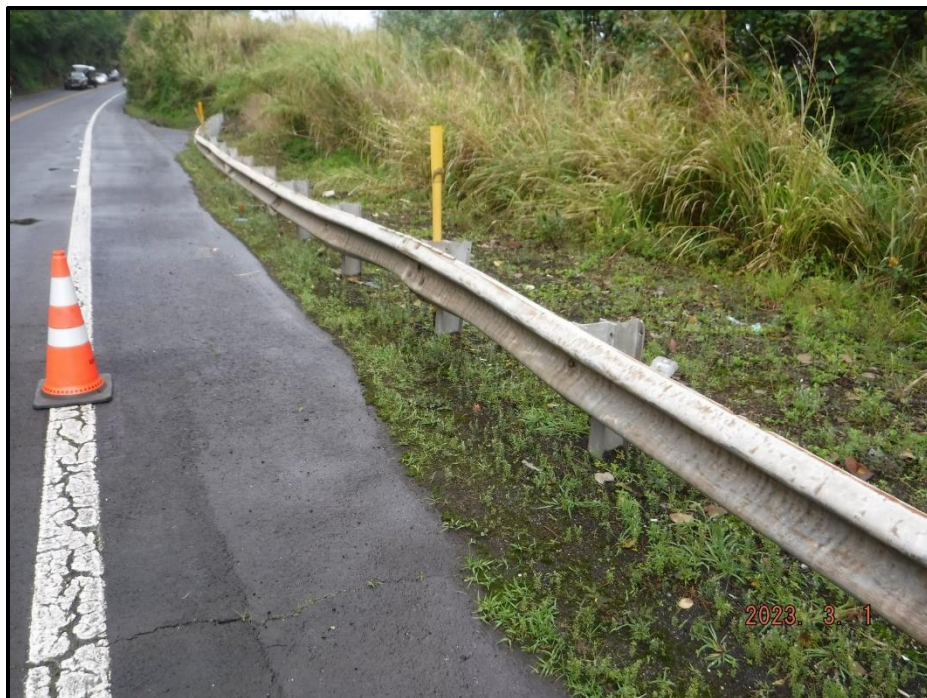
Photograph 54. Northeast guardrail, looking northeast. (2) areas of impact damage, (1) 10' L x 3" deflection and (1) 2' L x 2" deflection.

-Northeast guardrail, (2) areas of impact damage, (1) 10' L x 3" deflection and (1) 2' L x 2" deflection, (See Photo 54).

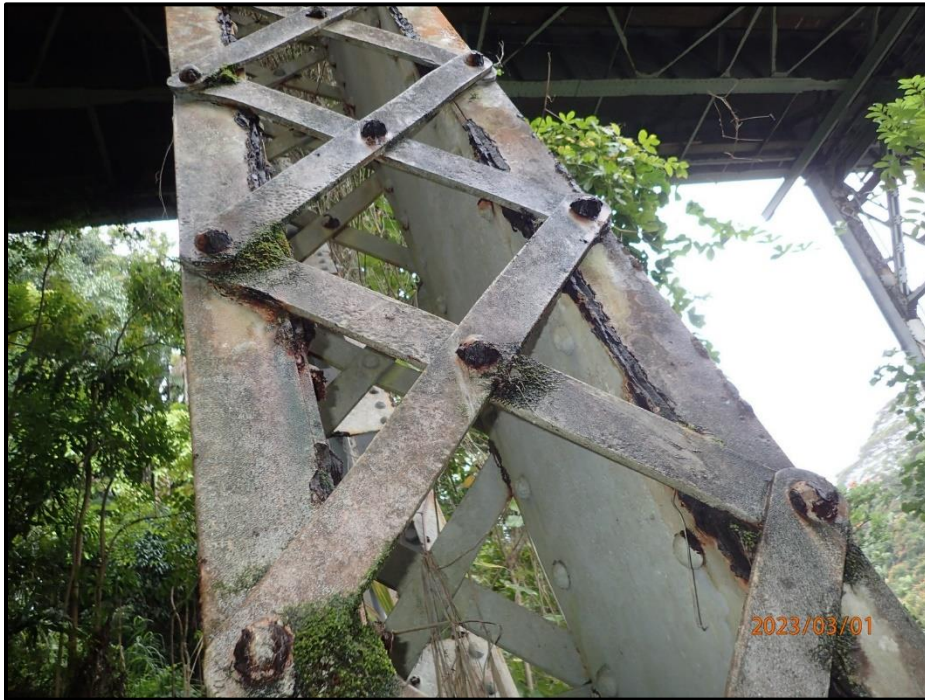
Photograph 55. Bent 1, Level 1, Column A, looking northwest. Typical pitting, pack rust and laminar corrosion, CS3.

Defect ID	Caption
44	Bent 1, Level 1, Column A. (2) adjacent lacing bar rivets on south interior face of Column D with 100% section loss to heads, CS3. (Similar to Photo 57)
45	Bent 1, Level 1, Column A. Typical pitting, pack rust and laminar corrosion, CS3. (See Photo 55)
46	Bent 1, Level 1, Column D, east face, near midheight horizontal. Missing batten plate, CS3. (See Photo 56)
47	Bent 1, Level 1, Column D, south face. Scattered rivets with up to 100% section loss, CS3. (See Photo 57)

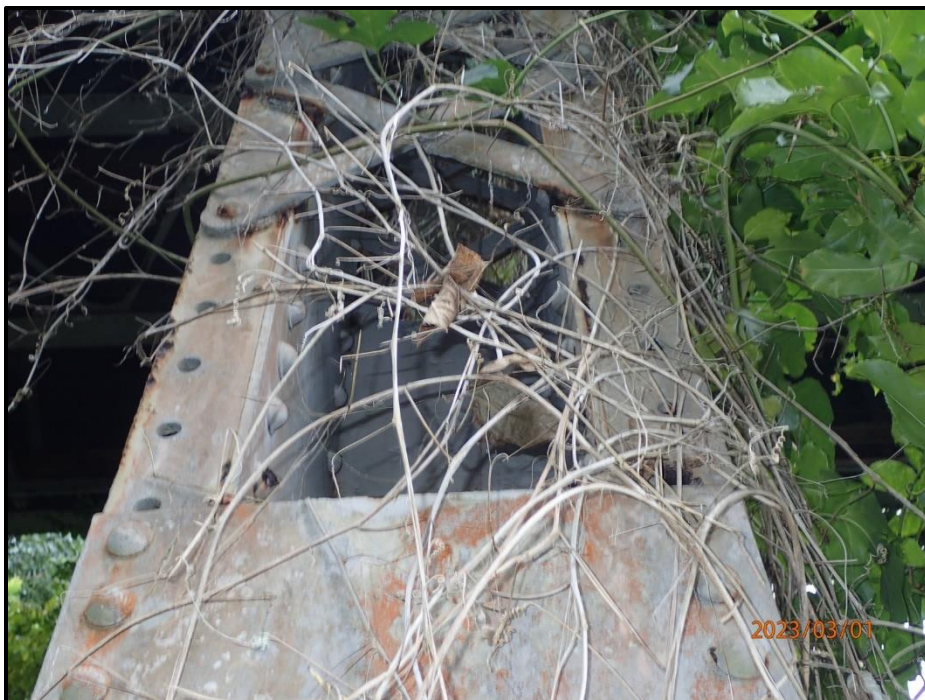
Photograph 56. Bent 1, Level 1, Column D, east face, near mid height horizontal, looking west. Missing batten plate, CS3.

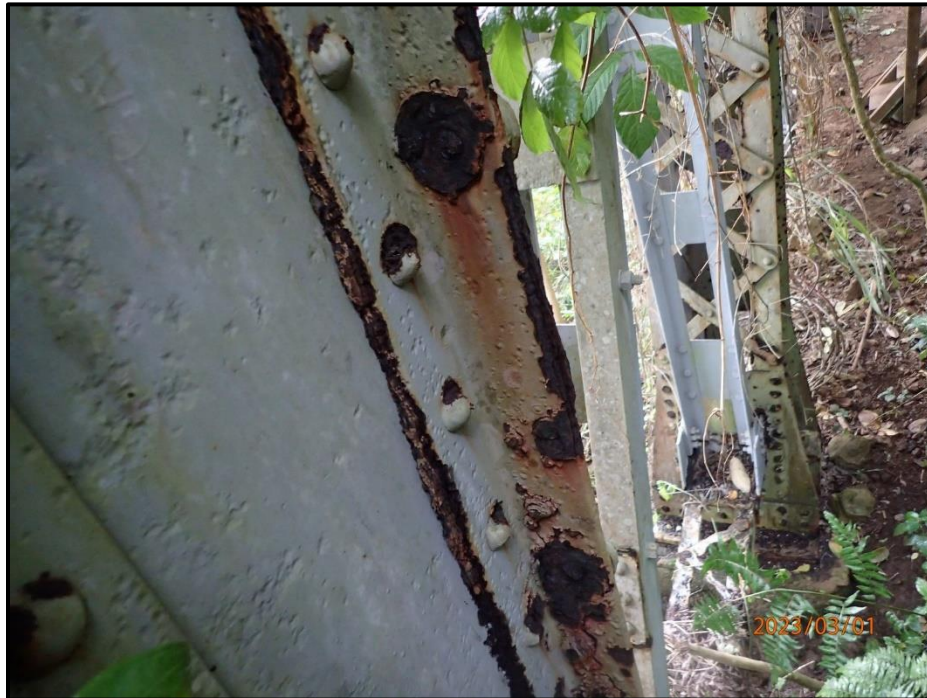
Photograph 57. Bent 1, Level 1, Column D, south face, looking east. Scattered rivets with up to 100% section loss, CS3.

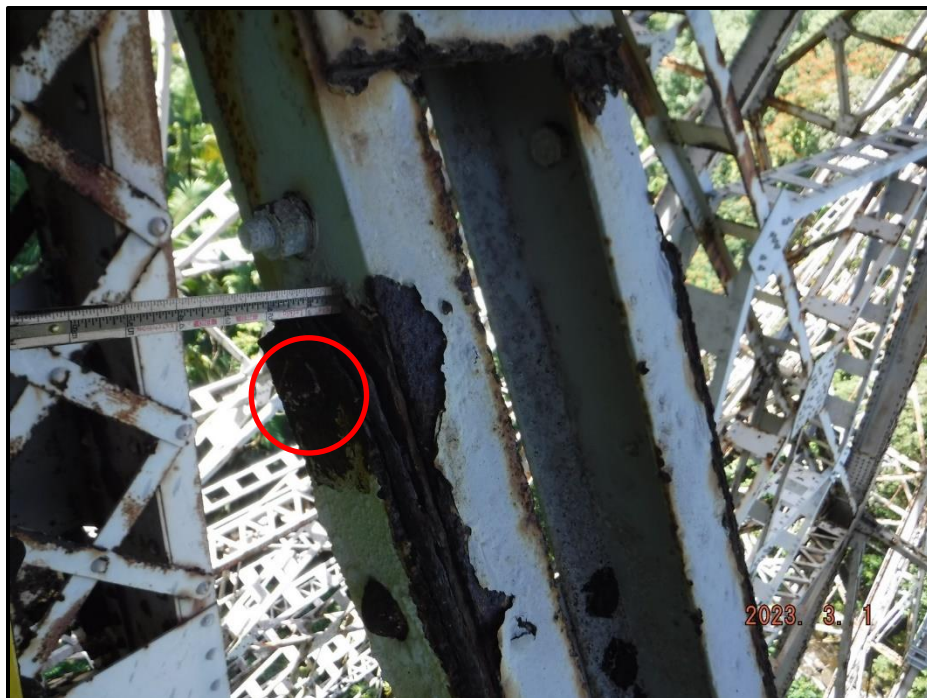
Photograph 58. Bent 2, Level 1, upper section, between Columns A and B, diagonal bracing, both cover plates at mid-length, looking north. Pack rust up to 3/4" thick causing separation of plate and one broken rivet on north cover plate, CS3.

Defect ID	Caption
48	Bent 2, Level 1, upper section, between Columns A and B, diagonal bracing, both cover plates at mid-length. Pack rust up to 3/4" thick causing separation of plate and one broken rivet on north cover plate, CS3. (See Photo 58)
49	Bent 2, Level 1, upper section, between Columns B and C, horizontal bracing. West face has (3) lacing bars with 50% section loss and (1) with 90% section loss, CS3. (See Photo 59)
50	Bent 2, Level 1, upper section, Column C. (1) lacing bar has 90% section loss, CS3. (Similar to Photo 125)
51	Bent 2, Level 1, lower section, between Columns A and B, horizontal bracing. South face of angle has 1' 8" L x 1" H x up to 100% section loss with (3) lacing bars up to 75% section loss. The south angle has approximately 30% section loss near Column A. Angle original section is 3" x 4-1/2", remaining is 1-1/2" x 3-3/4", CS3. (See Photo 60)
52	Bent 2, Level 1, lower section, between Columns B and C diagonals, mid-horizontal bracing. Members have 1" knife-edging typical along entire length, CS3. (Similar to Photo 63)

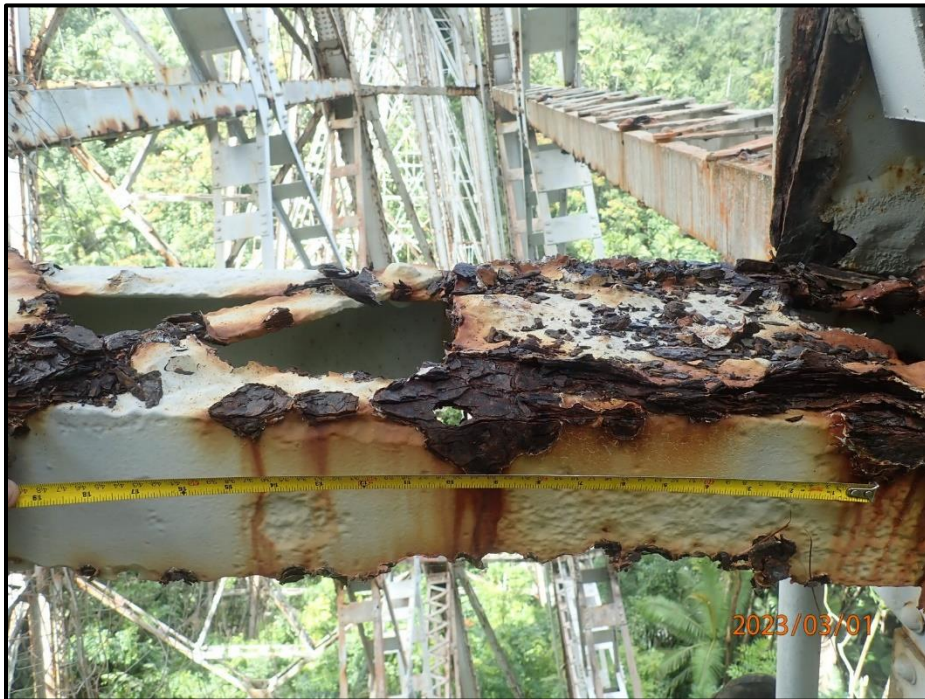
Photograph 60. Bent 2, Level 1, lower section, between Columns A and B, horizontal bracing, looking north. South face of angle has 1' 8" L x 1" H x up to 100% section loss with (3) lacing bars up to 75% section loss. The south angle has approximately 30% section loss

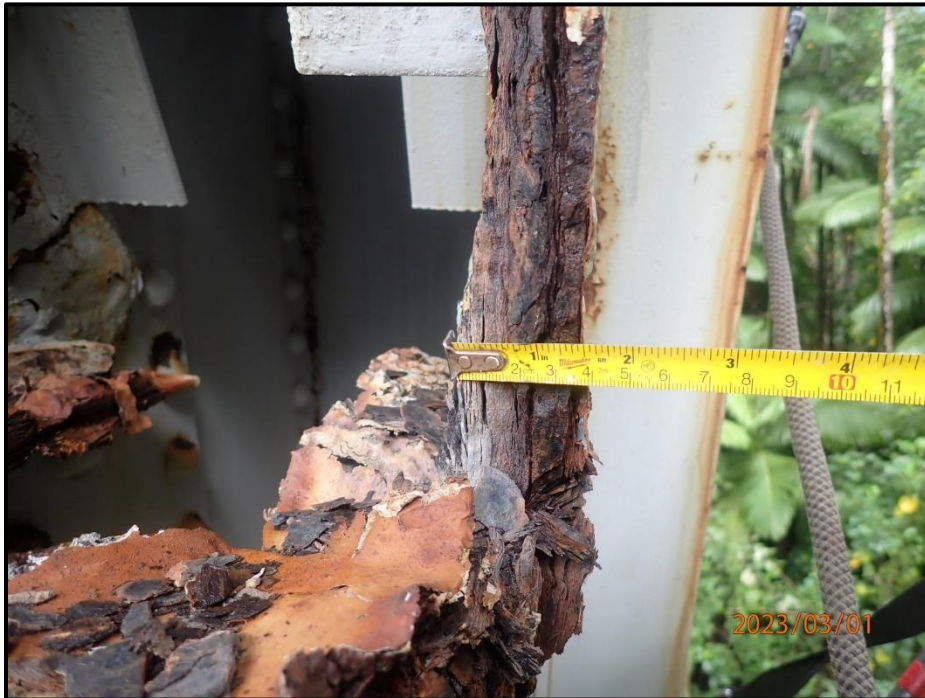
Photograph 61. Bent 2, Level 1, lower section, Column A, interior gusset plates, looking east. Up to 1" W x full length section loss where all members frame in, CS3.

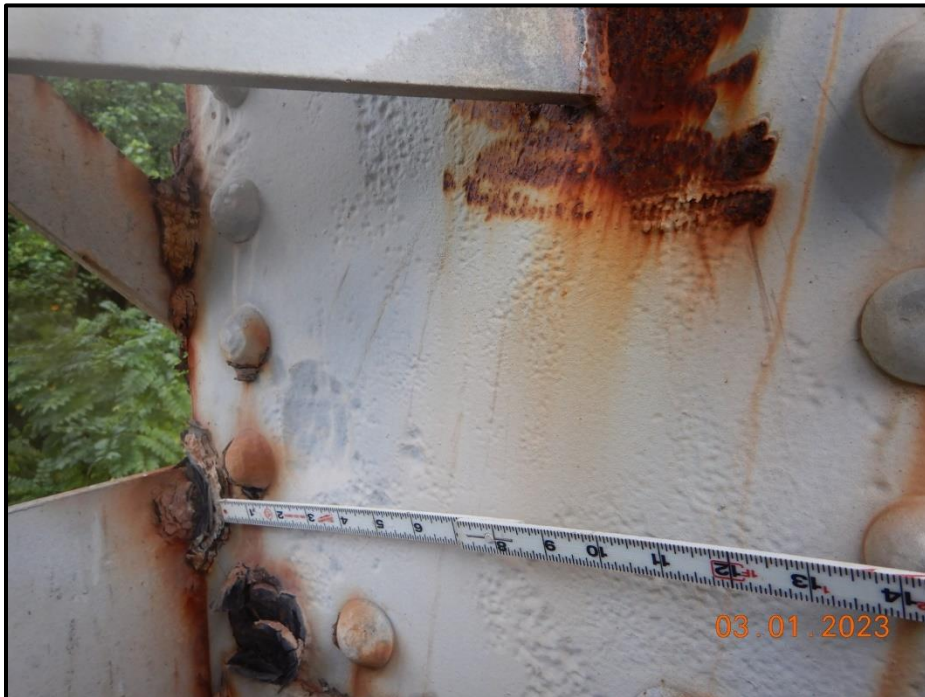
Photograph 62. Bent 2, Level 1, lower section, Column C, interior face of south web cover plate, looking southeast. Painted-over pitting up to 3" diameter x 1/4" deep, CS3.

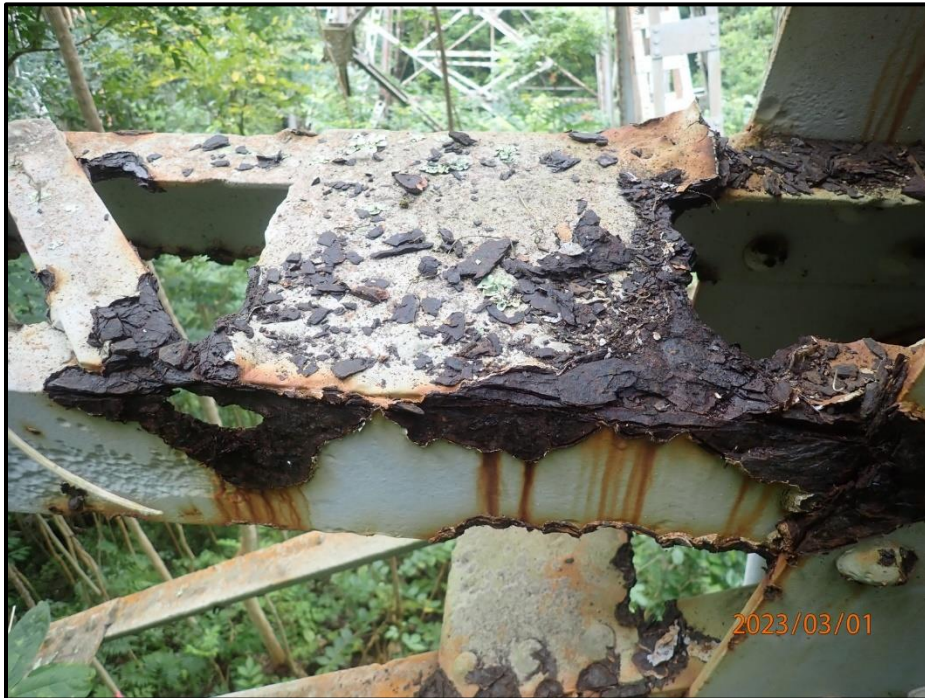
Photograph 63. Bent 2, Level 2, between Columns B and C, horizontal bracing near Column B, looking north. The bottom 1" of both angles have knife-edging to 100% section loss. There is an area of 90% section loss to the south angle, CS3.

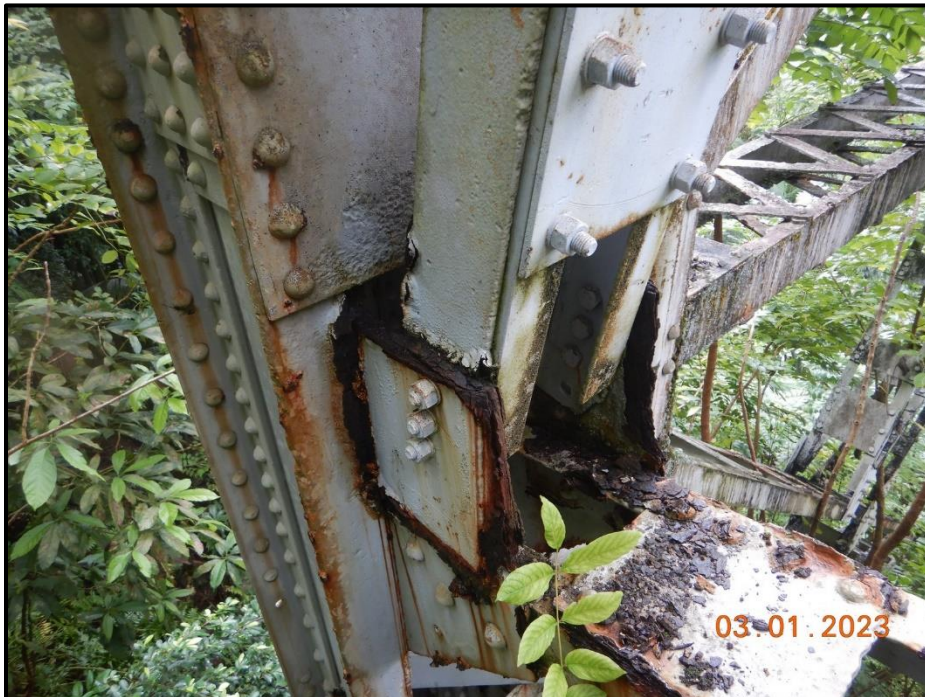
Photograph 64. Bent 2, Level 2, Column D, transverse bracing gusset plates, looking northwest. Typical heavy laminar corrosion, CS3.

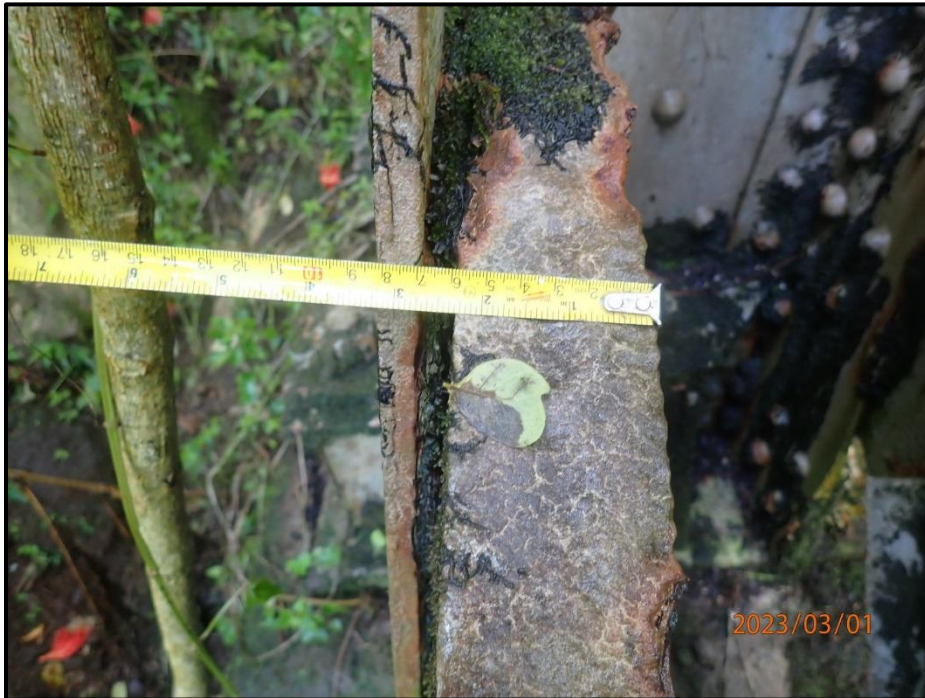
Photograph 65. Bent 2, Level 3, Column A, horizontal bracing, gusset plate, looking south. Pack rust up to 1/4" thick, CS3.

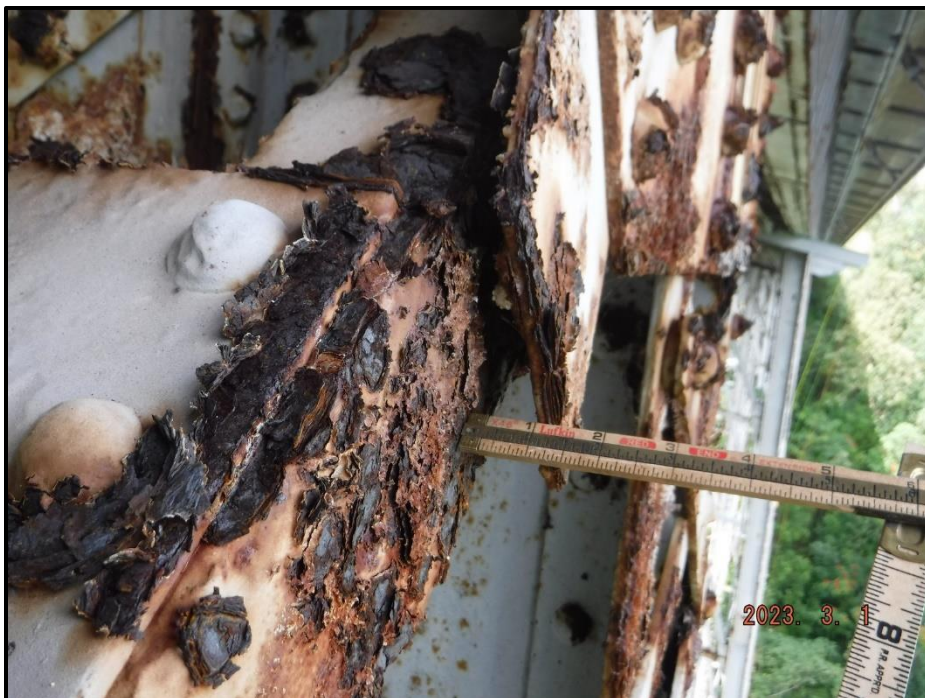
Photograph 66. Tower 2, Level 1, Column A , upper north diagonal bracing, near Bent 3, looking north. 6" x 2" corrosion hole in vertical leg of interior angle near Column A connection. Exterior leg has area of pack rust causing separation of gusset plate up to 1", CS3

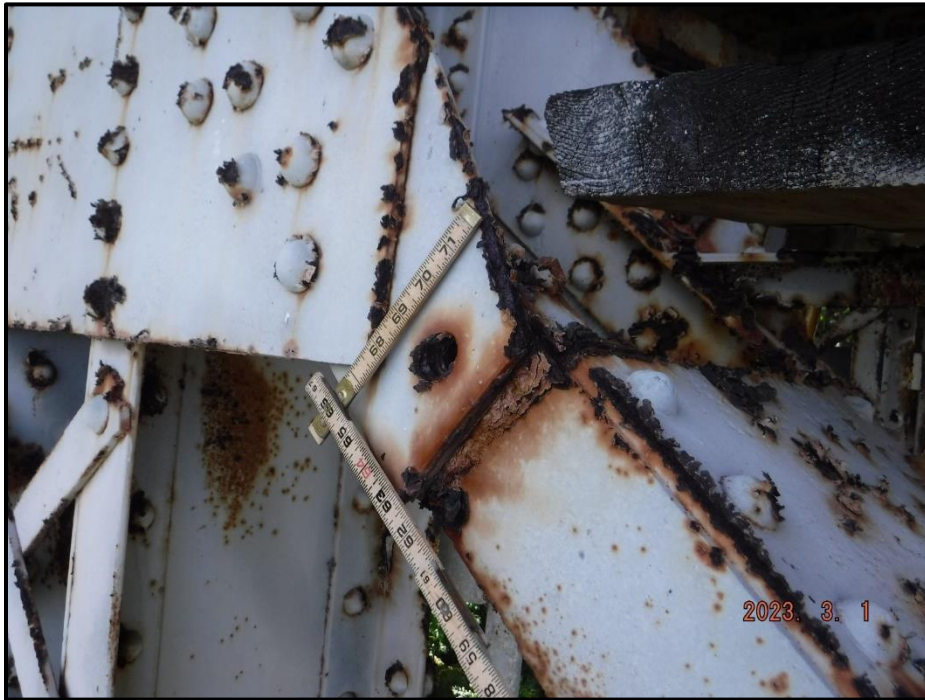
Photograph 67. Tower 2, Level 1, Column A, Bent 2, gusset plate to diagonal connection, looking west. (1) missing rivet with pack rust up to 1/2" thick, CS3.

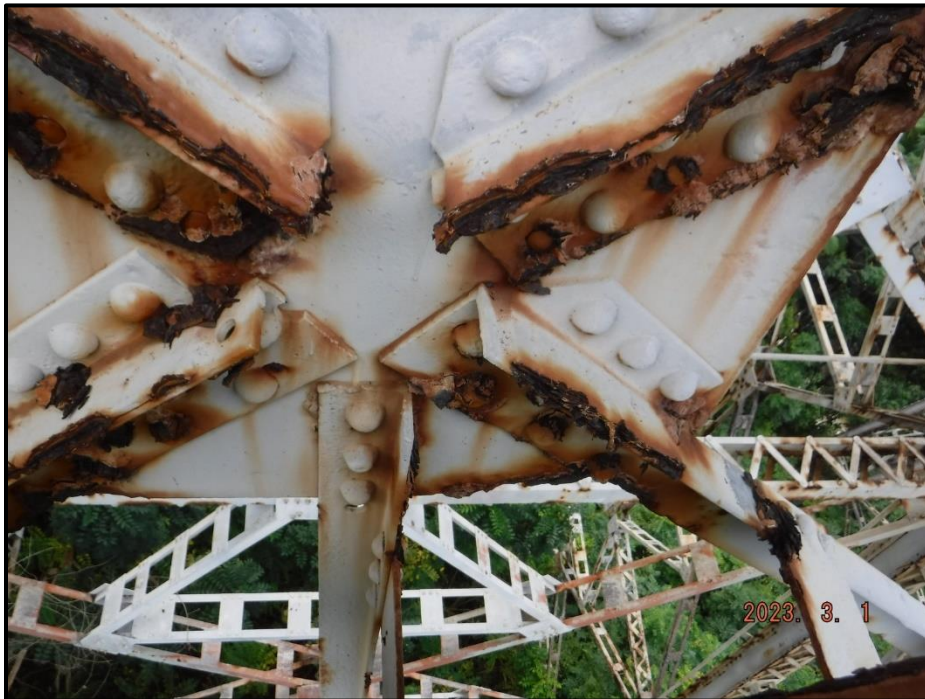
Photograph 68. Tower 2, Level 1, Column A, lower north diagonal bracing, east face of diagonal, interior center gusset plate, looking west. 9" W x 3" H area of 100% section loss and areas of laminar corrosion, CS3.

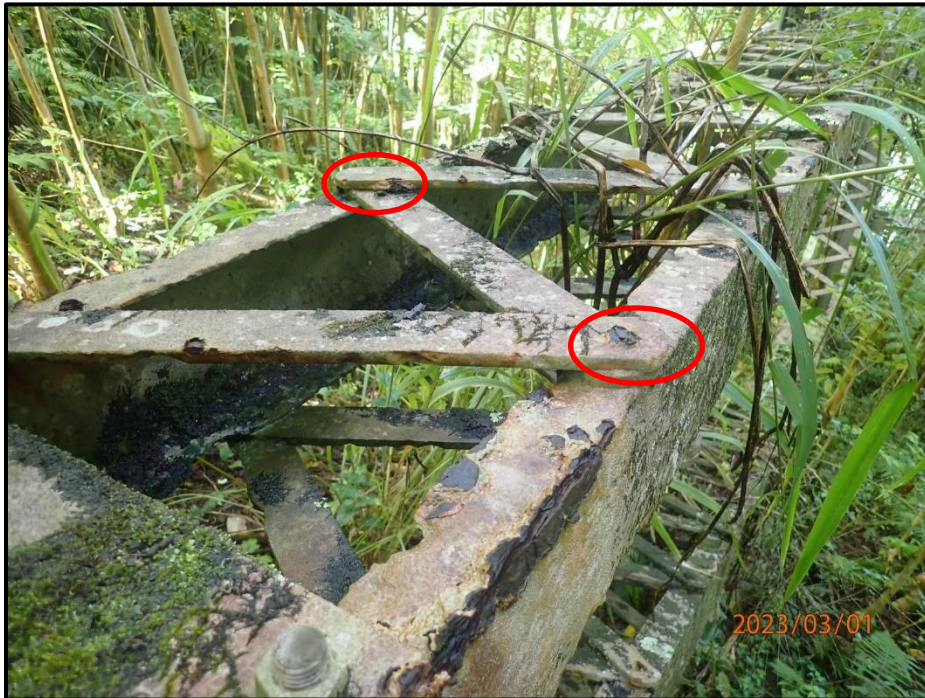
Photograph 69. Tower 2, Level 3, Column B, horizontal bracing, looking north. Numerous rivet heads in horizontal strut with up to 100% section loss, CS3.

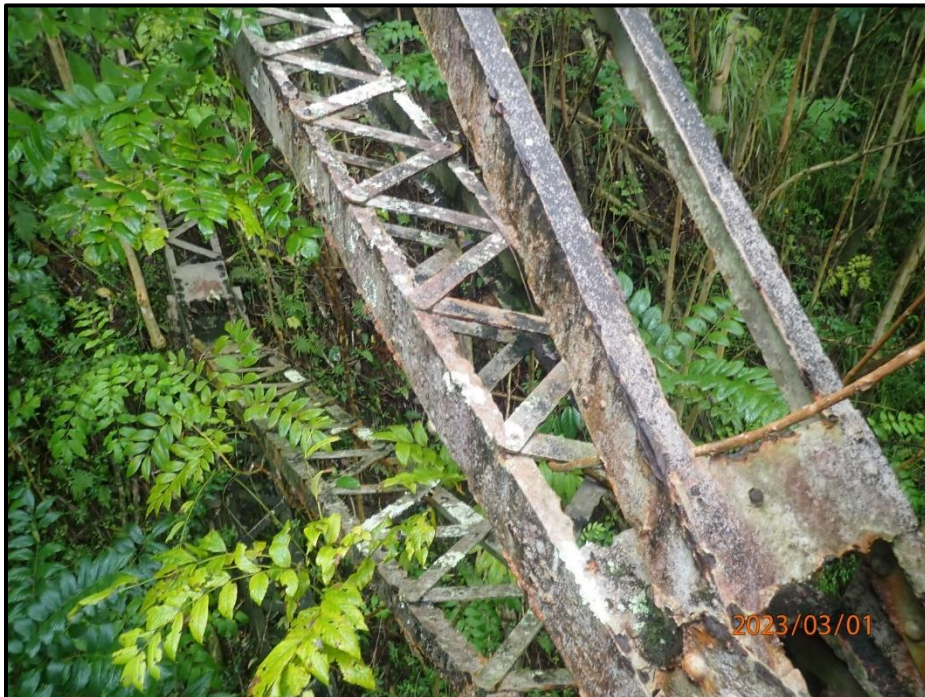
Photograph 70. Tower 2, Level 3, Column B, looking west. Multiple up to 3/4" diameter corrosion holes throughout, and covered in vegetation, CS3.

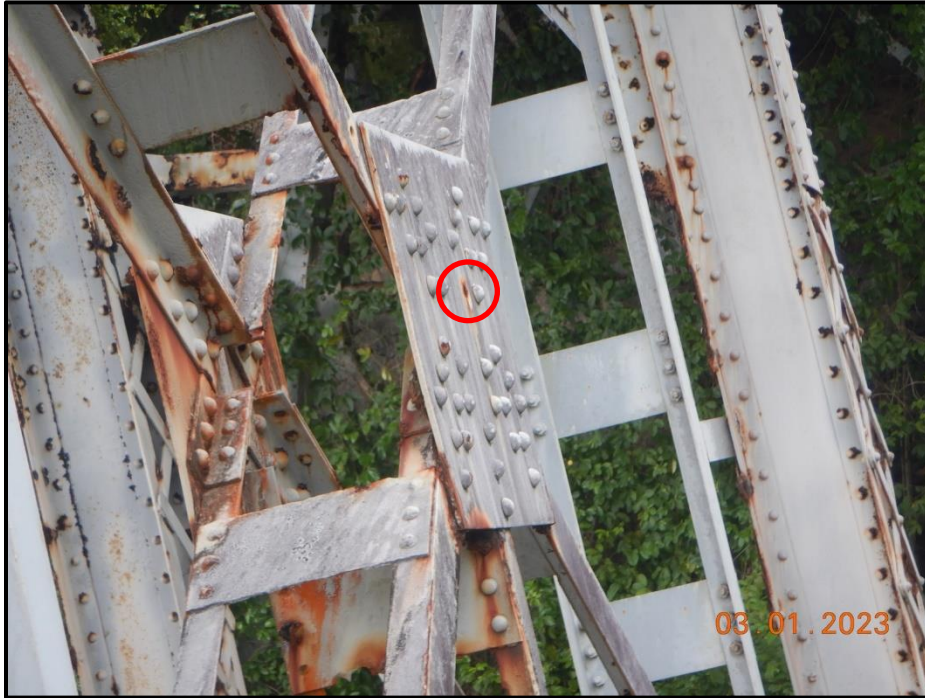
Photograph 71. Tower 2, Level 1, Column D, center gusset plate, looking north. (1) missing rivet, CS3.

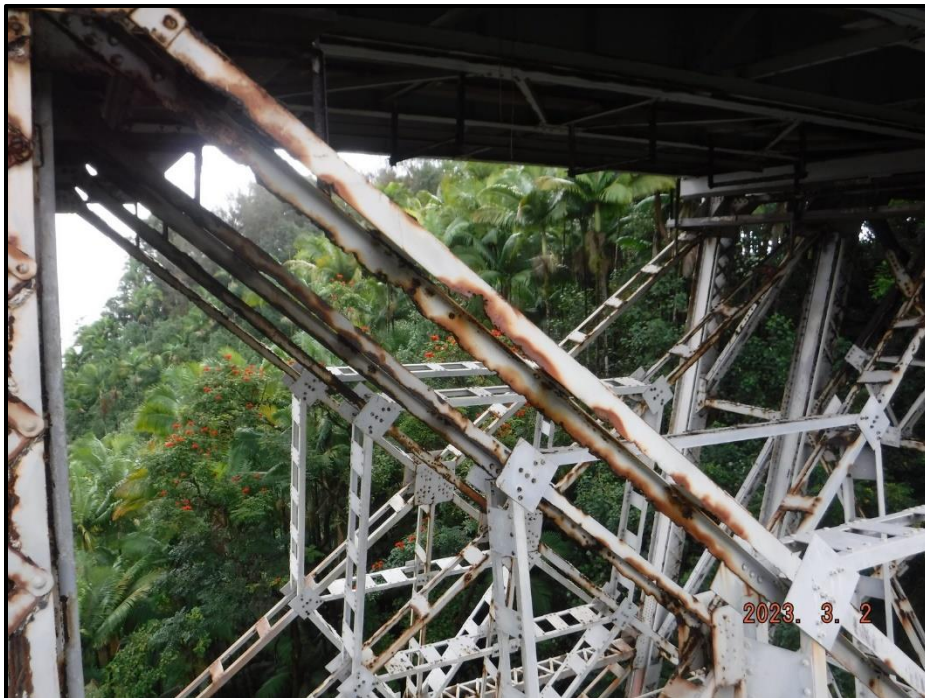
Photograph 72. Tower 2, Level 1, Column D, upper north diagonal bracing, near Bent 3, looking east. Heavy knife-edging and 6" L x 2" H corrosion holes, CS3.

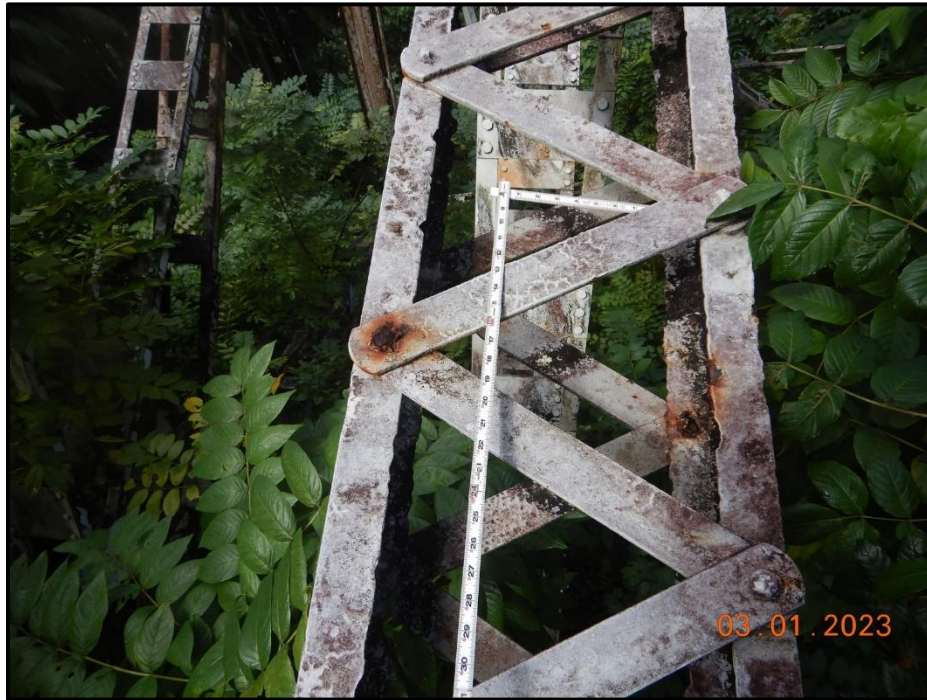
Photograph 73. Tower 2, Level 2, Column C, horizontal bracing, near mid-length slightly closer to Bent 2, looking north. Up to 3/16" deep pitting throughout with areas of knife-edging to original members of interior west face and isolated corrosion holes up to 1/2" diameter.

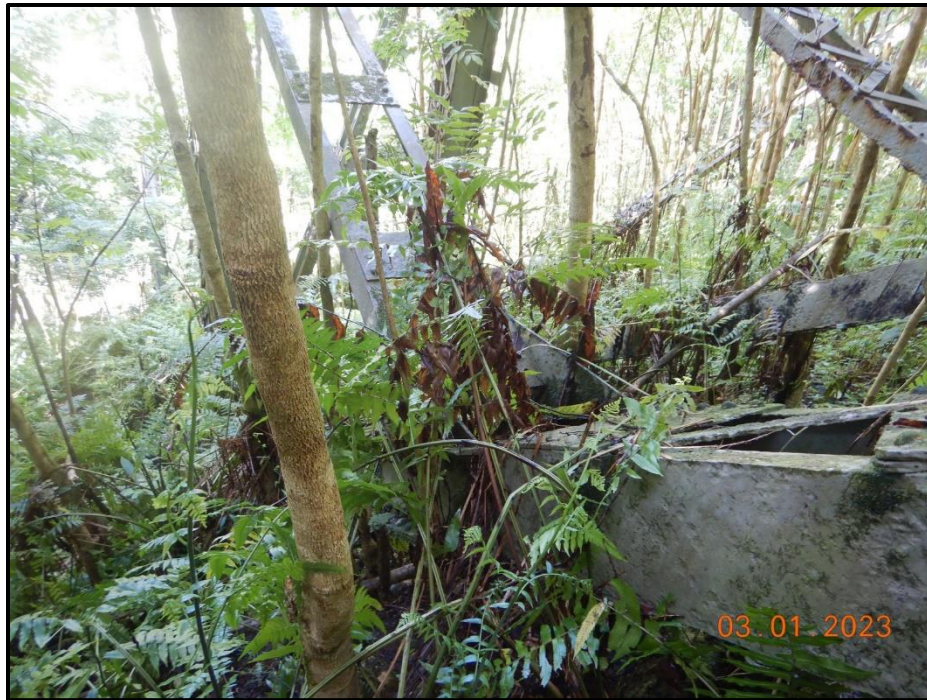
Photograph 74. Tower 2, Level 4, Column D, lower diagonal bracing, looking north. Heavy growth with trees growing through the members.

Defect ID	Caption	Defect ID	Caption
68	Tower 2, Level 1, Column A, Bent 2, gusset plate to diagonal connection. (1) missing rivet with pack rust up to 1/2" thick, CS3. (See Photo 67)	94	Tower 2, Level 3, Column D, lower north diagonal bracing. Typical pitting on angle legs, CS3. (Similar to Photo 72)
69	Tower 2, Level 1, Column A, horizontal bracing. Areas of 100% section loss, up to 1-1/2" W x 6" L on interior channel top/bottom flanges near Bent 3, CS3. (Similar to Photo 101)	95	Tower 2, Level 3, Column D, upper north diagonal bracing. Pitting and knife-edging with up to 1/16" section loss, CS3. (Similar to Photo 72)
70	Tower 2, Level 1, Column A, horizontal bracing. Up to 1" W x 6" L areas of 100% section loss, on interior channel bottom flange near bracing mid point, CS3. (Similar to Photo 101)	96	Tower 2, Level 4, Column D, lower diagonal bracing. Heavy growth with trees growing through the members. (See Photo 74)

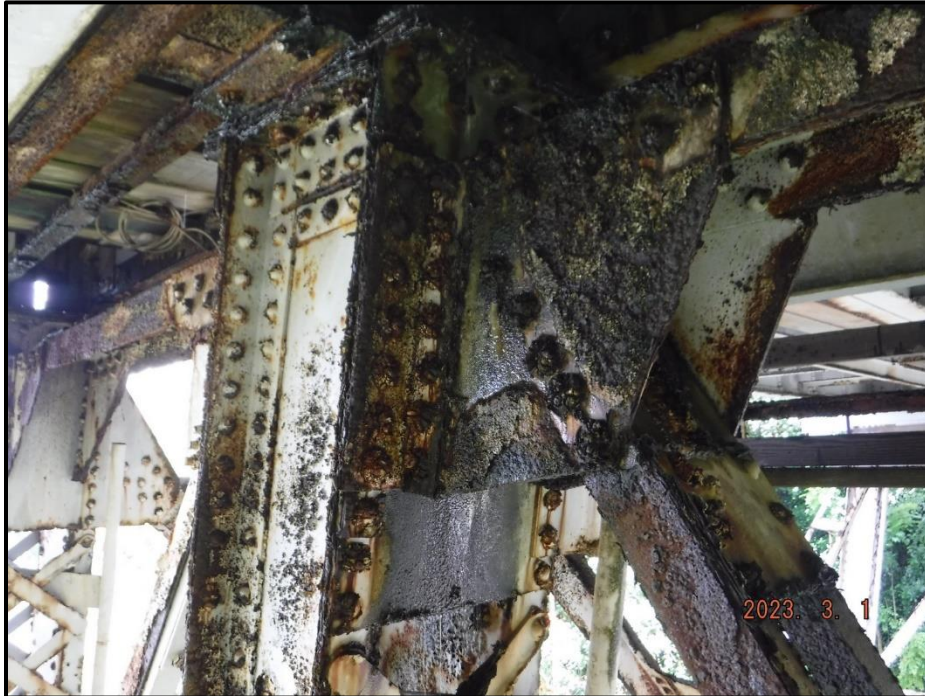
Photograph 75. Bent 3, Level 1, upper section, Column B, top gusset plate and longitudinal bracing, looking southeast. Laminar corrosion and areas of section loss on members and rivet heads due to active water leakage from the bridge, CS3.

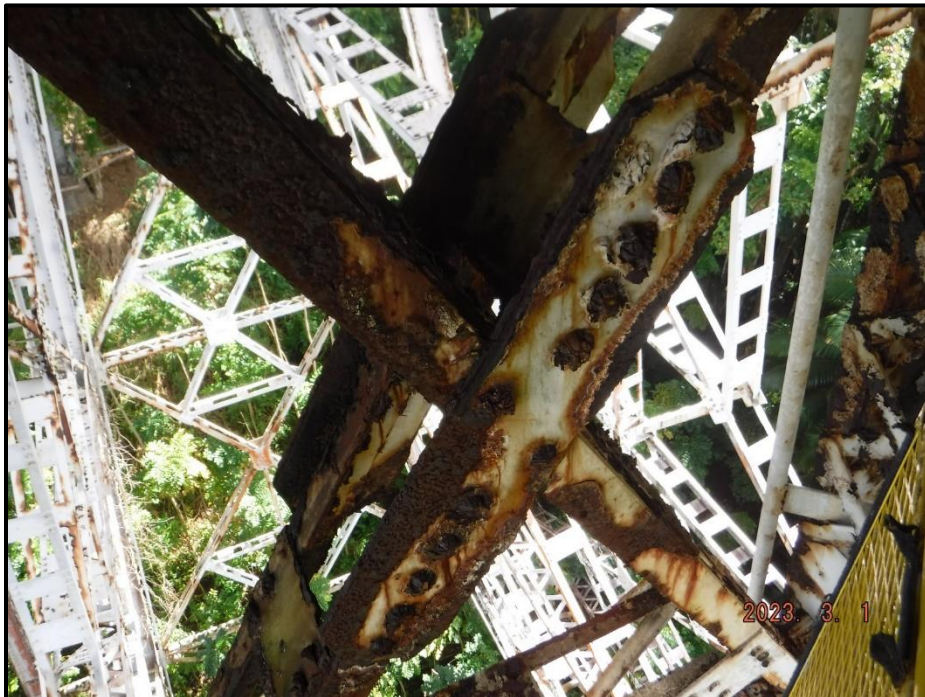
Photograph 76. Bent 3, Level 1, upper section, between Columns B and C, center gusset plates, looking south. Laminar corrosion on plates and transverse bracing members, CS3.

71	Tower 2, Level 1, Column A, lower north diagonal bracing, east face of diagonal, interior center gusset plate. 9" W x 3" H area of 100% section loss and areas of laminar corrosion, CS3. (See Photo 68)	97	Bent 3, Level 1, upper section, Column A, exterior face. Widespread laminar corrosion on edges over top 12', CS3. (Similar to Photo 77)
72	Tower 2, Level 1, Column A, upper north diagonal bracing. Multiple areas of knife-edging along interior angle over 8' length with individual areas up to 1" x 6" exhibiting 100% section loss, CS3. (Similar to Photo 72)	98	Bent 3, Level 1, upper section, Column B, top gusset plate and longitudinal bracing. Laminar corrosion and areas of section loss on members and rivet heads due to active water leakage from the bridge, CS3. (See Photo 75)
73	Tower 2, Level 1, Column B, diagonal bracing at center gusset plates. Pack rust up to 1-1/2" thick with moderate laminar corrosion at the corners and knife-edging on angle legs and batten plates, CS3. (Similar to Photo 72)	99	Bent 3, Level 1, upper section, between Columns B and C, center gusset plates. Laminar corrosion on plates and transverse bracing members, CS3. (See Photo 76)

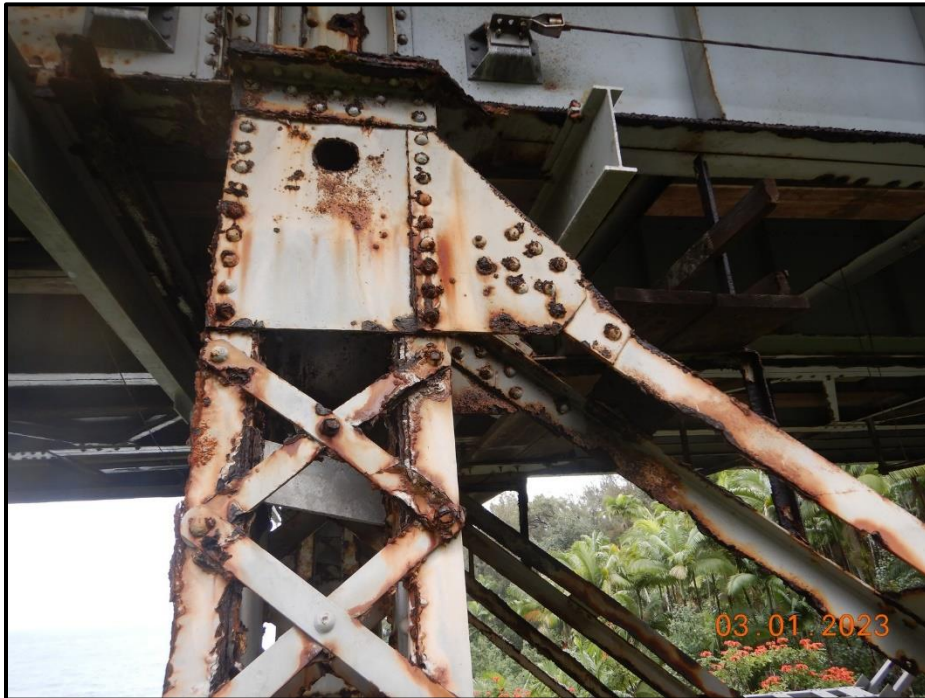
Photograph 77. Bent 3, Level 1, upper section, Column D, vertical near top, looking north. Typical laminar corrosion at upper levels, CS3.

74	Tower 2, Level 1, Column B, lower north diagonal bracing. Areas of 100% section loss up to 1-1/2" W x 1' L on both angle legs at isolated locations along full member length, CS3. (Similar to Photo 134)	100	Bent 3, Level 1, upper section, Column D, vertical near top. Typical laminar corrosion at upper levels, CS3. (See Photo 77)
75	Tower 2, Level 1, Column B, lower north diagonal bracing. Up to 1/8" section loss to gusset plate and diagonal at connection, 1" diameter corrosion hole in diagonal near center connection, CS3. (Similar to Photo 134)	101	Bent 3, Level 1, upper section, Column D. Corrosion hole up to 2" diameter in southeast angle with (2) adjacent lacing bars with 100% section loss near the top, CS3. (Similar to Photo 145)
76	Tower 2, Level 1, Column B, upper north diagonal bracing, near Bent 3. Areas of 100% section loss up to 1-1/2" x 1' L on interior vertical angle leg over 3' near center connection, CS3. (Similar to Photo 134)	102	Bent 3, Level 1, upper section, Column D, southeast flange. (1) 2-1/2" diameter corrosion hole, CS3. (Similar to Photo 145)

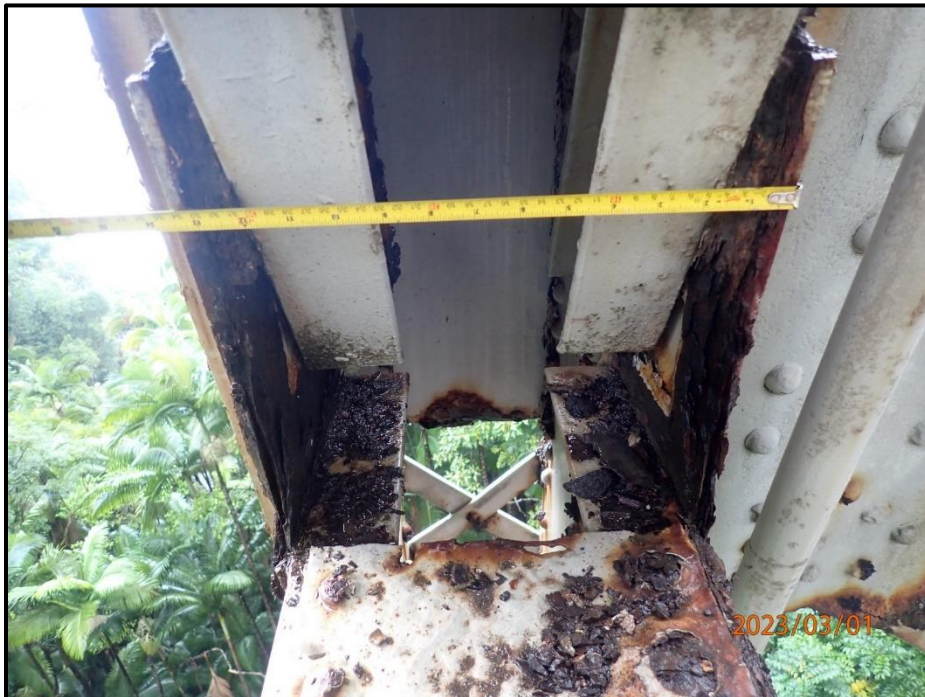
Photograph 78. Bent 3, Level 1, lower section, Columns A and B, horizontal bracing, looking east. Pack rust up to 1 1/2" thick with section loss up to 30% to gusset plates and 100% loss to rivet heads of batten plate, CS3.

83	Tower 2, Level 1, Column C, upper north diagonal bracing near Bent 3. West angle has deformation 3' L x 1" out-of-plane. Laminar corrosion throughout with section loss along member up to approximately 15% loss of total cross sectional area, CS3. (Similar to Photo 72)	109	Bent 3, Level 1, lower section, Column C, bottom quarter point cover plate. Up to 1-1/2" diameter corrosion holes, CS3. (Similar to Photo 94)
84	Tower 2, Level 1, Column D, center gusset plate. (1) missing rivet, CS3. (See Photo 71)	110	Bent 3, Level 1, lower section, Column C. (3) lacing bars with 100% section loss in lower section, CS3. (Similar to Photo 125)
85	Tower 2, Level 1, Column D, upper north diagonal bracing, near Bent 3. Heavy knife-edging and 6" L x 2" H corrosion holes, CS3. (See Photo 72)	111	Bent 3, Level 1, lower section, Columns A and B, horizontal bracing. Pack rust up to 1-1/2" thick with section loss up to 30% to gusset plates and 100% loss to rivet heads of batten plate, CS3. (See Photo 78)

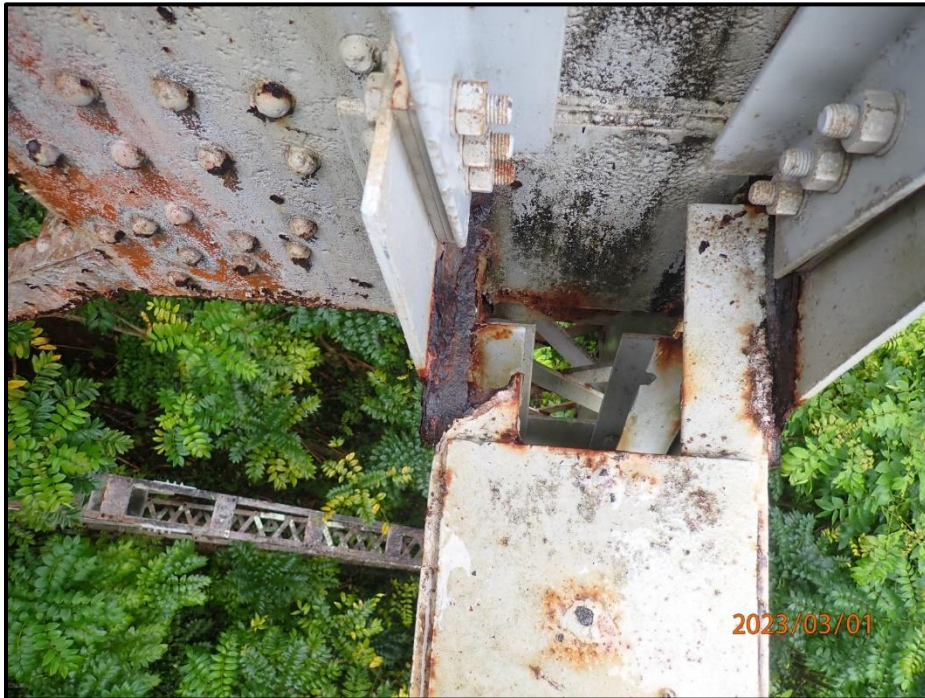
Photograph 79. Bent 3, Level 2, Column B, horizontal bracing, south flange, looking north. 9" L x full width of angle area of 100% section loss, CS3.

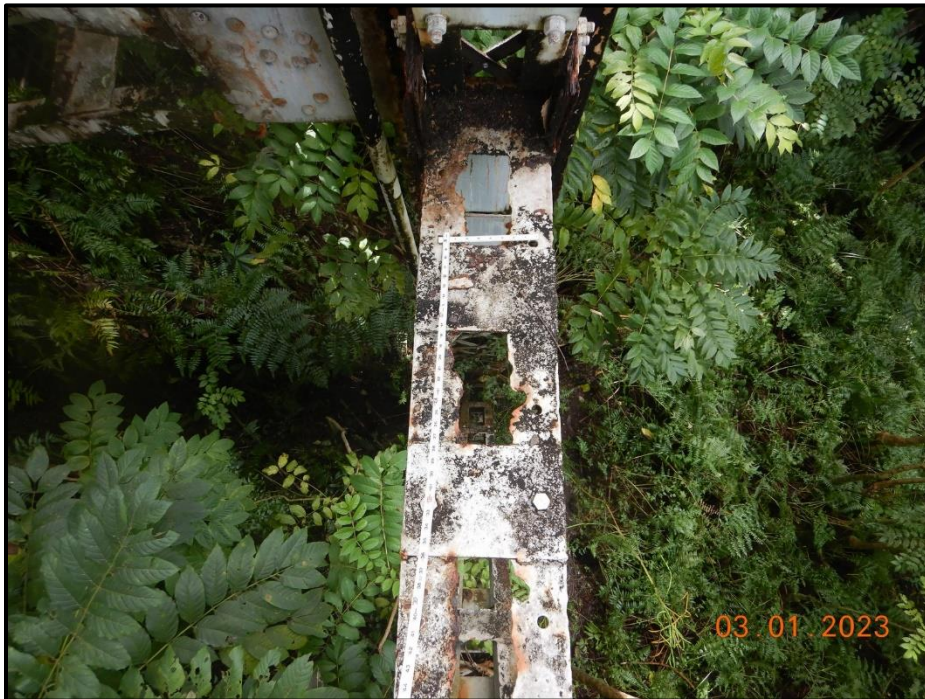
Photograph 80. Bent 3, Level 3, between Columns C and D, horizontal bracing, looking west. Knife-edging and multiple corrosion holes up to 2" diameter across full member length, CS3.

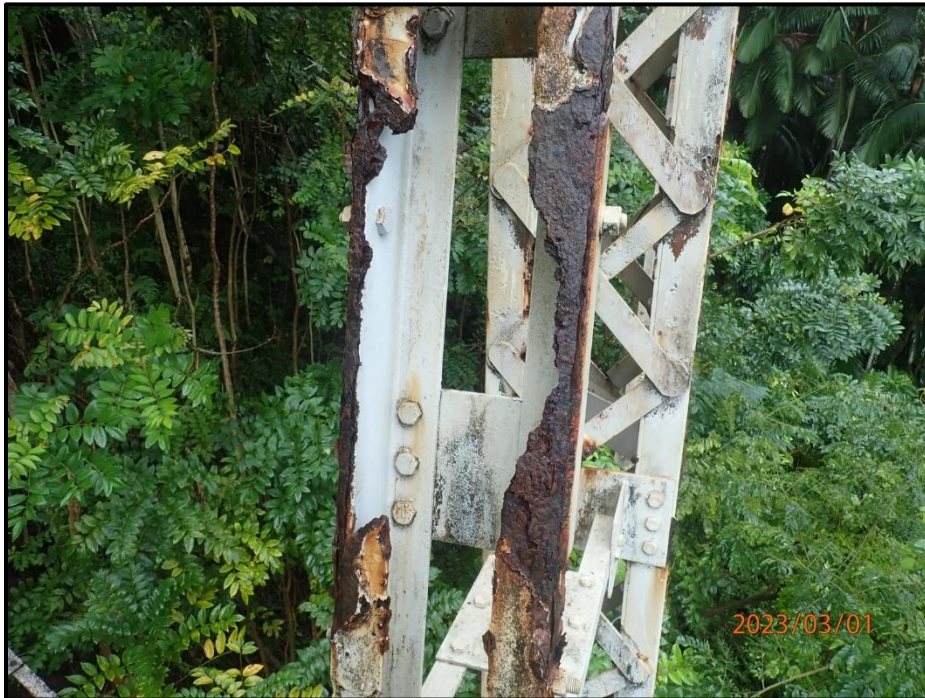
Photograph 81. Bent 3, Level 3, between Columns A and B, diagonal bracing above interior connection, looking east. 3' L x full width of angle area of section loss on top flanges (CS3). Note this member has been retrofitted and retrofit is in good condition.

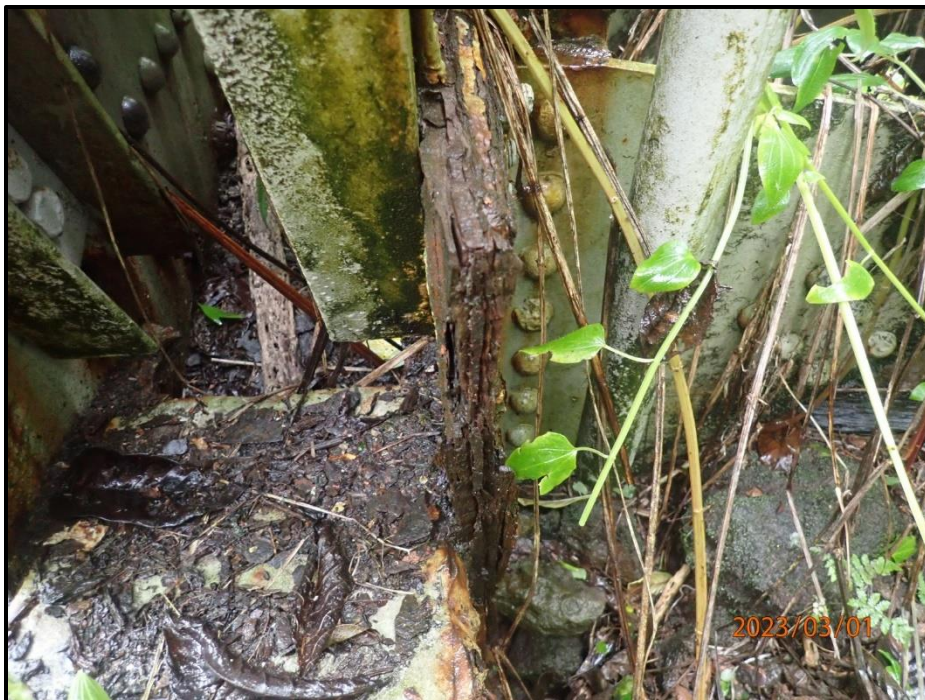
Photograph 82. Bent 3, Level 4, Column A, just above bearing, gusset plates, looking east. Plates are distorted and bowed to the south up to 1/8" for the horizontal bracing member, CS3.
