**STATE OF HAWAII
DEPARTMENT OF TRANSPORTATION**

**ADDENDUM NO. 2
FOR
HAWAII BELT ROAD
NANUE STREAM BRIDGE REHABILITATION
VICINITY OF HILO
DISTRICT OF HILO, ISLAND OF HAWAII
FEDERAL-AID PROJECT NO. BR-019-2(077)**

December 13, 2024

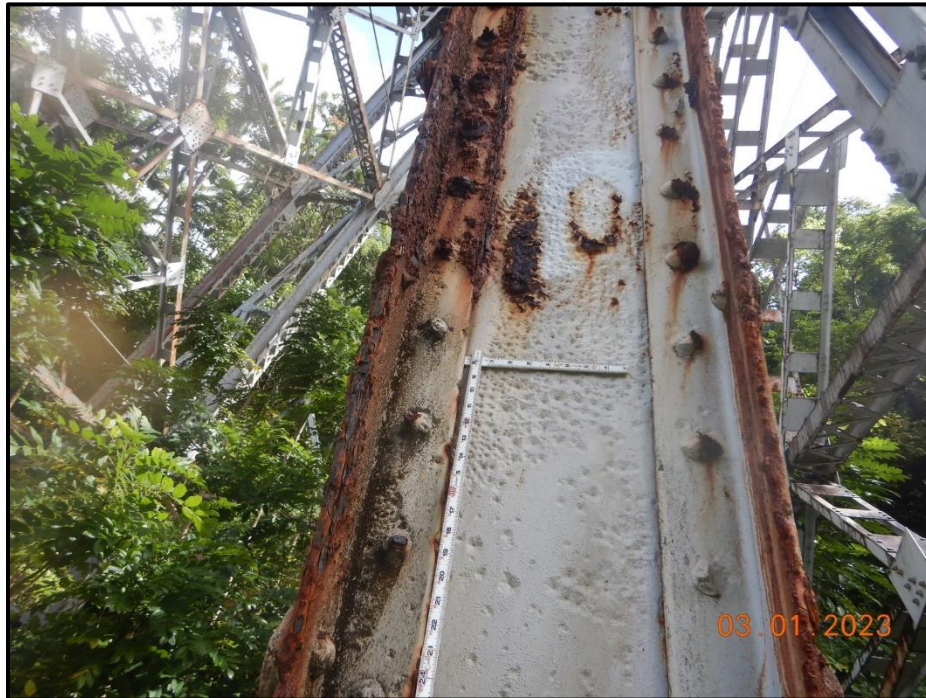
Photograph 83. Bent 3, Level 4, Column C, looking northeast. Typical painted over pitting, laminar corrosion, knife-edging, and corroded rivet heads, CS3.

Defect ID	Caption
60	Bent 2, Level 2, between Columns B and C, horizontal bracing near Column B. The bottom 1" of both angles have knife-edging to 100% section loss. There is an area of 90% section loss to the south angle, CS3. (See Photo 63)
61	Bent 2, Level 2, between Columns B and C, upper east diagonal bracing near Column B. Knife-edging along flanges with up to 1-1/2" L x 1" W corrosion holes, CS3. (Similar to Photo 87)
62	Bent 2, Level 2, Column D, transverse bracing gusset plates. Typical heavy laminar corrosion, CS3. (See Photo 64)
63	Bent 2, Level 3, Column A, horizontal bracing, gusset plate. Pack rust up to 1/4" thick, CS3. (See Photo 65)
64	Bent 2, Level 3, Column B. (1) lacing bar on east face has 100% section loss, CS3. (Similar to Photo 125)
65	Bent 2, Level 3, Column C. (1) lacing bar on west face has 100% section loss, CS3. (Similar to Photo 125)
66	Bent 2, Level 3, Column D web, north face. Typical painted-over pitting with pack rust and corroded rivet heads, CS3. (Similar to Photo 83)

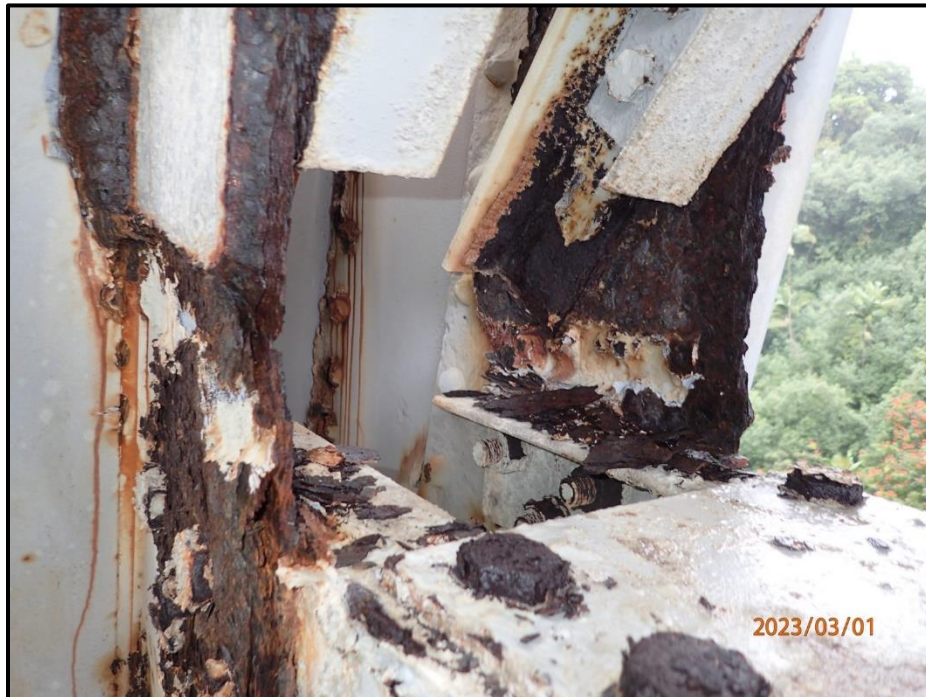
Photograph 84. Bent 4, Level 1, upper section, Column D, upper gusset plates, looking northwest. Heavy laminar corrosion and approximately 1/4" to 3/8" remaining section on gusset plate between diagonal and horizontal bracing member, CS3.

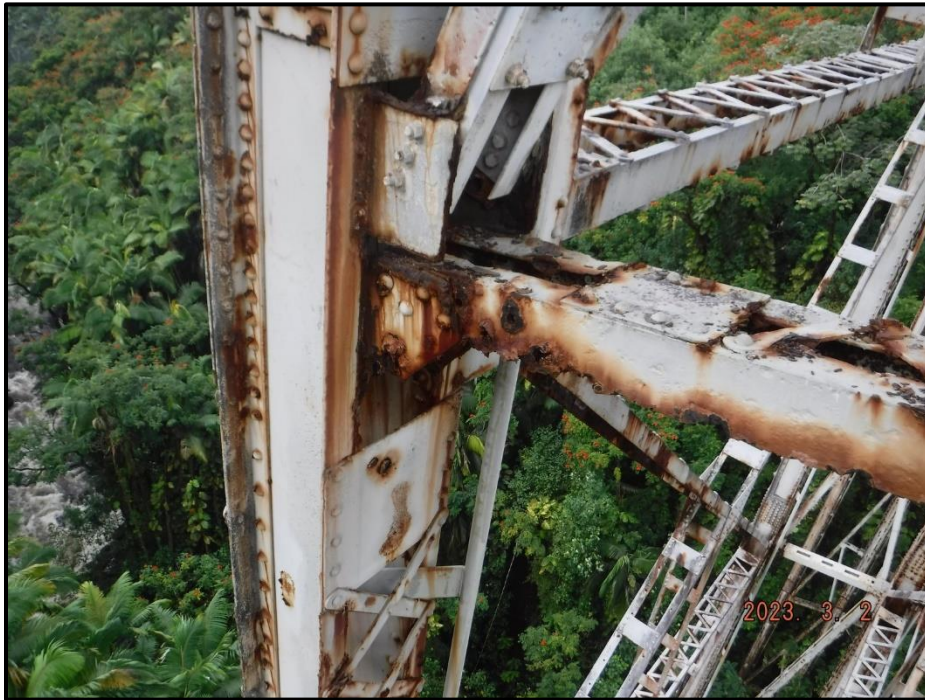
Photograph 85. Bent 4, Level 1, lower section, Column D, lower gusset plates, looking northwest. Pack rust up to 1" thick with areas of 100% section loss and only retrofit gusset plate remaining, no change from previous inspection, CS3.

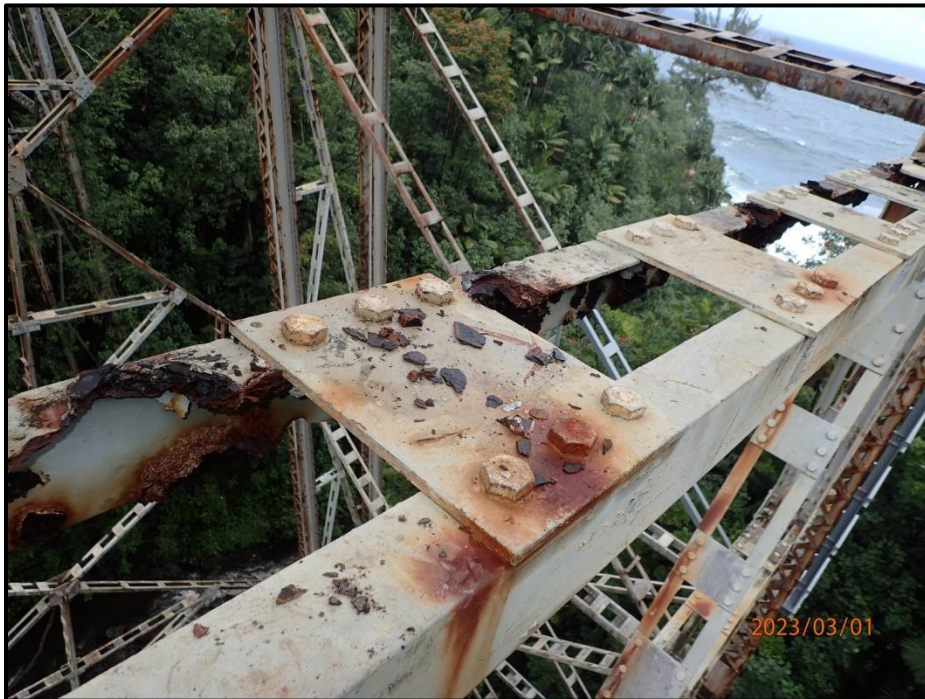
Photograph 86. Bent 4, Level 2, between Columns B and C, horizontal bracing adjacent to Column C, vertical connection, looking northeast. (7) 2" diameter corrosion holes in interior top flange along member, CS3.

53	Bent 2, Level 1, lower section, between Columns B and C, horizontal bracing, adjacent to Column B. Diagonals and horizontals on south face have knife-edging and holes in flanges throughout, CS3. (Similar to Photo 86)
54	Bent 2, Level 1, lower section, between Columns B and C, horizontal bracing. (2) lacing bars have 75% section loss, CS3. (Similar to Photo 125)
55	Bent 2, Level 1, lower section, between Columns B and C, upper west diagonal bracing near Column C. North angle has 3" L x up to 1" W x 100% section loss, CS3. (Similar to Photo 72)
56	Bent 2, Level 1, lower section, between Columns C and D, diagonal bracing near Column C. (2) batten plates have (3) of (6) rivet heads with up to 80% section loss, CS3. (Similar to Photo 57)
57	Bent 2, Level 1, lower section, Column A, interior gusset plates. Up to 1" W x full length section loss where all members frame in, CS3. (See Photo 61)
58	Bent 2, Level 1, lower section, Column C, cover plate. Up to 2" diameter corrosion holes, CS3. (Similar to Photo 130)

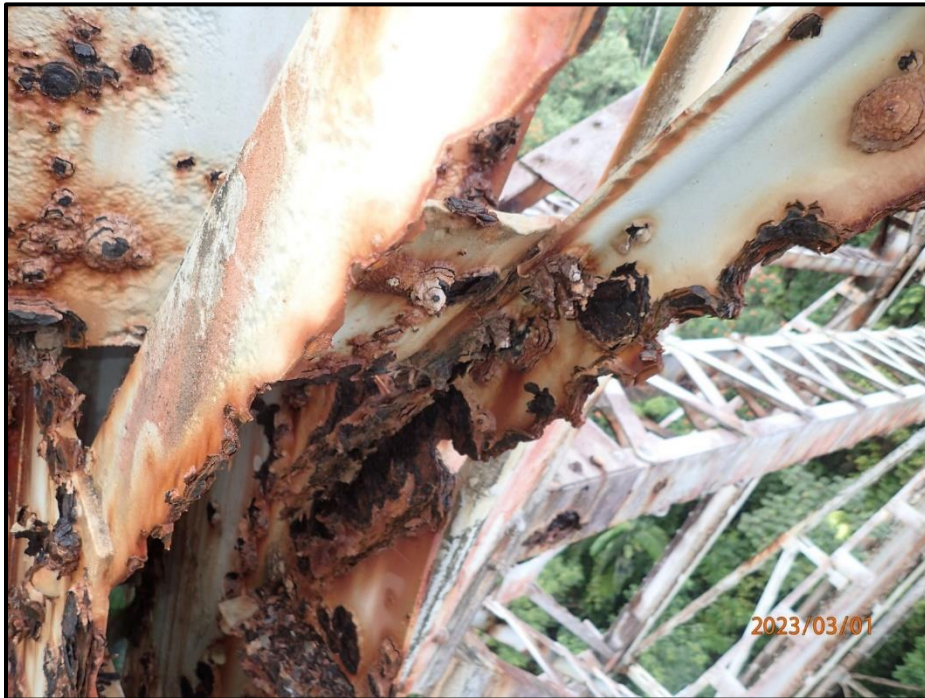
Photograph 87. Bent 4, Level 2, between Columns B and C, lower west diagonal bracing, near Column C, looking northwest. Knife-edging and 80% section loss to the interior angle, CS3.

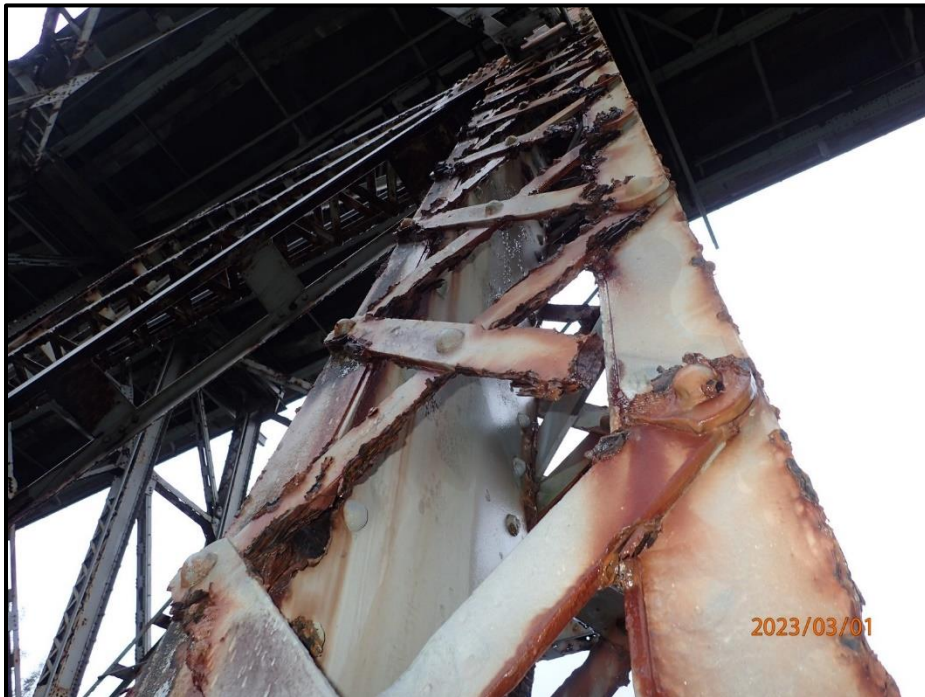
-Bent 4, Level 2, Column C, 50% of lacing bars on west face have 100% section loss, remaining bars on both faces have average 30% section loss, 32 LF CS4, (See Photo 88).

Photograph 88. Bent 4, Level 2, Column C, looking northeast. 50% of lacing bars on west face have 100% section loss, remaining bars on both faces have average 30% section loss, CS4.

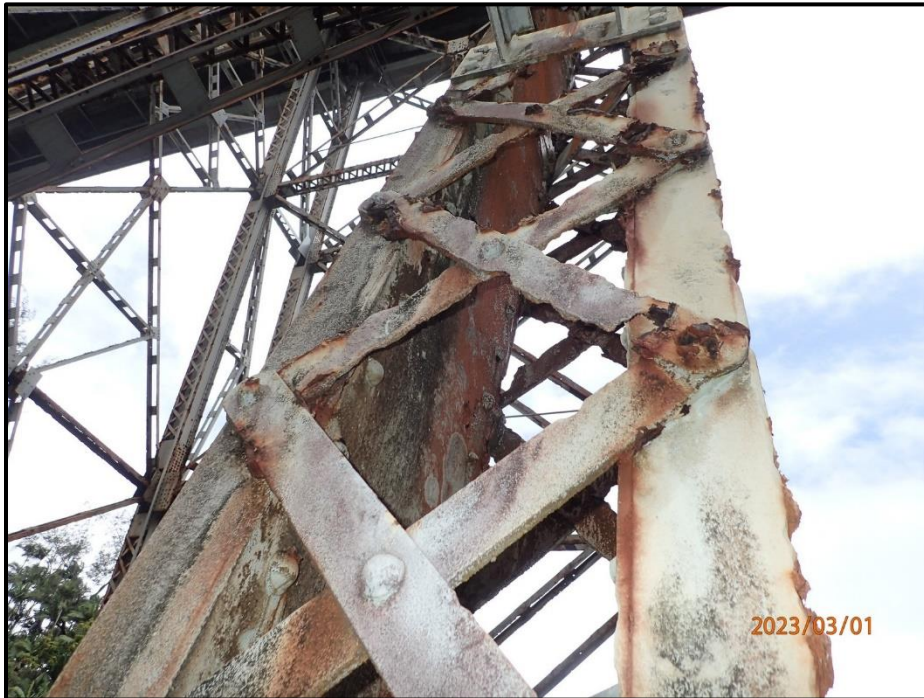
Photograph 89. Bent 4, Level 3, Column C, looking east. Lacing bars have an average 75% section loss in this section of column. Except for top 10' of west face which are in good condition, CS3.

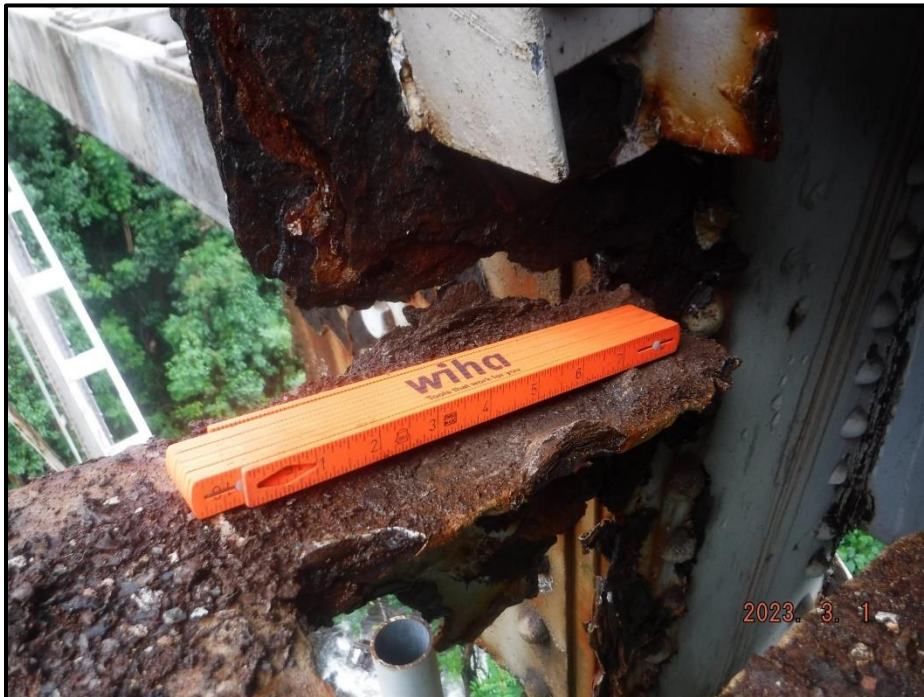
Photograph 90. Bent 4, Level 3, horizontal bracing at gusset plates at Column A, looking north. Horizontal bracing gusset plate has 100% section loss on all sides. This member is not connected to Column A anymore, CS4.

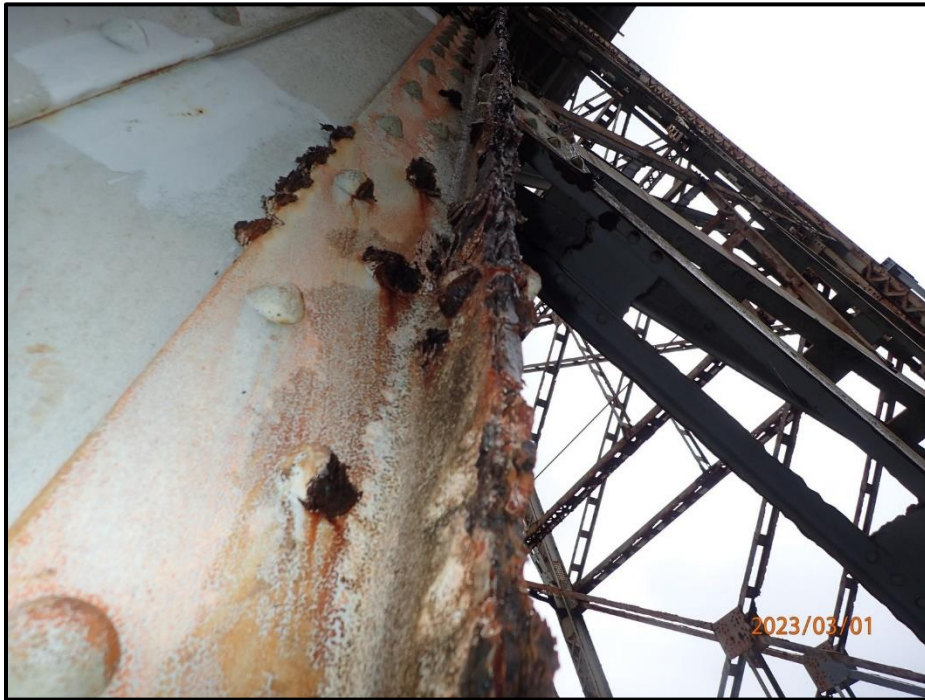
Photograph 91. Bent 4, Level 4, Column C, looking northeast. Knife-edging of flanges, CS3.

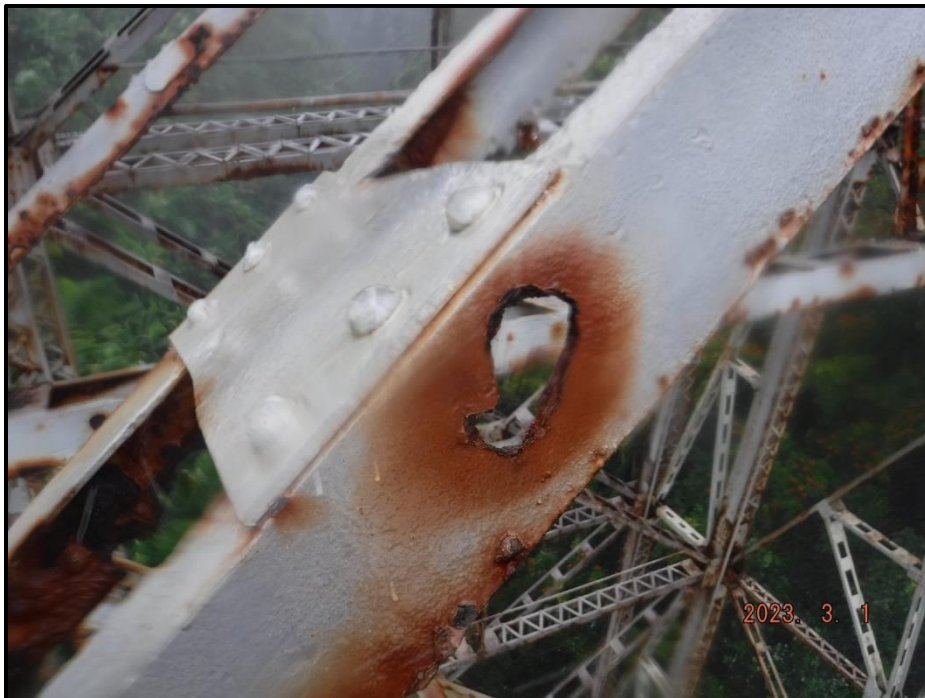
Photograph 92. Tower 3, Level 1, Column A, lower south diagonal bracing, looking west. Several corrosion holes along the west and east angle legs up to 2" diameter, 3' L x 2" H area of 100% section loss on west angle near Bent 4, CS3.

77	Tower 2, Level 2, Column B, diagonal gusset plate connection, lower diagonals. Up to 4" L x 2" H corrosion holes, CS3. (Similar to Photo 92)	103	Bent 3, Level 1, lower section, between Columns B and C, horizontal bracing. Corrosion holes up to 1" diameter in top channel flanges, batten plate, and lacing bar near Column C, CS3. (Similar to Photo 86)
78	Tower 2, Level 2, Column B, upper south diagonal bracing. 1' L x 3" W of 100% loss on inner west angle vertical flange, CS3. (Similar to Photo 134)	104	Bent 3, Level 1, lower section, between Columns B and C, lower east diagonal bracing near Column B, adjacent to batton plates top flange of angles. knife-edging with areas of 4" L x 2" W of up to 100% section loss, CS3. (Similar to Photo 87)
79	Tower 2, Level 3, Column B, horizontal bracing. Numerous rivet heads in horizontal strut with up to 100% section loss, CS3. (See Photo 69)	105	Bent 3, Level 1, lower section, between Columns B and C, lower west diagonal bracing just above lower horizontal on Column C side. Diagonals and horizontals on north face have knife-edging and corrosion holes throughout, CS3. (Similar to Photo 122)

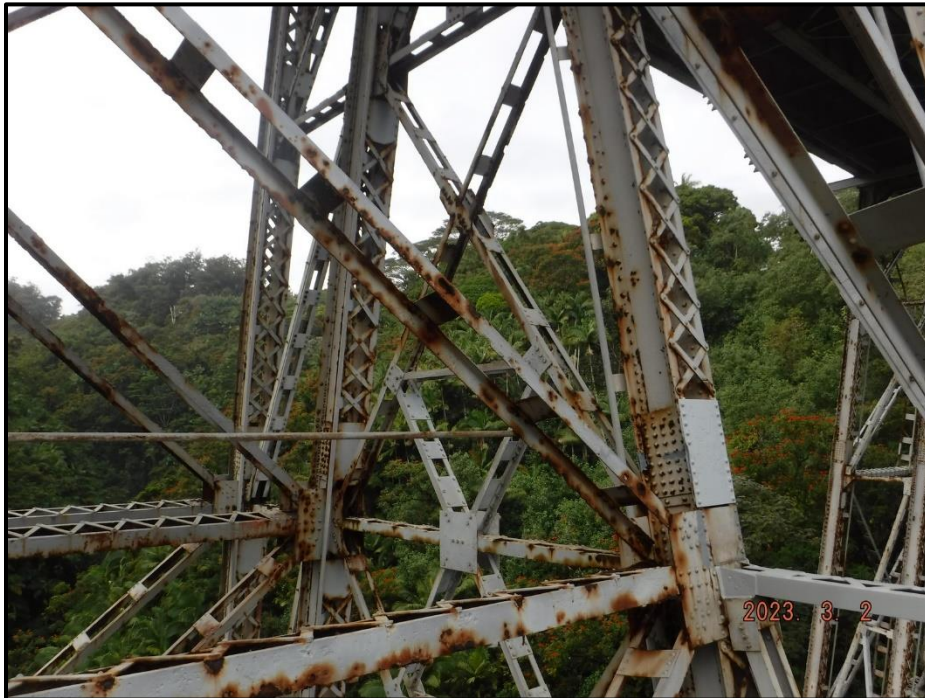
Photograph 93. Tower 3, Level 1, Column B, lower north diagonal bracing, looking west. Worst case is a 4" diameter corrosion hole near center gusset plate. Approximately 60% section remaining, CS3.

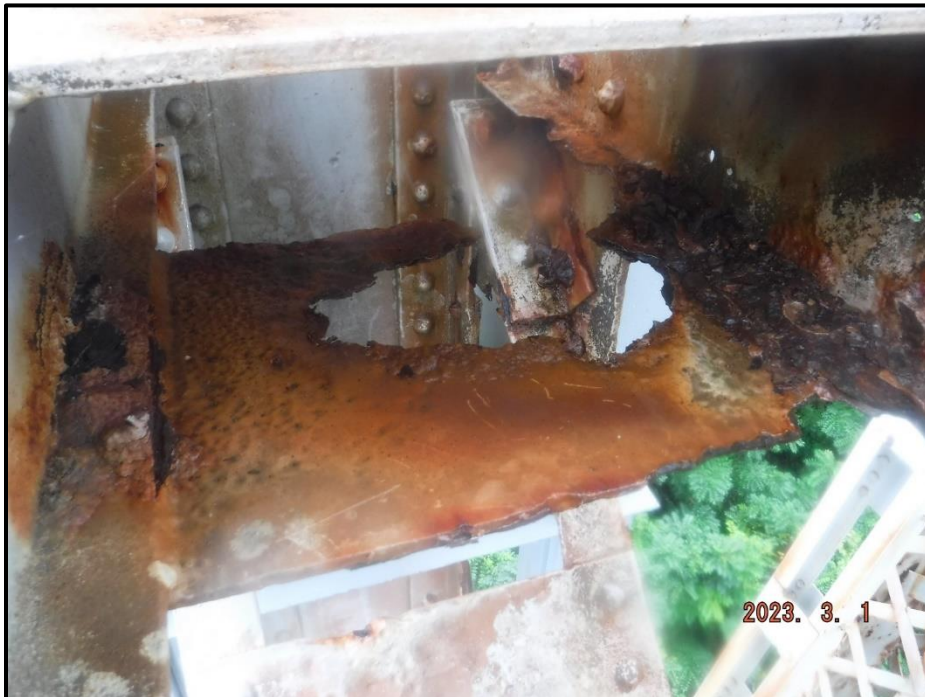
Photograph 94. Tower 3, Level 2, Column A, horizontal bracing, looking south. 9" diameter corrosion hole in lower batten plate with 3" W x 1/8" section remaining, CS3.

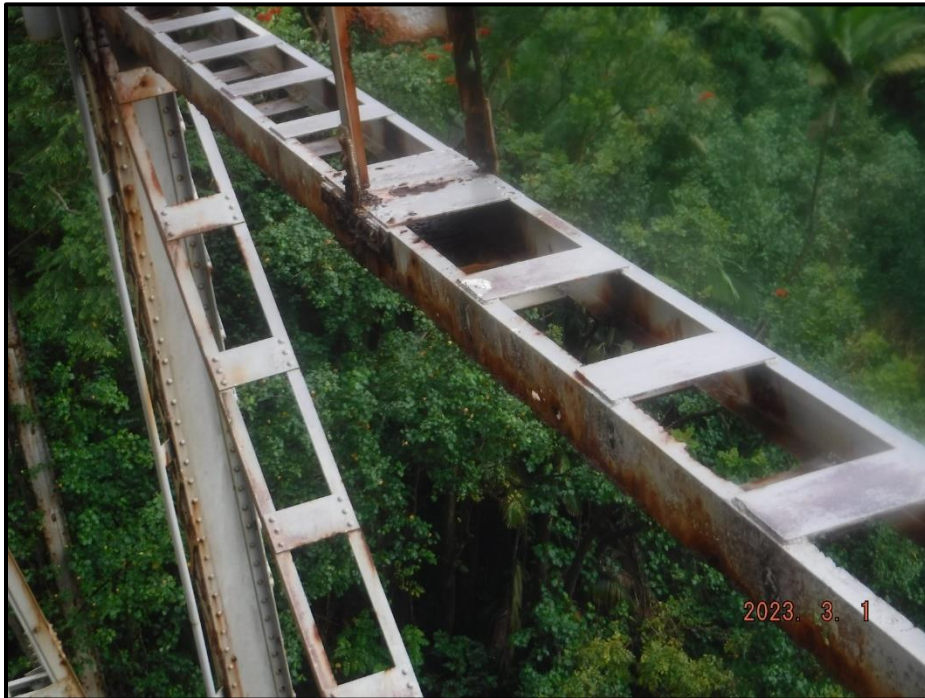
Photograph 95. Tower 3, Level 2, Column A, horizontal bracing, near Bent 4, looking northeast. 50% section loss to entire member with holes throughout, CS4.

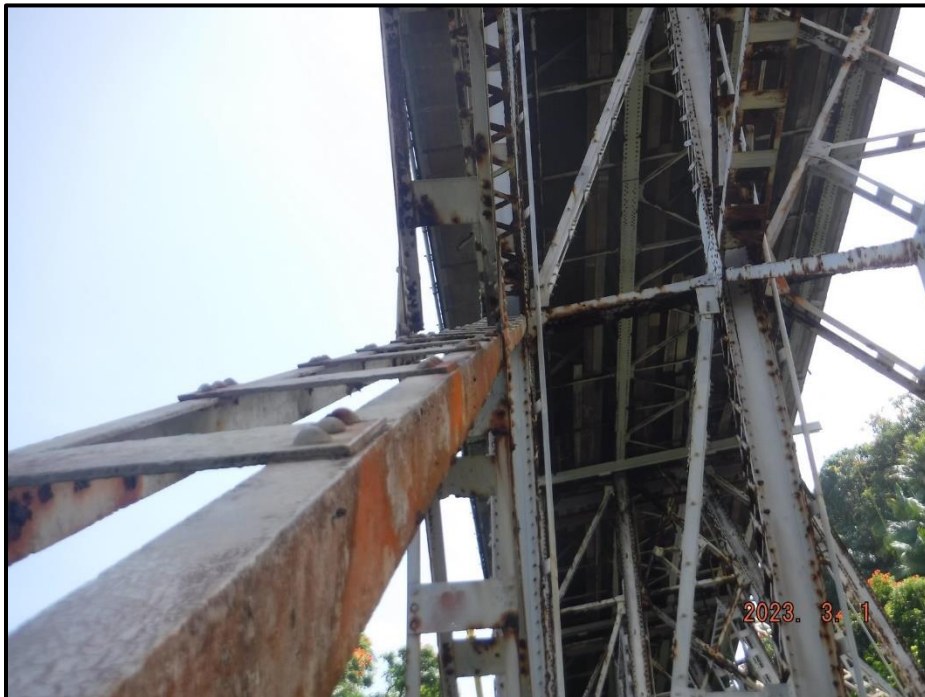
Photograph 96. Tower 3, Level 2, Column A, upper south to lower north diagonal bracing, looking south. Global distortion to the diagonal members within level, CS3.

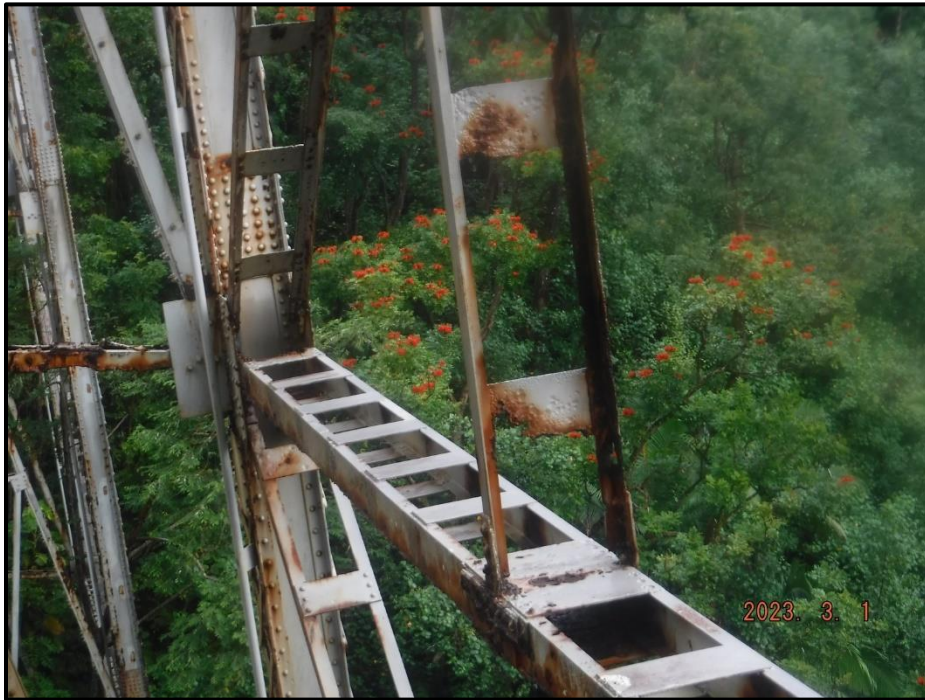
Photograph 97. Tower 3, Level 2, Column A, vertical bracing, looking north. Batten plates typically exhibit pitting up to 1/8" deep with corrosion holes up to 5" diameter, CS3.

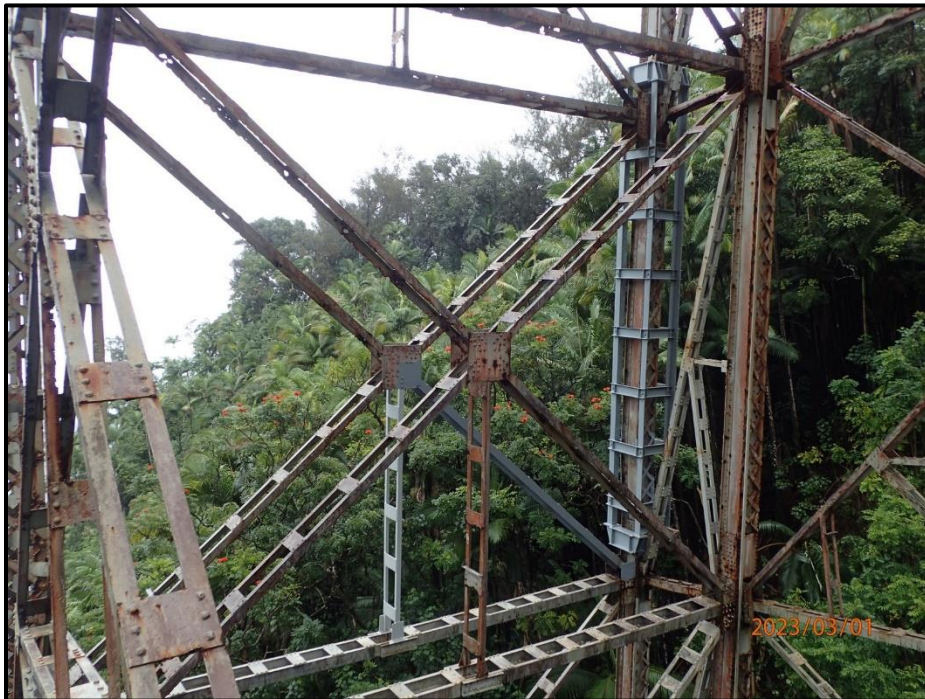
Photograph 98. Tower 3, Level 3, Column A, lower south diagonal, and vertical bracing, looking southeast. Repaired.

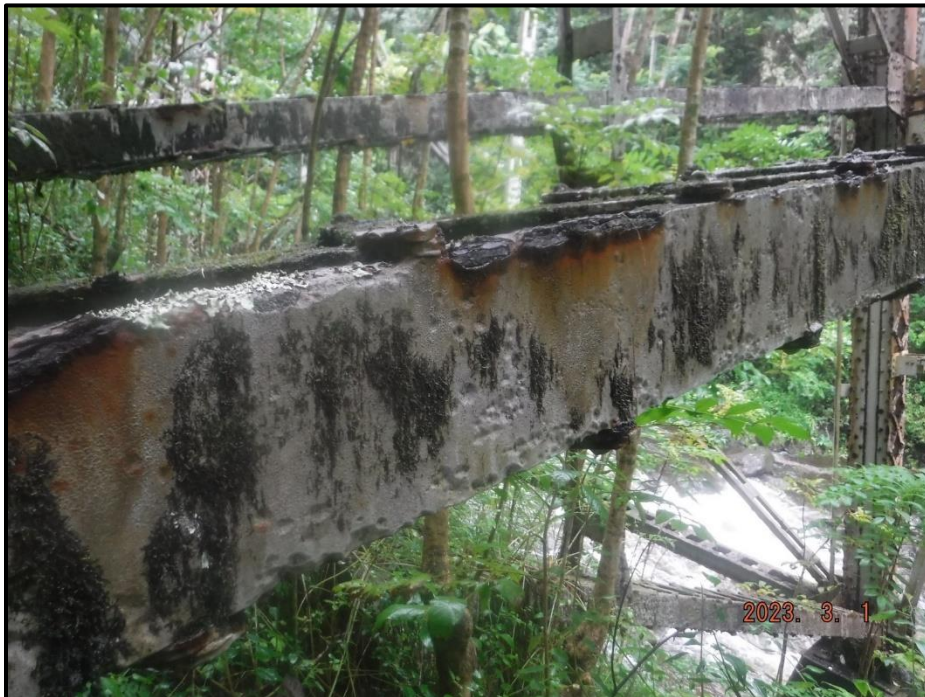
Photograph 100. Tower 3, Level 6, Column A, lower horizontal bracing, looking northwest. Knife-edging with 4" L x 1-1/2" H section loss, CS3.

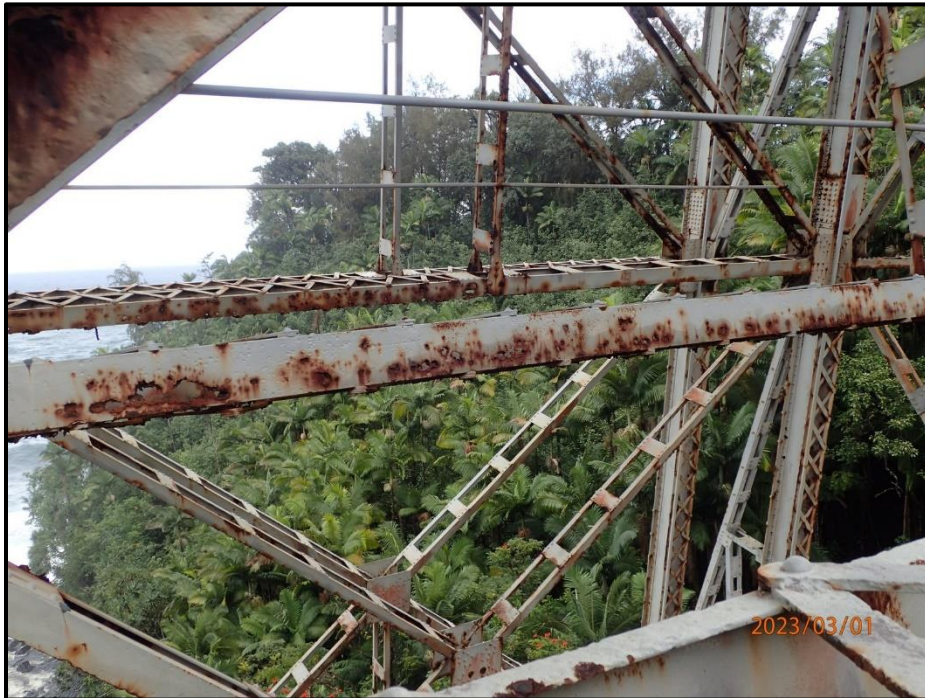
Photograph 101. Tower 3, Level 1, Column C, lower horizontal bracing, looking east. Multiple corrosion holes up to 6" diameter in east and west channels, CS3.

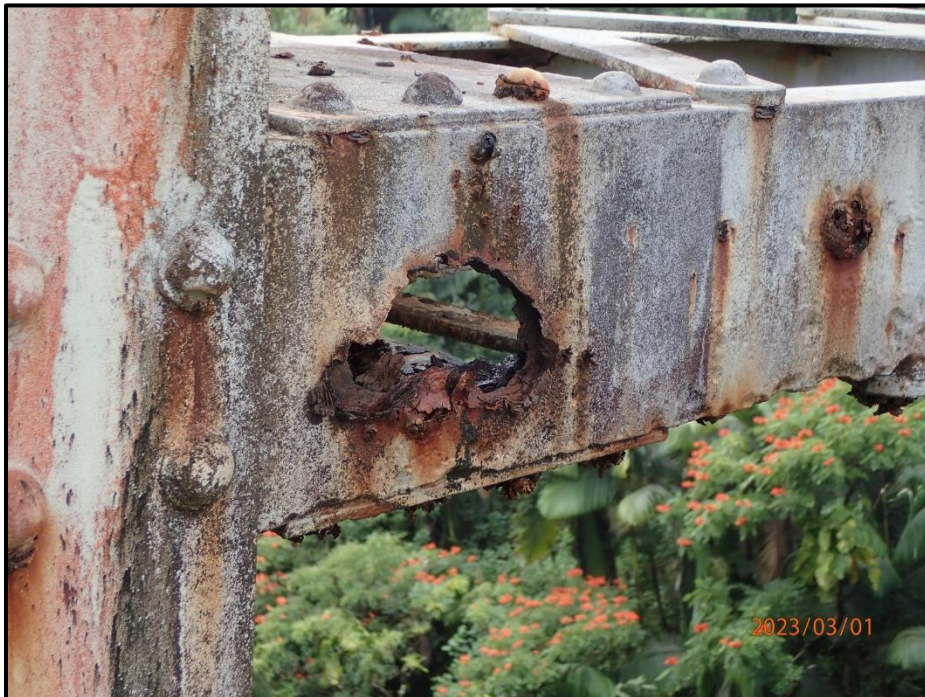
Photograph 102. Tower 3, Level 2, Column C, horizontal bracing, east channel, looking west. 8" L x 2" H corrosion hole, CS3.

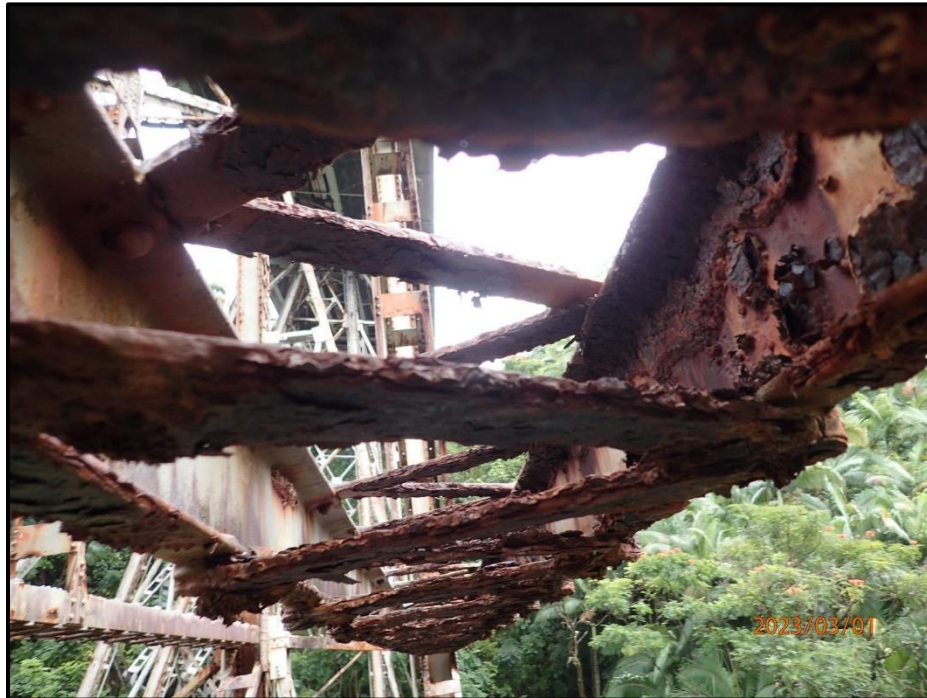
Photograph 103. Tower 3, Level 2, Column D, horizontal bracing, exterior channel side face, looking south. Heavy laminar corrosion, CS3.

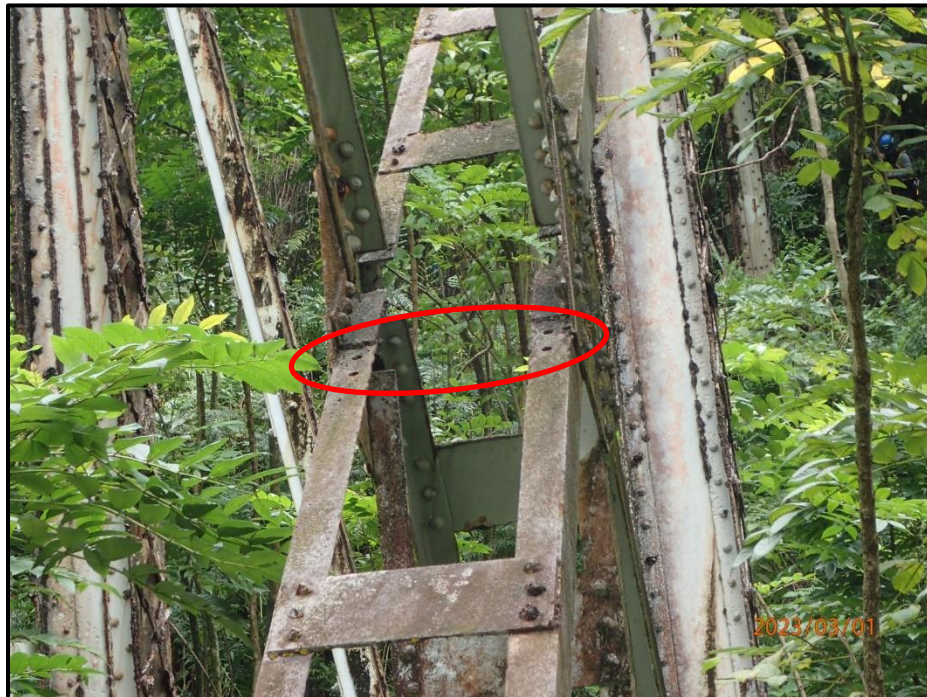
Photograph 104. Tower 3, Level 5, Column D, lower north diagonal bracing, at center gusset plate, looking south. Batten plates missing, CS3.

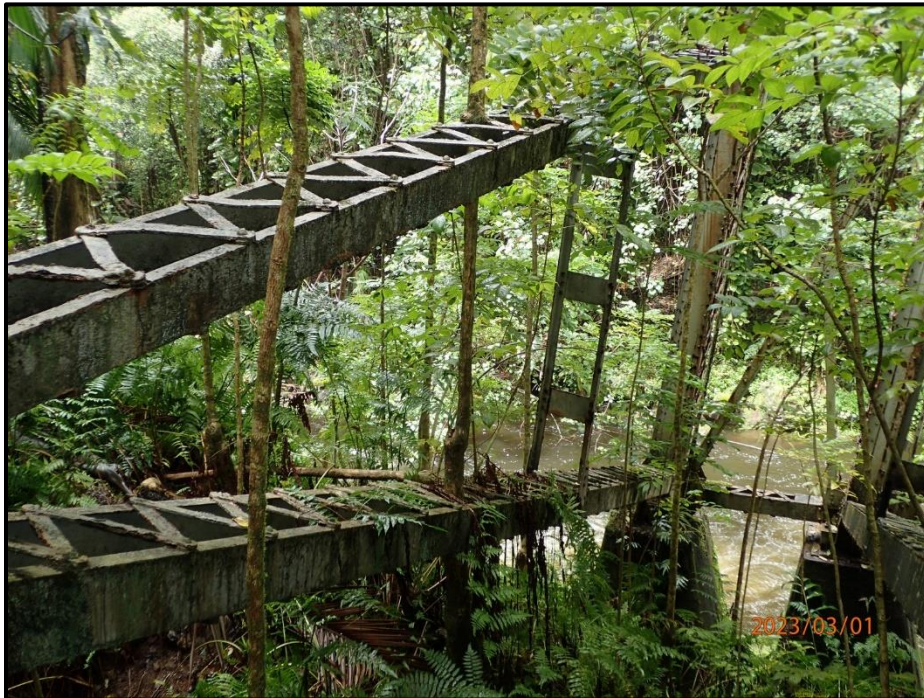
Photograph 105. Tower 3, Level 6, Column D, upper horizontal bracing, looking northwest. Vegetation, tree growing through members.

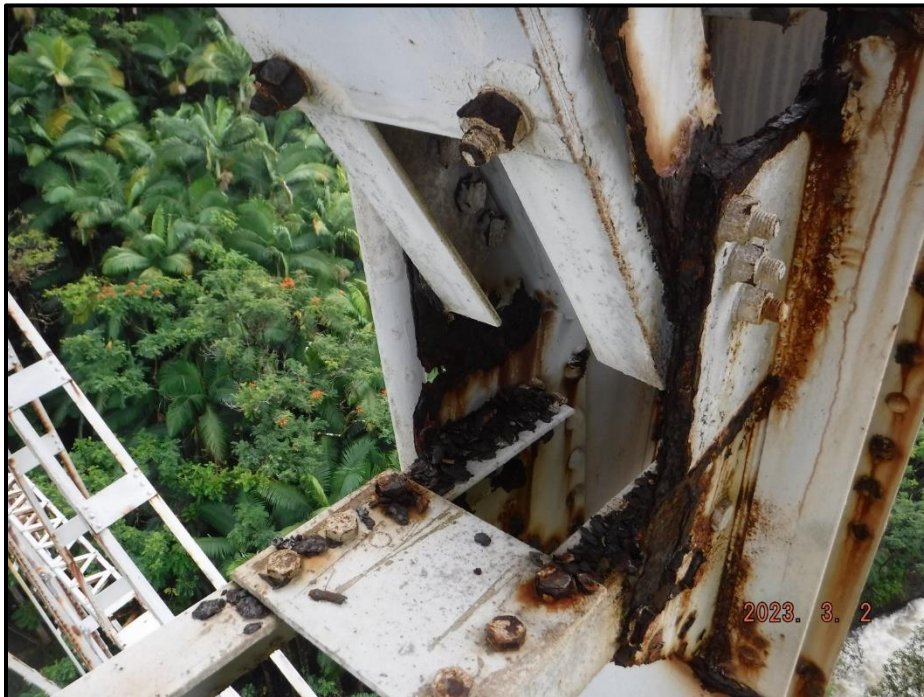
Photograph 106. Bent 5, Level 1, upper section, Column D, lower gusset plates, looking southwest. Heavy laminar corrosion with up to 100% section loss, CS3.

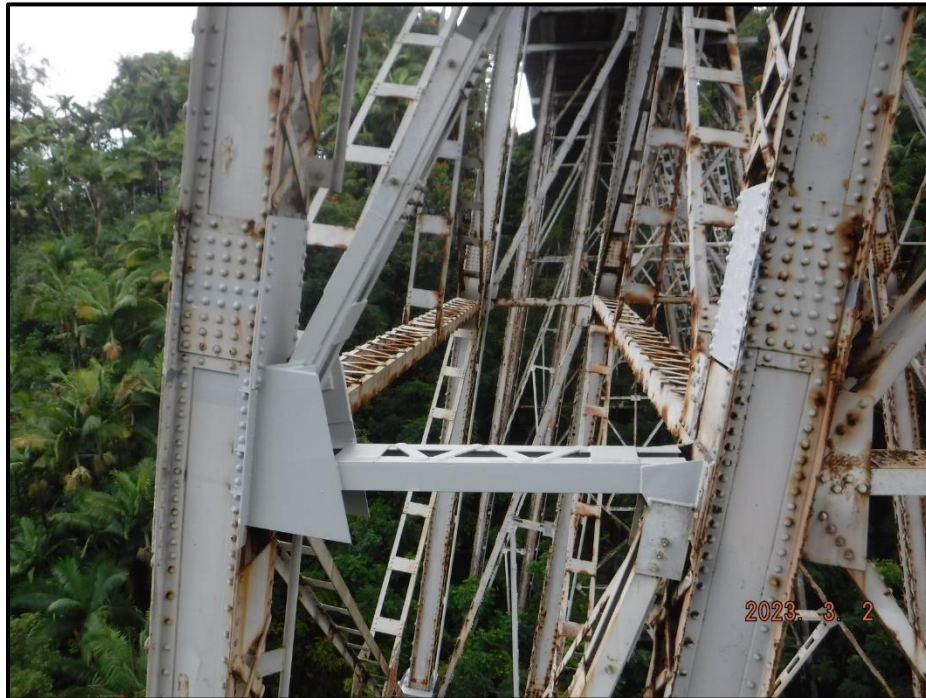
Photograph 107. Bent 5, Level 1, lower section, between Columns A and B, lower horizontal bracing, looking south. Column A lower gusset plates exhibit up to 100% section loss above and below horizontal member with 5" L segments of 25% section left holding members. – Repaired.

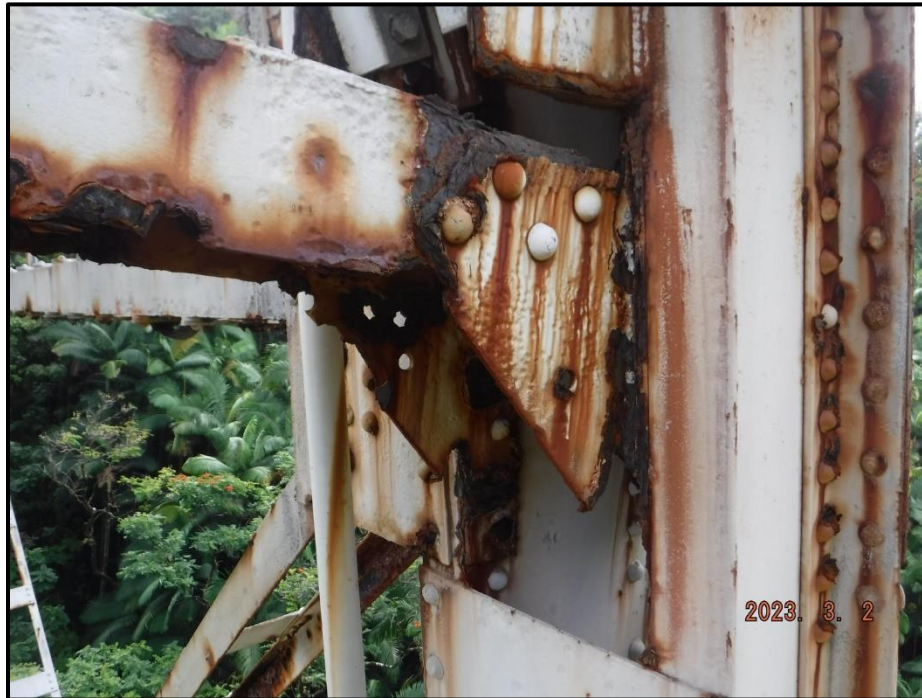
Photograph 108. Bent 5, Level 1, lower section, Column D, horizontal bracing, gusset plate, looking south. North gusset plate has 8" L area of 100% section loss at connection to Column D, CS4. South gusset plate (4) corrosion holes up to 2" diameter and (1) on north gusset plate, CS3.

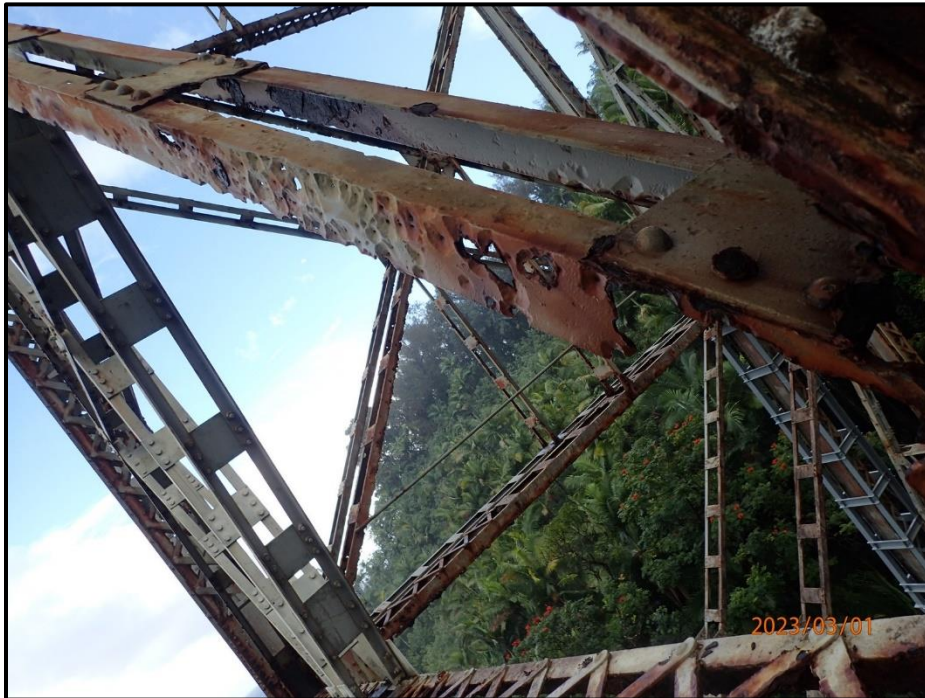
Photograph 109. Bent 5, Level 2, between Columns B and C, lower west diagonal bracing, connection to Column C, looking south. North angle exhibits two 10" L x up to 4" H holes with 1" x 3" remaining section. Remaining length of diagonal exhibits knife-edging and pitting, CS4.

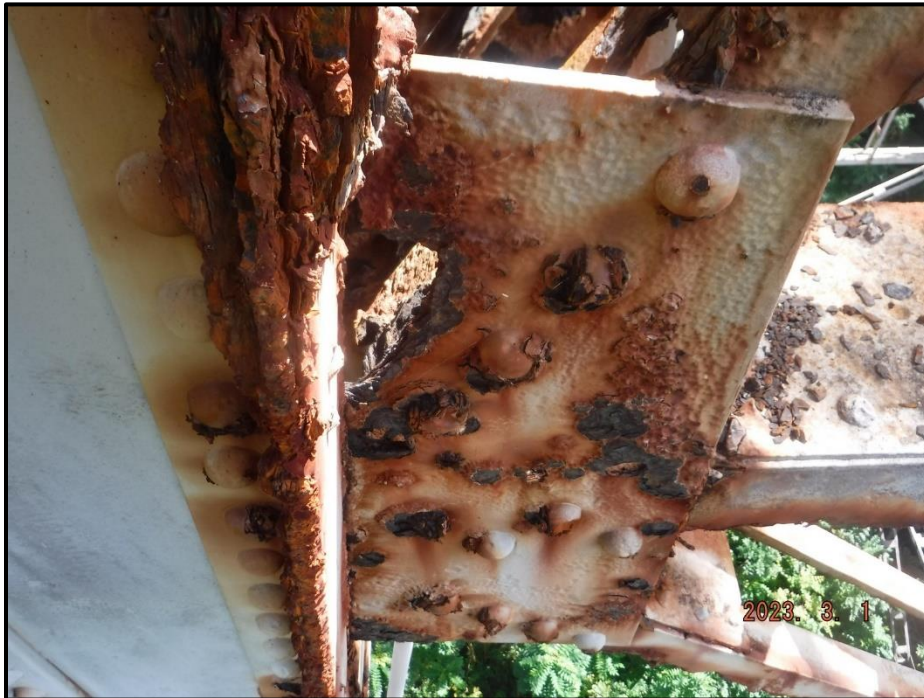
Photograph 110. Bent 5, Level 2, Column B, exterior gusset plate, looking south. Multiple corrosion holes up to 5" x 2 1/2" and pitting up to 1/16" deep in exterior gusset plate; interior rivet heads at connection to column typically have 10% section remaining in this location, CS3.

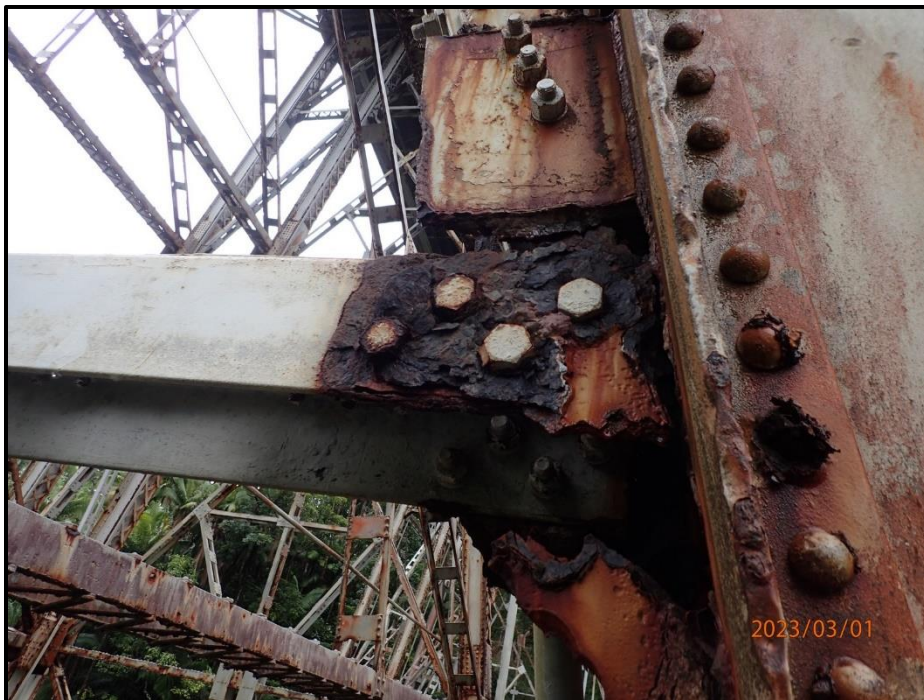
Photograph 111. Bent 5, Level 2, Column D, horizontal bracing gusset plates, looking south. Heavy laminar corrosion with up to 100% section loss with 15% section remaining of the north gusset plate and repair plates becoming ineffective, CS4.

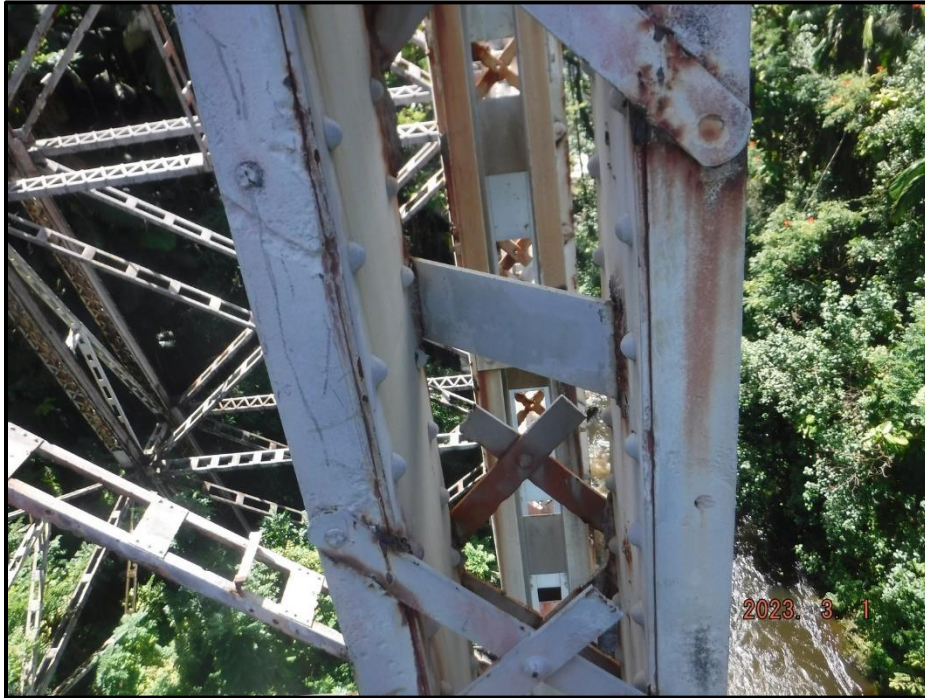
Photograph 112. Bent 5, Level 3, Column A, looking west. (9) lacing bars removed from column, CS3.

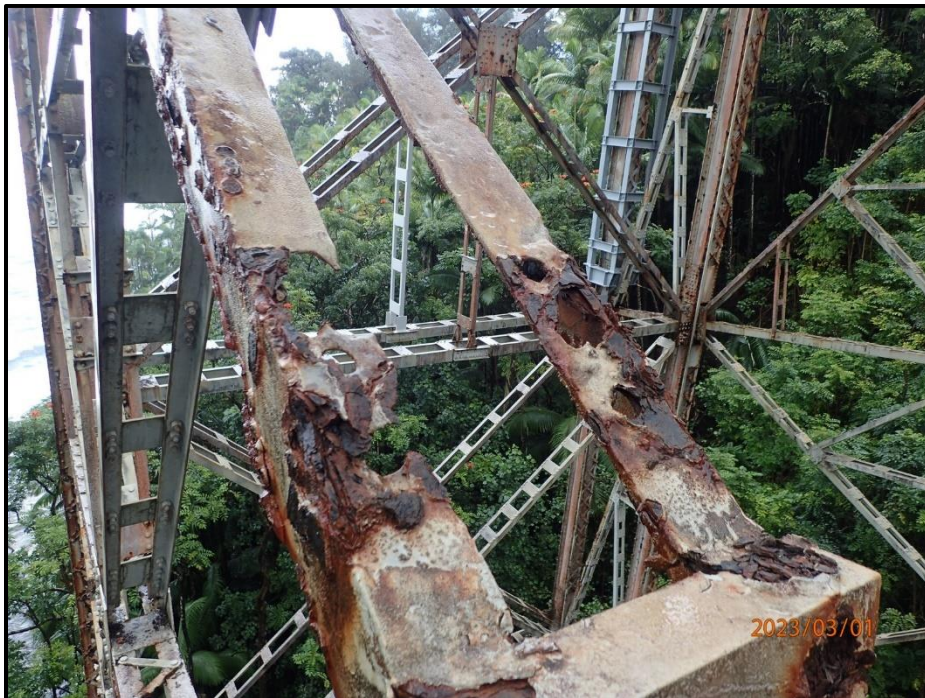
Photograph 113. Bent 5, Level 3, between Columns B and C, lower west diagonal near Column C, looking east. 10" of top flange missing on both angles, CS3.

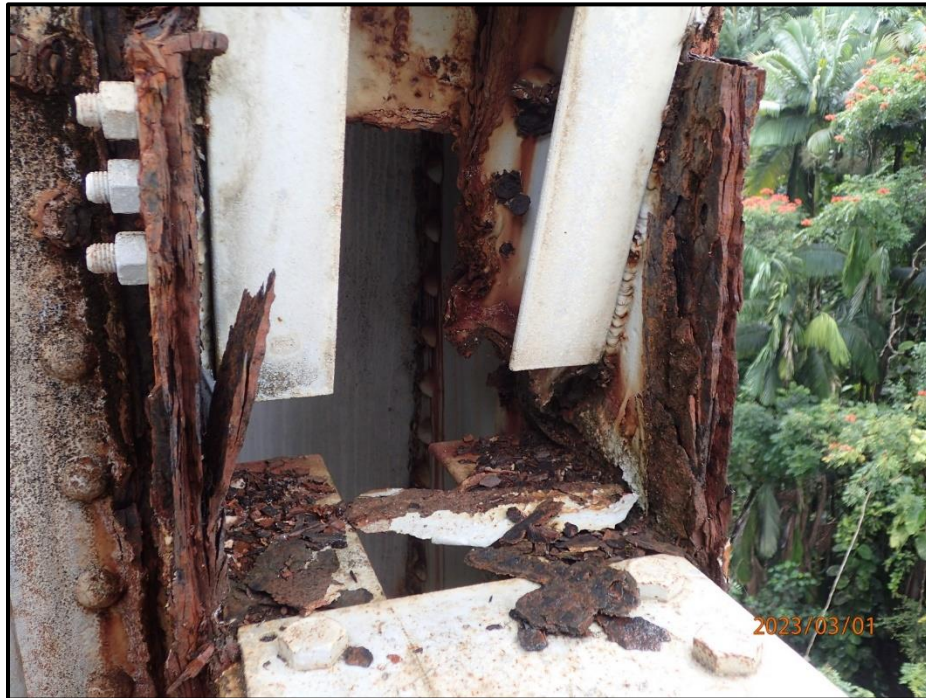
Photograph 114. Bent 5, Level 3, between Columns C and D, diagonal bracing, outboard angles, looking west. 10" L x up to Full Height section loss with adjacent corrosion holes, extreme deterioration up to 90% cross section reduction having no change from previous inspection, CS4.
