**STATE OF HAWAII
DEPARTMENT OF TRANSPORTATION**

**ADDENDUM NO. 2
FOR
HAWAII BELT ROAD
NANUE STREAM BRIDGE REHABILITATION
VICINITY OF HILO
DISTRICT OF HILO, ISLAND OF HAWAII
FEDERAL-AID PROJECT NO. BR-019-2(077)**

December 13, 2024

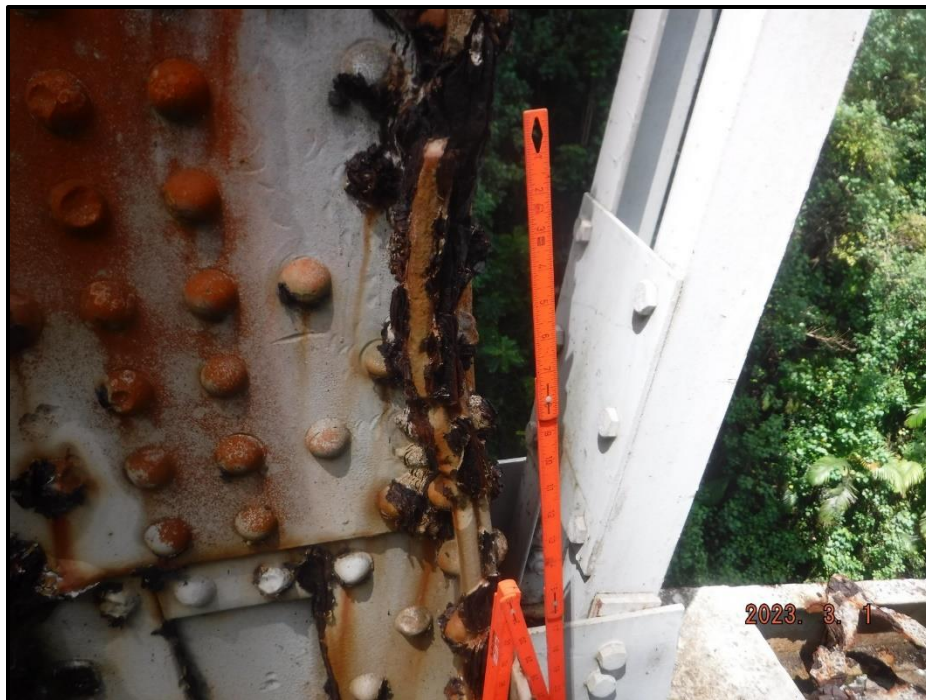
Photograph 115. Bent 5, Level 4, Column B, vertical at southeast flange splice, looking north. Column is deformed, 1' 10" L x 1" deflection, CS3.

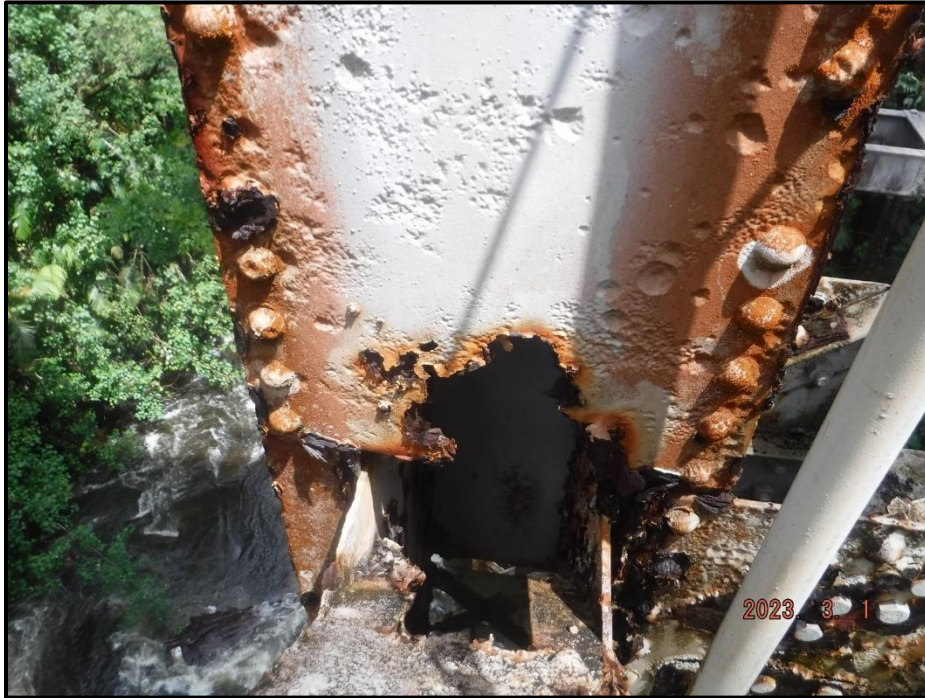
Photograph 116. Bent 5, Level 4, Column B, west batten plate, looking east. 9" diameter corrosion hole, CS3.

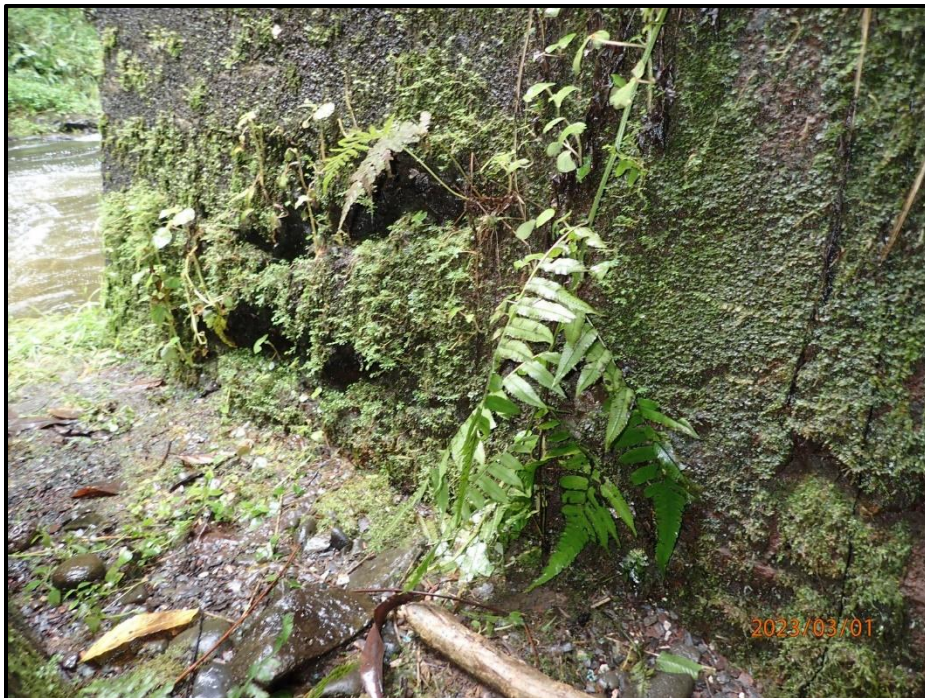
Photograph 117. Bent 5, Level 6, Column C, footing, base of pedestal on west side, looking northeast. 3' x 2' abrasion with course aggregate exposed and missing, CS3.

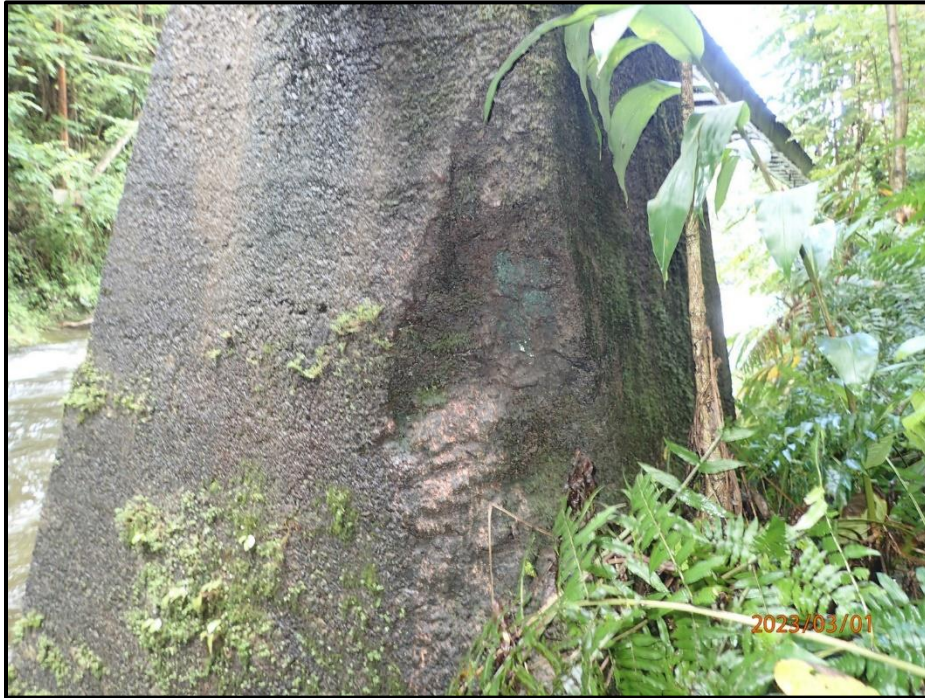
Photograph 118. Bent 5, Level 6, Column C, footing, southwest corner, looking east. 5' W x 1' 4" H x 1' deep spall, CS3.

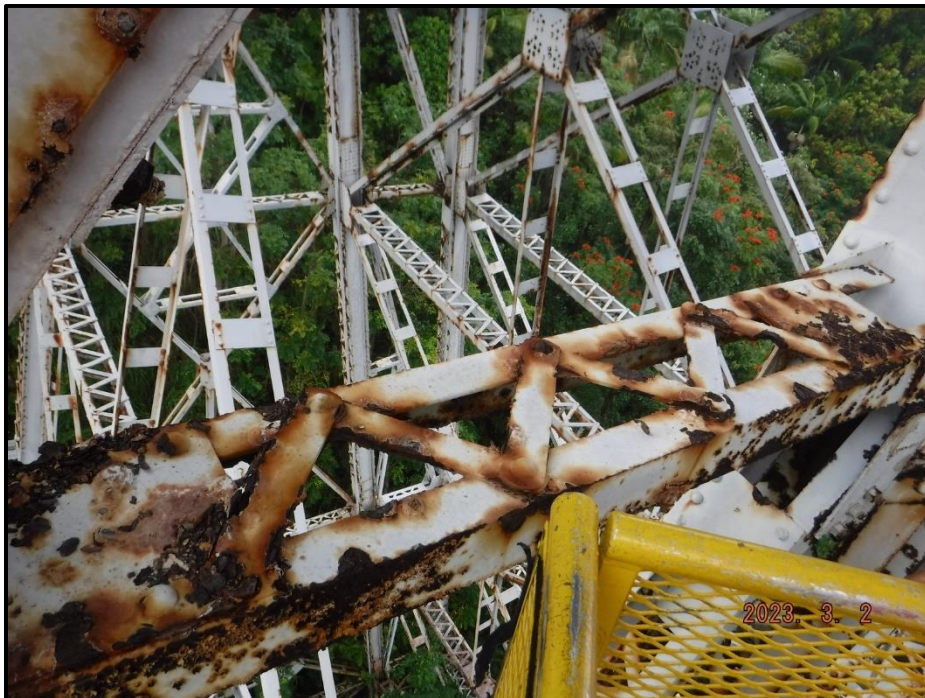
Photograph 119. Bent 6, Level 1, upper section, between Columns C and D, horizontal bracing, looking south. Heavy pitting with 1' 6" L x 2" H area of 100% section loss, CS3.

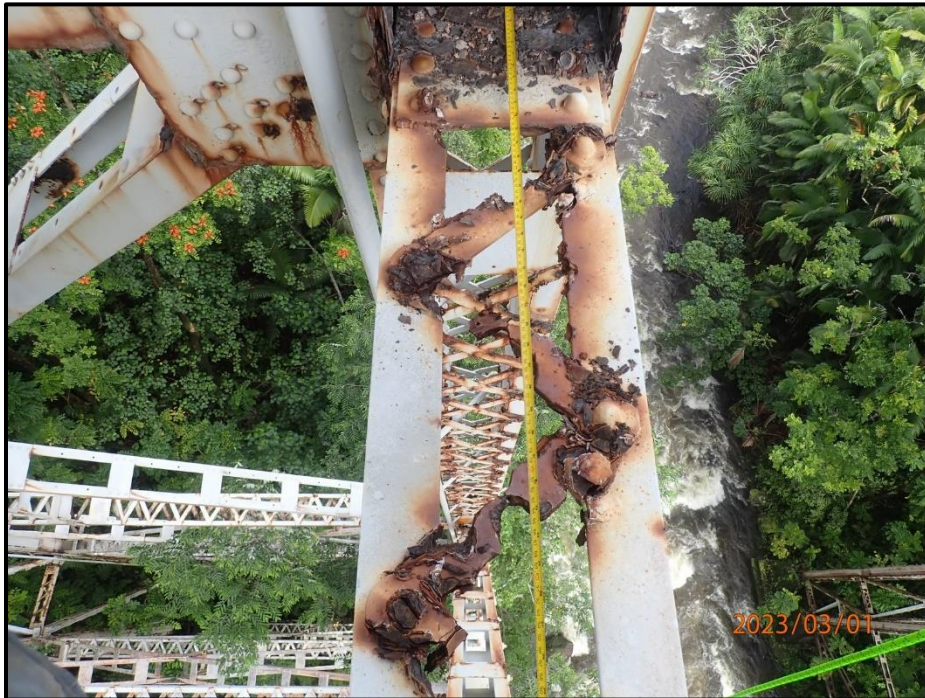
Photograph 120. Bent 6, Level 1, lower section, between Columns A and B, horizontal bracing, looking east. 100% section loss; (5) of (6) bars, CS3.

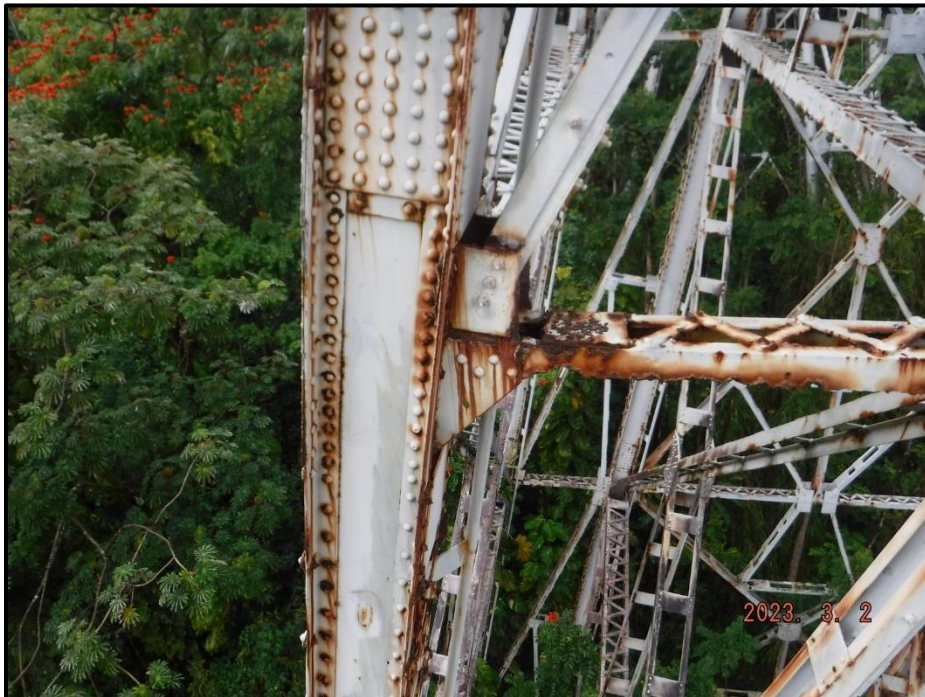
Photograph 121. Bent 6, Level 1, lower section, between Columns C and D, horizontal bracing, looking north. 25% section loss with knife-edging on south angle. Column D gusset plate has severe laminar corrosion between the horizontal and diagonal and appears to be failing at that location (deformation to the north), CS3.

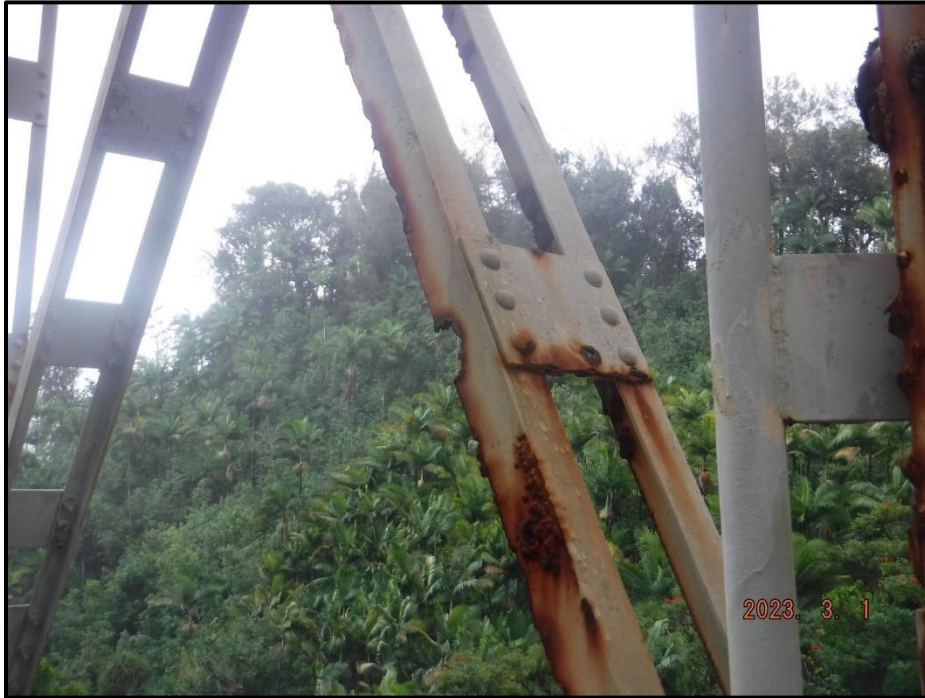
Photograph 122. Bent 6, Level 2, between Columns C and D, lower west diagonal bracing near Column D, looking southeast. 3" L x 2" H corrosion hole on north angle vertical leg, CS3.

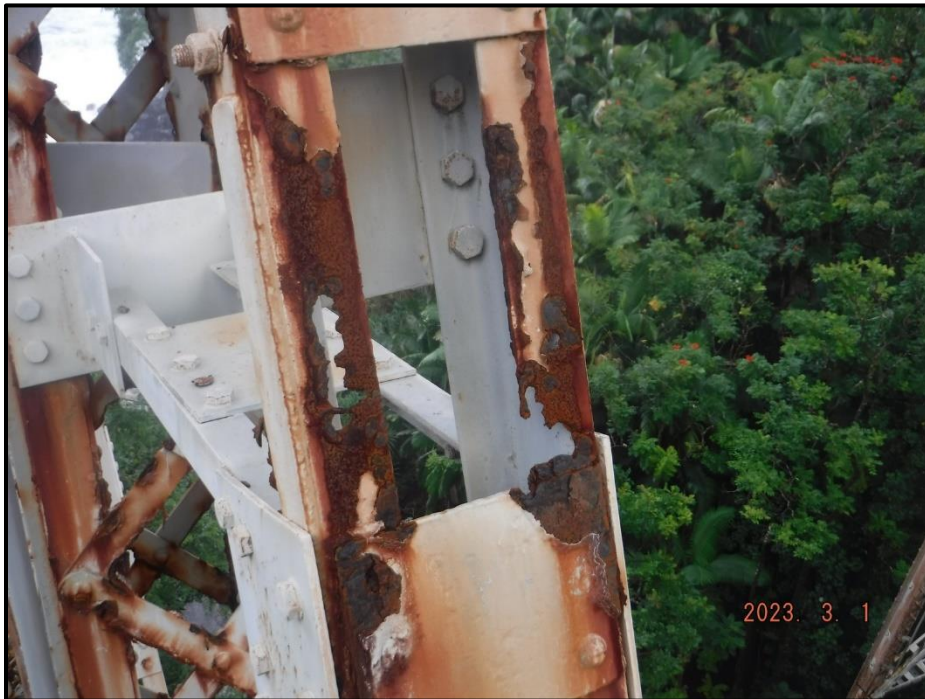
Photograph 123. Bent 6, Level 2, between Columns C and D, near mid-length of longest diagonal bracing, outer flanges, looking southeast. Up to 5" long corrosion holes, CS3.

77	Tower 2, Level 2, Column B, diagonal gusset plate connection, lower diagonals. Up to 4" L x 2" H corrosion holes, CS3. (Similar to Photo 92)	103	Bent 3, Level 1, lower section, between Columns B and C, horizontal bracing. Corrosion holes up to 1" diameter in top channel flanges, batten plate, and lacing bar near Column C, CS3. (Similar to Photo 86)
78	Tower 2, Level 2, Column B, upper south diagonal bracing. 1' L x 3" W of 100% loss on inner west angle vertical flange, CS3. (Similar to Photo 134)	104	Bent 3, Level 1, lower section, between Columns B and C, lower east diagonal bracing near Column B, adjacent to batton plates top flange of angles. knife-edging with areas of 4" L x 2" W of up to 100% section loss, CS3. (Similar to Photo 87)
79	Tower 2, Level 3, Column B, horizontal bracing. Numerous rivet heads in horizontal strut with up to 100% section loss, CS3. (See Photo 69)	105	Bent 3, Level 1, lower section, between Columns B and C, lower west diagonal bracing just above lower horizontal on Column C side. Diagonals and horizontals on north face have knife-edging and corrosion holes throughout, CS3. (Similar to Photo 122)

86	Tower 2, Level 1, Column D, horizontal bracing, near Bent 3 east face. Interior flanges have up to 70% section loss, CS3. (Similar to Photo 134)	112	Bent 3, Level 2, between Columns B and C, lower west diagonal bracing. Multiple corrosion holes up to 2" diameter in exterior flange, CS3. (Similar to Photo 122)
87	Tower 2, Level 2, Column C, horizontal bracing, near mid-length slightly closer to Bent 2. Up to 3/16" deep pitting throughout with areas of knife-edging to original members of interior west face and isolated corrosion holes up to 1/2" diameter, CS3. (See Photo 73)	113	Bent 3, Level 2, between Columns B and C, horizontal bracing. knife-edging with up to 1-1/2" diameter corrosion holes on both flanges, CS3. (Similar to Photo 86)
88	Tower 2, Level 2, Column C, lower south diagonal bracing near center gusset plate. East angle has laminar corrosion with 40% loss of cross sectional area, CS3. (Similar to Photo 68)	114	Bent 3, Level 2, between Columns B and C, lower east diagonal bracing near Column B. knife-edging and up to 1-1/2" diameter holes in both flanges of both angles, CS3. (Similar to Photo 122)

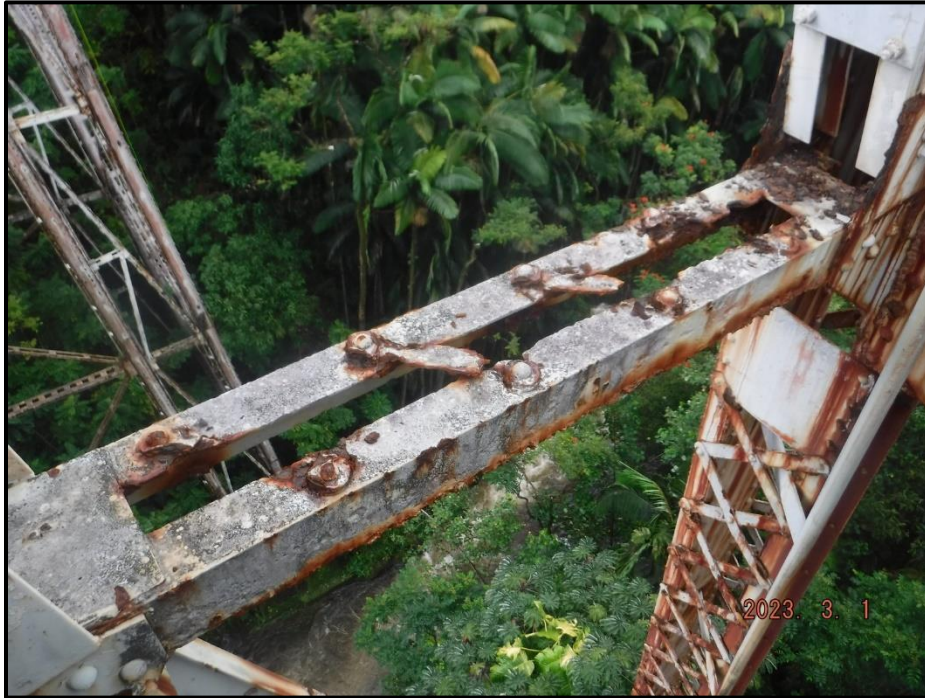
Photograph 124. Bent 6, Level 2, between Columns C and D, horizontal bracing, looking southwest. All (4) lacing bars have 100% section loss, CS3.

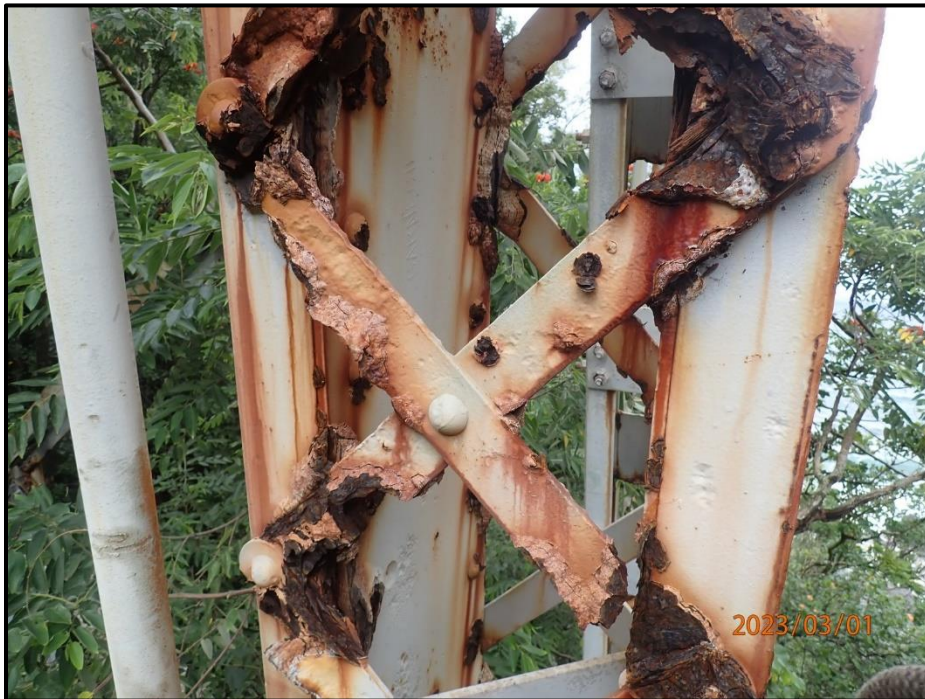
Photograph 125. Bent 6, Level 3, Column B, mid-height, west face, looking east. Multiple lacing bars with 100% section loss, CS3; similar condition on west face of Level 3, Level 2, west face, Level 4 both faces, and Level 5 east face. The west face of Level 5 only has five bars total intact.

Defect ID	Caption
127	Bent 4, Level 1, upper section, Column A, above lower connection. (1) lacing bar has 100% section loss, CS3. (Similar to Photo 125)
128	Bent 4, Level 1, upper section, Column A. West side lacing bar with 100% section loss, CS3. (Similar to Photo 125)
129	Bent 4, Level 1, upper section, Column D, upper gusset plates. Heavy laminar corrosion and approximately 1/4" to 3/8" remaining section on gusset plate between diagonal and horizontal bracing member, CS3. (See Photo 84)
130	Bent 4, Level 1, lower section, between Columns A and B, horizontal bracing. Vertical legs have knife-edging and areas of up to 100% section loss, CS3. (Similar to Photo 80)
131	Bent 4, Level 1, lower section, between Columns A and B, horizontal bracing. (1) lacing bar has 100% section loss and batten plate has 50% loss, CS3. (Similar to Photo 120)
132	Bent 4, Level 1, lower section, Column D, lower gusset plates. Pack rust up to 1" thick with areas of 100% section loss and only retrofit gusset plate remaining, no change from previous inspection, CS3. (See Photo 85)

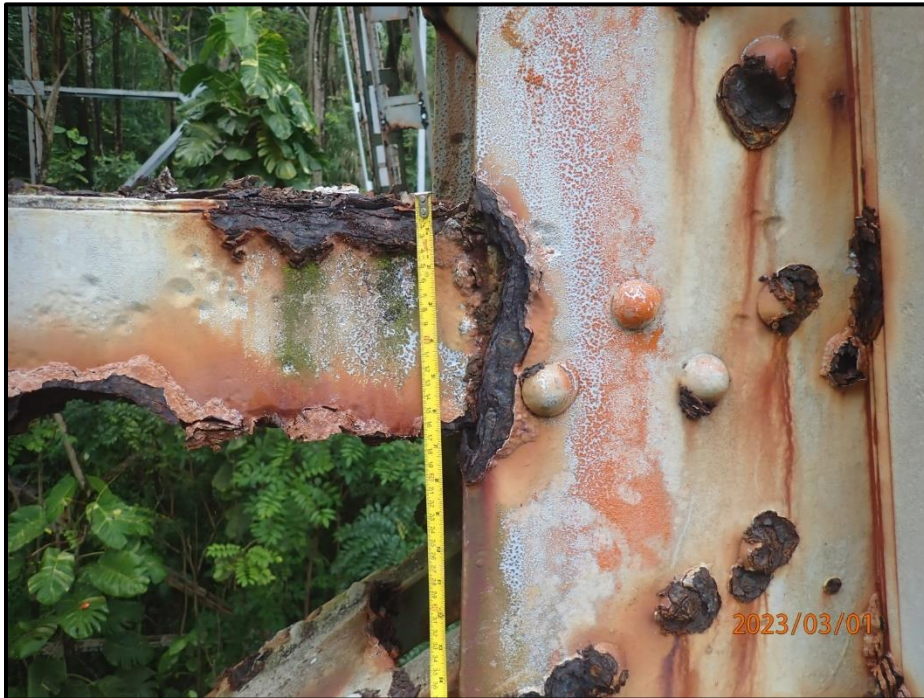
Photograph 126. Bent 6, Level 3, Column B, south gusset plate, west side, looking east. 1 1/2" W x 8" H area of 100% section loss, CS3.

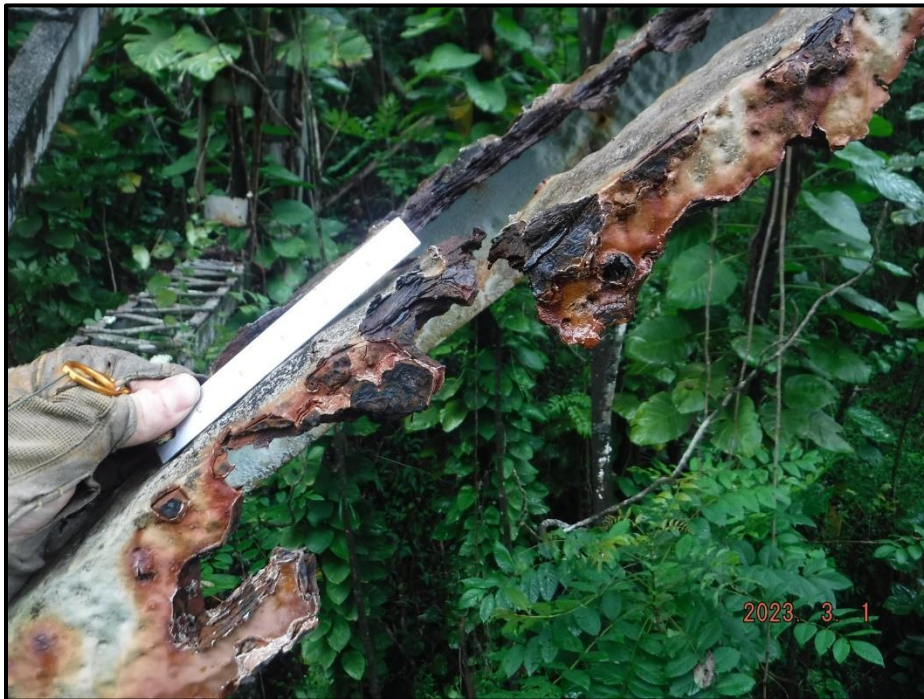
Photograph 127. Bent 6, Level 4, between Columns B and C, lower west diagonal adjacent to Column C, looking north. Corrosion holes and knife edging at exterior vertical flange and section of missing vertical flange at lower end for 1' 6" L, CS3.

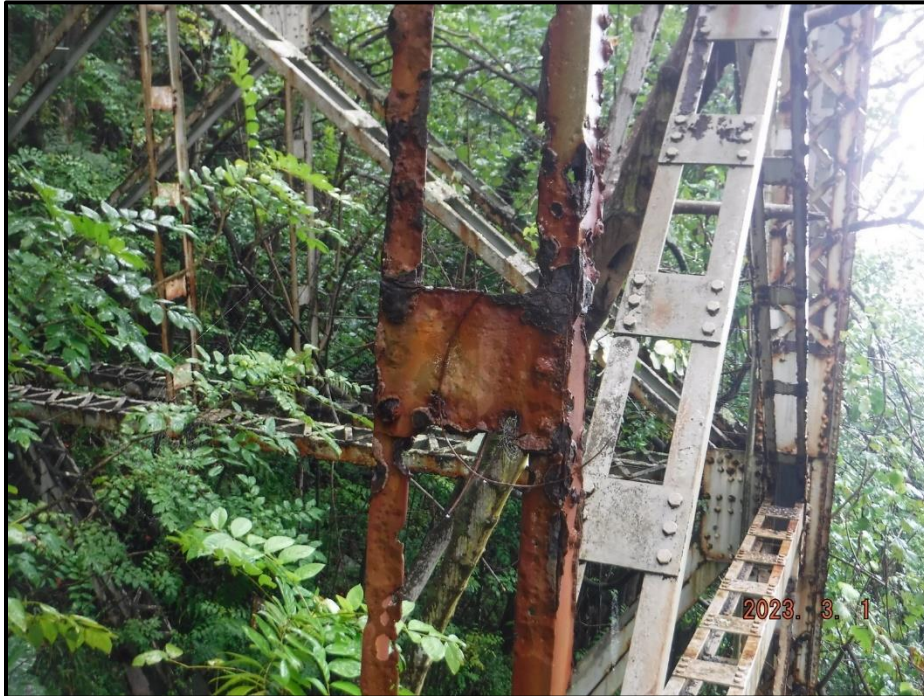
Photograph 128. Bent 6, Level 4, between Columns B and C, vertical bracing, looking north. Severe corrosion throughout this member with 40% section remaining, CS4.

123	Bent 3, Level 3, between Columns B and C, vertical bracing. Knife-edging and severe laminar corrosion with up to 50% section loss of flanges and corrosion hole up to 1-1/2" diameter in interior flange, CS3. (Similar to Photo 128)
124	Bent 3, Level 4, Column A, just above bearing, gusset plates. Plates are distorted and bowed to the south up to 1/8" for the horizontal bracing member, CS3. (See Photo 82)
125	Bent 3, Level 4, Column B. (1) lacing bar exhibits 100% section loss on both ends on the west column face, CS3. (Similar to Photo 125)
126	Bent 3, Level 4, Column C, typical painted-over pitting, laminar corrosion, knife-edging, and corroded rivet heads, CS3. (See Photo 83)

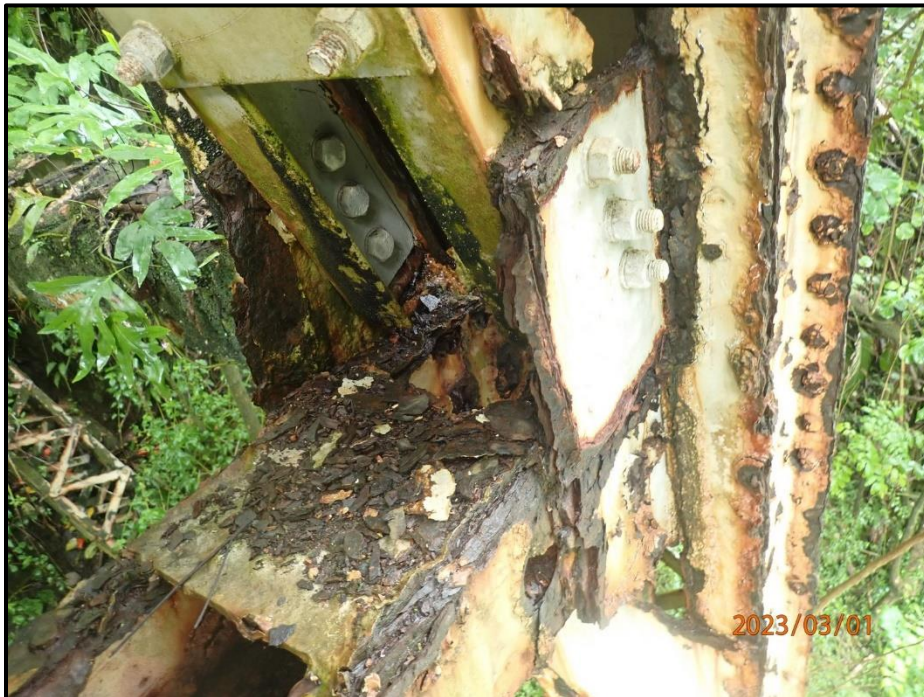
Photograph 129. Bent 6, Level 4, Column A, gusset plate at horizontal bracing, looking northeast. 75% section loss with corrosion holes, CS3.

240	Bent 6, Level 1, lower section, Column A, gusset plate at horizontal bracing. 75% section loss with corrosion holes, CS3. (Similar to Photo 129)

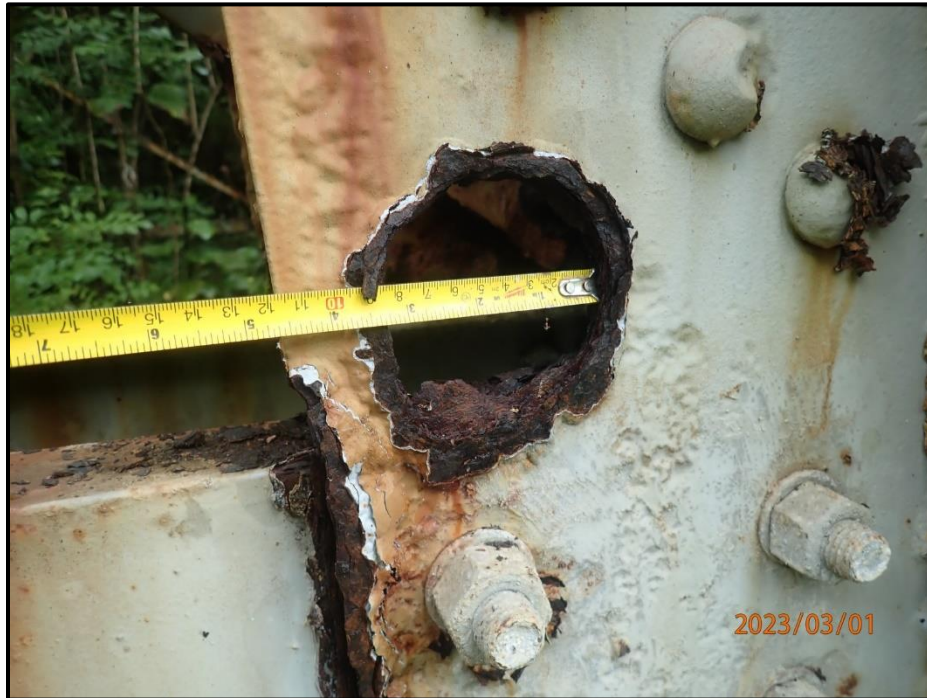
Photograph 130. Bent 6, Level 4, Column B, exterior gusset plate at horizontal bracing, looking south. 3 1/2" diameter corrosion hole, CS3.

53	Bent 2, Level 1, lower section, between Columns B and C, horizontal bracing, adjacent to Column B. Diagonals and horizontals on south face have knife-edging and holes in flanges throughout, CS3. (Similar to Photo 86)
54	Bent 2, Level 1, lower section, between Columns B and C, horizontal bracing. (2) lacing bars have 75% section loss, CS3. (Similar to Photo 125)
55	Bent 2, Level 1, lower section, between Columns B and C, upper west diagonal bracing near Column C. North angle has 3" L x up to 1" W x 100% section loss, CS3. (Similar to Photo 72)
56	Bent 2, Level 1, lower section, between Columns C and D, diagonal bracing near Column C. (2) batten plates have (3) of (6) rivet heads with up to 80% section loss, CS3. (Similar to Photo 57)
57	Bent 2, Level 1, lower section, Column A, interior gusset plates. Up to 1" W x full length section loss where all members frame in, CS3. (See Photo 61)
58	Bent 2, Level 1, lower section, Column C, cover plate. Up to 2" diameter corrosion holes, CS3. (Similar to Photo 130)

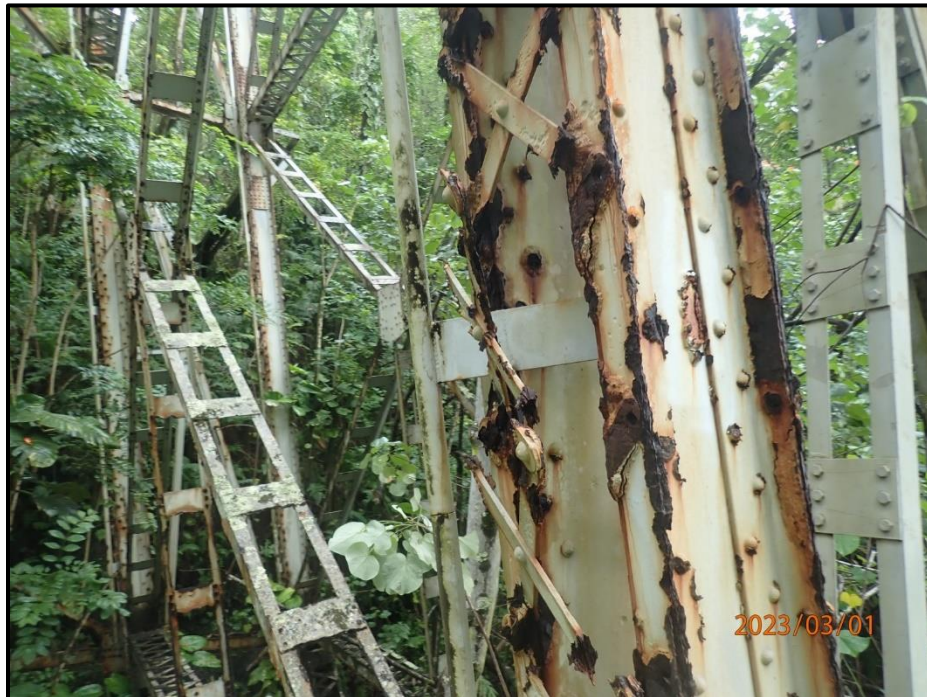
Photograph 131. Bent 6, Level 5, Column B, looking northeast. Almost all lacing bars on the west side of the column have 100% section loss; (6) bars with section loss remaining intact at time of inspection, CS4.

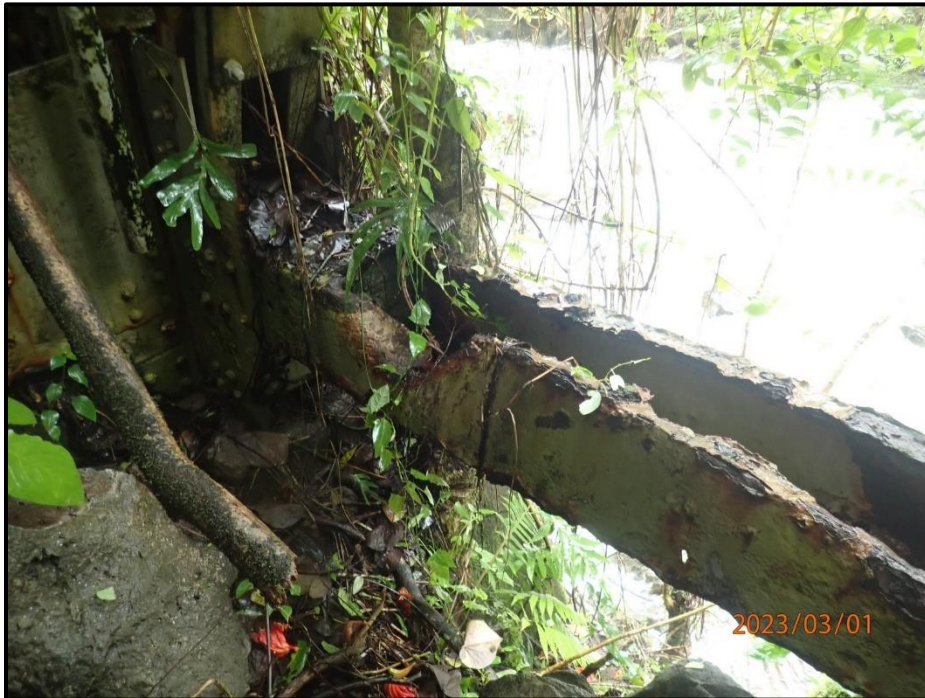
Photograph 132. Bent 6, Level 6, between Columns A and B, horizontal bracing, looking northeast. Member impacted by falling rocks, CS3.

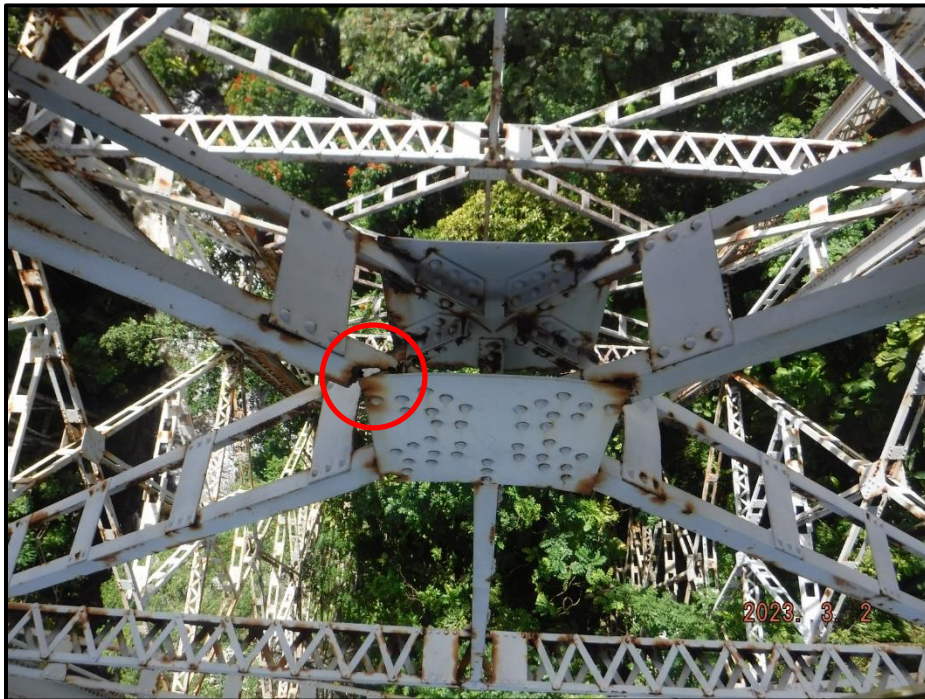
Photograph 133. Tower 4, Level 1, lower south diagonal bracing, looking west. Exterior angle of diagonal has 100% section loss to vertical leg and only 2 1/2" of section remaining on horizontal leg; angle is deformed 1/4" over 10" near section loss, CS4.

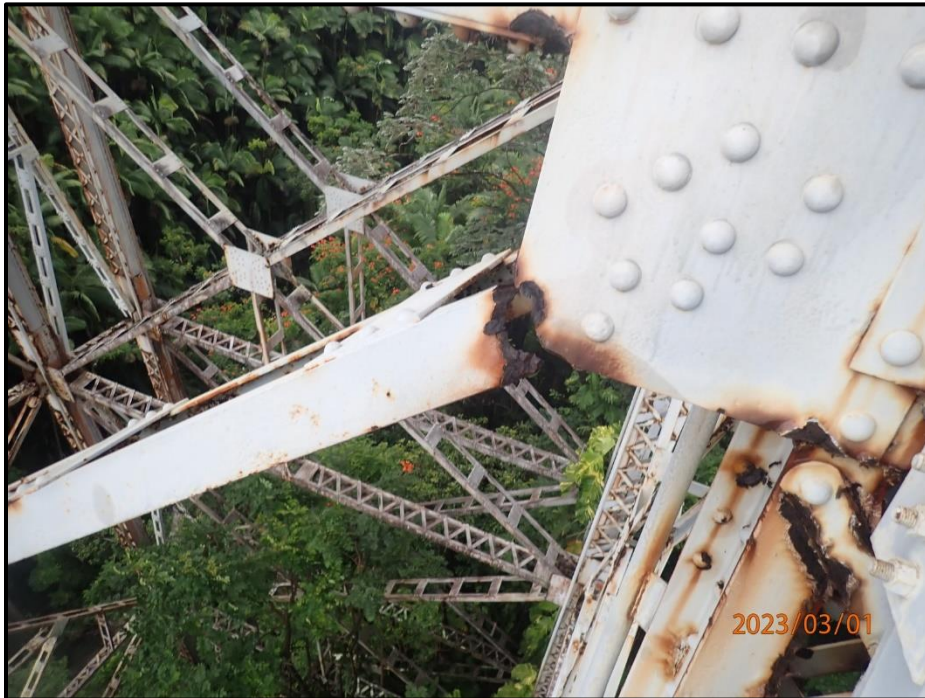
Photograph 134. Tower 4, Level 2, Column B, upper north diagonal bracing, looking west. Exterior angle of diagonal has 100% section loss to vertical leg, CS3.

74	Tower 2, Level 1, Column B, lower north diagonal bracing. Areas of 100% section loss up to 1-1/2" W x 1' L on both angle legs at isolated locations along full member length, CS3. (Similar to Photo 134)	100	Bent 3, Level 1, upper section, Column D, vertical near top. Typical laminar corrosion at upper levels, CS3. (See Photo 77)
75	Tower 2, Level 1, Column B, lower north diagonal bracing. Up to 1/8" section loss to gusset plate and diagonal at connection, 1" diameter corrosion hole in diagonal near center connection, CS3. (Similar to Photo 134)	101	Bent 3, Level 1, upper section, Column D. Corrosion hole up to 2" diameter in southeast angle with (2) adjacent lacing bars with 100% section loss near the top, CS3. (Similar to Photo 145)
76	Tower 2, Level 1, Column B, upper north diagonal bracing, near Bent 3. Areas of 100% section loss up to 1-1/2" x 1' L on interior vertical angle leg over 3' near center connection, CS3. (Similar to Photo 134)	102	Bent 3, Level 1, upper section, Column D, southeast flange. (1) 2-1/2" diameter corrosion hole, CS3. (Similar to Photo 145)

89	Tower 2, Level 2, Column C, upper north diagonal bracing near Bent 3. Laminar corrosion with section loss along member up to 10% loss of total cross sectional area, CS3. (Similar to Photo 134)	115	Bent 3, Level 2, between Columns B and C, north center gusset plate. 2" diameter corrosion hole, CS3. (Similar to Photo 144)
90	Tower 2, Level 2, Column D, horizontal bracing. Pinholes (corrosion holes) throughout the length, CS3. (Similar to Photo 101)	116	Bent 3, Level 2, between Columns B and C, vertical bracing. Knife-edging and severe laminar corrosion with up to 50% loss of flanges over 4' of length, and area of up to 1-1/2" W x 1" H corrosion holes, CS3. (Similar to Photo 128)
91	Tower 2, Level 2, Column D, vertical bracing. Up to 1/8" deep pitting with scattered areas of knife-edging, CS3. (Similar to Photo 97)		
92	Tower 2, Level 3, Column C, center gusset plate. 50% of rivet heads on the inside of panel point typically have 50-90% section loss, CS3. (Similar to Photo 99)

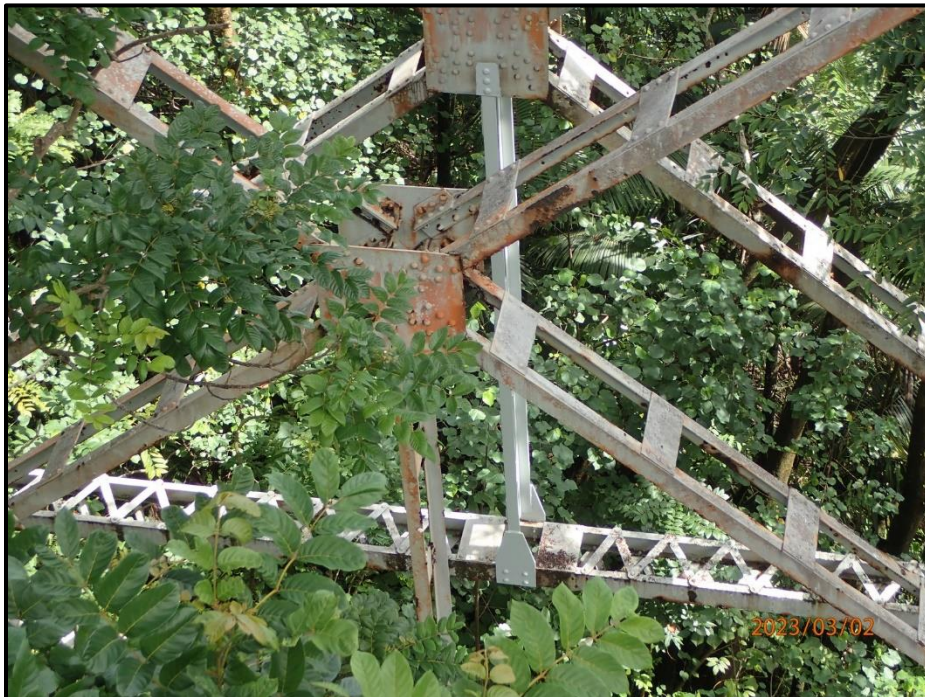
Photograph 135. Tower 4, Level 3, Column A, vertical bracing, looking east. Exterior leg with 80% section loss has been replaced.

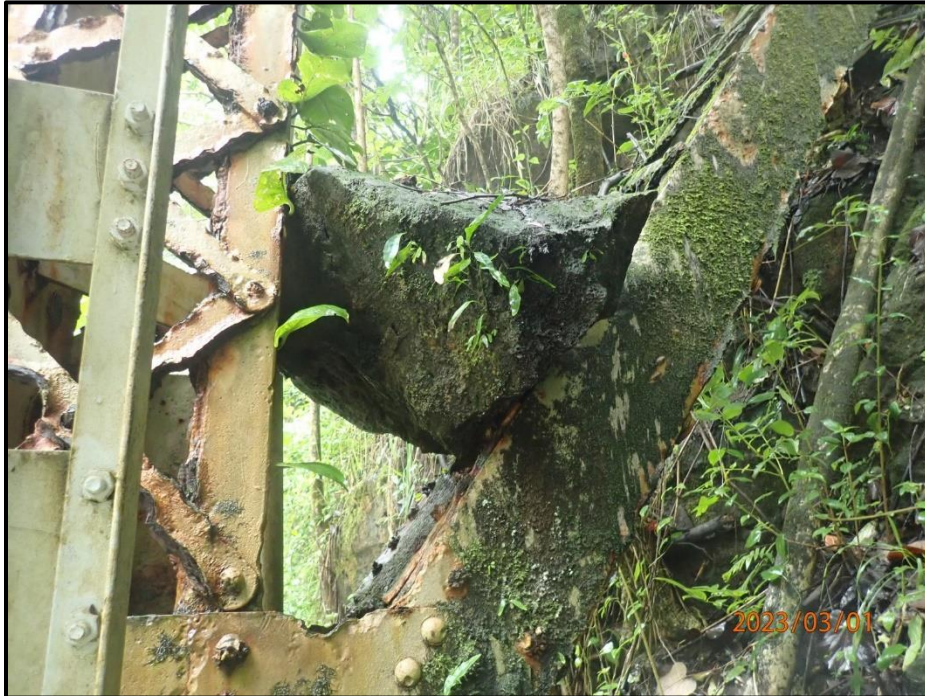
Photograph 136. Tower 4, Level 6, Column B, looking west. 3' diameter boulder on top of diagonal member at bottom connection; member appears to be deformed as a result.

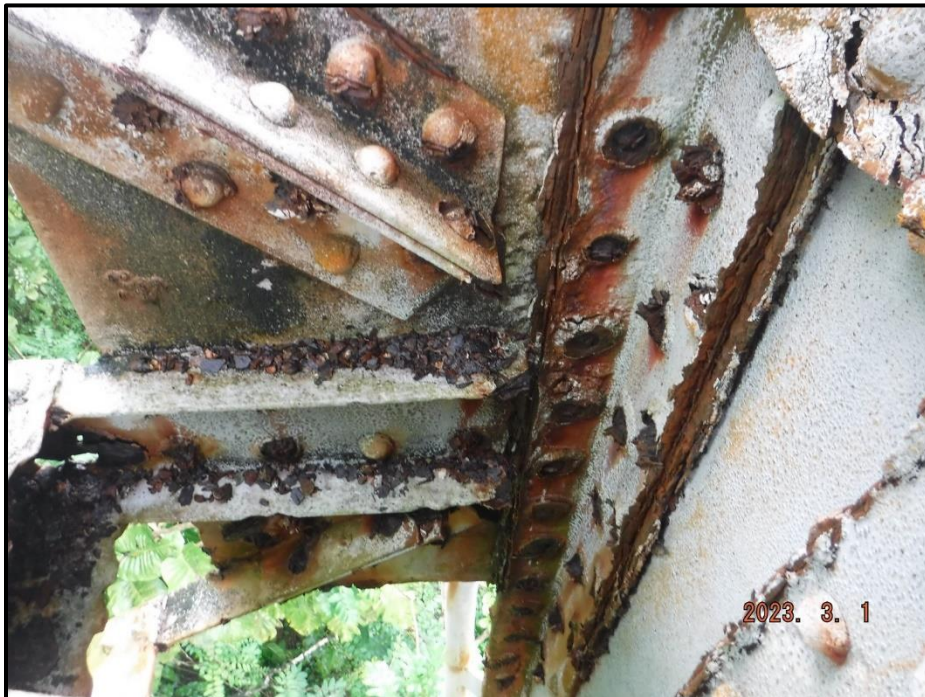
Photograph 137. Tower 4, Level 3, Column C, gusset plate connecting bracing to Bent 6, looking east. 14 of 18 rivet heads connecting the gusset plate to the column have 20% remaining on the inside face. East channel of bracing has more severe section loss at this location with five corrosion holes in the web up to 1" diameter, CS4.

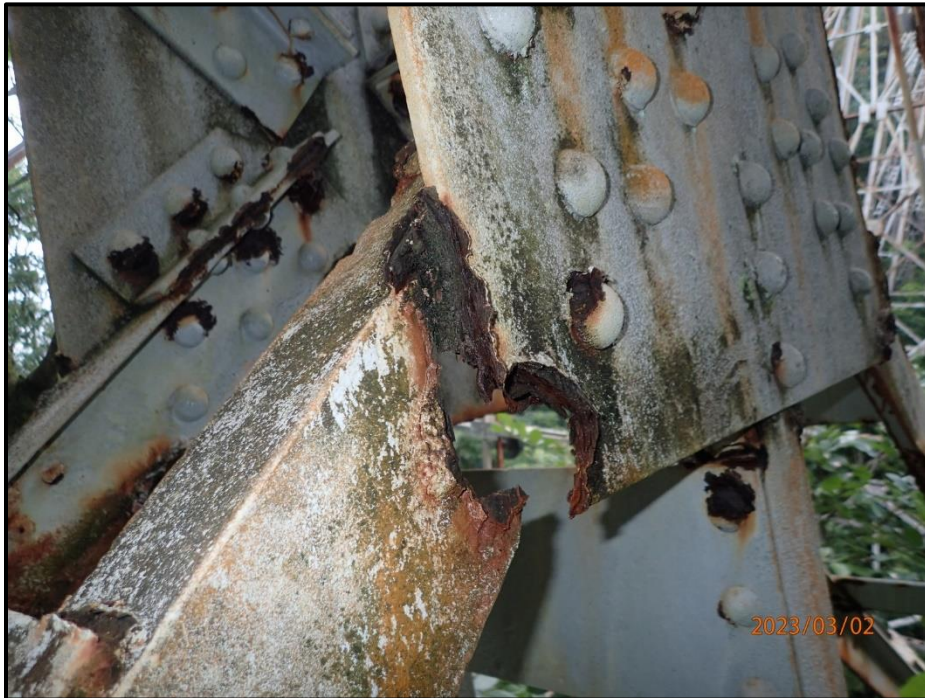
Photograph 138. Tower 4, Level 3, Column C, lower south diagonal bracing, looking east. West angle has 4" H x 2" L area of 100% section loss adjacent to the gusset plate, and the east angle has 1/4" loss in same location. Combined for 50% loss of member cross sectional area, CS4.

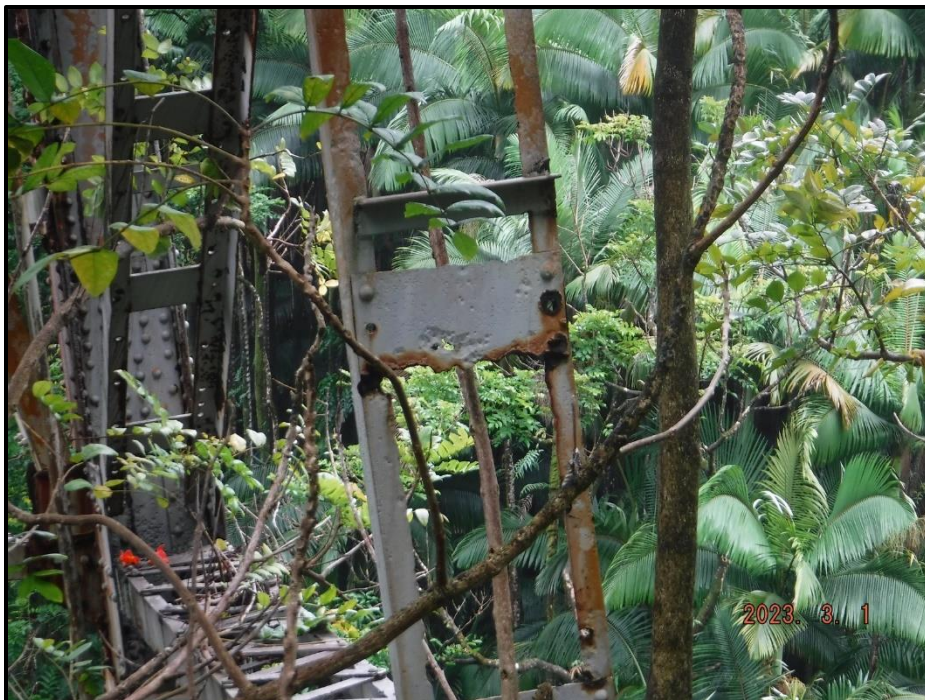
Photograph 139. Tower 4, Level 4, Column D, vertical bracing, looking north. Up to 1" H x full width area of 100% section loss across bottom edge of batten plate, CS3.

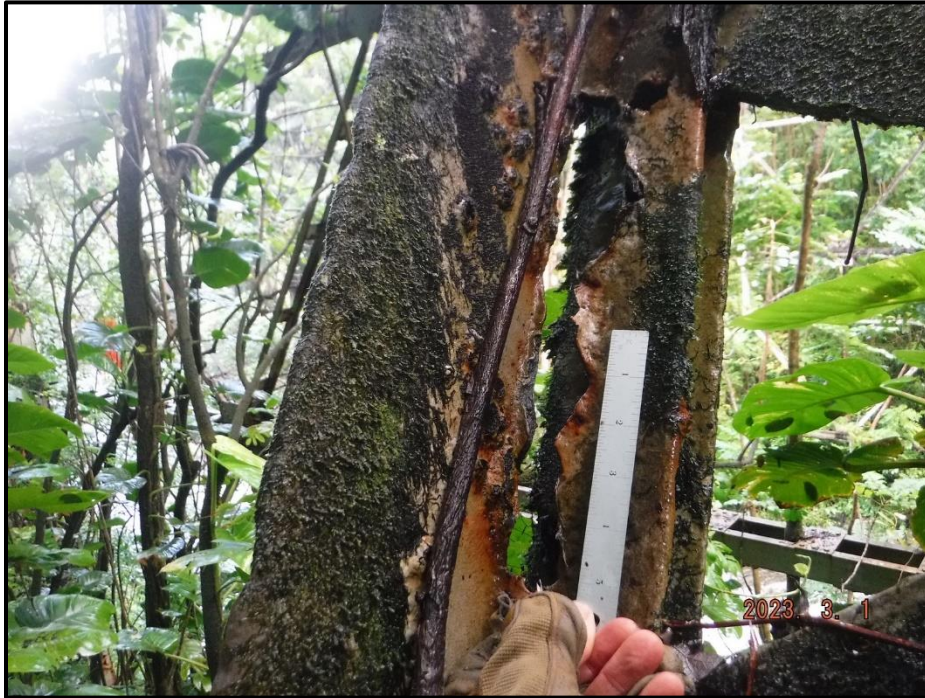
Photograph 140. Tower 4, Level 5, Column C, mid-diagonal mid-length, interior top angle, looking south. 100% section loss for most of length of horizontal flange. Approximately 20% loss of cross sectional area, CS3.

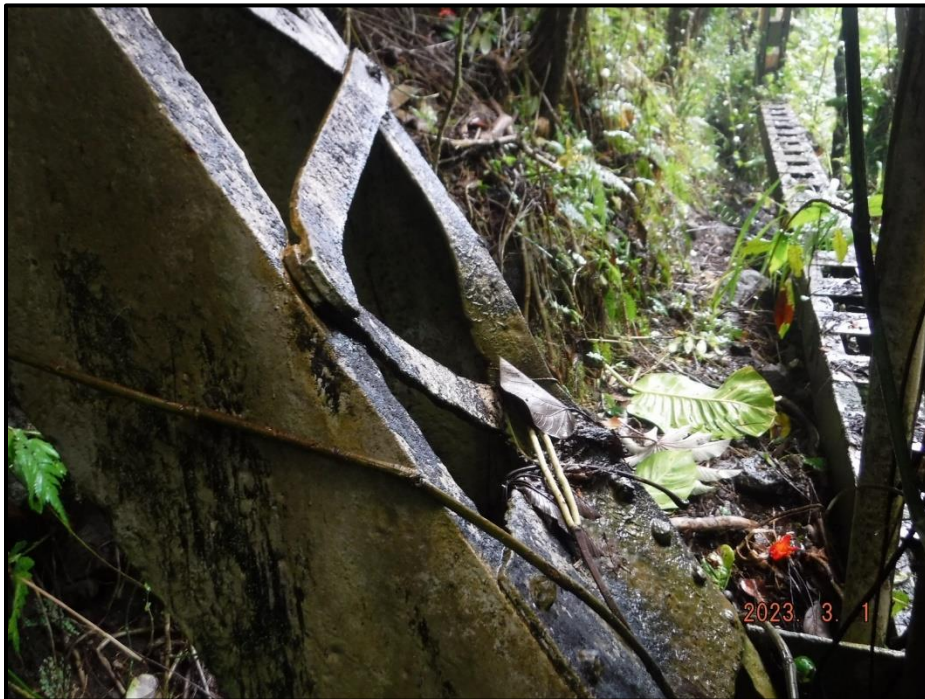
Photograph 141. Tower 4, Level 6, Column C, adjacent to Bent 6 pedestal, interior channel, looking east. 3" downward deformation over 1' 6", CS3.

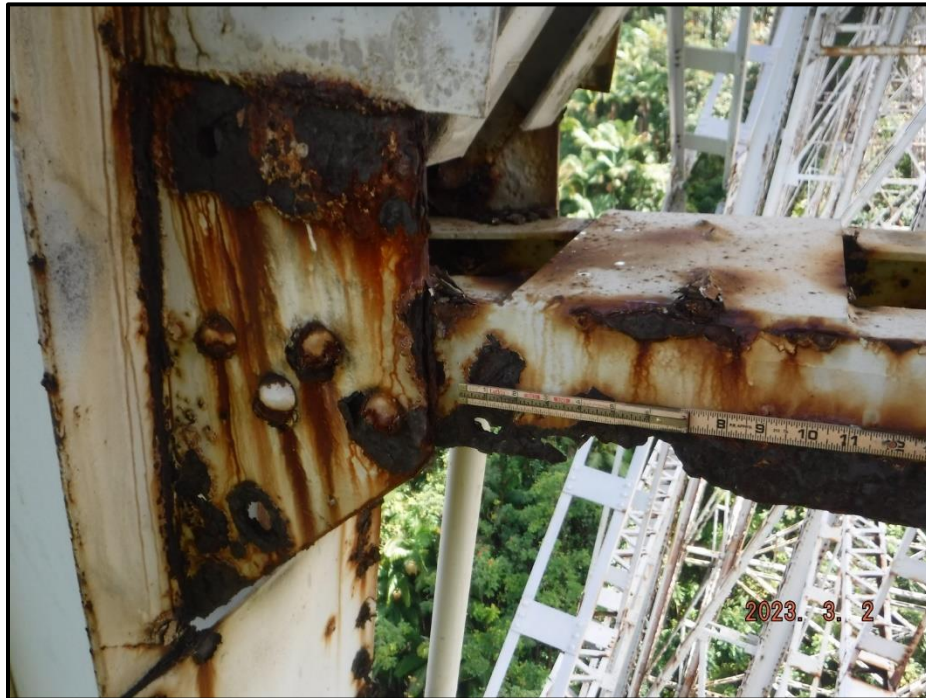
Photograph 142. Bent 7, Level 1, upper section, Column A, gusset plate, looking south. (2) corrosion holes up to 1" diameter and horizontal bracing connection to Column B has a 5" L x 1" H area of 100% section loss.

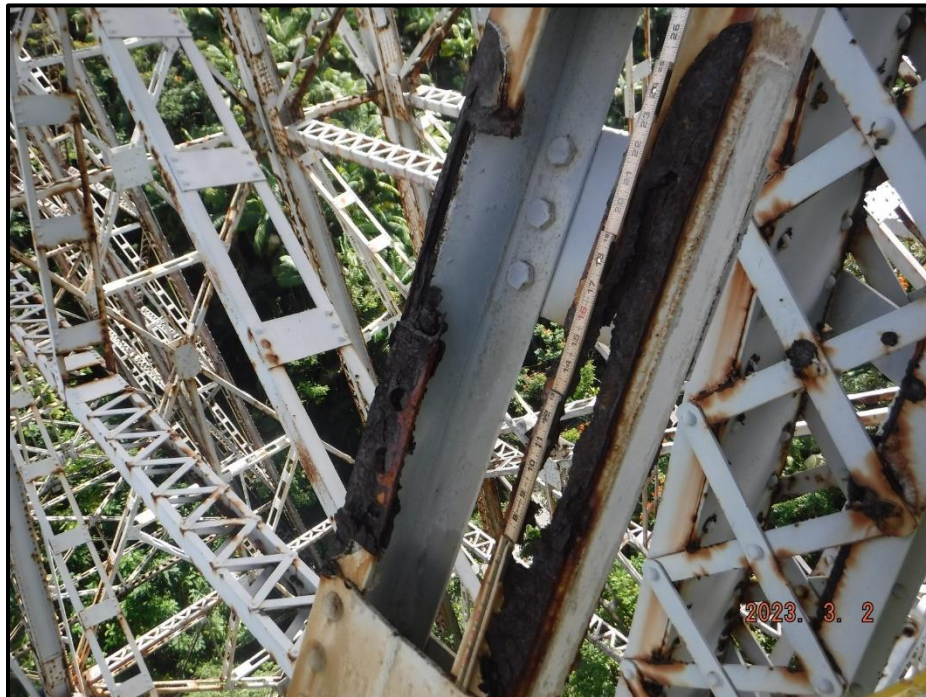
Photograph 143. Bent 7, Level 1, lower section, between Columns A and B, diagonal bracing top angle, looking southwest. section loss, 100% loss for 2' 4" L, CS3.

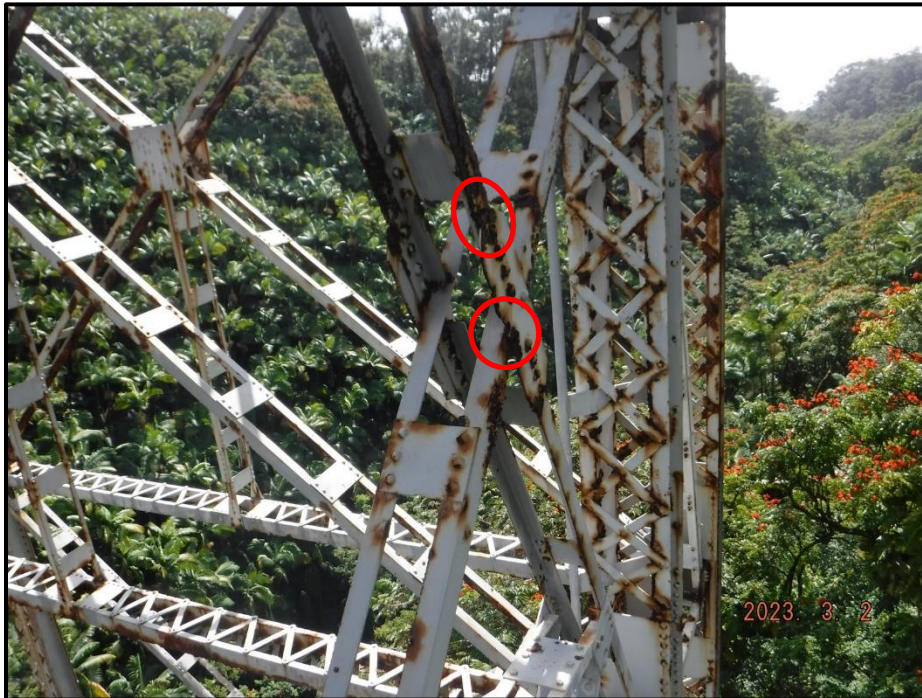
Photograph 144. Bent 7, Level 1, lower section, between Columns B and C, center gusset plate, looking southwest. Heavy pitting, lamellar corrosion, and knife-edging with 2" and 1" diameter corrosion holes, CS3.
