**STATE OF HAWAII
DEPARTMENT OF TRANSPORTATION**

**ADDENDUM NO. 2
FOR
HAWAII BELT ROAD
NANUE STREAM BRIDGE REHABILITATION
VICINITY OF HILO
DISTRICT OF HILO, ISLAND OF HAWAII
FEDERAL-AID PROJECT NO. BR-019-2(077)**

December 13, 2024

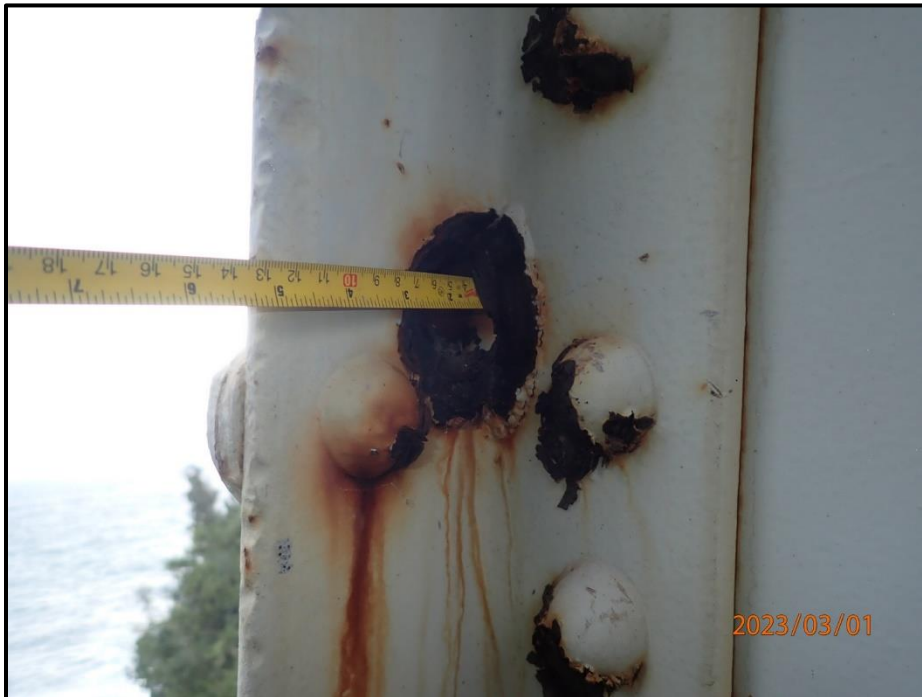
Photograph 145. Bent 7, Level 1, lower section, Column A, looking southeast. 2" diameter corrosion hole in northeast flange angle, CS3.

74	Tower 2, Level 1, Column B, lower north diagonal bracing. Areas of 100% section loss up to 1-1/2" W x 1' L on both angle legs at isolated locations along full member length, CS3. (Similar to Photo 134)	100	Bent 3, Level 1, upper section, Column D, vertical near top. Typical laminar corrosion at upper levels, CS3. (See Photo 77)
75	Tower 2, Level 1, Column B, lower north diagonal bracing. Up to 1/8" section loss to gusset plate and diagonal at connection, 1" diameter corrosion hole in diagonal near center connection, CS3. (Similar to Photo 134)	101	Bent 3, Level 1, upper section, Column D. Corrosion hole up to 2" diameter in southeast angle with (2) adjacent lacing bars with 100% section loss near the top, CS3. (Similar to Photo 145)
76	Tower 2, Level 1, Column B, upper north diagonal bracing, near Bent 3. Areas of 100% section loss up to 1-1/2" x 1' L on interior vertical angle leg over 3' near center connection, CS3. (Similar to Photo 134)	102	Bent 3, Level 1, upper section, Column D, southeast flange. (1) 2-1/2" diameter corrosion hole, CS3. (Similar to Photo 145)

80	Tower 2, Level 3, Column B. Multiple up to 3/4" diameter corrosion holes throughout, and covered in vegetation, CS3. (See Photo 70)	106	Bent 3, Level 1, lower section, between Columns B and C, lower west diagonal bracing, just above and below lower mid-horizontal on Column C side. Diagonals and horizontals on north face have knife-edging and corrosion holes throughout, CS3. (Similar to Photo 87)
81	Tower 2, Level 1, Column C, center gusset plate. Both gusset plates have pack rust at the incoming angles up to 1/2" thick. Laminar corrosion adjacent to angles throughout with up to 1" diameter x 100% section loss, CS3. (Similar to Photo 99)	107	Bent 3, Level 1, lower section, between Columns B and C, lower west diagonal bracing. Laminar corrosion with knife-edging and holes up to 1" diameter near center gusset plate, CS3. (Similar to Photo 87)
82	Tower 2, Level 1, Column C, lower south diagonal bracing, near Bent 2. East angle with corrosion holes and approximately 15% loss of cross sectional area, CS3. (Similar to Photo 134)	108	Bent 3, Level 1, lower section, Column B, southwest flange. 1-1/2" W x 1" H corrosion hole, CS3. (Similar to Photo 145)

Defect ID	Caption
117	Bent 3, Level 2, Column B. 2-1/2" diameter corrosion hole in southeast angle above horizontal brace connection, CS3. (Similar to Photo 145)
118	Bent 3, Level 2, Column B, east gusset plate. 6" L x 2" H area of 100% section loss at top corner and 2" W x 6" H area of 100% section loss at the horizontal bracing connection with pack rust up to 1" thick, CS3. (Similar to Photo 126)
119	Bent 3, Level 2, Column B, horizontal bracing, south flange. 9" L x full-width of angle area of 100% section loss, CS3. (See Photo 79)
120	Bent 3, Level 2, Column B, west gusset. Painted-over pitting up to 3/16" deep and rivet heads with up to 100% section loss, CS3. (Similar to Photo 126)
121	Bent 3, Level 3, between Columns C and D, horizontal bracing. Knife-edging and multiple corrosion holes up to 2" diameter across full member length, CS3. (See Photo 80)
122	Bent 3, Level 3, between Columns A and B, diagonal bracing above interior connection. 3' L x full-width of angle area of section loss on top flanges (CS3). - Note this member has been retrofitted and retrofit is in good condition. (See Photo 81)

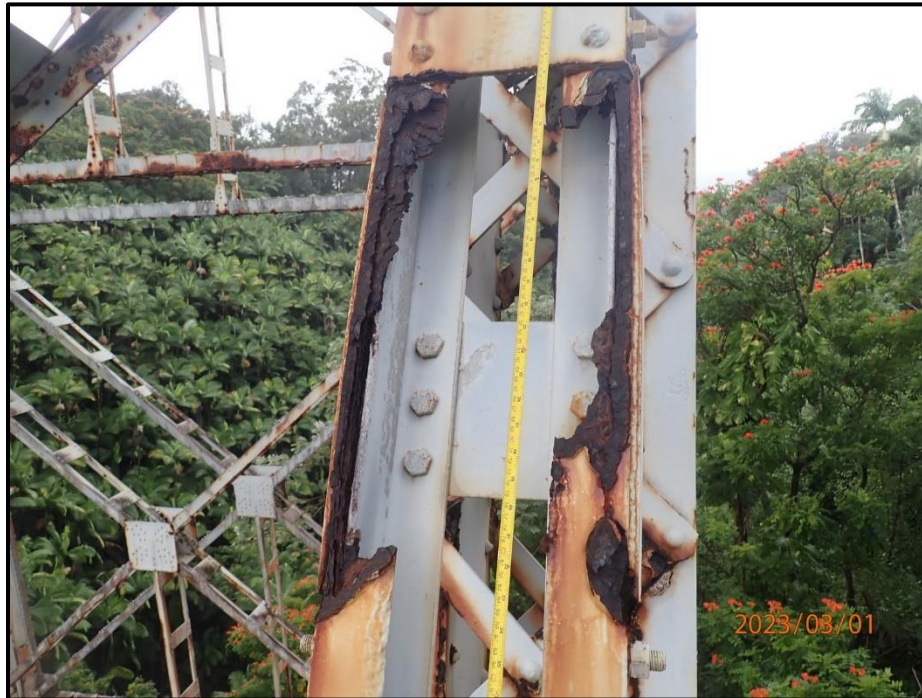
Photograph 146. Bent 7, Level 2, between Columns A and B, diagonal bracing top angle, looking west. Section loss, 100% loss for 2' 4" L, CS3.

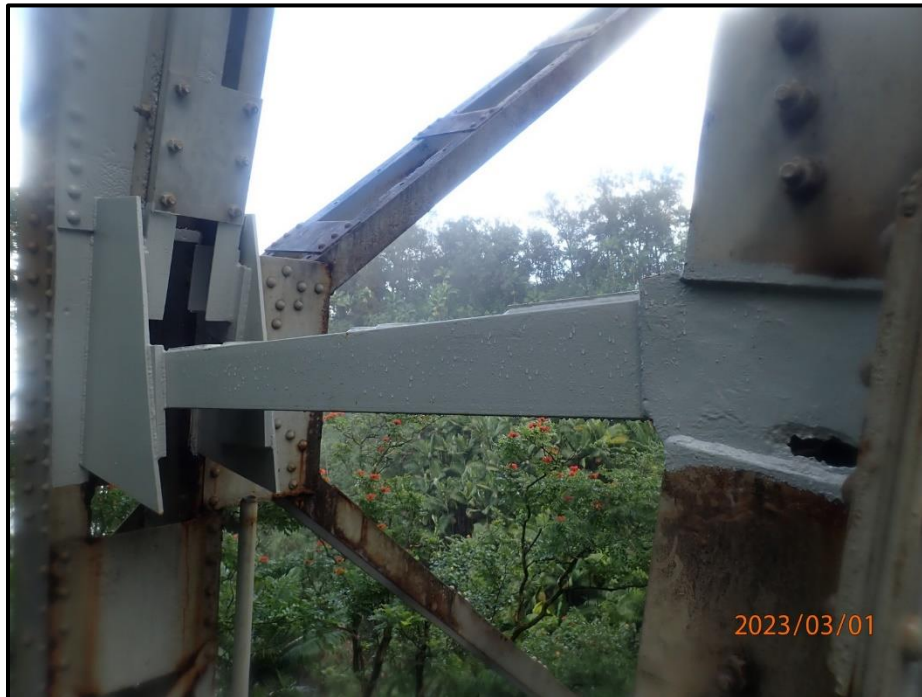
Photograph 147. Bent 7, Level 2, between Columns A and B, horizontal bracing and gusset plate at Column A, looking southeast. Previous detached bracing and gusset plate has been replaced.

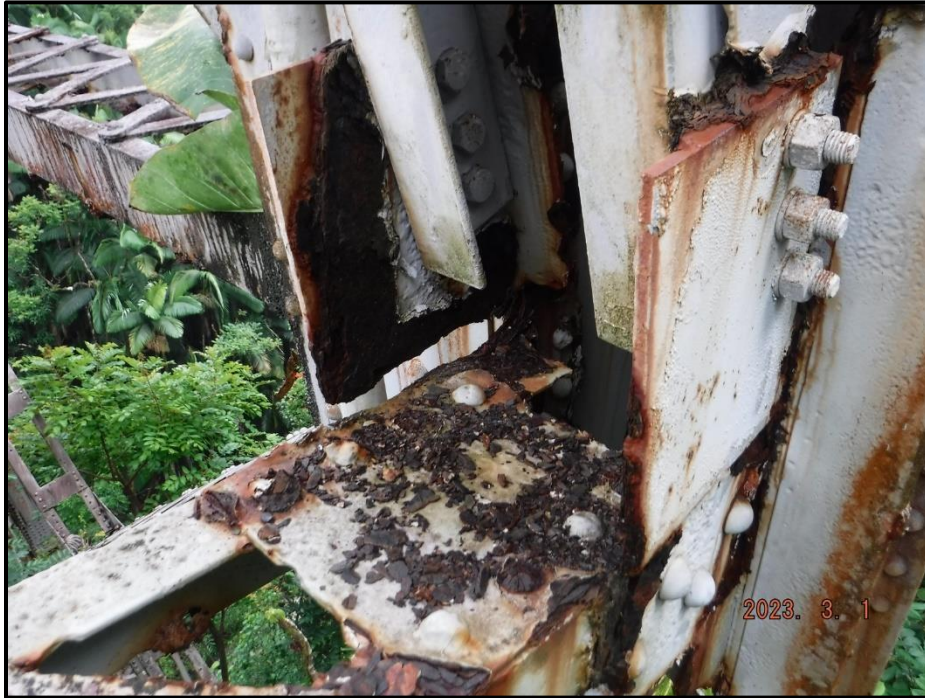
Photograph 148. Bent 7, Level 2, Column D, gusset plates, looking south. Corrosion, heavy laminar corrosion with diagonal lateral bracing corroded away and detached, CS4.

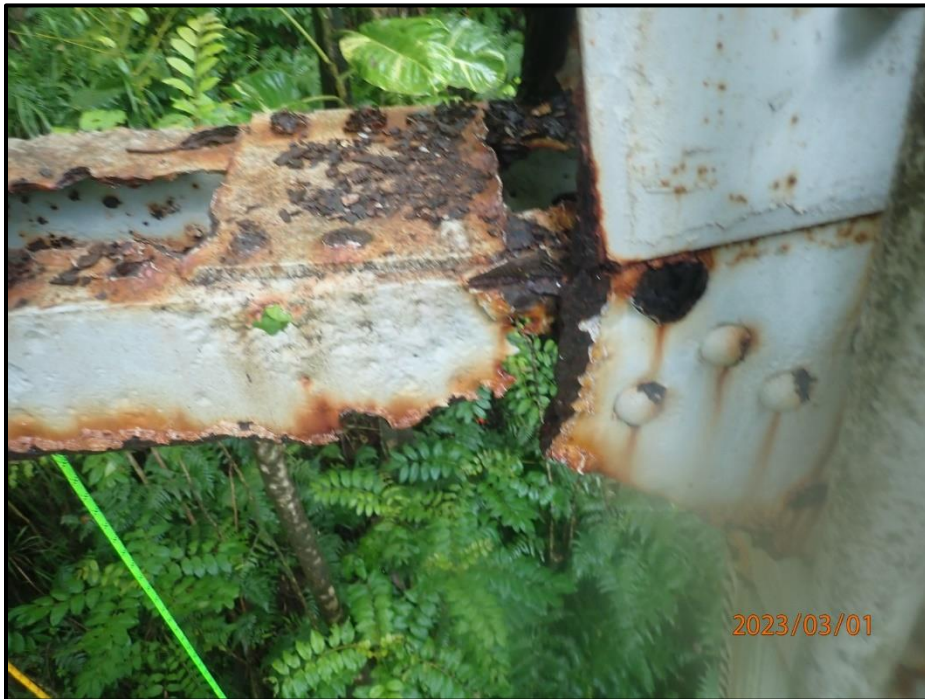
Photograph 149. Bent 7, Level 3, Column A, south horizontal bracing angle, looking north. 3" W x 4" H corrosion hole in vertical angle, CS3.

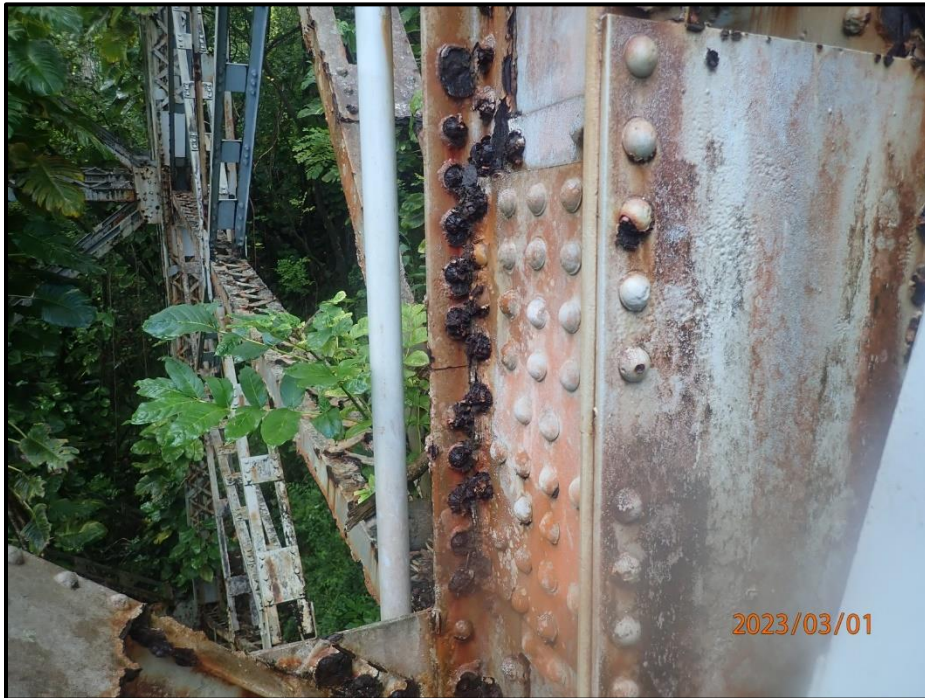
Photograph 150. Bent 7, Level 3, Column B splice plate, looking south. Majority of connection rivets for Column B have section loss and corrosion, CS3.

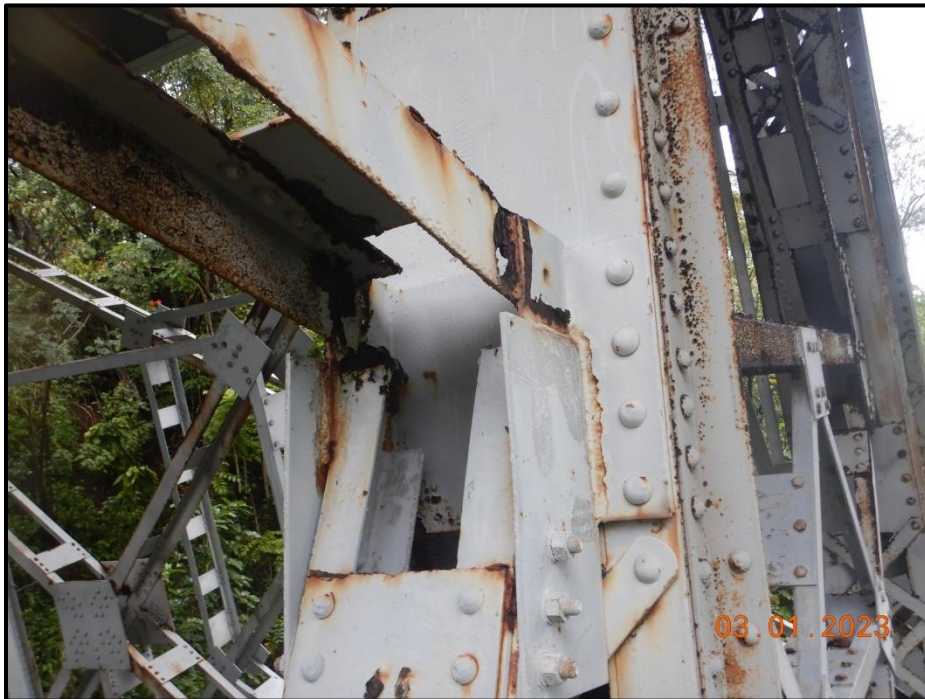
Photograph 151. Bent 8, Level 1, upper section, Column C, lower horizontal bracing, looking northeast. South angle has 3" H x 1" W corrosion hole adjacent to the gusset plate, CS3.

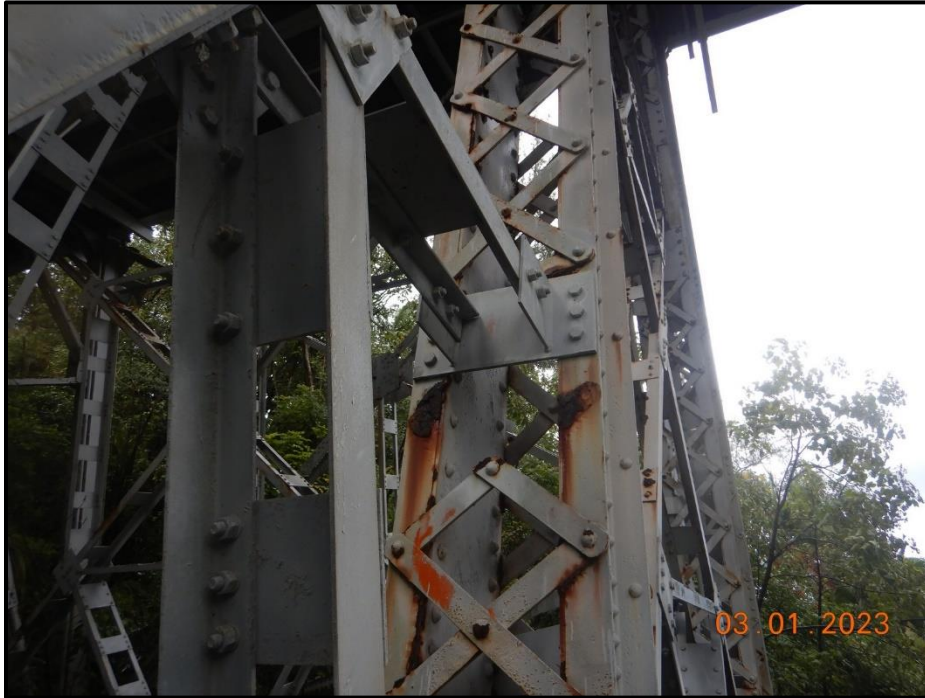
Photograph 152. Bent 8, Level 1, lower section, Column C, looking east. (2) lacing bars on west face have 100% section loss, CS3.

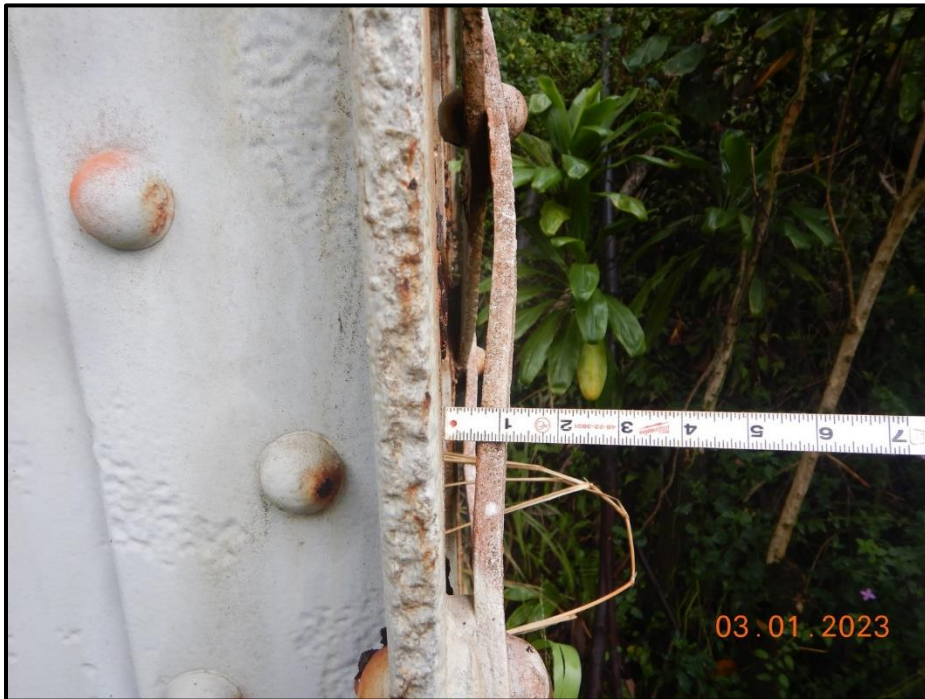
Photograph 153. Bent 8, Level 2, Column A, looking north. Batten plates and lacing bars are typically bent to the east on the east side, CS3.

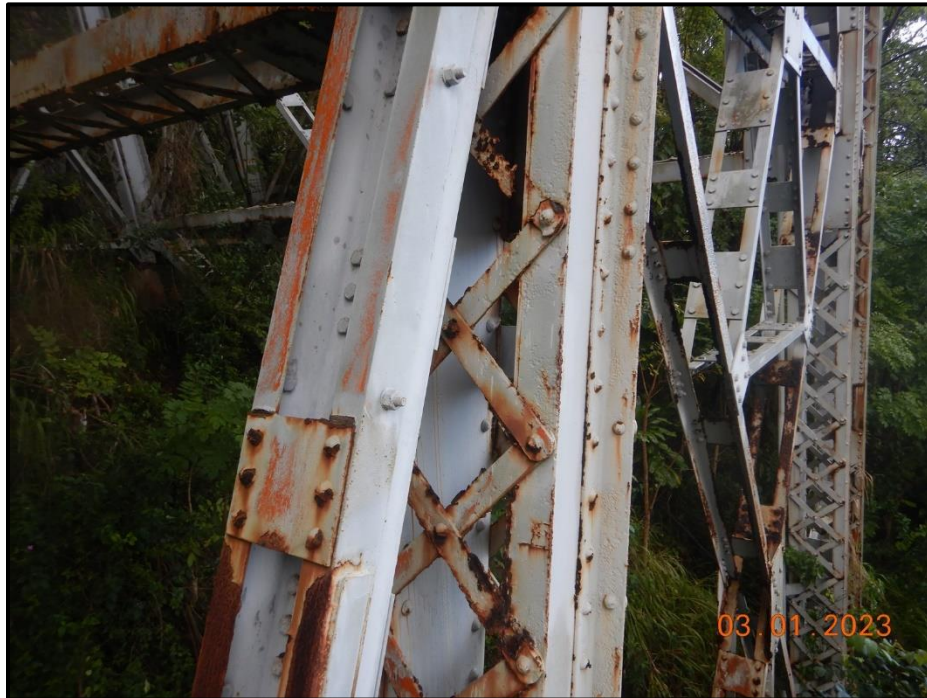
Photograph 154. Bent 8, Level 2, Column C, looking east. (3) lacing bars on west face have 100% section loss. (1) lacing bar on east face has 100% section loss, CS3.

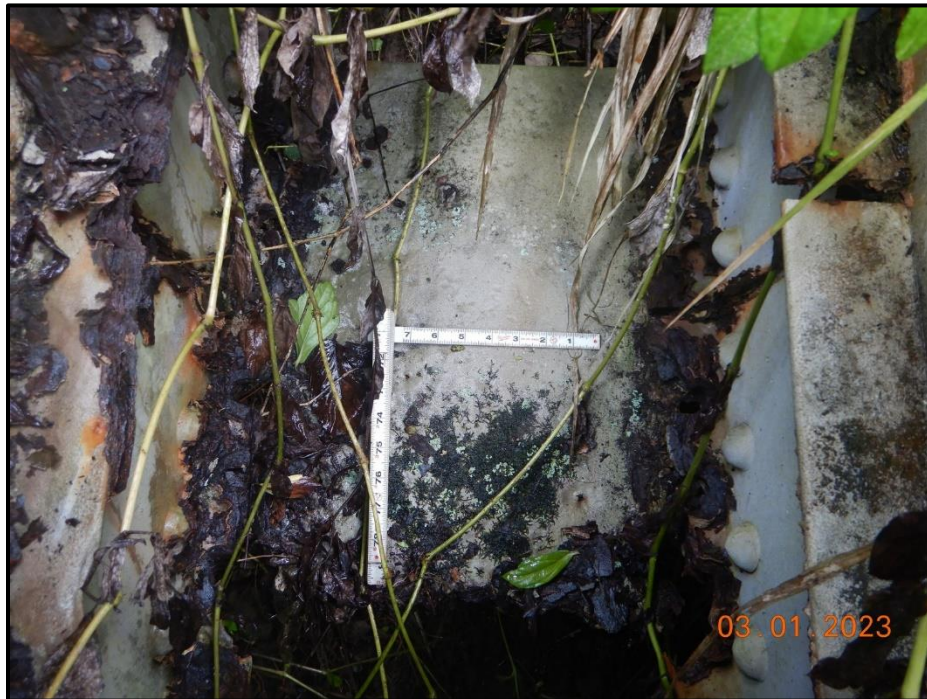
Photograph 155. Tower 5, Level 2, Column B, bottom horizontal, looking north. Underside batten plate has severe laminar corrosion and is not connected to the channels, CS3.

Defect ID	Caption
335	Bent 8, Level 1, upper section, Column C, lower horizontal bracing. South angle has 3" H x 1" W corrosion hole adjacent to the gusset plate, CS3. (See Photo 151)
336	Bent 8, Level 1, lower section, between Columns C and D, horizontal bracing at Column C. 3" H x 1" W corrosion hole adjacent to the gusset plate, CS3. (Similar to Photo 151)
337	Bent 8, Level 1, lower section, Column C. (2) lacing bars on west face have 100% section loss, CS3. (See Photo 152)
338	Bent 8, Level 2, Column A. Batten plates and lacing bars are typically bent to the east on the east side, CS3. (See Photo 153)
339	Bent 8, Level 2, Column C. (3) lacing bars on west face have 100% section loss. (1) lacing bar on east face has 100% section loss, CS3. (See Photo 154)
340	Tower 5, Level 1, Columns A and B center gusset. Pack rust up to 1" thick, CS3. (Similar to Photo 68)
341	Tower 5, Level 2, Column B, bottom horizontal. Underside batten plate has severe laminar corrosion and is not connected to the channels anymore, CS3. (See Photo 155)

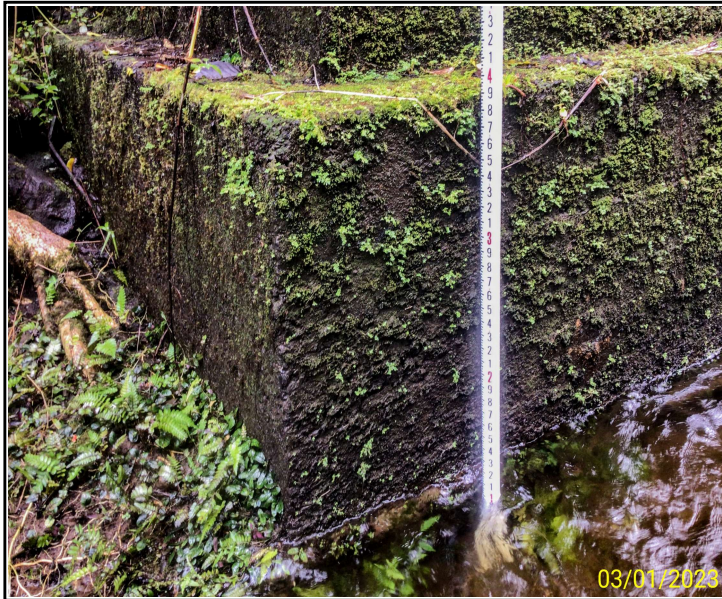
Photo 9. Bent 5, Column A footing, looking south. Exposure, up to 4' H

Bent 5, Column A, Footing - Exposed, up to 4' H, founded on rock (See Photo 9).

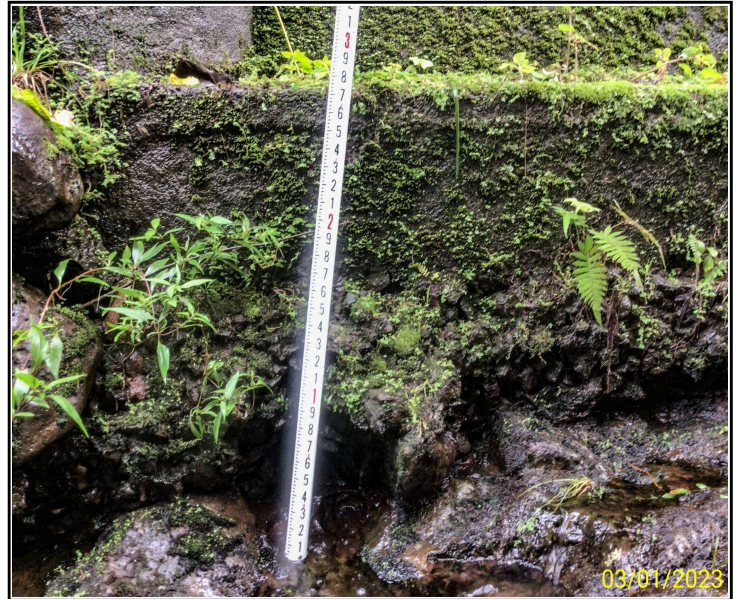
Photo 10. Bent 5, Column B footing, looking south. Exposure with grouted rocks exposed below, up to 1.4' H and a bottom rock layer of 1.6' H

Bent 5, Column B, Footing - Exposed up to 1.4' H and a bottom rock layer of 1.6' H (See Photo 10).

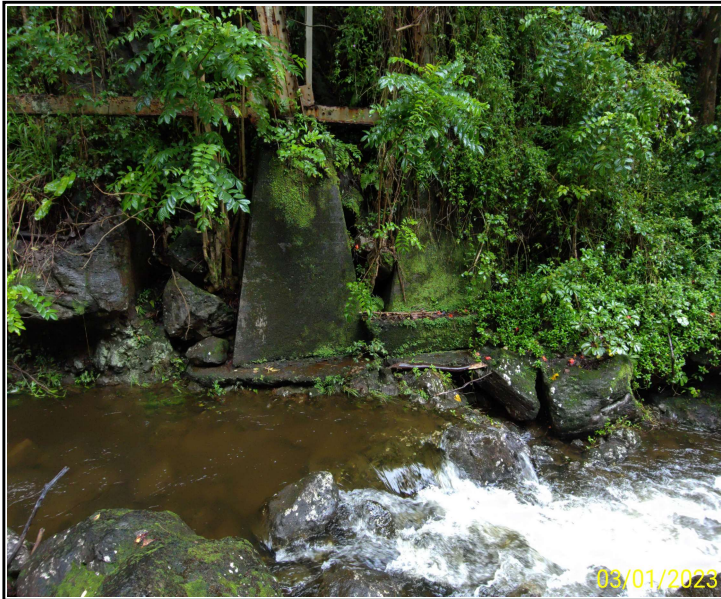
Photo 14. Bent 6, Column A, looking north. Undermined, 3' L x 2' H x 1.5" D, CS3

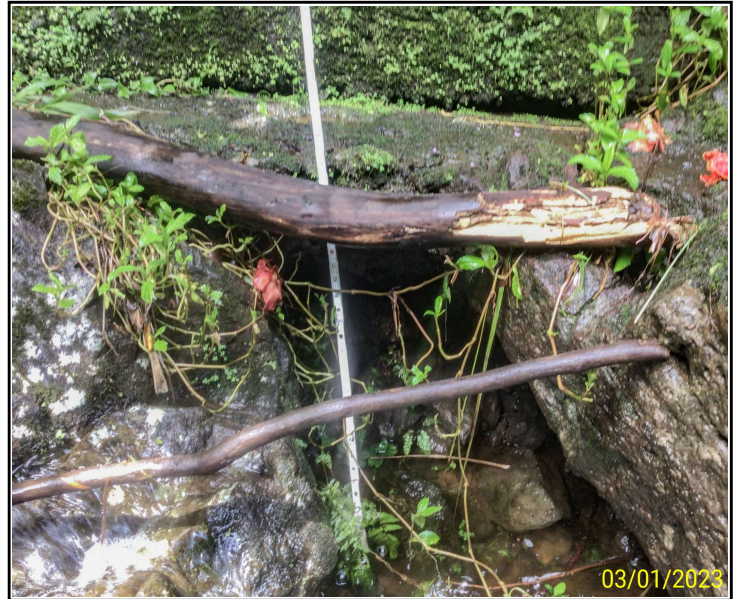
Photo 15. Bent 6, Column A Footing, looking north. Void below southwest corner, 8" L x 6" H x 9" D, CS2

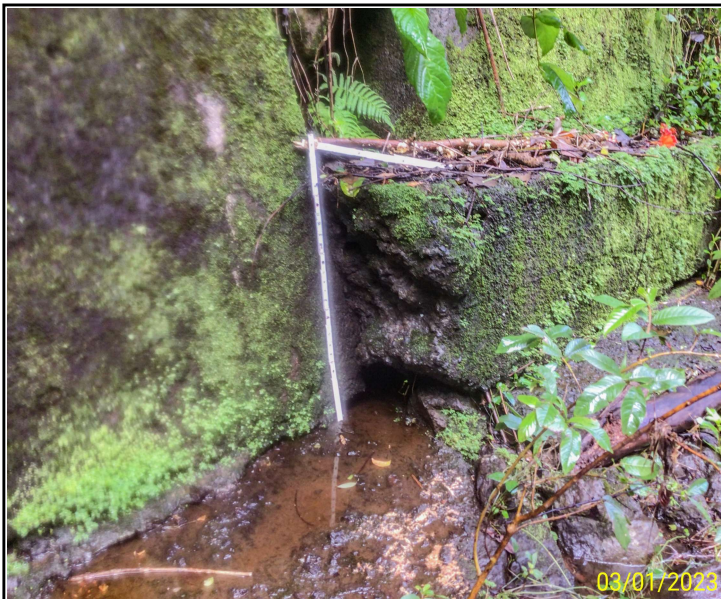
Photo 16. Bent 6, Column B footing, looking north. Undermined, up to 4" H x 6" D, CS2

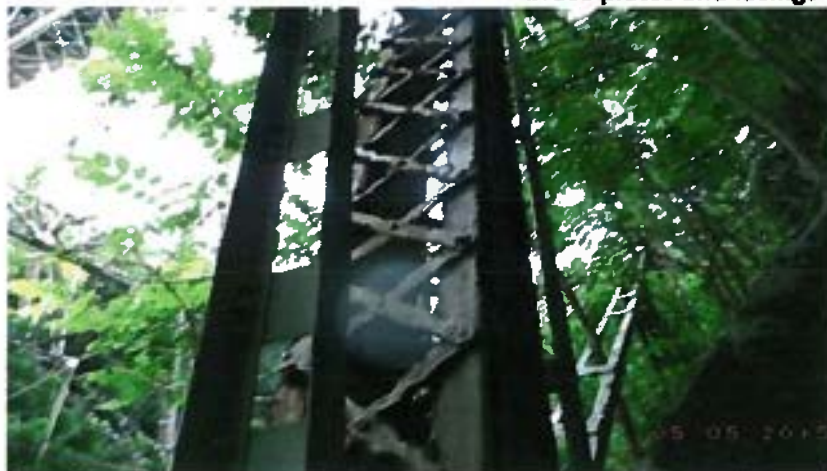
Center up right brace between bent 6 and 7 has corrosion on lacings.

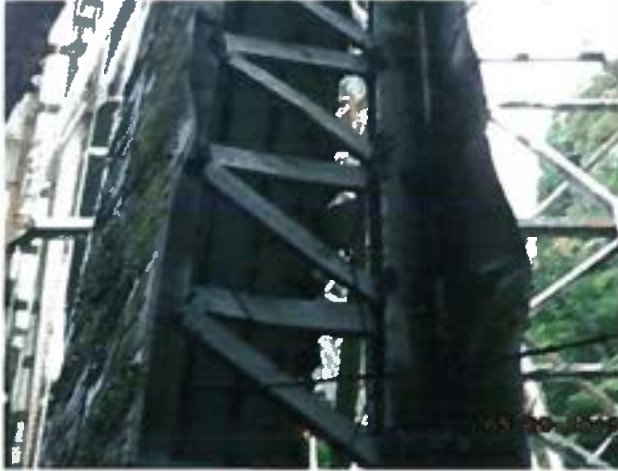
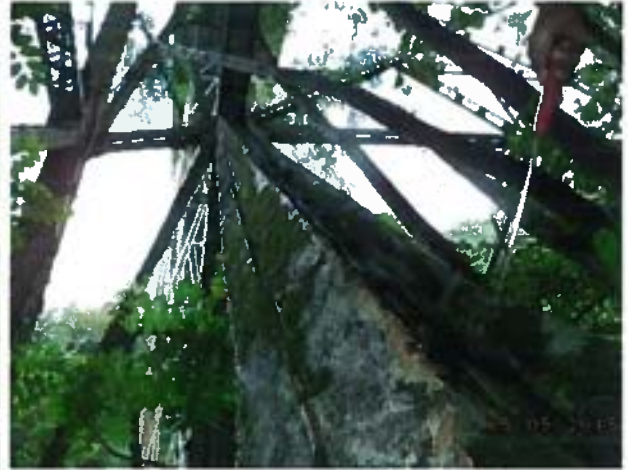
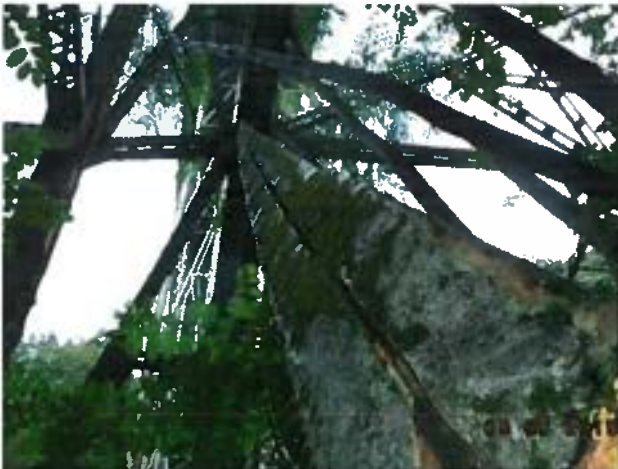
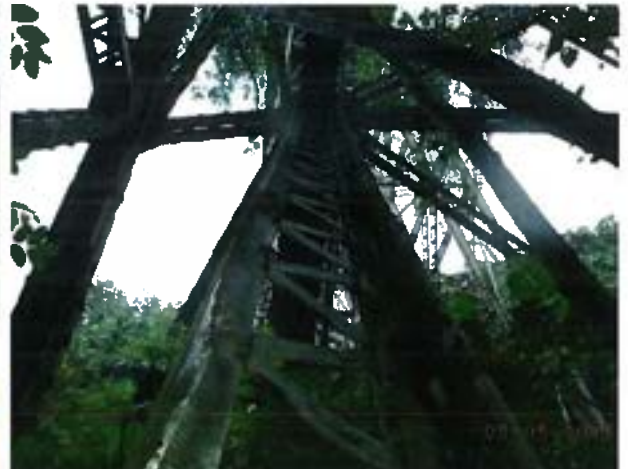
All four pictures shows damages done on angle brace between columns 6 & 7 were bolders.

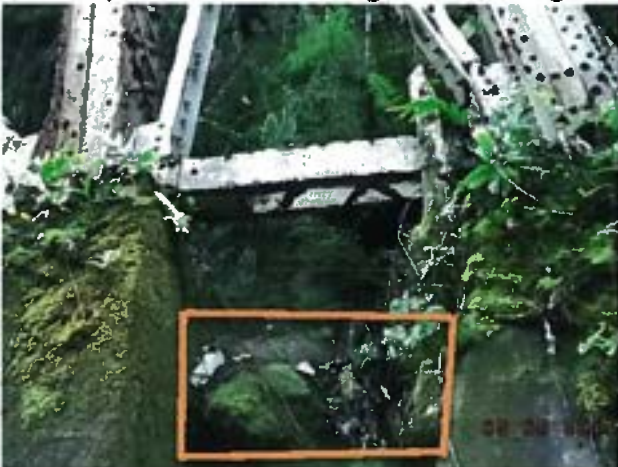
Picture of bent 6 with a bolder wedged between piers.

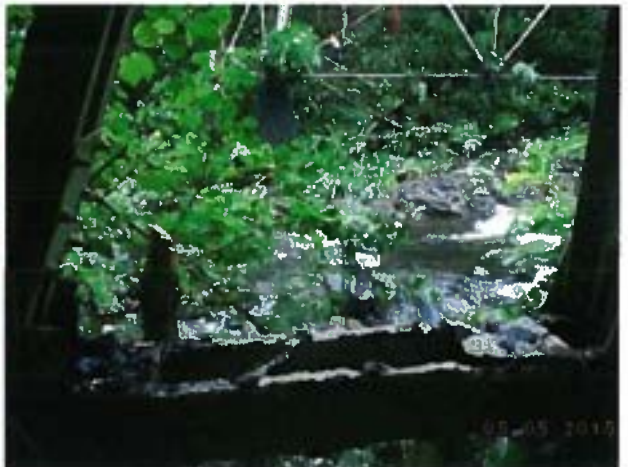
Column 6 bottom brace has corrosion and missing lacings.
