**ROUTINE BRIDGE INSPECTION REPORT  
FEDERAL-AID PROJECT NO. BRIS-NBIS(080)  
CONTRACT NO. SC-DDC-2200014**

**FARRINGTON HIGHWAY BRIDGE OVER HONOULIULI STREAM  
BRIDGE NO. 922  
STRUCTURE NO. 003922001100001**

**DATE OF INSPECTION: September 01, 2021**

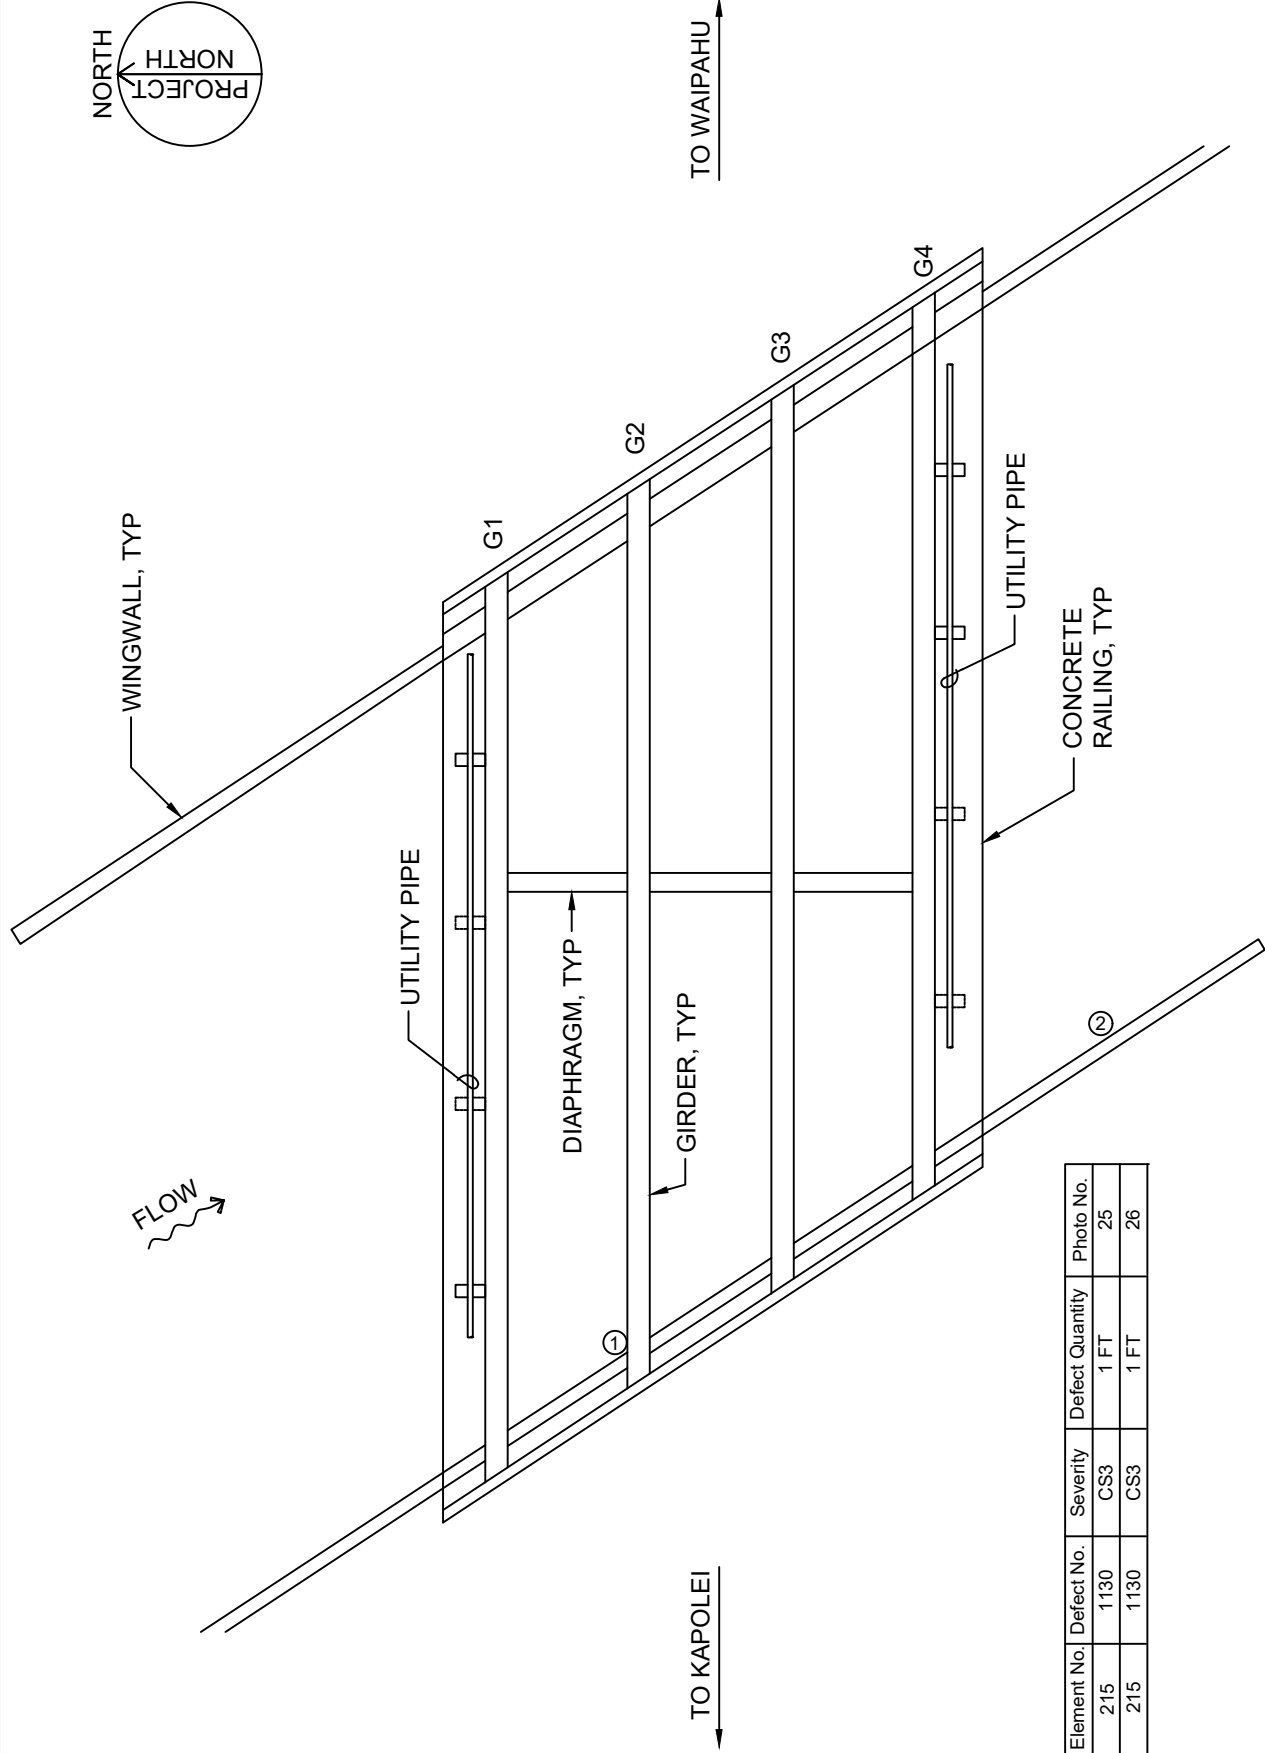
SOFFIT PLAN	NOT TO SCALE
BRIDGE NAME: FARRINGTON HIGHWAY BRIDGE OVER HONOULIULI STREAM	
City Bridge No. 922	Structure No. 003922001100001

Symbol	Element No.	Defect No.	Severity	Defect Quantity	Photo No.
①	215	1130	CS3	1 FT	25
②	215	1130	CS3	1 FT	26
