Material Analysis and Testing Report

Wilson Tunnel Plenum and Hanger Rods

September 6, 2022

Developed For: State of Hawaii Department of Transportation
District of Oahu

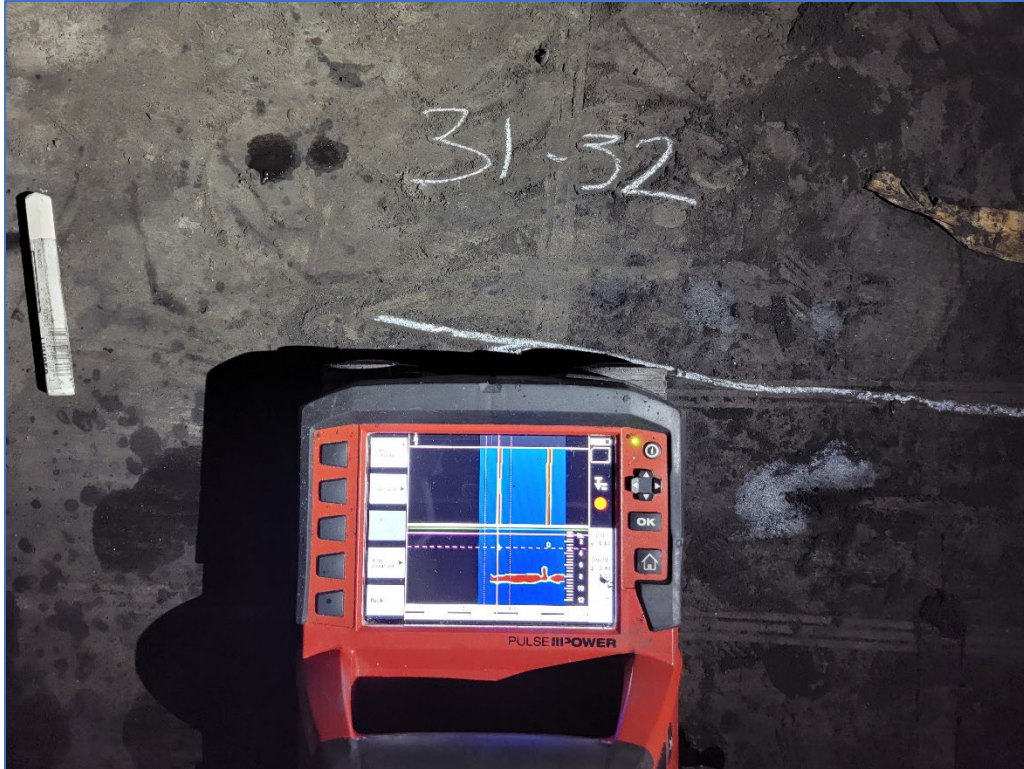
Photo 1: Concrete GPR scanner to locate embedded reinforcement to avoid impact with core drill.

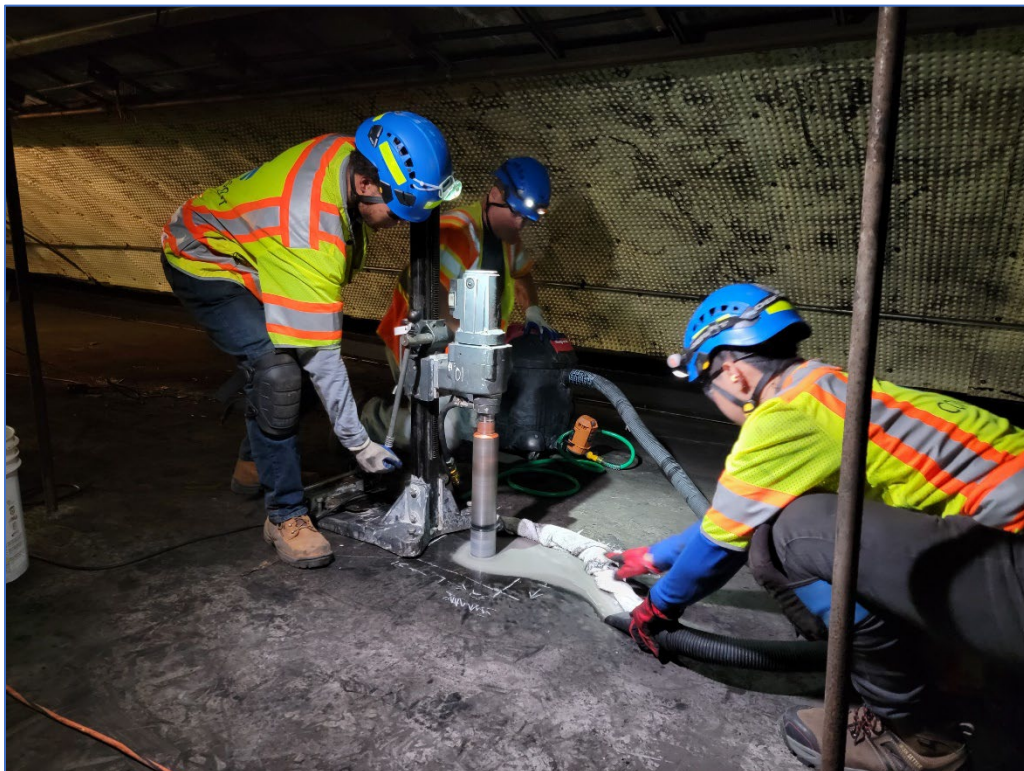
Photo 2: Core sample collection.

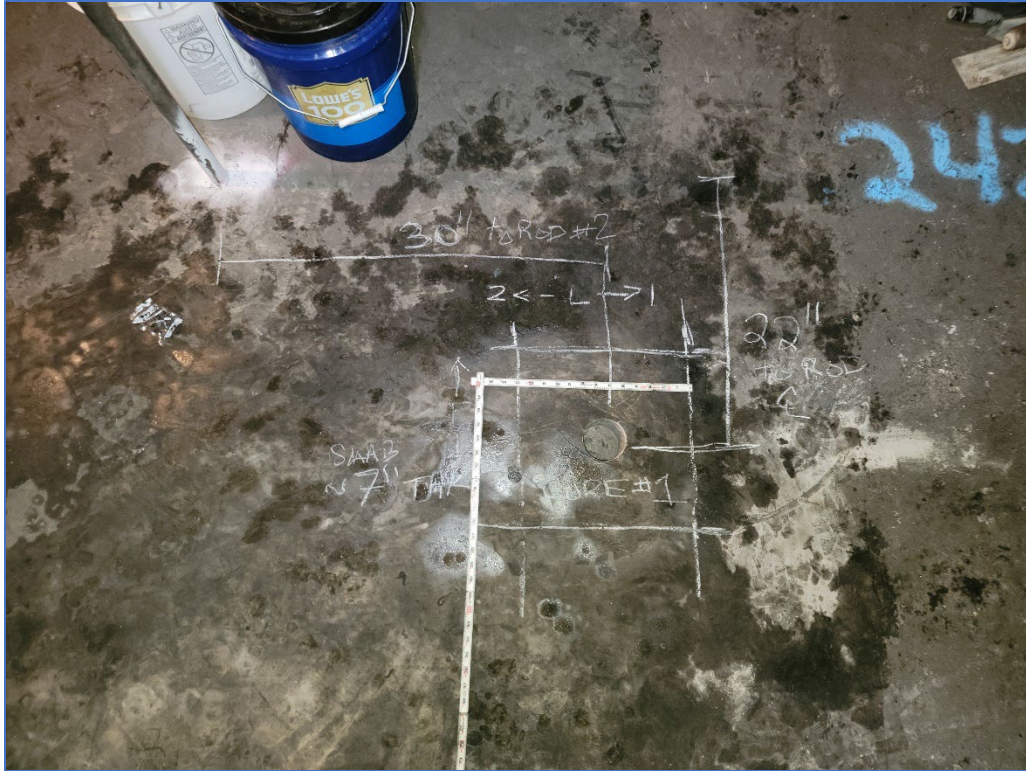
Photo 3: Typical sample hole after core extraction (Core 1 shown).

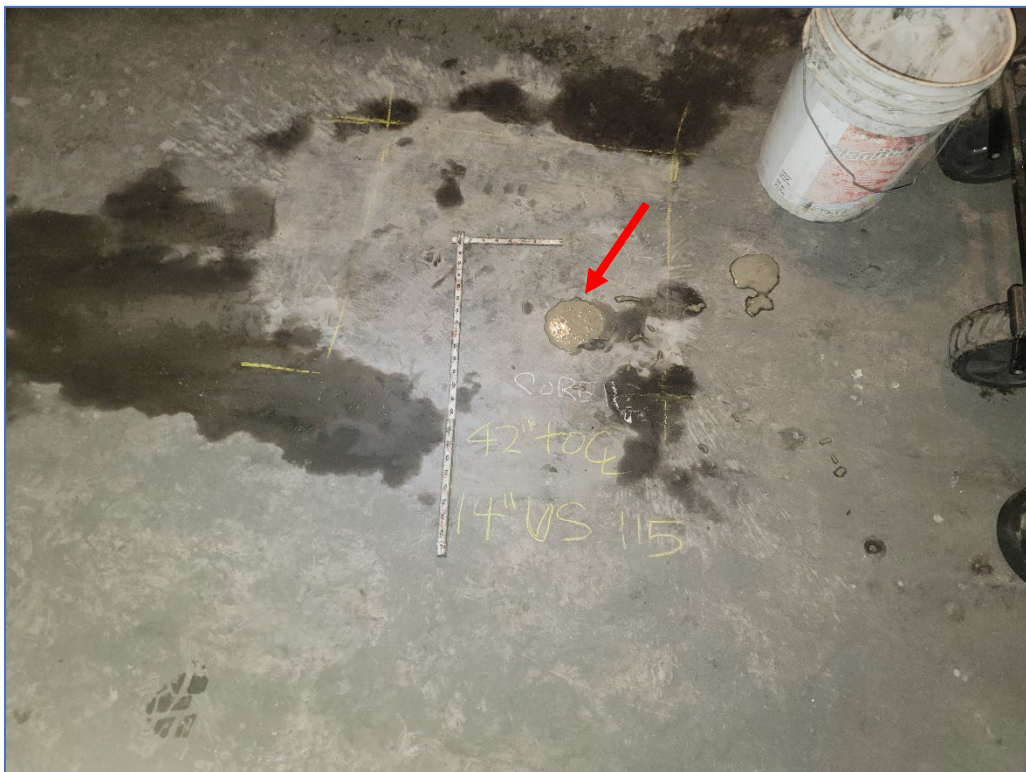
Photo 4: Typical core hole filled with cementitious grout (Core 11 shown).

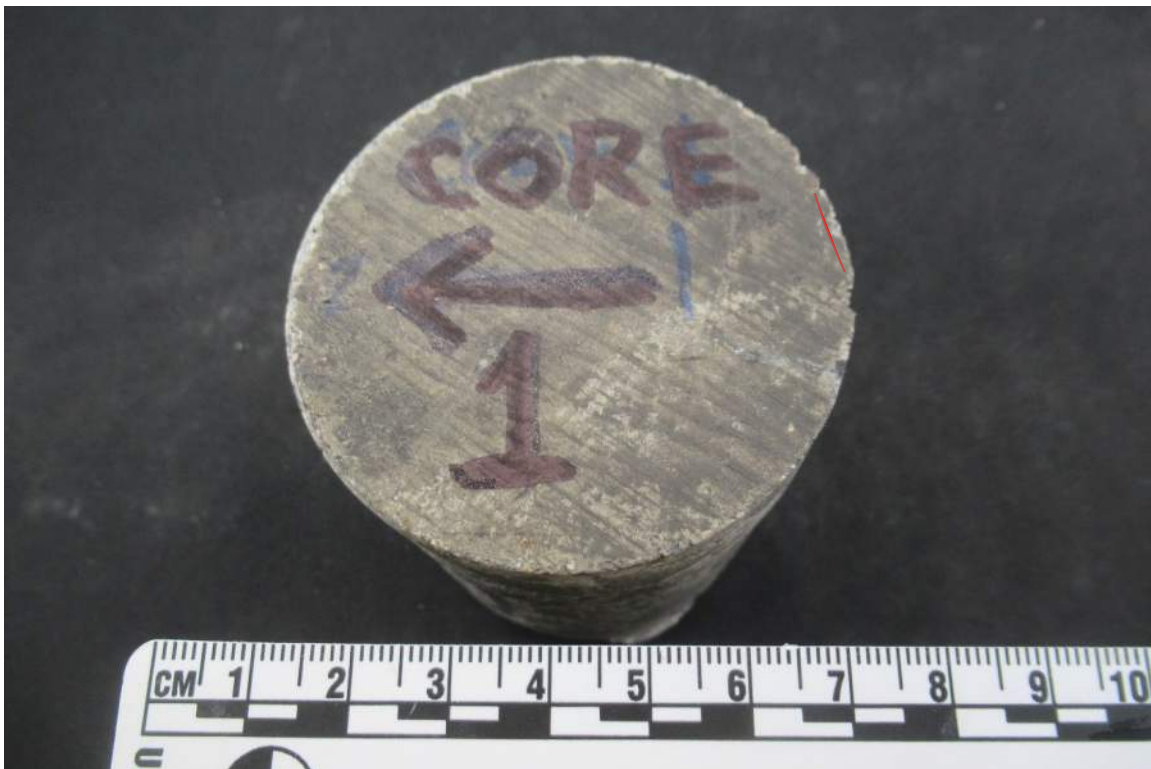
Photo: 2

Description: The formed outer surface of the sample as received. The red line shows the approximate location of the macrocrack.

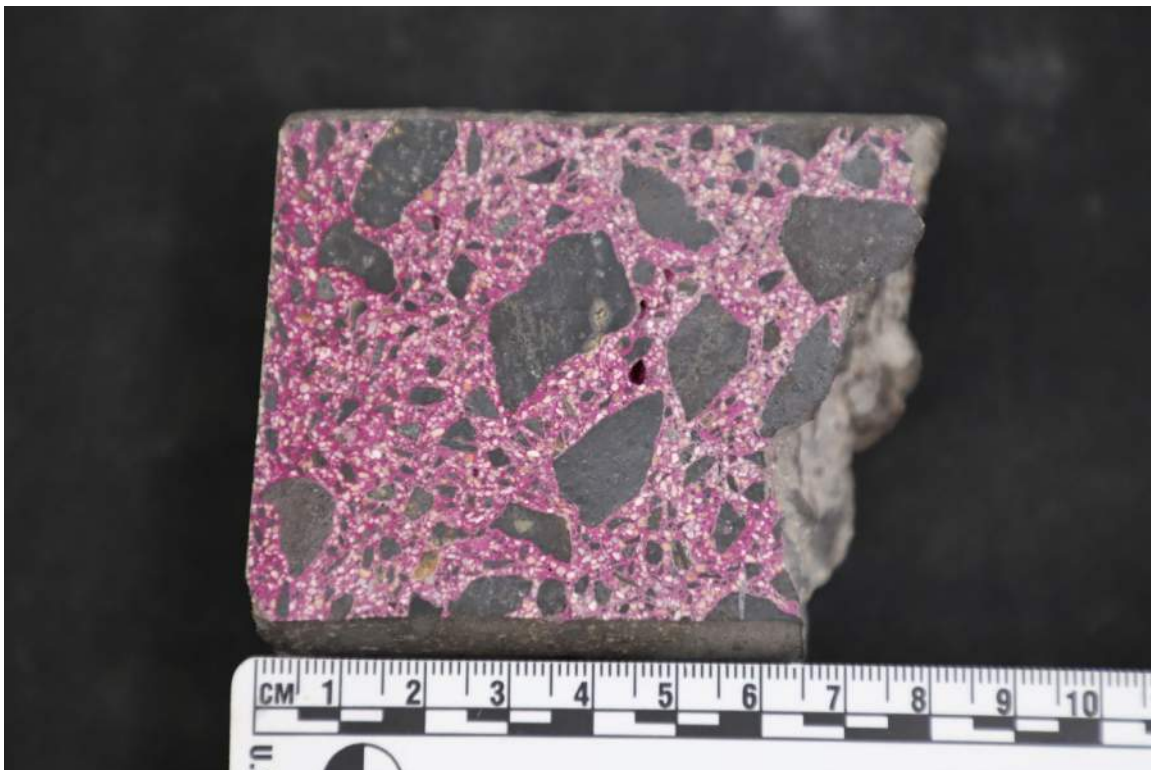
Photo: 30

Description: Saw cut and lapped cross section of the sample with the outer surface oriented to the left. Cracking was mapped in red ink.

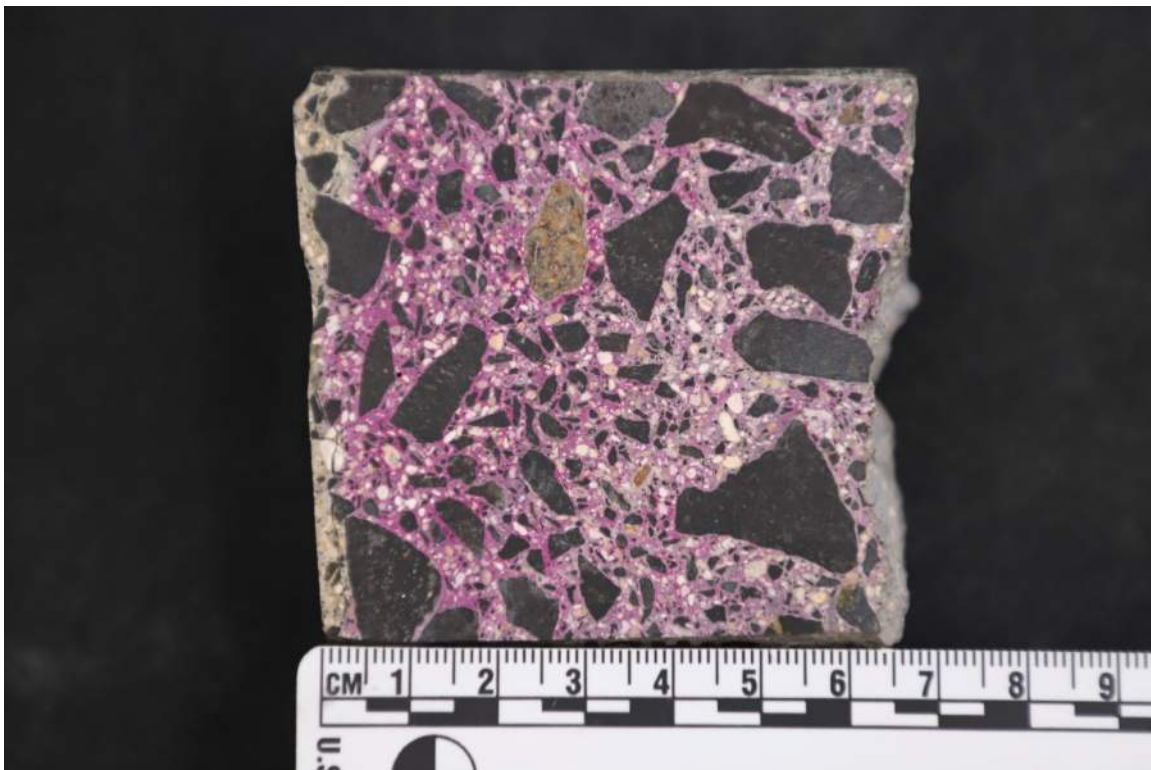
Photo: 32

Description: Saw cut and lapped cross section of the sample with the outer surface oriented to the left. Cracking was mapped in red ink.

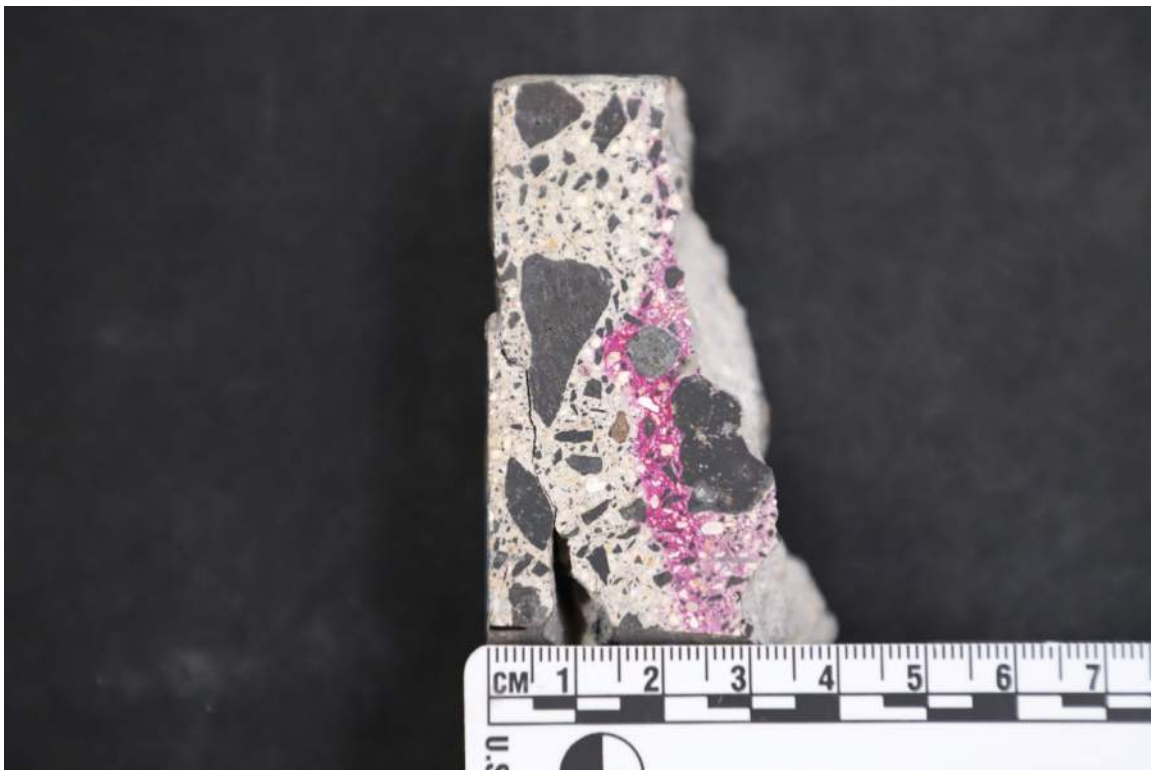
Photo: 34

Description: Saw cut and lapped cross section of the sample with the outer surface oriented to the left. Cracking was mapped in red ink.

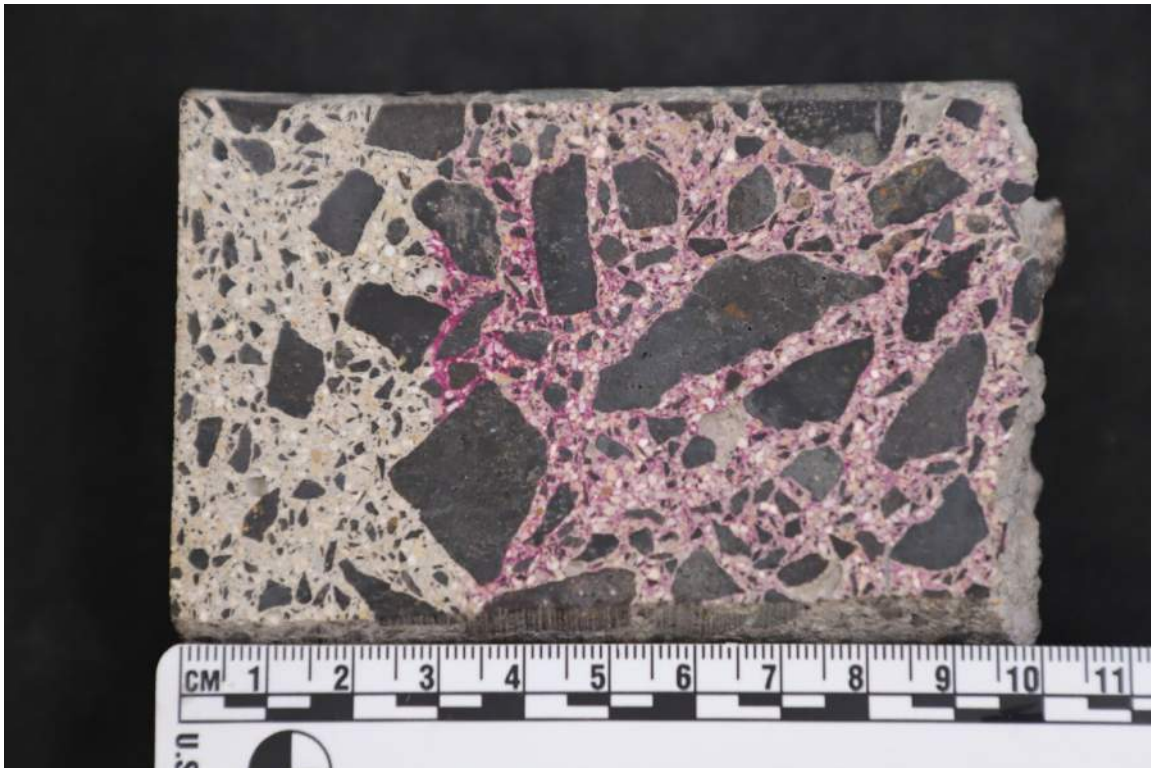
Photo: 38

Description: Saw cut and lapped cross section of the sample with the outer surface oriented to the left. Cracking was mapped in red ink.

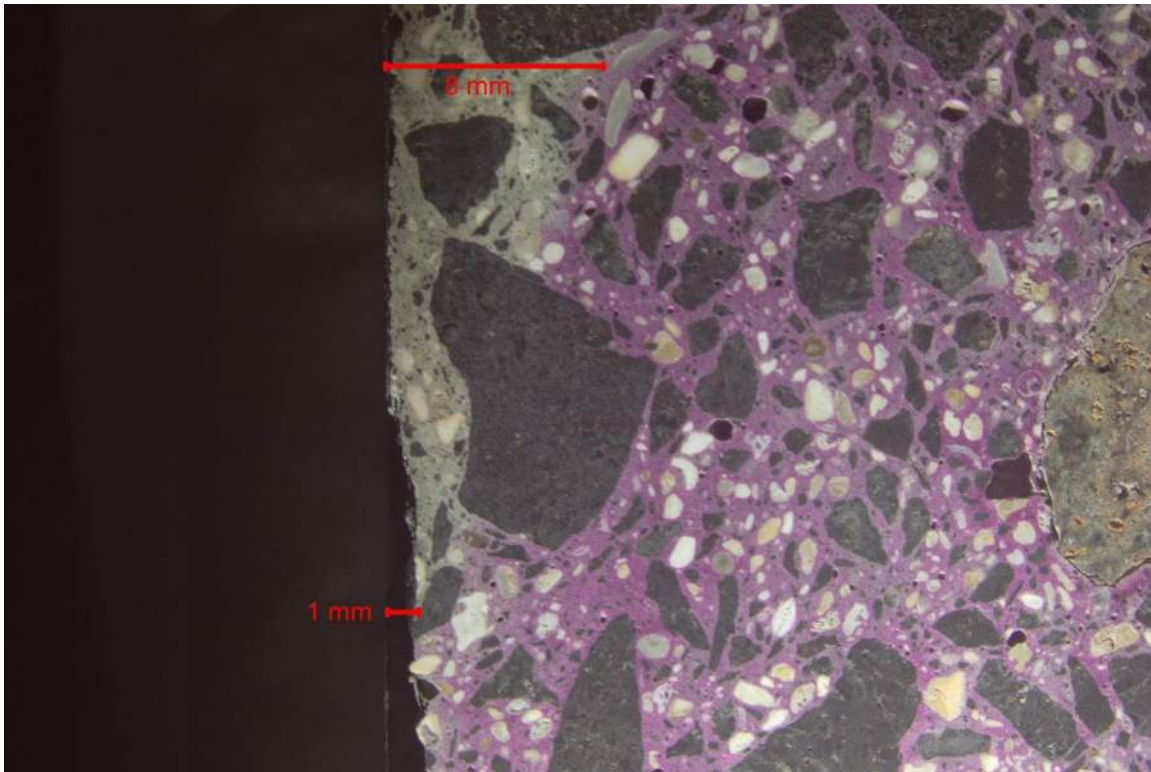
Photo: 45

Sample ID:
Mag:

Core 4
3.5x

Description: Carbonation (unstained paste, PH <8.5) ranged from 1 mm (1/32") up to 8 mm (5/16") from the outer surface, as viewed on saw cut and lapped cross section at low magnification.

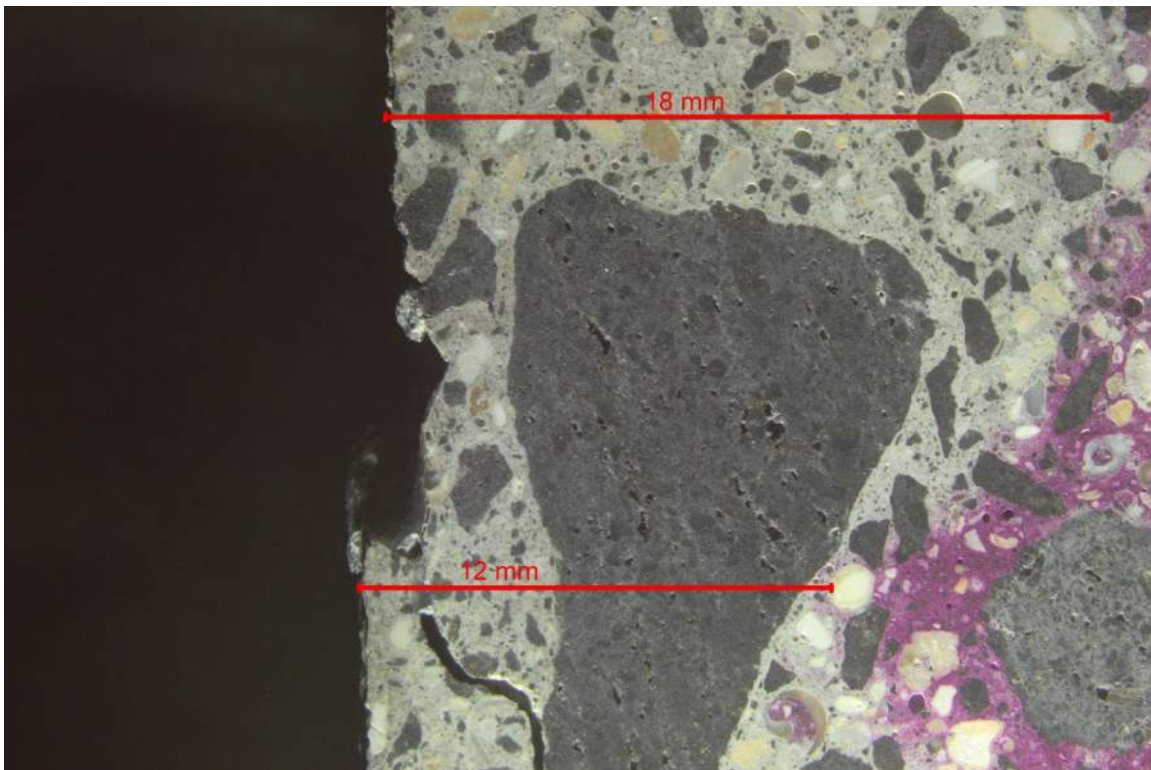
Photo: 46

Sample ID:
Mag:

Core 6
5x

Description: Carbonation (unstained paste, pH,8.5) ranged from 12 mm (1/2") up to 18 mm (11/16") from the outer surface, as viewed on saw cut and lapped cross section at low magnification.

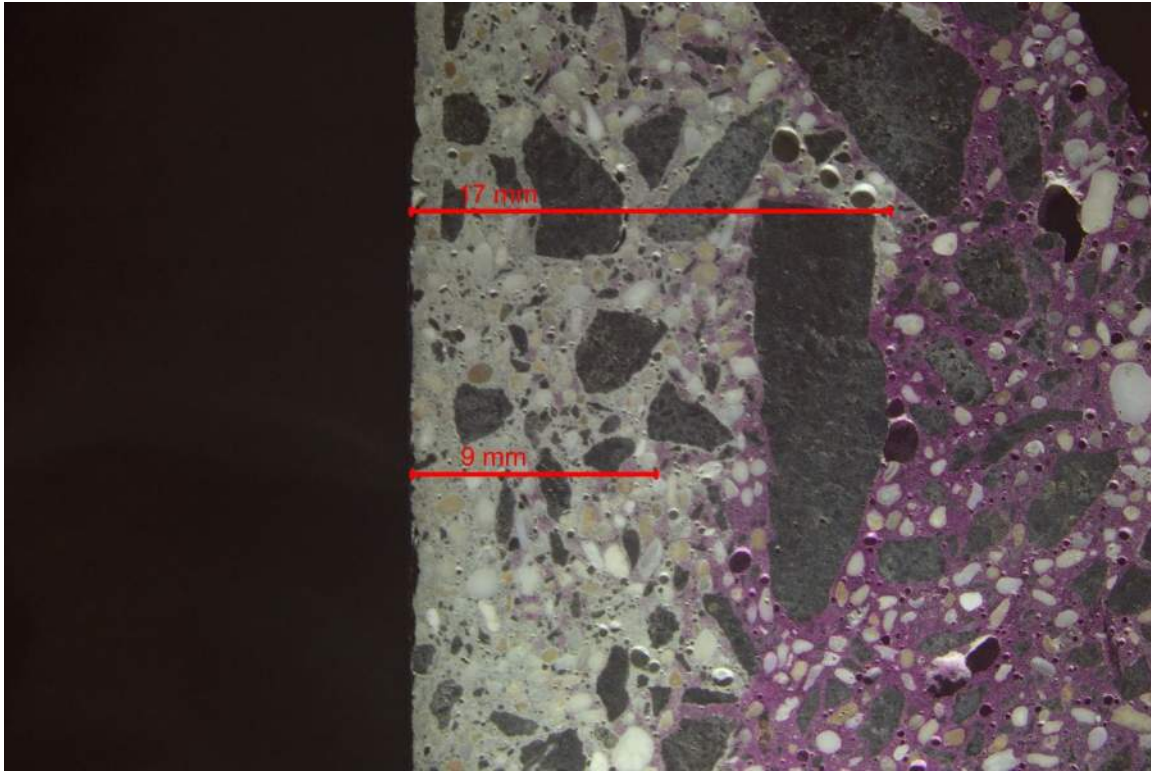
Photo: 47

Sample ID:
Mag:

Core 7
3.5x

Description: Carbonation (unstained paste, pH <8.5) ranged from 9 mm (3/8") up to 17 mm (11/16") from the outer surface, as viewed on saw cut and lapped cross section at low magnification.

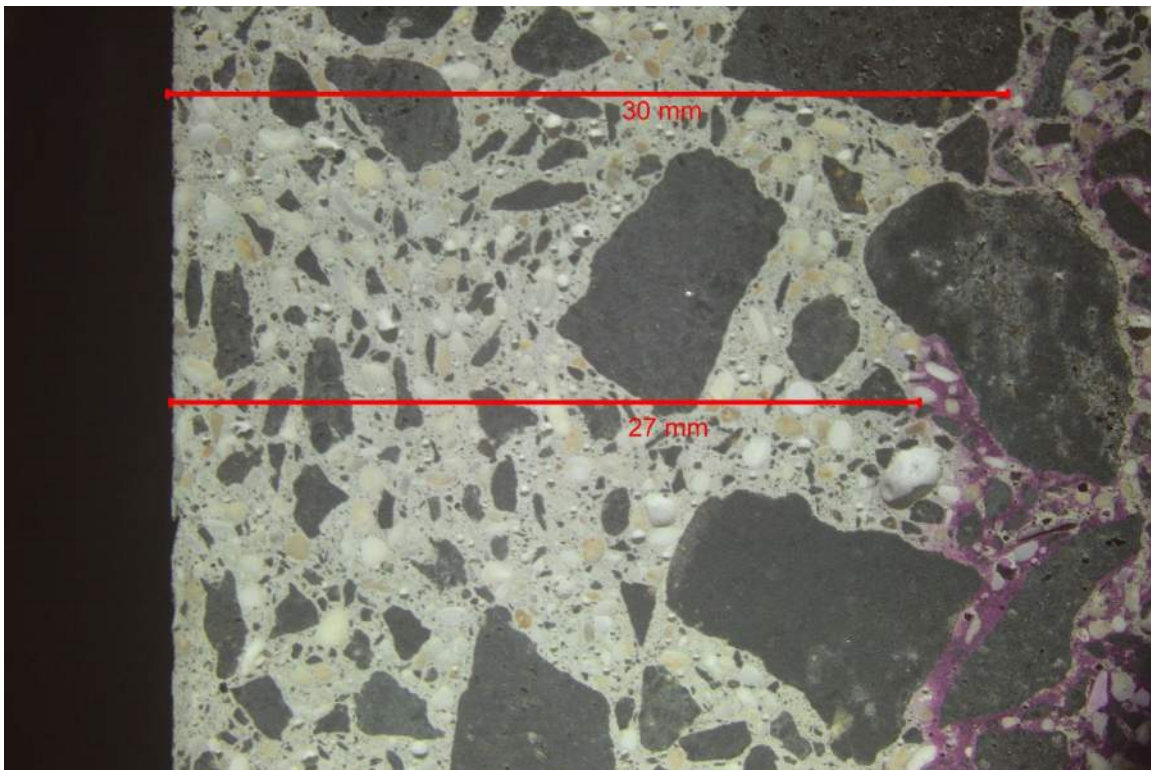
Photo: 48

Sample ID:
Mag:

Core 9
3.5x

Description: Carbonation (unstained paste, pH <8.5) ranged from 27 mm (1-1/16") up to 30 mm (1-3/16") from the outer surface, as viewed on saw cut and lapped cross section at low magnification.

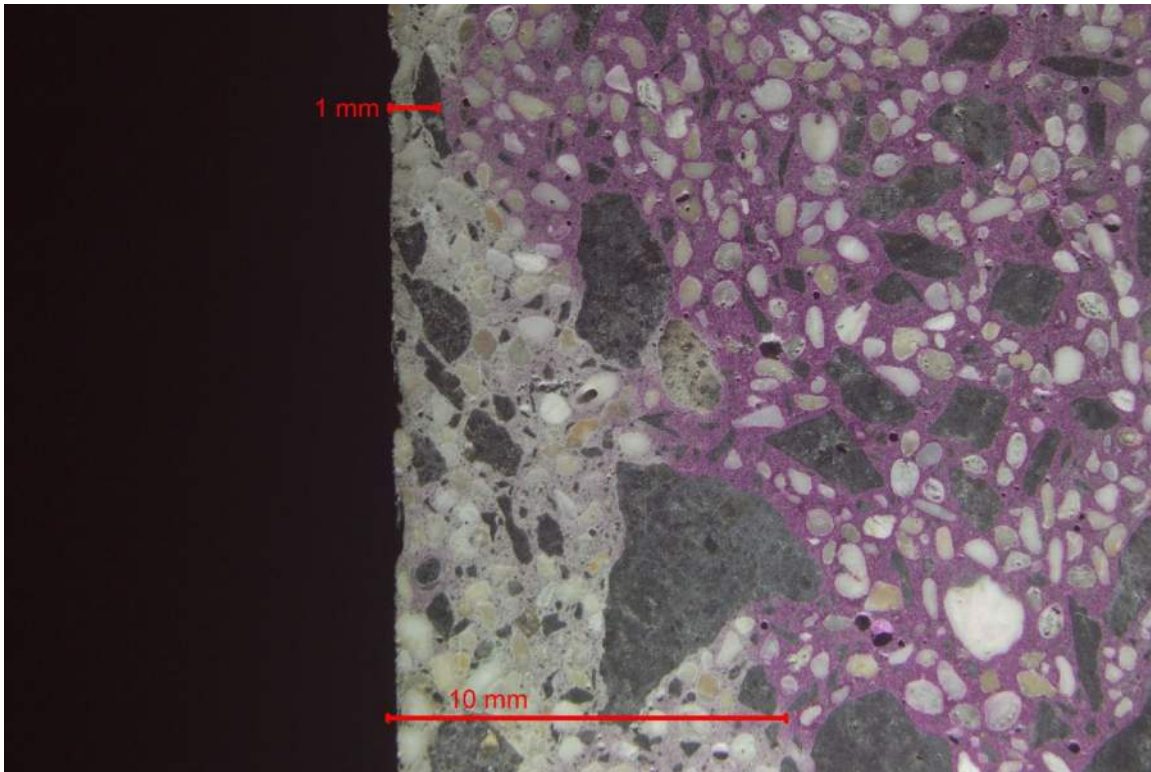
Photo: 49

Sample ID:
Mag:

Core 10
5x

Description: Carbonation (unstained paste, pH <8.5) ranged from 1 mm (1/32") up to 10 mm (3/8") from the outer surface, as viewed on saw cut and lapped cross section at low magnification.

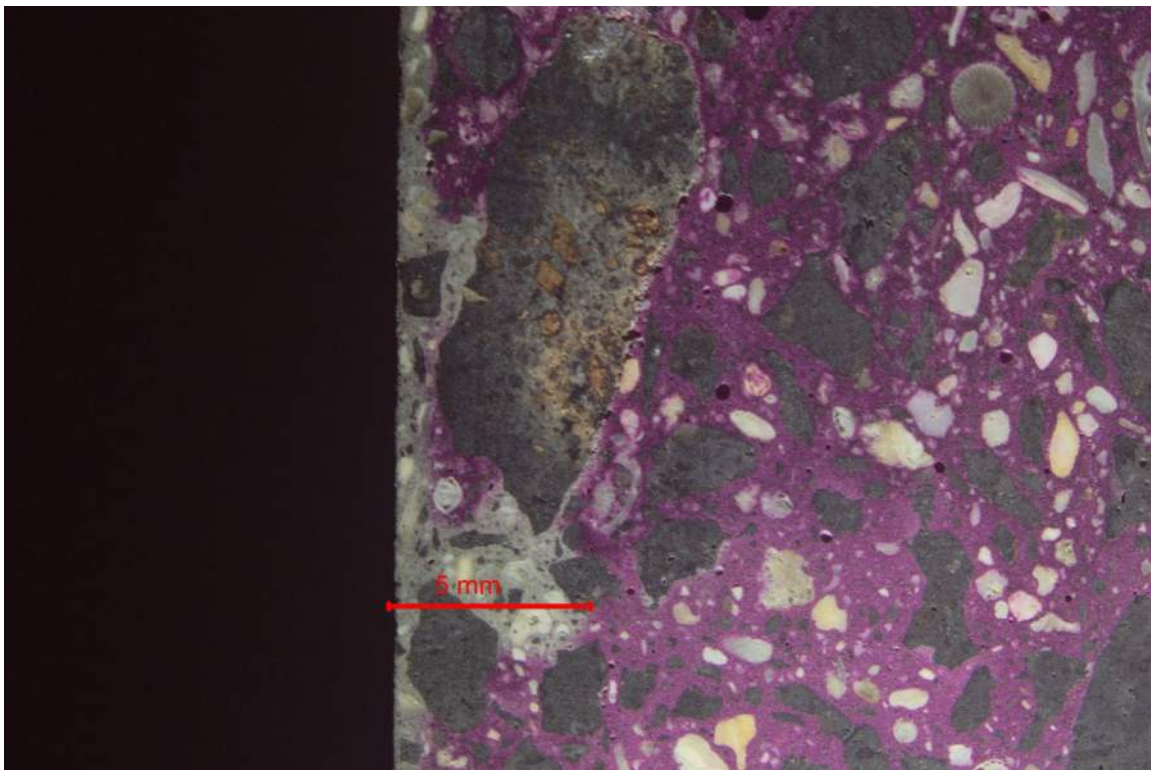
Photo: 50

Sample ID:
Mag:

Core 12
5x

Description: Carbonation (unstained paste, pH <8.5) ranged from negligible up to 5 mm (3/16") from the outer surface, as viewed on saw cut and lapped cross section at low magnification.

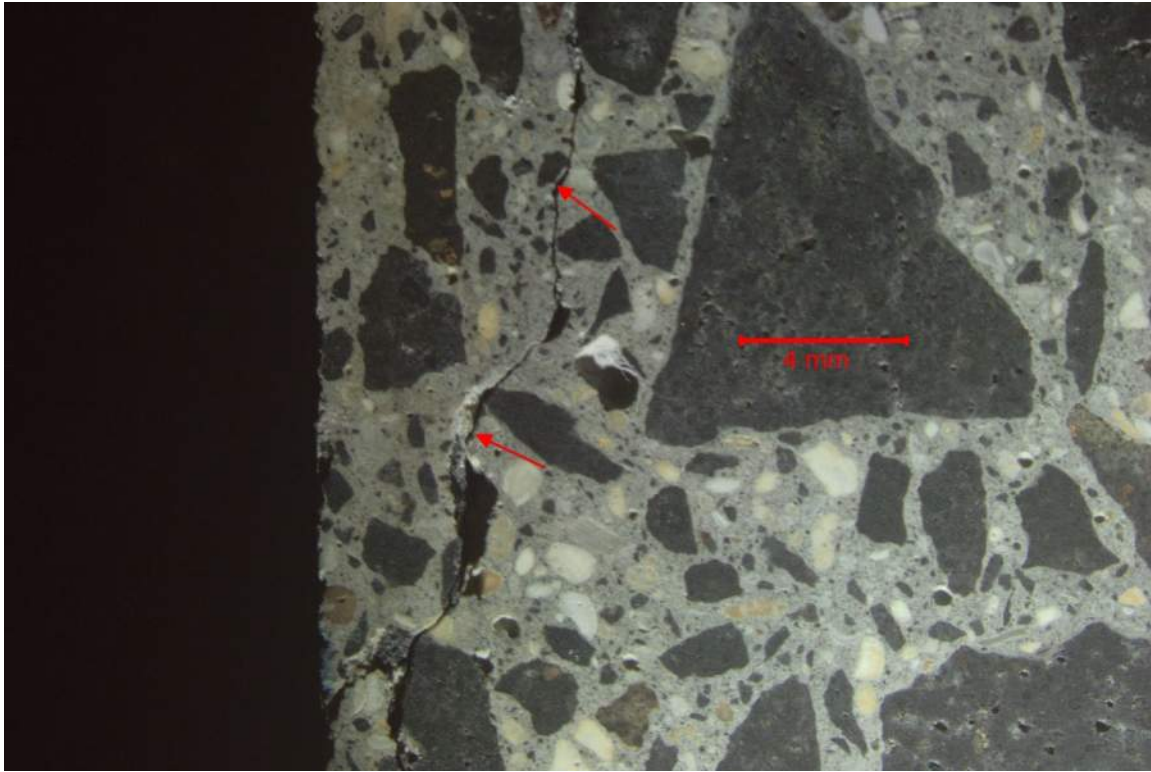
Photo: 51

Sample ID:
Mag:

Core 4
5x

Description: Spalling of the outer surface of the core sample, after the two sections of the sample were reattached, viewed on saw cut and lapped cross section at low magnification.

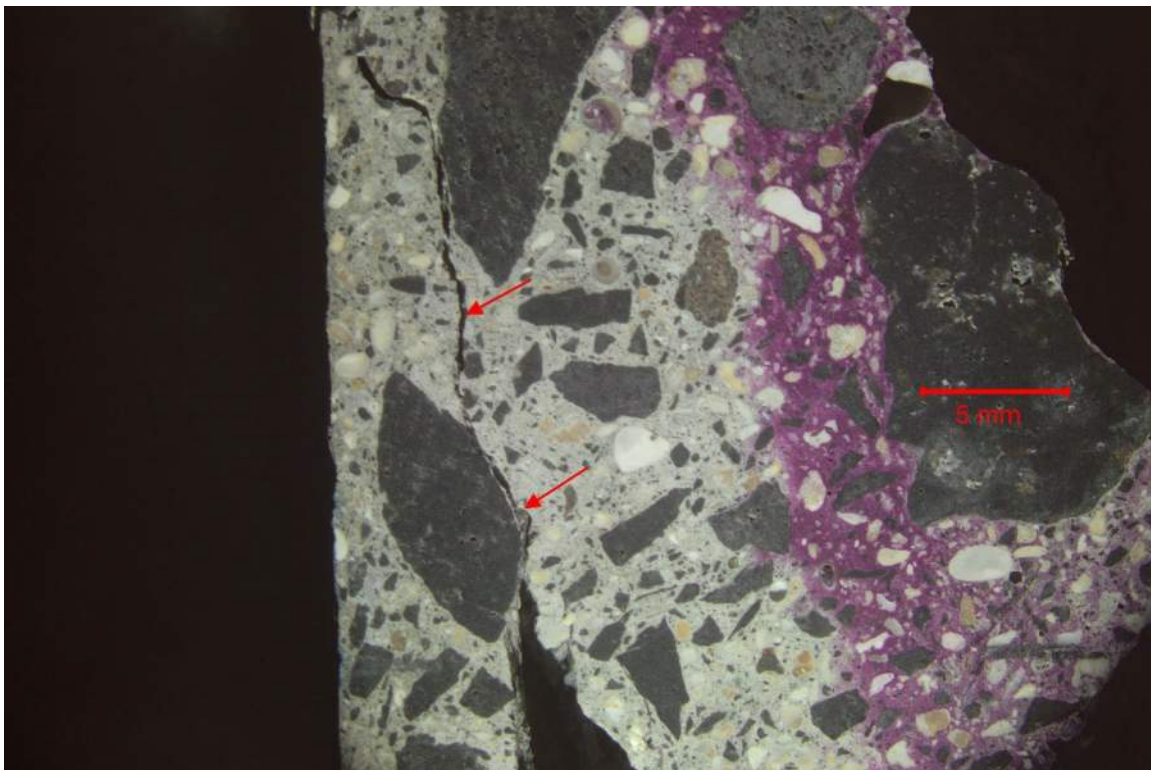
Photo: 52

Sample ID:
Mag:

Core 6
5x

Description: Spalling of the outer surface of the core sample, after the two sections of the sample were reattached, viewed on saw cut and lapped cross section at low magnification.

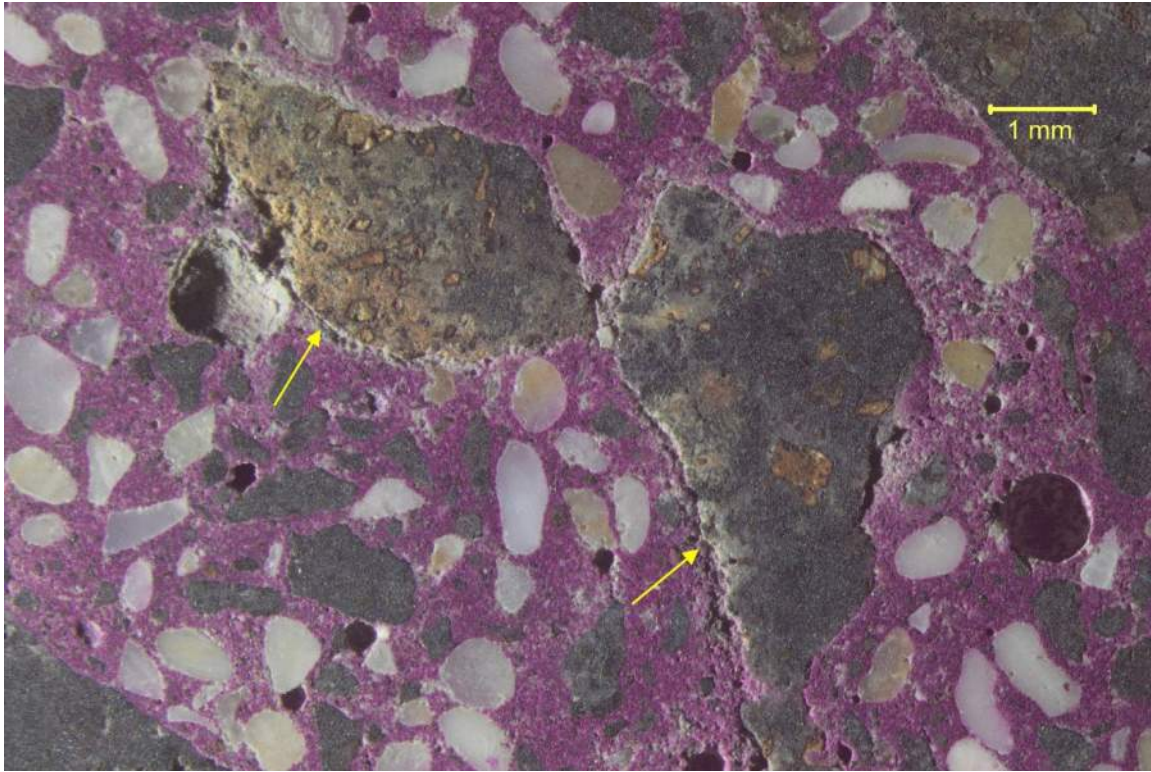
Photo: 53

Sample ID:
Mag:

Core 3
12.5x

Description: Weathered basalt coarse aggregate particles surrounded by soft paste which eroded during sample preparation, viewed on saw cut and lapped cross section at magnification.

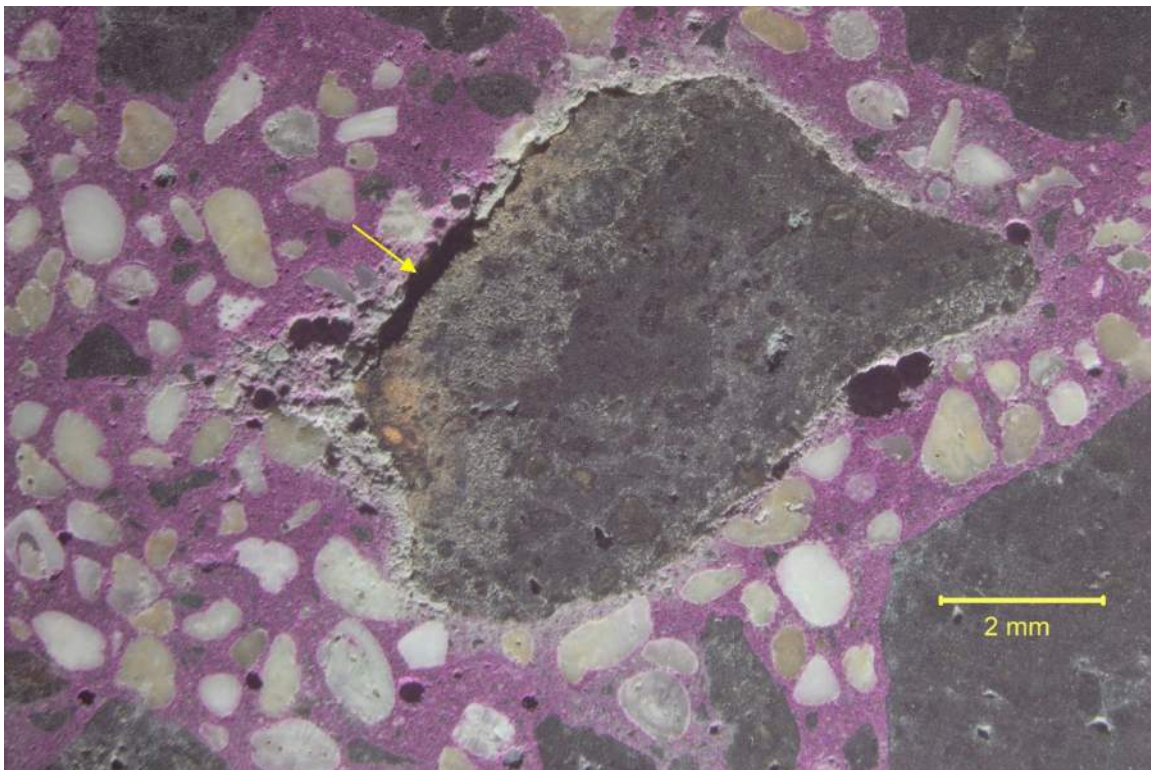
Photo: 54

Sample ID:
Mag:

Core 10
10x

Description: A weathered basalt coarse aggregate particle particles surrounded by soft paste which eroded during sample preparation, viewed on saw cut and lapped cross section at magnification.

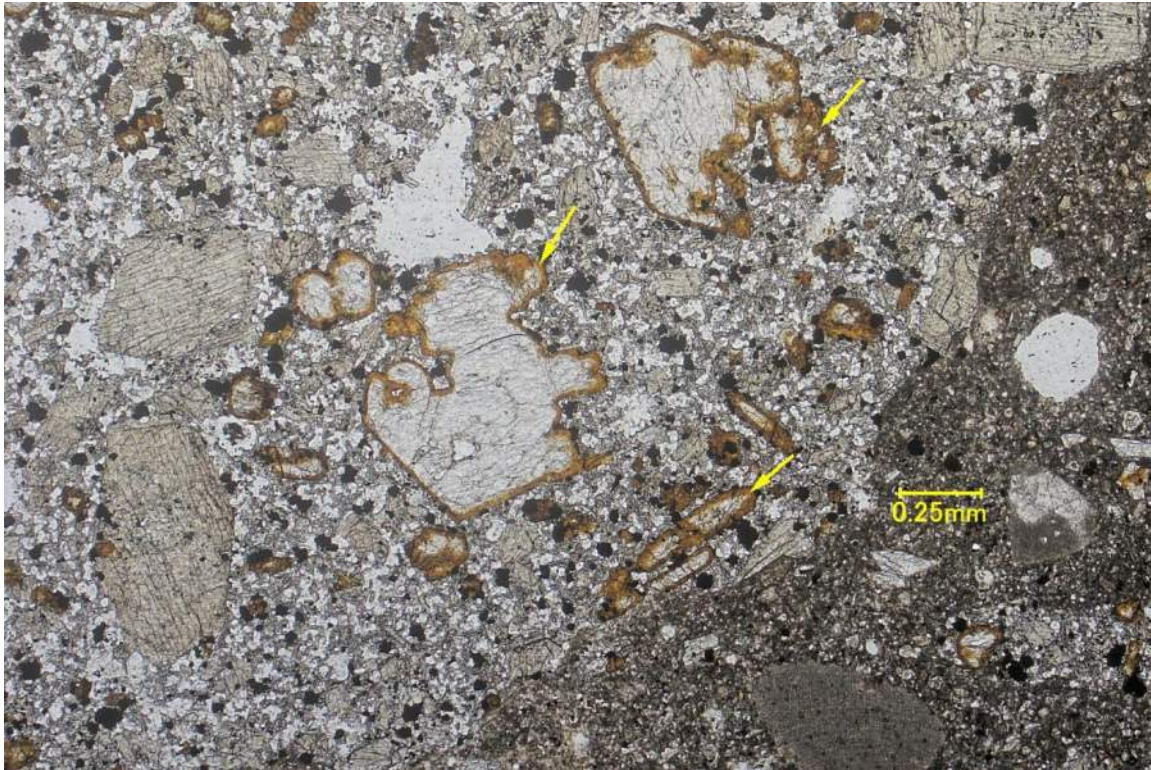
Photo: 55

Sample ID:
Mag:

Core 1
40x

Description: Olivine phenocrysts within a basaltic coarse aggregate particle altering to iddingsite, viewed in thin section of concrete paste with transmitted plane polarized light.

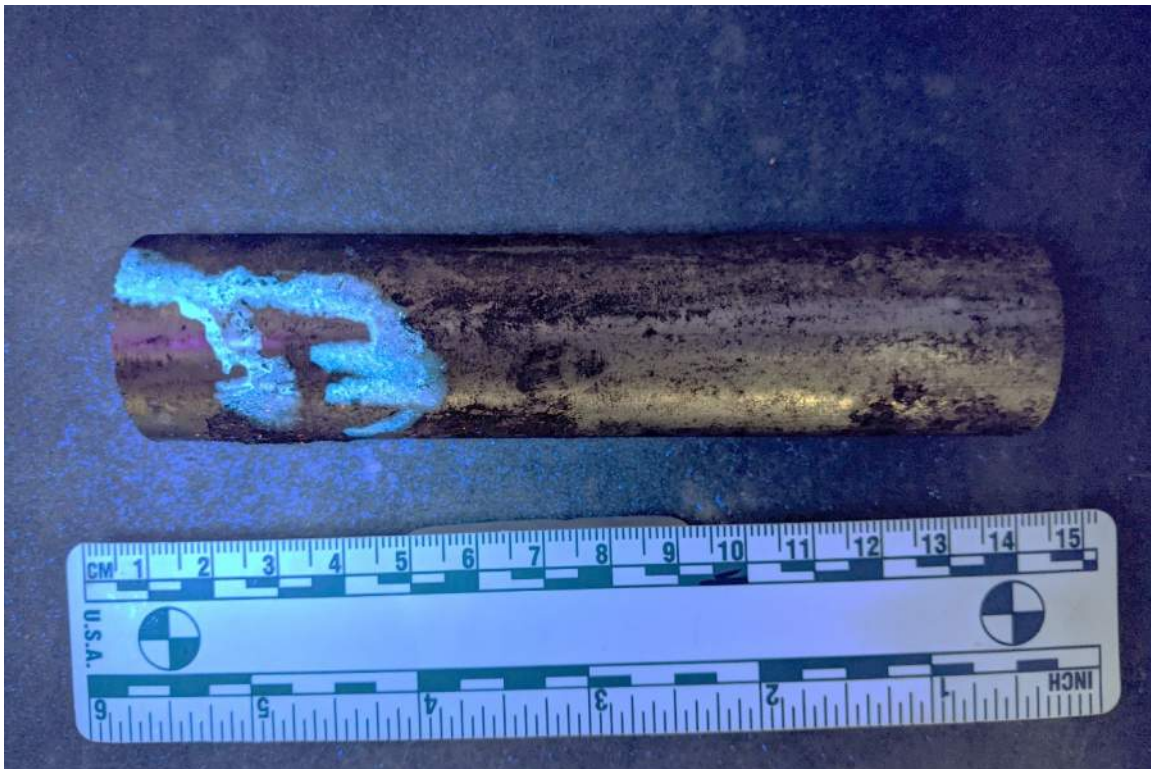
Photo: 68

Sample ID: SS Rod **Description:** Fractured end and SEM billet removed from bar (image left). UV illumination indicates presence of an epoxy type material.

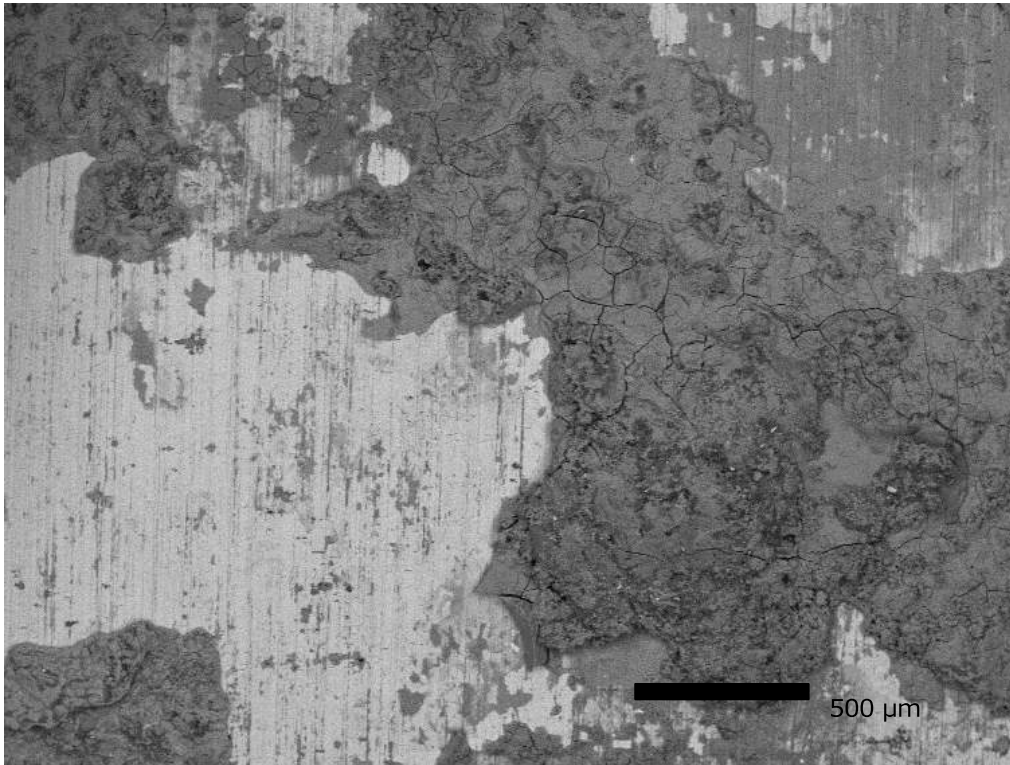
Photo: 69

Sample ID:
Mag:

SS Rod
50x

Description: Low magnification view of corrosion product on the surface of the 304 SS steel substrate.

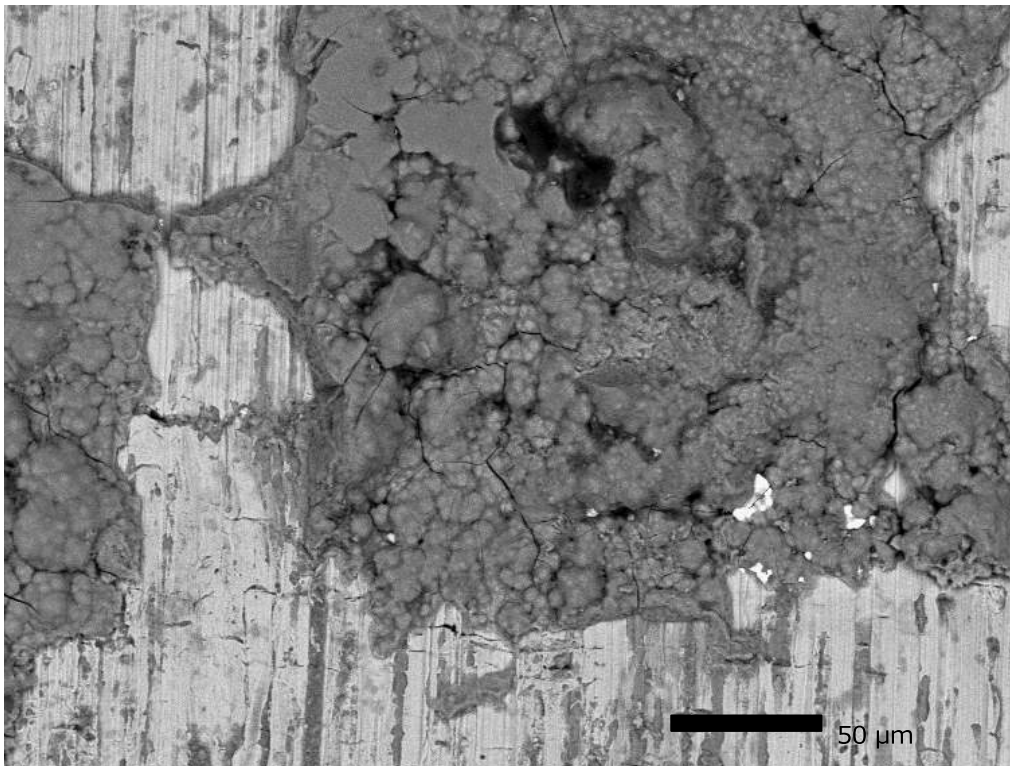
Photo: 70

Sample ID:
Mag:

SS Rod
330x

Description: Chemical analysis of this region in following photo section (71). Botryoidal texture can be seen under slightly higher magnification.

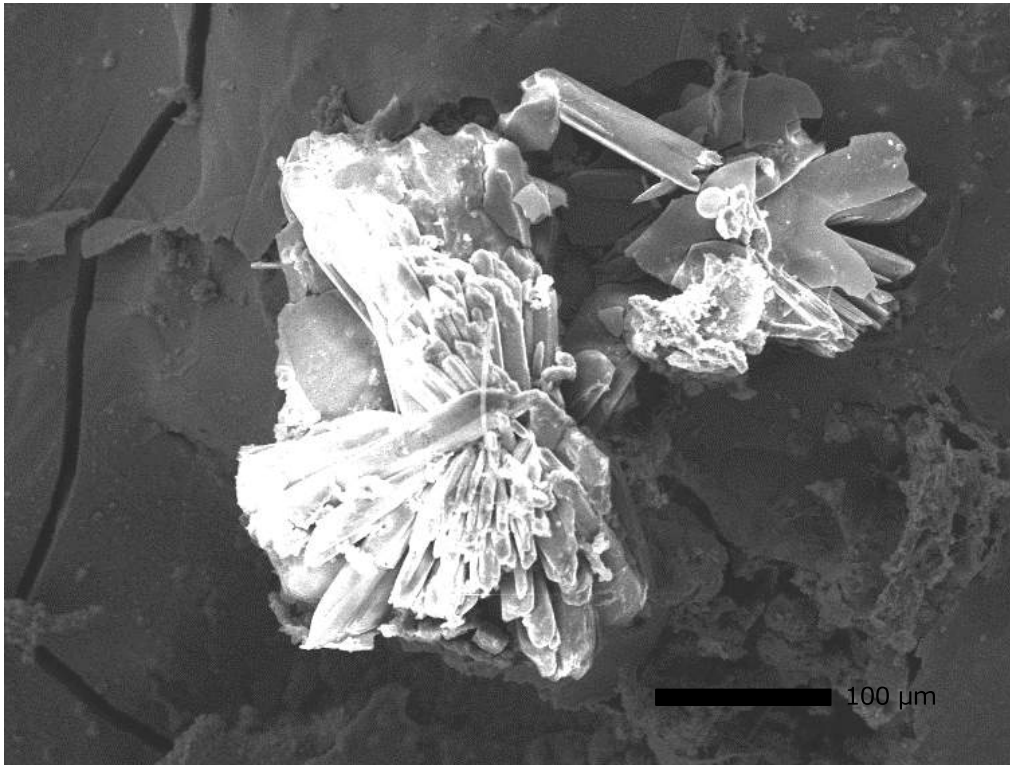
Photo: 71

Sample ID:
Mag:

SS Rod
220x

Description: Crystal cluster on fractured bar surface. Chemical constituents reflect the 304 SS substrate with the addition of chlorine.

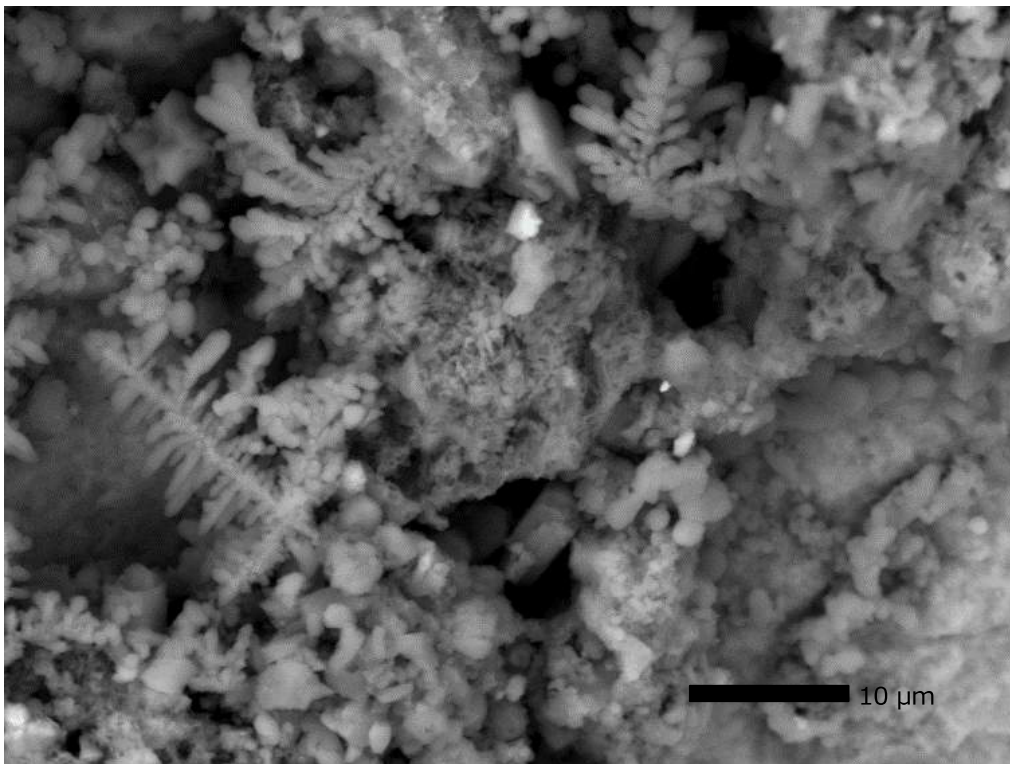
Photo: 72

Sample ID:
Mag:

SS Rod
2000x

Description: Very fine crystalline component (tree-like structures) to the corrosion product. Crystals are primarily comprised of chlorine, sodium, potassium.
