Material Analysis and Testing Report

Wilson Tunnel Plenum and Hanger Rods

September 6, 2022

Developed For: State of Hawaii Department of Transportation
District of Oahu

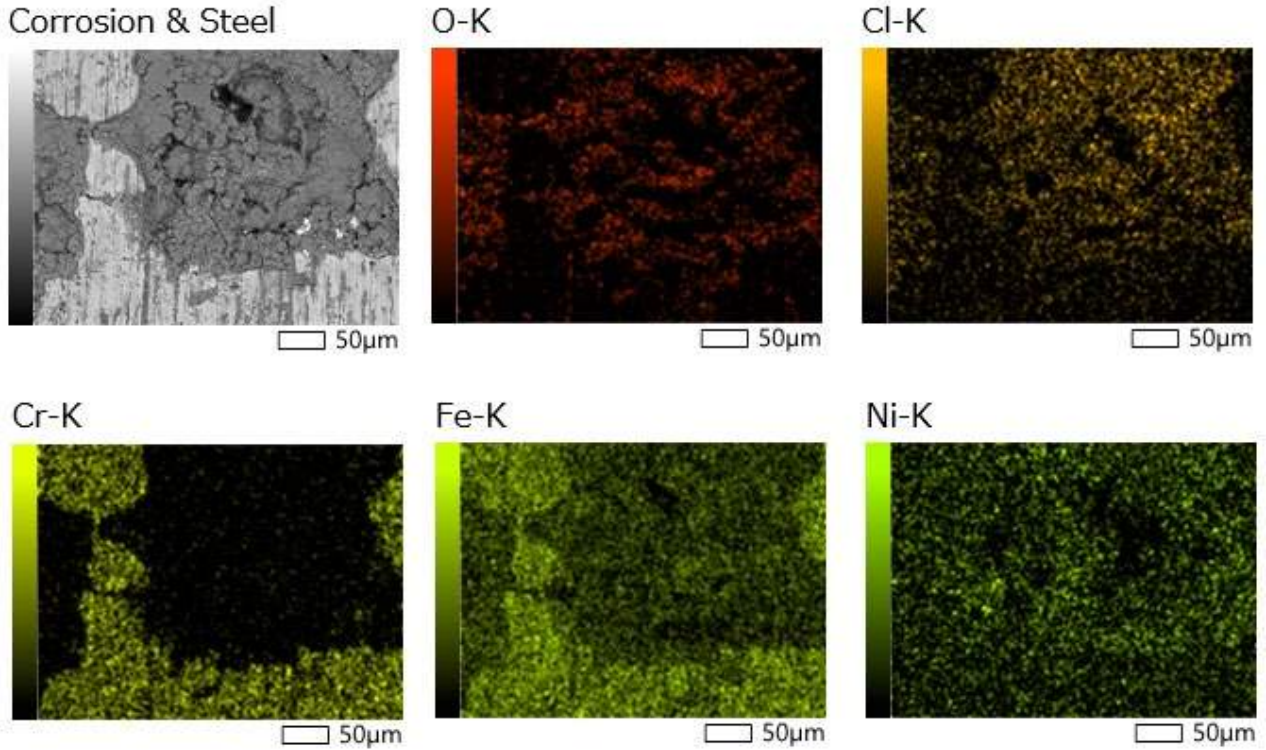
Photo: 73

Sample ID:
Mag:

SS Rod
 See Scale

Description: EDS Chemical mapping and Backscatter Detector images. Upper left BED image shows 304 SS substrate (light grey), and corrosion product consisting of oxidized substrate and chloride (dark grey). Individual analytes represented in remaining images.

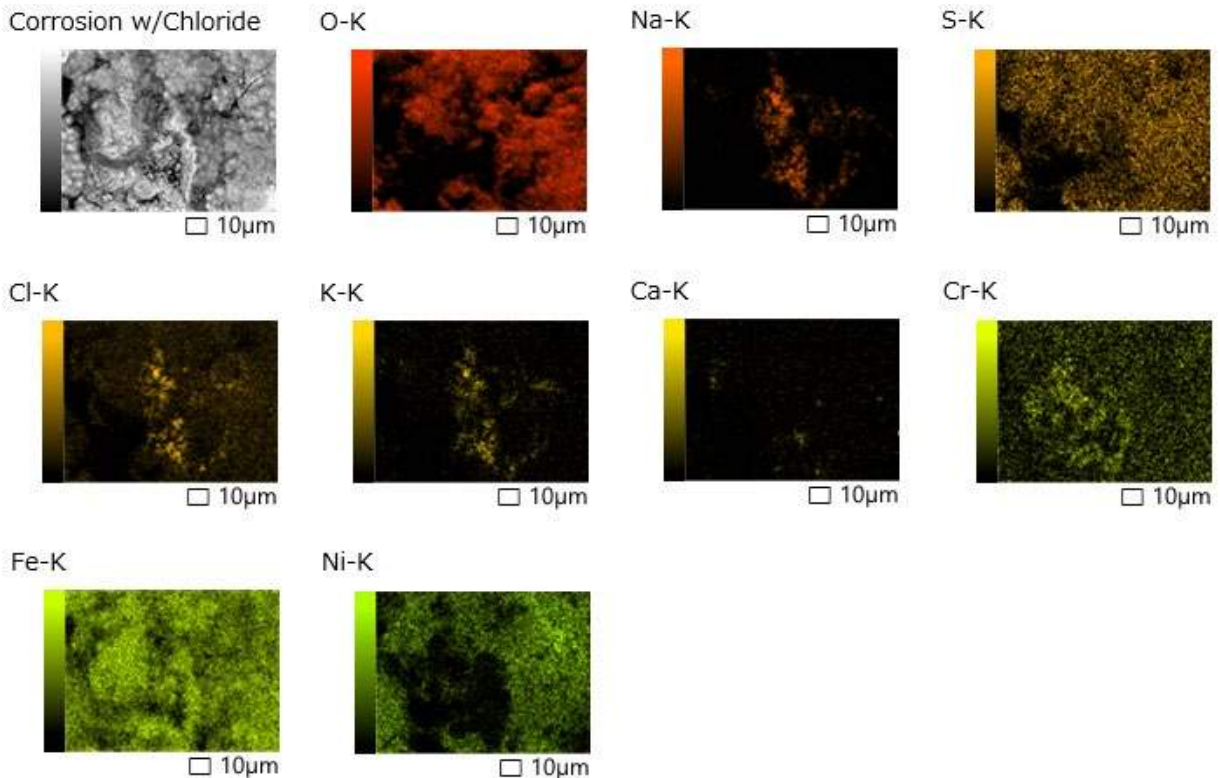
Photo: 74

Sample ID:
Mag:

SS Rod
 See Scale

Description: Similar to above image set, but entire field of view is of corrosion product. Crystals similar to those in photo 72 occupy the areas highlighted with Cl.

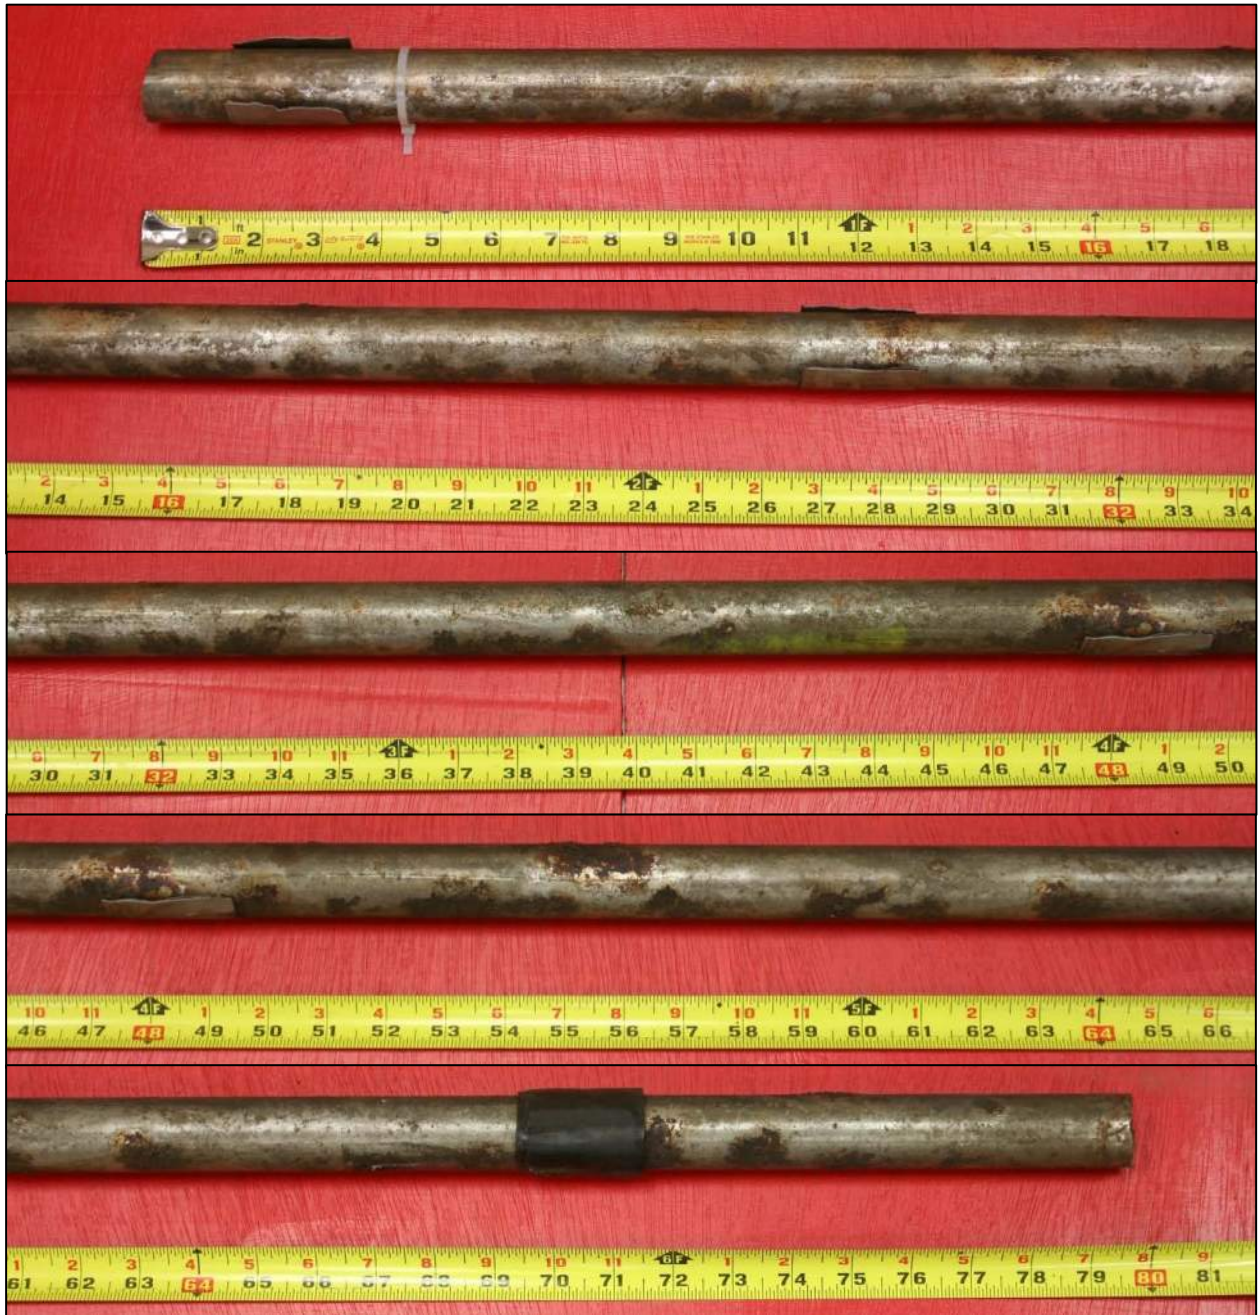
Figure 2. Photo. Close-up pictures of Rod 1.

Visually, the rods had surface corrosion product on them in distinct patches. Figure 2 and 3 show a series of close-up photos along the length of each of the rods, which were denoted as “Rod 1” and “Rod 2”. A tape measure is provided in each photo for reference; the cut end is zero inches, and the fractured end is at approximately 80 inches.

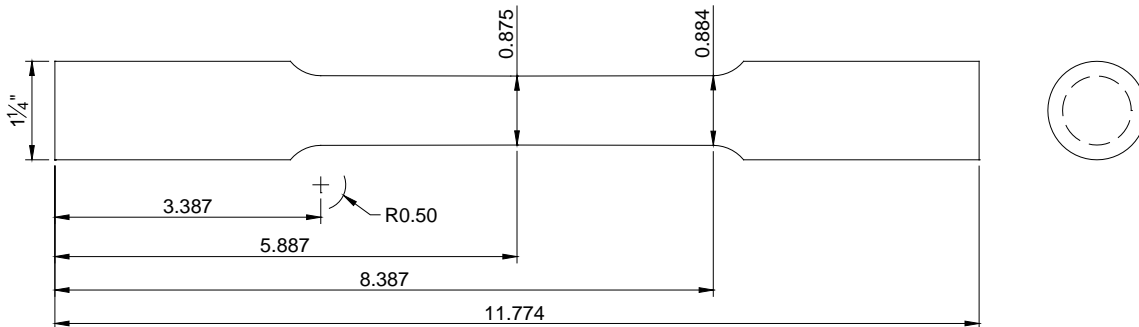
Figure 9. Schematic. Detailing of tensile coupon.

The tensile coupons were detailed according to the proportions of round bar specimens as specified in ASTM E8/E8M-13a “*Standard Test Methods for Tension Testing of Metallic Materials.*” However, some dimensions were modified such that the bar could be tested as close to its full diameter as possible. This resulted in a reduced diameter of 7/8 inch and a length of the reduced section of 5 inches. A tapered reduced diameter was machined into the specimens in accordance with ASTM E8/E8M-13a to ensure failure in the middle of the specimen. The dimensions of the coupons are shown in Figure 9.

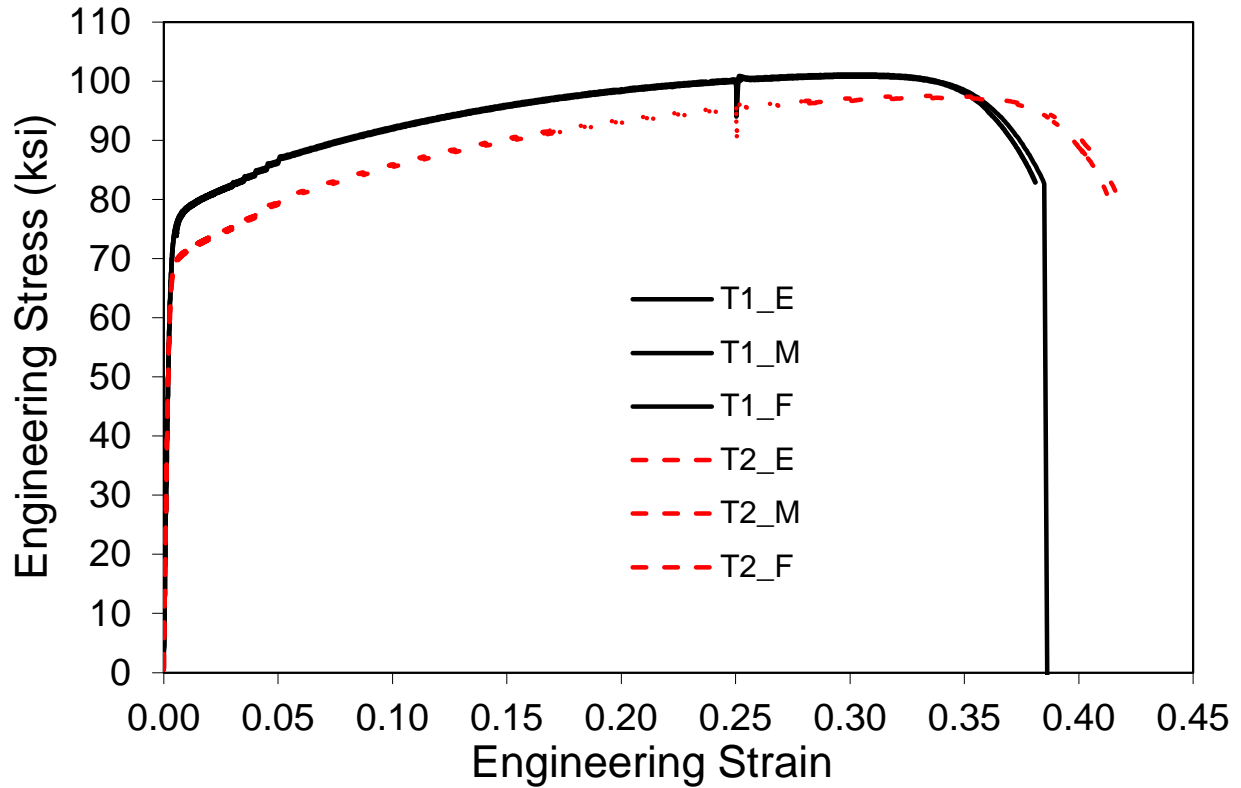
Figure 10. Graph. Engineering stress versus strain curves for all tensile specimens.

The results are reported in Tables 2 and 3, respectively for Rod 1 and Rod 2, with average yield strength of 74.5 ksi and a tensile strength of 100.9 ksi for Rod 1; and average yield strength of 68.5 ksi and a tensile strength of 97.3 ksi for Rod 2. The elongations of both rods were greater than 43 percent, and the reduction in area was more than 50 percent. The high yield and tensile properties of these rods suggests that they were cold-finished material, as the annealed condition of stainless steel would have corresponding values roughly half of that measured.

Plots of the six stress versus strain curves from tensile testing are shown in Figure 10. The results from Rod 1 are plotted with a heavy black line, and those for Rod 2 are with a heavy dashed red line. The three plots for each rod plot right on top each other so there was no noticeable difference in tensile properties along the length of either rod.

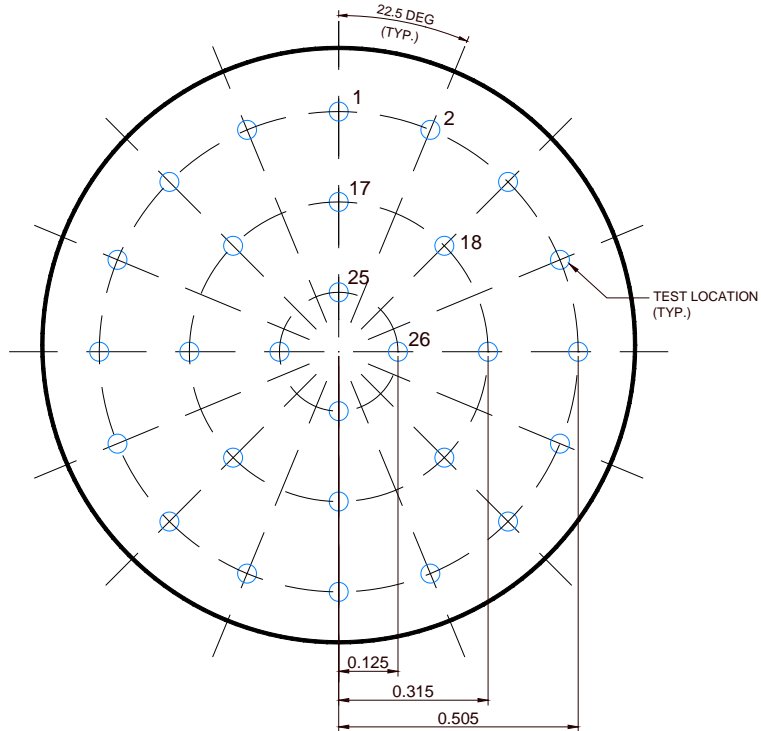
Figure 11. Schematic. Locations of hardness tests for Rods 1 and 2

Hardness tests were performed on 1.0-inch-thick cross sections removed from each rod. Tests were conducted using a 1/16-inch-diameter steel sphere using the Rockwell B scale. Figure 11 shows the locations of the 28 hardness tests taken on each rod cross-section. Test locations were laid out using a polar coordinate system and were selected to determine how the hardness varied through the radius of each rod. Sampling was generally performed near the center of the rod, the mid-radius, and near the outer perimeter. Test locations were determined based on ASTM E18, which requires that hardness readings be spaced at least 3 indent diameters apart, or 2.5 indent diameters from edges. All individual hardness measurements from both rods can be found in Appendix B.

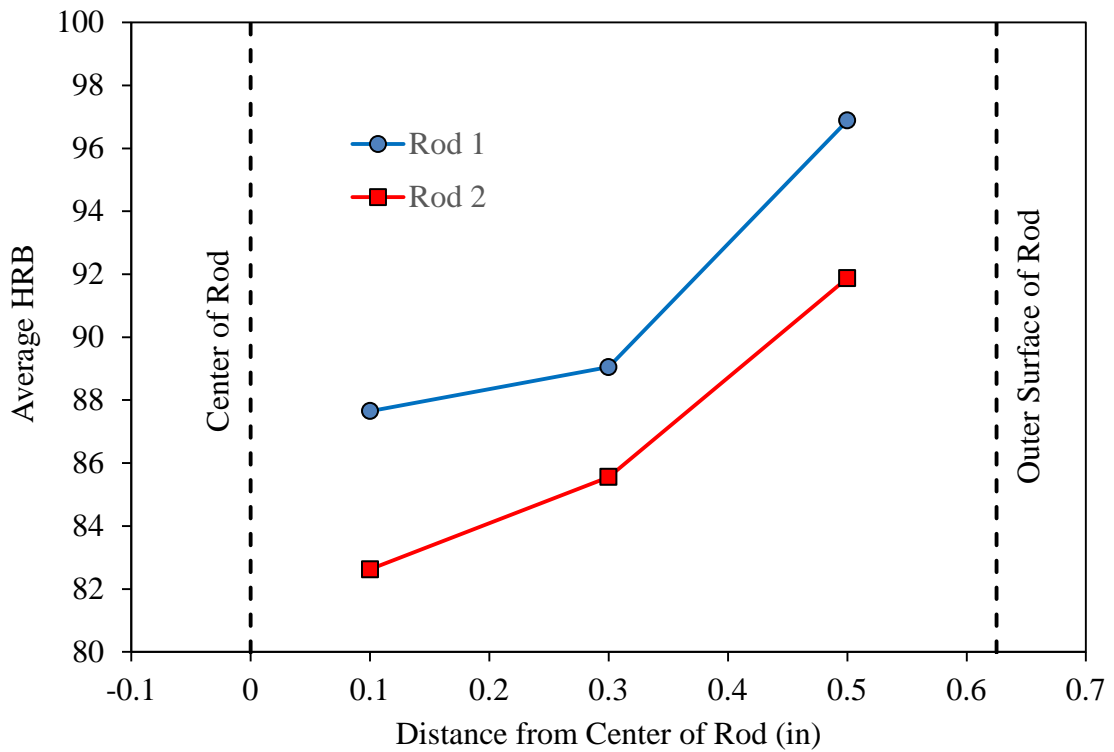
Figure 12. Graph. Constant radius average Rockwell B hardness of both rods.

Results from the hardness tests are compiled into Figure 12. In the plot, hardness values at a common radial distance were averaged and reported for each rod. The center and outer surface of the rods are shown on the figure as vertical dashed lines. Overall, both rods displayed hardness values ranging from 82-97 HRB. Rod 1 consistently showed slightly larger hardness values than Rod 2. This supports the tensile testing results which suggested that Rod 1 had larger yield and tensile strengths than Rod 2. Both rods exhibited a similar trend of increasing hardness from the center of the rod to the outer surface. The non-uniform hardness suggests there was some type of treatment process applied to the rods after rolling. Based on ASTM A 276 and considering the chemical analysis, tensile testing, and hardness tests, it appears the rods were cold-finished, though the exact process is unknown. Neither the 1949 or 1955 versions of ASTM A 276 specify any hardness requirements for Type 303 cold-finished steel. Both versions do specify minimum hardness values for chromium grade steels, but not for chromium-nickel grades, to which Type 303 belongs.

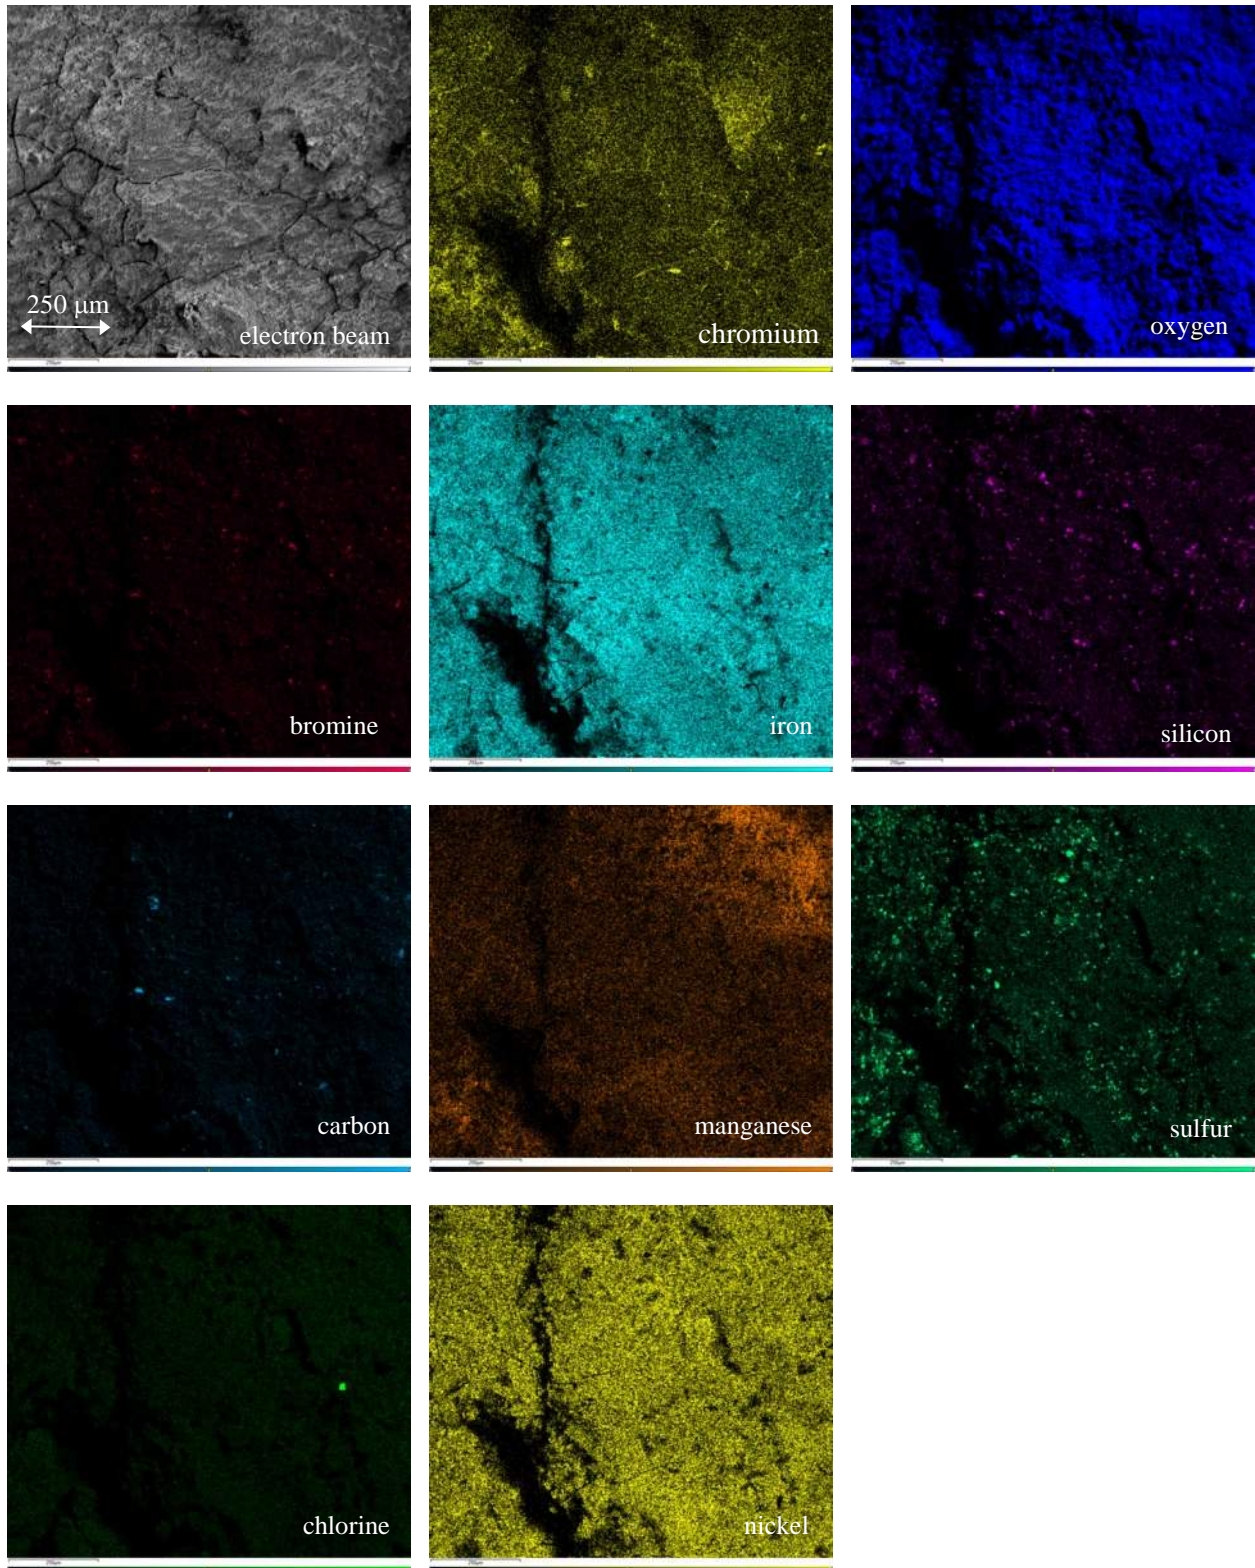
Figure 13. Image. EDX images of Rod 1 fracture surface (at 3 o'clock).

Before the fractured surfaces (F1 and F2) were cleaned, each was placed in the scanning electron microscope (SEM), and four typical areas were analyzed with the energy dispersive x-ray (EDX) detector. This detector has the ability to see elements that are present in the viewing area and represent them in a color contour plot. The areas were roughly at the mid radius at the 12, 3, 6, and 9 o'clock positions relative to how the specimen was loaded into the microscope. Figure 13 displays the elements detected through the EDX at a particular point on the fracture surfaces of Rod 1. For the purposes of scale, each image is roughly 0.045 inches square. The electron beam image represents the surface at high magnification; and it shows a mud-cracked looking surface where there are corrosion products. As expected of steel, the EDX detected alloying elements of iron, chromium, and nickel with oxygen on the surfaces, which indicates the amount of oxides. There were also traces of chlorine and bromine, which correlate with contaminants found in a marine environment such as seawater. These EDX spectra are considered "typical" for each of the rod fractures; that is, four positions were examined with the EDX on each rod, but the overall findings presented in Figure 13 was not significantly different between the eight positions examined.

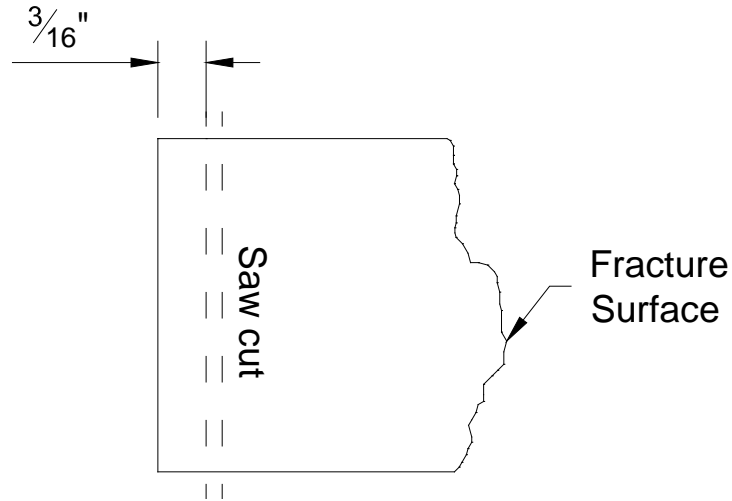
Figure 17. Schematic. Cut plan for transverse slices of F1 and F2 fracture sections.

When the Rod 2 fracture was saw cut from the overall rod, many cracks were observed on the cut edge. To investigate this further, an additional 3/16 inch thick cross-section was removed from the ends of the fracture sections of F1 and F2, then polished to expose any cracks. Figure 17 shows a schematic of where these transverse sections were removed. A suitable picture could not be attained in the polished condition because of the surface reflectivity; therefore the pictures shown in Figure 18 from each rod transverse section have been roughened with 60 grit sandpaper. The picture of the transverse sections clearly show that there are multiple cracks originating from various points on the surface and into the depth of the rod, and that the group of cracks in each section are oriented in a general clockwise direction around the rod center.

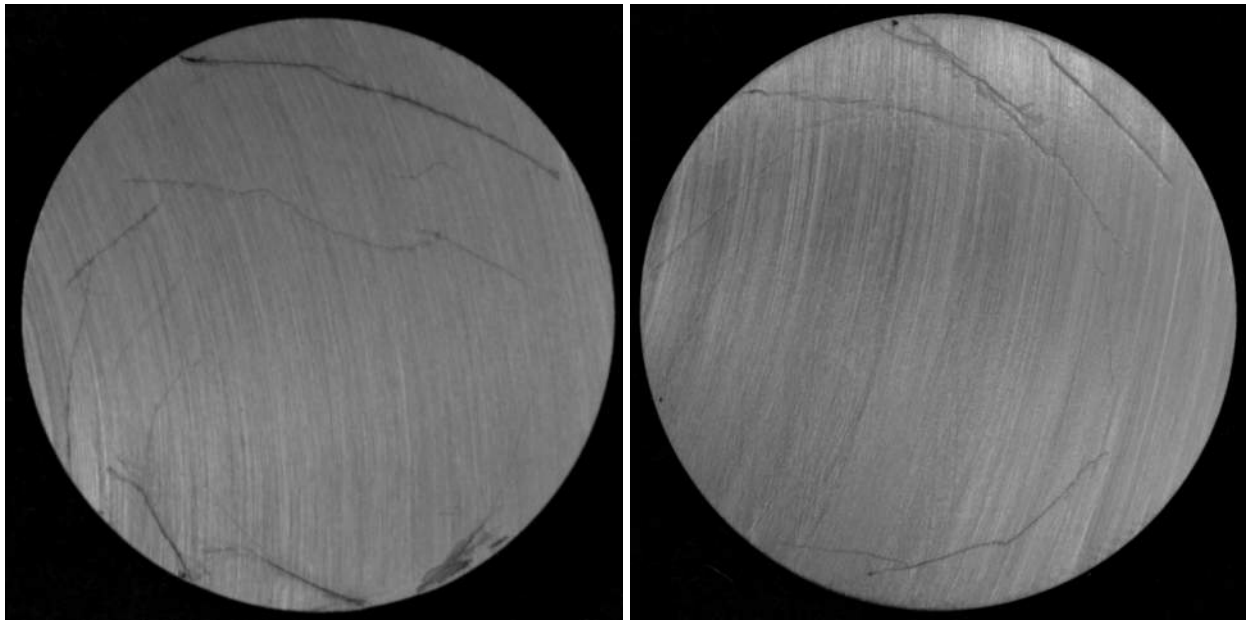
Figure 18. Photo. Transverse cracks in fracture surface sections; Rod 1 (left), Rod 2 (right).

figures 18 and 19 that the cracks grew in a mixed mode between trans- and intergranular cracking.

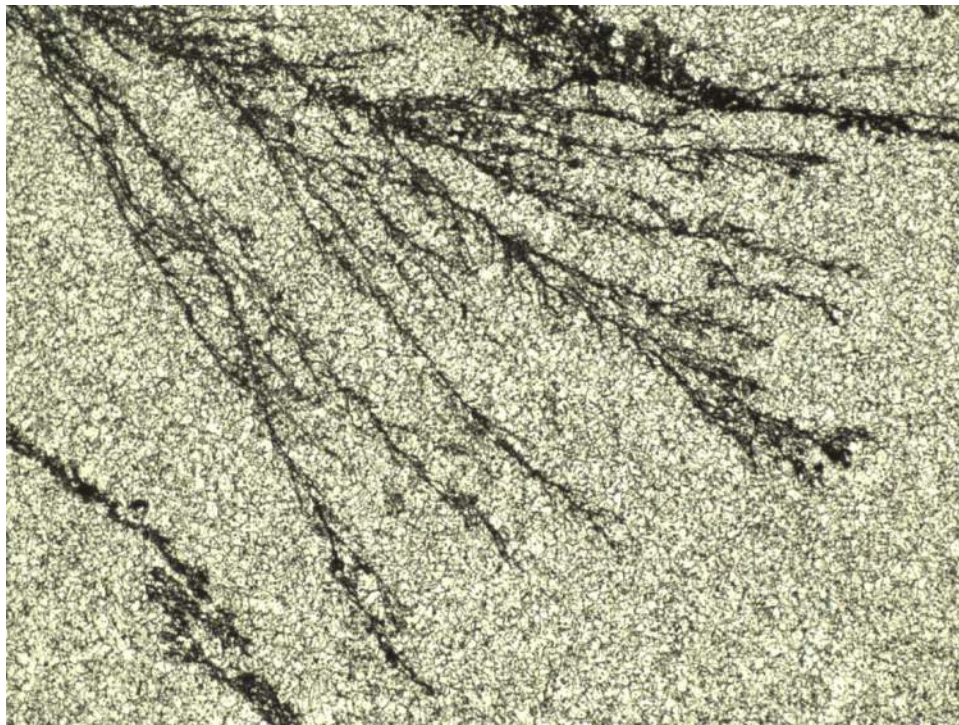
Figure 20. Photo. Rod 2 transverse section at 50x magnification. Electrolytic oxalic acid etch for 30 s.

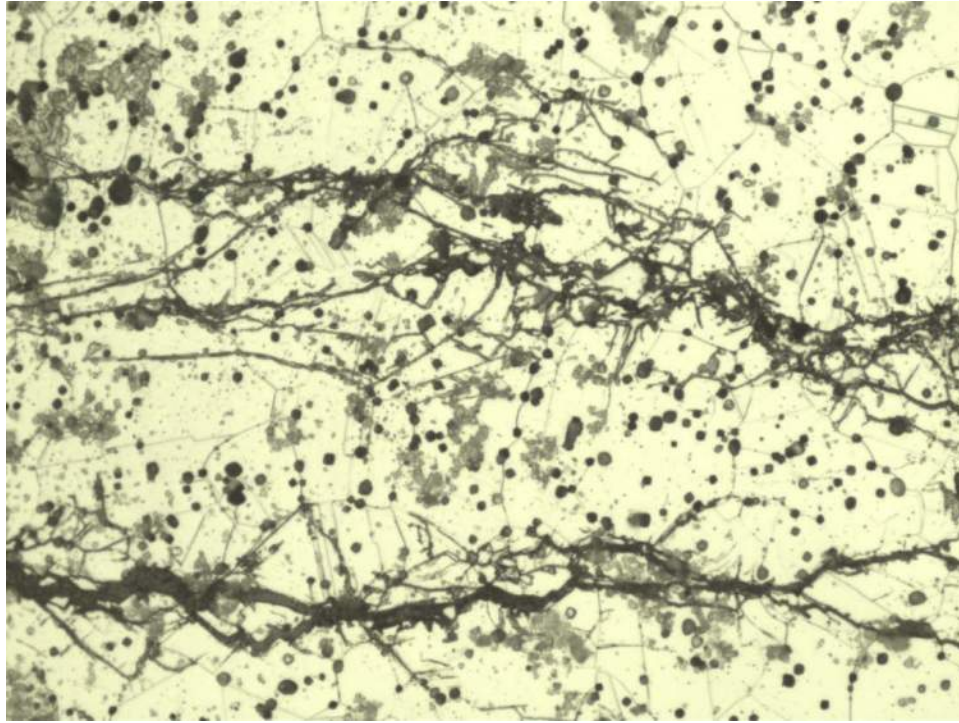
Figure 21. Photo. Zoomed in view of a crack branch in Figure 20 at 500x magnification.

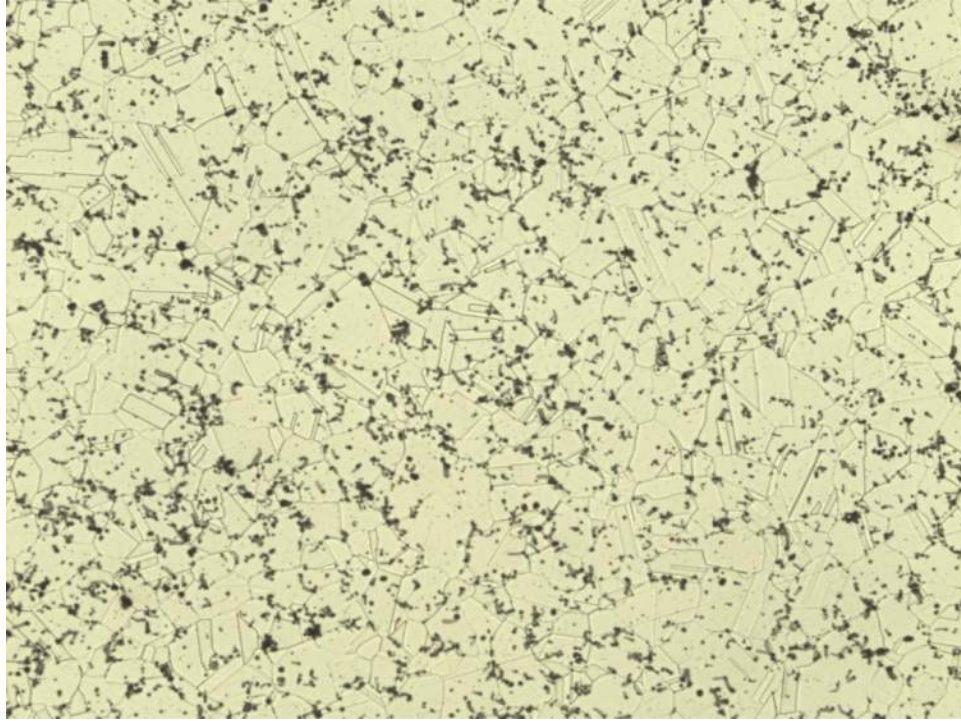
Transverse and longitudinal sections were polished and etched to reveal the microstructure. The transverse sections were the M1 and M2 sections as depicted in Figures 7 and 8. The longitudinal sections were taken from the ends which were gripped during the tensile testing of the T1-F and T2-F specimens. The microstructures between the two rods were identical and thus only the microstructure from Rod 2 will be presented. Figure 22 shows the transverse microstructure at 200x magnification after a 30 seconds electrolytic etch in oxalic acid. The grain boundaries can be faintly seen, but the most dominant feature in the micrograph is the black, round inclusions speckled throughout the transverse cross-section. The longitudinal section in Figure 23 shows a similar grain structure however the black inclusions are elongated in the longitudinal axis of the rod. The inclusions were analyzed with the EDX (see Figure 24) and were confirmed to be manganese sulfide. Their amount is not surprising for this free-machining grade of stainless steel. Manganese sulfides are typical inclusions in steel, and their transverse and longitudinal shapes are typical for a hot-rolled, or cold-drawn product where they become elongated in the direction of roll or drawing.

Figure 22. Photo. Typical grain structure on M2 section at 200x magnification after 30 second electrolytic etch in oxalic acid.

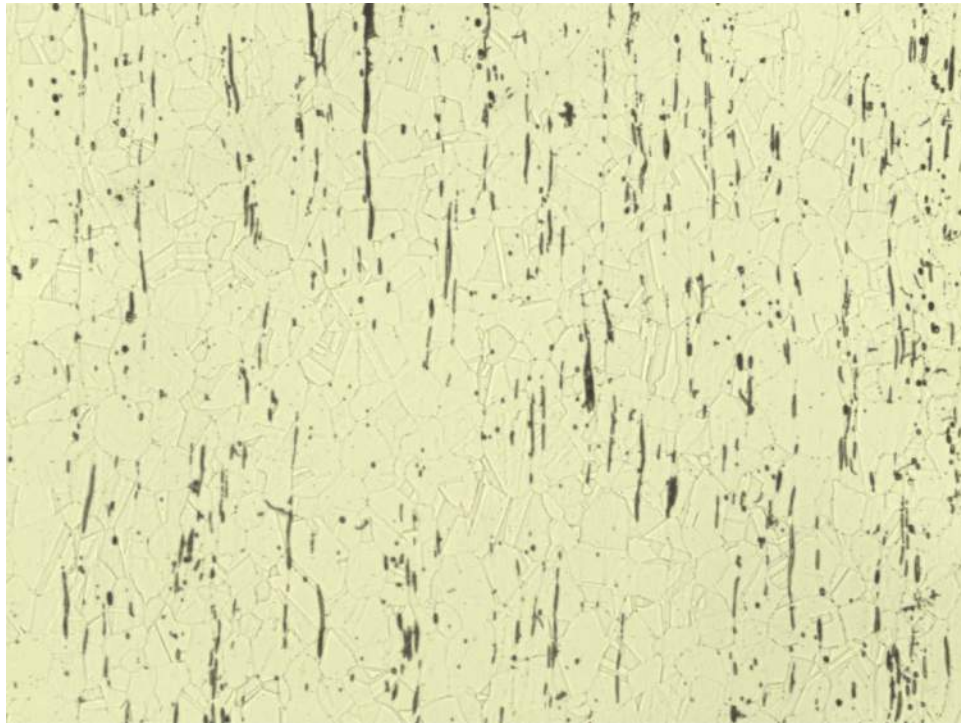
Figure 23. Photo. Longitudinal microetch from Rod 2 at 200x magnification after 30 s. electrolytic etch in oxalic acid.

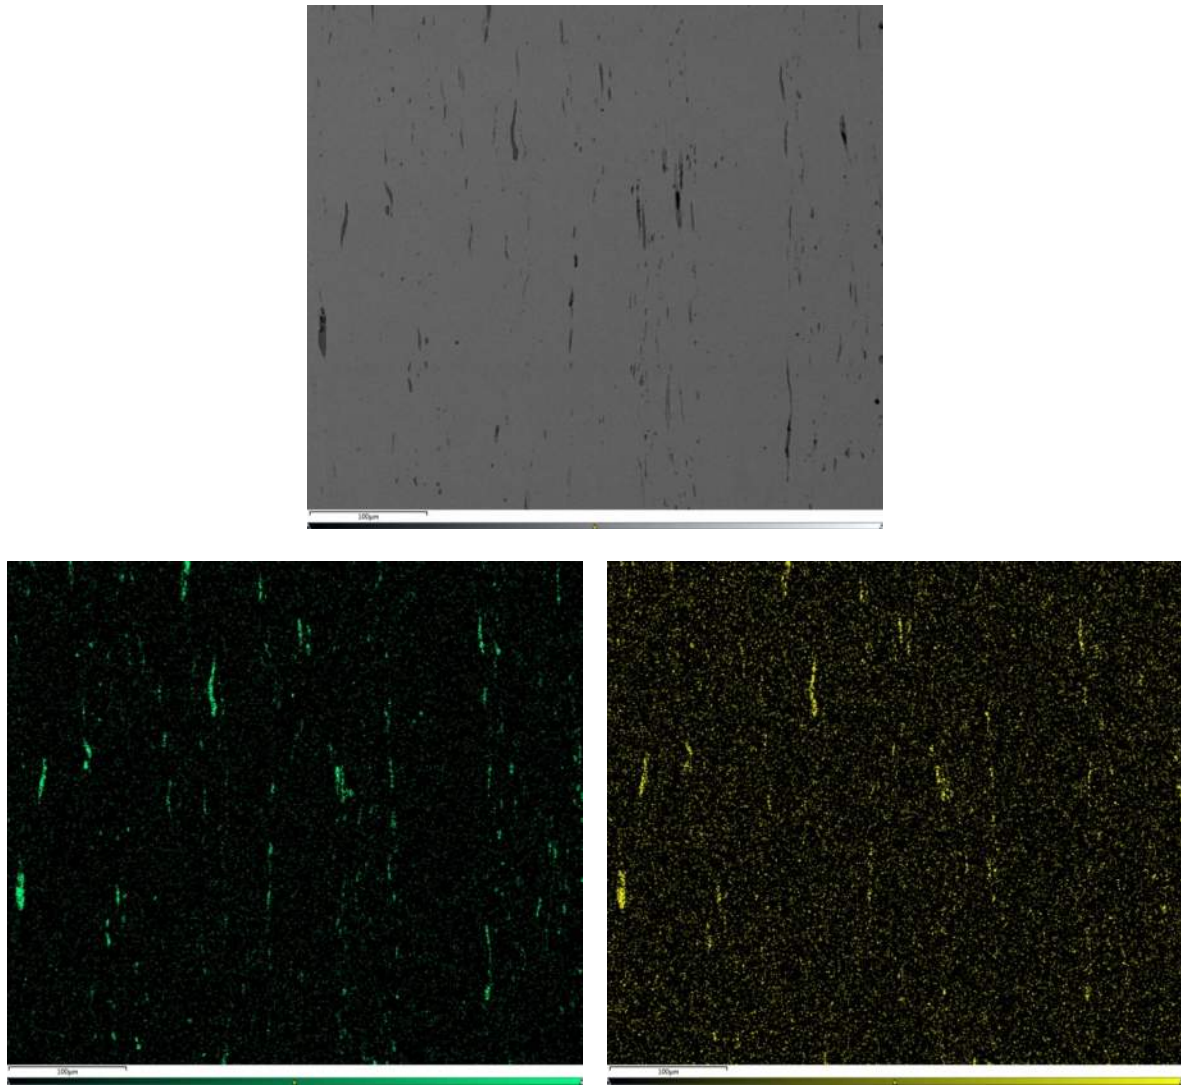
Figure 24. Image. Polished longitudinal section viewed with SEM and EDX, electron beam image (top), sulfur image (bottom-left), manganese image (bottom-right).
