Material Analysis and Testing Report

Wilson Tunnel Plenum and Hanger Rods

September 6, 2022

Developed For: State of Hawaii Department of Transportation
District of Oahu

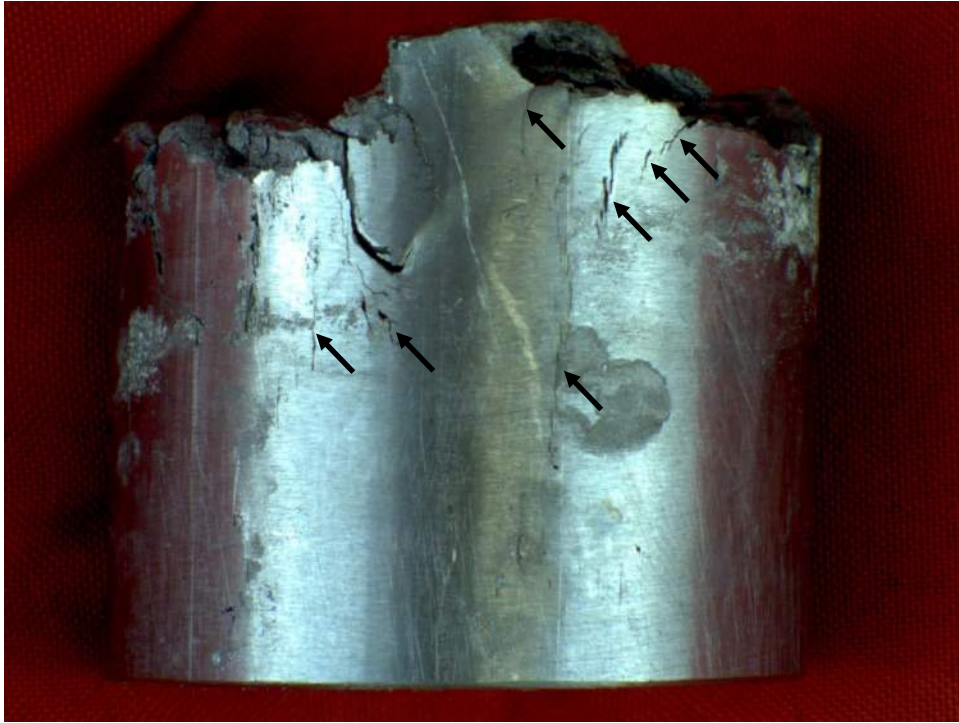
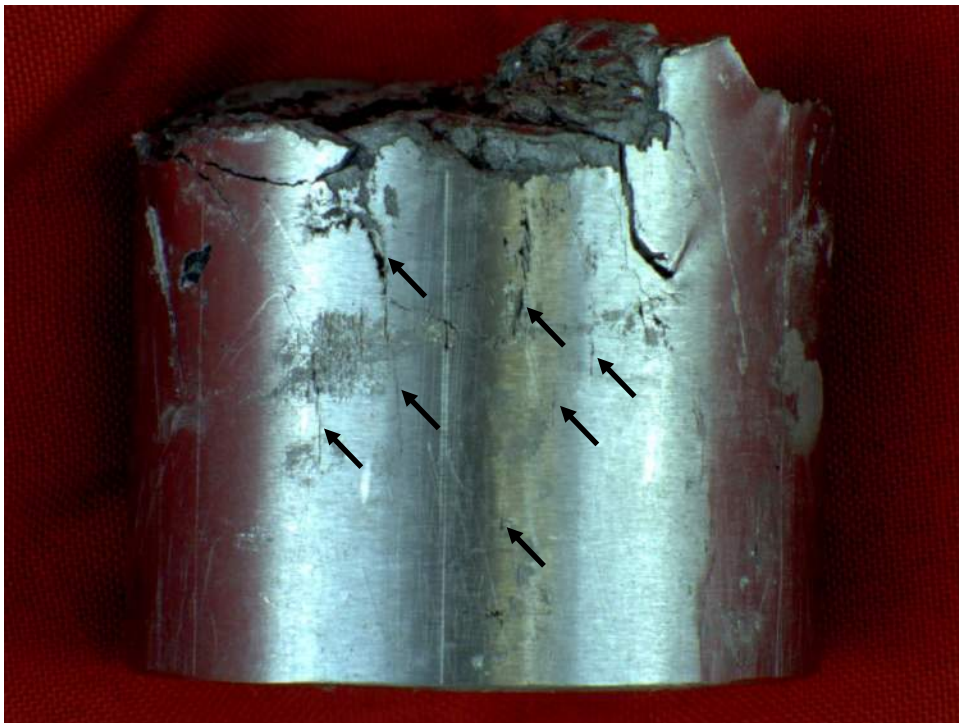
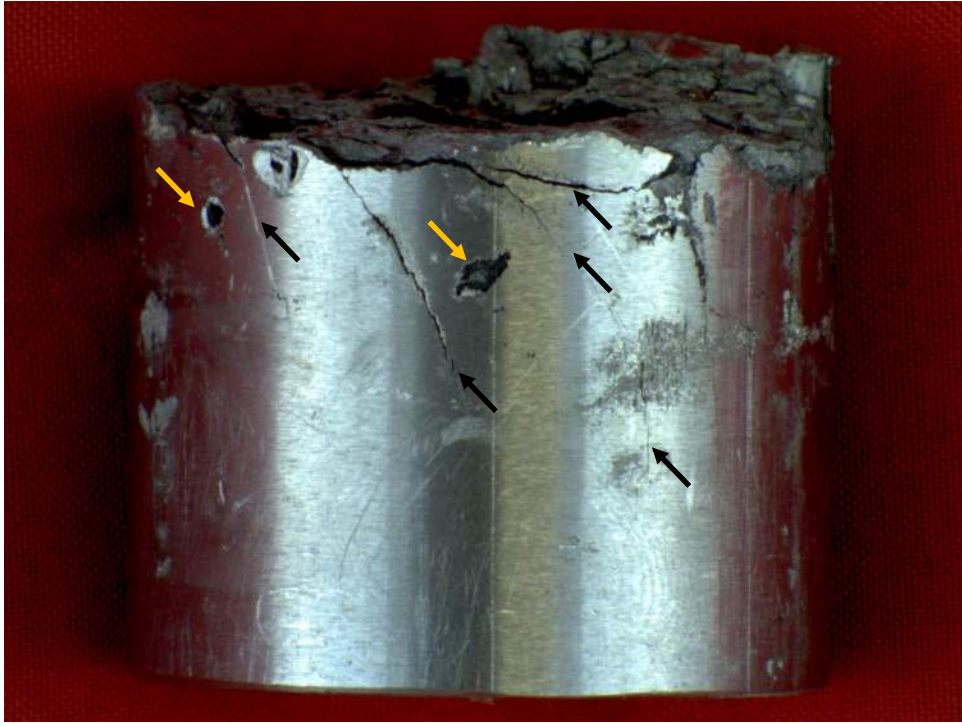
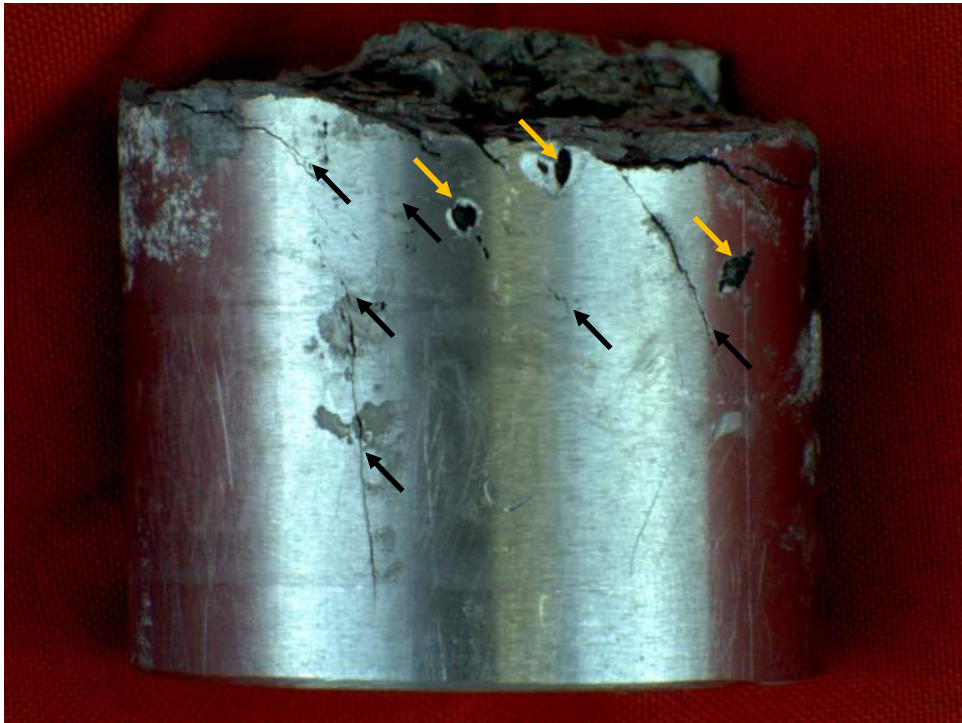
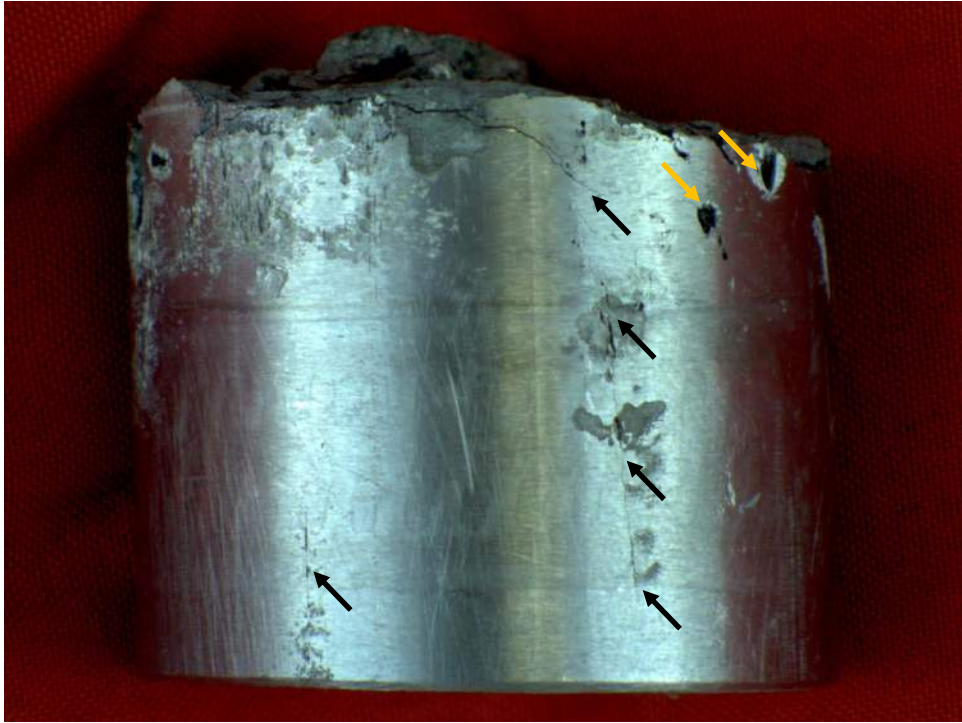
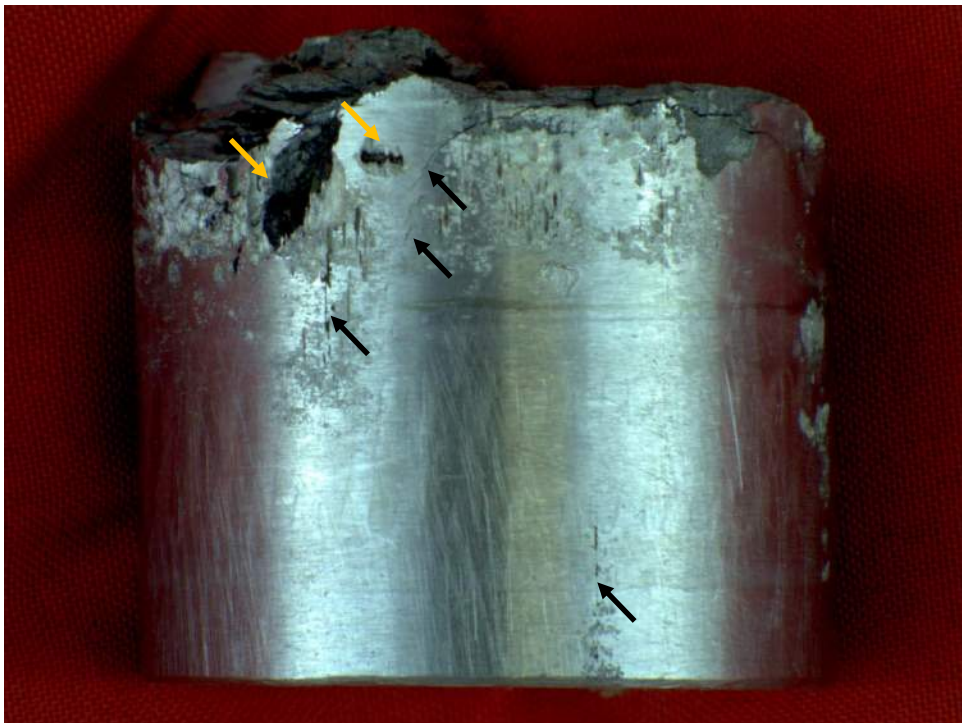
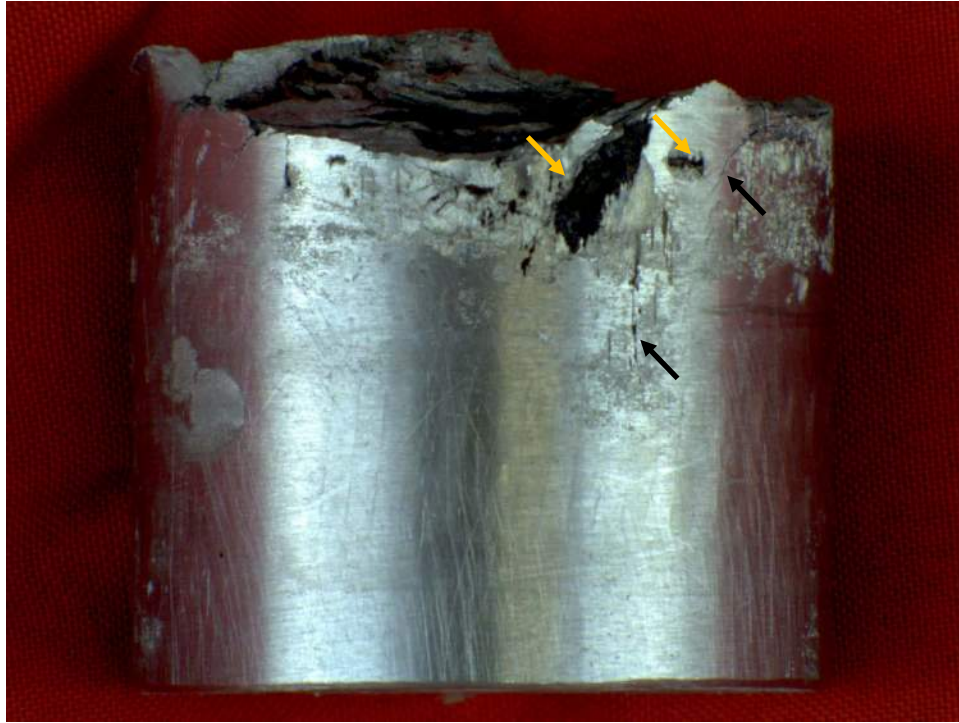
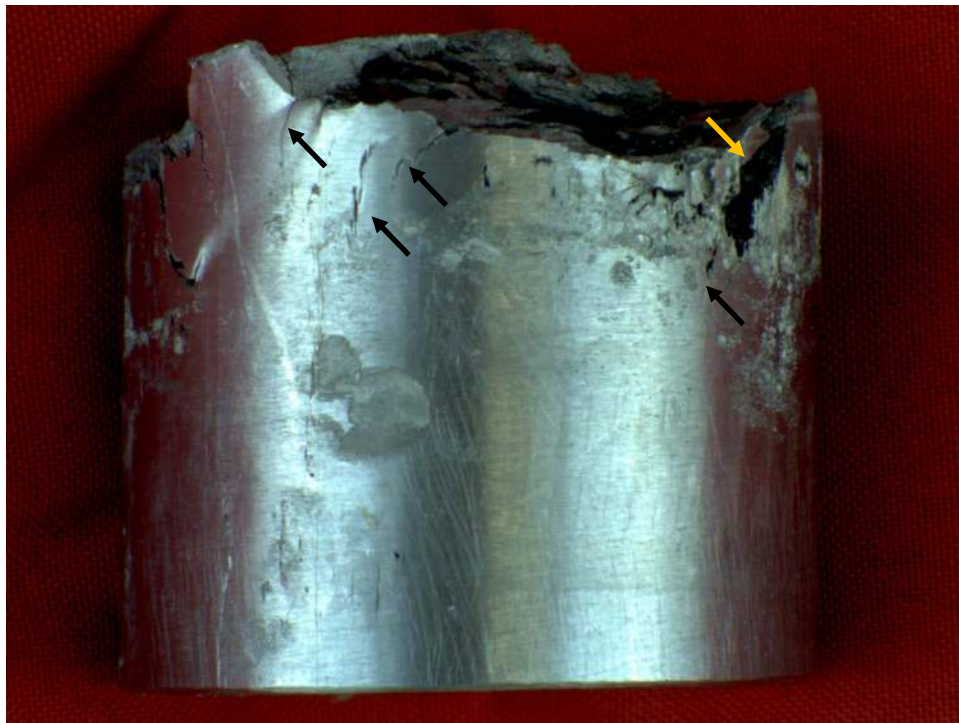
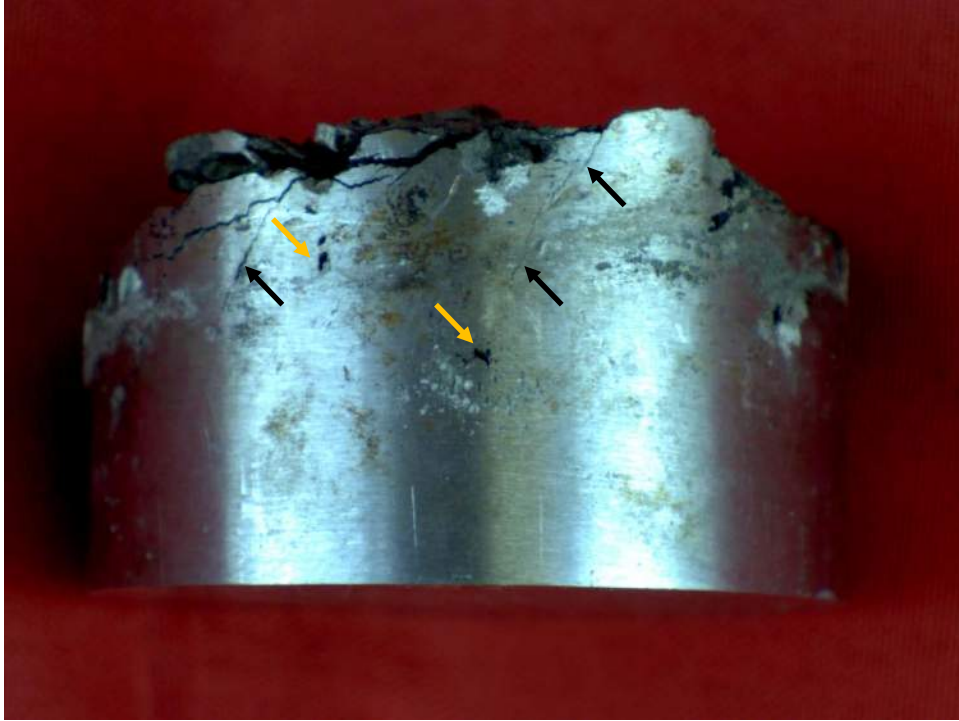
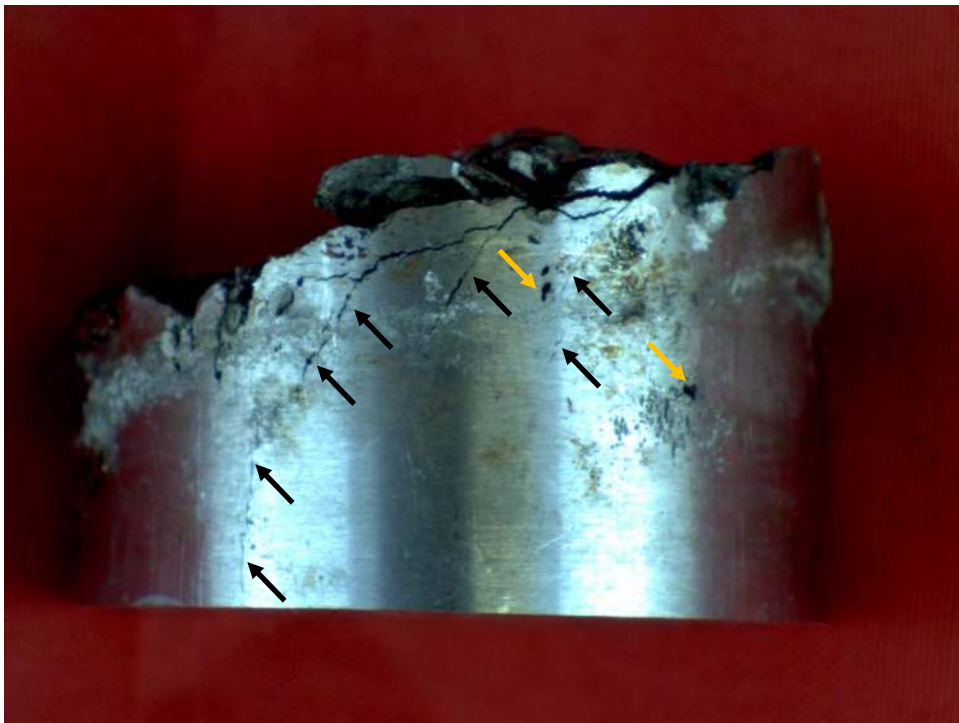
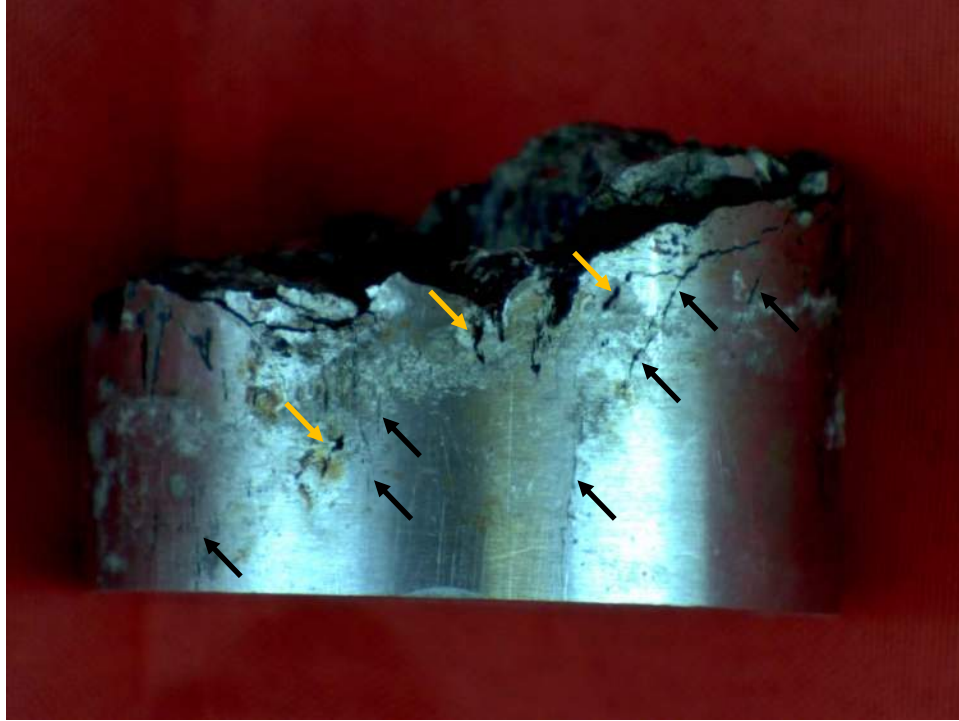
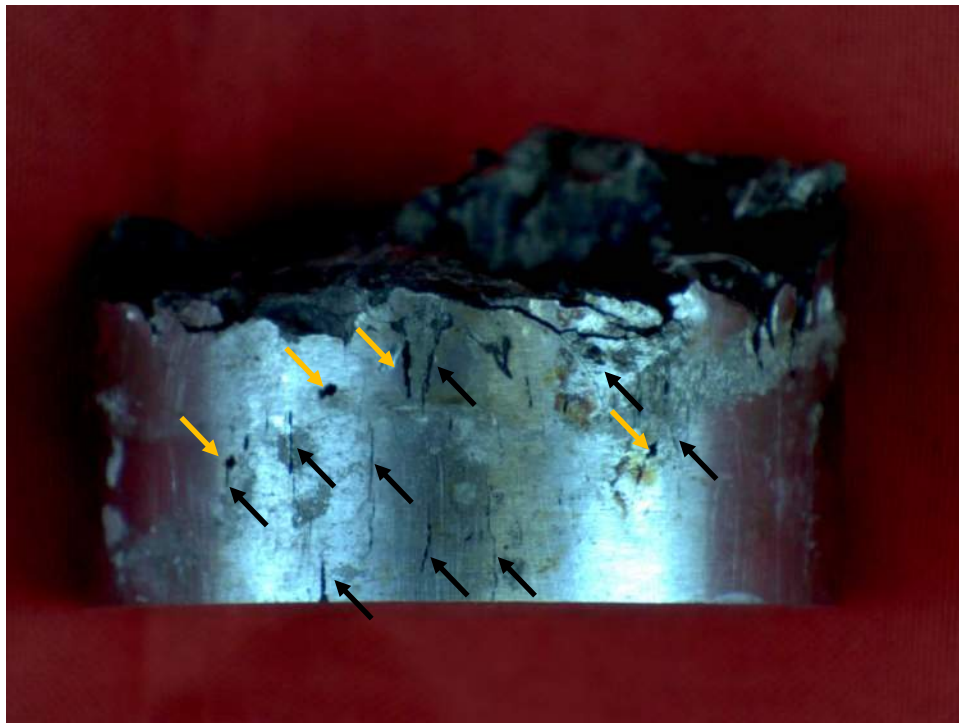
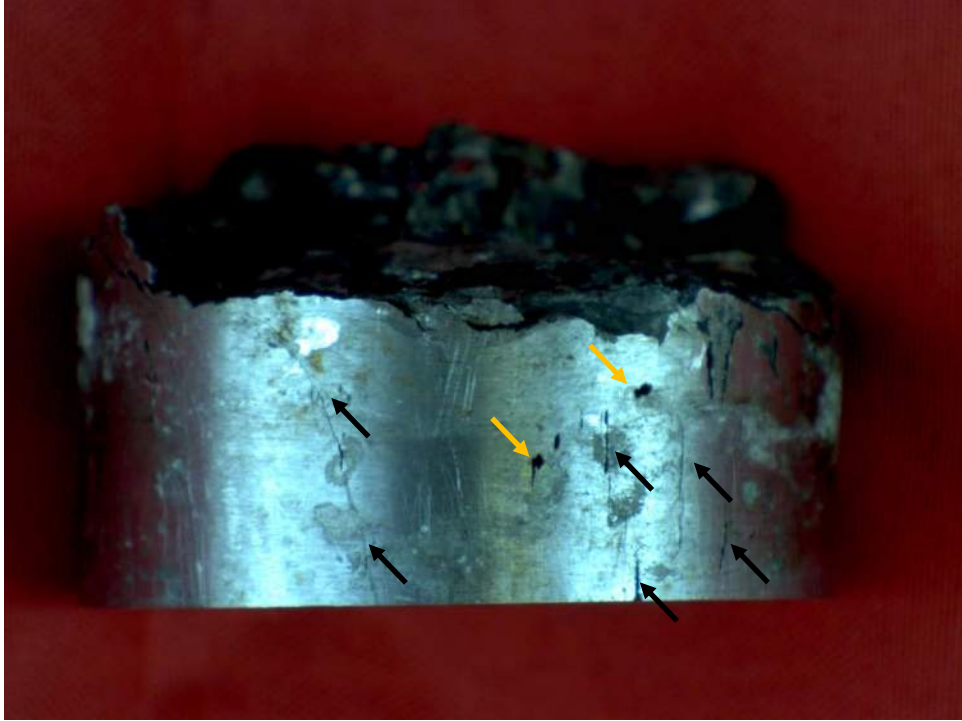
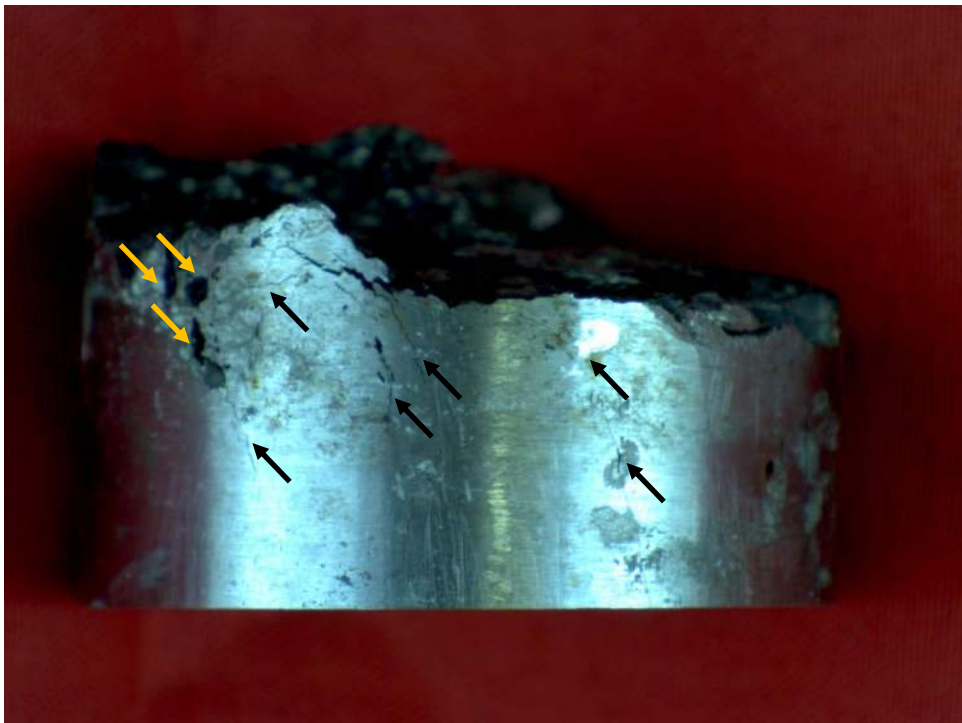
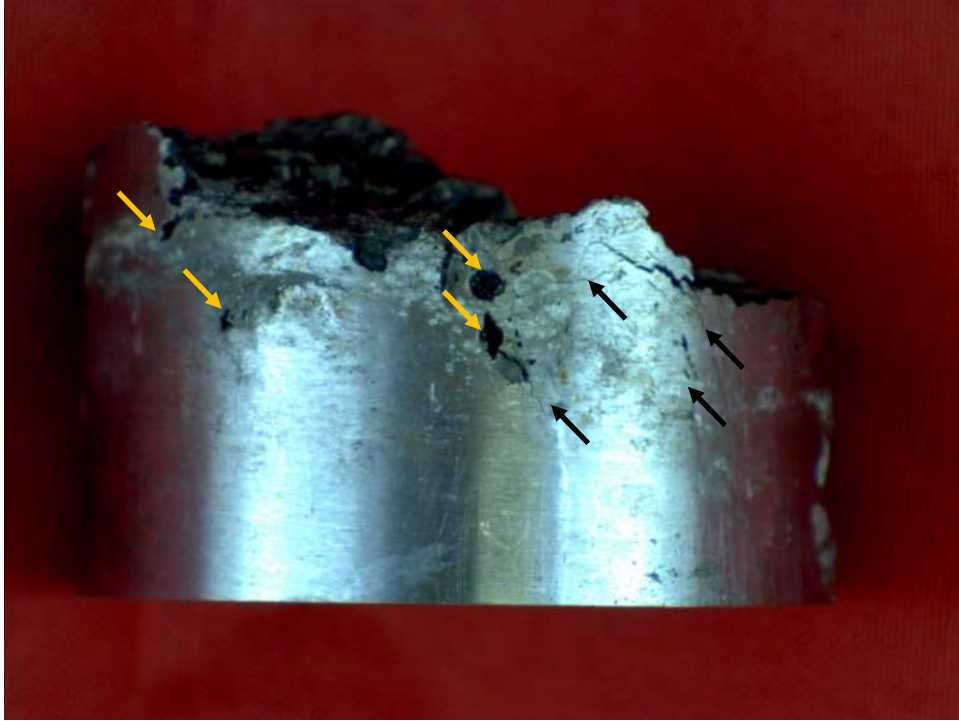
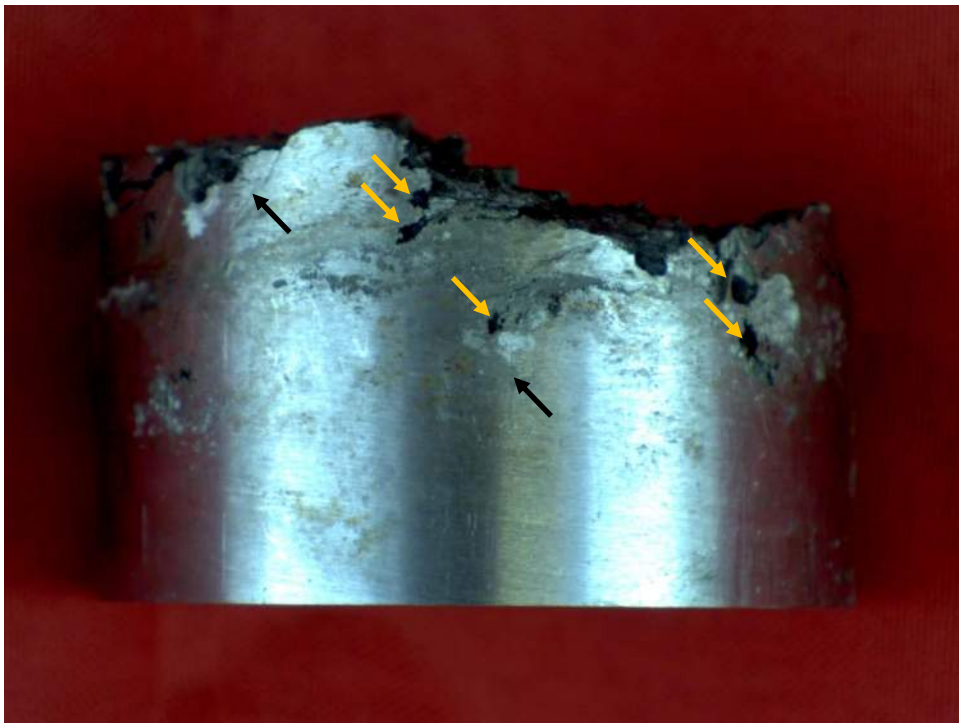
After cleaning it was also quite evident that each rod had a multitude of cracks that could visibly be seen around the perimeter of the rods. Eight photos were taken around each rod perimeter to show these cracks; all of these photos are presented in Appendix A. The pictures were taken by starting at one position (denoted zero degrees) then each subsequent picture was taken by rotating the specimen 45 degrees about its longitudinal axis.

This appendix shows pictures taken around the perimeter of each rod section containing the fracture surface. The first picture taken of each rod section is referred to as the zero degree position, and then the subsequent seven pictures for each rod section are taken after rotating the section 45 degrees about its longitudinal axis. Visually, many cracks and pits can be seen on the outer perimeter; however, black arrows are used to highlight those that are cracks (as some are faint and could be confused with scratches), and orange arrows call out corrosion pits.
