EXISTING CONDITIONS - ASBESTOS / LEAD / HAZARDOUS MATERIAL SURVEY

Wai'anapanapa State Park
Cabin Park Improvements
CABIN 1

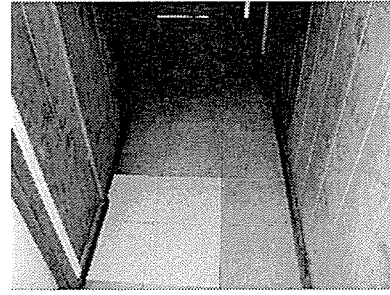
Photo #28
Asbestos containing 12"x12" light-gray tile with with white and maroon specks.

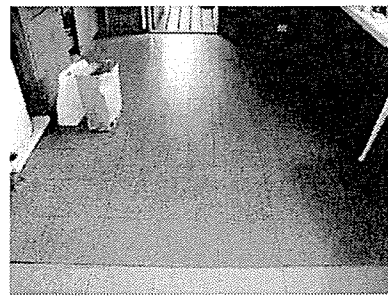
Photo #34
Kitchen, Asbestos containing tile and mastic under the 12"x12" brown speckled tile.

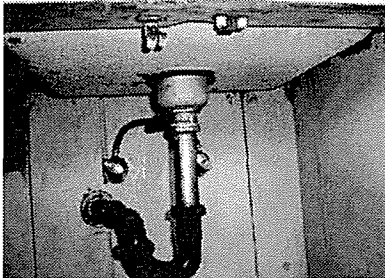
Photo #60
Asbestos containing gray undercoating sink mastic.
