LIMITED LEAD PAINT SURVEY State of Hawaii Laboratories Division 2725 Waimano Home Road Pearl City, Hawaii 96782

January 2025

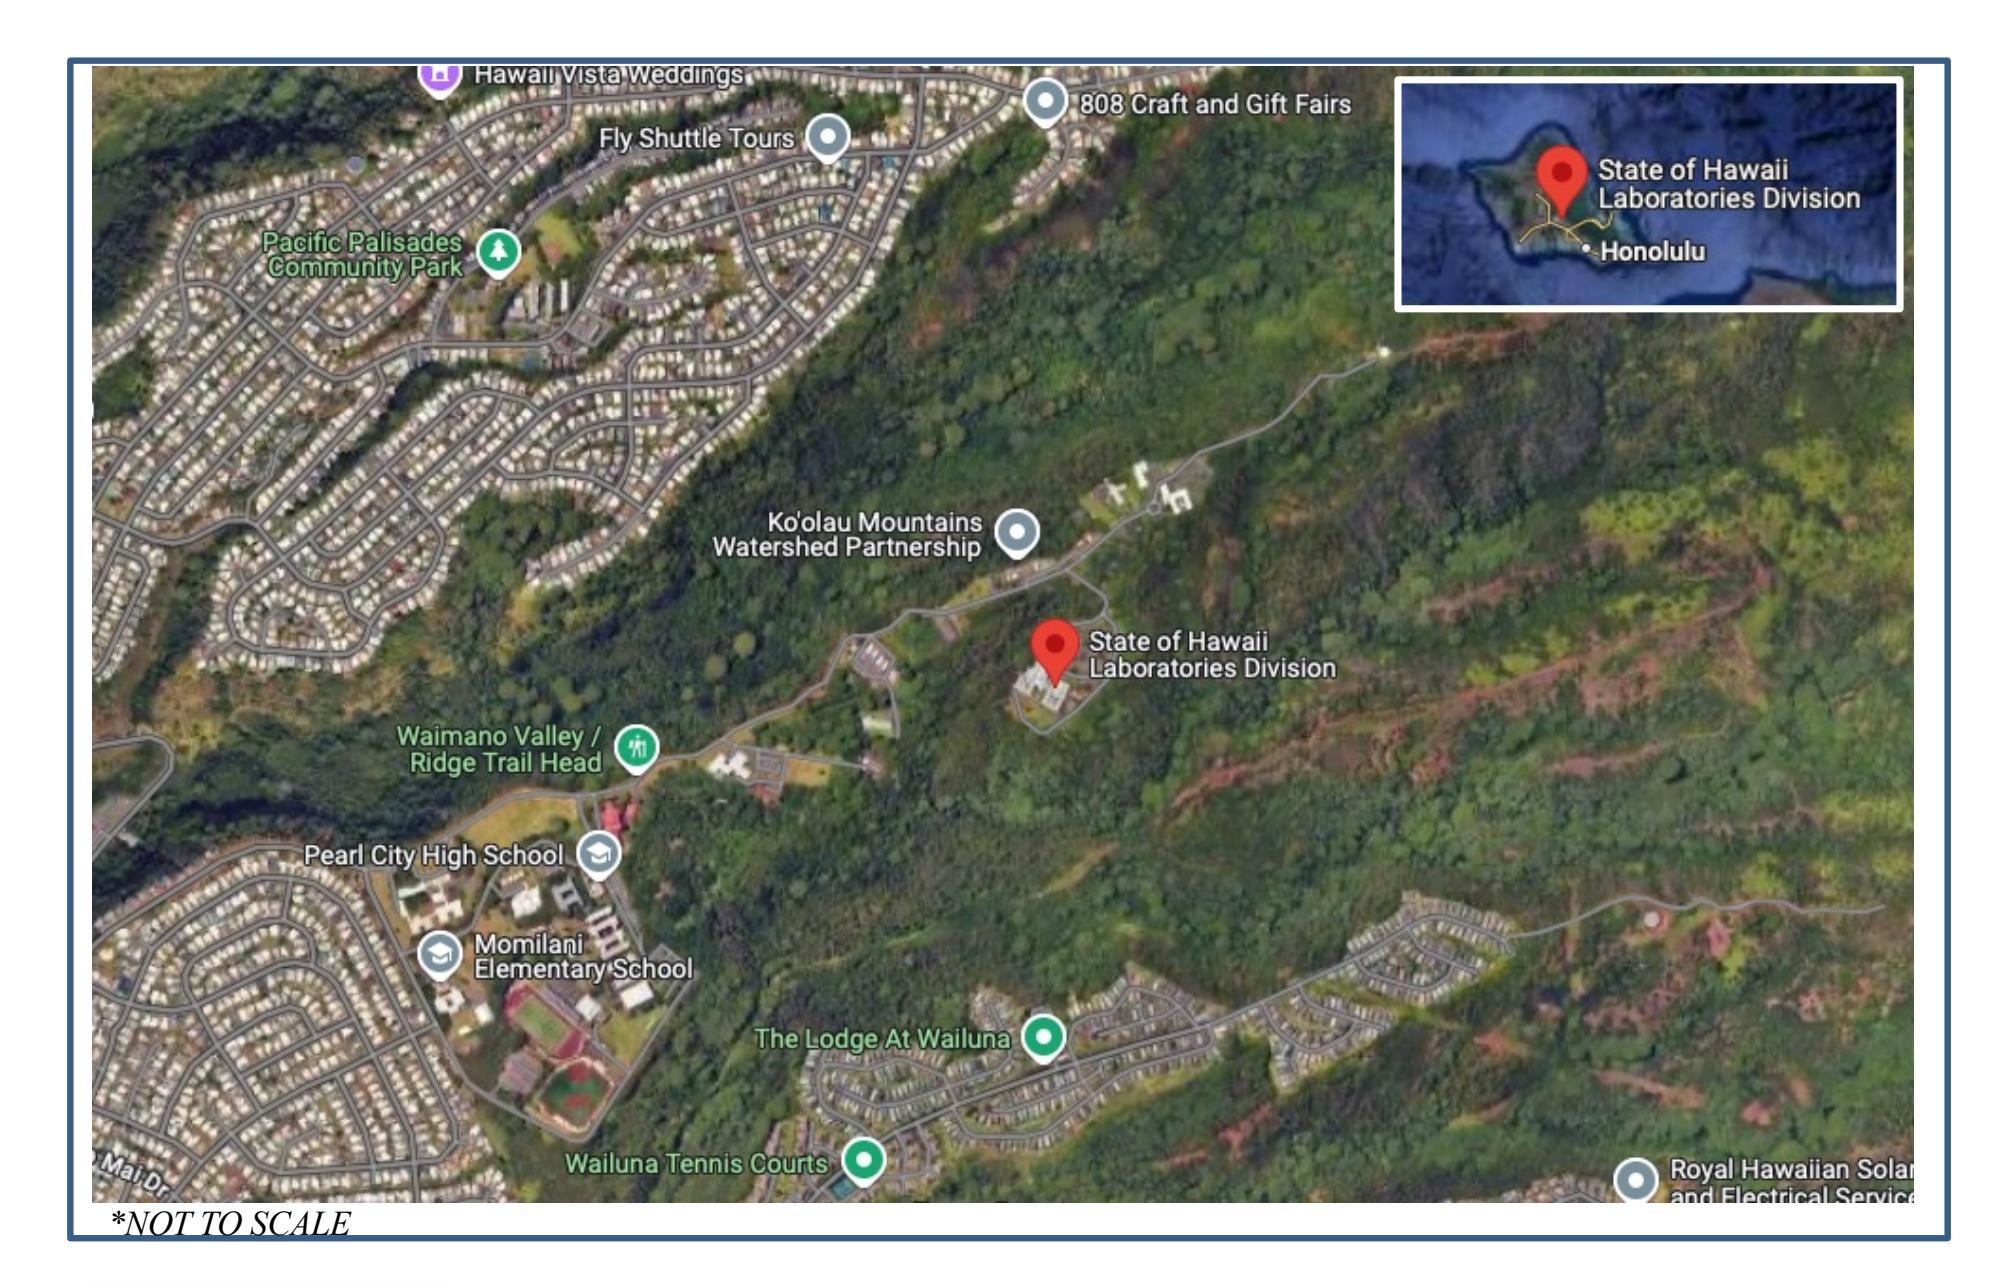
Four (4) paint chip samples were collected as part of this survey. One (1) material was identified with detectable concentrations of lead. Although not applicable to this project, none of the four (4) samples contained concentrations greater than the Department of Housing and Urban Development (HUD) lead based paint classification of 0.5% per weight or 5,000 milligrams/kilogram. Table 1 summarizes the locations of the lead paint chip sampling, color of paint, sample location and the corresponding results. Sample locations are depicted in Figure 2 in Appendix B. Laboratory reports and chain of custody are presented in Appendix D

Sample Location Map 2725 Waimano Home Road Pearl City, Hawaii 96782
