# HAZARDOUS MATERIALS SURVEY REPORT

HAWAII ARMY NATIONAL GUARD  
KEAUKAHA MILITARY RESERVATION  
BUILDING NUMBERS: 501, 502, 629, 630 & 631 AND FIRING  
RANGE BUILDING NUMBERS: 636 & 638  
1304 KEKUANAOKA STREET  
HILO, HAWAII 96720

STATE OF HAWAII – DEPARTMENT OF DEFENSE  
3949 DIAMOND HEAD ROAD  
HONOLULU, HAWAII 96816-4495

**DATE:** MARCH 31, 2026

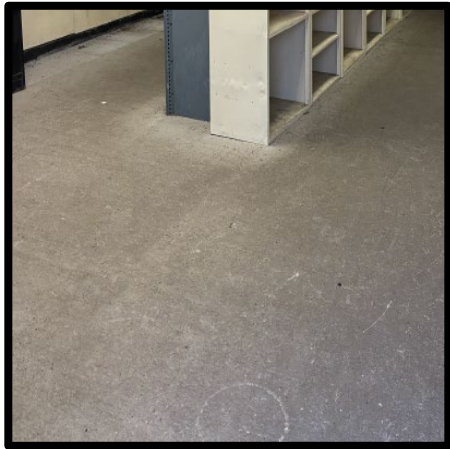
**B501 A1: None Detected**  
**B501 A2: None Detected**  
**B501 A3: None Detected**

Interior grey concrete floor located in room 1 of building 501.

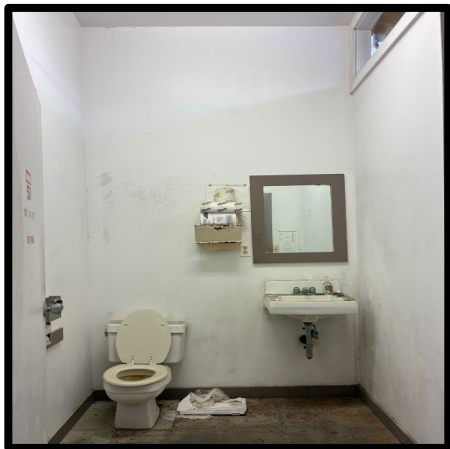
**B501 A4: None Detected**  
**B501 A5: None Detected**  
**B501 A6: None Detected**

Interior white sheetrock wall with joint compound located in room 2 and room 4 of building 501.

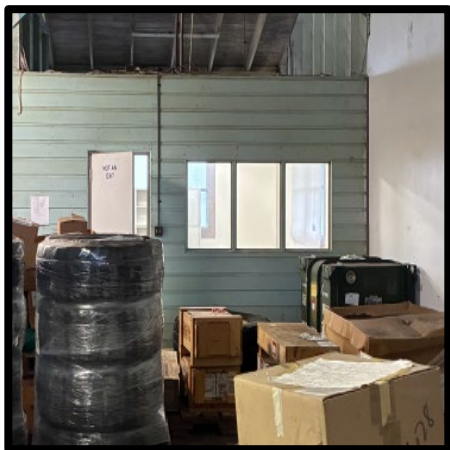
**B501 A7: None Detected**  
**B501 A8: None Detected**  
**B501 A9: None Detected**

Interior white window frame caulking located throughout building 501.

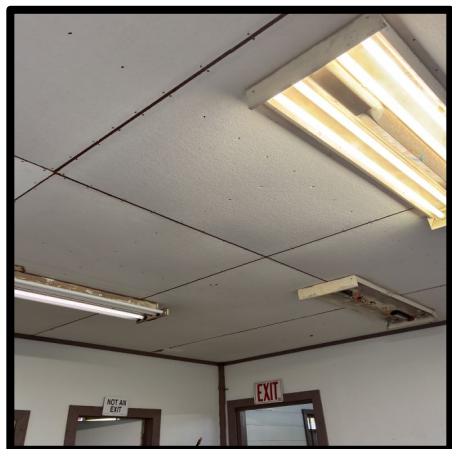
**B501 A10: None Detected**  
**B501 A11: None Detected**  
**B501 A12: None Detected**

Interior white canec ceiling located in room 2 of building 501.

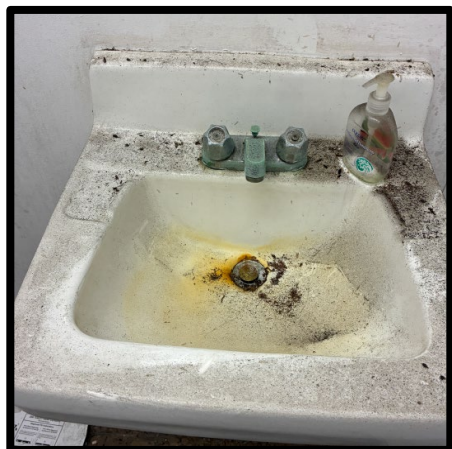
**B501 A13: None Detected**  
**B501 A14: None Detected**  
**B501 A15: None Detected**

Interior white sink caulking located in room 4 of building 501.

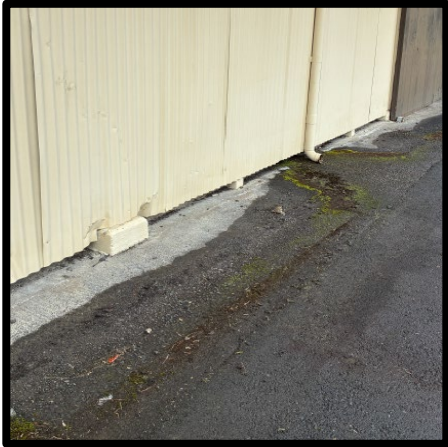
**B501 A19: None Detected**  
**B501 A20: None Detected**  
**B501 A21: None Detected**

Exterior beige concrete post blocks located throughout building 501.

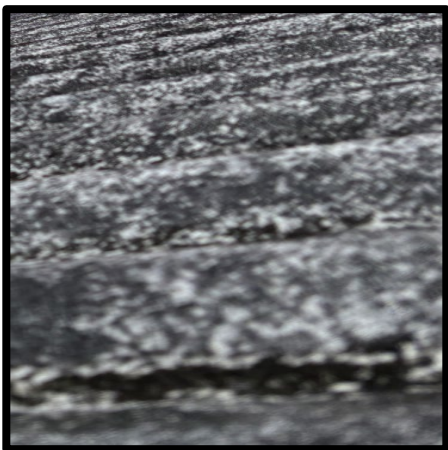
**B501 A25: None Detected**  
**B501 A26: None Detected**  
**B501 A27: None Detected**

Exterior black/white roof panel layer located on the roof of building 501.

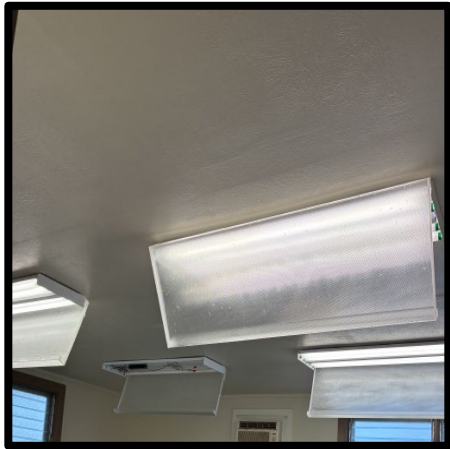
**B502 A1: 2% Chrysotile (Off-white joint compound/paper)**

**B502 A2: Not Analyzed**

**B502 A3: Not Analyzed**

Interior white sheetrock ceiling with joint compound located in room 1 and 6 of building 502.

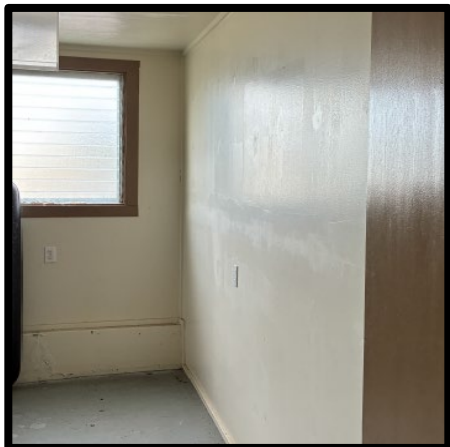
**B502 A4: 2% Chrysotile (Off-white joint compound/paper/beige paint)**

**B502 A5: Not Analyzed**

**B502 A6: Not Analyzed**

Interior white sheetrock wall with joint compound located in room 1, 5 6 of building 502.

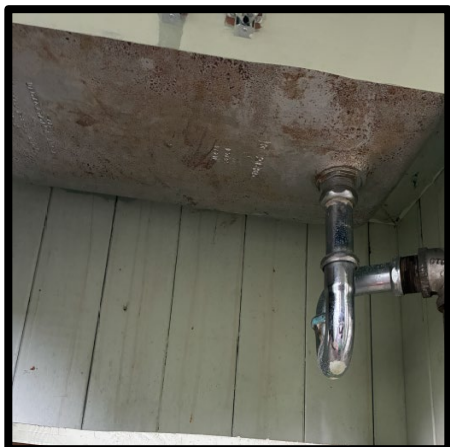
**B502 A7: None Detected**

**B502 A8: None Detected**

Interior grey sink undercoating located in room 2 of building 502.

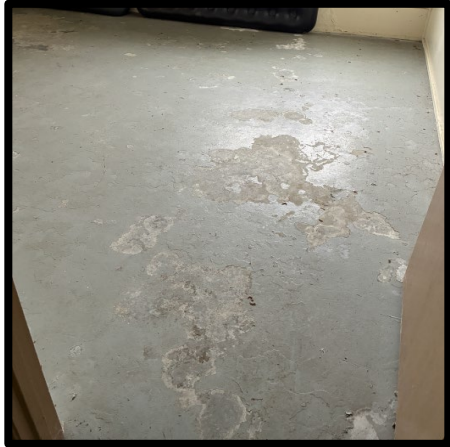
**B502 A10: None Detected  
B502 A11: None Detected  
B502 A12: None Detected**

Interior grey concrete floor located in room 3, room 4, room 5, and room 6 of building 502.

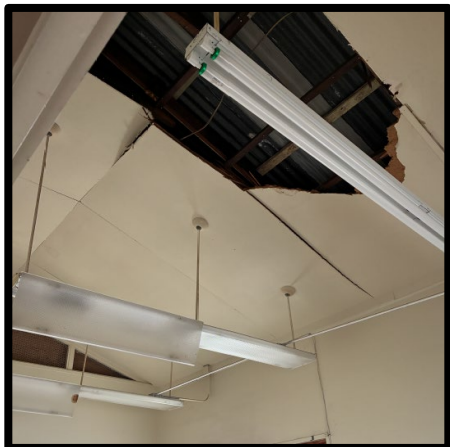
**B502 A13: None Detected  
B502 A14: None Detected  
B502 A15: None Detected**

Interior white canec ceiling located in room 4 and 5 of building 502.

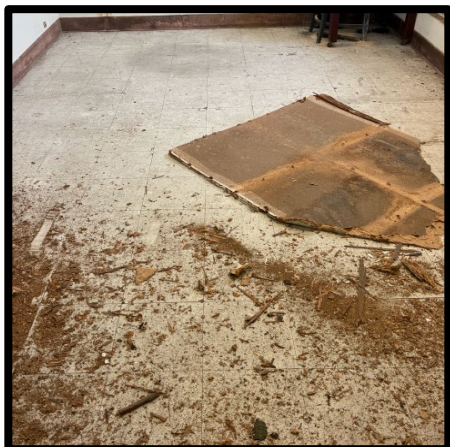
**B502 A16: 4% Chrysotile (Black mastic) <1 %  
Chrysotile (Off-White Vinyl Floor Tile)  
B502 A17: Not Analyzed  
B502 A18: Not Analyzed**

Interior grey 12"x12" vinyl floor tile with black mastic located in room 5 of building 502.

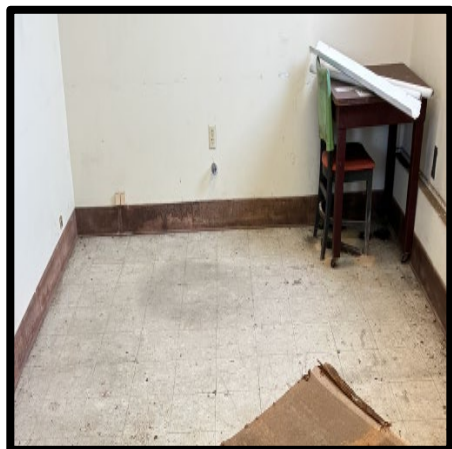
**B502 A19: None Detected**  
**B502 A20: None Detected**  
**B502 A21: None Detected**

Interior brown cove base with adhesive located in room 5 of building 502.

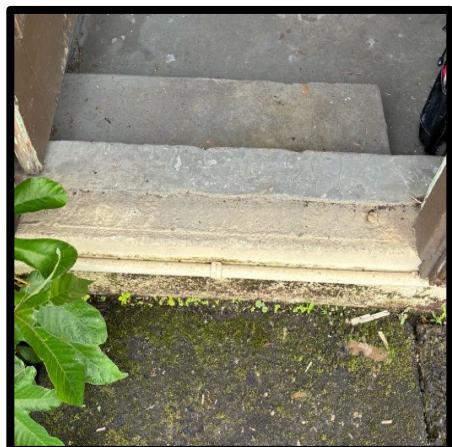
**B502 A22: None Detected**  
**B502 A23: None Detected**  
**B502 A24: None Detected**

Exterior tan concrete base skim coat located throughout building 502.

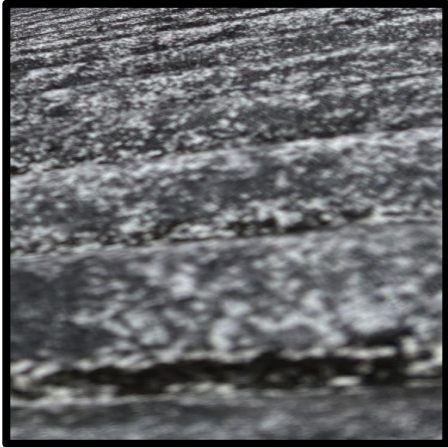
**B502 A28: None Detected**  
**B502 A29: None Detected**  
**B502 A30: None Detected**

Exterior black/white roof panel layer located on the roof of building 502.

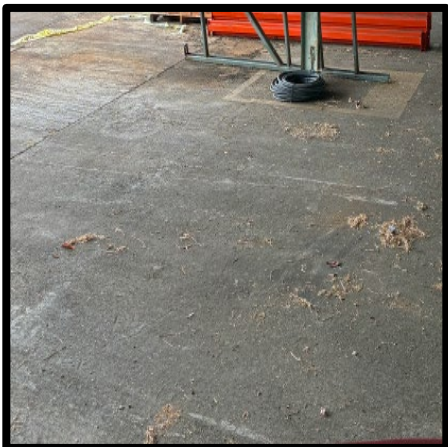
**B629 A1: None Detected**  
**B629 A2: None Detected**  
**B629 A3: None Detected**

Interior grey concrete floor located throughout building 629.

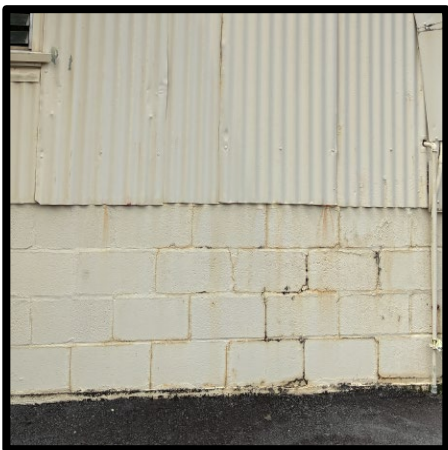
**B629 A4: None Detected**  
**B629 A5: None Detected**  
**B629 A6: None Detected**

Exterior light-yellow CMU skim coat wall located throughout building 629.

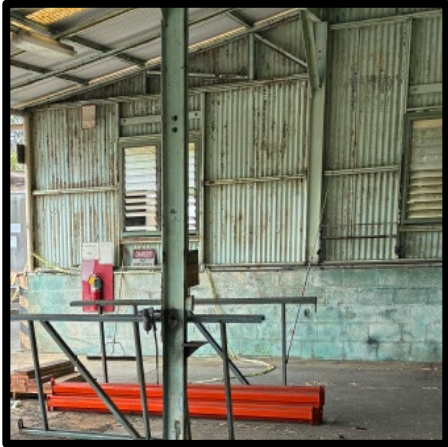
**B629 A7: None Detected**  
**B629 A8: None Detected**  
**B629 A9: None Detected**

Interior green CMU skim coat wall located throughout building 629.

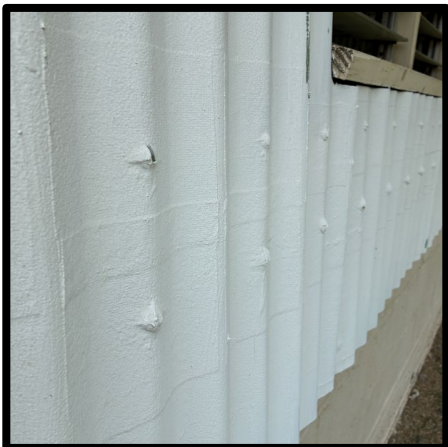
**B629 A10: None Detected**  
**B629 A11: None Detected**  
**B629 A12: None Detected**

Interior white corrugated wall patching tape located throughout building 629.

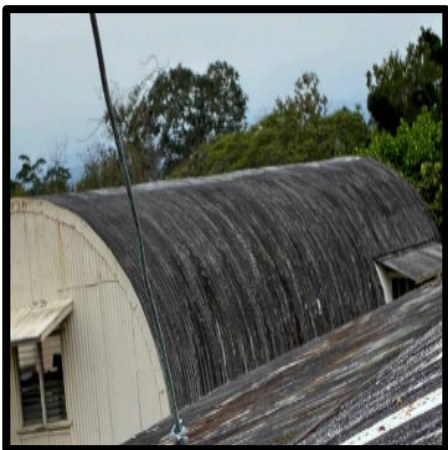
**B629 A13: None Detected**  
**B629 A14: None Detected**  
**B629 A15: None Detected**

Interior black/white roof panel layer throughout building 629.

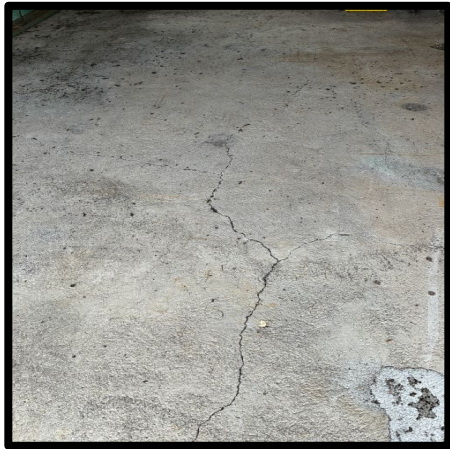
**B630 A1: None Detected**  
**B630 A2: None Detected**  
**B630 A3: None Detected**

Interior grey concrete floor located throughout building 630.

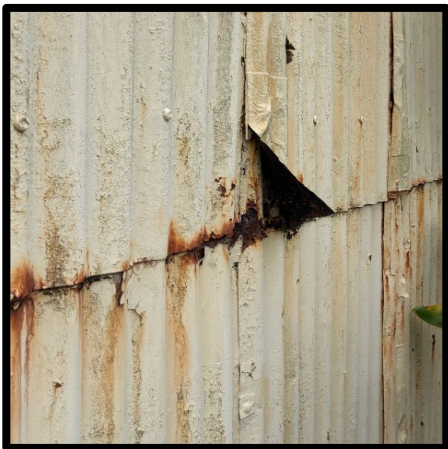
**B630 A13: None Detected**  
**B630 A14: None Detected**  
**B630 A15: None Detected**

Exterior black mastic tape located throughout building 630.

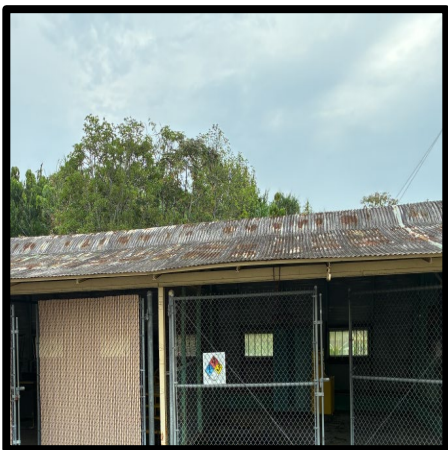
**B630 A16: None Detected**  
**B630 A17: None Detected**  
**B630 A18: None Detected**

Exterior black/white roof panel layer located throughout the roof of building 630.

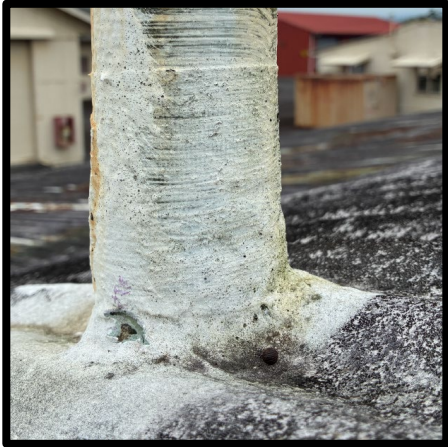
**B630 A19: None Detected**  
**B630 A20: None Detected**  
**B630 A21: None Detected**

Exterior white vent caulking located on the roof of building 630.

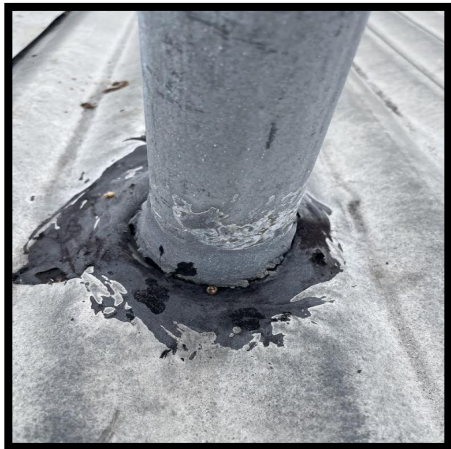
**B631 A1: 8% Chrysotile (Black mastic)**  
**B631 A2: Not Analyzed**  
**B631 A3: Not Analyzed**

Exterior white tape with black mastic located throughout the roof of building 631.

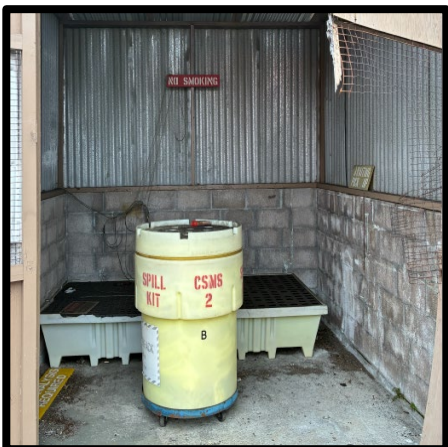
**B631 A4: None Detected**  
**B631 A5: None Detected**  
**B631 A6: None Detected**

Interior grey CMU skim coat wall located in room 1 of building 631.

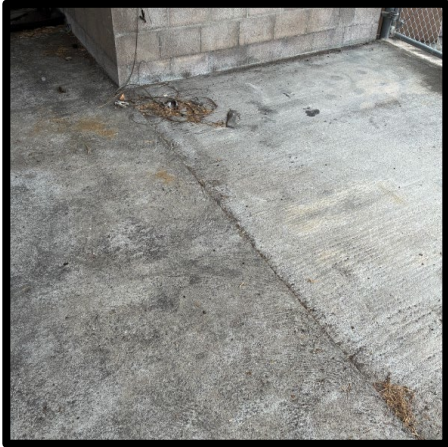
**B631 A7: None Detected**  
**B631 A8: None Detected**  
**B631 A9: None Detected**

Interior grey concrete floor located throughout building 631.

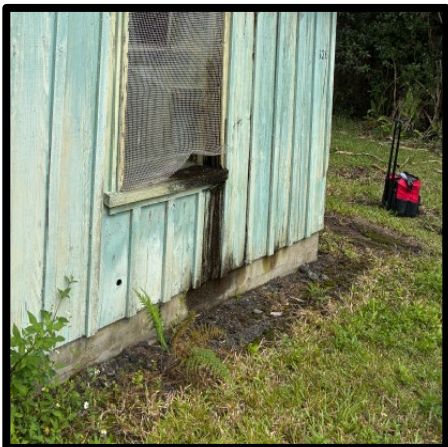
**B636 A1: None Detected**  
**B636 A2: None Detected**  
**B636 A3: None Detected**

Exterior grey concrete base located throughout building 636.

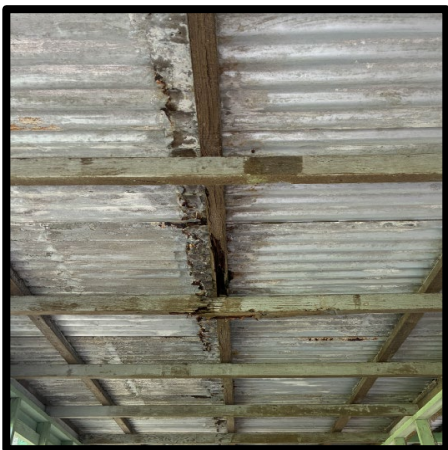
**B638 A1: 2% Chrysotile (Silver coat)**  
**B638 A2: Not Analyzed**  
**B638 A3: Not Analyzed**

Exterior silver underroof paint located on the roof of building 638.

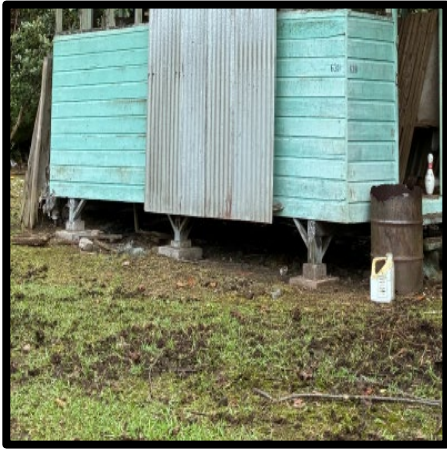
**B638 A4: 2% Chrysotile (Silver coat)**

**B638 A5: Not Analyzed**

**B638 A6: Not Analyzed**

Exterior silver understructure framing located throughout building 638.

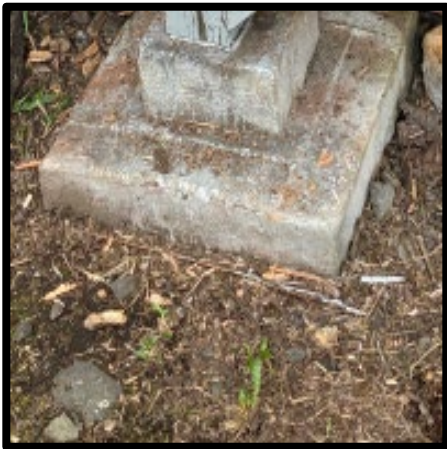
**B638 A7: <1 % Chrysotile (Silver Coat)**

**B638 A8: Not Analyzed**

Exterior grey concrete pier block located throughout building 638.

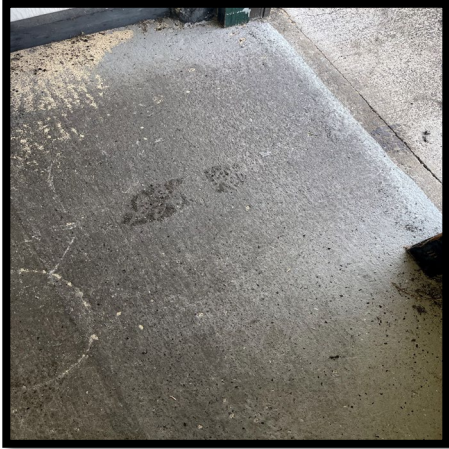
**B501 L1: LCP (470 mg/kg)**

Interior grey concrete flooring located in room 1 of building 501.

- If planned renovation and/or demolition activities occur at the Subject Site, spot remove and dispose of all loose and flaking (poor condition) LBP and LCP that may be disturbed or become dislodged during renovation/demolition activities in accordance with applicable local, state, and federal regulations.
- Workers performing disturbance of LBP and LCP must take appropriate measures to comply with applicable OSHA and HIOSH regulations pertaining to the handling of lead containing materials, lead dust and worker protection. Note that OSHA and HIOSH regulate activities that disturb paint which contain any detectable concentration of lead.
- A qualified consultant should be obtained to conduct air monitoring and inspection activities to ensure compliance with applicable state and federal regulations pertaining to the handling of lead paint.

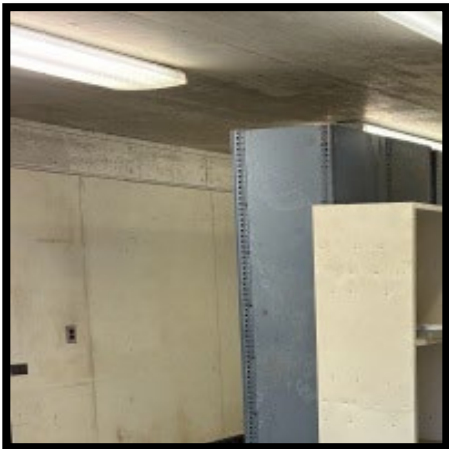
**B501 L2: LCP (45 mg/kg)**

Interior white wood wall and ceiling located in room 1 of building 501.

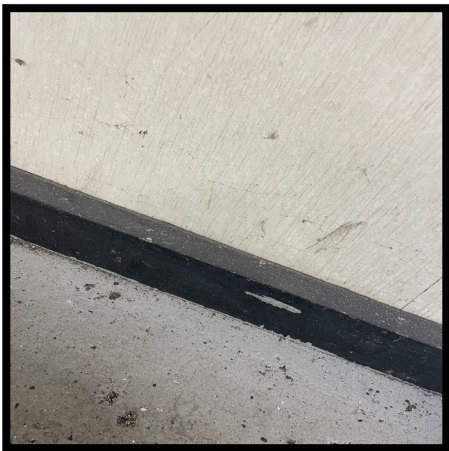
**B501 L3: LCP (330 mg/kg)**

Interior black wood baseboard located in room 1 of building 501.

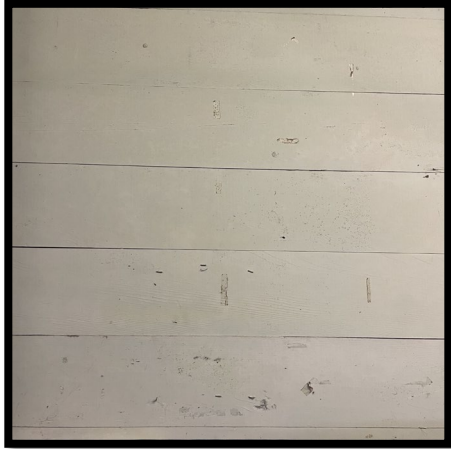
**B501 L4: LBP (11,000 mg/kg)**

Interior green wood walls located throughout building 501.

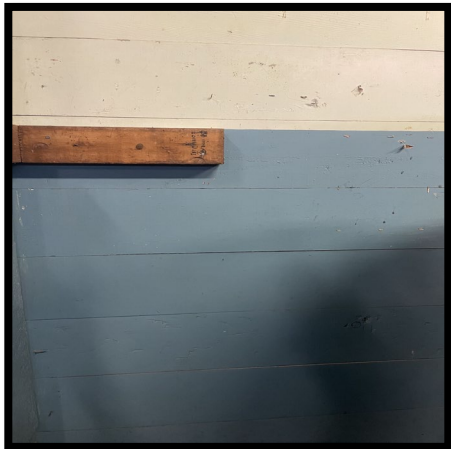
**B501 L5: LBP (42,000 mg/kg)**

Interior blue wood walls and supports located throughout building 501.

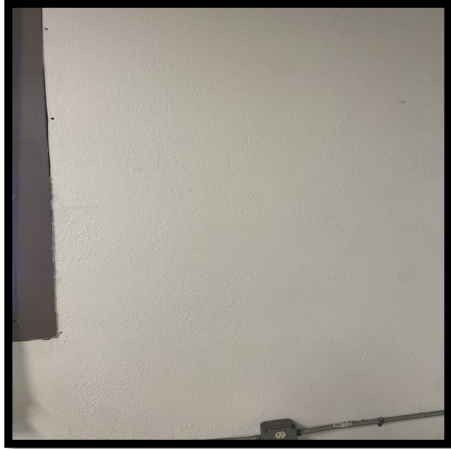
**B501 L7: Does not contain lead above the laboratory detection limit (< 40 mg/kg)**

Interior white sheetrock walls located in room 2 and 4 of building 501.

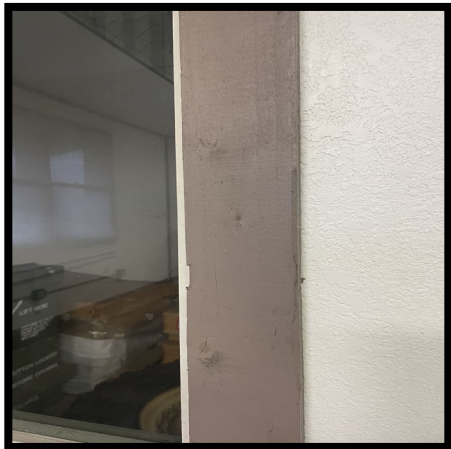
**B501 L8: Does not contain lead above the laboratory detection limit (< 40 mg/kg)**

Interior brown wood window frames located in room 2 of building 501.

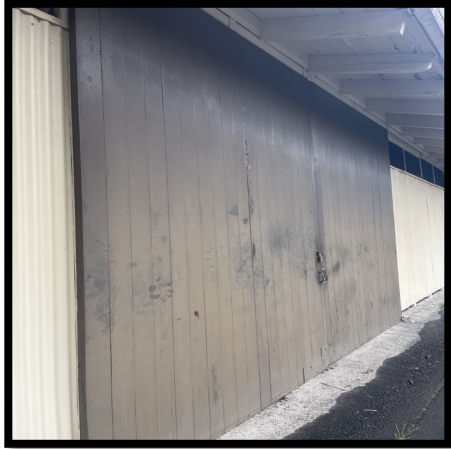
**B501 L10: LBP (7,900 mg/kg)**

Interior and exterior brown wood apparatus door located throughout building 501.

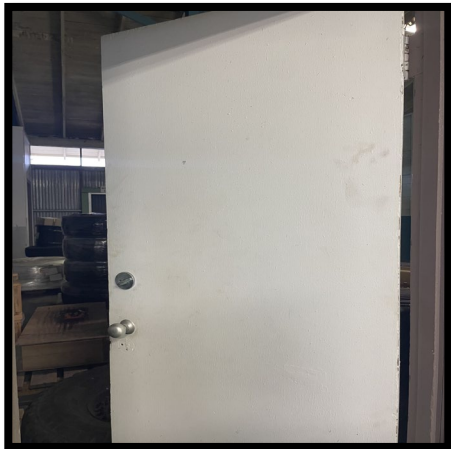
**B501 L11: LCP (580 mg/kg)**

Interior white wood doors located in room 2 of building 501.

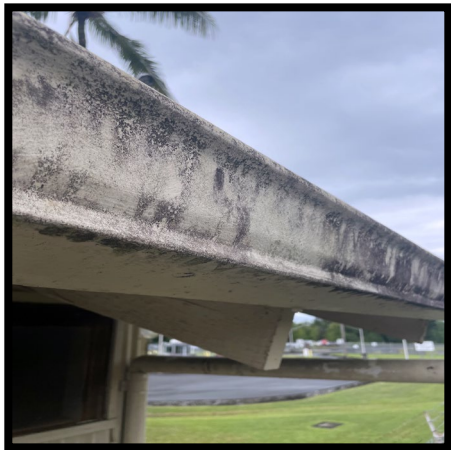
**B501 L15: Does not contain lead above the laboratory detection limit (<40 mg/kg)**

Exterior beige PVC gutters located throughout building 501.

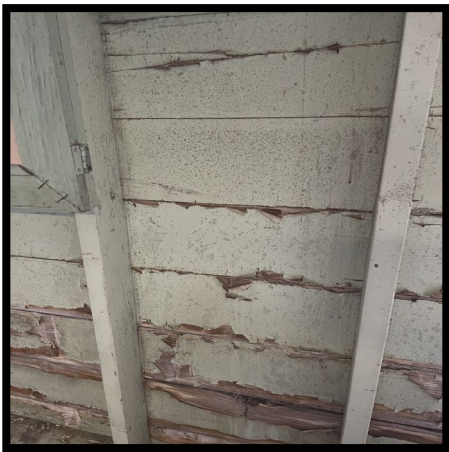
**B502 L1: LCP (1,900 mg/kg)**

Interior green wood wall, door and door frame located throughout building 502.

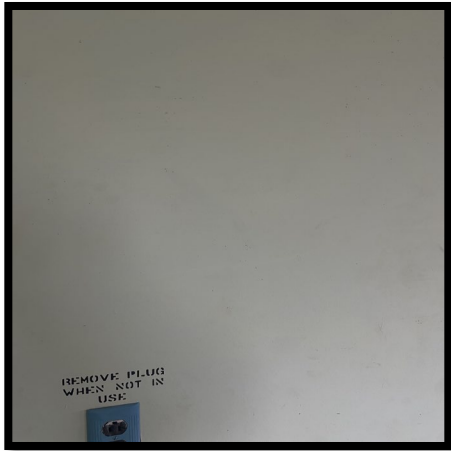
**B502 L6: LCP (1,500 mg/kg)**

Interior green sheetrock walls located in rooms 1, 2 and 3 of building 502.

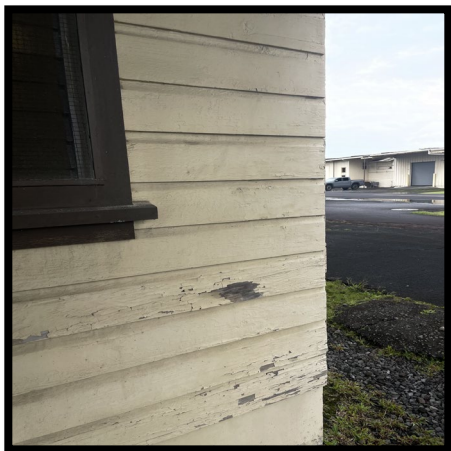
**B502 L7: LCP (1,300 mg/kg)**

Exterior beige wood walls and rafters located throughout building 502.

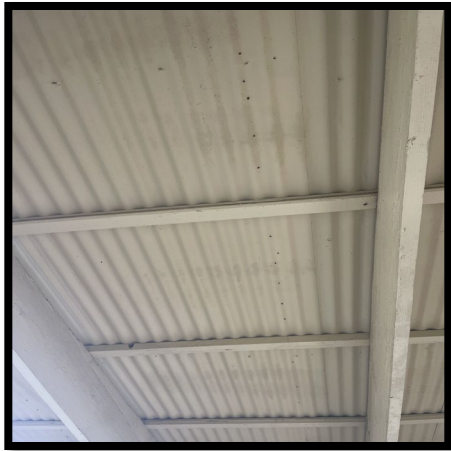
**B502 L9: Does not contain lead above the laboratory detection limit (< 40 mg/kg)**

Exterior beige metal corrugated roof panel underside located throughout building 502.

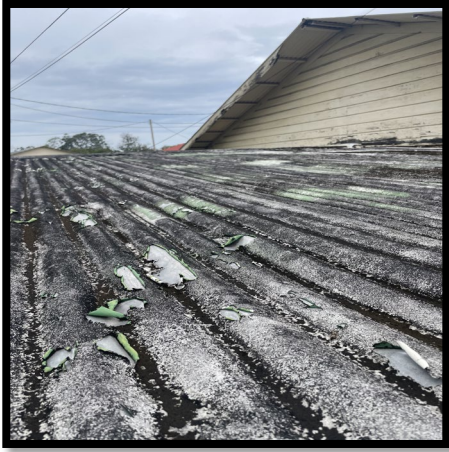
**B502 L14: Does not contain lead above the laboratory detection limit ( $< 40$  mg/kg)**

Exterior off white metal corrugated roof panel top located throughout building 502.

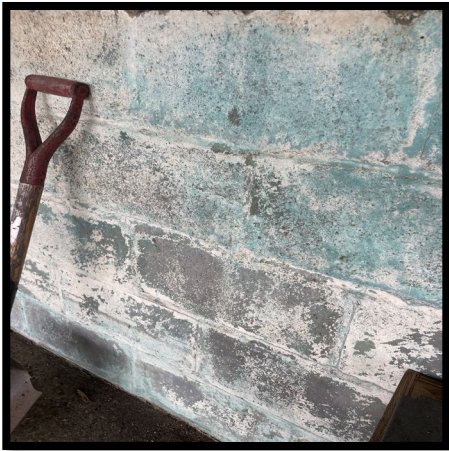
**B629 L1: LBP (8,200 mg/kg)**

Interior green CMU wall located throughout building 629.

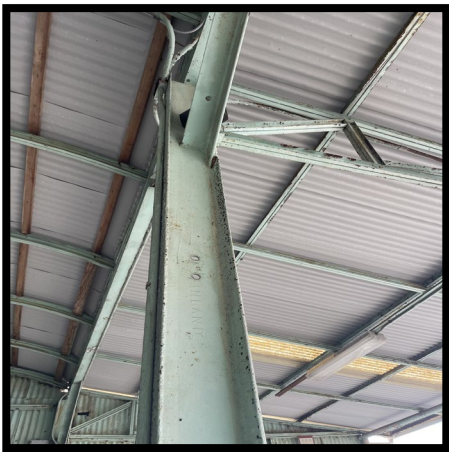
**B629 L2: LBP (50,000 mg/kg)**

Interior green metal posts and framing located throughout building 629.

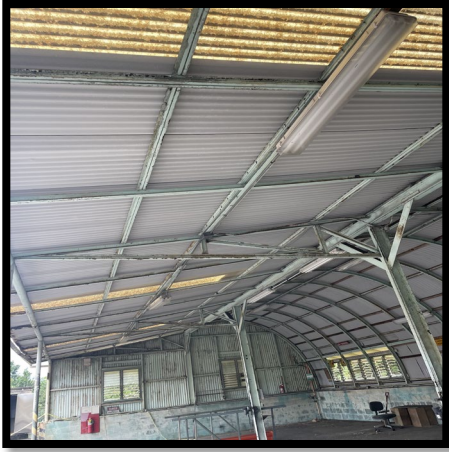
**B629 L3: LCP (570 mg/kg)**

Interior grey metal corrugated roof panel ceiling located throughout building 629.

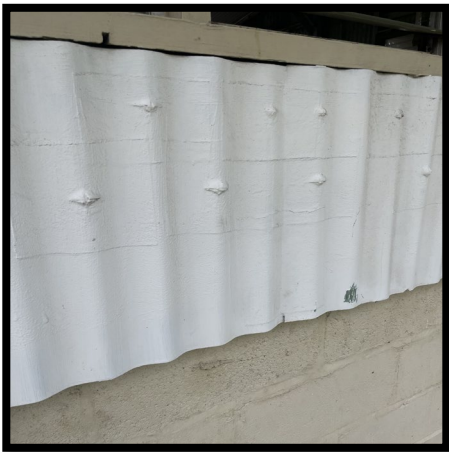
**B629 L4: Does not contain lead above the laboratory detection limit (< 40 mg/kg)**

Exterior off white metal corrugated roof panel located throughout building 629.

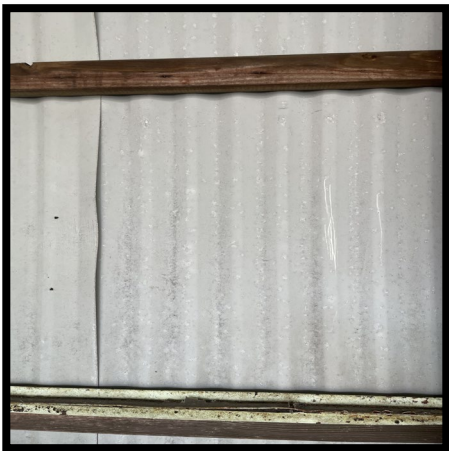
**B629 L5: LCP (860 mg/kg)**

Interior green metal corrugated wall panel located throughout building 629.

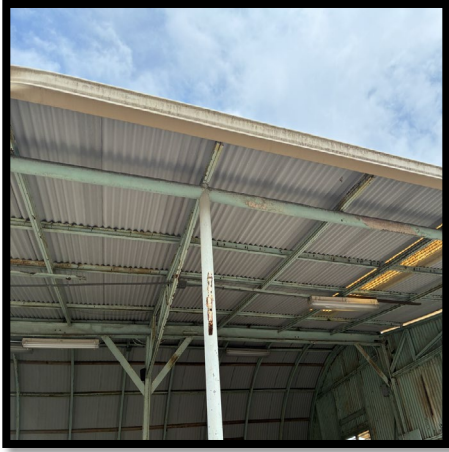
**B629 L6: Does not contain lead above the laboratory detection limit ( $< 40$  mg/kg)**

Exterior beige PVC downspout located throughout building 629.

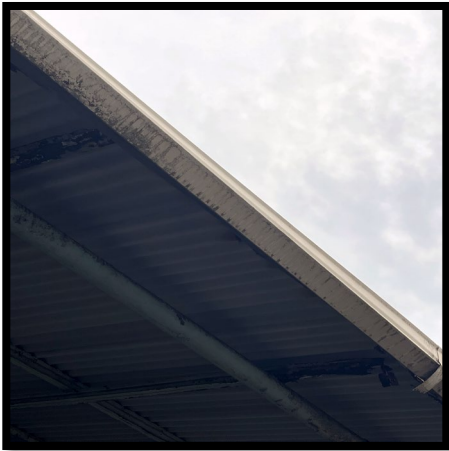
**B629 L7: LCP (66 mg/kg)**

Exterior beige metal gutters located throughout building 629.

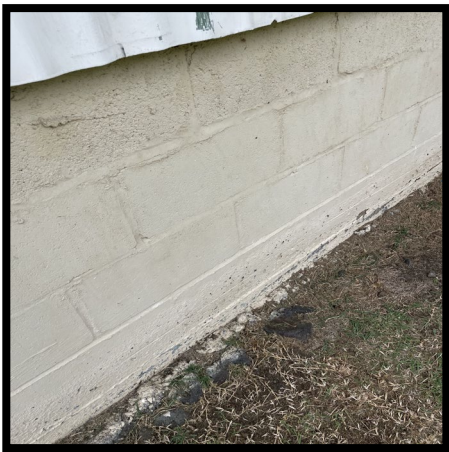
**B629 L8: LCP (100 mg/kg)**

Exterior beige CMU walls located throughout building 629.

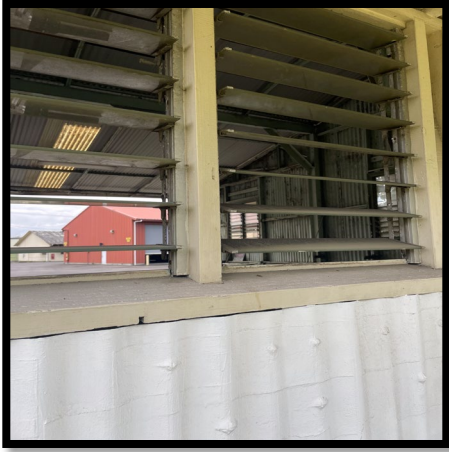
**B629 L9: LCP (2,700 mg/kg)**

Exterior brown wood window frame located throughout building 629.

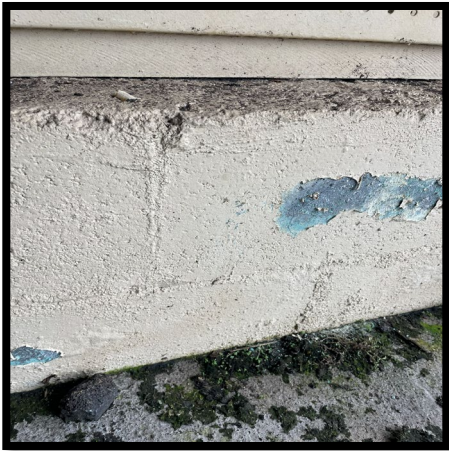
**B630 L1: LCP (220 mg/kg)**

Interior and exterior beige CMU wall located throughout building 630.

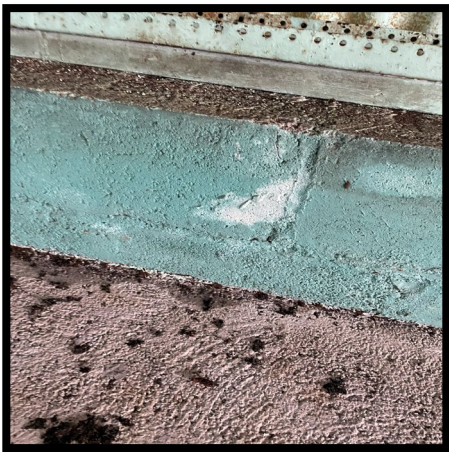
**B630 L2: LCP (520 mg/kg)**

Interior green CMU wall located throughout building 630.

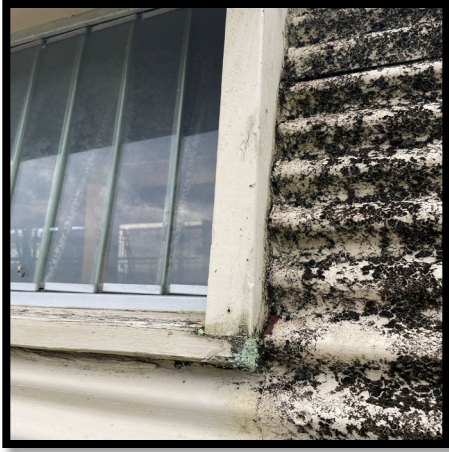
**B630 L6: Does not contain lead above the laboratory detection limit ( $< 40$  mg/kg)**

Exterior off-white metal corrugated wall and roof panels located throughout building 630.

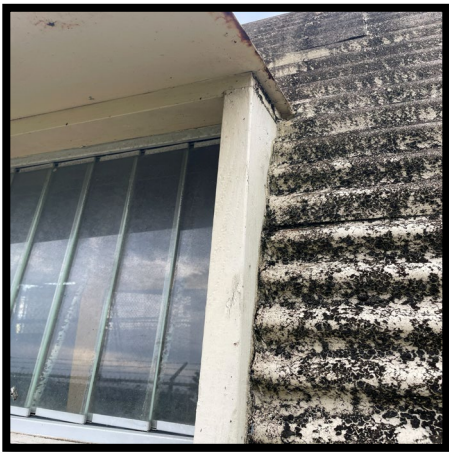
**B630 L7: LCP (120 mg/kg)**

Exterior beige wood window frame located throughout building 630.

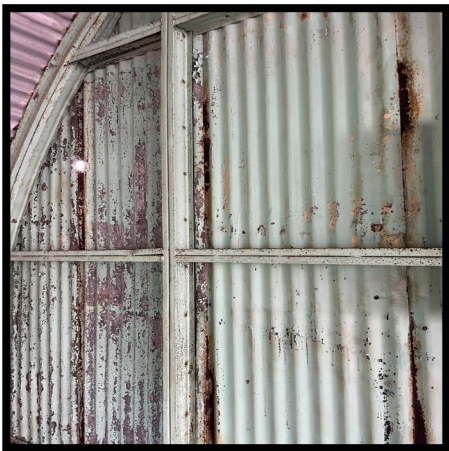
**B630 L8: LCP (2,700 mg/kg)**

Interior and exterior green metal corrugated wall panels located throughout building 630.

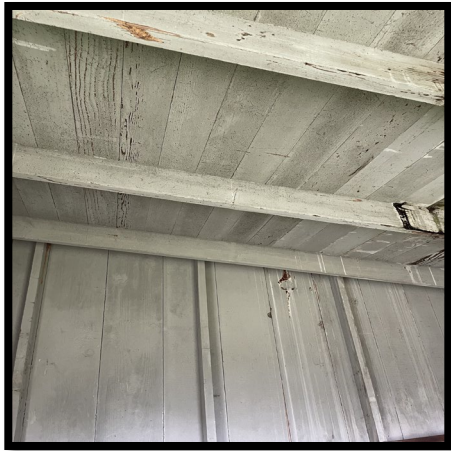
**B636 L2: LCP (4,200 mg/kg)**

Interior grey wood walls and framing located throughout building 636.

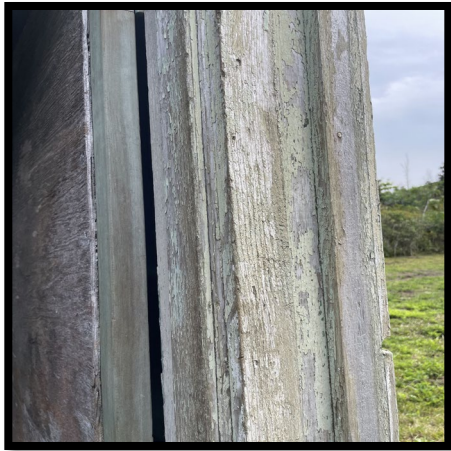
**B636 L5: LBP (50,000 mg/kg)**

Interior and exterior grey wood door and door frame located throughout building 636.

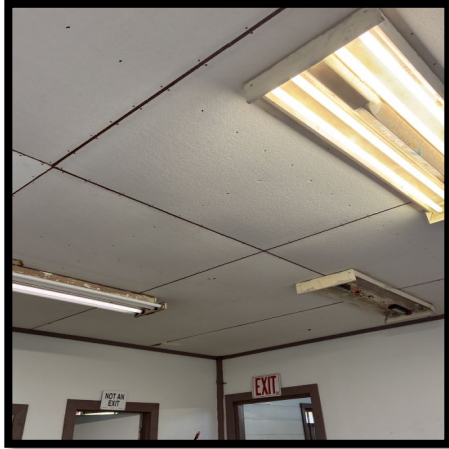
**B501 AR1: Arsenic-containing building product  
(4,500 mg/kg)**

Interior white canec ceiling located in room 2 of building 501.

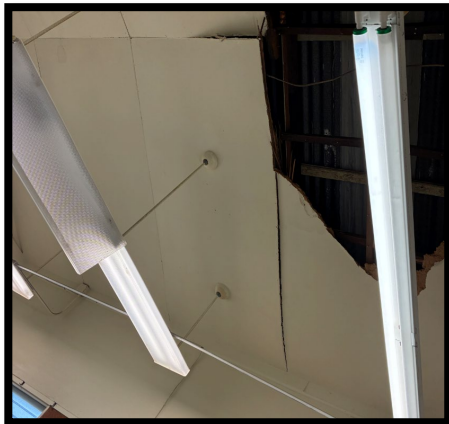
**B502 AR1: Arsenic-containing building product  
(4,500 mg/kg)**

Interior white canec ceiling located in room 4 and 6 of building 502.

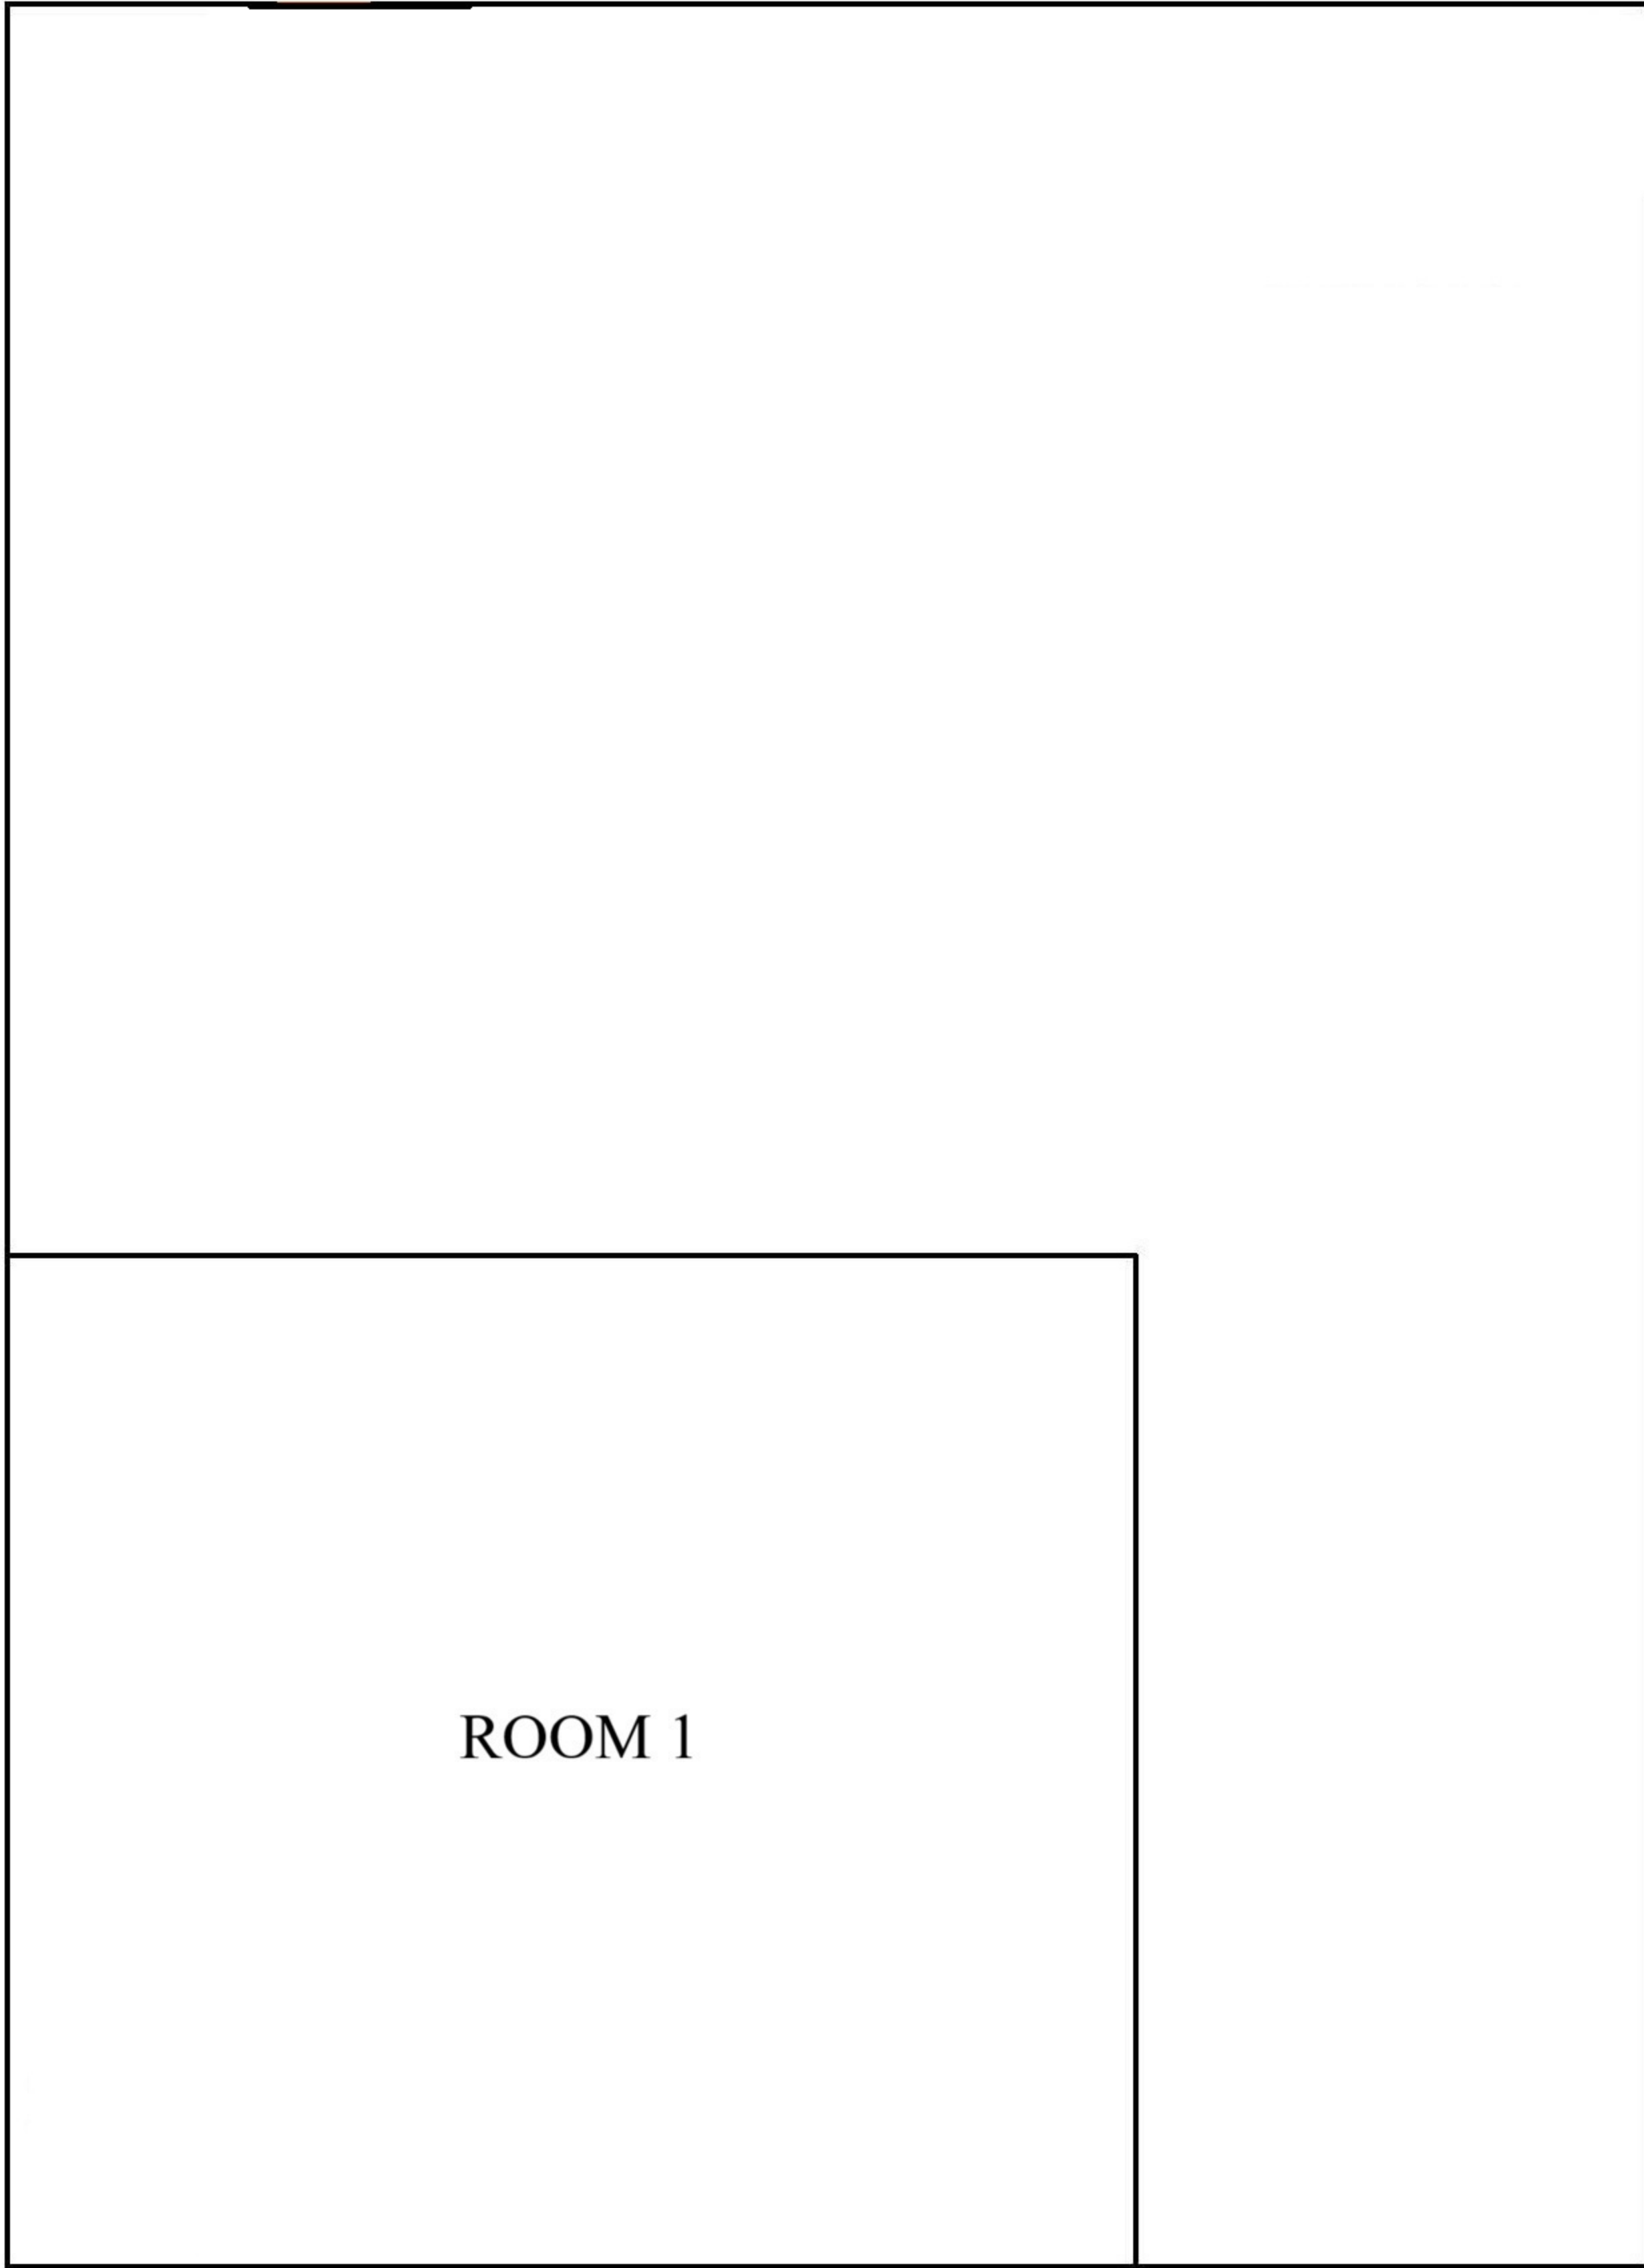
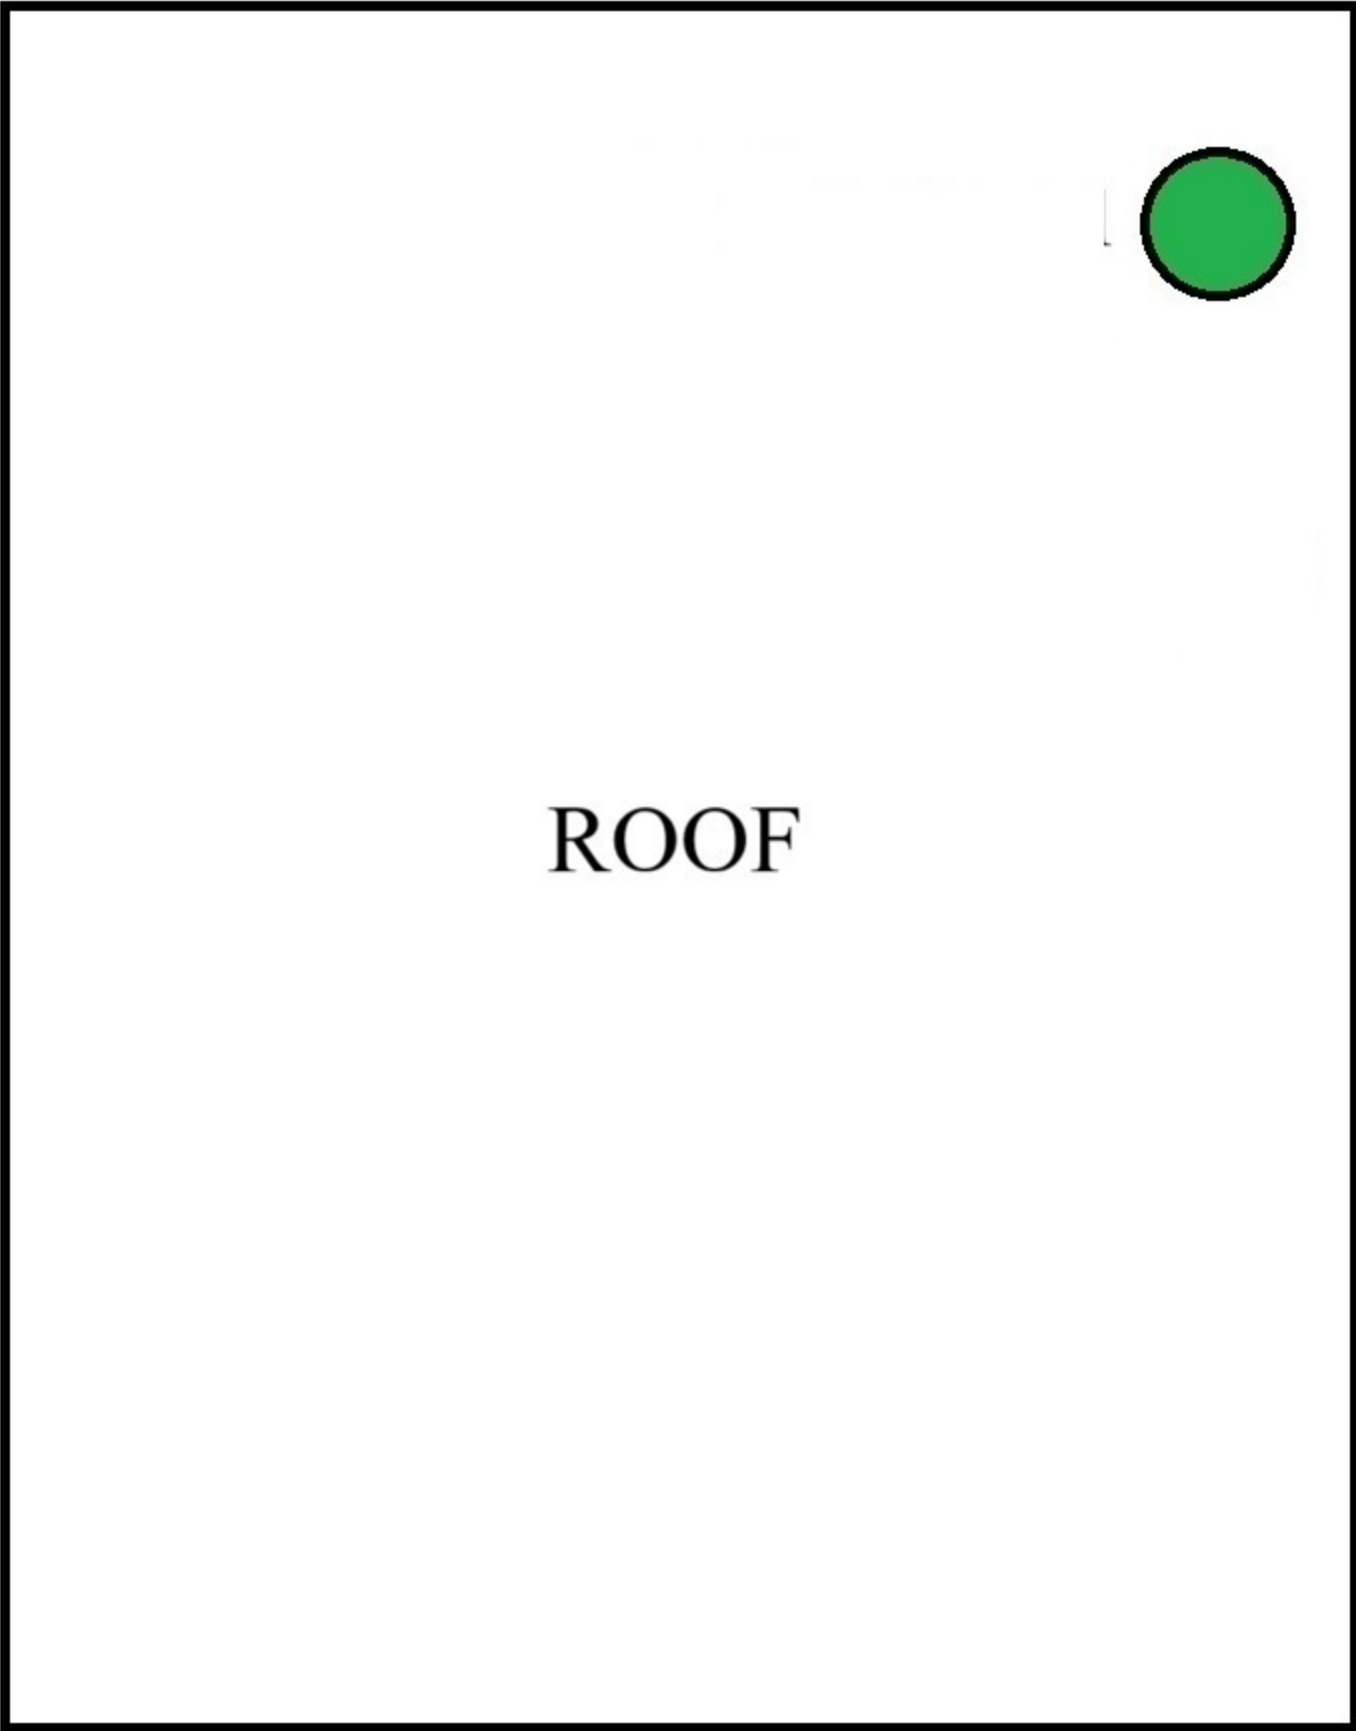
| | FIGURE<br>3C | BUILDNG 638 ACM Location<br>LOCATION MAP |

| <u>LEGEND</u> | |
|---|---|
| | Identified ACM. Exterior<br>Black Vent Mastic |
