**DRAFT**  
**GEOTECHNICAL ENGINEERING EXPLORATION**  
**IAO VALLEY STATE MONUMENT FLOOD REPAIRS**  
**JOB NO. J45CM41A**  
**INTERIM REMEDIAL MEASURES**  
**WAILUKU, MAUI, HAWAII**

**W.O. 7417-00(A)    DECEMBER 1, 2016**

**WILSON OKAMOTO CORPORATION**

**STATE OF HAWAII**  
**DEPARTMENT OF LAND & NATURAL RESOURCES**

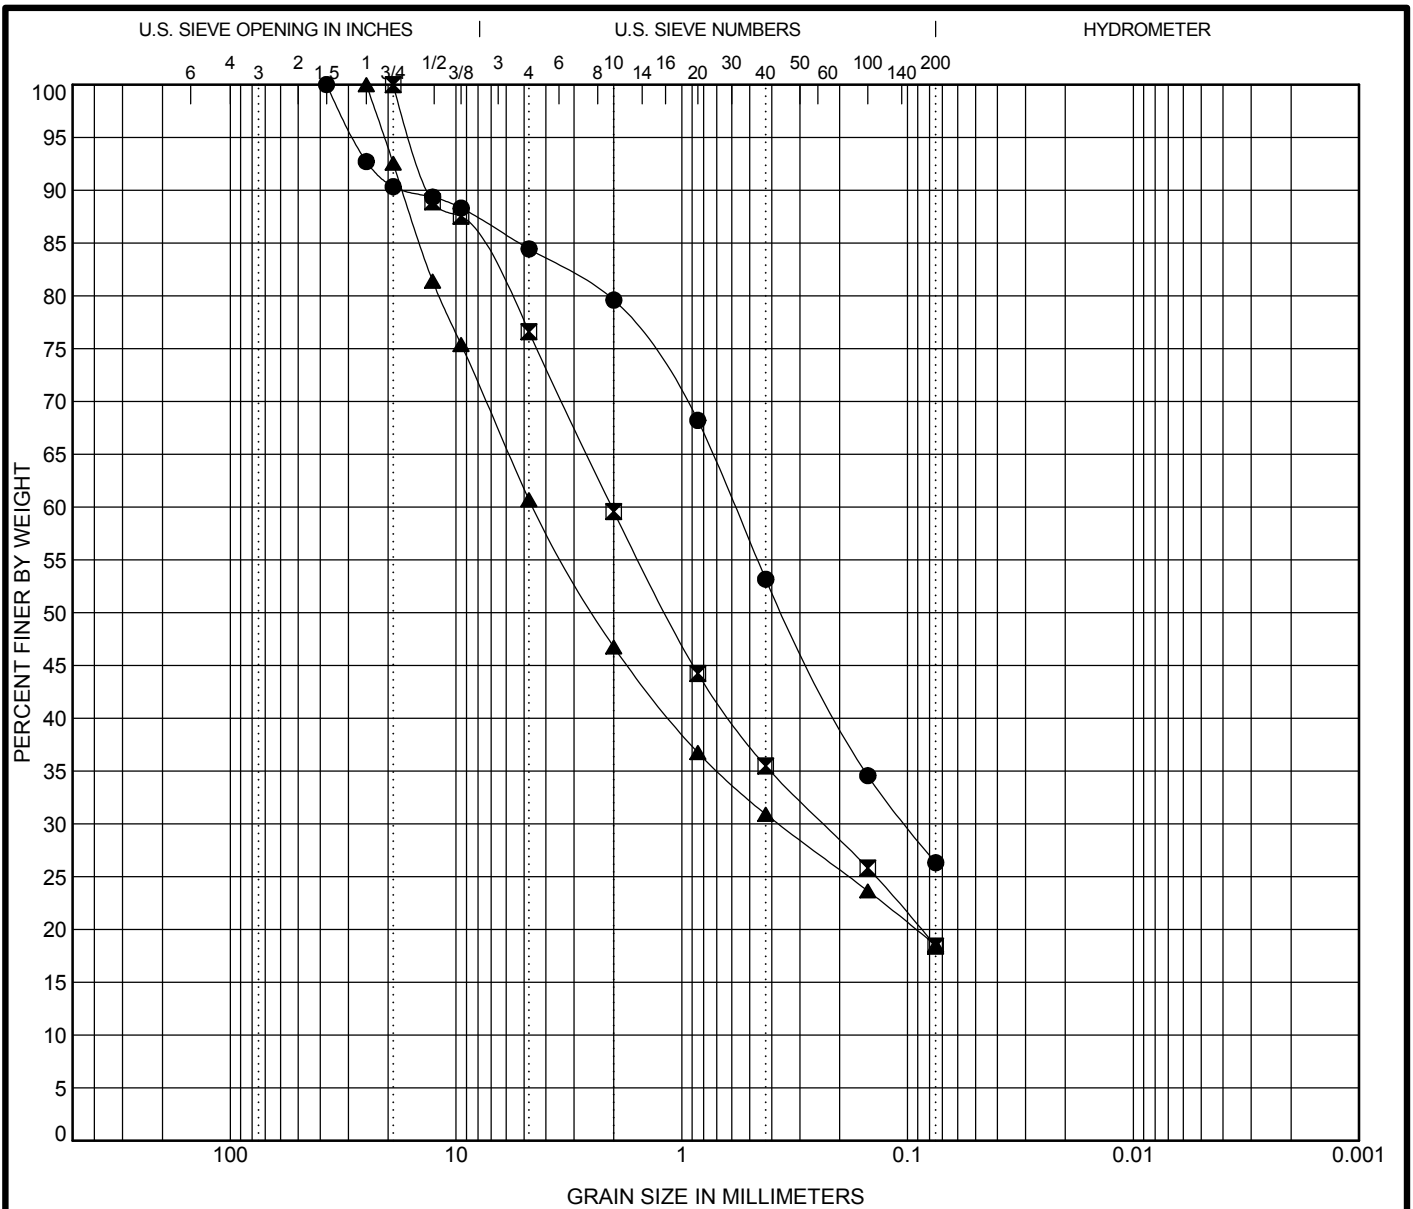
Three Sieve Analysis tests (ASTM C117 & C136) including four hydrometer tests [ASTM D422-63(2007)e2] were performed on selected soil samples to evaluate the gradation characteristics of the soils and to aid in soil classification. Graphic presentation of the grain size distributions is provided on Plate B-1.
