**HAZARDOUS MATERIAL SURVEY REPORT
FOR
KEKAHA KAI STATE PARK
IMPROVEMENT PROJECT
KONA, HAWAI'I**

**MNA PROJECT 1522_2
STATE PROJECT NO. H-87C836D**

JUNE 5, 2013

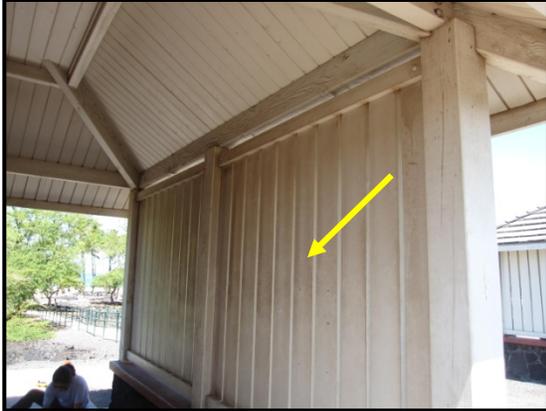
HM ID 1
Men's Restrooms
Floor 1

Exterior
White paint on wood wall.

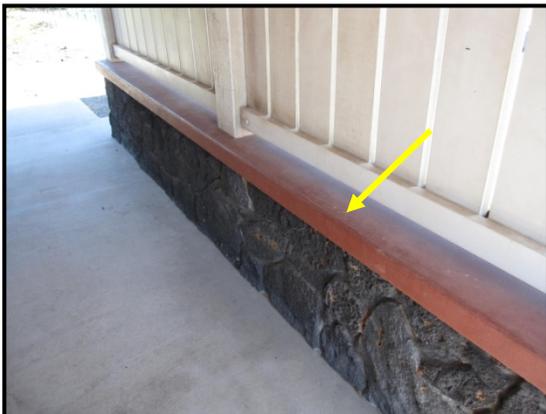
HM ID 3
Men's Restrooms
Floor 1

Exterior
Red paint on concrete ledge.

Non-LCP
1522-P3A: <960 mg/kg
1522-P3B: <450 mg/kg

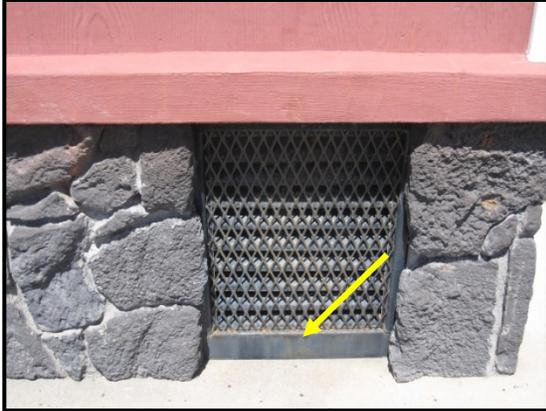
HM ID 4
Men's Restrooms
Floor 1

Exterior
Black paint on metal vent.

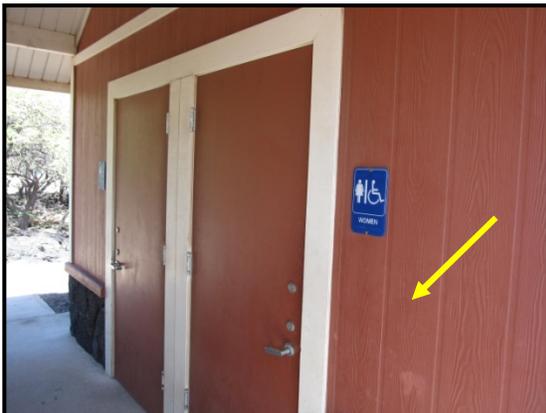
HM ID 6
Women's Restrooms
Floor 1

Exterior
Red paint on wood wall.

Non-LCP
1522-P5A: <100 mg/kg
1522-P5B: <100 mg/kg

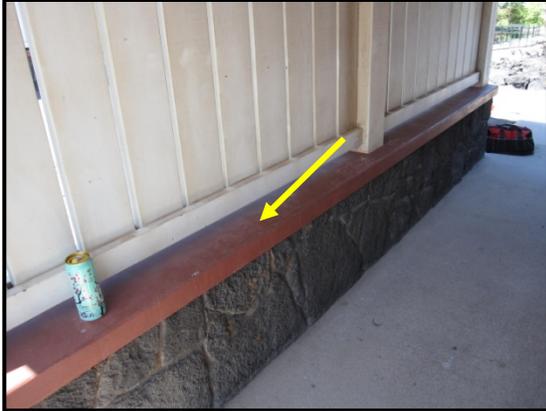
HM ID 7
Women's Restrooms
Floor 1
Exterior
Red paint on concrete ledge.

Non-LCP
1522-P6A: <100 mg/kg
1522-P6B: <100 mg/kg

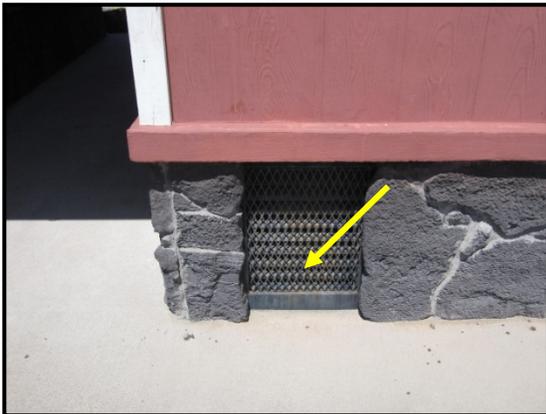
HM ID 8
Women's Restrooms
Floor 1
Exterior
Black paint on metal vent.

Material was not sampled as it is factory paint.
Assume LCP

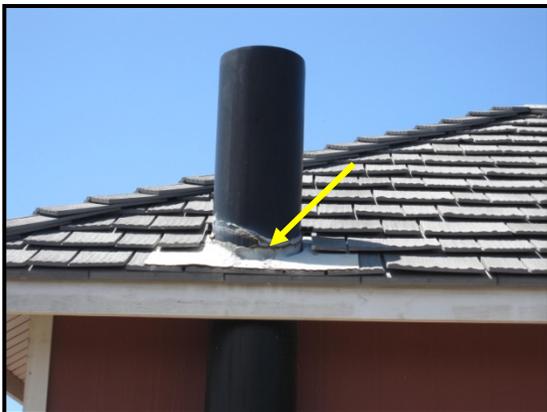
HM ID 12
Women's Restrooms
Roof

Roof
White caulking on wood roof.

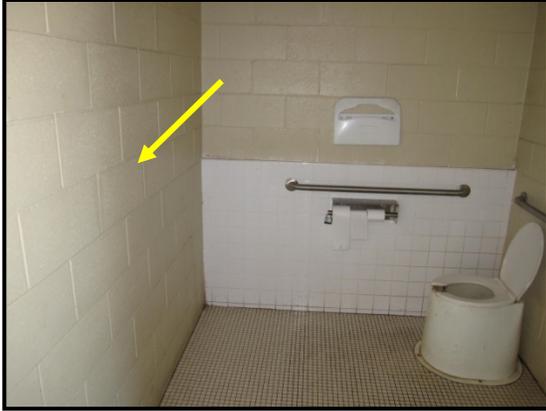
HM ID 13
Men's Restrooms
Floor 1

Men's Restroom 1
Off-white paint on concrete block wall.

Non-LCP
1522-P8A: <100 mg/kg
1522-P8B: <100 mg/kg

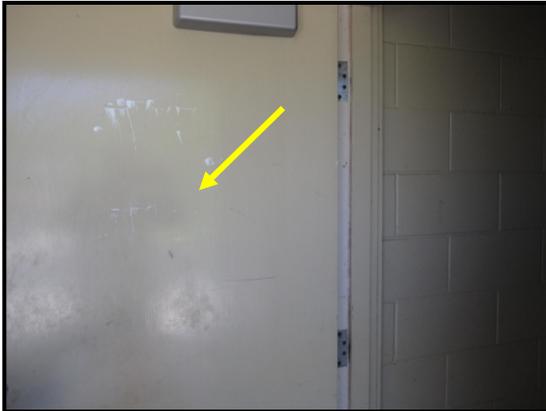
HM ID 14
Men's Restrooms
Floor 1

Men's Restroom 1
Off-white paint on wood door.

Non-LCP
1522-P9A: <390 mg/kg
1522-P9B: <200 mg/kg

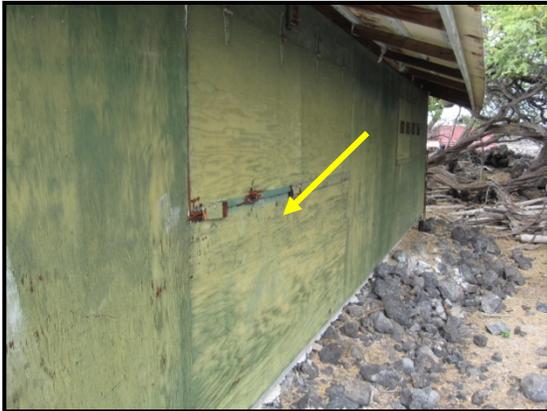
HM ID 23
House 1
Floor 1

Exterior
Light green paint on wood wall.

LCP
1522-P14A: 660 mg/kg
1522-P14B: 980 mg/kg

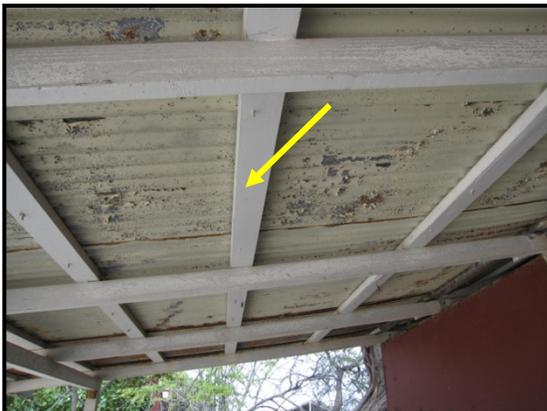
HM ID 24
House 1
Floor 1

Exterior
White paint on wood purlin.

LCP
1522-P15A: 330 mg/kg
1522-P15B: 360 mg/kg

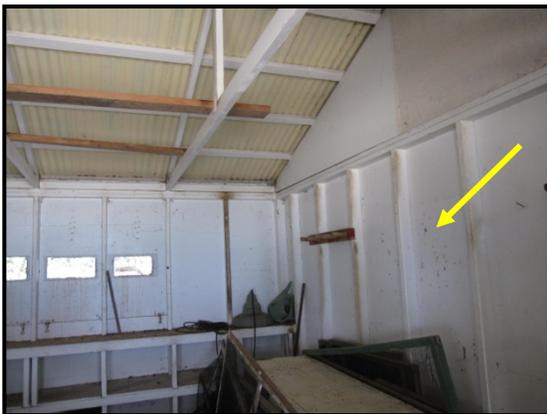
HM ID 27
House 1
Floor 1

Room 1
White paint on wood wall.

Non-LCP
1522-P18A: <220 mg/kg
1522-P18B: <190 mg/kg

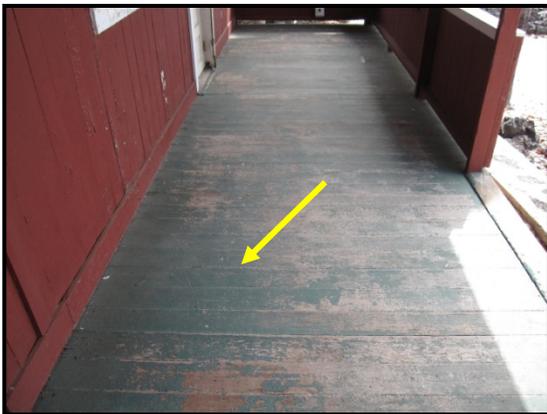
HM ID 33
House 2
Floor 1

Exterior
Green paint on wood floor.

LBP
1522-P23A: 39,000 mg/kg
1522-P23B: 6,900 mg/kg

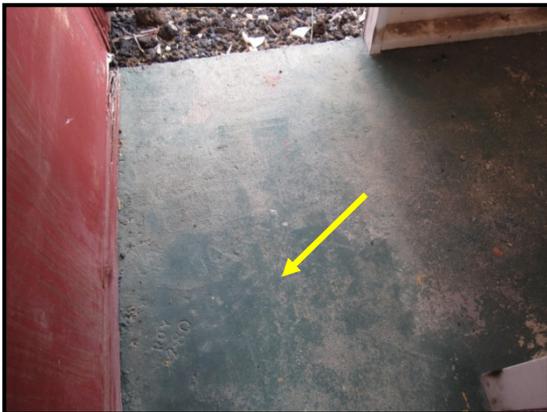
HM ID 36
House 2
Floor 1

Exterior
Green paint on concrete floor.

LCP
1522-P26A: 630 mg/kg
1522-P26B: 460 mg/kg

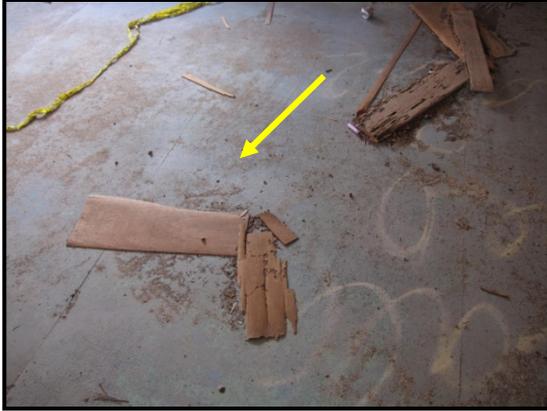
HM ID 38
House 2
Floor 1

Exterior
Light blue paint on fiberboard floor.

Non-Arsenic
1522-Ars1A: <10 mg/kg
1522-Ars1B: <10 mg/kg

LCP
1522-P28A: 770 mg/kg
1522-P28B: 610 mg/kg

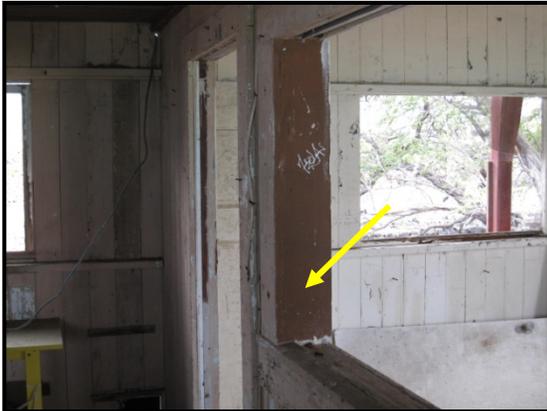
HM ID 39
House 2
Floor 1

Room 1
Brown paint on wood window frame.

LBP
1522-P31A: 2,100 mg/kg
1522-P31B: 13,000 mg/kg

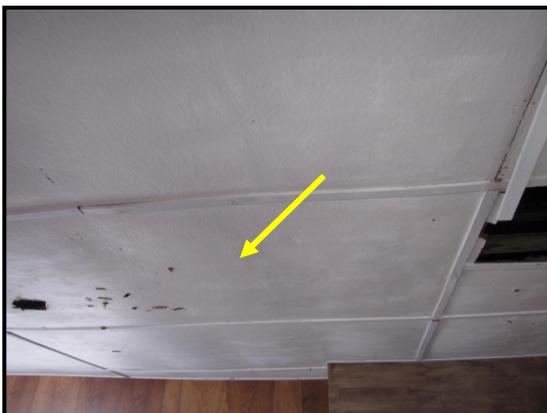
HM ID 40
House 2
Floor 1

Room 1
Off-white paint on fireboard ceiling.

Non-Arsenic
1522-Ars2A: <10 mg/kg
1522-Ars2B: <10 mg/kg

Non-LCP
1522-P30A: <100 mg/kg
1522-P30B: <100 mg/kg

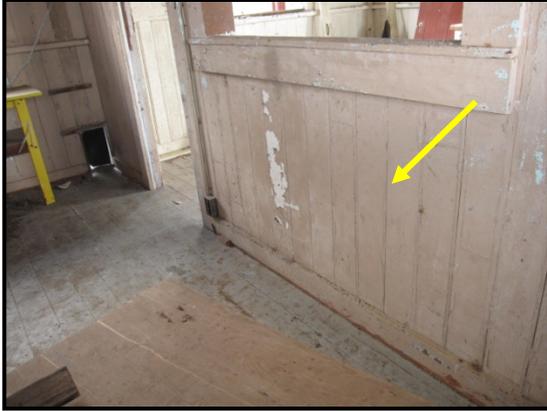
HM ID 41
House 2
Floor 1

Room 2
Beige paint on wood wall.

LBP
1522-P29A: 6,100 mg/kg
1522-P29B: 6,200 mg/kg

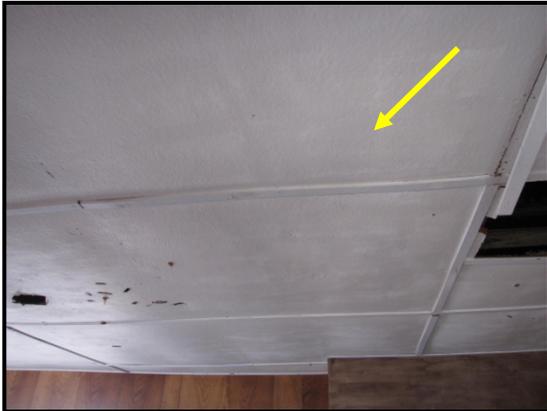
HM ID 42
House 2
Floor 1

Room 2
White paint on wood ceiling.

LCP
1522-P32A: 640 mg/kg
1522-P32B: 510 mg/kg

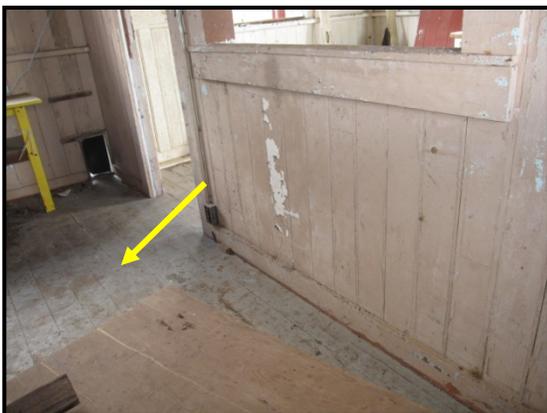
HM ID 43
House 2
Floor 1

Room 2
Light blue paint on wood floor.

LCP
1522-P33A: 760 mg/kg
1522-P33B: 1,300 mg/kg

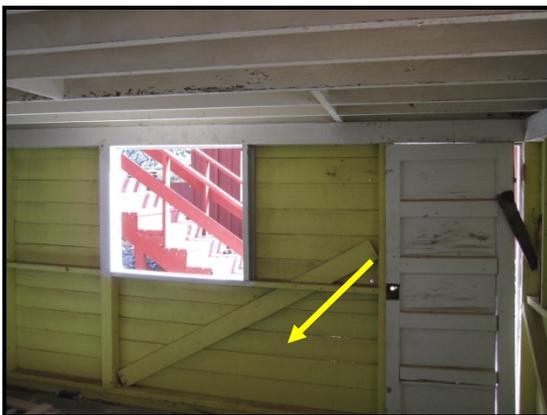
HM ID 49
House 3
Floor 1

Room 1
Yellow paint on wood wall.

LBP
1522-P39A: 84,000 mg/kg
1522-P39B: 99,000 mg/kg

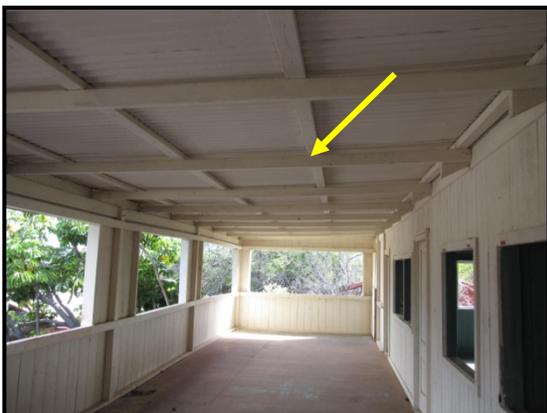
HM ID 52
House 3
Floor 2

Exterior
White paint on wood purlin.

LCP
1522-P42A: 1,400 mg/kg
1522-P42B: 1,800 mg/kg

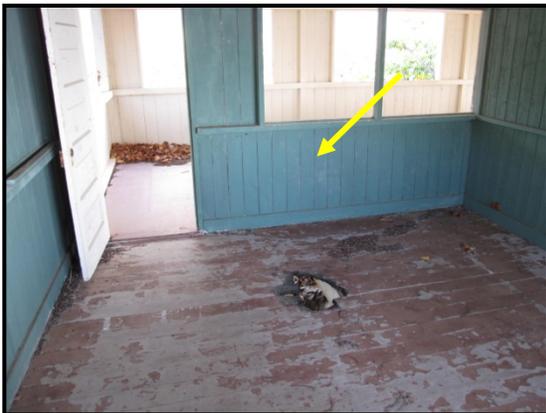
HM ID 55
House 3
Floor 2

Room 2
Green paint on wood wall.

LCP
1522-P45A: 860 mg/kg
1522-P45B: 1,200 mg/kg

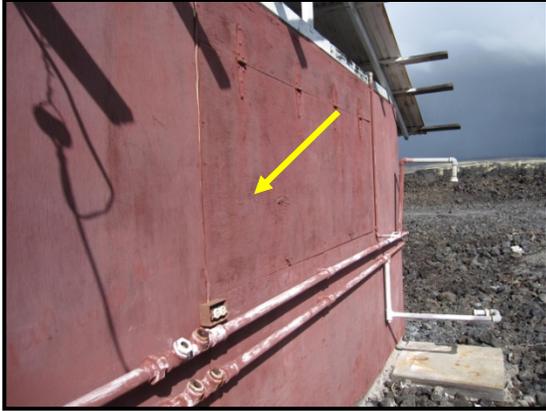
HM ID 56
House 4
Floor 1

Exterior
Red paint on wood wall.

LCP
1522-P46A: 480 mg/kg
1522-P46B: 530 mg/kg

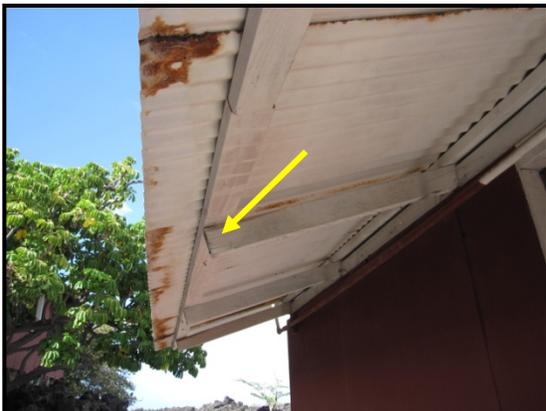
HM ID 58
House 4
Floor 1

Exterior
White paint on wood purlin.

LCP
1522-P48A: 490 mg/kg
1522-P48B: 400 mg/kg

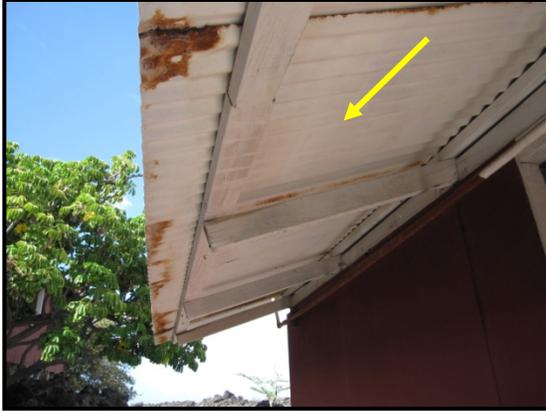
HM ID 59
House 4
Floor 1

Exterior
White paint on metal awning.

LCP
1522-P49A: 3,300 mg/kg
1522-P49B: 4,700 mg/kg

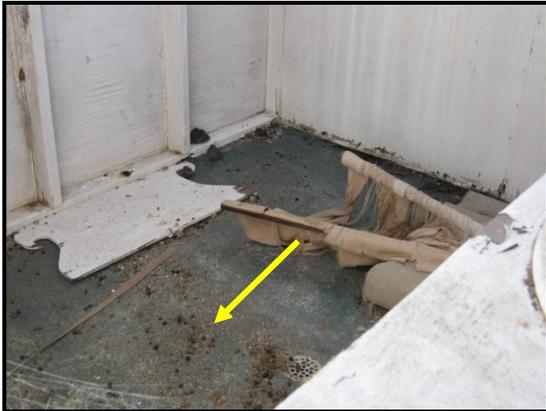
HM ID 60
House 4
Floor 1

Room 1
Green paint on concrete floor.

LCP
1522-P50A: 120 mg/kg
1522-P50B: 100 mg/kg

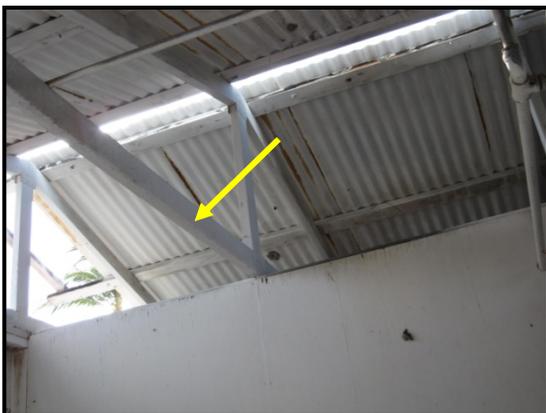
HM ID 61
House 4
Floor 1

Room 1
White paint on wood trusses.

LCP
1522-P51A: 450 mg/kg
1522-P51B: 850 mg/kg

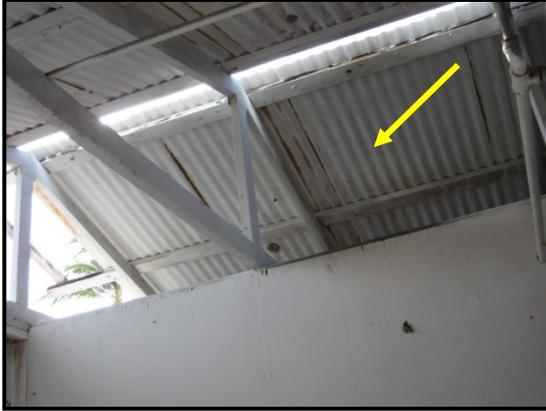
HM ID 62
House 4
Floor 1

Room 1
White paint on metal ceiling.

LCP
1522-P52A: 100 mg/kg
1522-P52B: <100 mg/kg

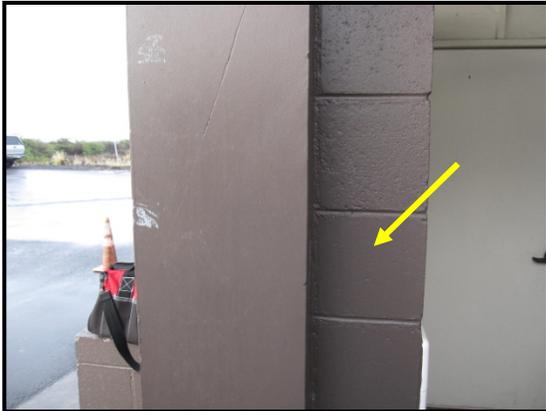
HM ID 63
Comfort Station
Floor 1

Exterior
Brown paint on concrete block wall.

Non-LCP
1522-P53A: <110 mg/kg
1522-P53B: <110 mg/kg

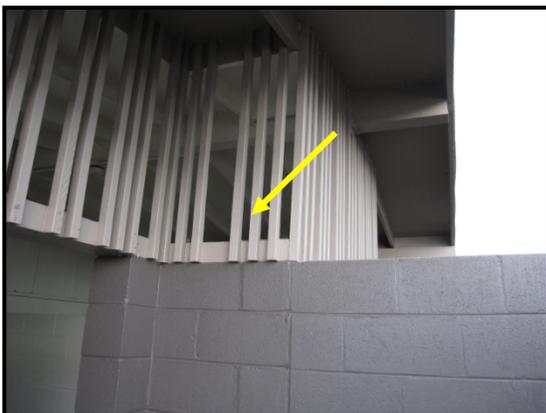
HM ID 64
Comfort Station
Floor 1

Exterior
Light brown paint on wood slat.

Non-LCP
1522-P54A: <110 mg/kg
1522-P54B: <110 mg/kg

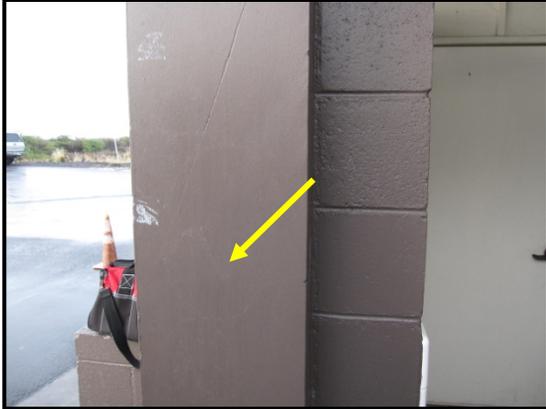
HM ID 65
Comfort Station
Floor 1

Exterior
Brown paint on concrete column.

Non-LCP
1522-P55A: <110 mg/kg
1522-P55B: <110 mg/kg

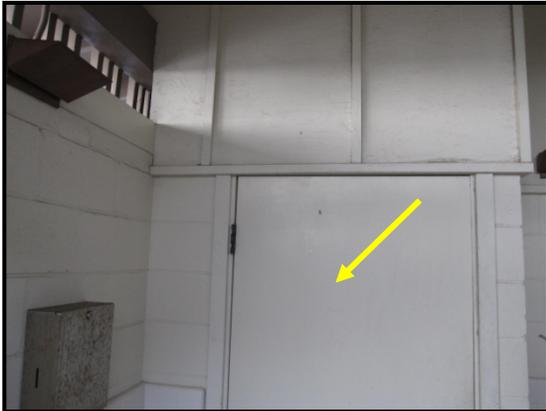
HM ID 66
Comfort Station
Floor 1

Men's Restroom
White paint on wood door.

Non-LCP
1522-P56A: <110 mg/kg
1522-P56B: <110 mg/kg

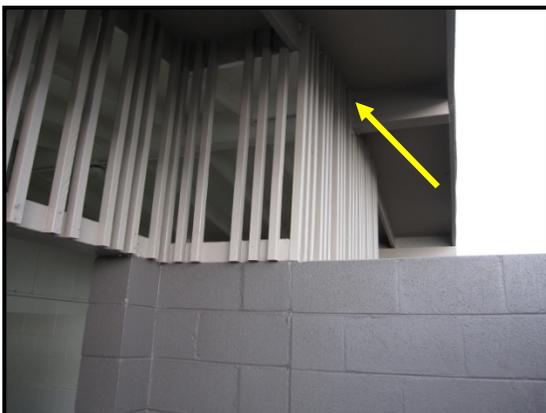
HM ID 67
Comfort Station
Floor 1

Exterior
White paint on metal clips.

Non-LCP
1522-P57A: <110 mg/kg
1522-P57B: <110 mg/kg

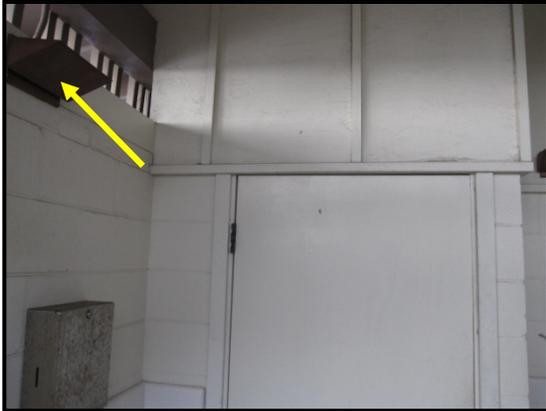
HM ID 68
Comfort Station
Floor 1

Men's Restroom
Brown paint on metal vents.

Non-LCP
1522-P58A: <110 mg/kg
1522-P58B: <110 mg/kg
